**Cell 1 Regional Coastal Monitoring Programme
Coastal Walkover Inspections 2010**

**Durham County Council
Final Report**

September 2010

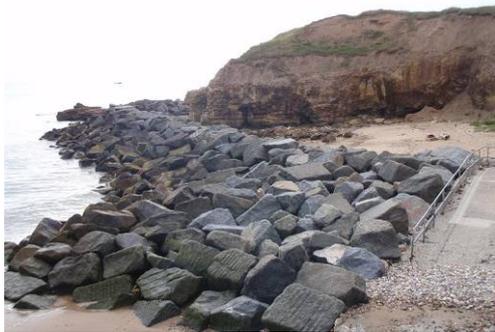
Around Featherbed Rocks, a rock revetment has been constructed extending around the headland and further south (below left). Where this structure stands proud of the toe of the cliff, some rockfalls and slumps in the softer material remain ongoing (slumps shown below right). In places this is releasing rubble down the cliff face.

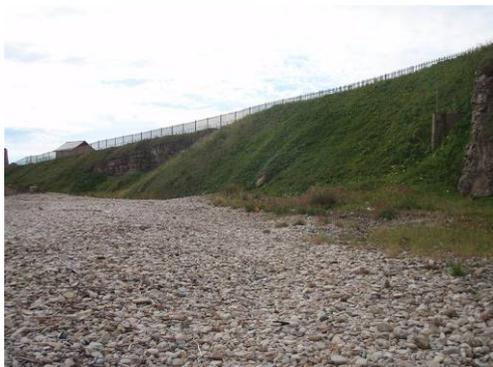
The cliffs in the small bay south of the access steps are well protected by high beach levels and are currently stable (below left). The landward end of North Pier, at Red Acre Point, has been reinforced with rock armour and although there appears to be some erosion to the landward end of this (below right), it is not worse than was recorded in 2008.

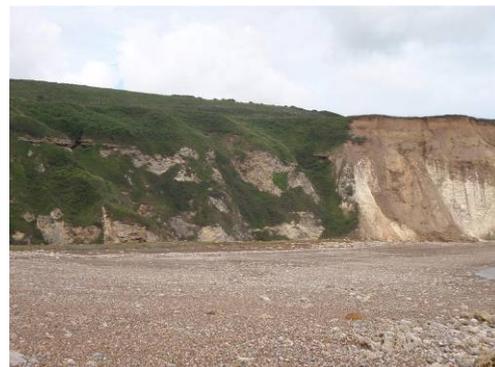
The colliery spoil beach at Shippersea Bay again provides protection to the backing cliffs (below left). There is a clear distinction (below right) at the northern end of the bay, just south of Beacon Point, between where colliery spoil protects the cliff and where the cliffs are unprotected.

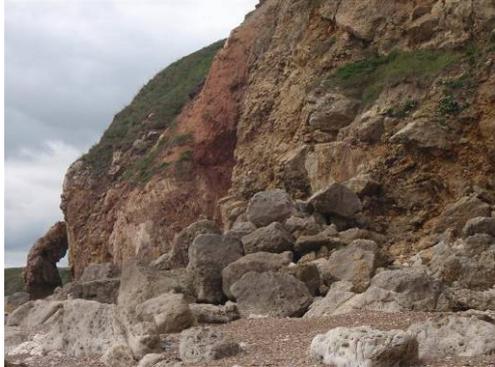
Around Shippersea Point the cliffs are subject to cave and arch formation at their base, with local rockfalls occasionally occurring (below left). The cliffs around Shot Rock and Loom are particularly active with rockfalls and there has been one large collapse from the upper cliff section (below right), resulting in fencing being erected near this susceptible cliff edge to locally divert walkers away from the cliff-top footpath.

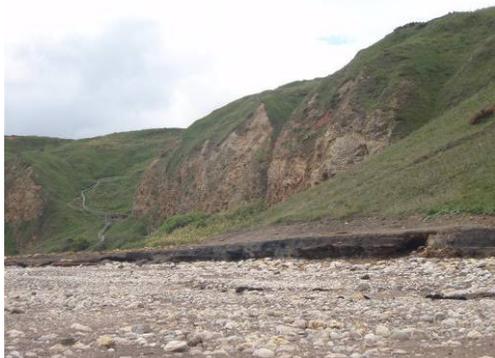
Between Loom and Fox Holes colliery waste again provides a protective beach (below left) but south from the outfall at Fox Hole Dene to Horden Point, the cliffs again are eroding through occasional slumps (below right).

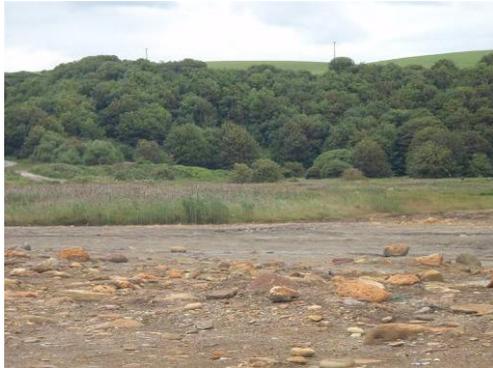
Several lagoons are also formed at the rear of the spoil beach, where levels are sufficiently high to prevent regular marine action (below left). There is one location where some outfall pipes are present on the lower foreshore, one of which is still discharging (below right), as well as some debris from a concrete structure.
