Walk-over Visual Inspections of Assets

**Hartlepool Borough Council
Final Report**

October 2012

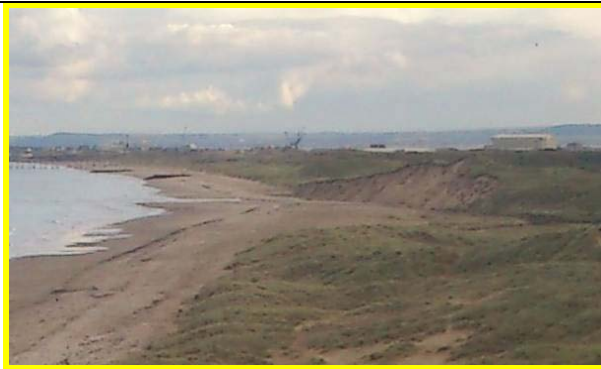
Crimdon beck in mid photo, showing steep eroding dune face where beck is close to toe. (Asset ref. No. 1221C901C0301C01)

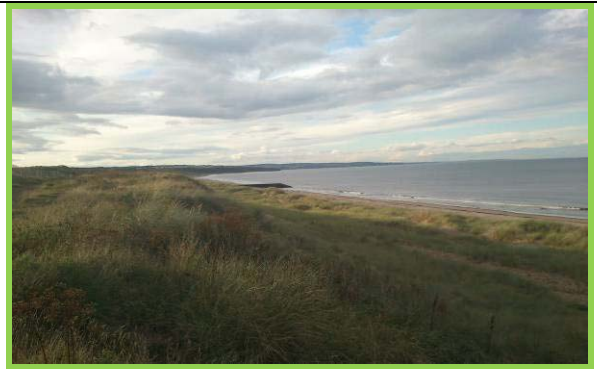
Looking north towards Crimdon from Britmag works, showing well vegetated dunes (Asset ref. No. 1221C901C0302C01)

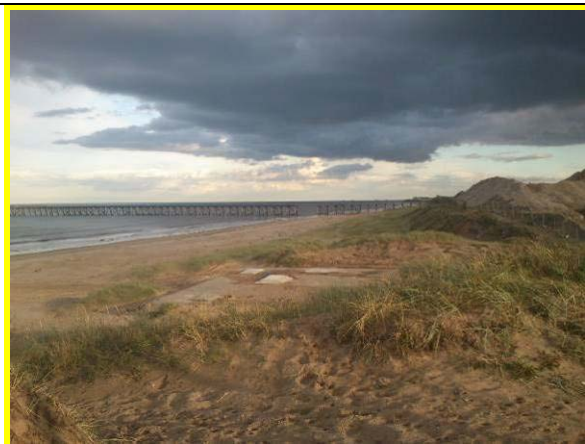
Wide beach at North Sands adjacent to former Britmag works (redevelopment underway). (Asset ref. No. 1221C901C0302C01)

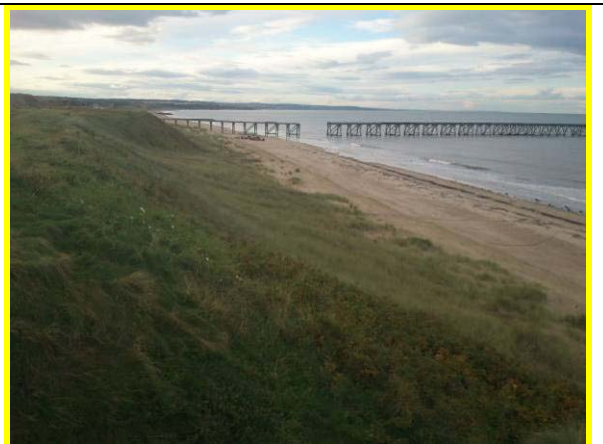
Looking north from Cemetery towards Britmag jetty showing low dunes in front of slag embankment (Asset ref. No. 1221C901C0302C01)

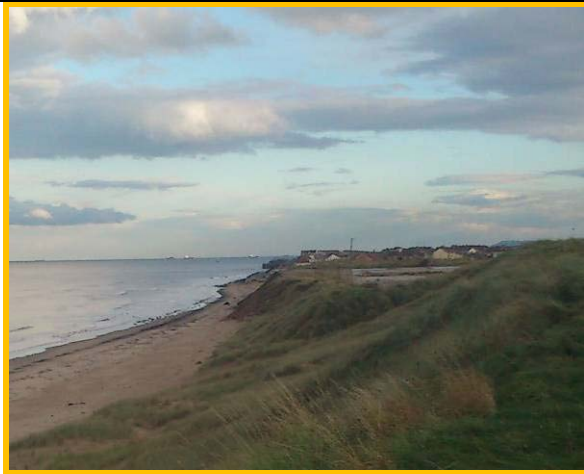
The frontage at the former Britmag works consists of a slag and rubble embankment fronted by sand dunes (above right). Moving south the embankment becomes higher and further seaward. East of Spion Kop cemetery the slag embankment is actively eroding in front of the former industrial site, see below left.

Eroding embankment east of cemetery in mid-distance (redevelopment underway).
(Asset ref. No. 1221C901C0302C01)

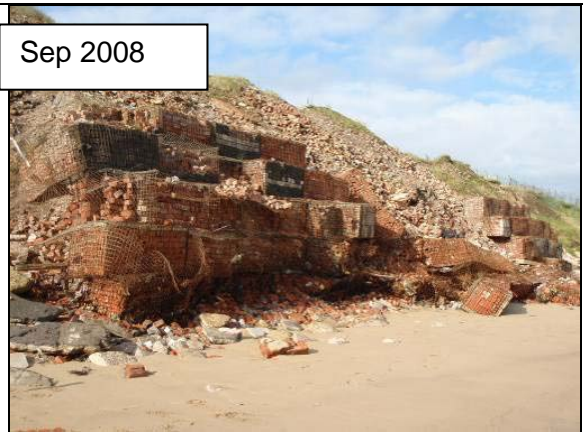
The slag embankment previously had a short, around 100m near vertical section (Asset ref. No. 1221C901C0302C02) protecting the cliff adjacent to a former large industrial building, that was protected by brick filled wire gabions, see photos from 2008 and 2010 below. Many of the failing gabion baskets were removed on health and safety grounds prior to the 2010 inspections and the asset now consists of a brick / waste rubble slope/revetment rather than the vertical structure observed in 2008 (above right).

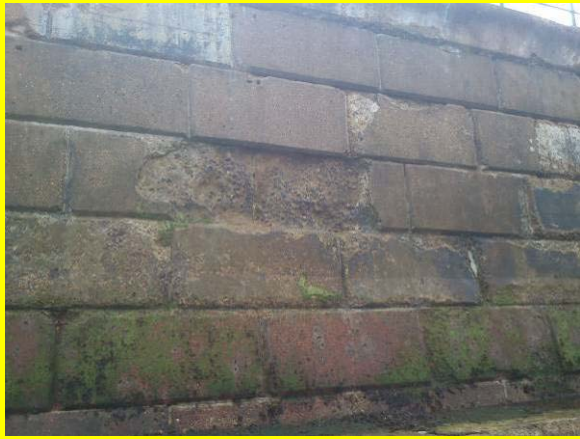
Further south east, the seawall fronting Sea View Terrace and the Town Moor (Asset ref. No. 1221C901C0303C02) is constructed from larger concrete blocks, see below upper left. Spalling of the concrete coping units was extensive (below lower right) and abrasion of the blockwork surface appeared to worsen to the south.

Loss of facing of concrete blocks. (Asset ref. No. 1221C901C0303C02)

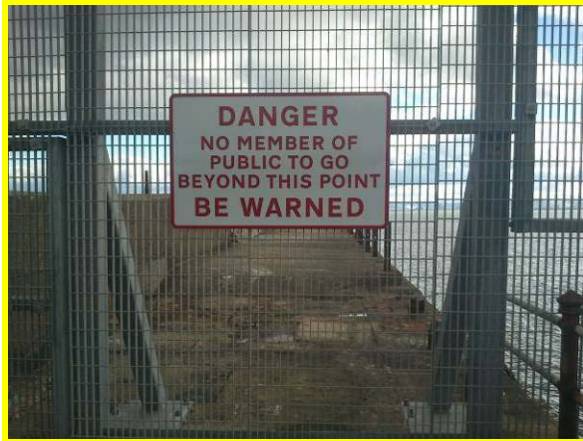
Only the landward section of the Heugh Breakwater, which is privately owned, is accessible to the public and so the seaward half was not inspected. The landward section appeared to be in fair condition with no obvious gaps in the blockwork. It is understood that the seaward end has been in a failing condition for many years. There is fencing and signs to prevent access to the seaward section, see below lower left.

Fencing and warning signs at mid length of breakwater. (Asset ref. No. 1221C901C0401C01)

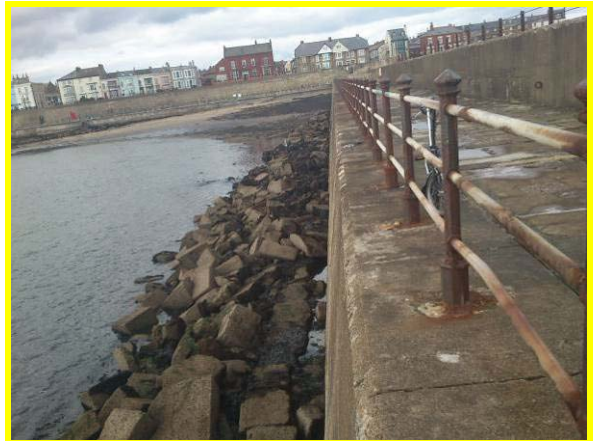
Armouring to toe of inner face of breakwater (Asset ref. No. 1221C901C0401C01)

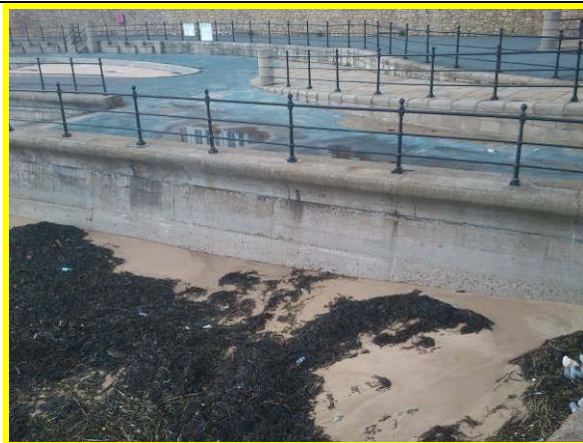
Block Sands seawall at north near Heugh Breakwater (Asset ref. No. 1221C901C0401C04)

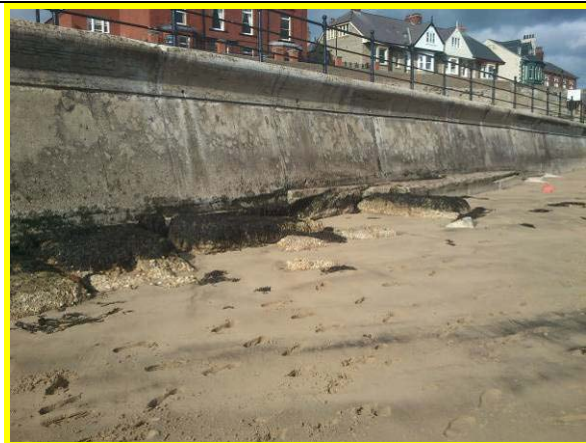
Bock Sands is located in the lee of the Heugh Breakwater and has a low wall in front of the reclaimed area containing Block Sands paddling pool and a larger set back retaining wall supporting the road and properties to the rear. The low beach levels were exposing the toe of the low front wall, particularly to the south and there were areas of undermining that require attention to prevent loss of infill and void formation, see below upper right and lower left.

Toe scour and undermining towards south of Block Sands wall. (Asset ref. No. 1221C901C0401C04)

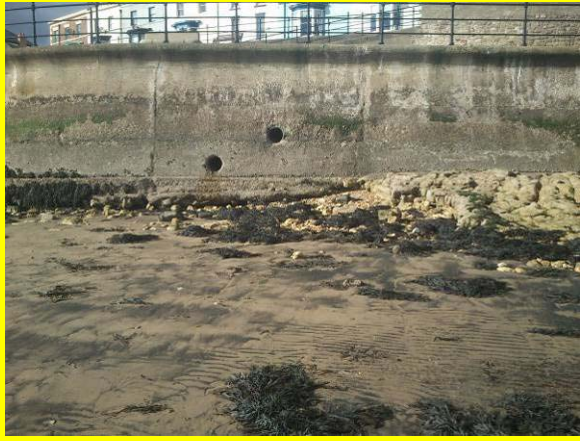
Low beach levels undermining wall near south of Block Sands reclamation.
(Asset ref. No. 1221C901C0401C04)

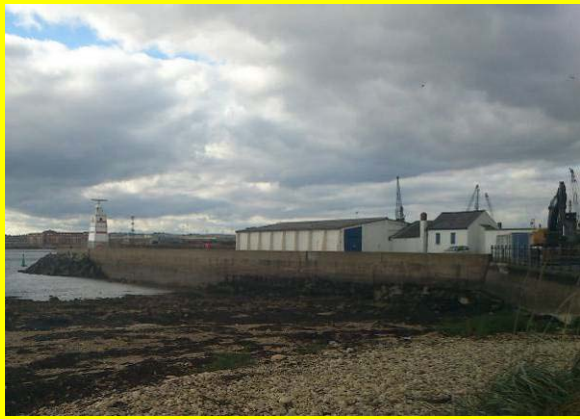
Old Pier, (Asset ref. No. 1221C901C0401C34) is a masonry and concrete breakwater with Accropode armour protection at the southern extent which provides shelter to Fish Sands and the Town Wall. The structure appeared in fair condition with minor settlement of blockwork observed on the inward face (below lower left). Armour units appeared in good condition with appropriate voids and interlock. There was cracking in the deck adjacent to wall and through the concrete parapet wall in a number of places, see below right. Some of the construction joints have opened, which may indicate settlement of the overall wall rather than simply damage to the parapet.

General view of Old Pier seaward side
(Asset ref. No. 1221C901C0401C34)

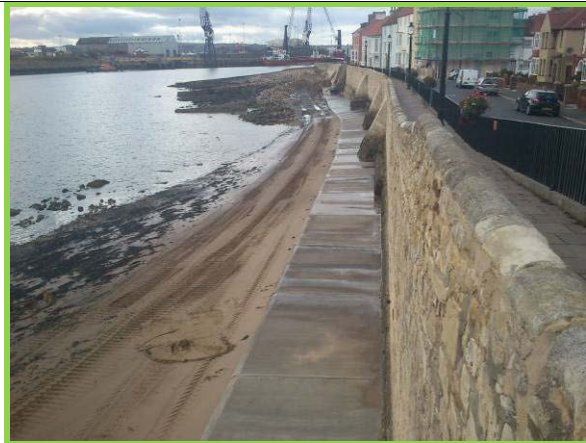
View of Town Wall from east end, showing new toe protection apron (Asset ref. No. 1221C901C0401C35)

The 2010 inspections noted that the low beach levels along the main part of the Town Wall to the west of the access gate had exposed the timber piles forming the foundation of the wall, and that undercutting below the concrete apron was evident throughout. The 2010 report recommended works to protect the toe of the wall, which is a Scheduled Ancient Monument, including grouting any voids at the base of the wall to prevent further deterioration. These works were underway during the October 2012 inspections, see photos above right and below left.

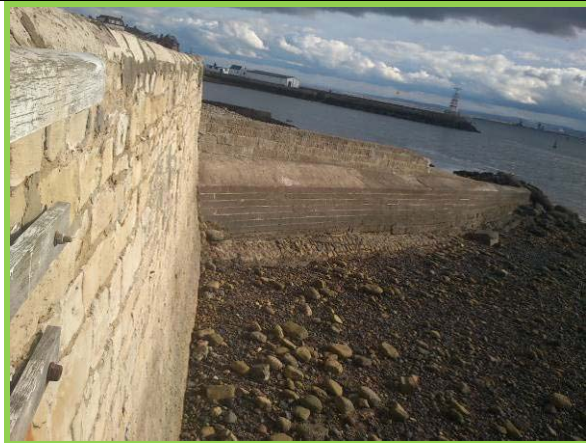
Large groyne structure near mid point of Town Wall marks large change in beach levels. (Asset ref. No. 1221C901C0401C35)

The paving stones and highway retained to the full length of the rear of the seawall appeared to be in very good condition. Beach levels increase from the gateway in the wall to the large masonry groyne at the slight headland near the mid point of the wall, above right. There is a large (2 to 3m) change in level of the (mainly cobble) beach either side of this groyne, with low beach levels extending fairly consistently to the west, see below left. The wall here appeared to be in fair condition and it is assumed that any minor defects such as open joints missing mortar will be made good as part of the ongoing works. At the western end of the frontage the redundant

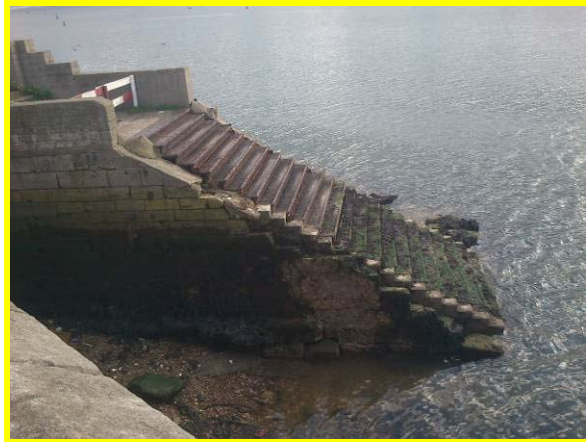
Steps at former passenger ferry landing at west end of town Wall,
(Asset ref. No. 1221C901C0401C35)

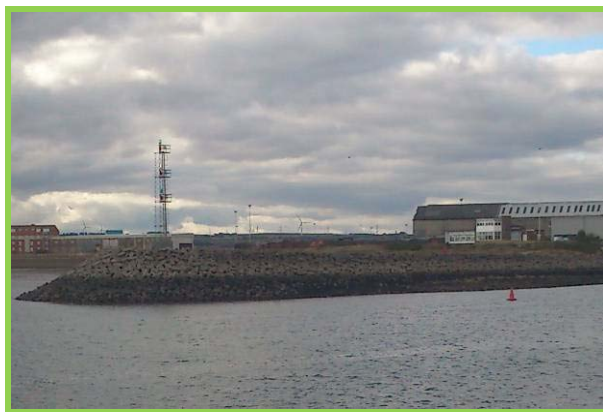
View of Accropode armoured breakwater.
(Asset ref. No. 1221C901C0401C16)

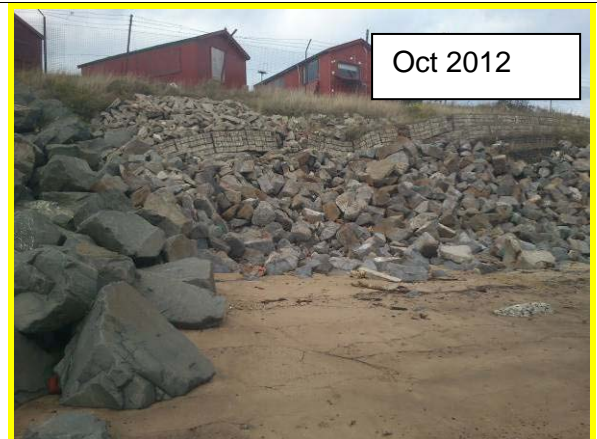
Adjacent to Middleton Jetty to the south is a gabion basket wall with a stepped profile, (Asset Ref. No. 1221C901C0401C17). The Gabion baskets (below left and right) are fronted by low sand dunes in the north and rock armour in the south. Rock armour units increased in size towards the south and appear to be performing well. The gabion baskets were reported to have settled locally in 2010 inspections and the situation appeared very similar in 2012, see photos below. The baskets were still largely intact although should be monitored as the wall could unravel rapidly should baskets fail. Consideration should be given to adding more rock armour, and reprofiling the rock in front of the failing gabions.

View of Gabion baskets with rock armour.
 (Asset ref. No. 1221C901C0401C17)

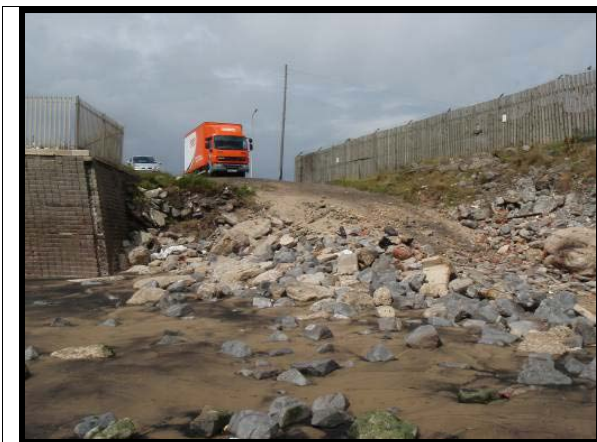
South of the rock armour, there is an informal access ramp to the beach, which is recorded as 'undefended' in NFCDD. Demolition waste rubble appeared to have been tipped informally, possibly to help resist erosion or to prevent / reduce public vehicle access onto the beach. The slope to the southern side of the access appeared to be less stable than that to the north, indicating potential for outflanking of the defences to the south if left unmanaged.

Photo from 2010 report.
 (Asset ref. No. 1221C901C0401C18)

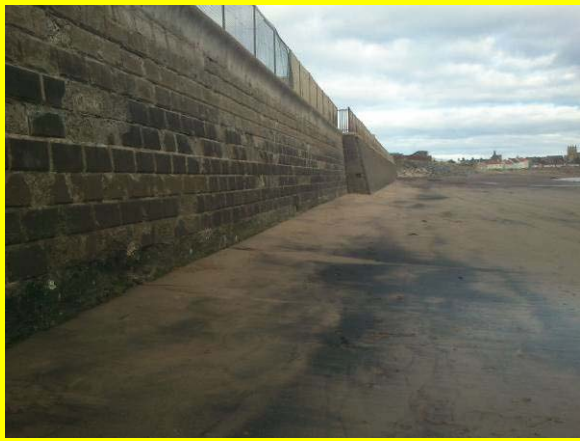
The near vertical wall to the south (Asset ref. No. 1221C901C0401C19) has two forms of construction, with the north eastern 2/3 a near vertical apparently loose stacked block / brick wall, whilst the south western 1/3 is an older vertical concrete block wall, see photos below. The eastern wall fronting the industrial property was in fair condition with similar defects to those noted in the 2010 inspection. There is local widening of construction joints, minor bulging and missing blocks from both front face and the coping. These defects should be repaired to prevent them spreading through the structure.

Older concrete block wall in foreground; newer slightly sloping smaller block wall in distance.
(Asset ref. No. 1221C901C0401C19)

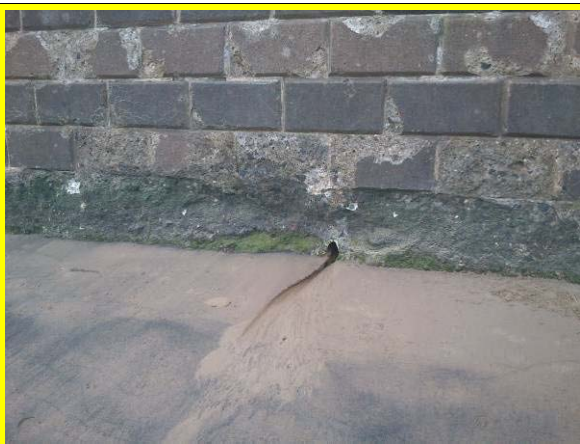
The concrete block wall to the south has extensive abrasion damage to the faces of the blockwork (below left), particularly at lower levels, see below left and right. Cracking of the concrete coping was also observed and there are a previous repairs to damage to the facing of the south facing section of wall that appears to be holding well.

Older concrete block wall in foreground; newer slightly sloping smaller block wall in distance.
(Asset ref. No. 1221C901C0401C19)

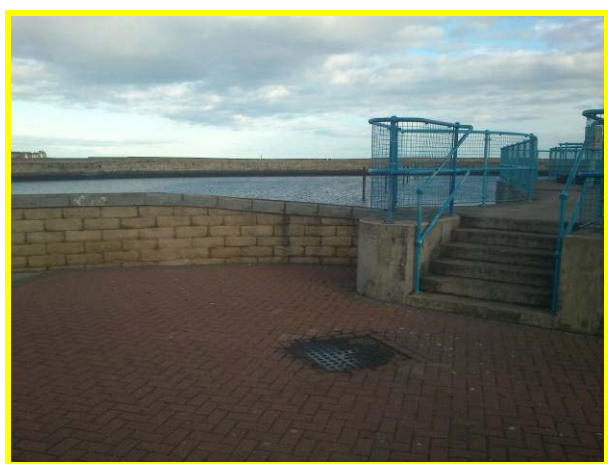
Flood wall tie into lock structure.
Asset ref. No. 1221C901C0401C22)

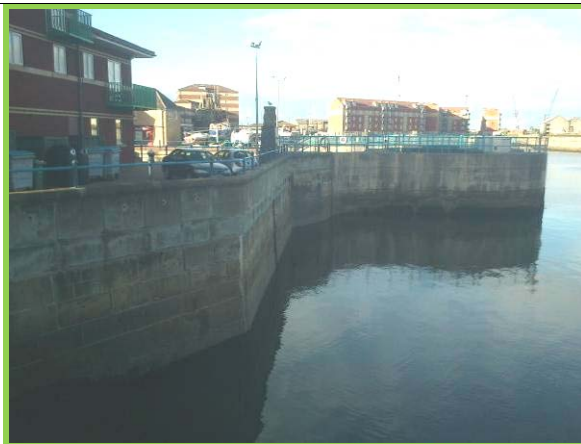
The concrete structures forming the lock entrance were in good condition, although water level prevented the inspection of the lower section of these walls. The toe apron of the short section of wall to the south of the lock, (Asset ref. No. 1221C901C0401C25) was covered in seaweed so not able to be inspected, but the wall itself is in good condition..

Wall to south side of lock entrance.
(Asset ref. No. 1221C901C0401C25)

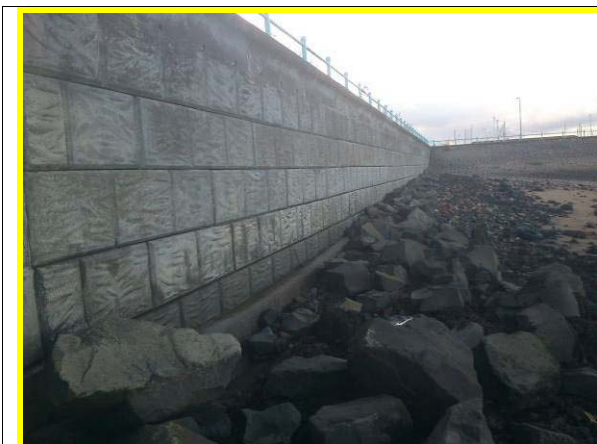
The vertical quay wall landward of Middle Pier, to the north of the Yacht Club was noted to have problems with undercutting at the steps and slipway from the yacht club in the 2010 inspections, see photo above right. The situation was similar in October 2012, with undercutting at the slipway, the steps and also at the wall between the steps and the slipway. The voids under the apron should be repaired and additional protective rock armour placed to reduce wave reflections and help avoid further scour damage.

Rock armour at toe of wall looking west from
steps (Asset ref. No. 1221C901C0401C27)

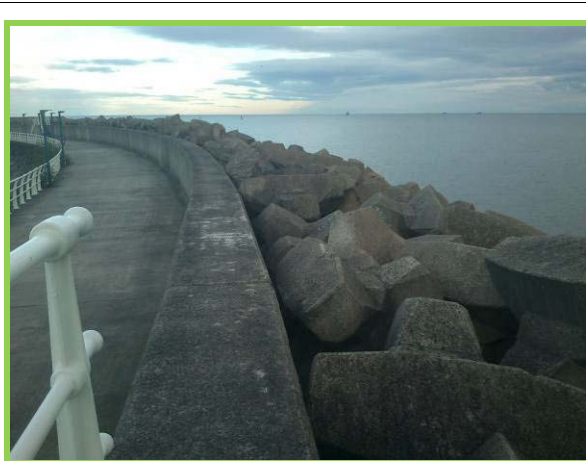
South Pier Accropode armour on outer face (Asset ref. No. 1221C901C0401C32)

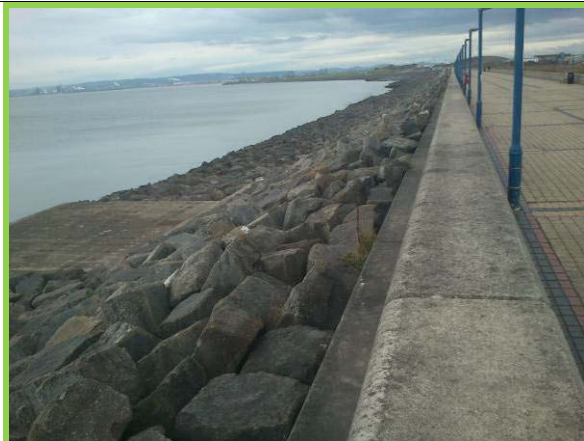
Rock armour defence in good condition to south of South Pier
(Asset ref. No. 1221C901C0401C33)

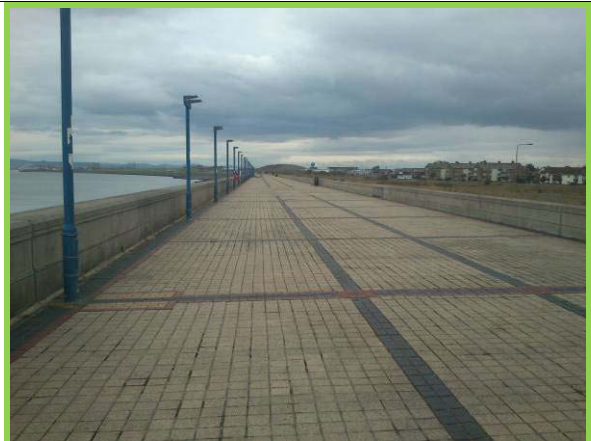
Promenade with crest wall to left and low flood wall to rear
(Asset ref. No. 1221C901C0401C33)

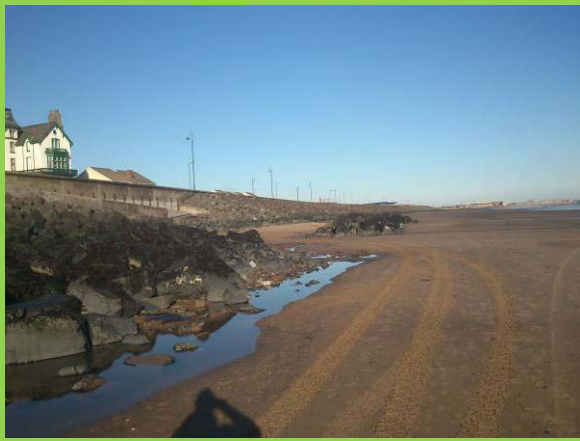
At Little Scar at the northern limit of Seaton Carew the concrete seawall is protected by rock armour. There is a rock beach control structure protecting the beach access ramp and rock armouring to the seawall toe, see below left and right. The rock beach control structures have been reconfigured since the 2010 aerial photographs as there is now a gap directly opposite the access ramp, whereas previously the rock structure was open only to the north.

Rock armour beach control structures near Little Scar (Asset Ref. No. 1221C901C0501C05 foreground, 1221C901C0401C33 in distance)

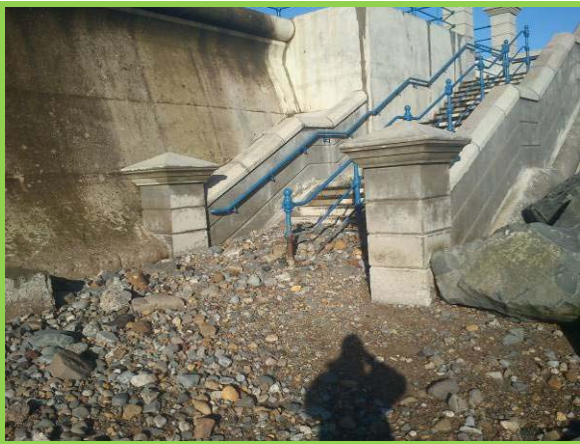
High cobble beach level adjacent to rebuilt northern steps. (Asset Ref. No. 1221C901C0501C05)

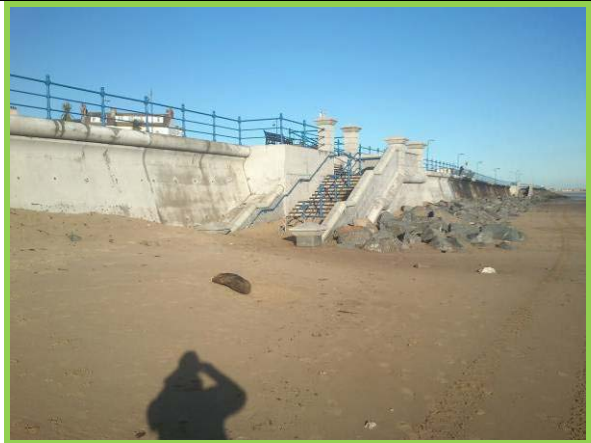
The beach access steps and adjacent sections of seawall that were noted to have significant defects in the 2008 and 2010 inspections have been reconstructed, with repairs to adjacent sections of wall and improvements to the promenade. The repairs to the coping and wall joints appear to be holding well. It was noted that a cobble beach has built up at the newly constructed southern set of access steps, making access difficult, see below centre left.

High sand levels at new southern set of steps, showing rebuilt section of wall next to new step structure. (Asset Ref. No. 1221C901C0501C05)

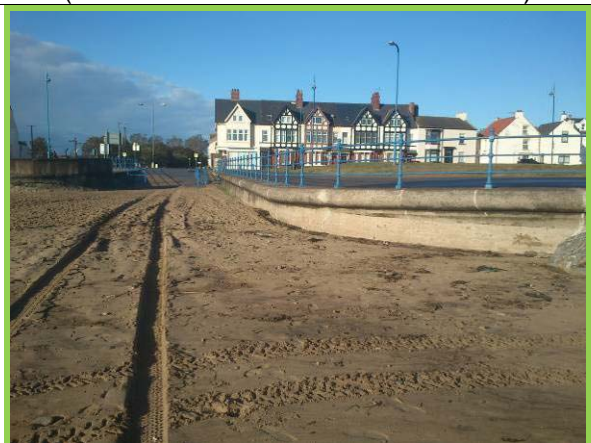
Beach access point at south end of main seawall. (Asset Ref. No. 1221C901C0501C05)

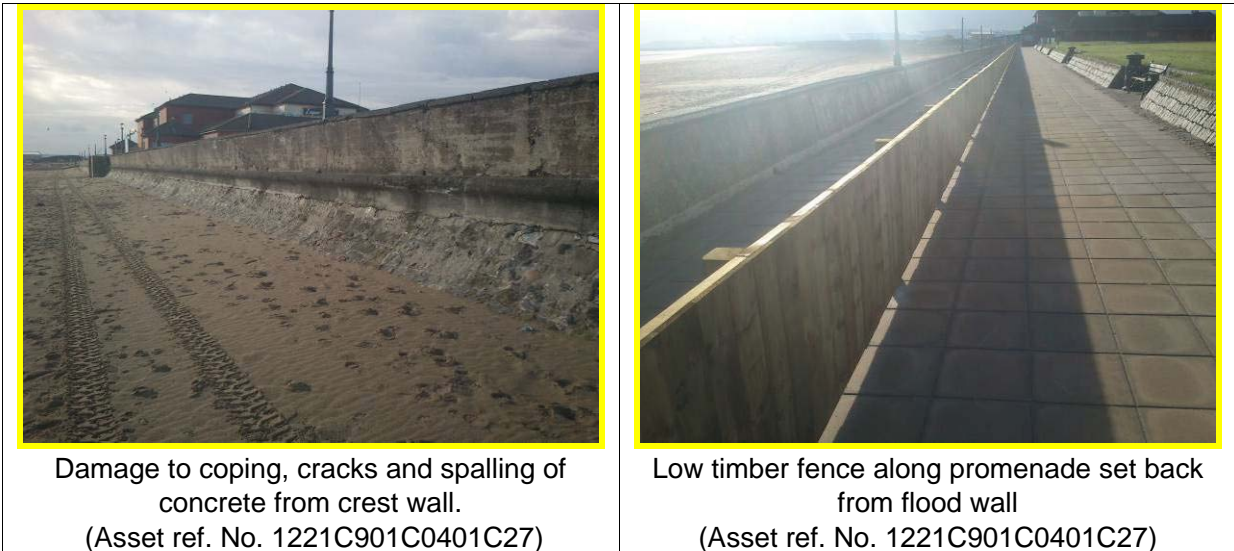
South of the beach access point the land levels are lower, but the seawall, Asset ref. no. 1221C901C0501C04 is fronted by a wide beach. This section of wall is in fair condition, with many of the defects noted in previous surveys still present. This includes abrasion of concrete exposing aggregate and reinforcement locally and spalling of concrete (particularly copings and

surrounding impact damage) (below left). A low timber fence had recently been constructed along the promenade (below right). It was not clear what the purpose of the fence was but it appeared to be intended to limit public access to the front wall.

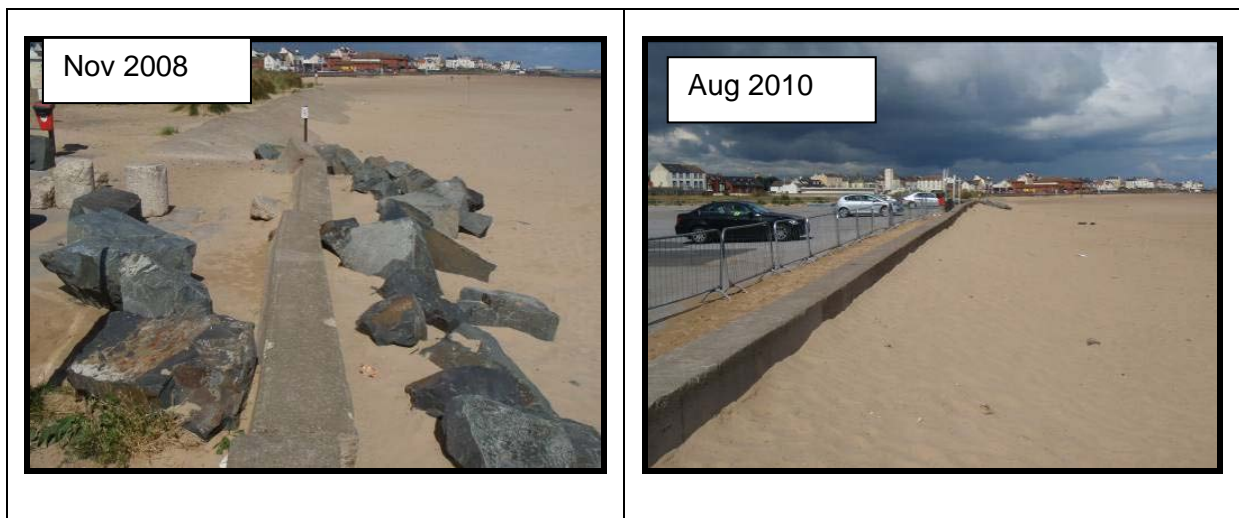
The low concrete wall at the public car park to the south of Seaton Carew (Asset ref. No. 1221C901C0501C02) was reported to have displaced sections of wall at the northern extent in 2008, with undercutting of the concrete apron. In 2010 the high beach levels were obscuring the defects. At the time of the 2012 inspections major works were being undertaken by the water company in the area and sections of the wall had been dismantled, see photographs overleaf, resulting the condition for the two assets in this area being reported as poor. Once the works have been completed it is recommended that the area is inspected to confirm that the coastal defences have been adequately reinstated and left in good condition by the contractors.

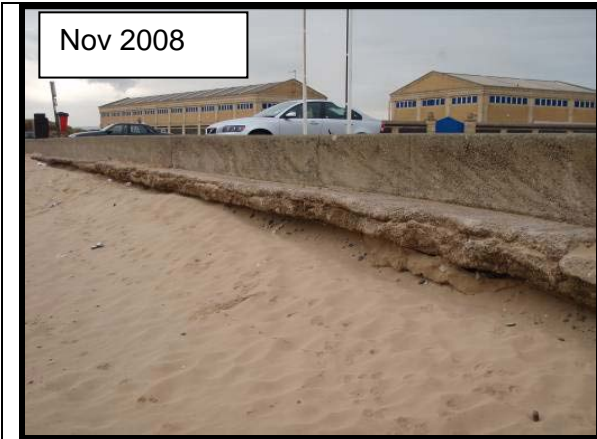
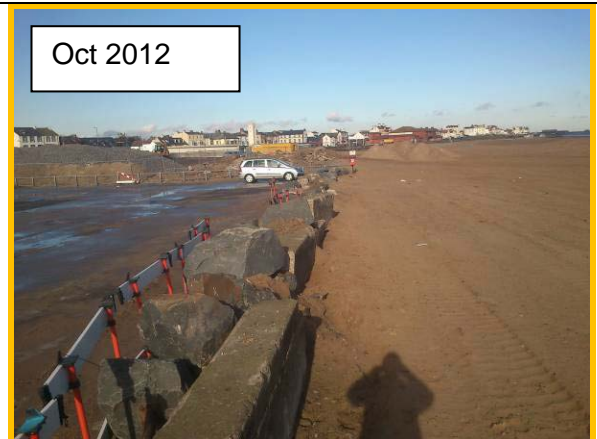
Section of wall at car park dismantled during ongoing water company works in area (Asset Ref. No. 1221C901C0501C03)

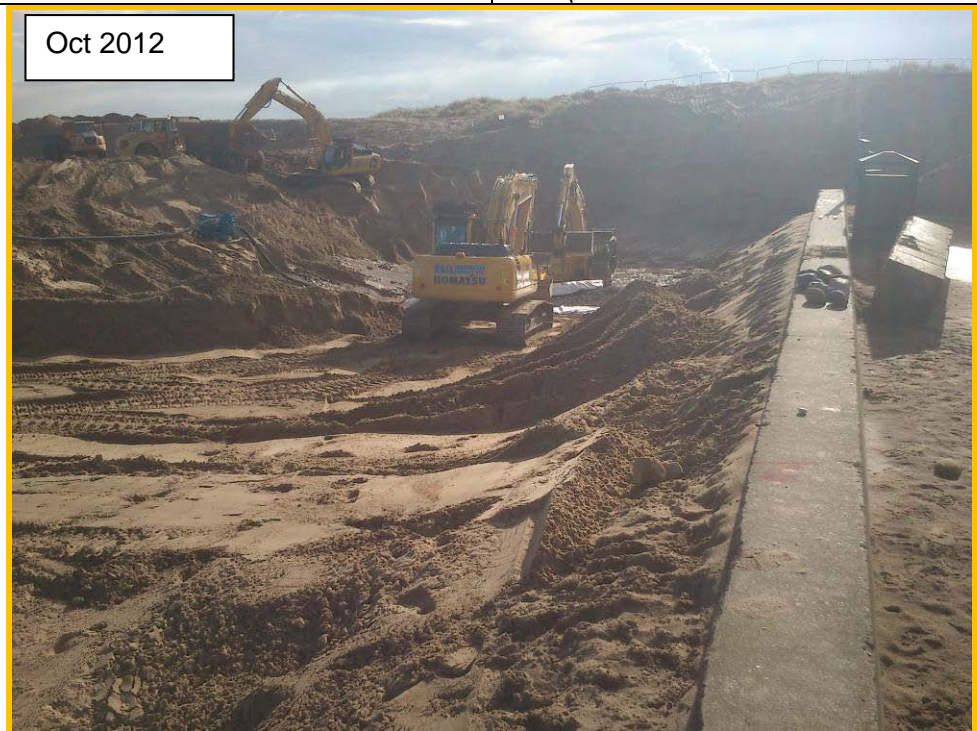
Works underway adjacent to low seawall at water treatment works. (Asset Ref. No. 1221C901C0501C02)

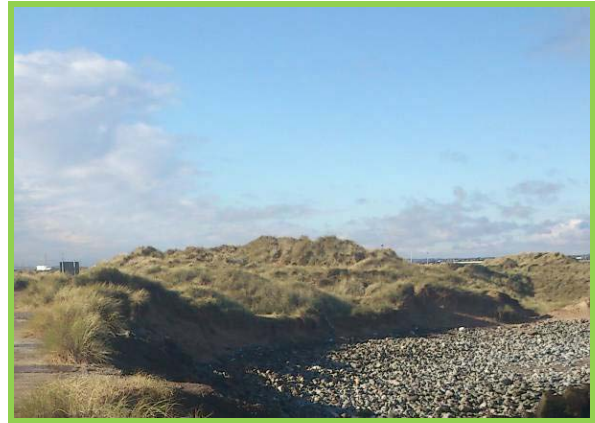
Localised cliffing of the dunes immediately north of North Gare, adjacent to rubble revetment placed to manage outflanking.
(Asset ref. No. 1221C901C0502C01)

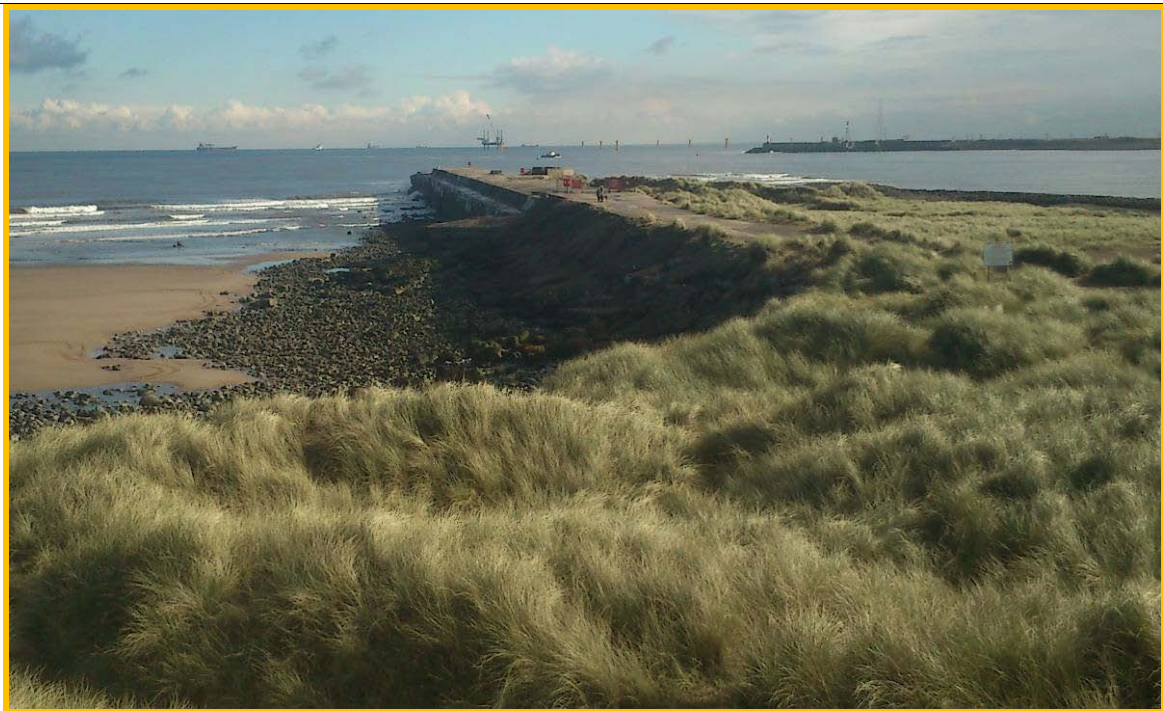
The North Gare Breakwater is a private structure at the entrance to the Tees, marking the southern extent of Hartlepool BC's coastal frontage. The massive structure stabilises the shoreline to the north, retaining the beach and dune system, but also provides shelter to the beach located in the lee to the south where a stable dune field has developed. As reported in 2008 and 2010 the structure remains in poor condition.

General view of North Gare breakwater.
(Asset ref. No. 1221C901C0502C01)

There remains a need for action at North Gare Breakwater which provides important shelter to the mouth of the River Tees and acts to retain Carr House Sands. The structure was recorded as poor condition in 2008 and had continued to deteriorate in 2010 and was in a similar state in 2012.

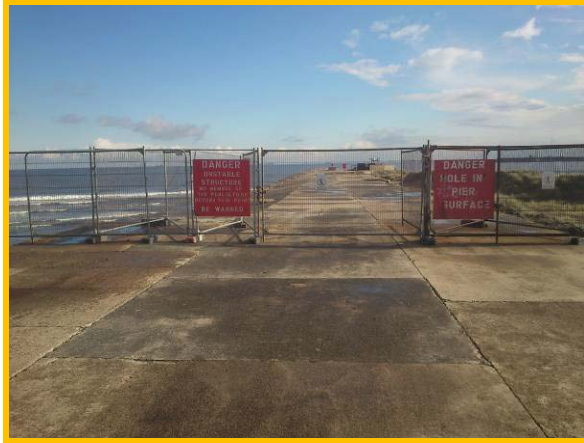
The structure remains in a dangerous condition with fencing and signs to deter members of the public from accessing the seaward section, see below left. However, it is fairly easy to walk past this fencing on the adjacent foreshore to the south of the breakwater, below right.

Fencing and warning signs on North Gare breakwater.
(Asset ref. No. 1221C901C0502C01)

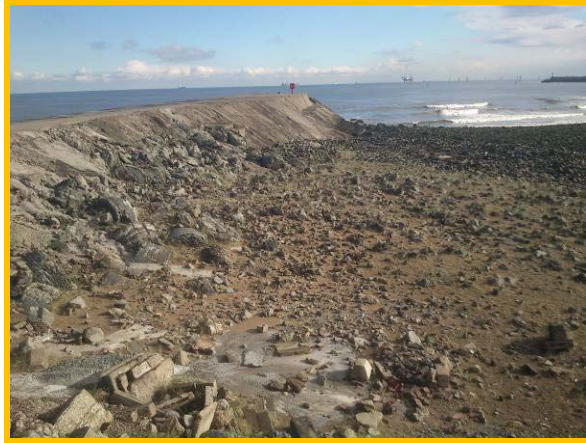
Rubble / slag beach to the south side of North Gare Breakwater.
(Asset ref. No. 1221C901C0502C01)
