## Walk-over Visual Inspections of Assets

**Hartlepool Borough Council  
Final Report**

**July 2014**

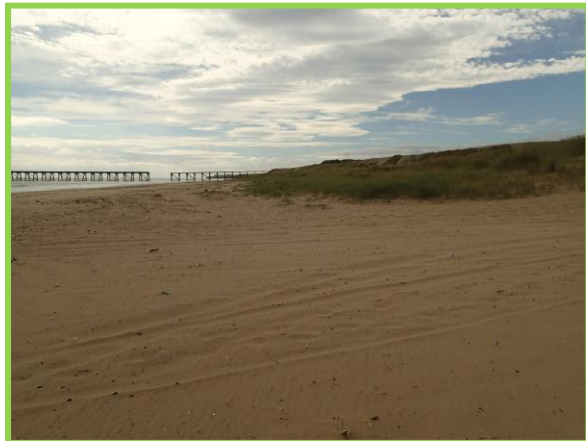
Wide beach at North Sands adjacent to former Britmag site.  
(Asset ref. No. 1221C901C0302C01)

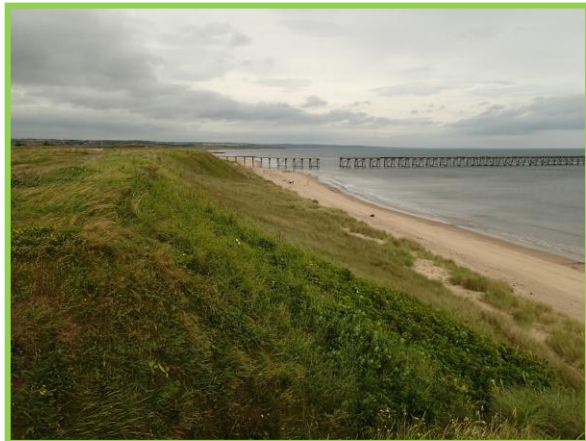
Looking north from Cemetery towards Britmag jetty showing low dunes forming in front of slag embankment  
(Asset ref. No. 1221C901C0302C01)

The frontage at the former Britmag works consists of a slag and rubble embankment fronted by sand dunes (above right). Moving south the embankment becomes higher and further seaward. East of Spion Kop cemetery the slag embankment is actively eroding in front of the former industrial site, see below.

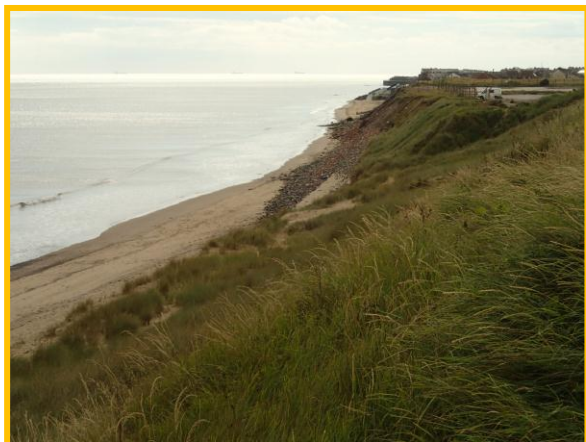
Eroding embankment east of cemetery in mid-distance.  
(Asset ref. No. 1221C901C0302C01)

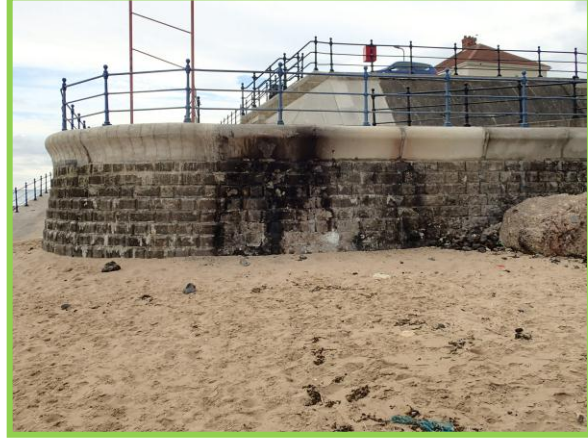
Seawall at return end (Asset ref. No. 1221C901C0303C01)

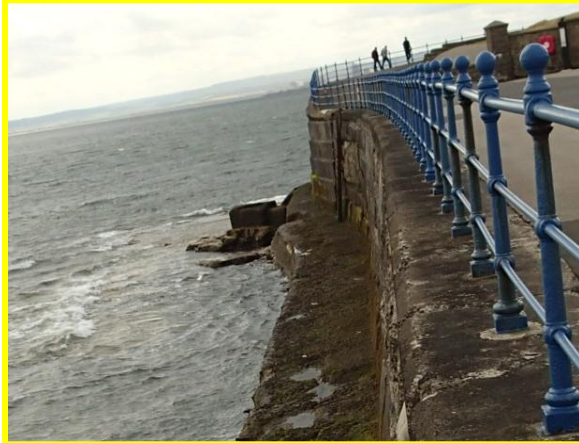
The short length of wall at the apex of the headland (Asset ref No. 1221C901C0303C03) near the Coastguard building, below left, has a slightly stepped profile to the concrete blocks. Previous repairs to the capping beam are showing further damage. There have been extensive previous repairs and as the area around here is the most exposed section of defence there is a need for regular ongoing maintenance.

Stepped wall at apex of Headland.(Asset ref. No. 1221C901C0303C03)

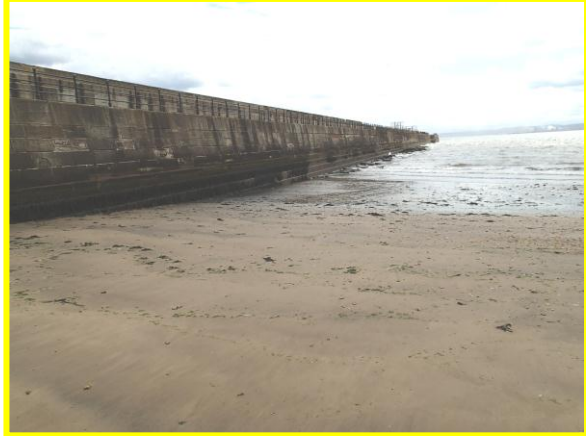
South side of landward end of Heugh breakwater (Asset ref. No. 1221C901C0401C01)

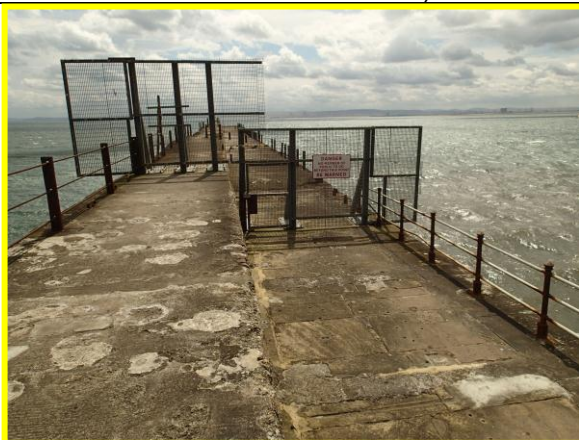
Fencing and warning signs at mid length of breakwater. (Asset ref. No. 1221C901C0401C01)

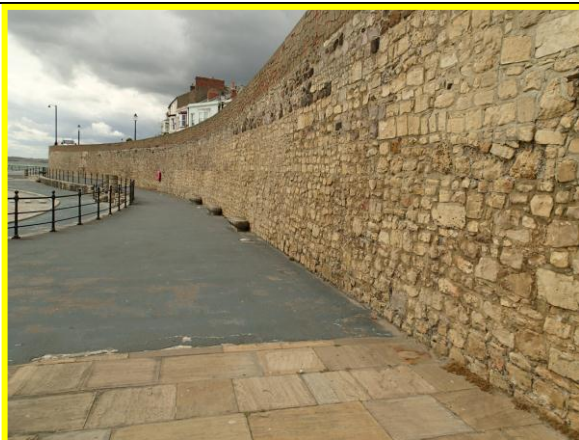
Rear retaining wall at Block Sands.  
(Asset ref. No. 1221C901C0401C04)

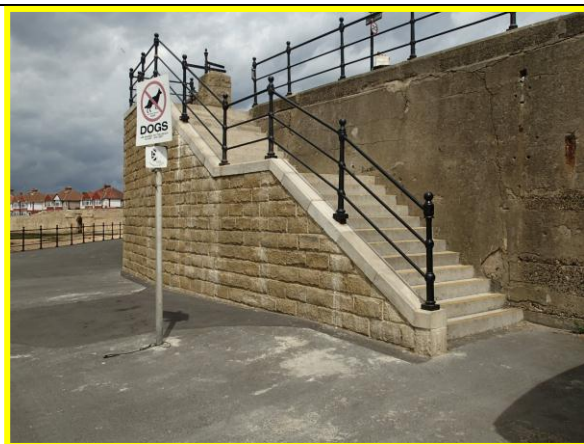
New steps at west end of rear retaining wall, (Asset ref. No. 1221C901C0401C05)

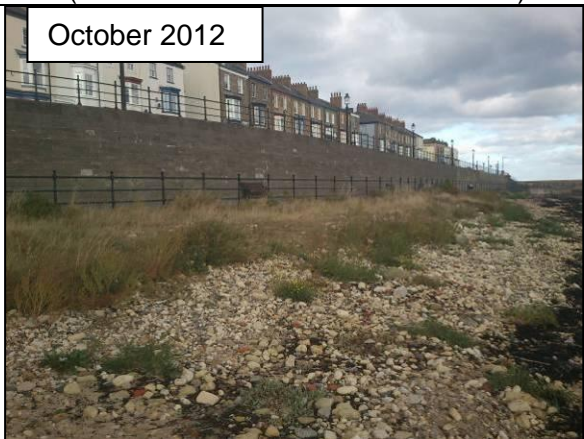
High cobble beach at mid-length of wall (Asset ref. No. 1221C901C0401C05)

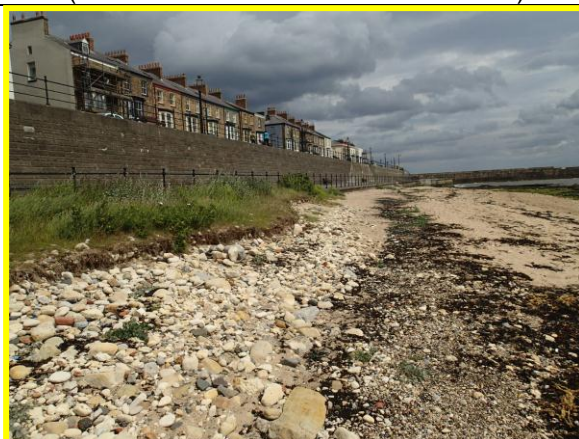
Erosion at edge of cobble beach (Asset ref. No. 1221C901C0401C05)

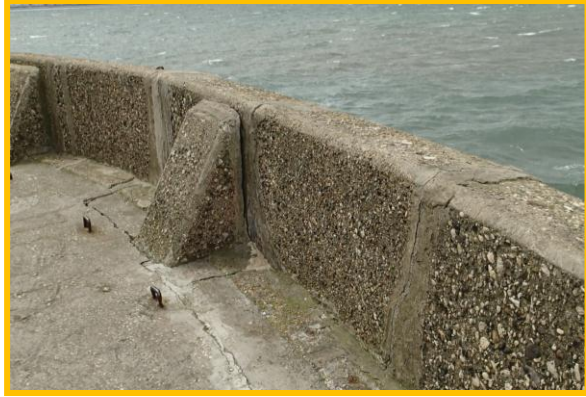
Old Pier, (Asset ref. No. 1221C901C0401C34 and C06) is a masonry and concrete breakwater with Accropode armour protection at the south western extent which provides shelter to Fish Sands and the Town Wall. The larger building that was on the pier has been demolished and the pier concrete surface replaced where it was removed. New handrails have also been placed along the previously unprotected north side. The structure appeared in generally fair condition with minor settlement of blockwork observed on the inward face (below lower left). Armour units appeared in good condition with appropriate voids and interlock. There was cracking in the deck adjacent to wall and through the concrete parapet wall in a number of places, see below right. This was seen in 2010 and although repairs have been undertaken the cracking has opened again in some locations, notably at the seaward end where the crest wall is leaning seawards, below right. As previously noted in 2012 the cracking may indicate settlement of the overall wall rather than simply damage to the parapet.

Cracks through deck and crest wall.  
(Asset ref. No. 1221C901C0401C34)

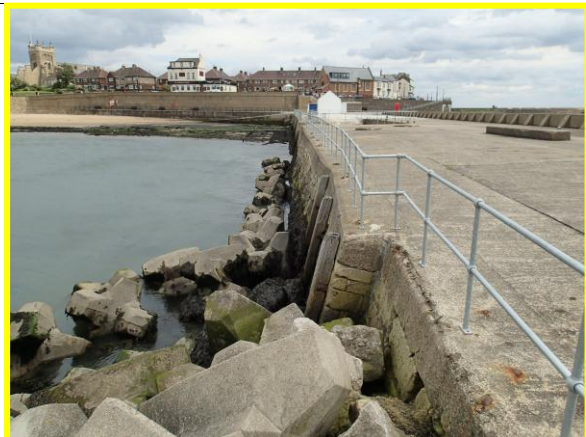
Landwards side of pier showing new handrails.  
(Asset ref. No. 1221C901C0401C06)

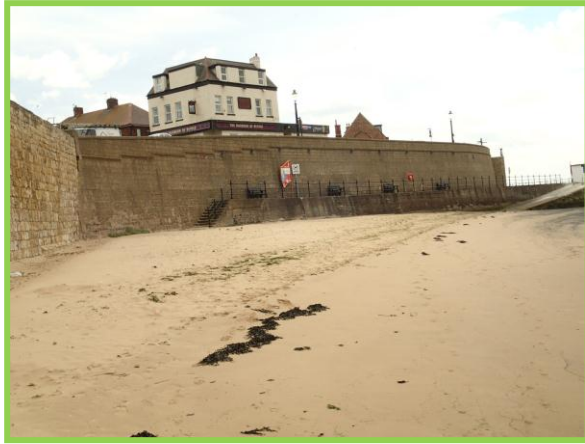
Masonry wall at south east end of Town Wall.  
(Asset ref. No. 1221C901C0401C35)

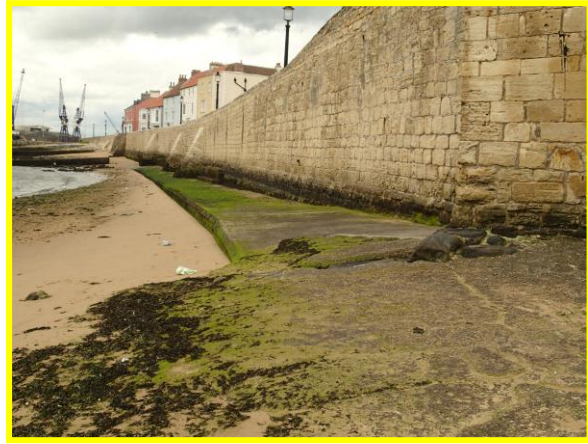
View of Town Wall from east end, showing new toe protection apron (Asset ref. No. 1221C901C0401C35)

The toe protection apron constructed in 2012 appeared to be performing well. However, although three of the groyne had been repaired the beach remains low. The channel seawards of the beach toe is probably dredged for access to the harbour and so there is no supply of sand to this beach and any storm draw-down will be lost into the channel. It is suggested that coarse sand recharge could be considered, and it may be beneficial to extend the groyne back to the seawall to help retain a recharged beach.

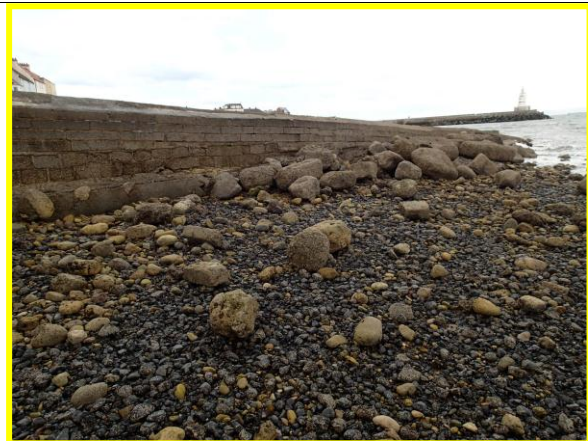
Large groyne structure near mid point of Town Wall marks large change in beach levels, cobble slag beach on west side in foreground.  
(Asset ref. No. 1221C901C0401C35)

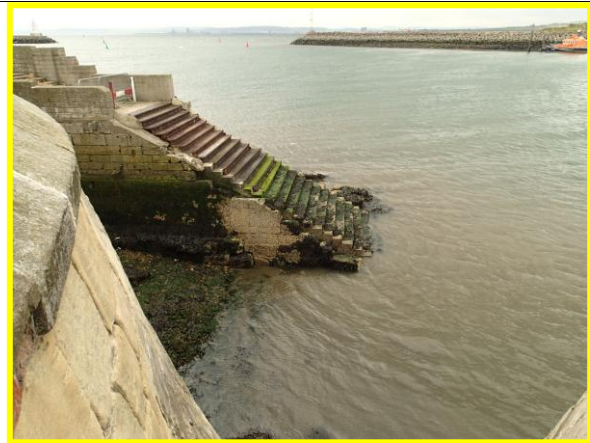
gravel, see below left. The wall here appeared to be in fair condition as reported in previous inspections. At the western end of the frontage the redundant steps at the old ferry terminus remain in poor to fair condition with significant corrosion to the steps and spalling to the wing walls with missing masonry. However, the condition of this part of the structure is not a significant concern since the area is barriered off to the public.

Steps at former passenger ferry landing at west end of town Wall,  
(Asset ref. No. 1221C901C0401C35)

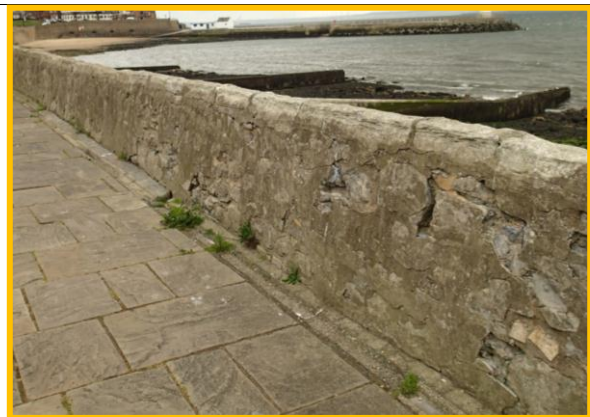
The Town Wall requires regular maintenance as it is a Scheduled Monument and the materials that can be used in repair are not very durable. It is assumed that the pointing would have been repaired when the major works to stabilise the wall were undertaken in 2012. However, the inner face of the crest wall is now in a poor condition and requires urgent repairs to replace missing stones and mortar in various isolated locations, see photos below left and right.

Central part of parapet wall to Town Wall showing missing mortar  
(Asset ref. No. 1221C901C0401C35)

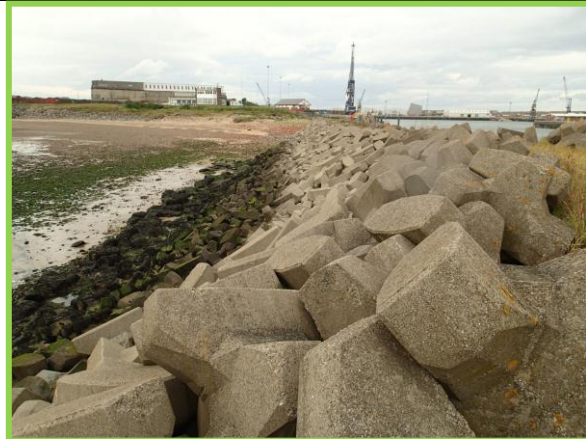
Middleton Jetty in good condition. Retains sand and rubble beach to south  
(Asset ref. No. 1221C901C0401C16)

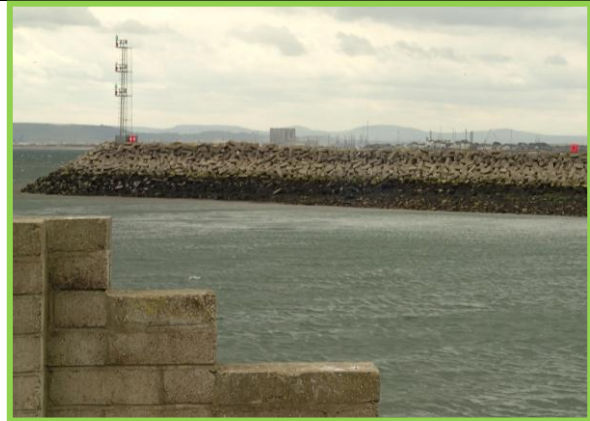
View of Accropode armoured breakwater (Middleton Jetty) from Town Wall.  
(Asset ref. No. 1221C901C0401C16)

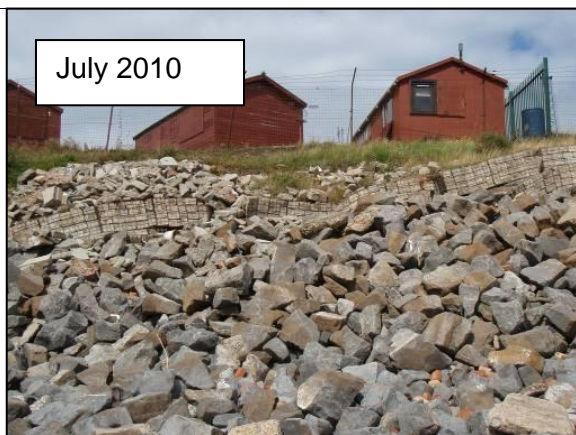
View of Gabion baskets with rock armour.  
Photo from 2010 report.  
(Asset ref. No. 1221C901C0401C17)

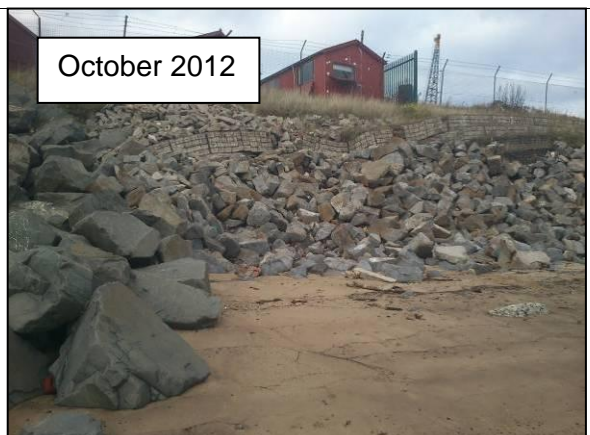
View of Gabion baskets with rock armour.  
Photo from 2012 report.  
(Asset ref. No. 1221C901C0401C17)

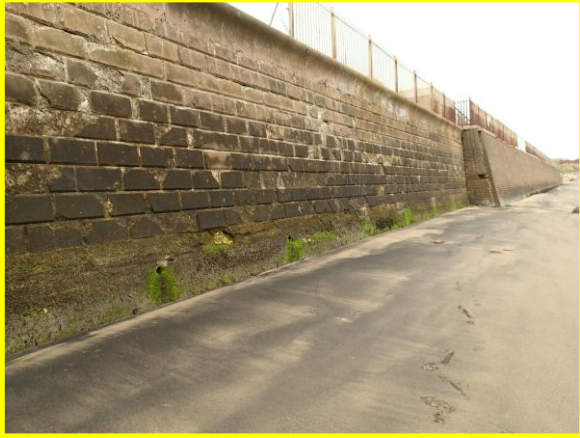
Older concrete block wall in foreground; newer slightly sloping smaller block wall in distance.  
(Asset ref. No. 1221C901C0401C19)

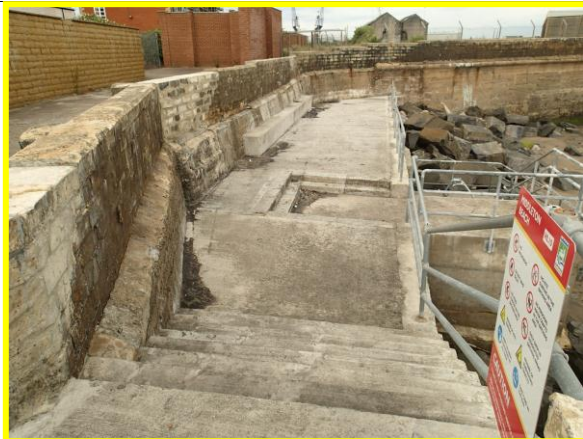
Steps giving access to Middleton beach from root of North Pier (Asset ref. No. 1221C901C0401C22)

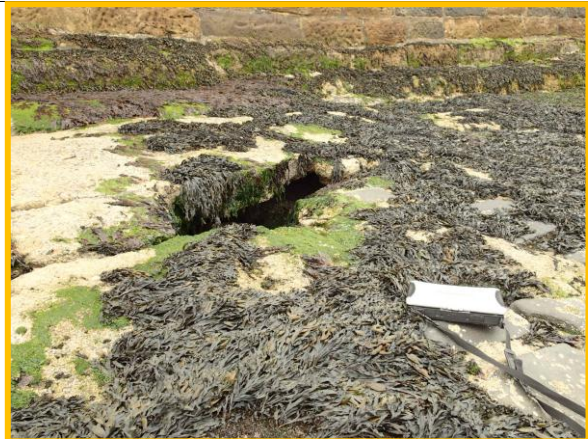
The outside face of North Pier appeared in generally fair condition from the landward, Middleton Beach end. However, as in 2012 the low beach levels had exposed the timber piles at the edge of the toe apron and the apron has areas of damage and voiding, see below right. There was evidence of patch previous defects in the apron, but there was a void under the face of the wall at the edge of the apron, below lower left. This and other similar defects should be repaired before the structure becomes destabilised.

Void in toe apron on north side of North Pier (Asset ref. No. 1221C901C0401C22)

1221C901C0401C21	CPSE-220/6745/02	New concrete head to masonry breakwater.	Breakwater (Inner arm of North Pier)	NZ52013297, NZ52013311	279.3	04/07/2014	No public access along piers so only partly inspected from distance. Appears fair condition. Missing mortar between masonry and spalling of masonry blocks. Concrete head in fair condition.	3	3	>20	Detailed structural survey including boat/dive survey.	routine
1221C901C0401C22	CPSE-220/6719/01	Breakwater and root wall to sheds and protection of redeveloped harbour area.	Breakwater (North Pier)	NZ52143290, NZ51943335	1033.5	04/07/2014	Repairs at N end holding. No public access - insp from dist. Some deterioratn since 2012. Missing /recessed mortar, loose/missing masonry. Cracks and voids in apron. Decaying timber piles visible at toe E side. Steelpiiles (W) fair cond where visible	4	4	11 - 20	Repair voids in apron adjacent to beach. Grout voids. Boat survey to end.	urgent

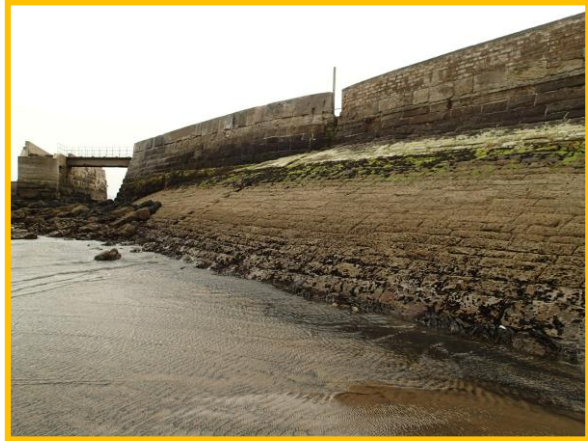
Middleton Beach side of North Pier near low water (Asset ref. No. 1221C901C0401C22)

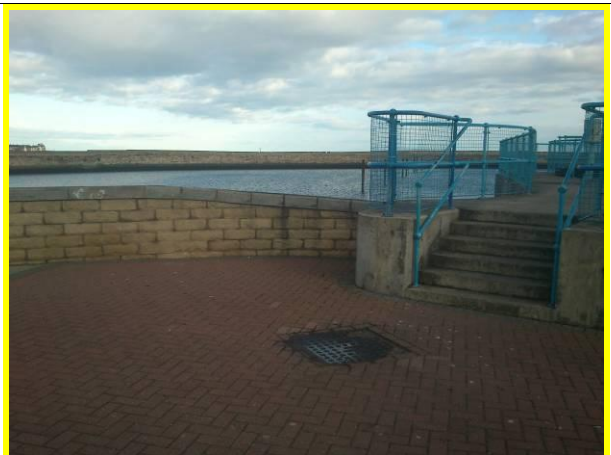
Flood wall tie into lock structure, photo from 2012 report. (Asset ref. No. 1221C901C0401C22)

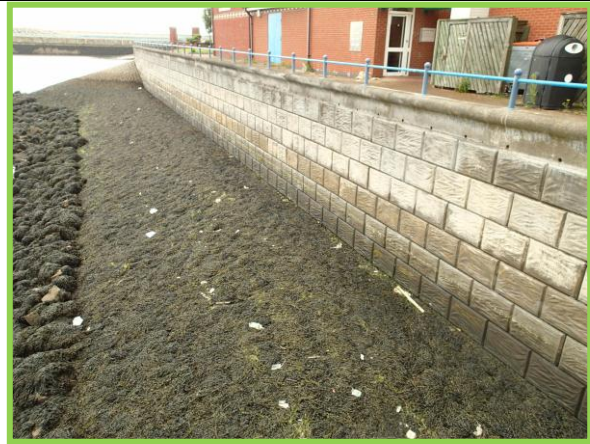
Wall to south side of lock entrance, toe apron covered in seaweed.  
(Asset ref. No. 1221C901C0401C25)

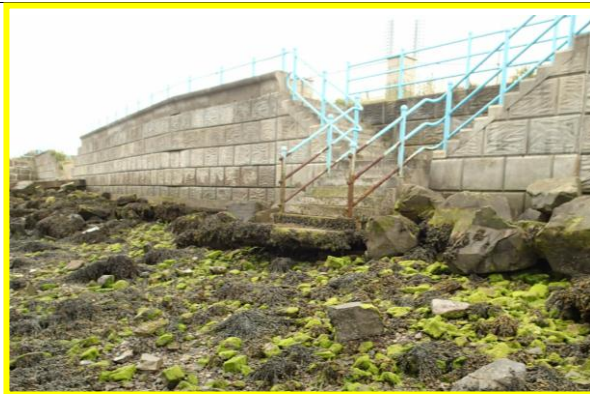
Undercutting of steps and wall near sailing club  
(Asset ref. No. 1221C901C0401C27)

The undercutting at the steps, slipway and walls to the vertical wall north of the Yacht Club first noted to have problems in the 2010 inspections, was similar or slightly worse in October 2012 and appeared more extensive in the July 2014 inspection, see photo above right and below left and right, with undercutting at the slipway, the steps and also at the wall between the steps and the slipway. As previously recommended the voids under the apron should be repaired and additional protective rock armour placed to reduce wave reflections and help avoid further scour damage.

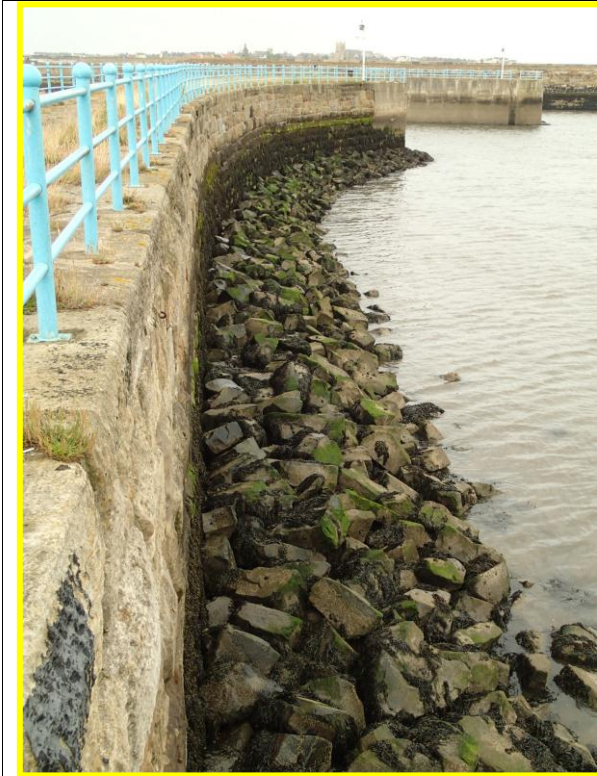
Outer face of Middle Pier, showing rock toe armour. (Asset ref. No. 1221C901C0401C28)

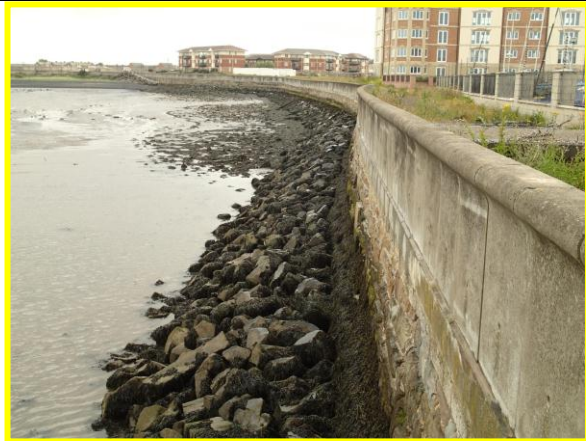
Flood wall and rock toe armour at harbour rear wall (Asset ref. No. 1221C901C0401C29)

The old masonry wall with newer concrete parapet flood wall along the rear of the southern part of the harbour (asset ref. 1221C901C0401C29), above right was in fair condition. There was again heavy coverage with seaweed obscuring the defence, but some open joints requiring repointing were visible in places.

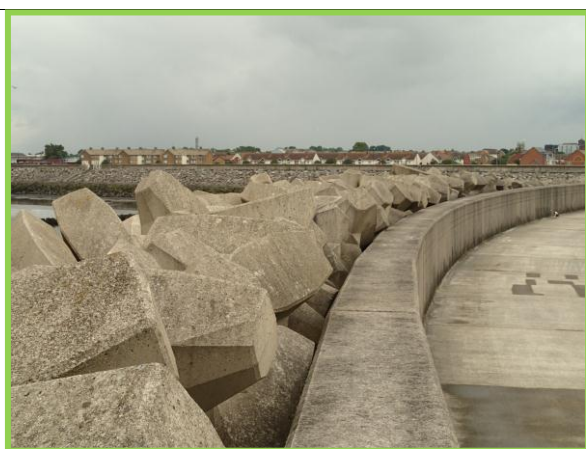
South Pier Accropode armour on outer face (Asset ref. No. 1221C901C0401C32)

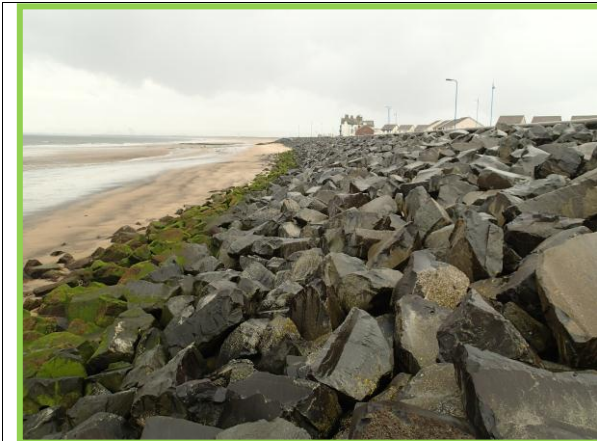
Rock armour in good condition near north end of Seaton Carew  
(Asset ref. No. 1221C901C0401C33)

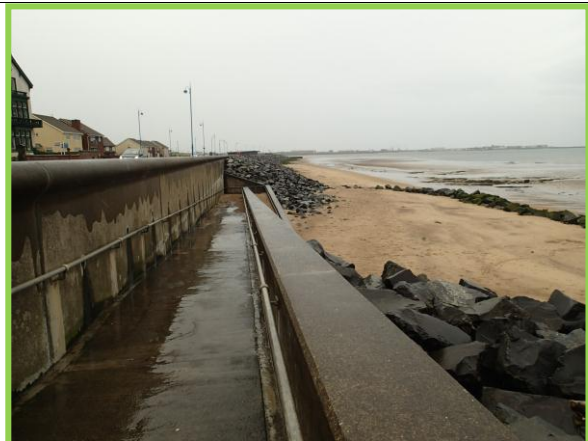
High beach levels almost covering rock bund at access ramp near Little Scar  
(Asset ref. No. 1221C901C0401C33)

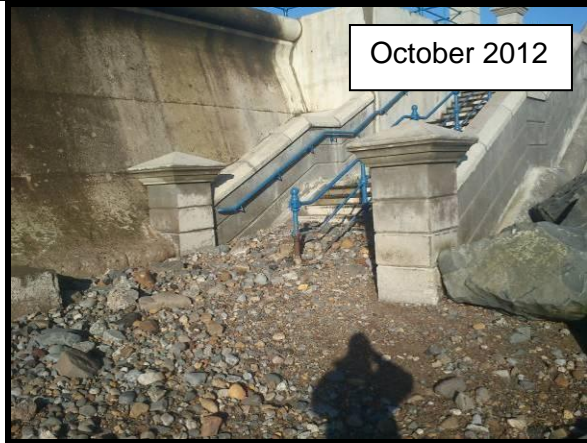
High cobble beach level adjacent to rebuilt northern steps in 2012.  
(Asset Ref. No. 1221C901C0501C05)

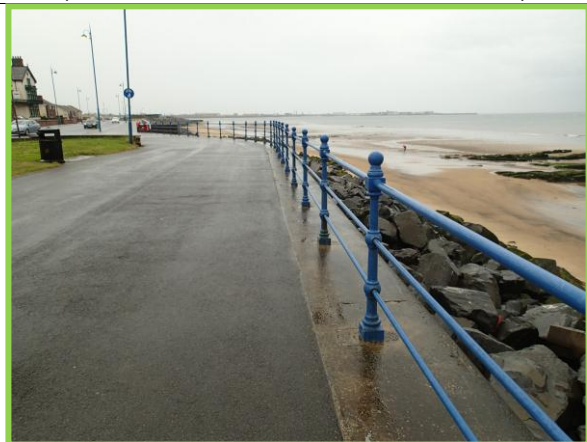
General view of promenade in good condition  
(Asset Ref. No. 1221C901C0501C05)

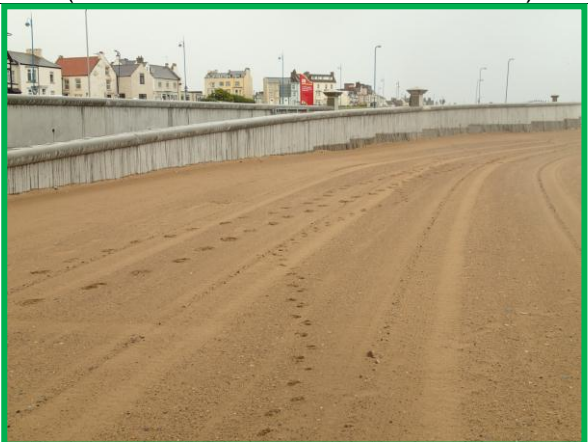
Recently constructed new beach access ramp and seawall at south end of main seawall.  
(Asset Ref. No. 1221C901C0501C05)

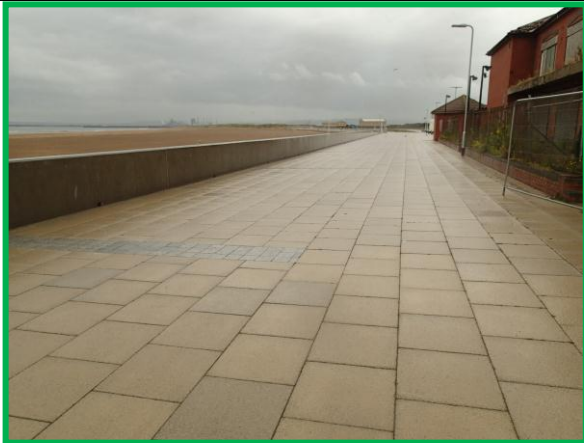
General view of new promenade  
(Asset ref. No. 1221C901C0501C02)

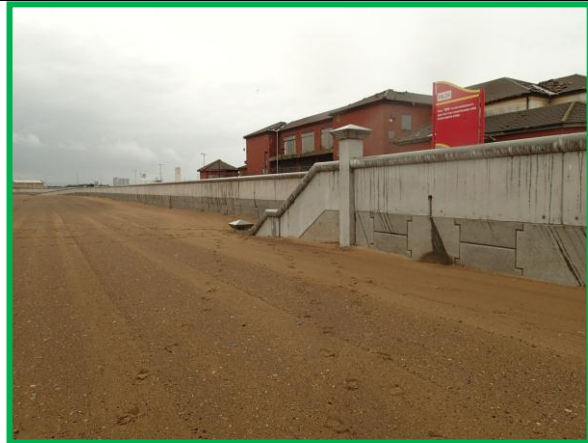
View of new seawall and northern access ramp  
(Asset ref. No. 1221C901C0401C02)

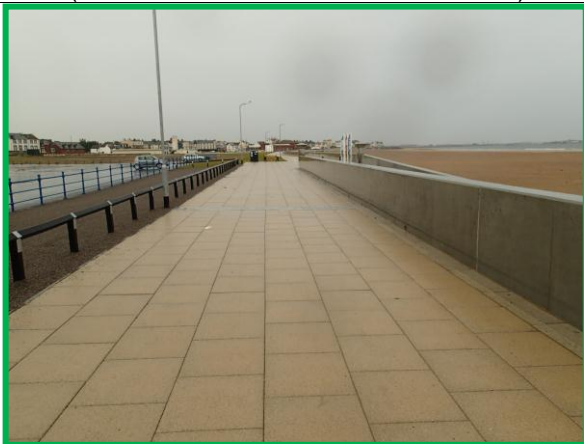
View of new promenade surfacing at car park  
north of pumping station  
(Asset Ref. No. 1221C901C0501C03)

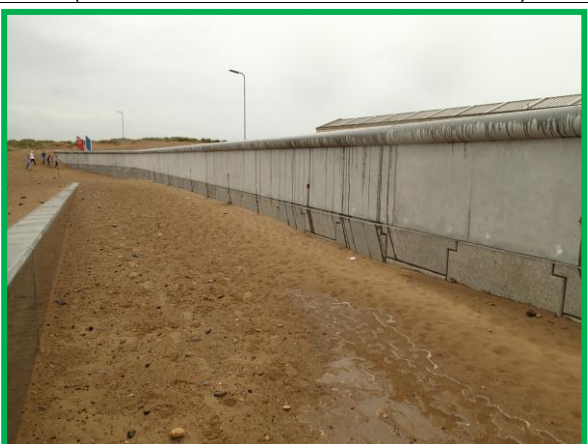
View down ramp access from new seawall at  
water treatment works.  
(Asset Ref. No. 1221C901C0501C02)

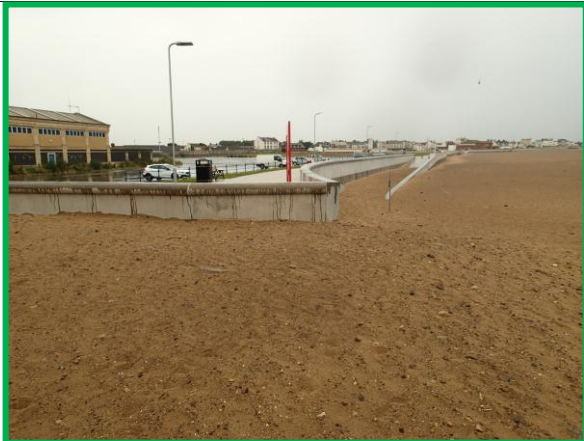
Southern end of new seawall at water  
treatment works.  
(Asset Ref. No. 1221C901C0501C02)

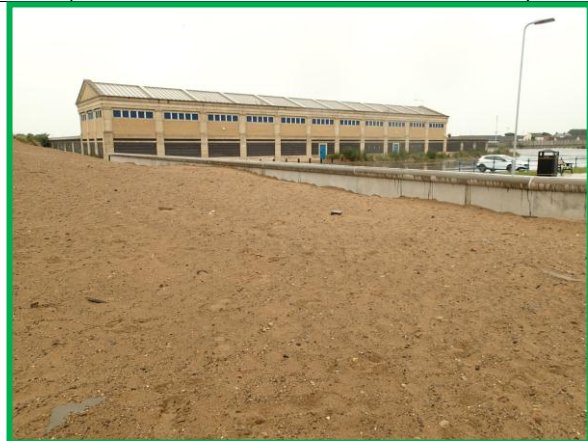
Tie in of seawall at water treatment works.  
(Asset Ref. No. 1221C901C0501C02)

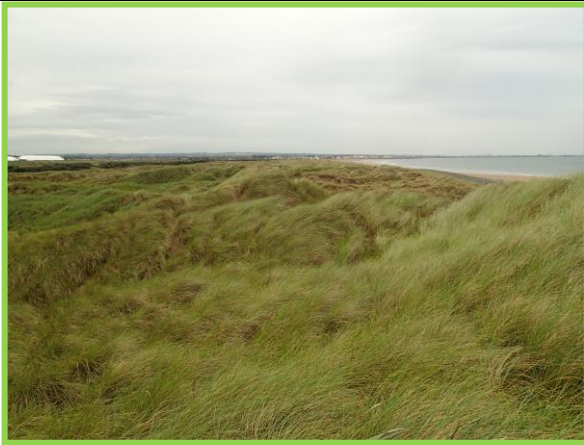
To the south of the sewage pumping station, the frontage is undefended and comprises of a relatively stable dune system which includes the Seaton Dunes Nature Reserve (photograph overleaf, left). As noted in previous years the dunes were well established and had a good coverage of vegetation. Local erosion was evident due to trampling from members of the public

View of dunes at Seaton Sands from near North Gare Breakwater.  
(Asset ref. No. 1221C901C0502C01)

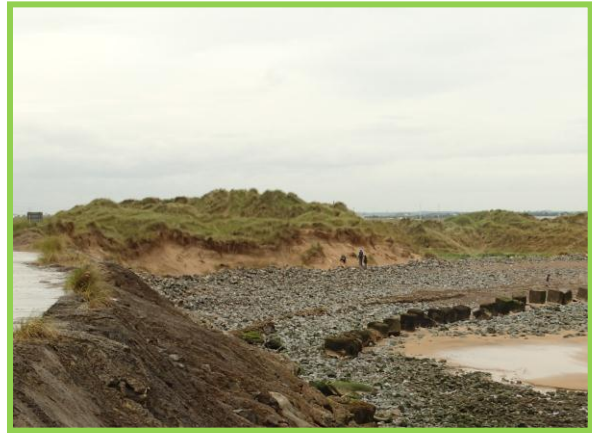
walking through the dunes, with a lowering of the crest of the most seaward dune in several locations. As in previous years, local cliffing was observed towards the south in close proximity to the North Gare breakwater (below, right). The level of the dune crests generally increases to the south and a healthy beach is maintained along Seaton Sands by the North Gare breakwater.

Localised cliffing of the dunes immediately north of North Gare, adjacent to rubble revetment placed to manage outflanking.  
(Asset ref. No. 1221C901C0502C01)

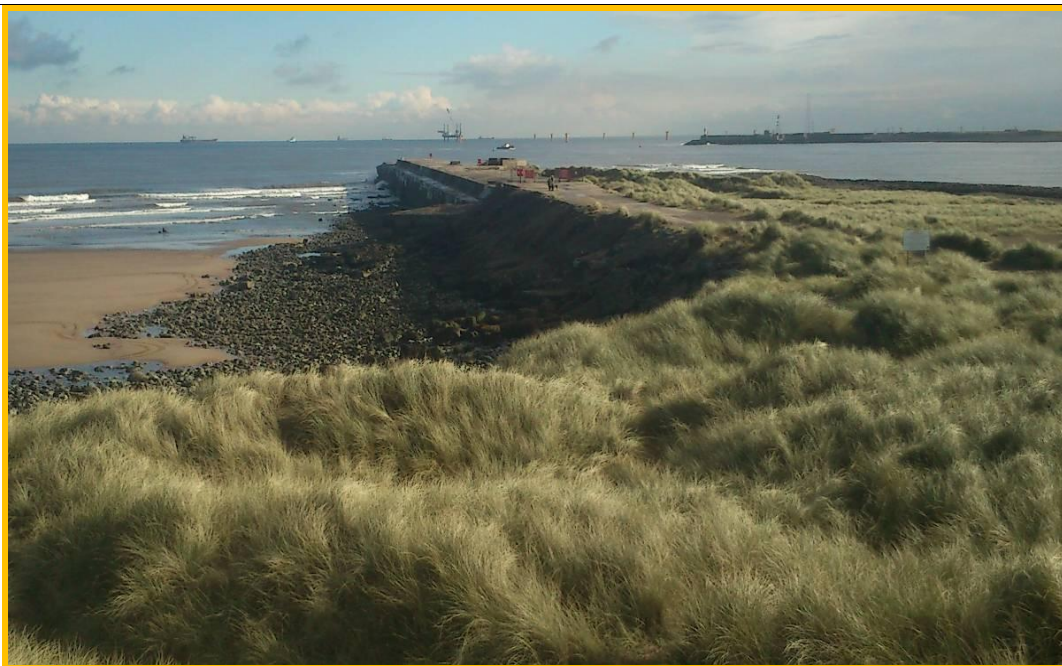
The North Gare Breakwater is a private structure at the entrance to the Tees, marking the southern extent of Hartlepool BC's coastal frontage. As well as protecting the navigation channel the massive structure stabilises the shoreline to the north, retaining the beach and dune system, and also provides shelter to the beach located in the lee to the south where a stable dune field has developed. As reported in 2008, 2010 and 2012 the structure is in poor condition. However, despite the poor structural condition the massive structure remains effective in controlling shoreline change.

General view of North Gare breakwater, photo from 2012 report.  
(Asset ref. No. 1221C901C0502C01)

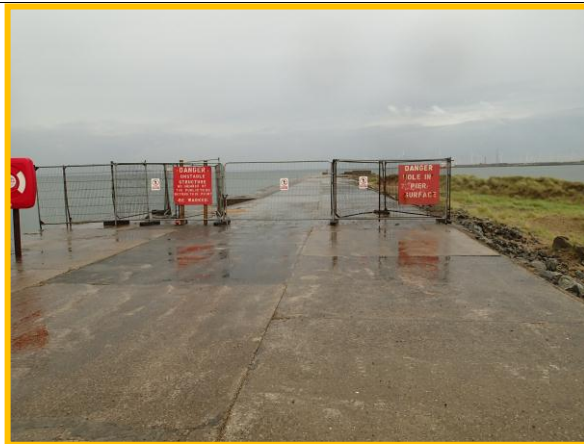
The North Gare breakwater remains in a dangerous condition with fencing and signs to deter members of the public from accessing the seaward section, see below left. However, it would be fairly easy to walk past this fencing on the adjacent foreshore to the south of the breakwater, below right.

Fencing and warning signs on North Gare breakwater.  
(Asset ref. No. 1221C901C0502C01)

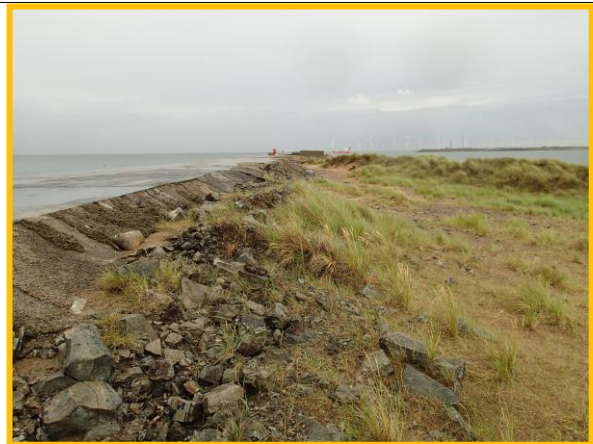
Rubble / slag beach to the south side of North Gare Breakwater.  
(Asset ref. No. 1221C901C0502C01)

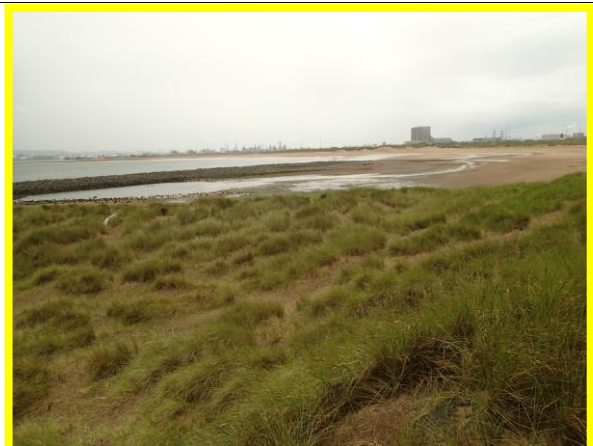
View of training wall and dunes to south of the breakwater in the Tees estuary mouth  
(Asset ref. No. 1221C901C0502C01)
