**Cell 1 Regional Coastal Monitoring Programme
Coastal Walkover Inspections 2010**

**Redcar and Cleveland
Borough Council
Final Report
December 2010**

This report documents the condition of the coastal cliffs and assets along Redcar and Cleveland Borough Council's frontage, which extends from the South Gare Breakwater in the north, to Cowbar Nab, Staithes in the south.

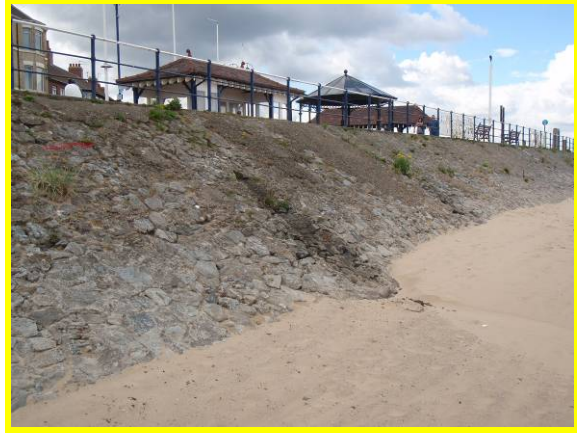
To the west of Redcar, the defences comprise a grouted stone revetment with a concrete wall along the crest. Beach levels were higher than during the 2008 inspections, obscuring most of the revetment element. The concrete wall was generally in good condition although missing a section towards its northern extent. This appeared to be used as an access point to the beach, resulting in a loss of beach material and exposure of the revetment. Beach levels were lower towards the south of the asset, exposing more of the revetment which appeared in fair condition with minor grout loss and vegetation growth.

Loss of concrete render exposing grouted stone
(Asset Ref No 12221C901C0601C01)

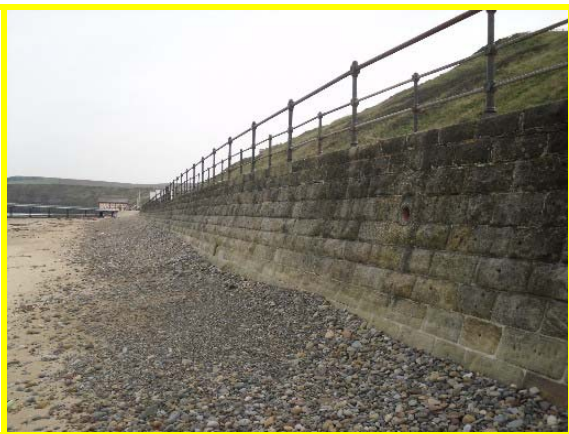
View looking east along Lower Promenade
(Asset Ref No 1221C901C0704C04)

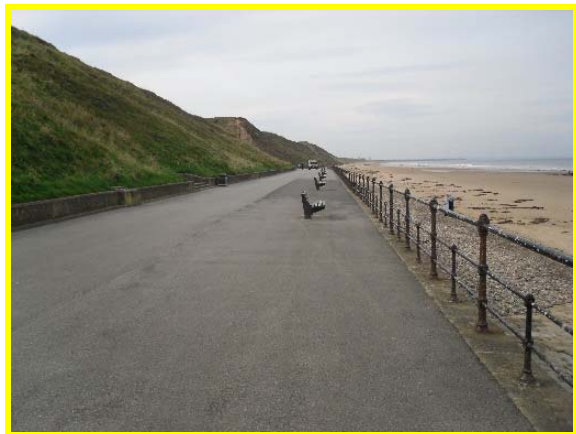
View looking west along Lower Promenade
(Asset Ref No 1221C901C0704C04)

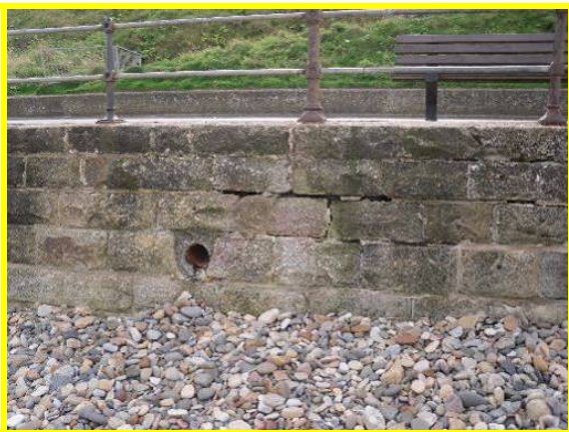
As during the previous inspection, the masonry seawall protecting much of the frontage at Saltburn (Asset Ref No's 1221C901C0703C02 to 1221C901C0704C06) requires repointing in places. East of Skelton Beck there are sea defences which in 2008 displayed extensive defects. These defects have now been repaired in an ad-hoc fashion.

Example of area where repointing is needed
(Asset Ref No 1221C901C0704C04)

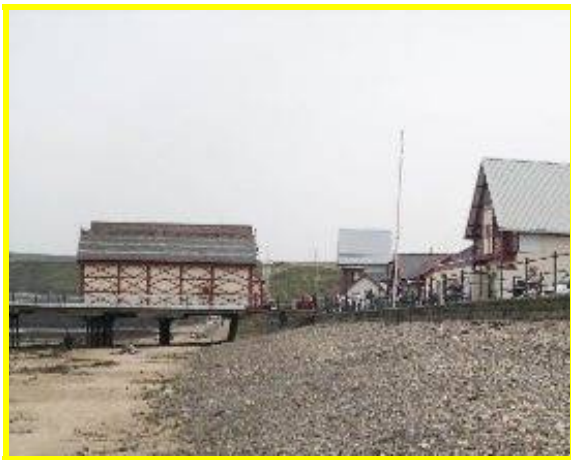
View of pier and sea wall.
(Asset Ref No 1221C901C0704C04)

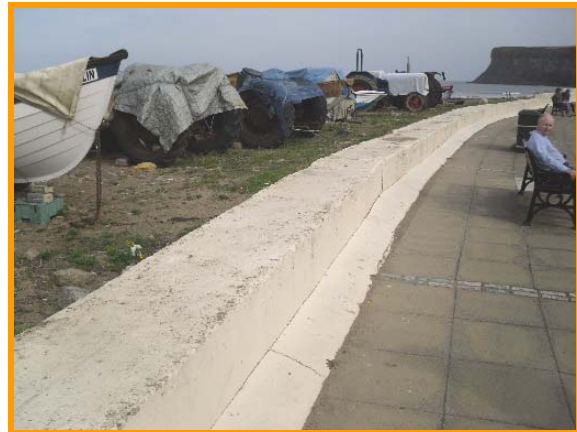
View of sea wall
(Asset Ref No. 1221C901C0704C03)

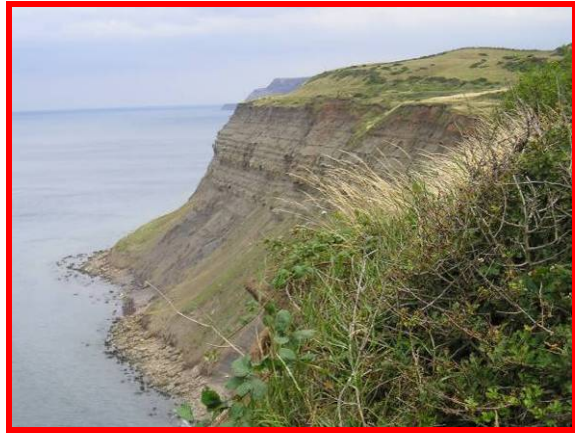
E54/3b looking southeast along Warsett Hill (Totally Active)

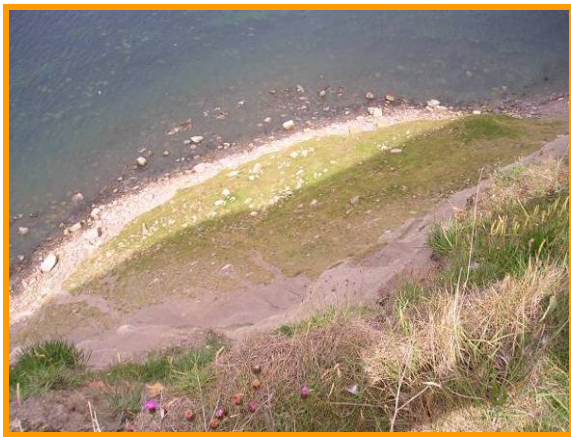
E54/3a looking down the cliff at the vegetated debris flow lobe at cliff base (Partly Active)

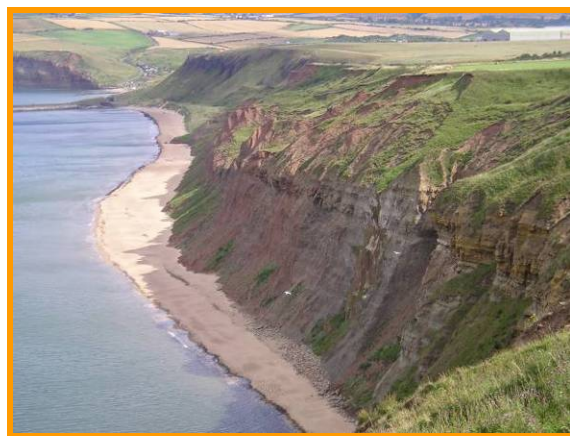
E55/2 looking southeast towards Skinningrove, steep debris cones at cliff base (Partly Active)

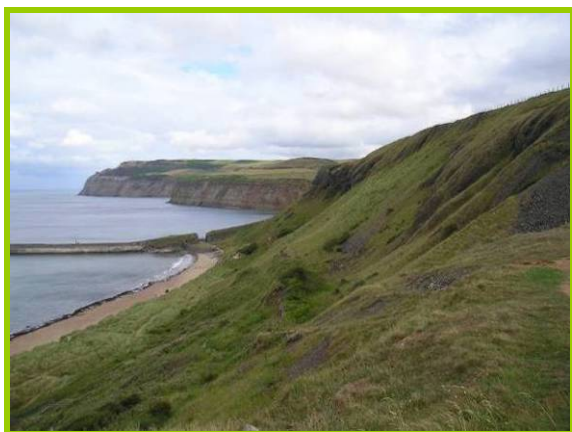
The unit above Cattersty Sands (immediately west of the jetty) (E56/2a) is classified as Inactive. The cliffs here have a shallower gradient with extensive vegetation cover. They are also provided protection at their base by a set of embryo dunes. The development of these dunes and lack of erosional activity within this unit may be due to the protection afforded by the adjacent jetty.

E56/2a looking southeast towards Skinningrove, showing shallow vegetated slopes and dunes at the toe (Inactive)

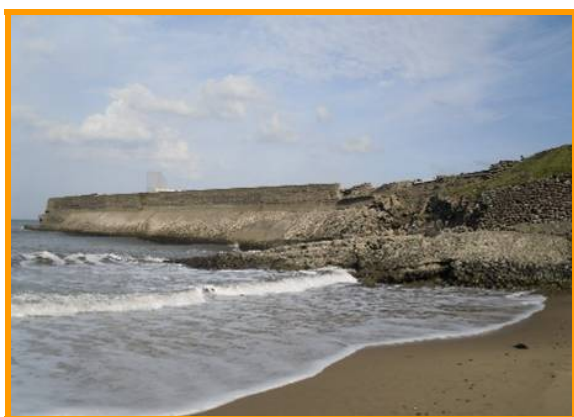
At Skinningrove, the jetty continues to show evidence of significant cracking, deformation and corrosion in places (Asset Ref No. 1221D901D0201C02). Although It is disused as a jetty, access is still possible and so consideration should be given to public health and safety. It is strongly recommended that the jetty is once again secured to prevent public access.

Jetty – view from NW side
(Asset Ref No. 1221D901D0201C02)

Within this area, coastal defences are present around Skinningrove village, but there are none west of the large jetty. The original mining breakwater (or 'jetty') is located 400m northwest of the village, although still present, it is redundant, and does not appear to be actively maintained. There are gates (currently broken open) which are in place to prevent access onto the jetty by the public. The jetty is constructed of concrete and sheet piles and shows evidence of significant cracking, deformation and corrosion in places (Asset Ref No. 1221D901D0201C02). It is recommended that this asset be confirmed as redundant, and that it is secured once again in order to prevent access by the public.

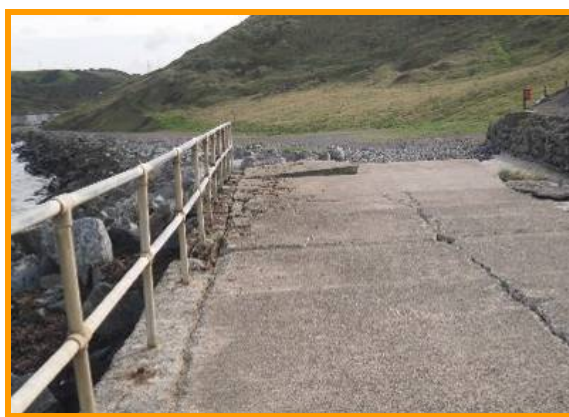
Landward end of jetty – showing movement
(Asset Ref No. 1221D901D0201C02)

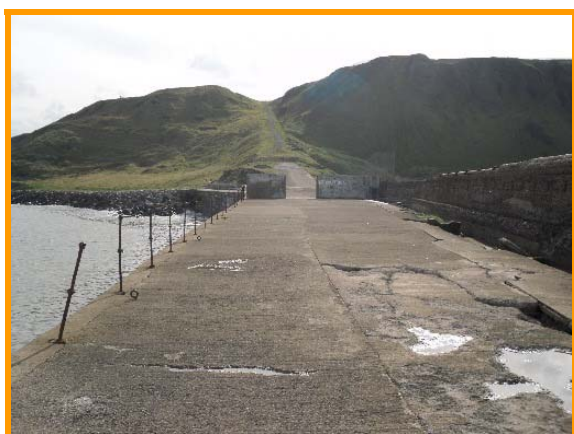
Looking landward along the jetty, showing open gates in background
(Asset Ref No. 1221D901D0201C02)

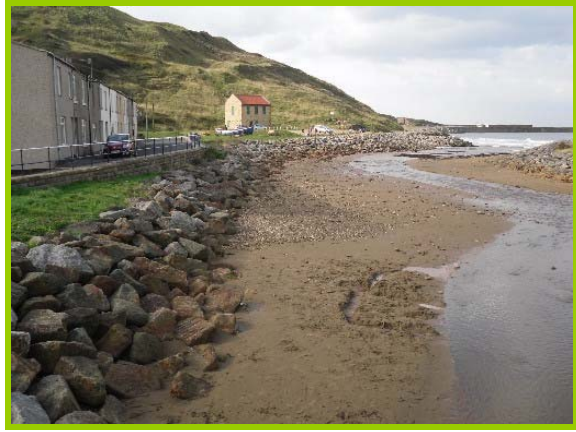
Rock armour along Beck with small wall behind in
Skinningrove village
(Asset Ref No. 1221D901D0202C02)

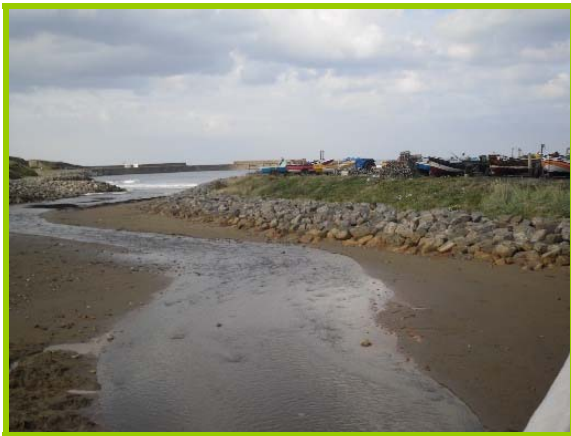
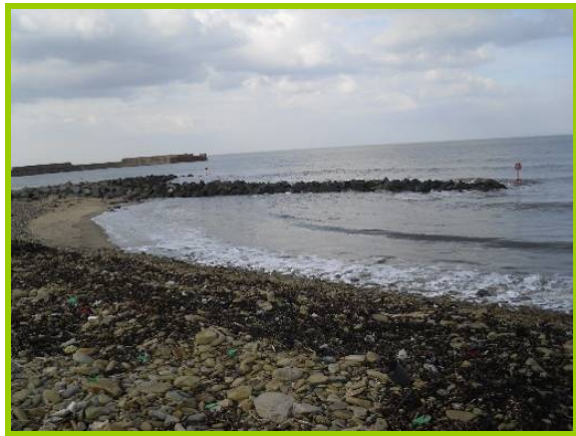
Fishtail breakwater
(Asset Ref No. 1221D901D0202C05)

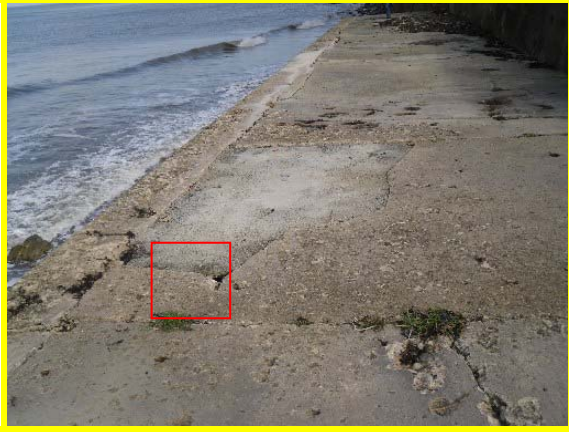
East of the breakwater there are two further assets, a shingle ridge (Asset Ref No. 1221D901D0202C04) and a concrete wall (Asset Ref No. 1221D901D0202C03). The inspection team was unable to inspect the toe of this wall, as beach levels were relatively high. The promenade was significantly cracked in places and there was a void, approximately 700mm deep. The retaining wall behind appeared to be sound at present.

Top of wall with void location indicated
(Asset Ref No. 1221D901D0202C03)

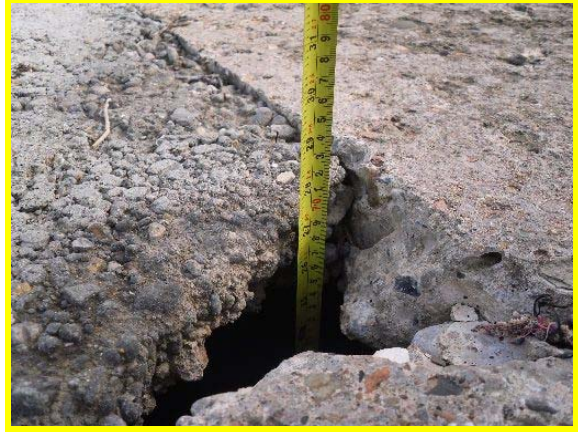
Void, showing 700mm depth
(Asset Ref No. 1221D901D0202C03)

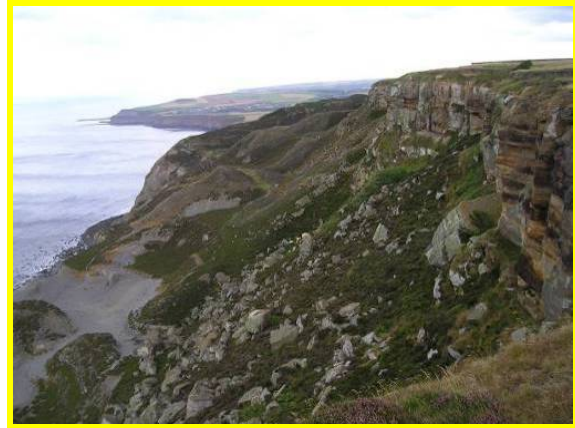
E58/2upper evidence of past rockfall (Locally Active)

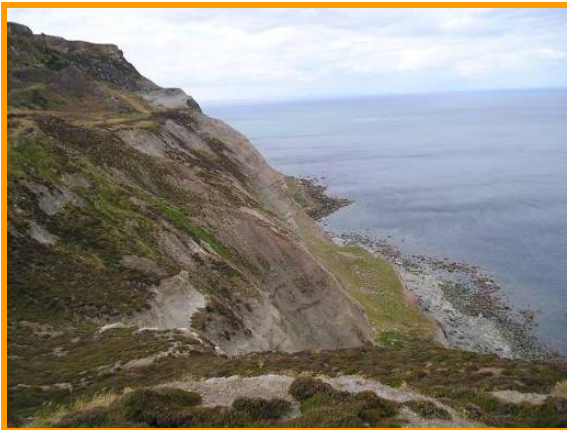
E58/2lower steeper, more active lower cliff face (Partly Active)

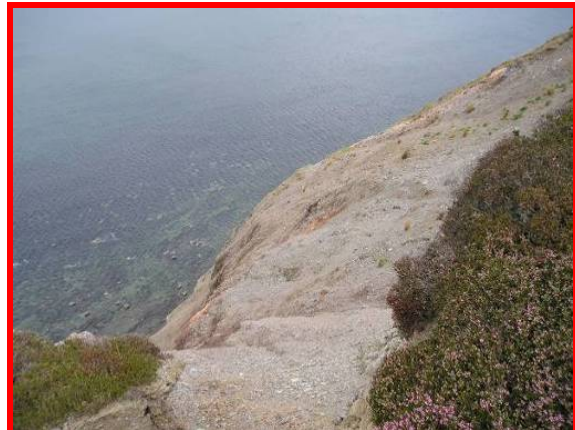
Below Rockhole Hill there is a single unit classified as Totally Active (E58/1c). Large block detachments are visible with tension cracks at the head. The slopes are largely devoid of vegetation cover and undergoing active erosion down their entire length.

E58/1c below Rockhole Hill - highly active lower slopes (Totally Active)

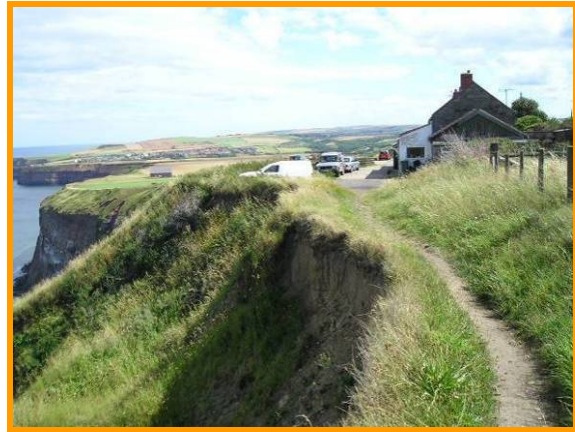
Within unit E58/1a there has been recent failure at the headscarp and associated cliff top recession. In time, this may lead to the loss of the Cleveland Way footpath immediately west of the buildings at Boulby Grange and at some point could threaten the properties.

E58/1a recent headscarp activity and risk to footpath at Boulby Grange (Partly Active)

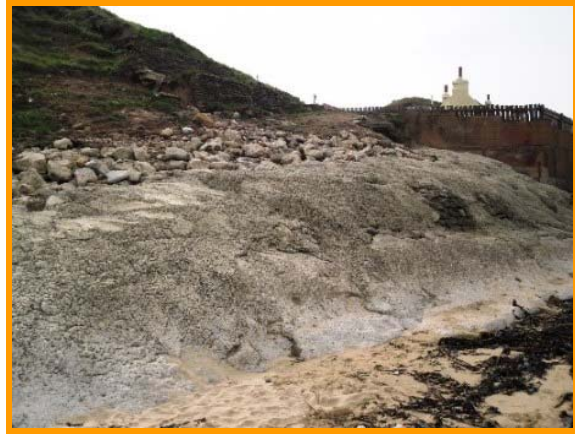
2010: Undercutting and excavation of concrete defences (Asset Ref No. 1221C901C0704C05)

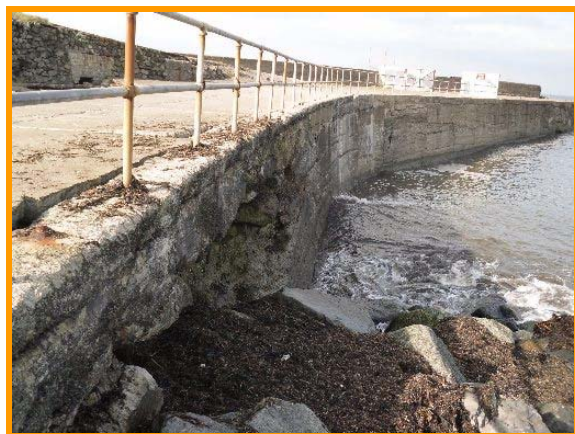
Looking seaward along the jetty, washout visible in foreground (Asset Ref No. 1221D901D0201C02)
