**Walk-over Visual Inspections of Assets
including Coastal Slopes**

**Redcar and Cleveland
Borough Council
Final Report**

July- August 2014

Cell One Coast Protection Assets and Coastal Slope Condition Analysis

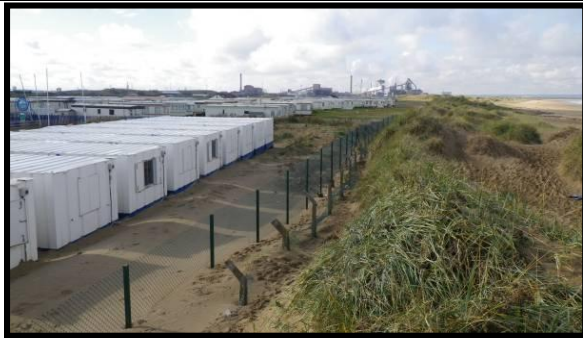
E52/11 view from south - Photo from 15/10/2012
(Inactive)

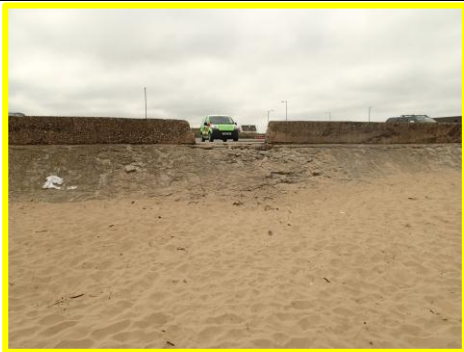
The concrete wall with grouted stone revetment, 1221C901C0601C01, remains in fair overall condition although there are a number of missing blocks and areas of grout loss. Much of the revetment was covered by the high beach levels, which give it some protection. There is still a missing section of crest wall towards its western extent, as noted in the 2010 and 2012 inspections, see below left and right. This appears to concentrate overtopping and drainage flows, resulting in a loss of beach material and exposure of the revetment. Further east the promenade was flooded, presumably due to wind blown sand and high beach levels blocking the drainage, lower left. At the eastern end of this asset the construction of the new Redcar seawall was progressing well and the interface with the new wall is shown below lower right.

Gap in concrete wall and exposed revetment
(Asset Ref No 12221C901C0601C01)

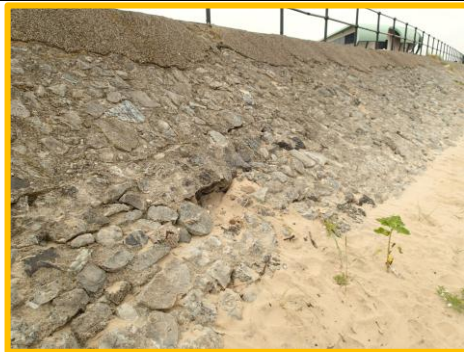
Damaged area of revetment
(Asset Ref No 12221C901C0601C01)

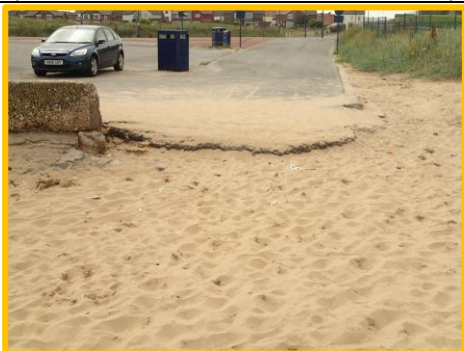
Damage at access ramp adjacent to west extent
(Asset Ref No 12221C901C0601C01)

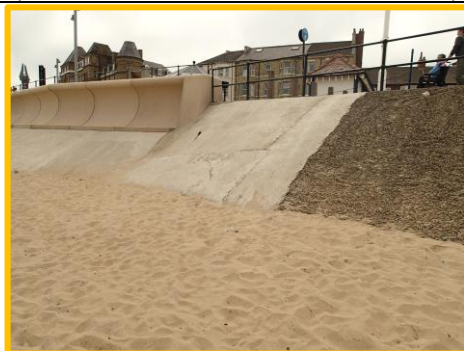
Interface with new seawall at the eastern end of
Asset Ref No 12221C901C0601C01

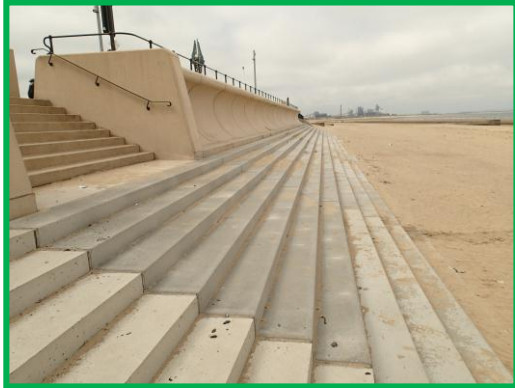
New stepped revetment and wave wall at west end of Redcar, Asset ref. 1221C901C0602C06

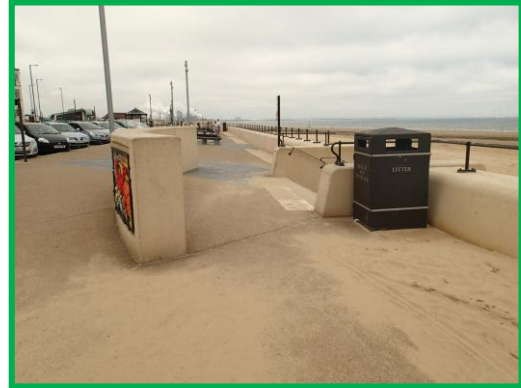
Promenade and wave wall in very good condition, Asset ref. 1221C901C0602C06

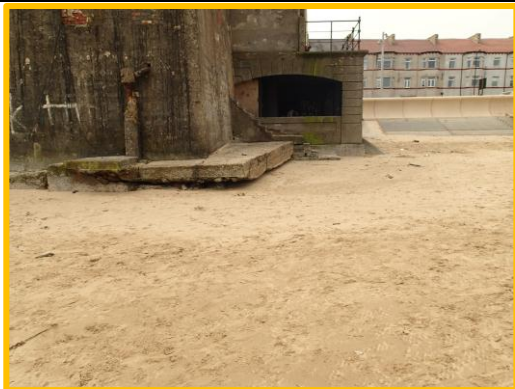
The seawall structures (Asset 1221C901C0602C05) protecting the old cinema building that is built on the beach have not been renewed as part of the recent scheme and have a number of defects including cracking and undermining of the apron on the north west corner.

Undermining of toe apron at cinema seawall
Asset ref No. 1221C901C0602C05

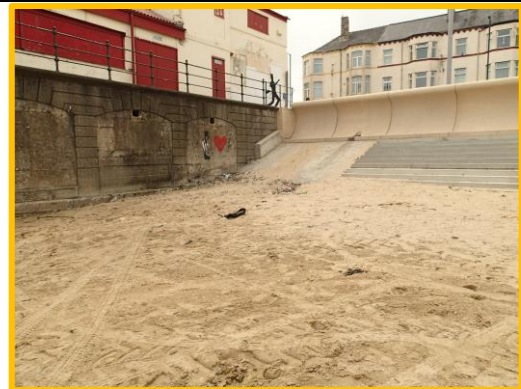
Interface between new seawall and cinema wall,
Asset ref Nos. 1221C901C0602C05 & 6

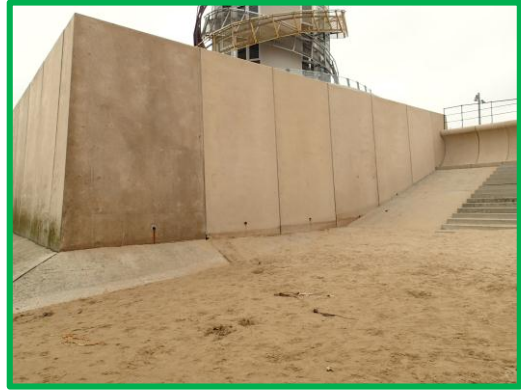
New vertical wall at the Beacon tower
reconstructed in 2012,
Asset ref No. 1221C901C0602C03

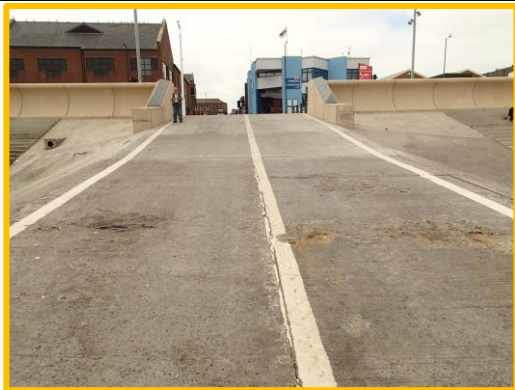
Localised damage to slipway at the RNLI building
Asset ref No. 1221C901C0602C02

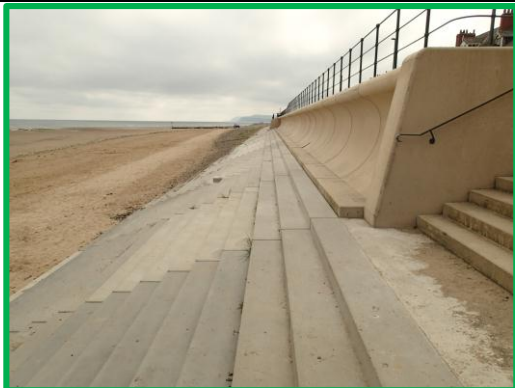
Stepped seawall and wave wall in very good
condition. Asset ref No. 1221C901C0602C01

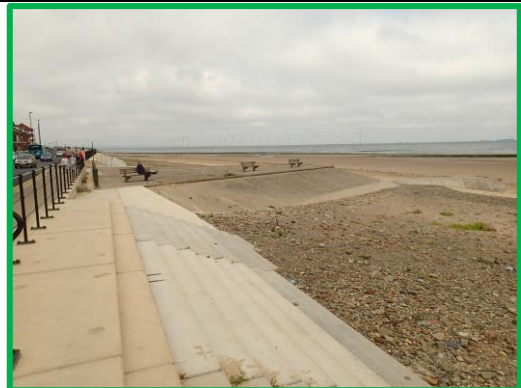
View of eastern end of main Redcar Seawall.
Asset ref No. 1221C901C0602C01

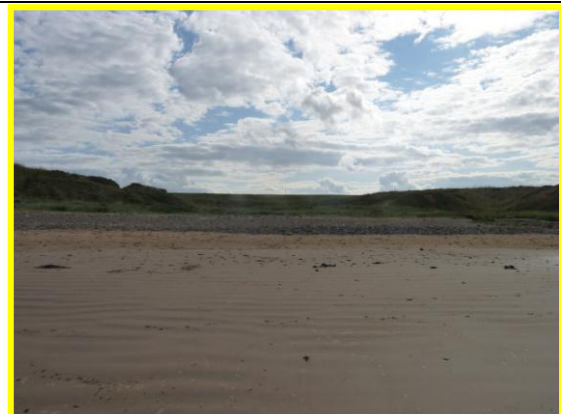
E52/9 Cobble beach gives protection to low and well vegetated cliff (Inactive). Photo August 2014

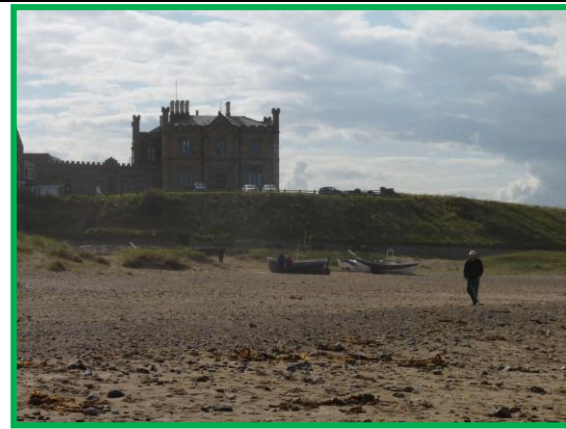
E52/8: Low, well vegetated cliff but with some localised toe erosion (Inactive). Photo August 2014

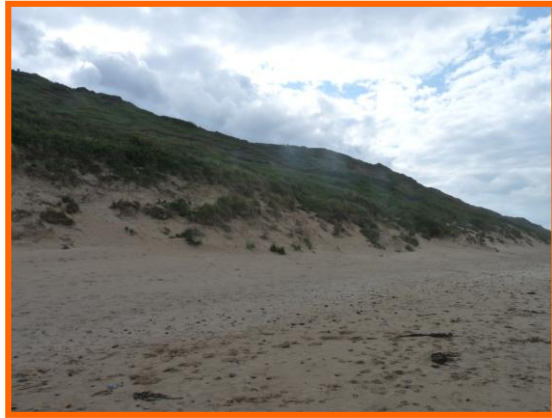
E52/4: QWestern end of unit - coastal slopes
viewed looking northwest west (Partly Active)
Photo August 2014

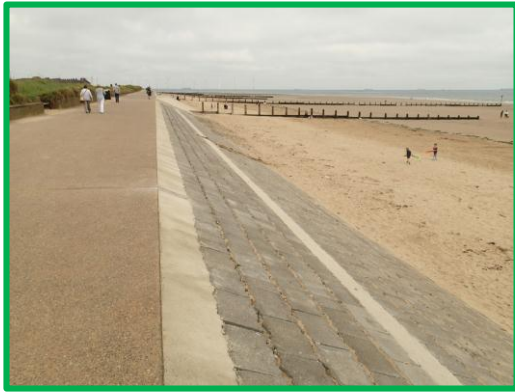
Concrete block revetment and concrete promenade in very good condition. Asset ref No. 1221C901C0603C01

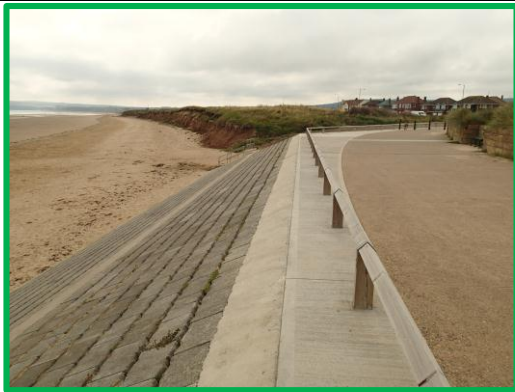
View towards eroding cliff at east end of seawall Asset ref No. 1221C901C0603C01, (with 1221C901C0701C01 in distance)

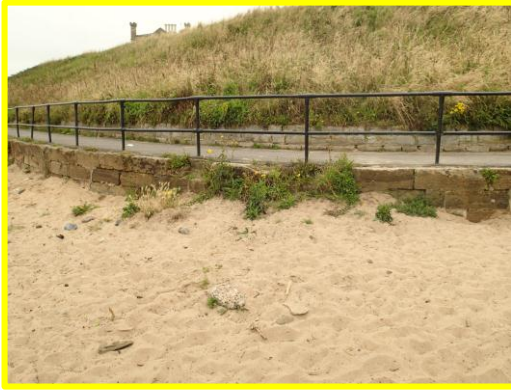
Missing coping blocks and open joints in masonry blockwork in wall below path. (No change from 2012) (Asset Ref No 12221C901C0702C03)

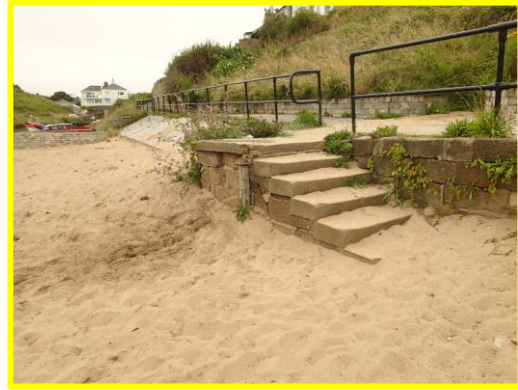
Missing mortar in joints and vegetation growth. (Asset Ref No 12221C901C0702C03)

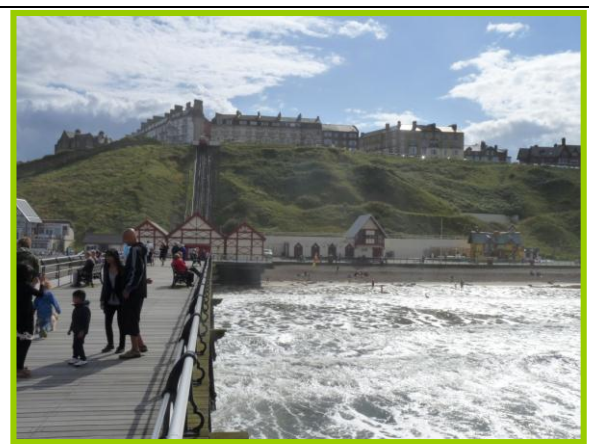
E52/3b from the stable and well vegetated cliffs above Saltburn Sands (Inactive). Photo August 2014

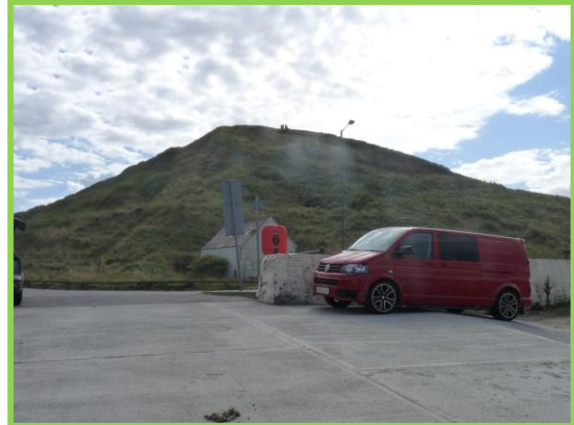
CBU **E52/1** shows a little more activity, with loose materials and localised erosion at the head of the large mound situated just east of Saltburn Gill. However, the activity is minimal and this unit has been downgraded from Locally Active to Inactive in 2014.

E52/1 looking up at well vegetated cliffs from Saltburn Sands (Inactive) Photo August 2014

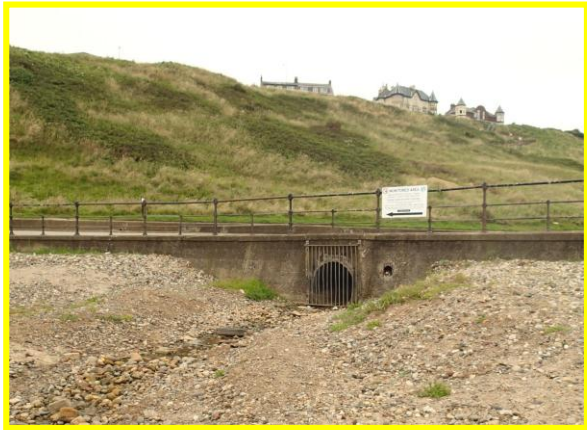
Outfall exiting through sea wall at Hazel Grove
sea wall at Hazel Grove Foot 24 July 2014
(Asset Ref No 1221C901C0703C02)

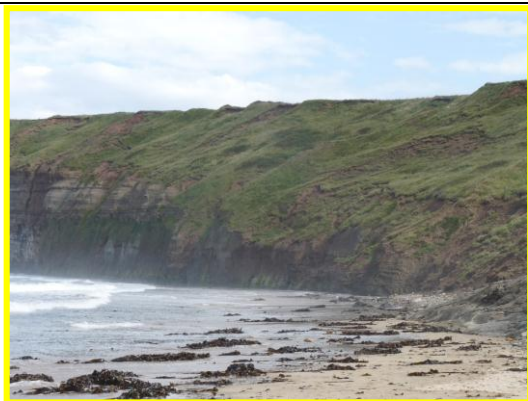
E53/4 Slumping in the till layer of the cliff northeast of Saltburn (Locally Active). Photo August 2014

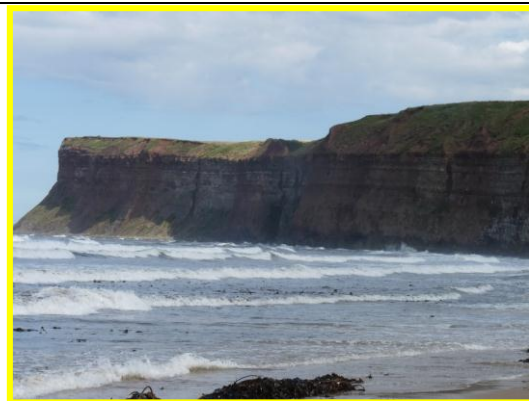
Unit **53/3 and 53/2** also have a slope-over-wall form. The units are classified as Locally Active (53/3) and Partly Active (53/2) reflecting the degree of mudslide activity in the till and wave erosion of the resulting debris cones. The Partly Active unit (E53/2) is characterised by widespread mudslide activity in the till. These units are unchanged in 2014, from the statuses allocated in 2012

Unit **53/1** is showing signs of mudsliding in the upper till section and is classified as Locally Active in 2014, unchanged since 2012.

E53/3, E53/2 (Partly Active) and E53/1 The rock part of the cliff is steep and exposed. The till part is much shallower and vegetated (Locally Active). Photo August 2014

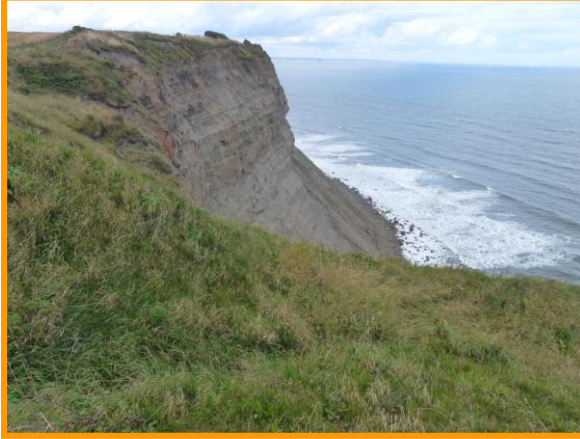
E54/4 looking northwest along Hunt Cliff showing active cliff face and debris apron (Partly Active) Photo August 2014

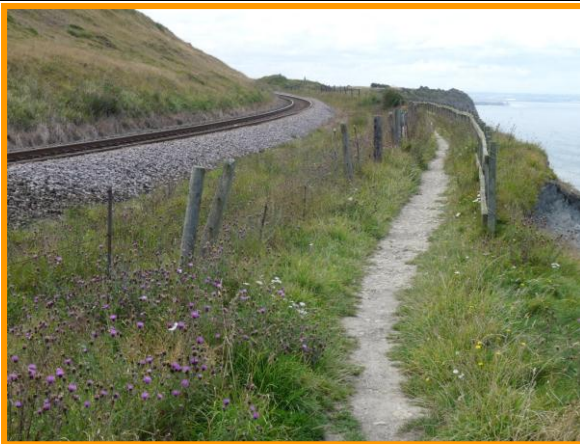
E54/3a proximity of footpath and railway line to actively eroding cliff top (Partly Active) Photo August 2014

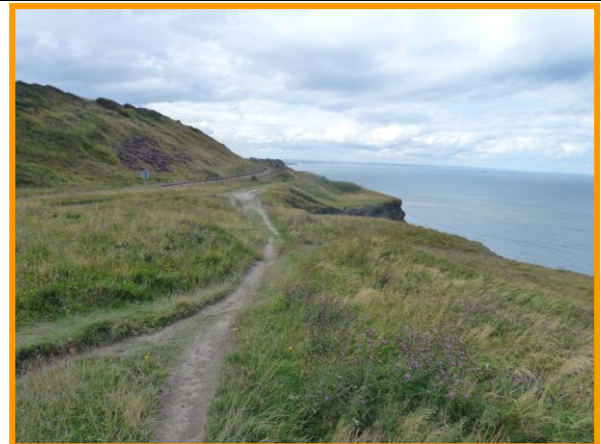
E54/2b some vegetation cover on the upper part of the cliff, looking west (Partly Active) Photo August 2014

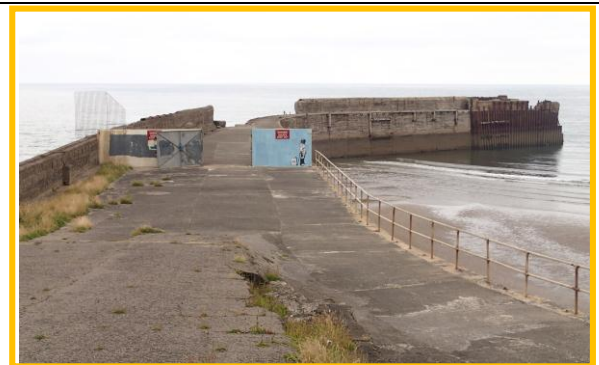
Although Skinningrove Jetty (Asset Ref No. 1221D901D0201C02) is redundant for its original purpose and is in a failing state, the massive structure provides some coastal stabilisation, fixing the orientation of the adjacent bay to the east and giving some protection to Skinningrove Village to the south east. It also helps hold the beach in front of the undefended cliffs to the west. There are gates to restrict public access to the unsafe structure, but, as seen in 2012, at the time of the inspection (27/07/2014) they were open. It is recommended that they are secured to prevent access by the public to this unsafe structure. The jetty is constructed of concrete and sheet piles and shows evidence of significant cracking, deformation and corrosion and significant sections of the structure are missing or collapsed (Asset Ref No. 1221D901D0201C02).

View of Jetty 24/07/2014 (Asset Ref No. 1221D901D0201C02)

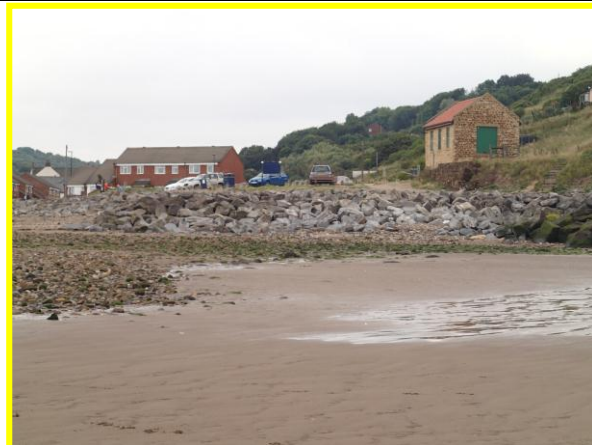
There were improvement works to the rock armour defences in the beck including construction of a spur section to reduce the wave scouring in the beck and widen the channel to the bridge in around 2004. As found in the 2010 and 2012 inspections, in general the rock armour to the north side of the beck (1221D901D0202C02), including in front of Marine Terrace, still appears to be mostly tightly packed and does not appear to have suffered from significant deformation or rock displacement, although some gaps were noted in the armour so it has been downgraded from good to fair. The low beach levels at the spur groyne noted in 2012 exposing the wrap around geotextile toe at the spur section to damage and potential undermining, had recovered with build-up of a cobble beach in the area, see below right.

Cobble beach has accreted around the spur groyne at end of the beck (Asset Ref No. 1221D901D0202C02)

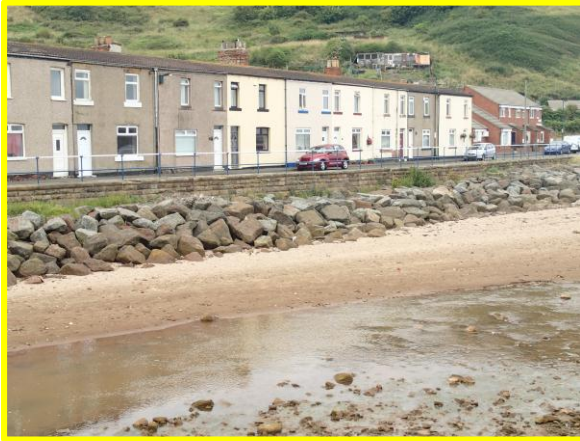
Rock armour and low sea wall in front of properties (Asset Ref No. 1221D901D0202C02)

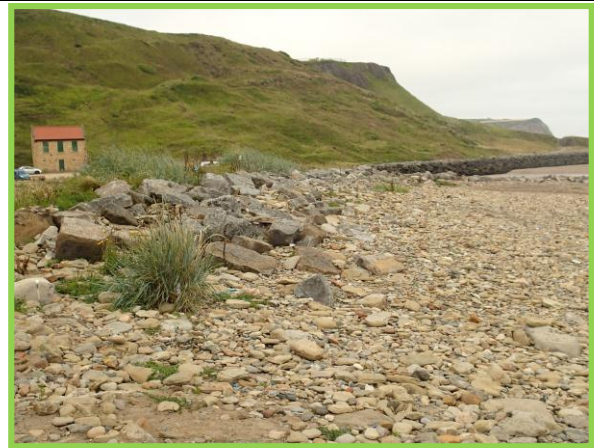
The shingle ridge, which is artificially stabilised by the fishtail groyne, was in good condition with high crest and gentle seaward slope. It has some rock armour at the crest. The adjacent wall, Asset Ref No. 1221D901D0202C03, which is next to the road is still in poor condition. The toe was exposed due to low beach levels and it has been significantly undercut, particularly towards the east. The crest / promenade area has been repaired and the retaining wall which was badly cracked has been shored up (see photo lower right). However, due to the toe being undermined and the whole structure at risk of collapse the overall condition of poor is retained.

Shingle ridge photo from 24/07/2014. (Asset Ref. No 1221D901D0202C04)

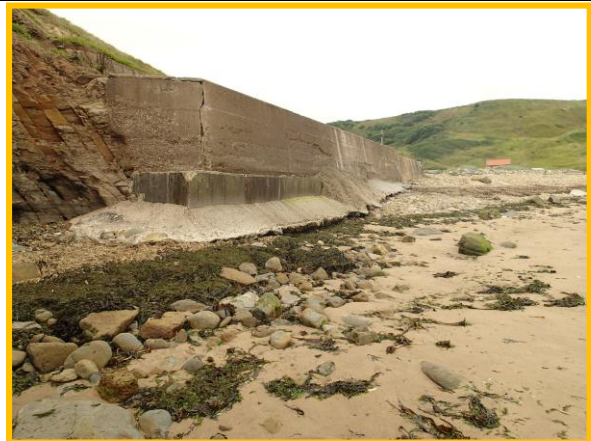
Undermining of wall toe exposing deep voids. (Asset Ref No. 1221D901D0202C03)

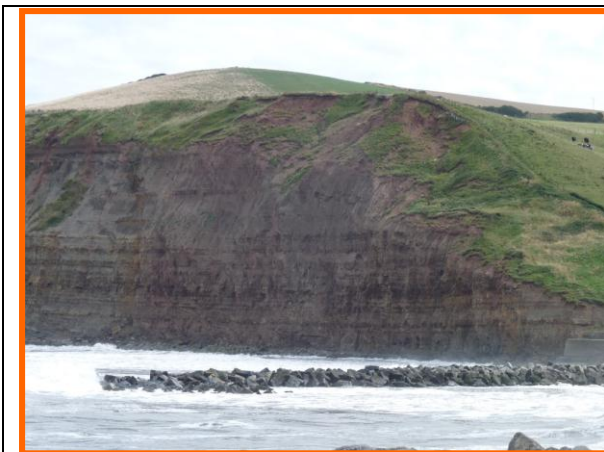
E57/7 looking southeast across the bay at Skinningrove (Partly Active)

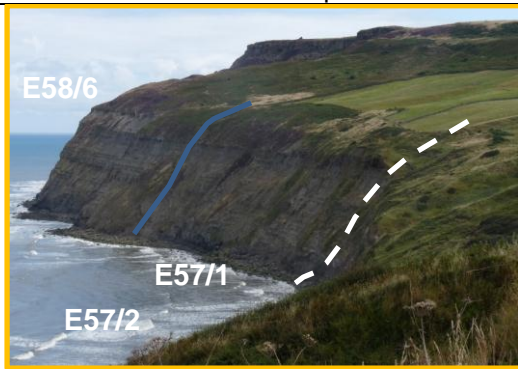
E57/1 (Locally Active) and E57/2 (Partly Active) – These units have an active and steep lower sea bedrock and a less active and well-vegetated, lower angle upper cliff. The lower angle, well vegetated part of E57/2 forms a much greater part of the cliff than at E57/1

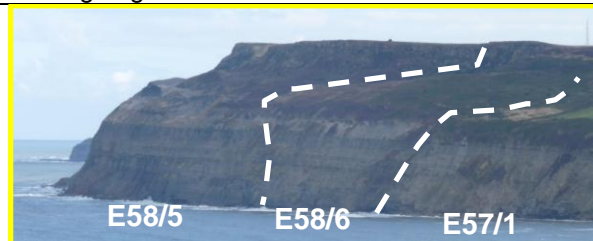
Unit 58/6, The Warren has vegetated upper slopes and lower slopes formed of quarry waste over natural cliffs (Locally Active).

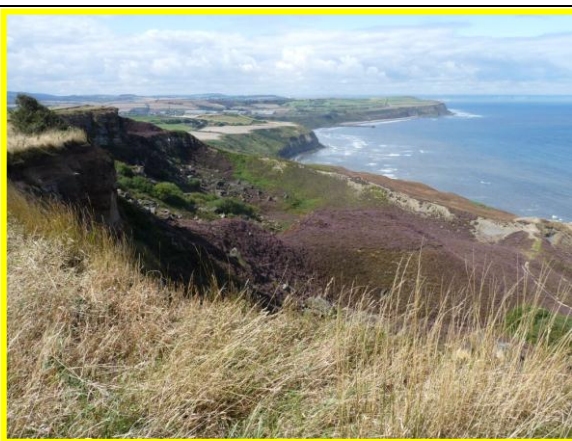
Unit 58/5 (West), Vegetated upper slopes and lower slopes formed of quarry waste over natural cliffs (Locally Active).

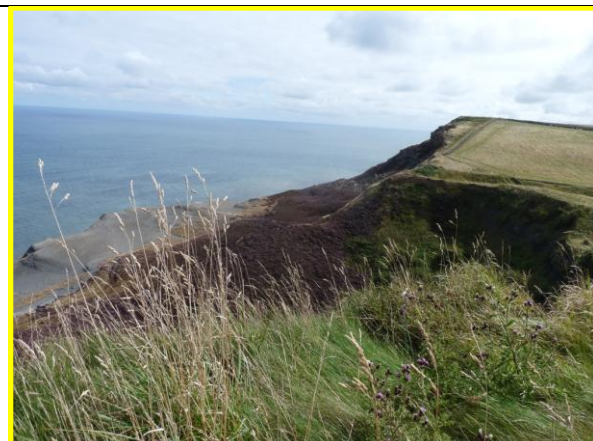
E56/5 (East) – Vegetated upper slopes and lower slopes formed of quarry waste over an active natural sea cliff.

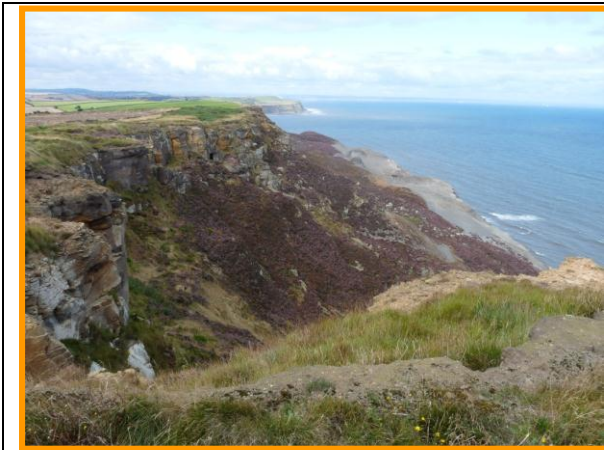
E58/4, Upper cliff has previously been quarries but is well vegetated. Lower cliff is actively retreating due to marine erosion (indicated by arrow). Upper cliff is Locally Active, lower cliff is Partly Active.

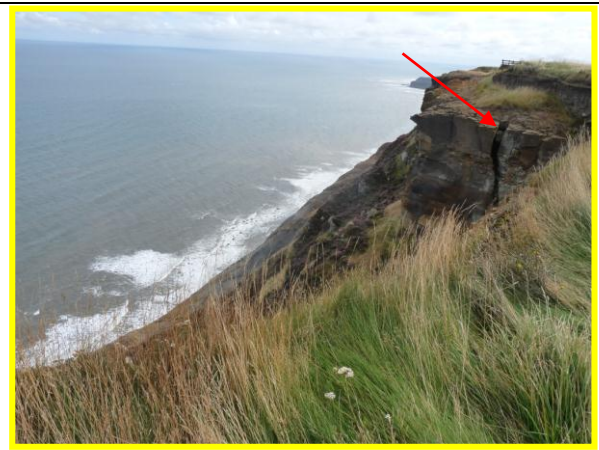
E58/3 The upper slope is Locally Active and the lower slope is Partly Active. Note the widely spaced joint indicated by the arrow – there were several locations in this section where there were local detachments of the rear scarp occurring.

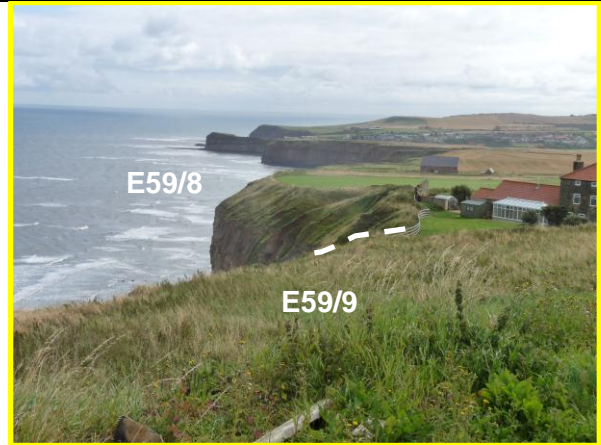
E59/9 (Locally Active) and E59/8 (Partly Active) – Limited activity at the cliff top in front of the cottages at Boulby which increases south-eastwards.

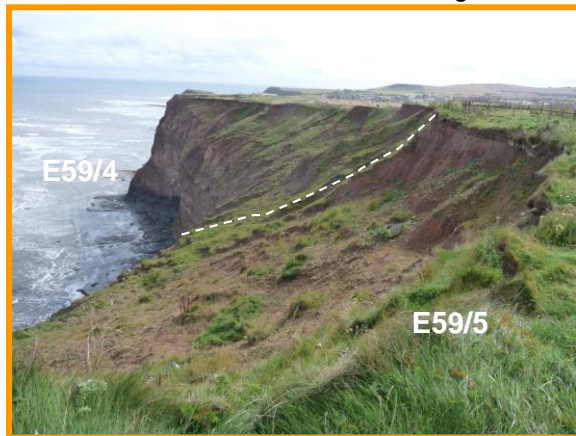
E59/5 and E59/4 Very active headscarp in till (Partly Active)

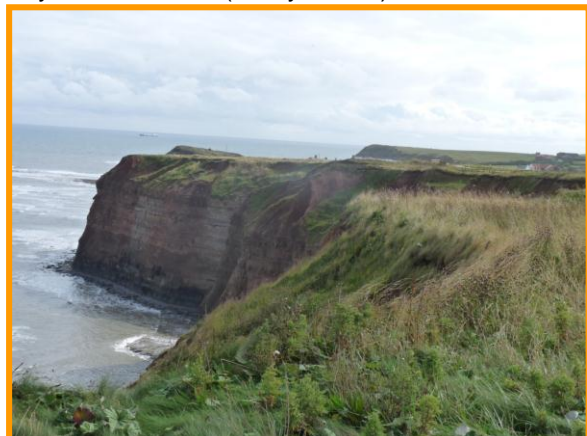
E59/3 lower cliff subject to marine erosion and cliff top actively receding (Partly Active)

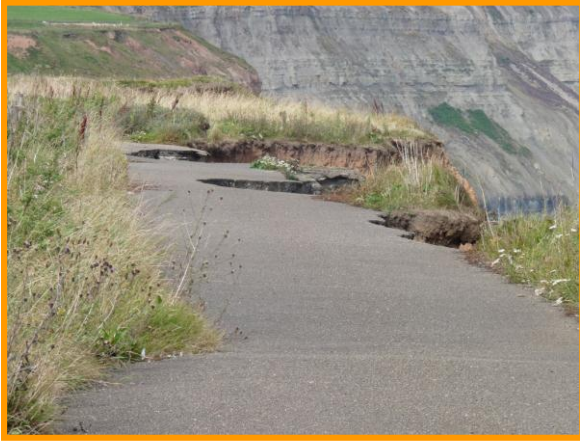
E59/3 ongoing recession of cliff top through old road (Partly Active)

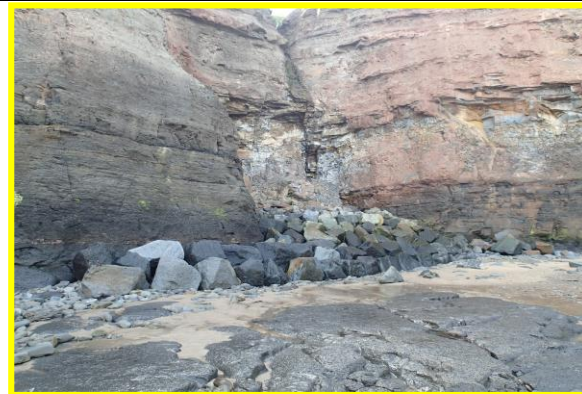
Although the NFCDD records show no specific coastal defence assets within this area there are two sections of rock armour that give some protection to the cliff toe adjacent to the pinch points next to the cottages on Cowbar Lane, constructed as part of the 2002 scheme at Staithes harbour. The rock armour was in fair condition, similar to that observed in 2012, and appears to comprise a mixture of imported granite and smaller locally sourced rock. The crest level is relatively low and the length of cliff protected short, so appears to be designed as an adaptive measure to slow the rate of erosion locally.

Western section of rock armour at cliff toe next to Cowbar lane Photo taken 12/09/2014 (Asset Ref No. 1221D901D0401C01)
