## **Cell 1 Regional Coastal Monitoring Programme Walkover Inspection Surveys 2016**

**Redcar & Cleveland  
Borough Council**

**September 2016**

## Walkover Inspection Surveys 2016

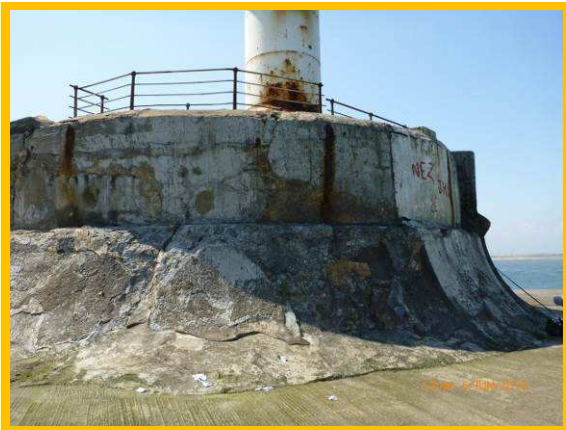
Northern extent of upper structure (/C0506C01)

Observed defects to the structure included extensive cracking and spalling, exposure of reinforcing steel, missing mortar/open joints, damaged render, missing masonry, undercutting and void formation beneath slag embankments, failure/collapse of historic western pier arm structure, damaged concrete Accropode units and rock armour units and displacement of/poor interlock between armour units. Multiple patchwork and ad-hoc repairs were evident throughout. As noted in previous surveys, a detailed survey of the structure is beyond the scope of the present inspections and a full structural survey of the breakwater is recommended in order to establish the full extent of the damage and identify any remedial works.

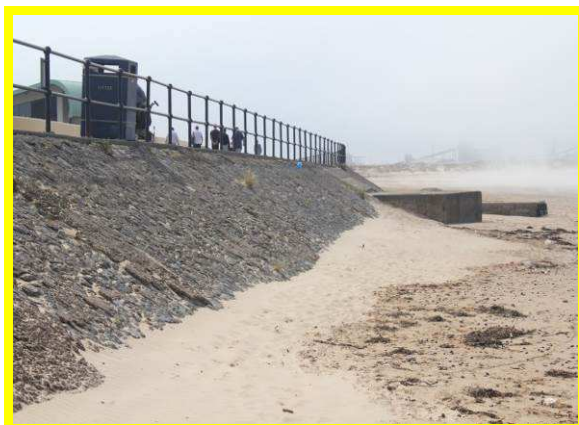
To the west of Redcar, defences comprise a concrete crest wall with grouted stone revetment fronting the promenade and car park. These remained in fair condition at the time of the inspections. Beach levels were slightly higher than in 2014 and may have obscured some of the defects previously identified, such as exposure/undermining of the northeastern extent of the wall and promenade, however local areas of damage and missing blocks were still visible. The concrete wall was generally in fair condition, with the approximately two metre gap towards the northeastern extent still present. Wind-blown sand was evident along much of the landward side of the crest wall.

*Grouted stone revetment (/C0601C01)*

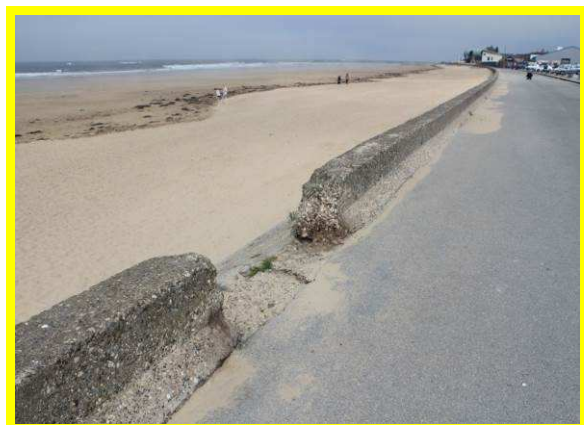
*Gap in concrete wall (/C0601C01)*

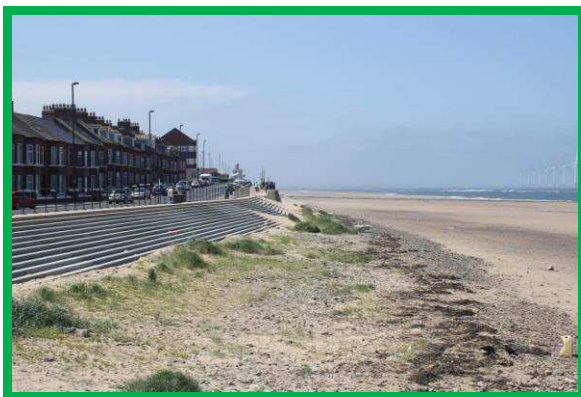
*South eastern extent of stepped concrete defences (/C0602C01)*

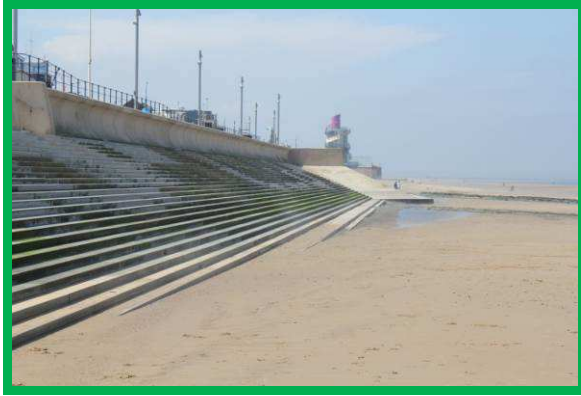
View looking north west – beach levels lower around access ramp and The Flashes rock outcrop (/C0602C01)

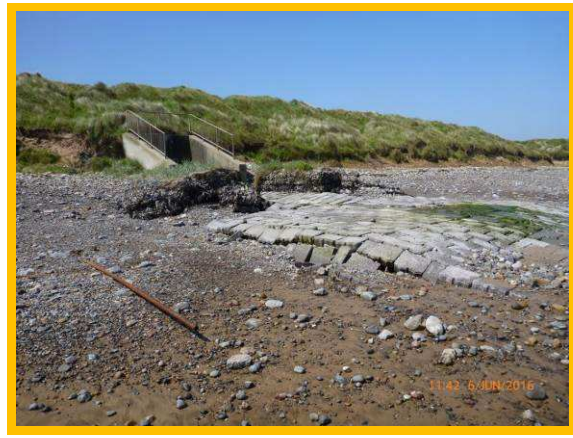
Concrete outfall structure (/C0701C01) CBU E52/10

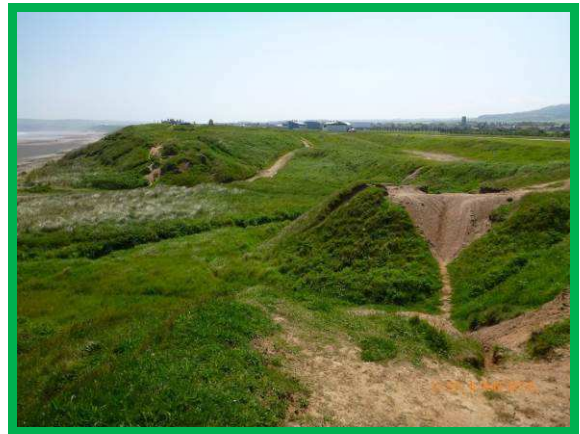
*View looking south east- erosion predominantly due to pedestrian access (/C0701C01) CBU E52/9*

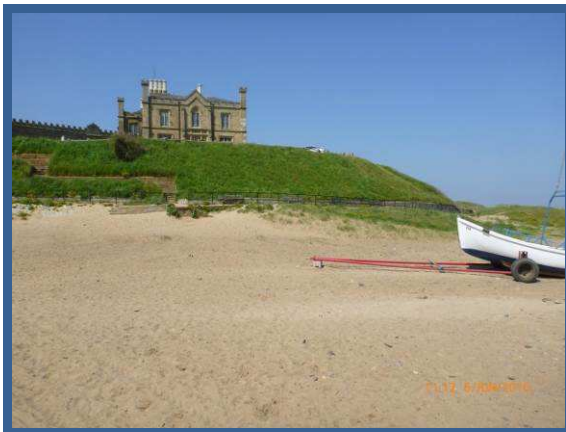
*Vegetated slope above masonry wall CBU E52/7*

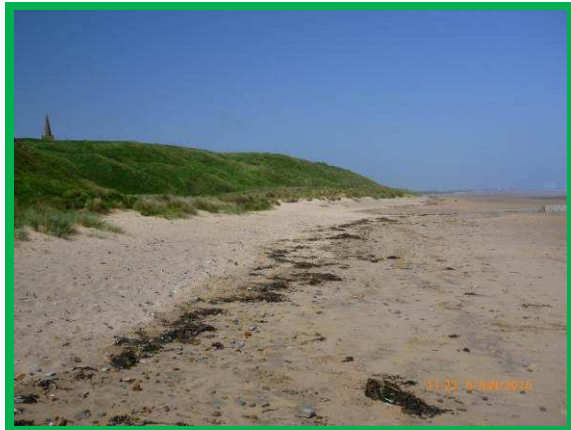
*View looking north east (CBU E52/6)*

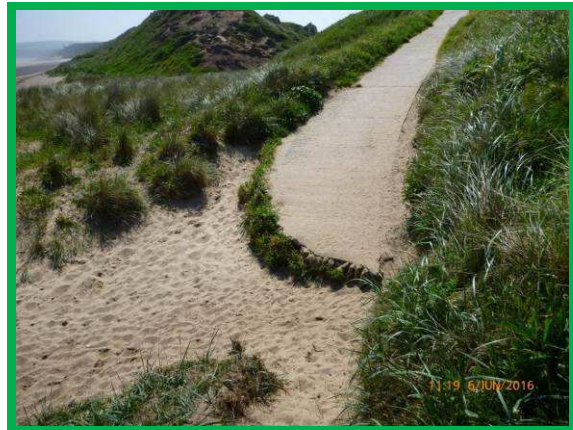
*Exposure of timber piles at foot of concrete footpath (CBU E52/6)*

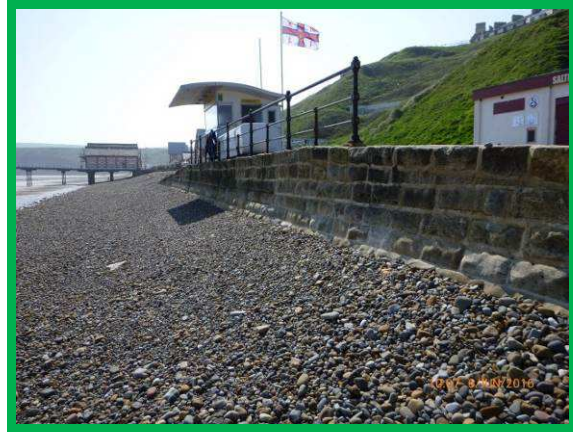
Exposed masonry at slipway (/C0702C04)

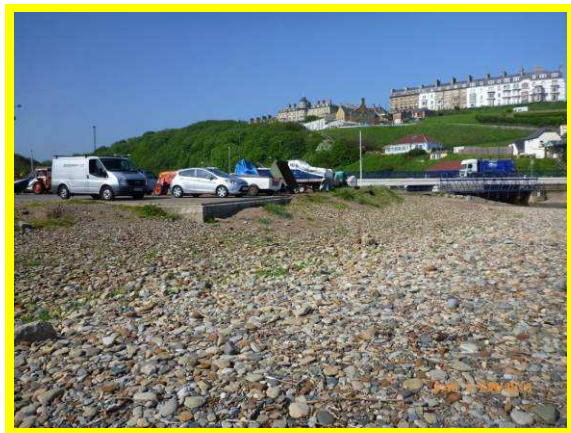
*Exposure of corner of car park (/C0704C02)*

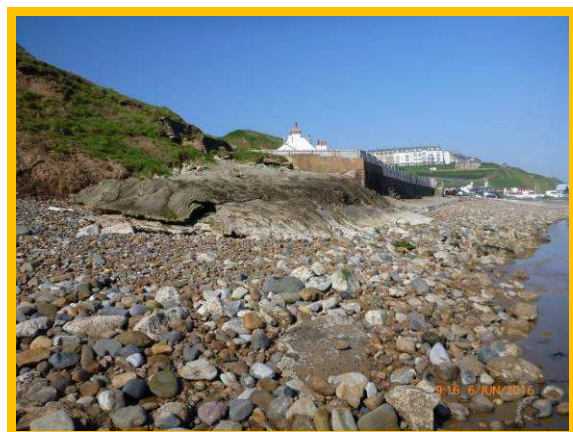
*Undercutting/voiding in in situ concrete apron (/C0704C05)*

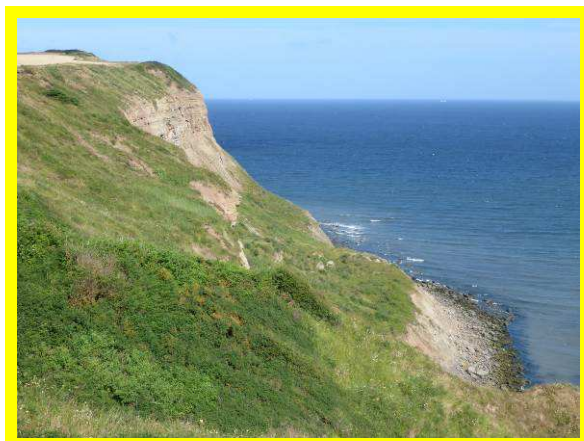
**E54/1** Vegetated layer of till, which sits above the Lower Jurassic bedrock (Locally Active)

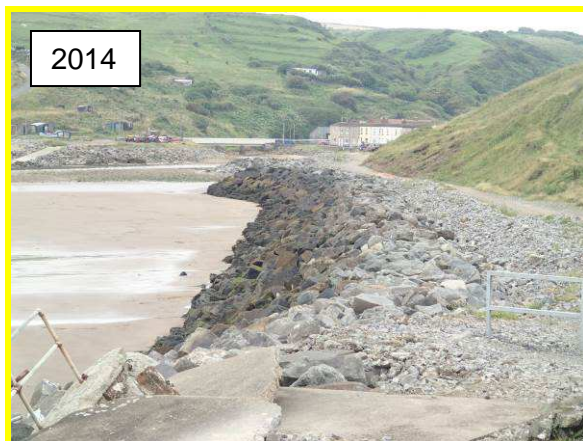
General view of revetment looking from Jetty towards village in 2014 (Asset Ref No. 1221D901D0202C01)

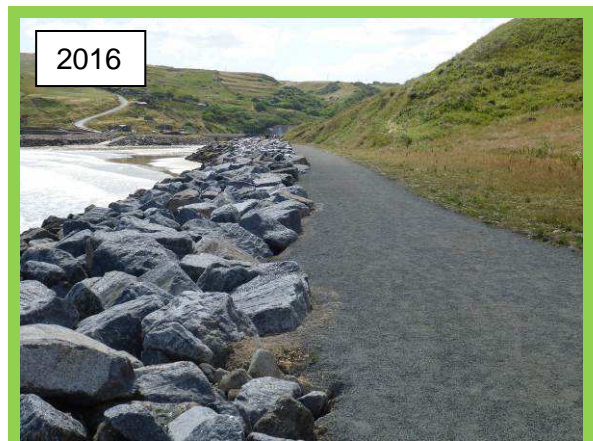
General view of modified revetment and surfaced path looking from Jetty towards village in 2016 (Asset Ref No. 1221D901D0202C01)
