## **Cell 1 Regional Coastal Monitoring Programme Walkover Inspection Surveys 2016**

**Scarborough  
Borough Council**

**September 2016**

## Walkover Inspection Surveys 2016

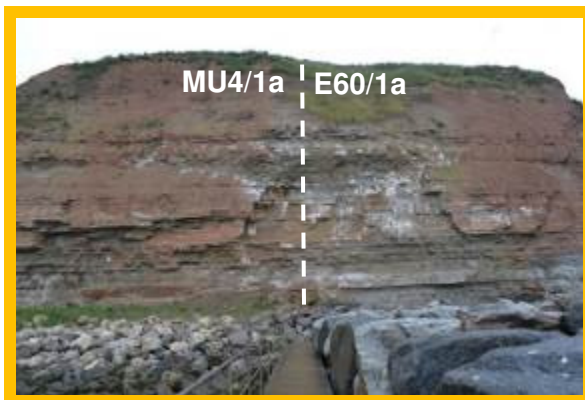
East-facing Cowbar Nab. E60/1a (right) and MU4/1a (left). Partly Active in June 2016

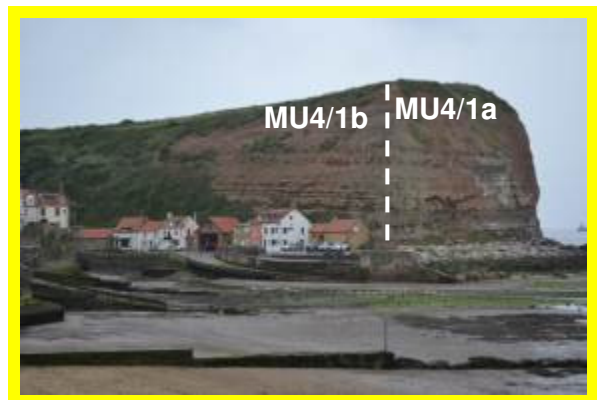
Unit MU4/1b is the south facing side of Cowbar Nab which runs adjacent to the north bank of Staithes Beck. This sandstone unit is sheltered from wave action behind the harbour walls. The cliff fails occasionally and is therefore classified as Locally Active, downgraded from Partly Active in 2014.

East-facing Cowbar Nab MU4/1a (right) (Partly Active in June 2016) and south-facing Cowbar Nab along Staithes Beck MU4/1b (left) (Locally Active in June 2016)

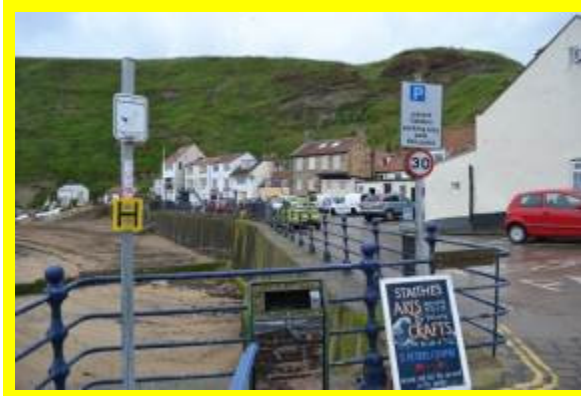
Unit MU4/2 is located behind Staithes Harbour. This sandstone cliff is well vegetated with small localised slumps and is classified as Locally Active, unchanged from 2014.

MU4/2 behind Staithes Harbour. Locally Active in June 2016

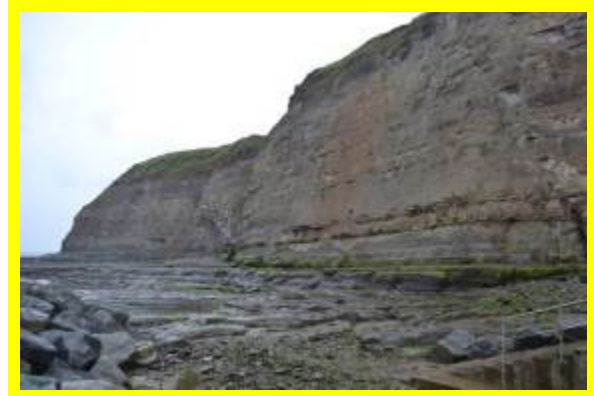
Further east, beyond the extent of Staithes Harbour is unit MU4/3. The cliffs are steep and the unvegetated sandstone is exposed to waves at its toes. This unit was classified as Partly Active in 2014, but is downgraded to Locally Active in 2016, because of the lack of evidence of significant continued activity.

Exposed sandstone of MU4/3. Locally Active in June 2016

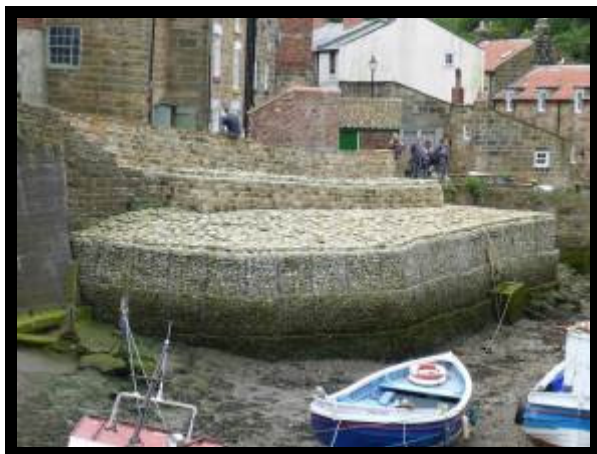
On the south side of the beck, a section of collapsed wall has been repaired by Scarborough Borough Council and is now protected with stone-filled gabion baskets through works completed in 2013.

*Works completed upstream of bridge in 2013 to repair collapsed wall (no asset ref)*

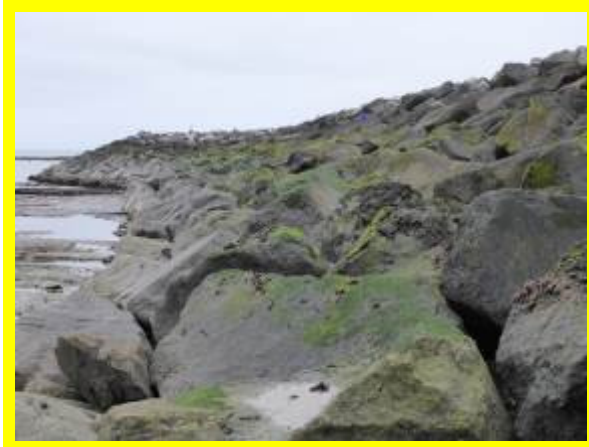
The North Breakwater (0402C01) is in fair condition overall, but certain elements are poor. The rock armour added in 2002 to the seaward face and wrapping around the end of the breakwater mostly remains tightly packed and in good condition. The missing crest blocks reported in 2014 have been replaced.

*Rock armour revetment on seaward face of North Breakwater (/0402C01)*

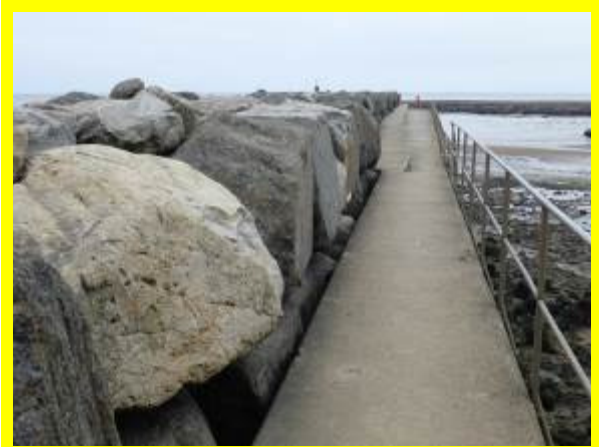
*Crest blocks and deck of North Breakwater (/0402C01)*

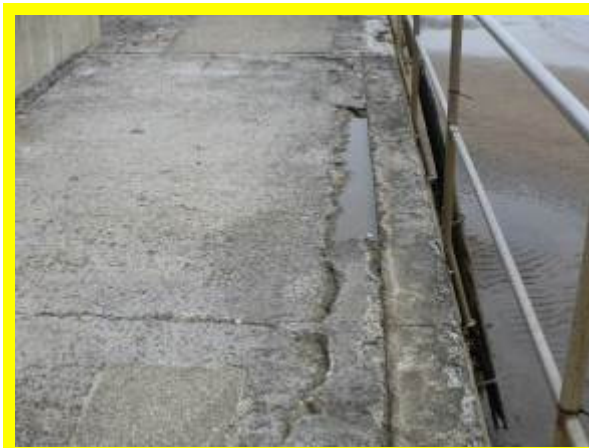
Part way along its length, the deck splits into two levels, with the lower level having cracking and abrasion in places. There is also abrasion, fairly heavily in localised patches, and rust-staining along parts of the inner-facing edge of the North Breakwater's deck and wall.

*Abrasion on lower deck of North Breakwater (/0402C01)*

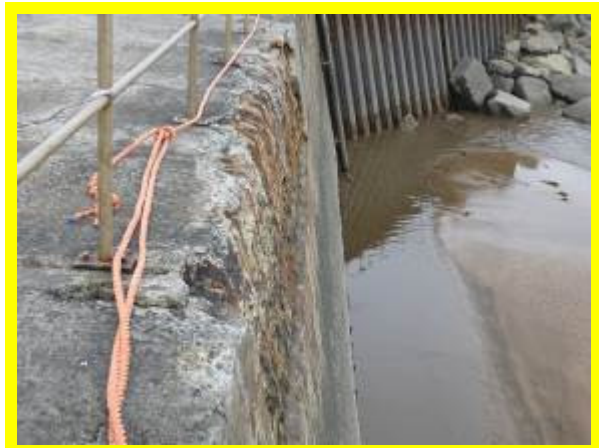
*Abrasion and rust-staining on inner-facing edge of North Breakwater (/0402C01)*

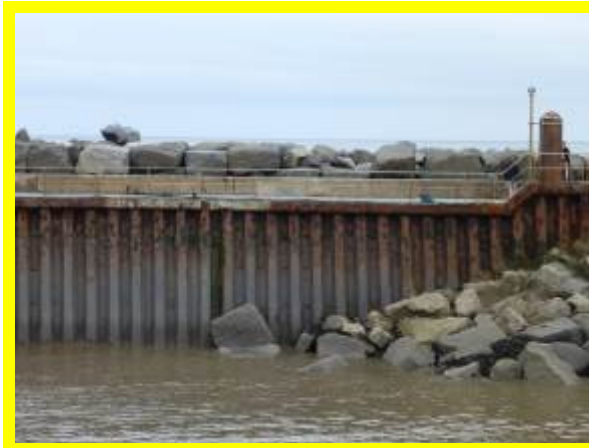
The sheet piling on the inner face of the east end of the breakwater is heavily corroded but the more major defect is undercutting to the inner-facing side of the North Breakwater wall.

*Corroded steel sheet piling on inner-face of North Breakwater (/0402C01)*

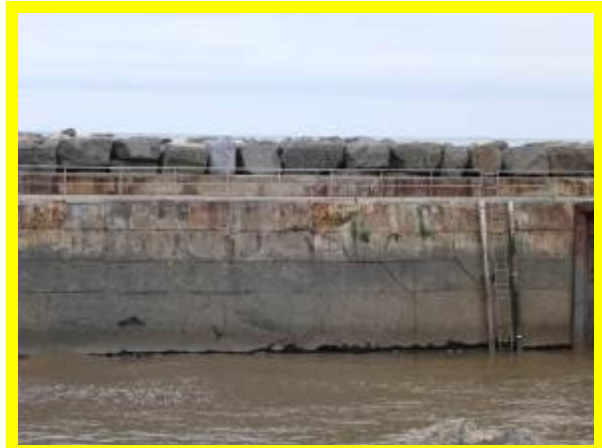
- The North Breakwater has undercutting on the inner-facing side, perhaps caused or exacerbated by propeller thrust.
- Some of the structures extending into the beck as either riverside walls or property walls are locally in poor condition, with notable gaps and voids, despite obvious previous repairs.

*Undercutting to a significant length of the inner-facing wall of North Breakwater (/0402C01)*

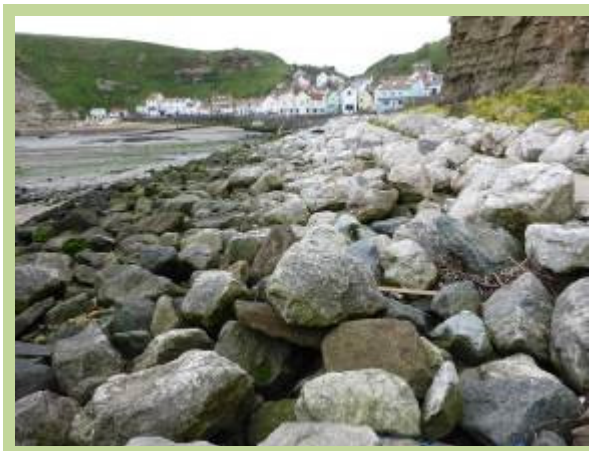
The rock armour defence running south from the North Breakwater to the end of Cowbar Lane (/0402C02) was constructed after the 2002 upgrade to the main breakwaters and is in good condition, with replacement of the previously displaced armourstones as noted across the pedestrian access deck near the root of the North Breakwater in 2014. The short section of seawall which is exposed at the southern end of the rock armour, adjacent to the slipway, is in fair condition.

*Rock revetment (/0402C02)*

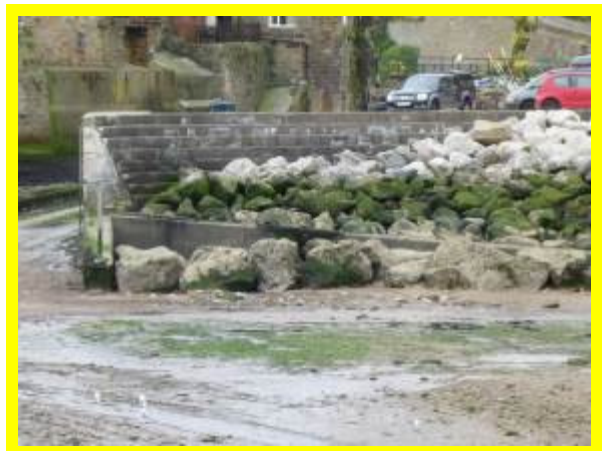
*Exposed section of wall south of rock revetment (/0402C02)*

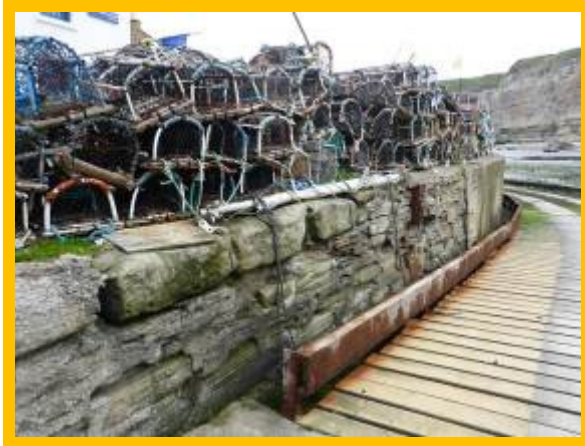
The defences that extend into the northern side of Staithes Beck are split into two asset lengths (/0402C03 and /0402C06), with the intersection at the west side of the RNLI slipway. The eastern section (/0402C03), which is in fair overall condition includes the slipway with gabion baskets beneath and a vertical concrete wall to the rear, tapering into a stone blockwork wall at the landward end of the slipway. The gabions are in a fair condition despite some settlement, but the stone wall is in poor condition along its length, with open joints between blocks and one hole caused by a missing block. The concrete wall to the rear of the slipway appears in fair condition along its landward section, but in poor condition further seaward with long longitudinal cracks and cold joints. The slipway itself is heavily covered in algae at its seaward end and is very slippery.

*Poor condition stone wall to rear of slipway (/0402C03)*

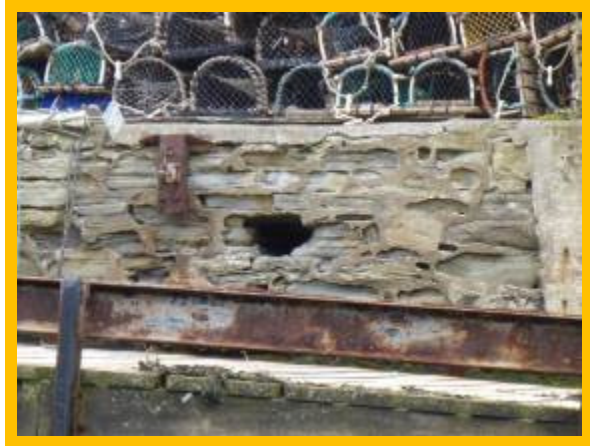
*Missing blockwork in stone wall to rear of slipway (/0402C03)*

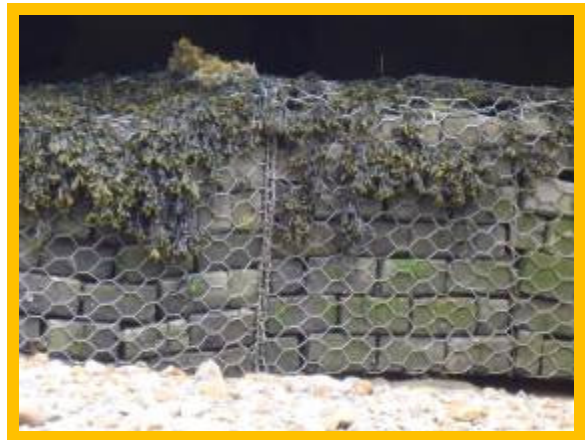
*Settlement of bricks in gabion baskets, but otherwise in generally fair condition (/0402C03)*

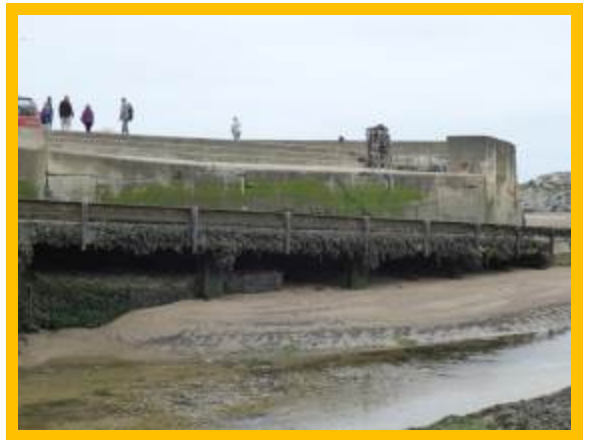
*Cracks and cold joints in concrete seawall to rear of slipway (/0402C03)*

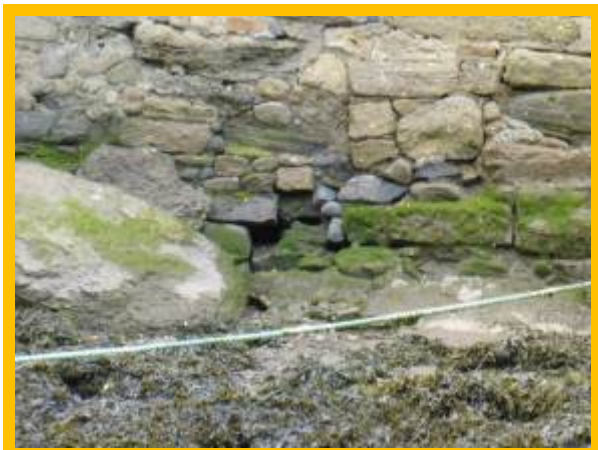
The walls between the RNLI slipway and the footbridge over Staithe Beck (/0402C06) are in a poor condition with missing pointing, settlement of blockwork and exposure of the toe. The small size rock toe protection that was placed as part of the 2002 works has been scattered in the beck or removed and no longer provides any protection. It is only the newly constructed wall immediately in front of the RNLI building that is in good condition, but there is a gap in the older stone blockworks wall at its interface with the newer wall which could compromise overall stability if voiding occurs behind.

*Wall on northern side of beck (missing blocks, open joints and voids) (/0402C06)*

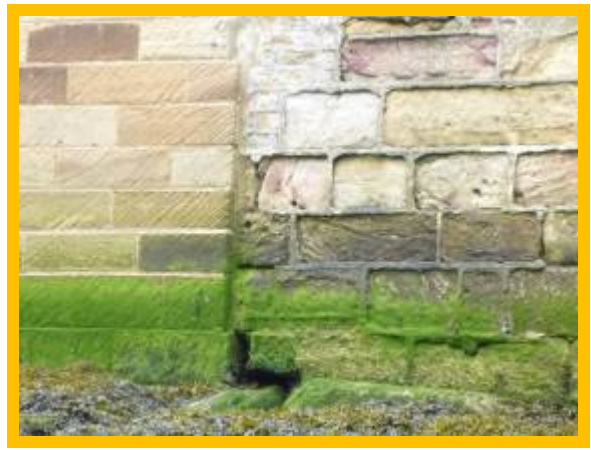
*Gap at base of interface between new and older walls in front of RNLI station (/0402C06)*

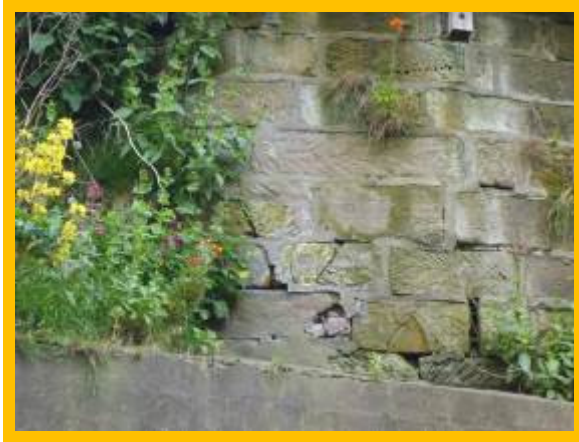
On the south side of the beck a hotchpotch of walls extends from the footbridge over Staithe Beck (/0402C04). Some of these have received previous repairs but whilst the walls generally remain in fair condition, locally this reduces to poor, with sections of loose blockwork, abrasion, cracking and vegetation growth in joints.

*Cracking, open joints and vegetation growth (/0402C04)*

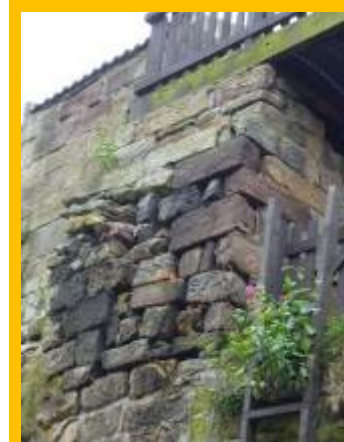
*Loose blockwork wall (/0402C04)*

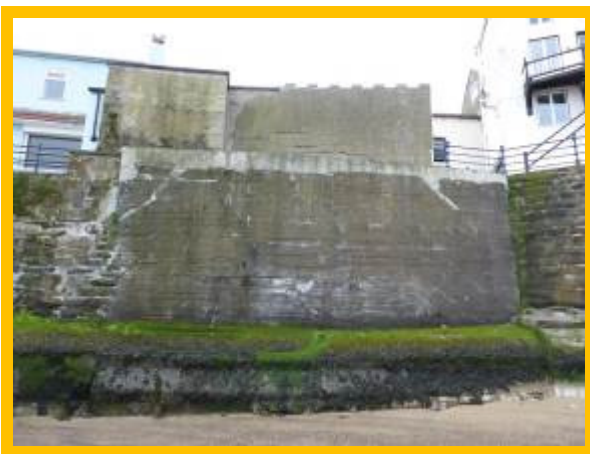
The walls continue as a series of masonry blockwork walls, often exterior walls of private properties (/0402C22), which continue to display visible loss of mortar causing open joints and missing blocks. It is recognised that some previous repairs have been undertaken, but deterioration continues. Although undercutting of the toe has previously been reported in several locations, exposing timber piling, this was not observed at the time of the present inspections.

*Cracking, open joints and vegetation growth (/0402C22)*

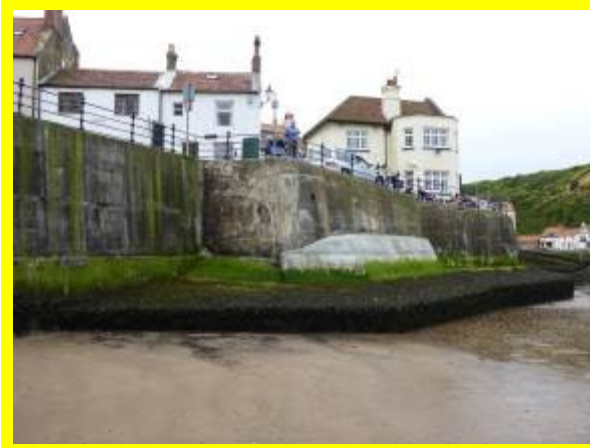
*Recent toe berm addition to wall west of Cod & Lobster (/0403C05)*

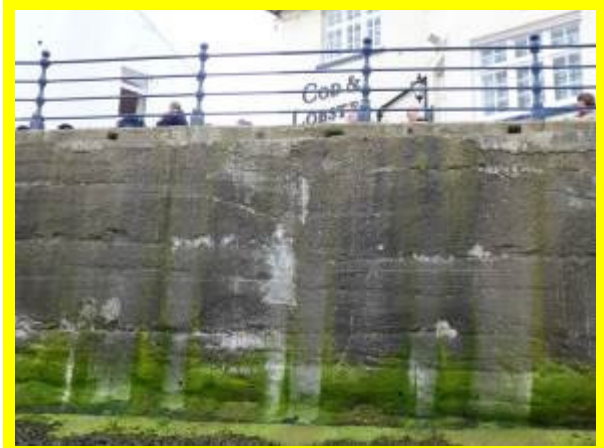
Whilst repairs and improvements have previously been undertaken a section of wall west of the Cod & Lobster (/0403C05), the wall remains heavily abraded and cracked in places, although in fair overall condition. There is notable cracking and loss of render at the interface between adjacent seawall sections. The concrete groyne (/0403C07) limiting sediment movement within the harbour is in fair condition.

*Abrasion and cracking to seawall face and crest (/0403C05)*

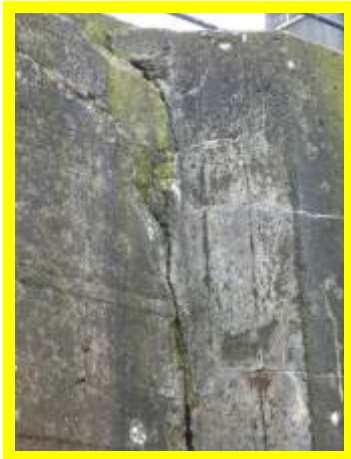
The seawalls extending to the Staithes Harbour Office (/0403C01 and /0403C02) are in fair condition, with previous repairs to cracks holding well. However, there is one full height vertical crack at the interface of adjacent wall sections which needs filling. The slipway and adjacent boat storage area at Staithes Harbour Office remain in good condition.

*Full height vertical crack (/0403C01)*

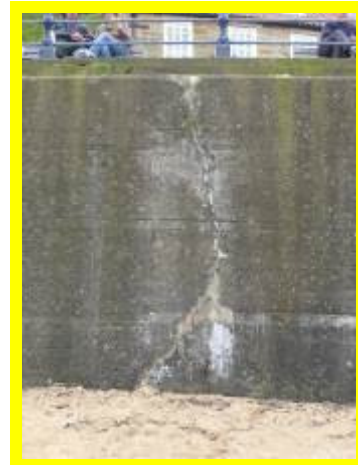
*Previous seawall repairs holding well (/0403C01)*

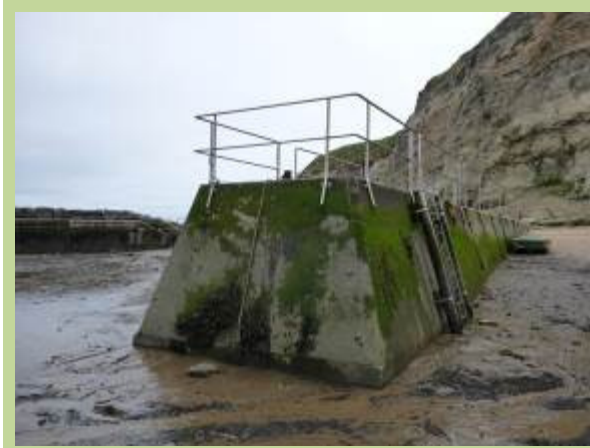
*Inner harbour concrete breakwater (/0403C04)*

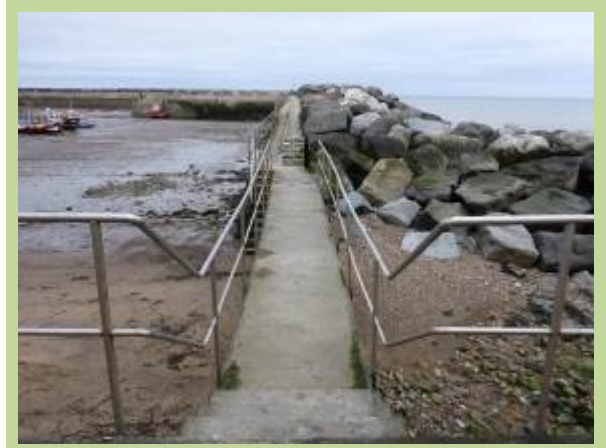
The inner harbour concrete breakwater (/0403C04) remains in good condition. The main South Breakwater of Stathes harbour (/0403C03) also is in good overall condition, although there is minor abrasion and spalling at the access steps and one local area of cracking at the edge of the deck and wall on the lower (inner-most) deck of the structure. The rock armour revetment appears to have had one or two blocks displaced as they remain scattered on the foreshore, but is otherwise in good condition.

*South Breakwater (/0403C03)*

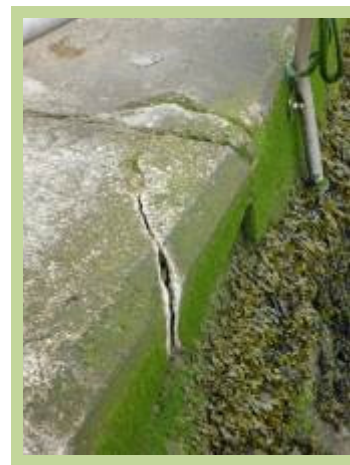
*Local cracking, but otherwise good condition (/0403C03)*

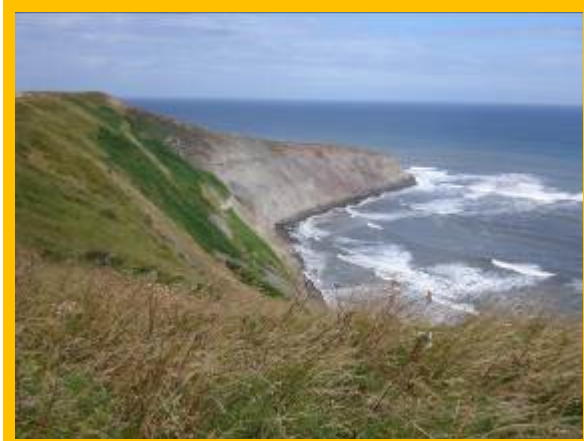
This section of cliff line remains classified as Partly Active in 2016, unchanged since 2012. Marine erosion is cutting into the hard stratified rock at the base of the cliffs. Some vegetation is supported on the upper slopes with exposed shales lower down showing evidence of on-going erosion. A number of small failures were noted in the centre of the management unit as coastal erosion continues.

**MU6/1** – Looking southeast across Brackenberry Wyke from Old Nab (Partly Active). August 2014.

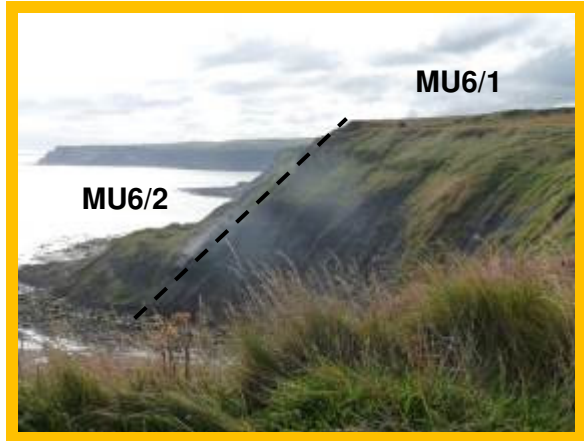
**MU6/1** – The eroding shales of the east facing side of Old Nab (Partly Active). The stabilised lobe of material in the background is MU6/2. August 2014.

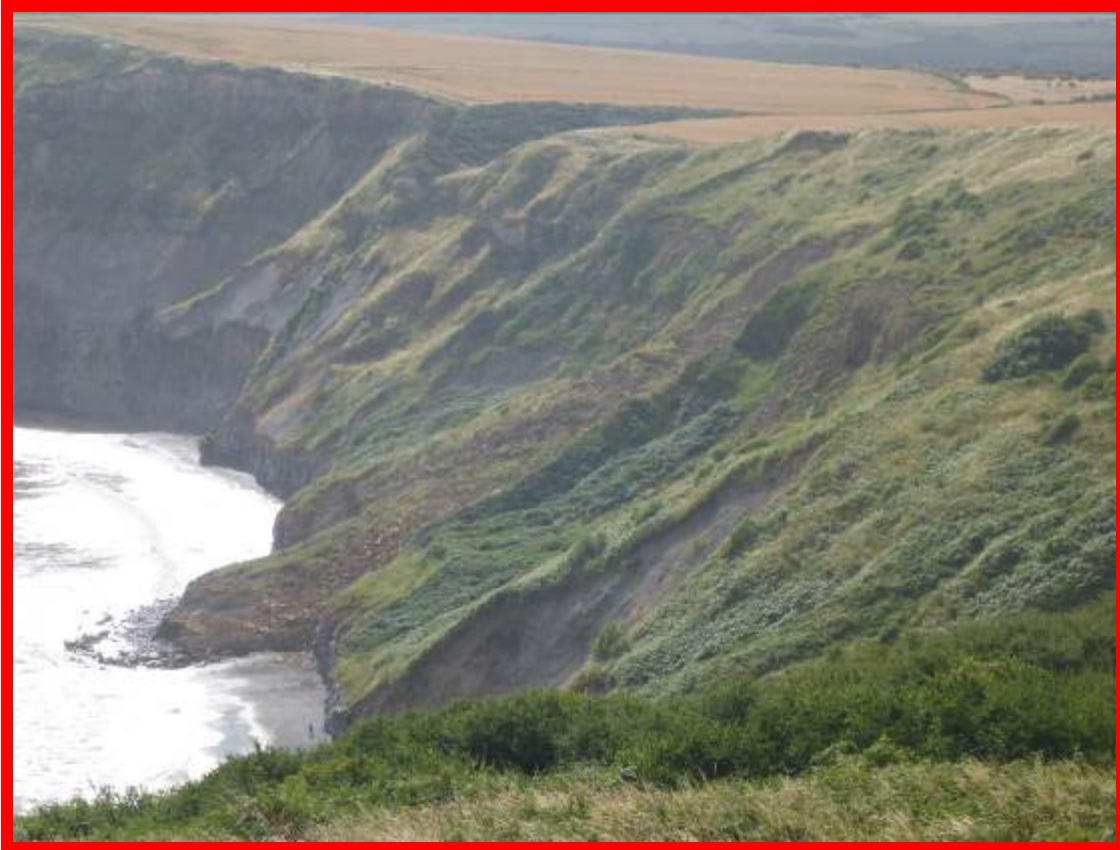
Unit MU6/5 is the most southerly cliff within this sub-management unit. It was characterised in 2014 by well-vegetated slopes with local areas of activity on the steeper, lower slopes, and classified as Locally Active in 2014. However, a few months prior to the August 2016 inspections, a large landslide occurred within the unit, rendering the public footpaths unsafe. The North York Moors National Park has closed off the site to public access by signage at each of the three access points to Port Mulgrave foreshore but despite this fishermen are regularly seen fishing from the dilapidated jetty.

**MU6/5** – View of the landslip looking across Port Mulgrave from west to east (Totally Active)

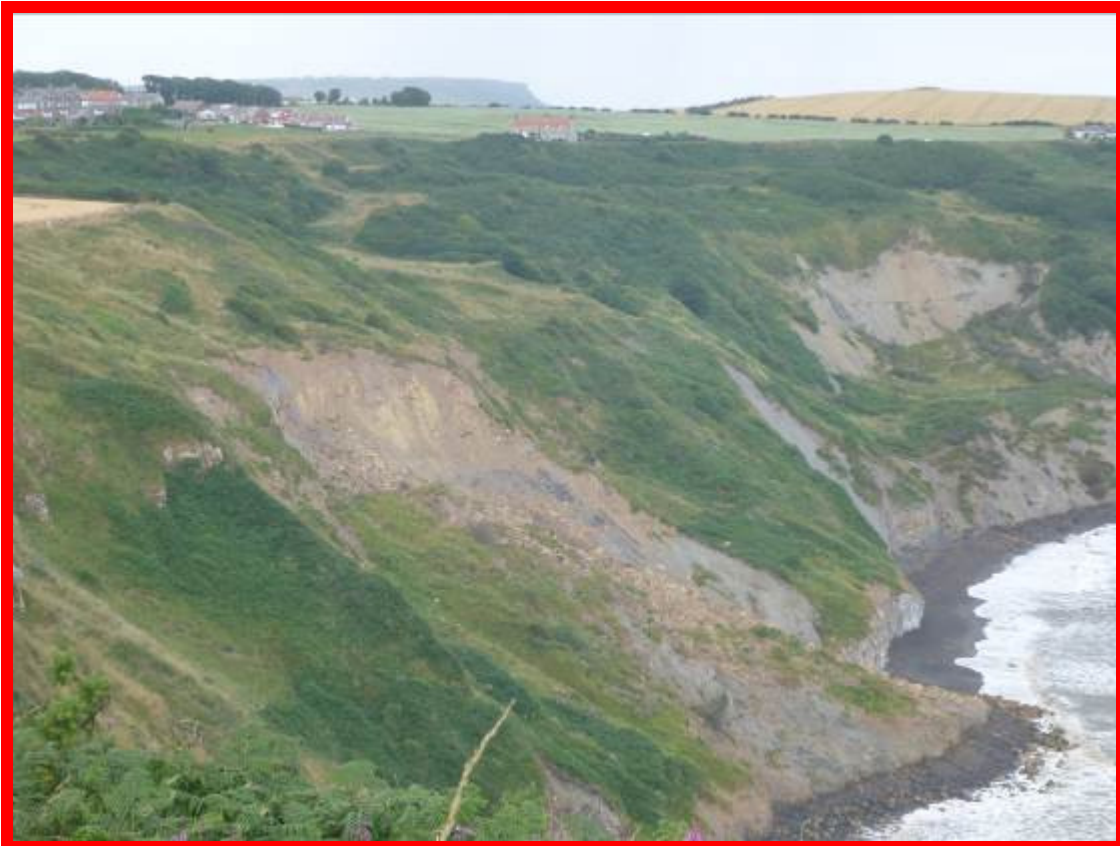
**MU6/5** – View of the landslip looking across Port Mulgrave from east to west (Totally Active)

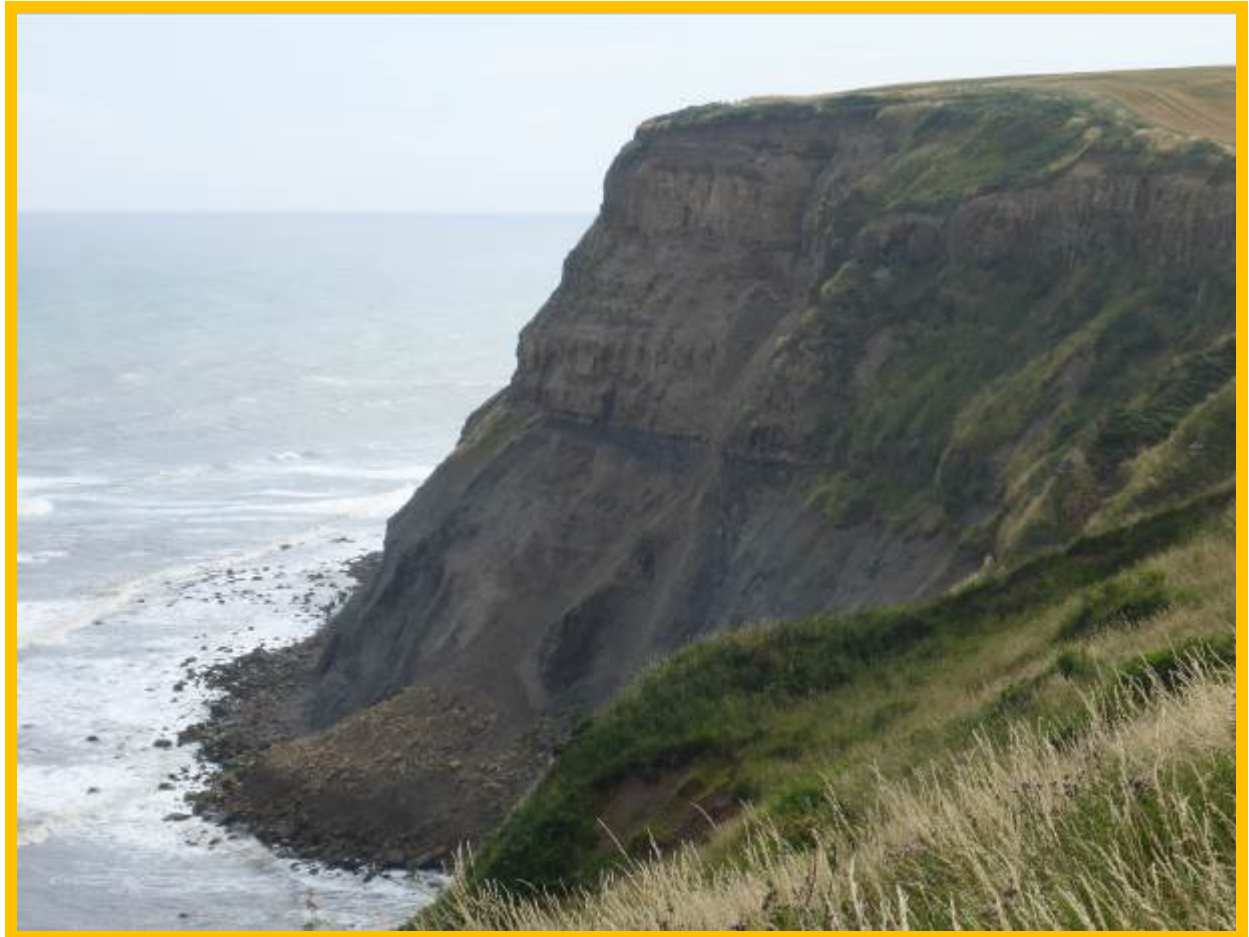
**Unit MU6/6** forms the northern part of the Lingrow Cliffs. The upper slopes support some vegetation cover while lower slopes are actively eroding. The unit continues to be classified as Partly Active in 2016 following a localised rock fall that has occurred since the previous inspections.

**MU6/6** – Localised rock fall (Partly Active)

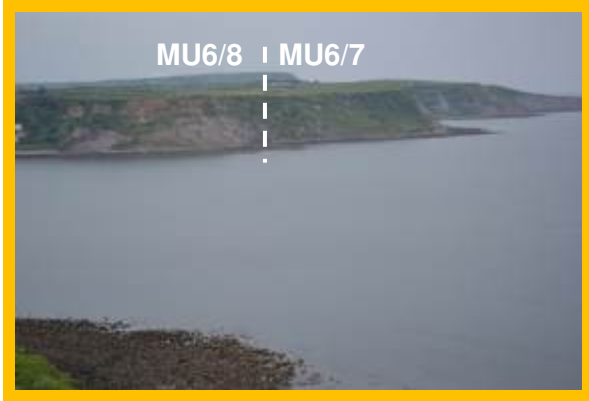
**Unit MU6/7** forms the central part of this sub-management unit and consists of a large relict debris run-out lobe. The cliff is well-vegetated with only localised activity at the toe. It remains classified as Locally Active in 2016, unchanged since 2002.

Unit MU6/8 is located north of the northern end of Runswick Bay seawall. The main bulk of the cliff is mudstone capped by sandstone. The main mudstone part of the cliff is vegetated in its upper part and is eroding in its lower part with debris fans splayed across the toe and occasional rock falls at the base. The sandstone top is a vertical unvegetated cliff. The activity in the mudstone cliff means the unit is classified as Partly Active in 2016, the same as 2014.

MU6/7 (right) and MU6/8 (left)  
(Partly Active in June 2016)

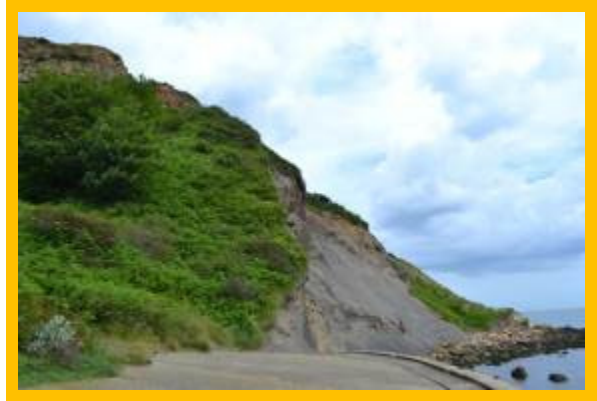
Debris fan at south end of MU6/8.  
(Partly Active in June 2016)

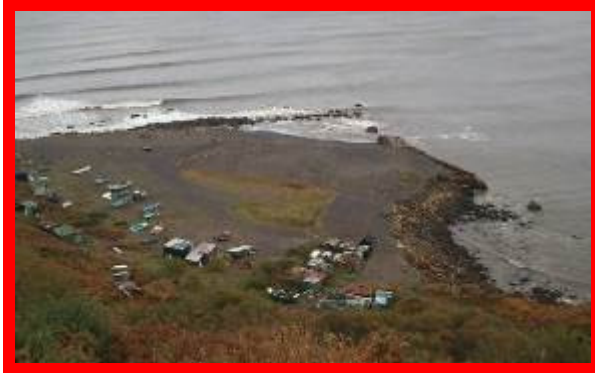
The jetty of the former port and ironstone mine at Port Mulgrave has been derelict for many years and is considered to be redundant. Virtually all coastal defences have been lost to the sea. What is left of the southern breakwater is undergoing large scale cracking, deformation, undercutting and outflanking. It is estimated that more than half of its original length has now been eroded (\0502C01).

Overview of asset in 2012 (\D0502C01)

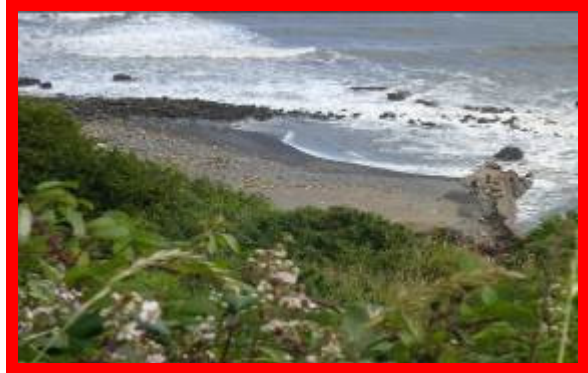
Overview of asset in 2016 (\D0502C01)

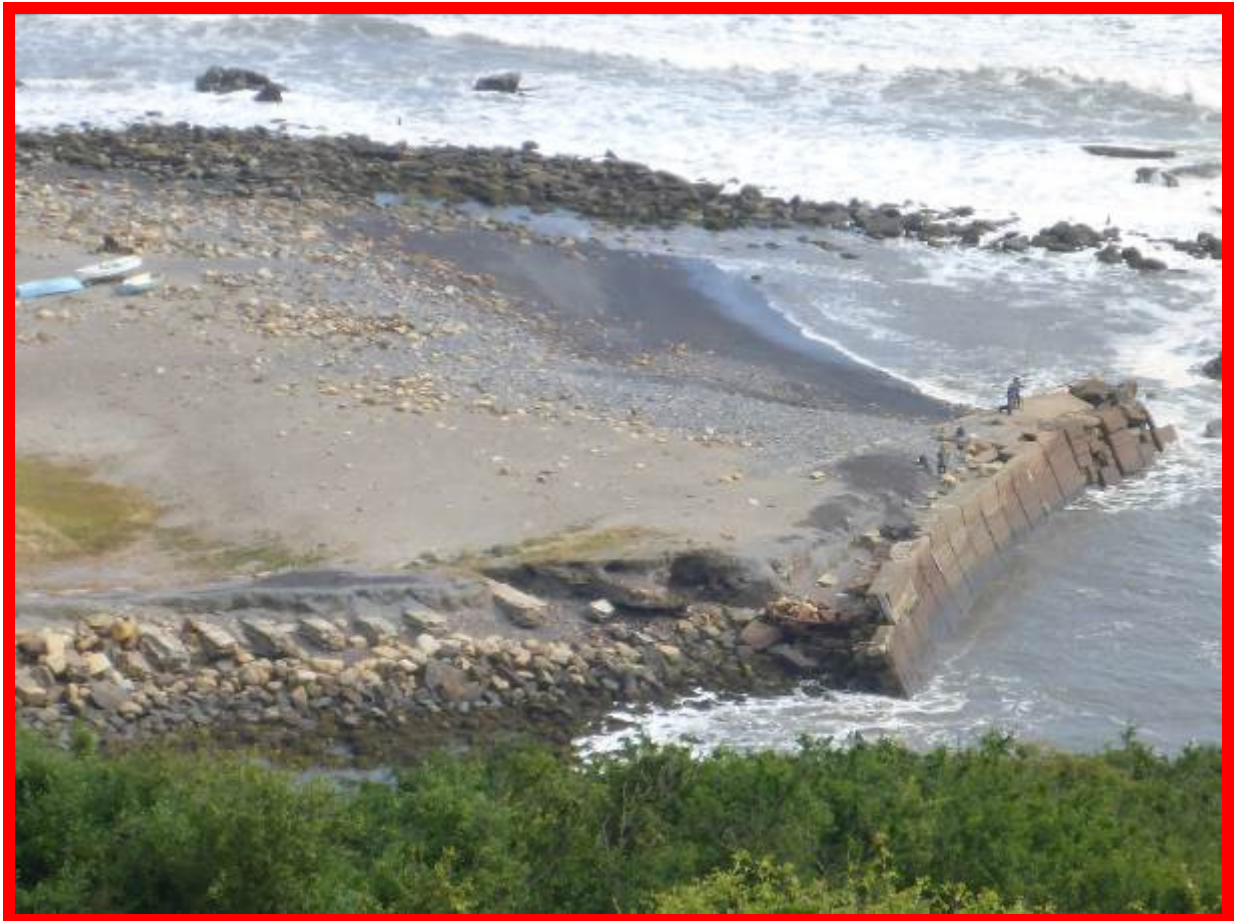
Dilapidated asset in 2016 (\D0502C01)

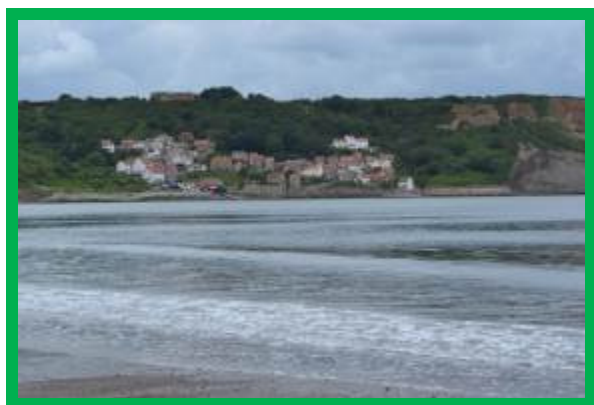
Unit MU7/1 includes Runswick Bay village and the adjacent glacial till slopes. It is well vegetated and defended at the toe by seawalls and rock armour. This unit is classified as Dormant in 2016, unchanged since 2014.

Slopes of Runswick Bay village. MU7/1  
Dormant in June 2016

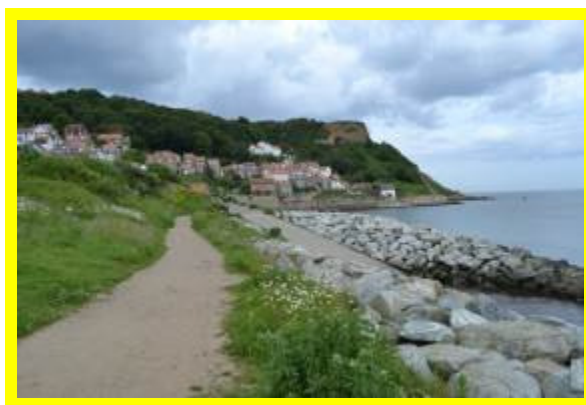
Unit MU7/2 occupies the area adjacent to and south of Runswick Bay village. It is well vegetated glacial till and defended at the toe by rock armour. This unit is classified as Locally Active, the same as 2014.

MU7/1 (background) (Dormant in June 2016)  
and MU7/2 (foreground) (Locally Active in June 2016)

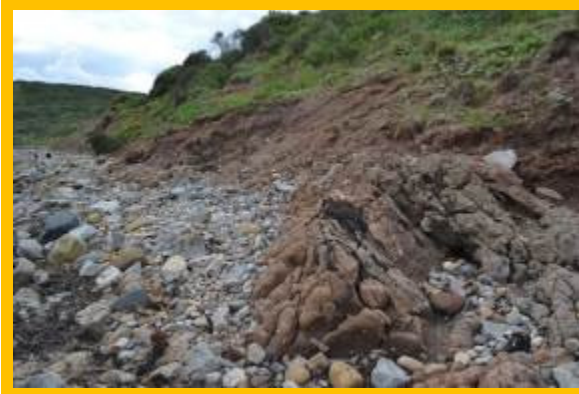
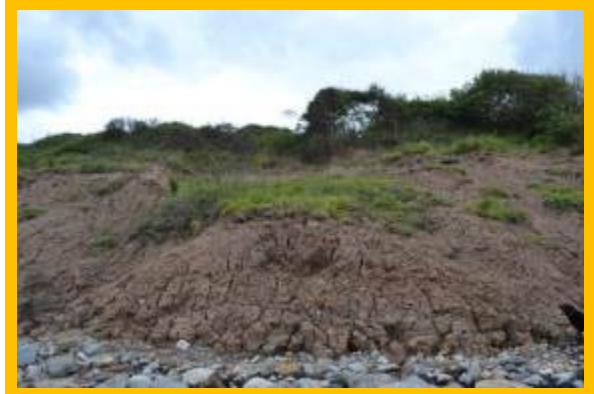
Unit MU7/3N is adjacent to and south of the southern end of Runswick Bay sea defences and comprises glacial till forming a landslide complex down to beach level. The cliff slope is relatively shallow and well vegetated and erosion is occurring along the active toe. Mudslides and shallow slumps are evident at the top of the beach. Due to this activity, this unit is upgraded from Locally Active in 2014 to Partly Active in 2016. Unit MU7/3S is a similar geomorphology to unit MU7/3N, but the till is well vegetated almost to beach level. There is little evidence of significant activity at the toe, and so is classified as Locally Active, the same as 2014.

Active toe of till cliffs in Runswick Bay. MU7/3N  
Partly Active in June 2016

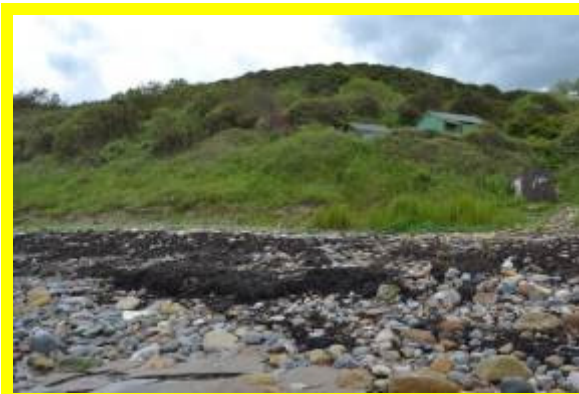
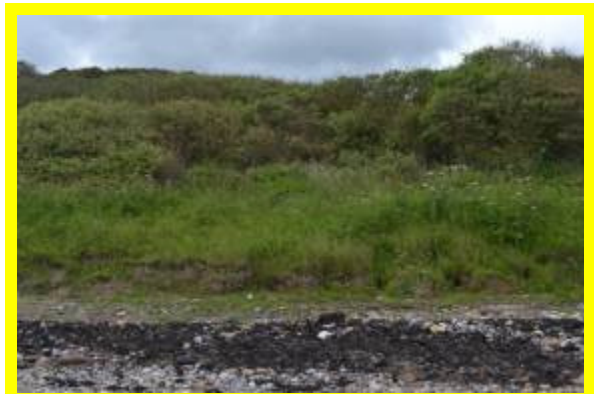
Well vegetated till in Runswick Bay. MU7/3S  
Locally Active in June 2016

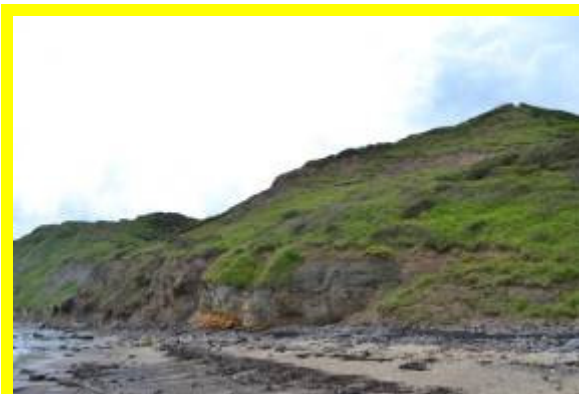
MU7/4 consists of a steep unvegetated cliff toe composed of mudstone behind which are shallower well-vegetated mid to upper slopes of till with local slumping. The cliff toe is generally steep but there is little evidence of recent activity, and so the unit is classified as Locally Active, unchanged since 2014.

Steep mudstone cliffs with overlying shallower  
sloping till with local slumps. MU7/4 Locally  
Active in June 2016

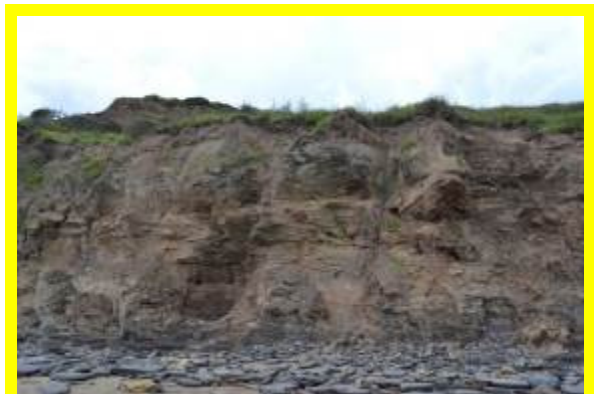
Steep cliff toe of mudstone. MU7/4 Locally  
Active in June 2016

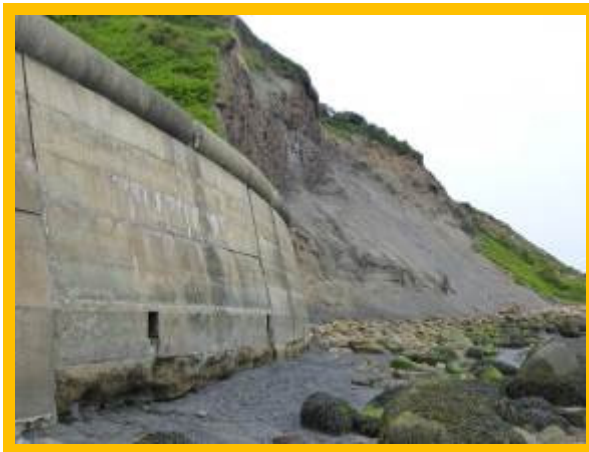
The most northern sea wall (/0601C01) is suffering from very heavy surface abrasion on its facing, as well as at both the toe and capping beam. Undercutting has led to small hole formation in places and erosion of the undefended cliffs to the north presents a risk of outflanking of the wall. Further defects include wash out of the joints under the capping beam and vertical cracks through the wall. The wall has been in this (fair to poor) condition since the time of the first Cell 1 Regional Coastal Monitoring Programme inspections in 2009 and is due to be refurbished as part of future capital works.

*Sea wall with undermining, surface cracks and heavy abrasion – note erosion of undefended cliffs to north (/0601C01)*

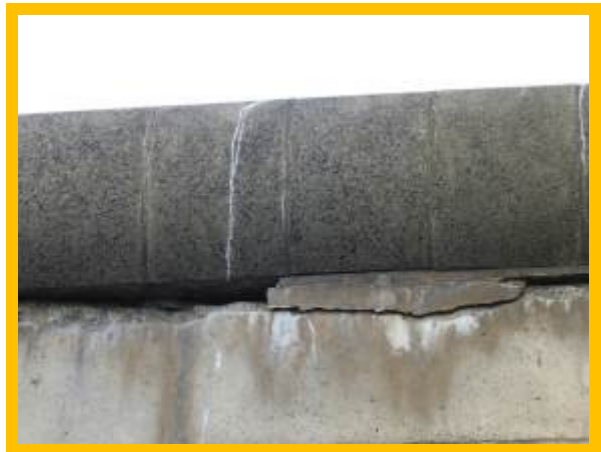
*Wash out of joints under the capping beam (/0601C01)*

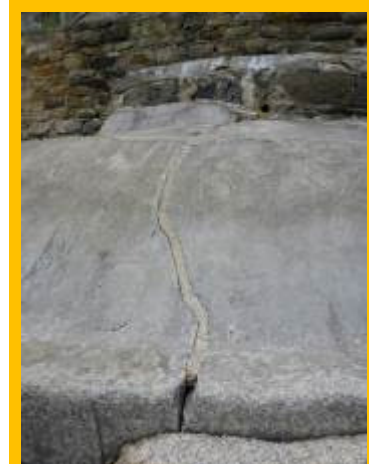
Moving south, the protruding section of wall (/0601C06) protecting the thatched cottage is in fair to poor condition. There are signs of repairs to the large vertical cracks in the wall and toe apron. However there are cracks remaining in the top of the concrete bagwork part of the wall. The concrete casing protecting the sewer pipe by the outfall of Runswick Beck is in undermined and failing condition, but the sewers are due to be relocated by Yorkshire Water as enabling works for the placement of the rock fillet in front of the sea wall.

*Previous repairs to crack in toe apron are holding well (/0601C06)*

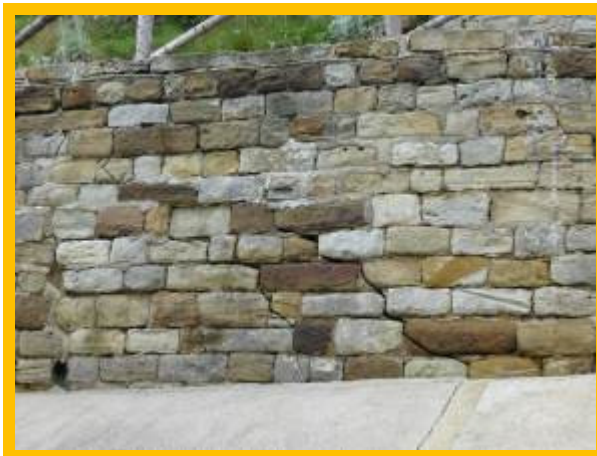
The toe apron continues below a stone wall and exhibits signs of notable longitudinal cracking in the concrete. The stone wall itself also shows signs of diagonal cracking, open joints, missing blocks and loose coping.

*Diagonal cracking in stone wall (/0601C06)*

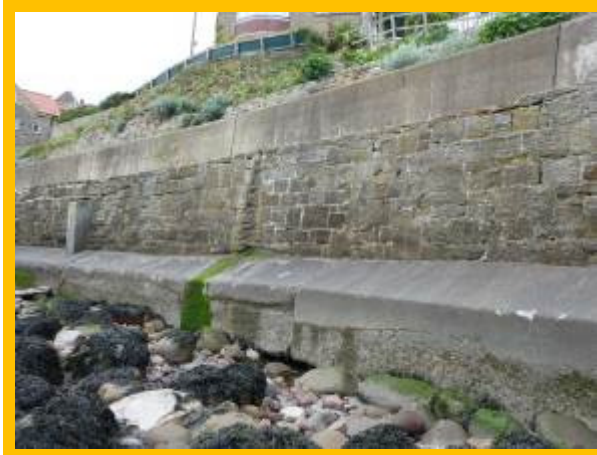
The main length of sea wall below the properties (0601C03) is in variable condition. Although there are signs of previous repair works there are significant cracks and open joints remaining in the wall and undercutting of the toe in several locations.

*Undermining, cracking and open joints in sea wall (/0601C03)*

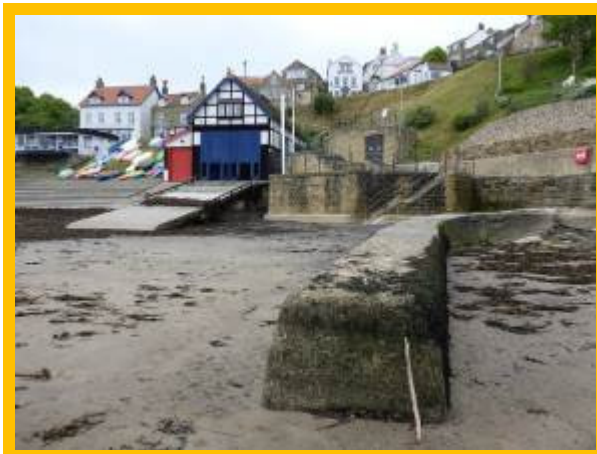
The concrete breakwater or groyne (/0601C02) to the north of the pumping station and old RNLI slip continues to be actively breaking up on both sides and remains in poor condition.

*Undermining, cracking and open joints in sea wall (/0601C02)*

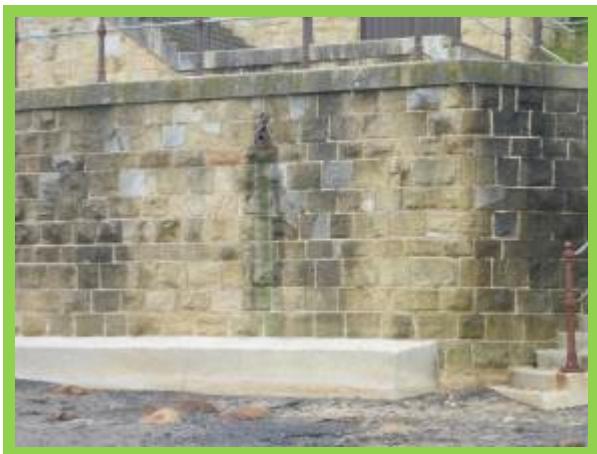
The sea wall around the recently built pumping station remains in good condition (/0601C07), with the slipways and boat storage area associated with the RNLI building (/0601C04) in good condition. The timber slipway was repaired following damage in the December 2013 storms.

*New seawall around pumping station (/1003C07)*

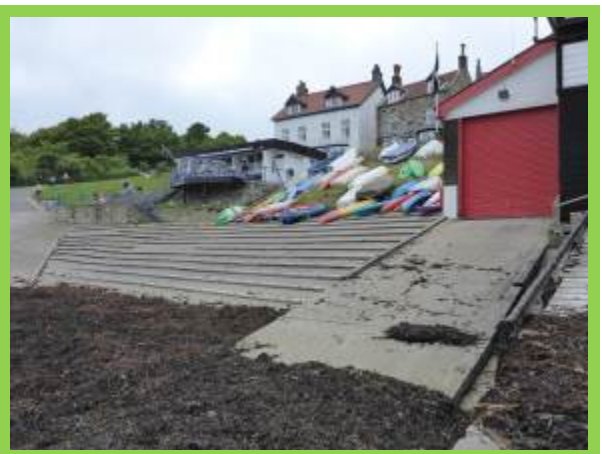
*RNLI slipway and adjacent boat storage (/1003C04)*

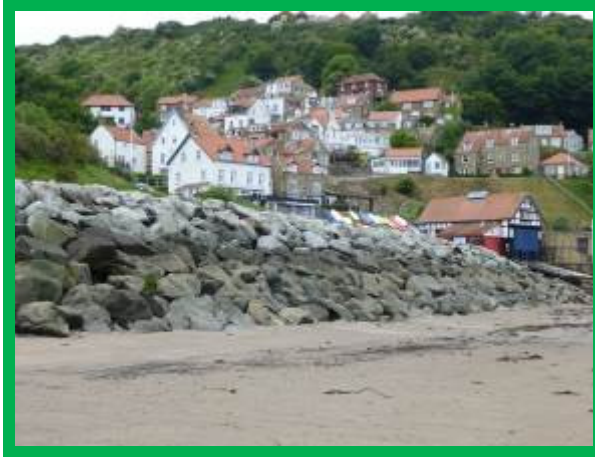
The rock armour defences (/0602C01) remain generally in very good condition, with the rocks tightly packed with good coverage. However, there is ongoing erosion of the undefended cliff at the southern end of the defence which should continue to be monitored for signs of outflanking of the revetment.

*Rock armour revetment (/0602C01)*

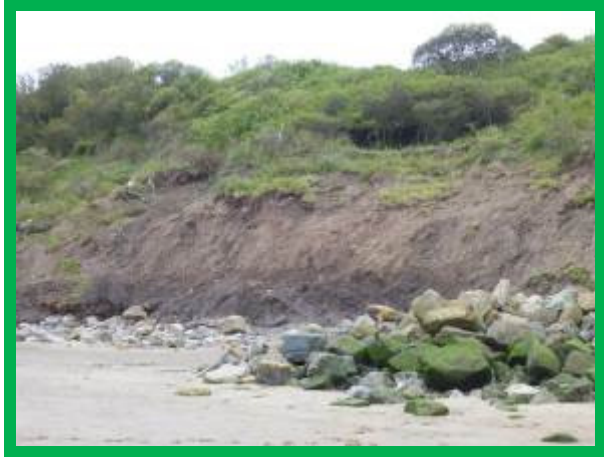
*Active cliffs near southern end of revetment (/0602C01)*

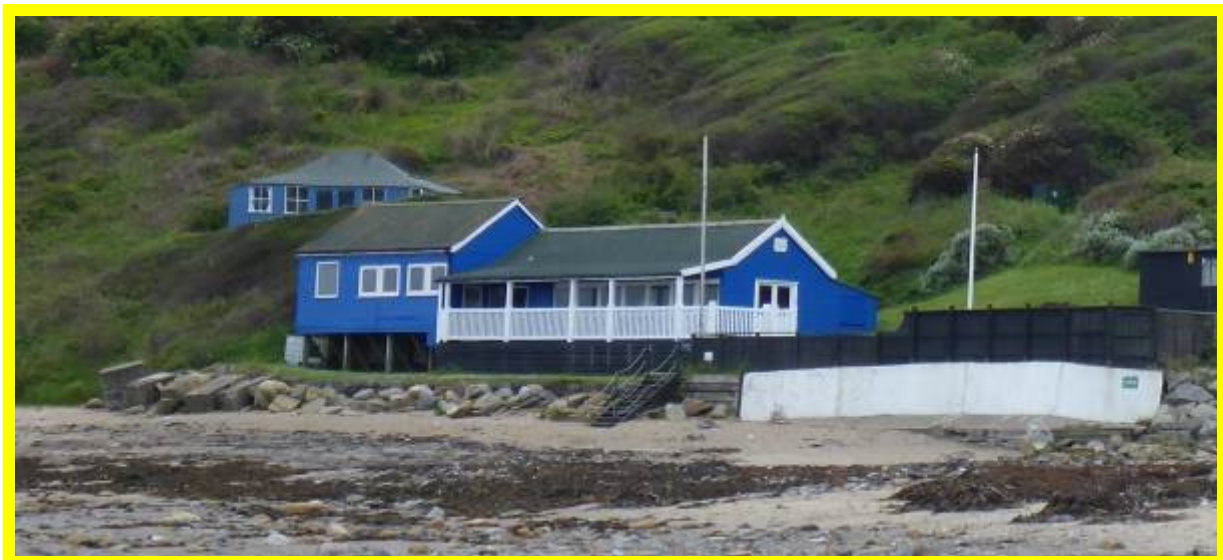
The Sailing Club is located in the bay some 600m south of the village, where the beach is wider. It has been constructed on timber struts and features a mix of coastal defences (/0602C05). A number of boulders and concrete blocks have been placed in front of the timber sleeper retaining wall defences which protect the main building since the previous inspections. This defence, and the white-washed wall to the north, are both in fair condition.

*Sailing Club defences (/0602C05)*

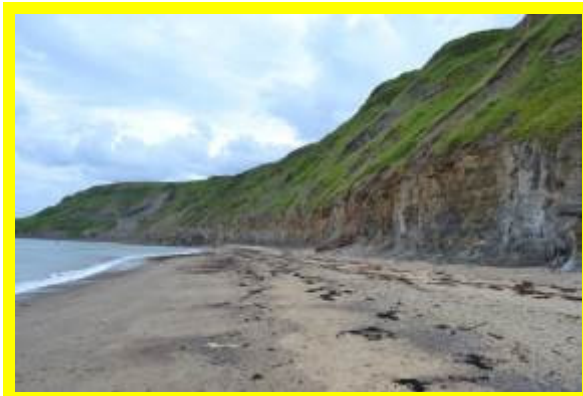
Steep mudstone cliffs with overlying shallower sloping till with local slumps. MU8/1 Locally Active in June 2016
