## **Cell 1 Regional Coastal Monitoring Programme Walkover Inspection Surveys 2016**

**Scarborough  
Borough Council**

**September 2016**

## Walkover Inspection Surveys 2016

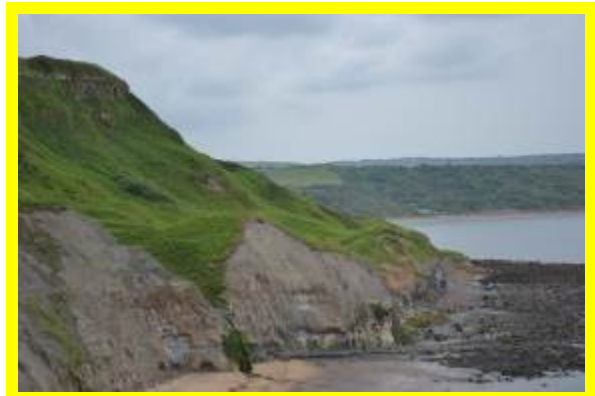
Relict debris run-out lobe. MU8/2 Locally Active in June 2016

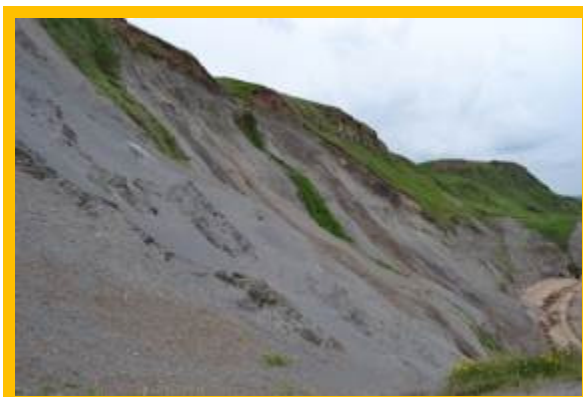
MU8/3 is located in front of the village of Kettle Ness. The cliff is high and steep with only the very top part covered in vegetation. The cliff slope comprises large debris flows, which extend as fans from near the cliff top to the toe, and slumps. This level of activity means this unit is classified as Partly Active, the same as 2014.

Steep cliff with debris flows. MU8/3 Partly Active in June 2016

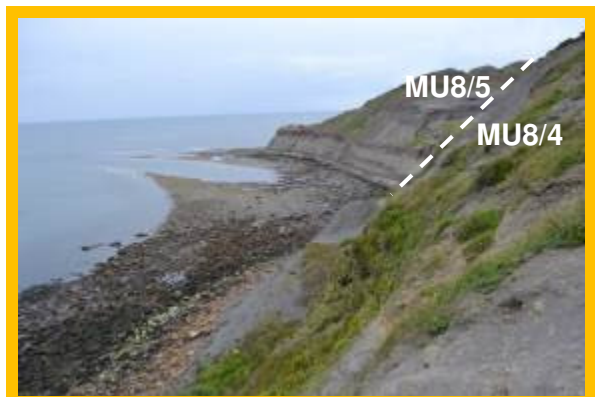
MU8/4 is immediately west of Kettle Ness headland. This unit is classified as Partly Active in 2016, unchanged since 2014.

MU8/4 (foreground) and west side of MU8/5 (background) (both Partly Active in June 2016)

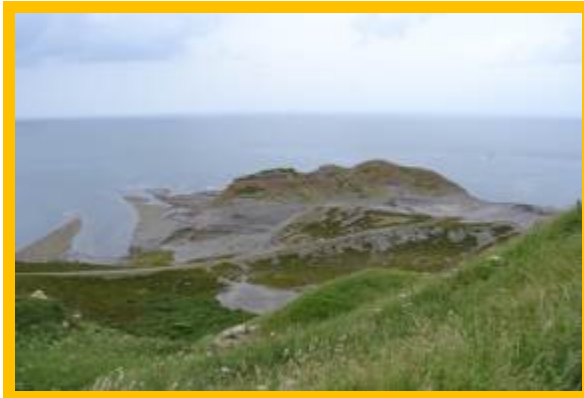
Unit MU8/5 forms the headland of Kettle Ness. This area has been extensively quarried for alum and as a result is now subject to ongoing erosion of the exposed weak bedrock. It remains classified as Partly Active in 2016, unchanged since 2014.

Kettleness headland. MU8/5 Partly Active in June 2016

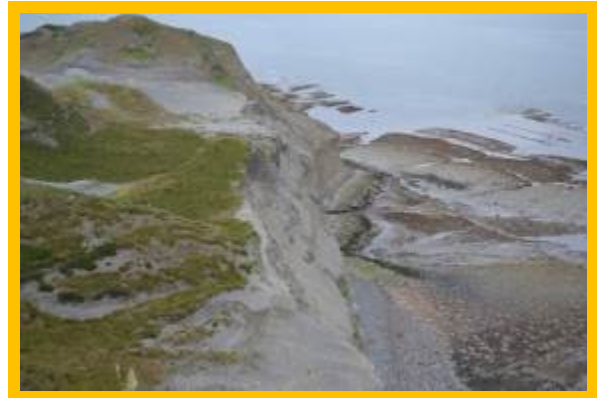
East side of Kettleness headland. MU8/5 Partly Active in June 2016

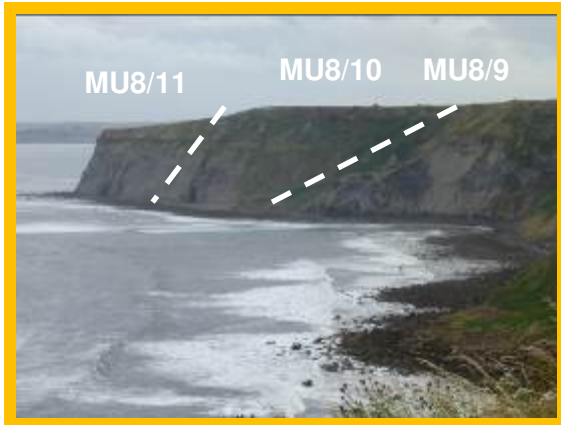
MU8/9 and MU8/11 are Partly Active sea cliffs. MU8/10 is a debris slide deposit classified as Partly Active.

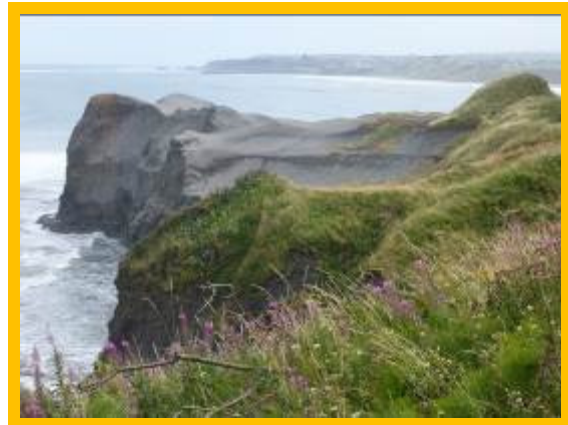
**Units MU8/13, MU8/14 and MU8/15** form the headland of Sandsend Ness and its adjacent cliffs. All units remain classified as Partly Active in 2016. The toes of these cliffs are subject to ongoing erosion and there is evidence for localised erosion on the upper slopes.

MU8/14 Sandsend Ness Partly Active in August 2016

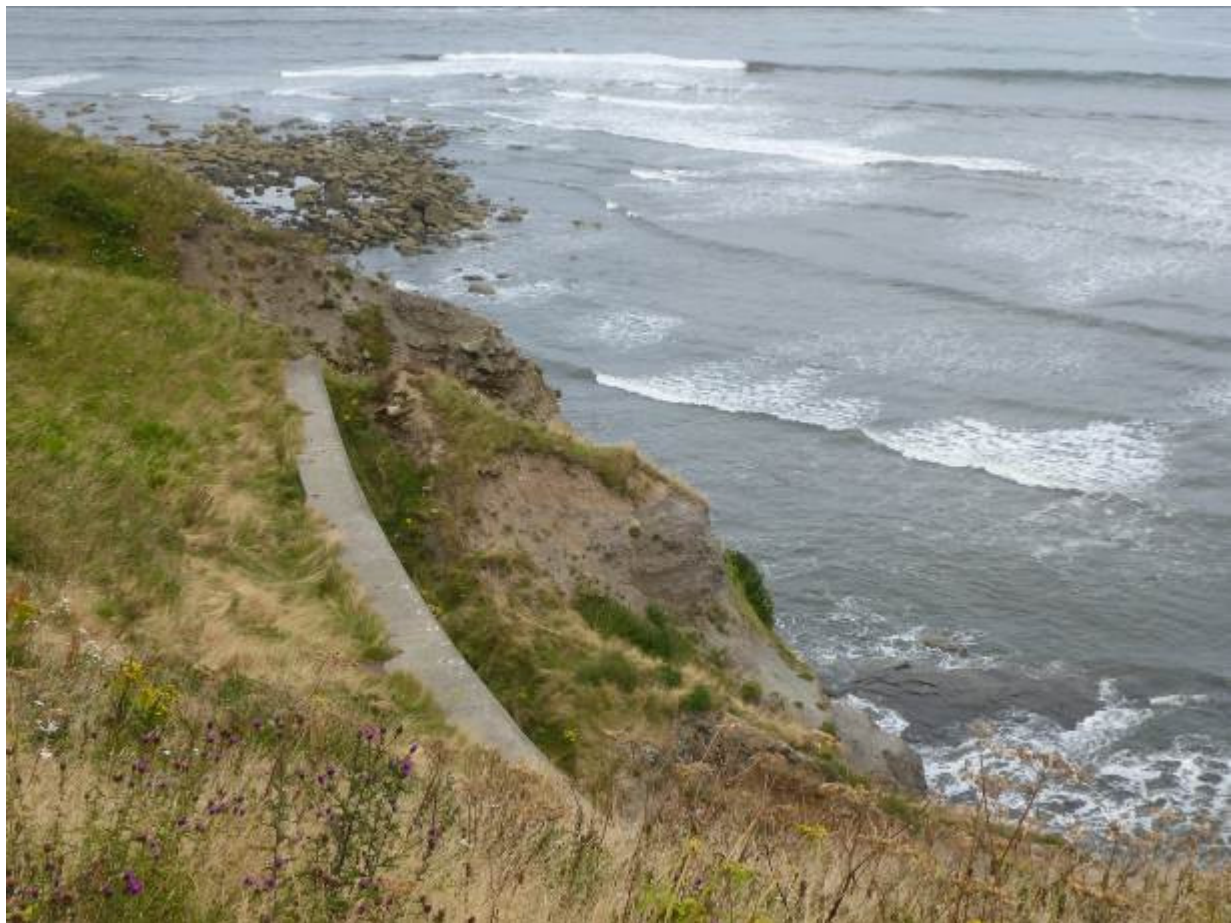
Two short lengths of retaining walls believed to have been originally intended to protect and support the disused railway line were identified along this section of coast in the 2009 inspection report. These are a brickwork wall at Deepgrove Wyke and a masonry wall south of The Scar that was noted to have failed. However, these two walls were not classed as coastal defences and were reported to be redundant in 2010, so as in 2012 and 2014 they have not been included in this inspection report.

Redundant retaining wall in MU8/14

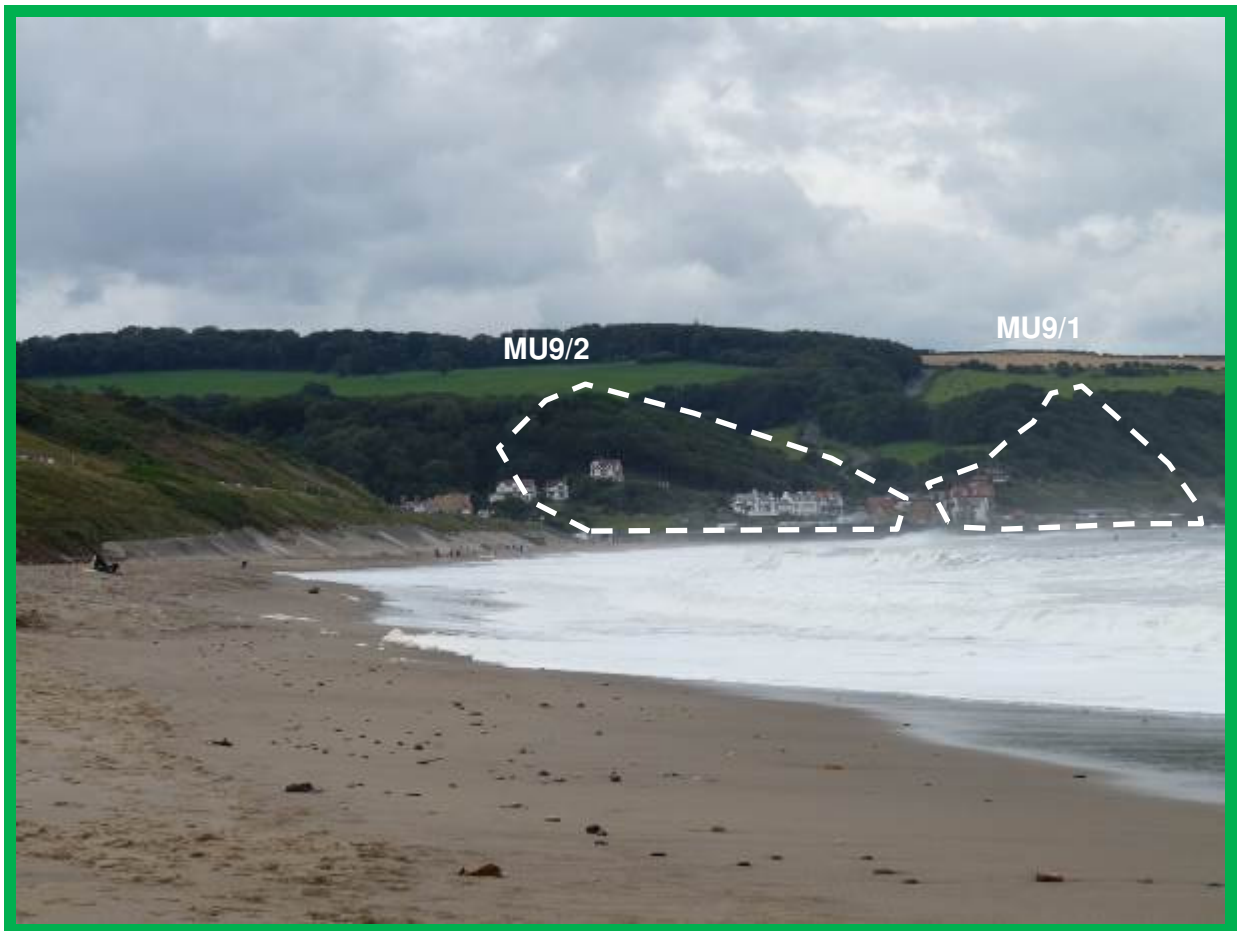
Management units MU9/1 and MU9/2 are Dormant cliffs behind Sandsend village. They are defended at the toe by a sea wall, groynes and rock armour. No evidence of activity was seen in 2016.

**MU9/1 and MU9/2** are located close to Sandsend and show no signs of activity (Dormant).  
(Figure reproduced from August 2014)

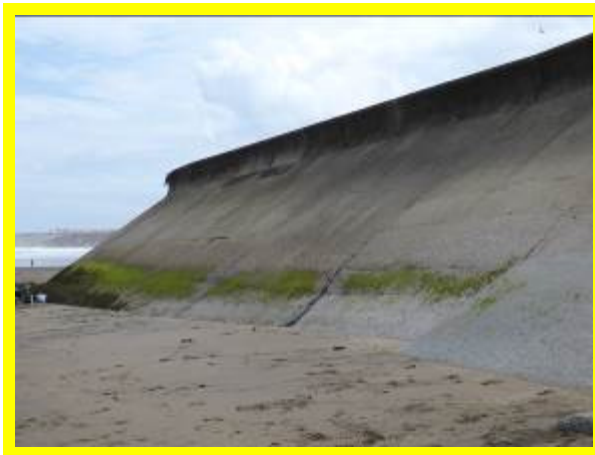
The most northerly defence is located at Sandsend car park. It is a sloping concrete revetment with a recurve crest wall (D0701C02). The concrete wall remains in fair condition with minimal damage to the surface, however the revetment has lost thickness of concrete at the base through abrasion, with exposure of reinforcement bars. Encasement of this reinforcement is advised from a structural perspective, as well as preventing any Health & Safety incidents occurring due to sharp edges of the exposed bars on this popular amenity beach. At the northern end of the structure is a tie-in section, comprised of steel sheet piling which is heavily corroded. At the southern end is a slipway adjacent to Sandsend Beck. The slipway is undermined in places, despite previous repairs at this location.

Sandsend car park sea wall (D0701C02)

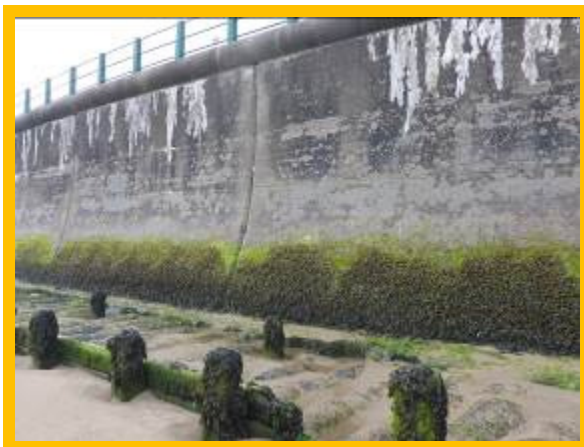
A concrete seawall (D0702C01) extends from Sandsend Beck to the east. The groyne field fronting the seawall is derelict and the remains have no significant impact on sand movement. The wall is fairly heavily abraded and timber breastwork exposed at the toe has progressively deteriorated since first observed in 2009. In some local areas it appears that new timber has been used to replace rotten sections of this breastwork. Where exposed at the toe, the steel sheet piling is heavily corroded. There are occasional cracks in the wall and significant abrasion at the steps. Also at most steps there are missing or heavily corroded sections hand rails.

Poor condition sea wall (D0702C01)

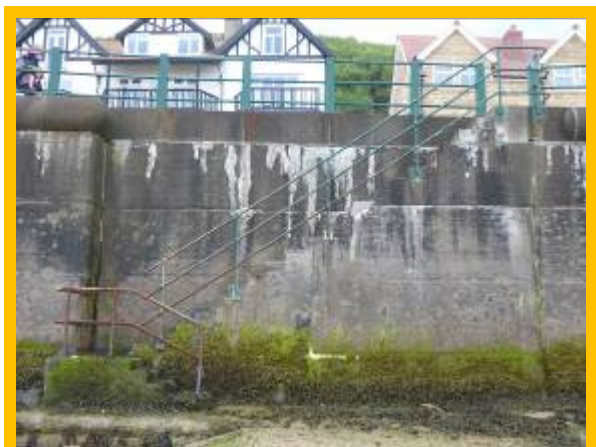
Particular defects at access steps (D0702C01)

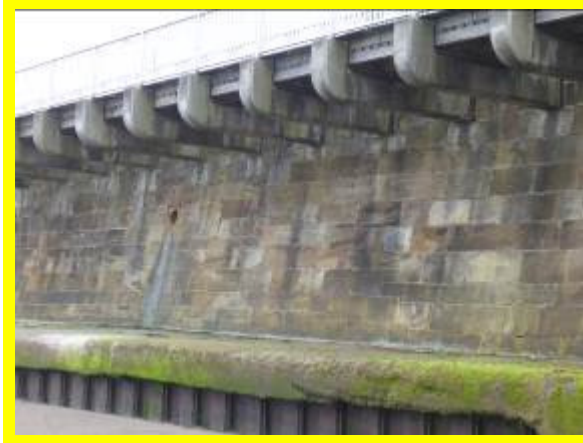
The newer short section of masonry blockwork sea wall (\D0702C04) that supports a cantilevered promenade just north of East Row Beck is in fair condition, although the steel toe piling is corroded and abraded. At the eastern end there are voids and undermining of a concrete apron which should be further investigated. The timber decking of the cantilever footway was destroyed during the December 2013 surge and repairs were made late 2014.

Masonry blockwork sea wall with cantilevered footway (\D0702C04)

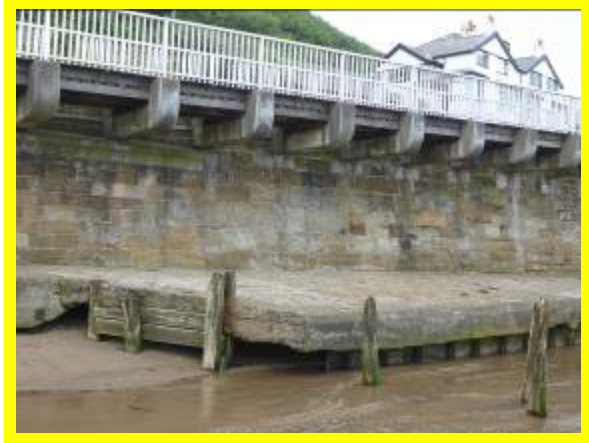
Voiding and undermining of concrete apron (\D0702C04)

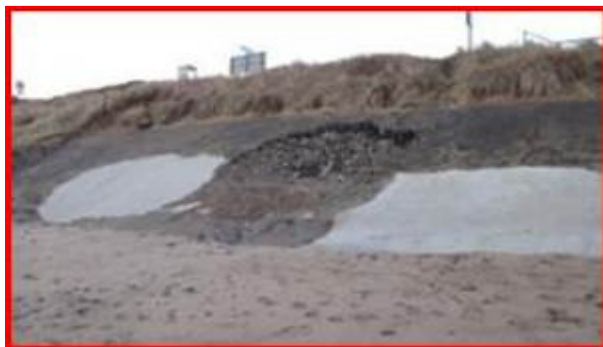
The sloping concrete revetment (\D0702C02) which used to provide the main coastal defence to the A174 Sandsend Road against erosion and overtopping was in a poor and deteriorating condition for many years and became further damage by the December 2013 storm surge, resulting in a previous grading of very poor condition in 2014, despite post-storm repairs.

Previous storm damage and very poor condition of sloping revetment at Sandsend Road

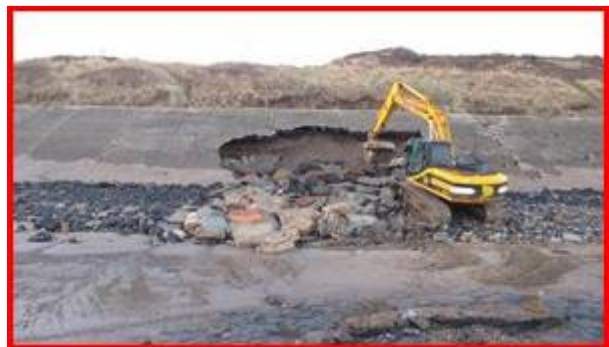
Previous temporary repairs to sloping revetment at Sandsend Road (\D0702C02)

These failing structures have now been replaced by new coastal defences constructed between early 2015 and summer 2016. The new defences comprise a lower section with a stepped revetment built from pre-cast concrete units and a buried concrete toe beam that was cast *in situ*, with an upper section of interlocking pre-cast Dycel units. Natural coastal slope extends above the upper units to the plateau upon which the highway and footpaths sit, with re-graded and stabilised high coastal slopes to landward of the road. Sloping concrete tie-in revetments exist at either end of the structure. The overall plan form of the new defence adopts a subtle 'S' curve when viewed in plan.

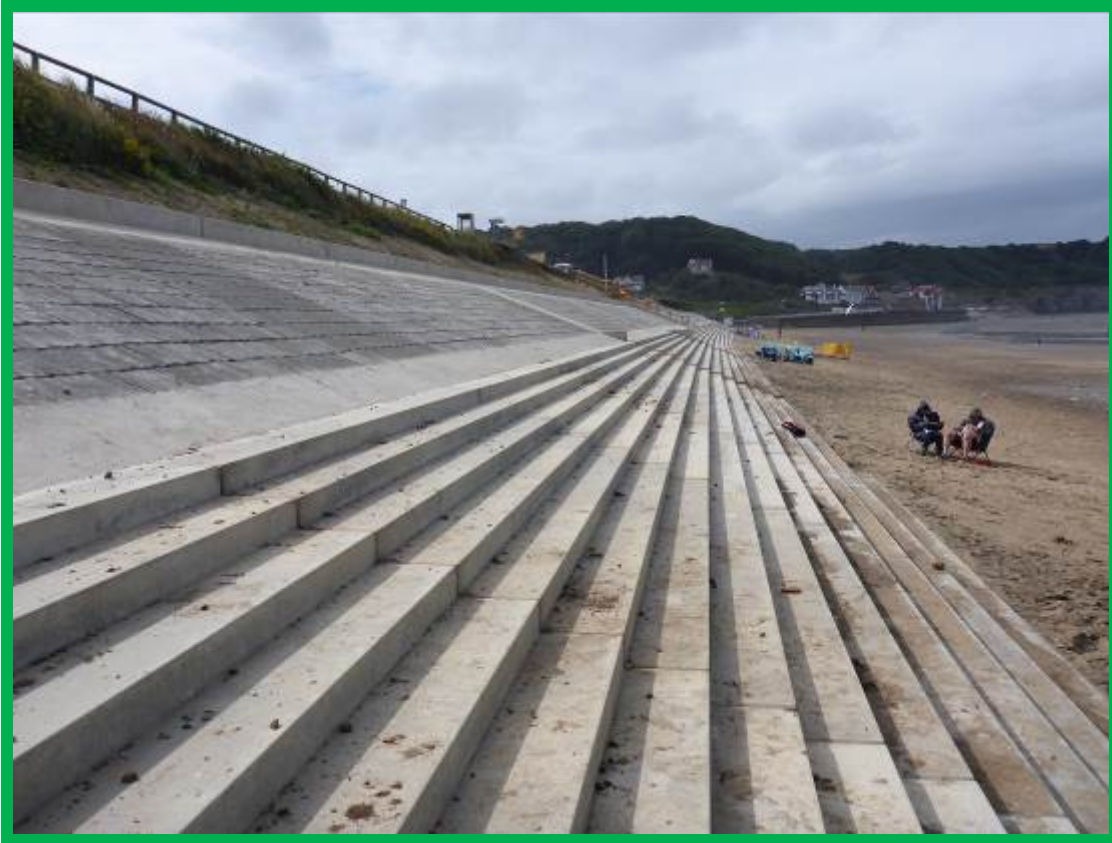
Cross section of coastal defences at Sandsend Road in 'as built' condition showing stepped pre-cast apron and upper Dycel units (\D0702C02)

With construction of the scheme having been completed in August 2016, the new defences are in very good (as built) condition.

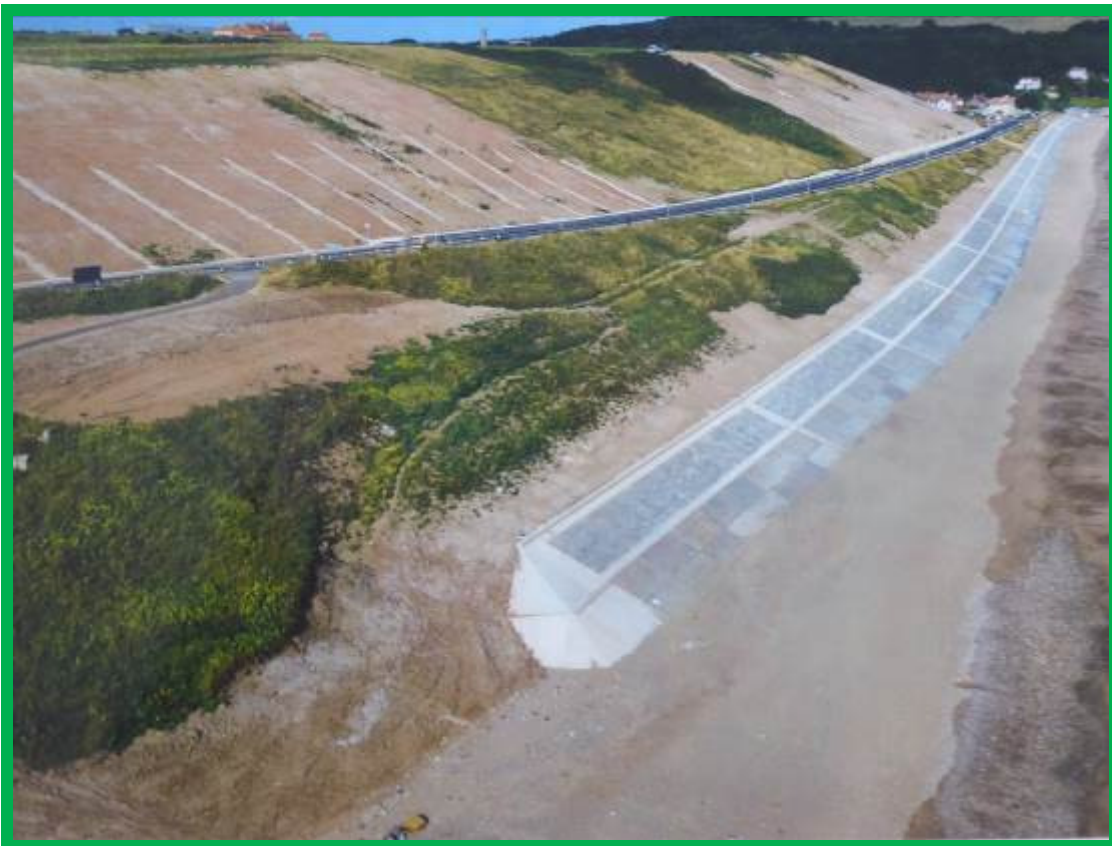
Oblique view of coastal defences at Sandsend Road in 'as built' condition showing subtle 'S' curve (\D0702C02)

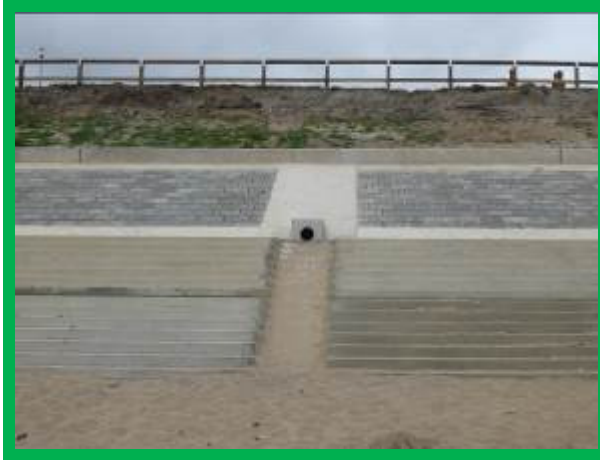
At lengths along the frontage is a series of ribs used as areas for connecting pre-cast units and accommodating subtle changes in alignment. Several of the ribs incorporate drainage outfalls. Formalised access steps are located at discrete points along the frontage.

Drainage outfalls and construction ribs  
(\D0702C01)

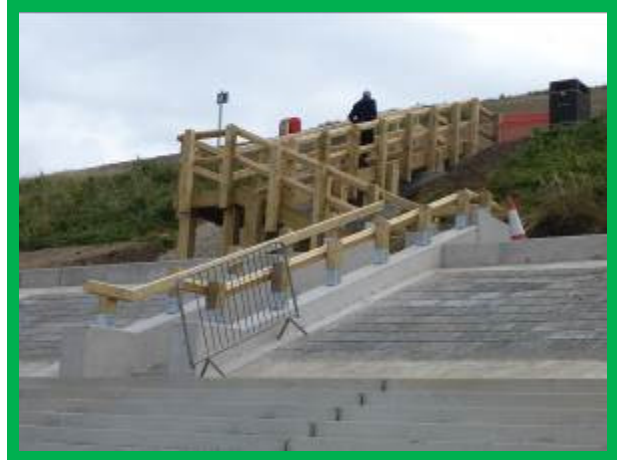
Access steps (\D0702C01)

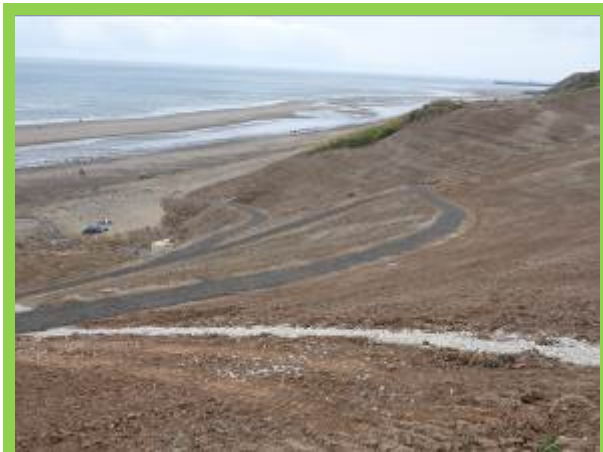
At the eastern end of the concrete defences, Raithwaite Gill has been infilled with material won from re-grading of the backing coastal slopes. The outfall which discharges through the gill has been extended to accommodate this infill.

**MU9/4** Infilling of Raithwaite Gill at the eastern end of the coastal slopes (Inactive) in 2016

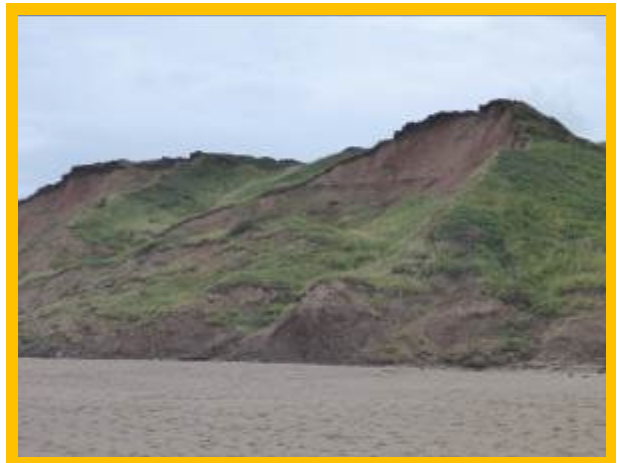
**MU10/2** comprises the till cliffs behind Upgang Beach that are prone to episodic mudslides and block failures. Vegetation cover is limited along the cliff face and the unit is classified as Partly Active in 2016, unchanged since the 2005 survey.

**MU10/2** Slumping cliffs along Upgang beach (Partly Active) in 2016

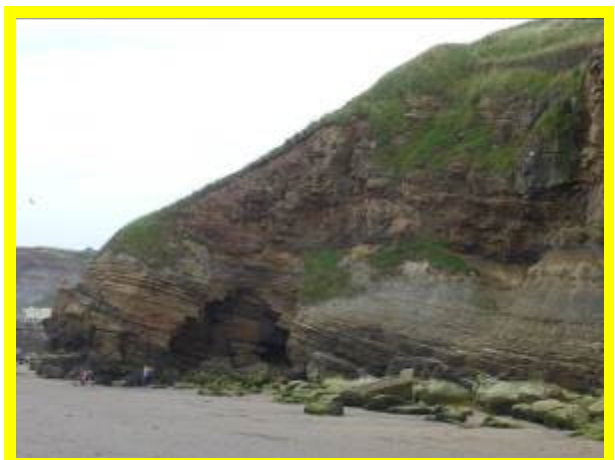
**MU11/4** Minor erosion in undefended cliff (Locally Active)

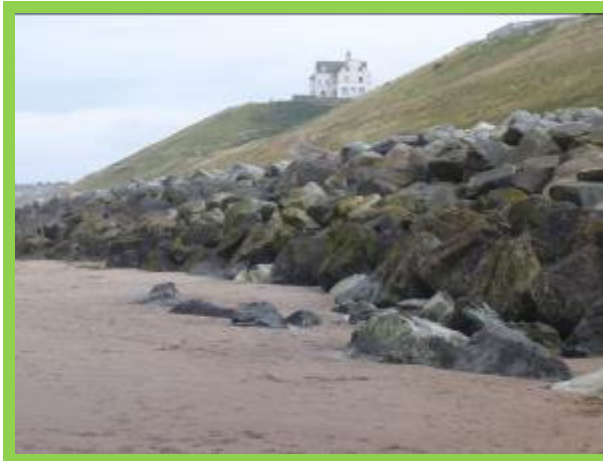
This Management Unit encompasses various sea walls and rock revetment to the west of Whitby Harbour. The most westerly defence is a rock armour revetment fronting the seawall and promenade (D0801C01). As in previous inspections, the rock armour is in good condition with only minor movement visible. The asset is in overall good condition although the promenade is rated as fair despite areas of repairs, due to previous longitudinal cracking. There is also damage to the wall to the rear of the promenade.

Rock revetment, promenade and coastal slopes of Whitby West Cliff (D0801C01)

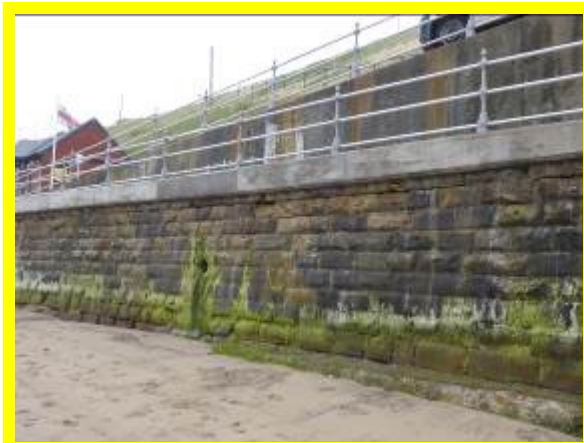
The masonry blockwork walls by the RNLI lifeguard station are in fair overall, with a new capping beam recently constructed to repair previously reported damage. There remains a sunken block and open joints in the blockwork below the new capping beam.

Fair condition masonry wall with recent capping beam to repair previous defects (D0802C07)

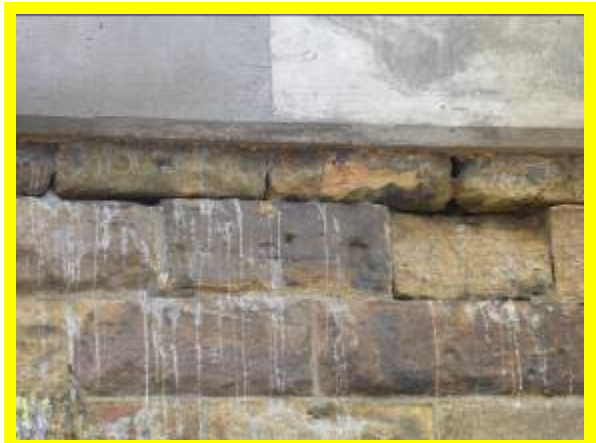
Local defect (sunken blockwork) below new capping beam (D0802C07)

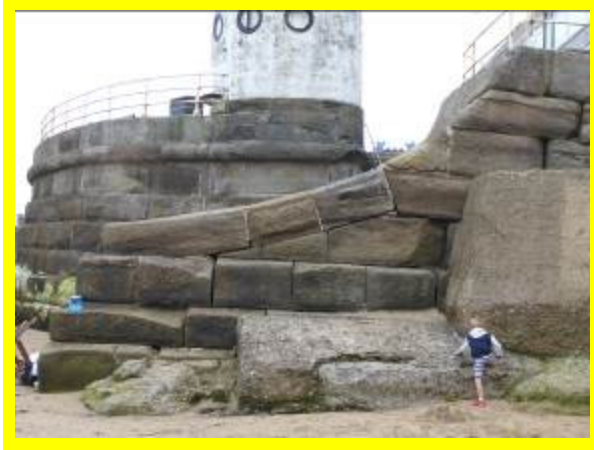
The Battery Wall, just west of Whitby West Pier, is formed of large sandstone blocks. Although repairs to some gaps between blocks are evident, further repairs are deemed necessary in numerous areas, especially at the wing wall of the access steps to the beach. Despite this, the asset remains in overall fair condition.

Open joints in wing wall to access steps  
(\D0802C12)

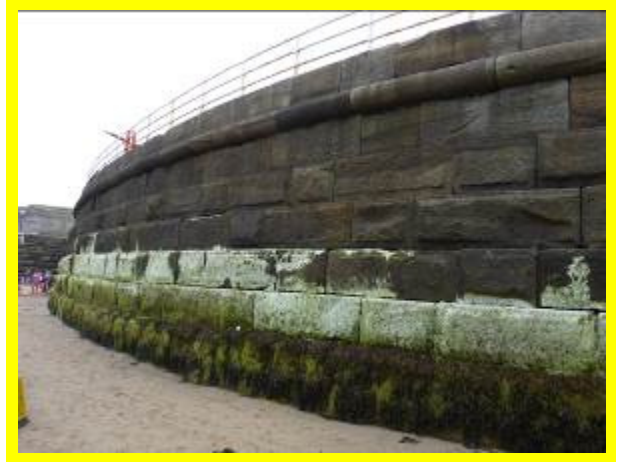
Battery Wall, with some open joints between  
blocks (\D0802C12)

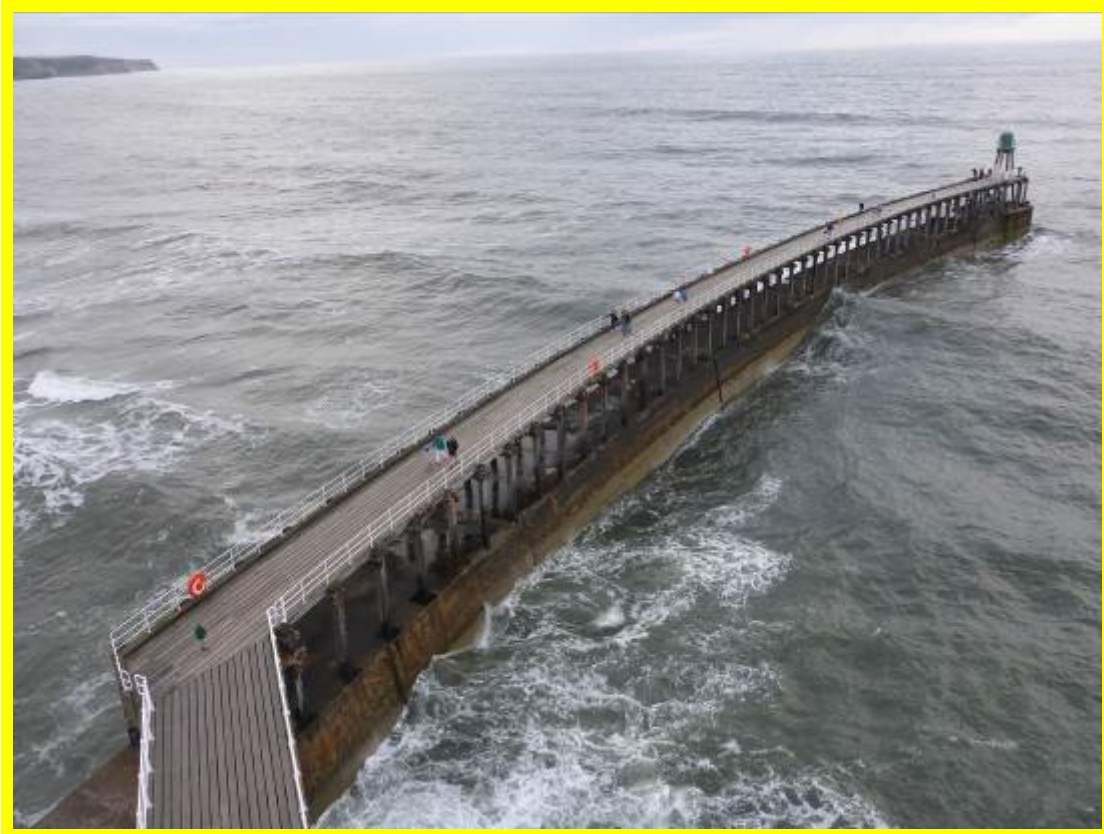
West Pier extension, generally in fair condition (\803C01)

The pier extensions are generally considered to be in fair condition, despite considerable abrasion along almost their entire length, although it should be noted that the lower sections of each structure were fully submerged by water at the time of the inspections. An urgent works scheme was undertaken in 2011/12 to repair the southern end of the East Pier extension where a large void had formed in the structure behind the sheet pile toe which had failed following corrosion and abrasion.

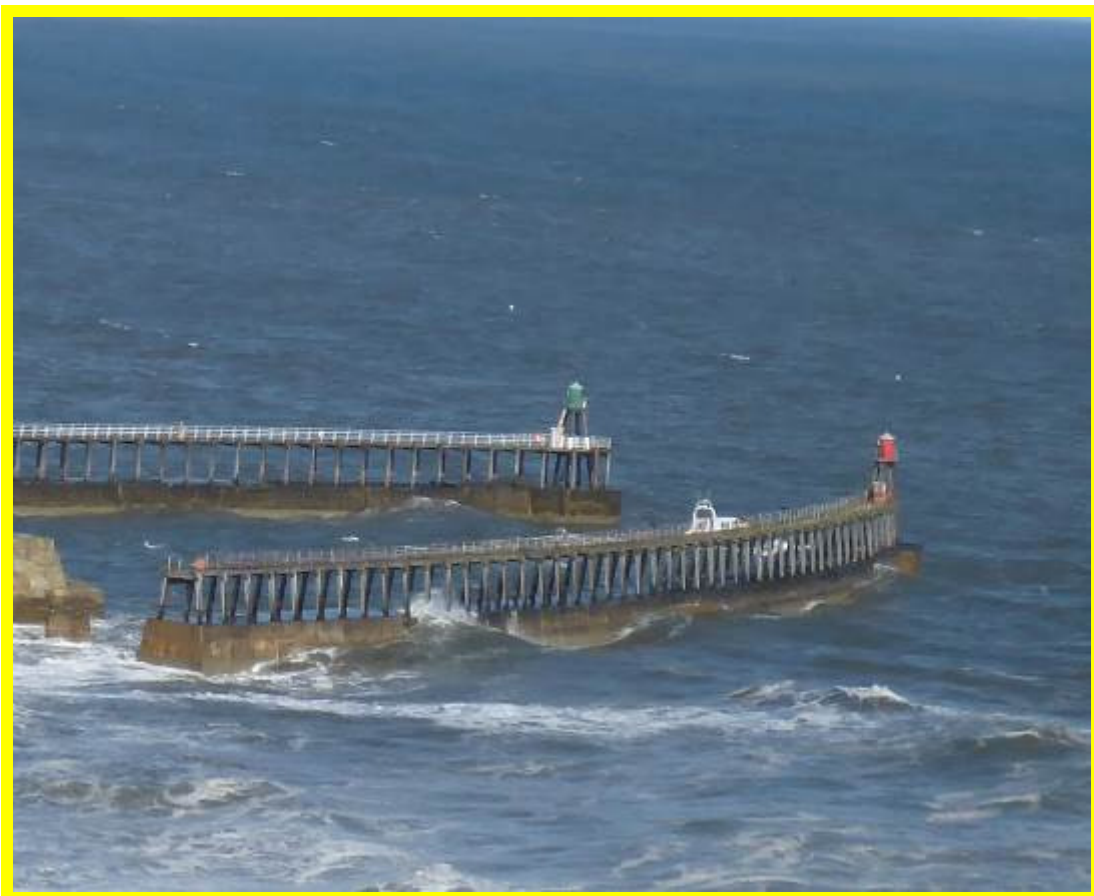
East Pier extension, generally in fair condition (\803C04)

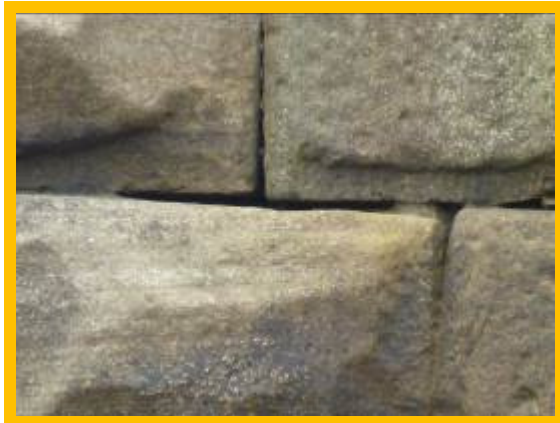
Both main harbour piers have loose and cracked blocks and vertical movement (settlement) in at least one location on each arm. This potentially is indicative of wash-out of backing fill material and voiding. It is recommended that the proposed capital works to the main piers are implemented as soon as practically possible. Loose blocks could potentially become displaced or missing during a storm and there may be a significant quantity of wash-out of material from the core, leading to the consequent weakening and collapse of the structure. The situation is particularly bad on the inner face of the East Pier.

Local poor condition of West Pier due to open joints between blocks (\803C02)

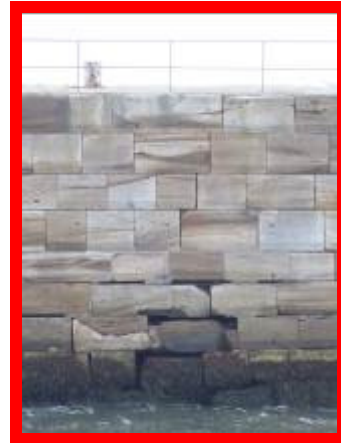
Local very poor condition of East Pier due to open joints and settled blocks (\803C04)

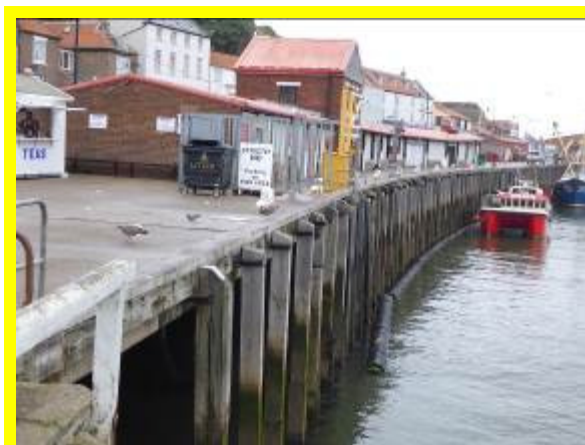
The western quayside of the Risk Esk from the harbour to the Swing Bridge consists partly of blockwork quay walls, similar in construction to the harbour piers, and partly of sections of concrete slab suspended over the original quay wall with concrete filled vertical and raking steel pile supports. The quayside structures are generally in fair condition, but poor in places due to specific localised defects. For example, in the blockwork sections, there are sections of wall with open joints which require sealing. In the suspended deck section, there remains corrosion to the steel piles. It was not possible to inspect the underside properly as this would require a boat even at low tide. A more detailed structural inspection of the quay walls is therefore recommended.

Generally fair condition of suspended deck section of quay wall (\803C06)

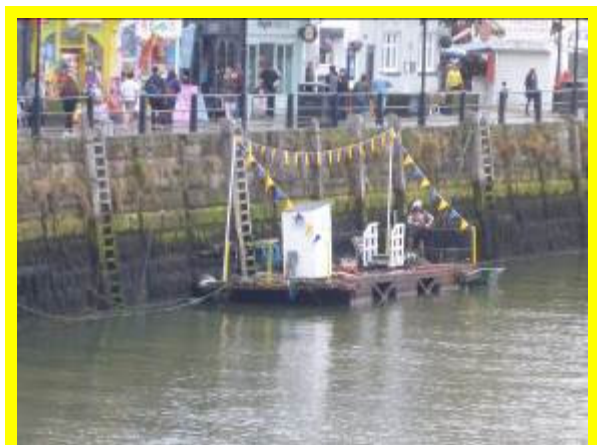
Generally fair condition of blockwork section of quay wall (\803C07)

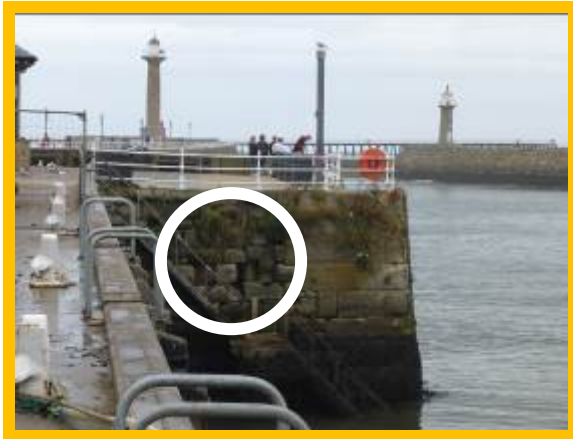
Local poor condition of quay wall due to open joints between blocks (\803C06)

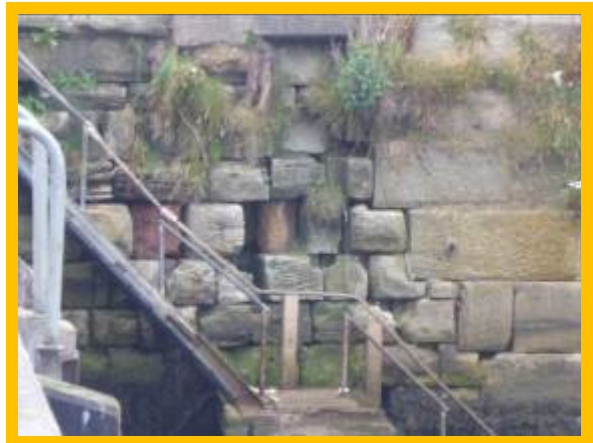
Local poor condition of quay wall due to open joints between blocks (\803C06)

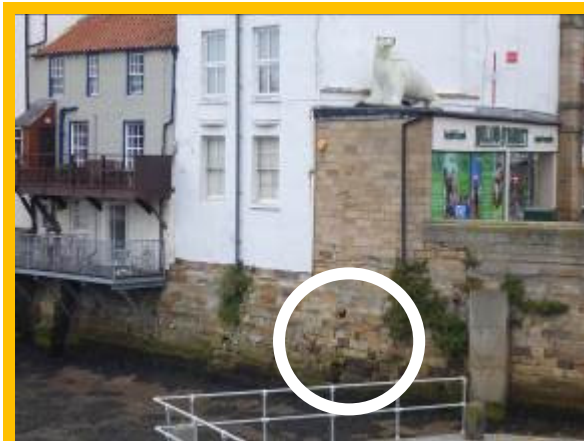
The eastern quayside of the Risk Esk consists partly of blockwall quay walls, similar in construction to the harbour piers, and partly of sections of property walls. Similar to the western quayside, the quayside structures are generally in fair condition, but poor in places due to specific localised defects. For example, in the property wall sections there are areas of sunken blocks or missing pointing and in the blockwork quay walls there are also several areas of open joints and heavily abraded blocks, most notably on Tate Hill Pier.

Local poor condition of quay wall due to open joints between blocks (\803C06)

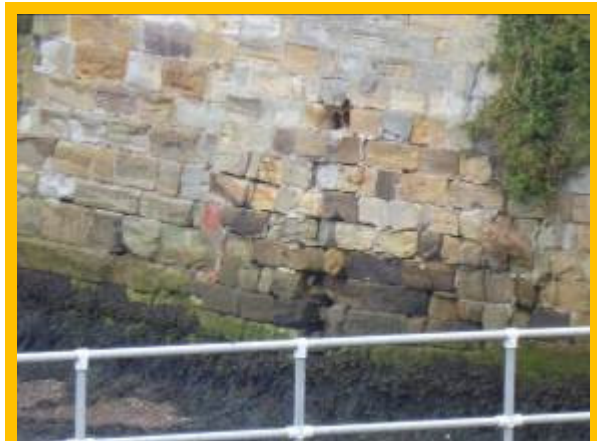
Local poor condition of quay wall due to open joints between blocks (\803C06)

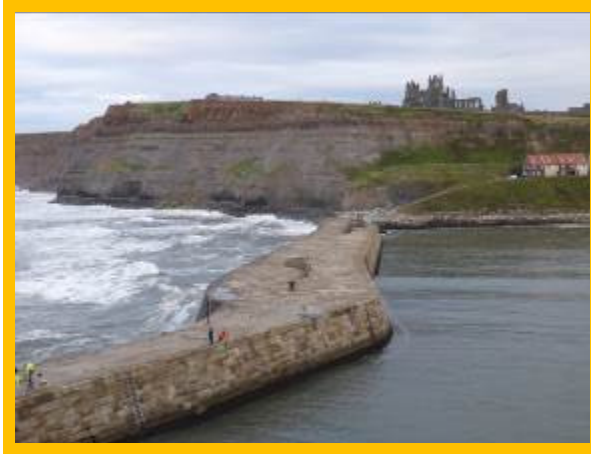
Unit **MU12/2** comprises high cliffs protected by rock armour. There is evidence of a past rockfalls from the upper part of the cliff in the form of debris slopes and almost the entire cliff face is exposed, with very little vegetation cover. The cliffs therefore remain classified as Partly Active.

MU12/2 Cliffs east of Whitby (Partly Active)

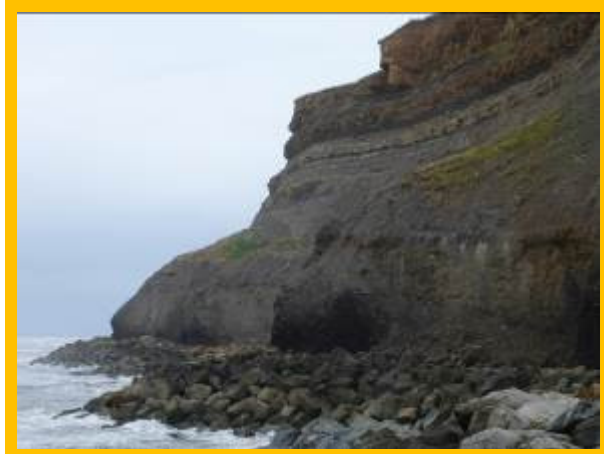
MU12/2 Cliffs east of Whitby (Partly Active)

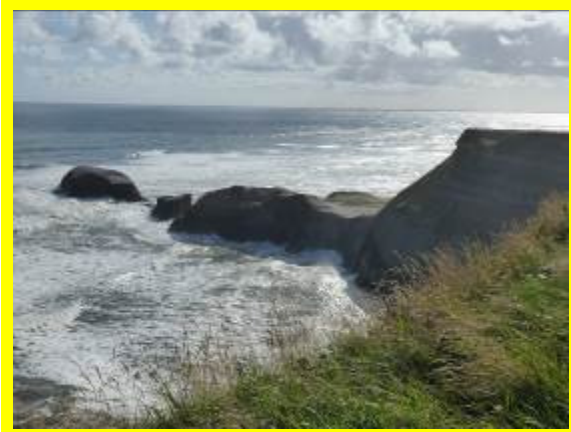
**Unit MU13/2** comprises the eroded headland of Saltwick Nab. This unit is continuing to actively erode and supports little vegetation cover. Rilling and gullyng is evident on the exposed faces. As a result this unit remains classified as Partly Active in 2016.

MU13/2 Saltwick Nab (Locally Active)

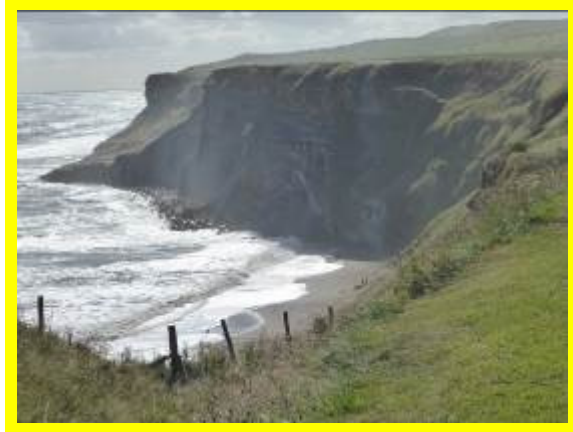
The cliffs within **unit MU13/3** are located within Saltwick Bay. The cliffs of this embayment are protected to some extent from marine action by the high stable beach. As a result, the unit is generally less active and well vegetated and was classified as Locally Active in 2014. This remains a valid classification, despite the occurrence of a local rockfall since that time.

MU13/3 Rockfall at cliffs within Saltwick Bay (Locally Active)

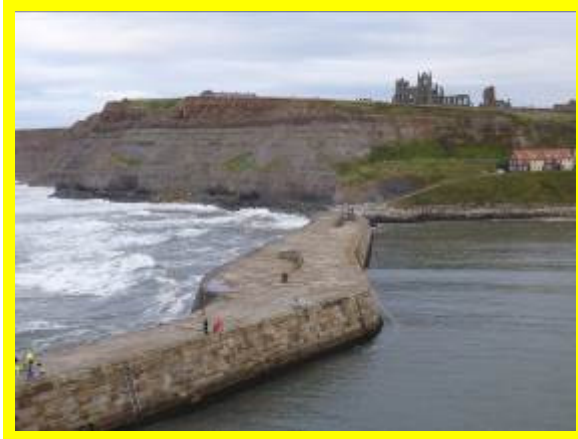
There is a section of rock armour giving protection to the toe of Abbey Cliff directly to the east of Whitby Harbour's East Pier. The rock armour varies in size from 1-4 tonnes to 5-8 tonnes and is in fair overall condition.

Rock armour protection to toe of Abbey Cliff  
(\803C06)

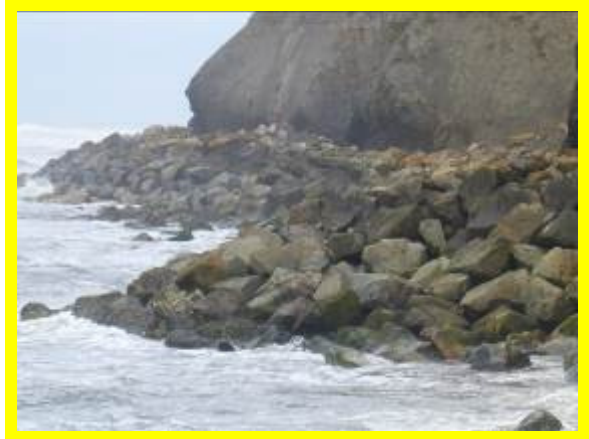
Rock armour protection to toe of Abbey Cliff  
(\803C06)

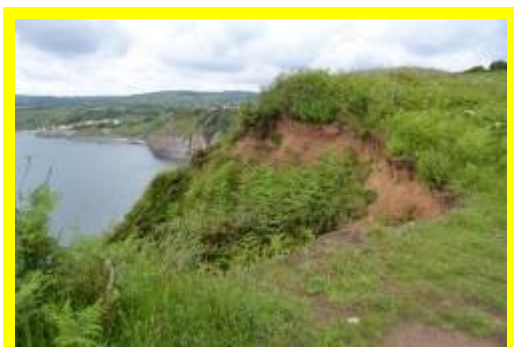
**Unit MU15/3** is largely comprised of the headland of Bay Ness, north of Robin Hood’s Bay. The cliffs are high and steep and composed mainly of sandstone overlain by a thin cap of glacial till. There is evidence of debris fans in the lower half of the cliff face with localised slumping of the head scarp cut into the till. Several exposed head scarps are going to potentially undermine the Cleveland Way. This unit is classified as Locally Active in 2016, downgraded from Partly Active in 2014. Just north of Robin Hood’s Bay village is unit MU15/4, which has a similar geomorphology to MU15/3, although the till cap appears to be less active than further north. This unit is classified as Locally Active in 2016, downgraded from Partly Active in 2014.

Local slumping of head scarp in MU15/3 (Locally Active in June 2016)

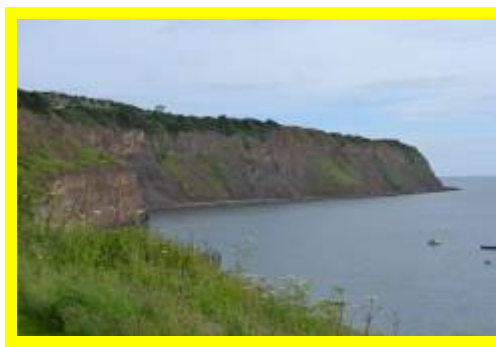
Steep sandstone cliffs of MU15/4 (Locally Active in June 2016)

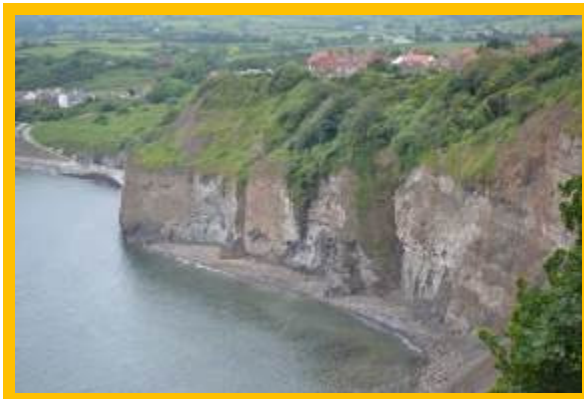
Unit MU16/1 is the composite cliff complex fronting the northern part of Robin Hood’s Bay village and is classified as Partly Active in 2016, the same as 2014. The cliff comprises a near-vertical lower cliff of mainly sandstone overlain by shallower sloping heavily vegetated glacial till with evidence of slumping and recession of the head scarp.

MU16/1 Sandstone cliff overlain by shallow till (Partly Active)

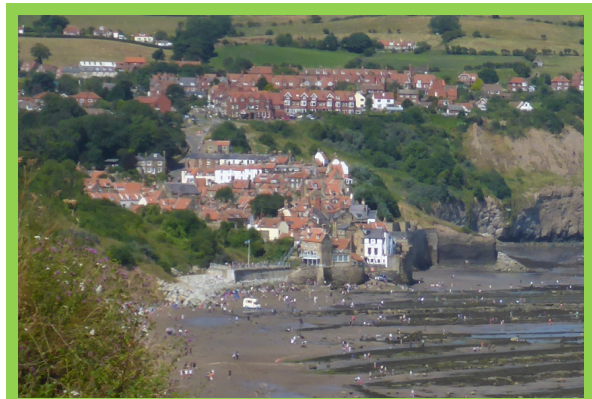
Units MU16/2 is a stabilised landslide that forms the southern part of Robin Hood’s Bay village. There is little evidence of any activity and so it is classified as Inactive in 2016, downgraded from Locally Active in 2014. MU16/3 protected by sea defences retains its Dormant status in 2016.

MU16/2 Stabilised landslide (Inactive)

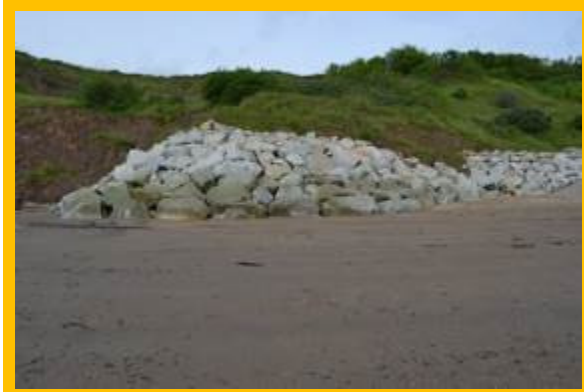
Unit MU17/2 comprises glacial till cliffs to beach level protected by rock armour at their toe. The slopes are generally well vegetated with some exposed areas at the head scarp and mid-slope where there is evidence of slumping. This unit is classified as Partly Active in 2016, due to the evidence of instability. Slumping at the head scarp could undermine the Cleveland Way.

Protected toe of till cliffs in Robin Hood's Bay. MU17/2 (Partly Active in June 2016)

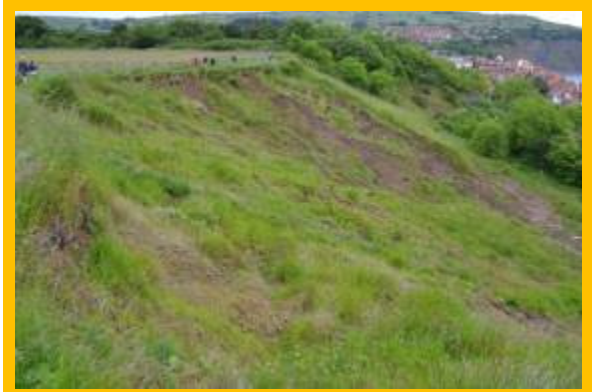
Head scarp in MU17/2 (Partly Active in June 2016)

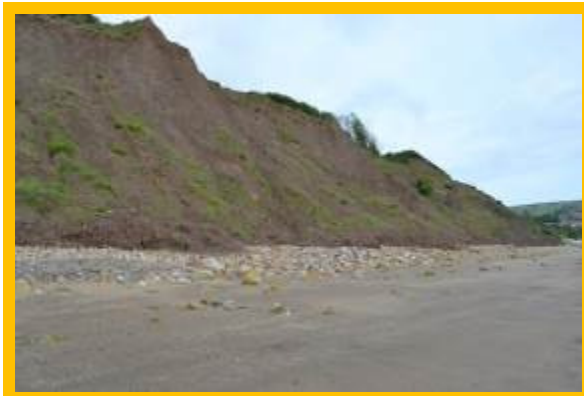
Further south, within unit MU17/3, defences are absent and the cliffs are active. There is massive slumping at beach level and in the mid to upper slopes. This unit is classified as Partly Active in 2016, no change from 2014.

Active toe of till cliffs in Robin Hood's Bay. MU17/3 (Partly Active in June 2016)

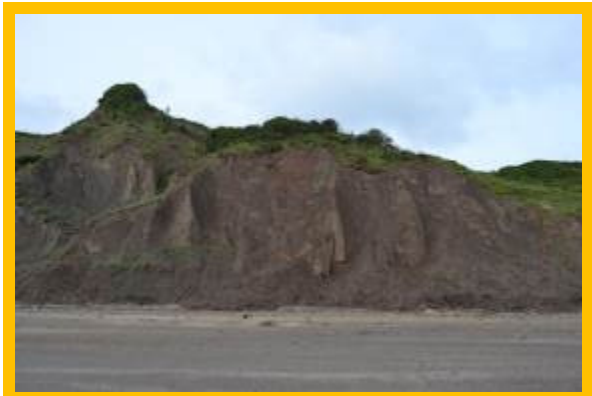
Active toe of till cliffs in Robin Hood's Bay. MU17/3 (Partly Active in June 2016)

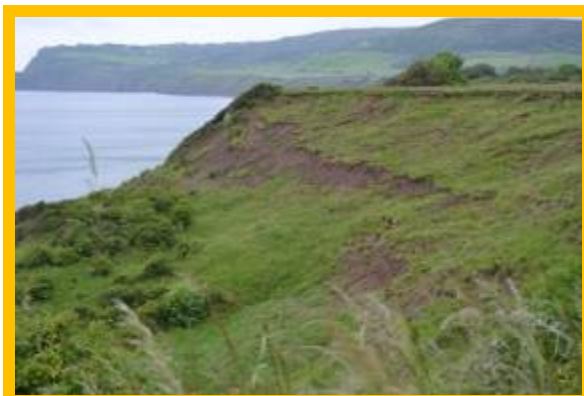
Head scarp in MU17/3 (Partly Active in June 2016)

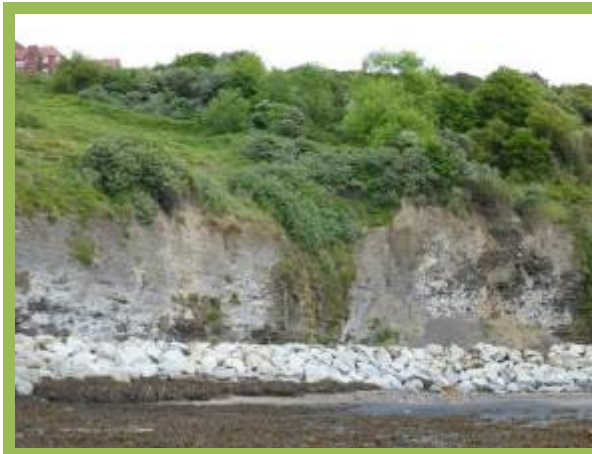
The most northern defence is a section of rock armour that gives some limited protection to the cliff toe to the north of the northern slipway / beach access ramp (/1002C02). This rock armour was constructed as part of the 2001 scheme and remains in good condition. As the rock armour extends south (/1002C01) it fronts the wingwall of a slipway / ramp from the boatyard and then a large blockwork sea wall that was built in 2001. Overall, both the wall and the revetment are in good condition. Cliffs to the rear of the slipway have rock netting which remains in good condition.

*Rock revetment fronting sea cliffs (/1002C02)*

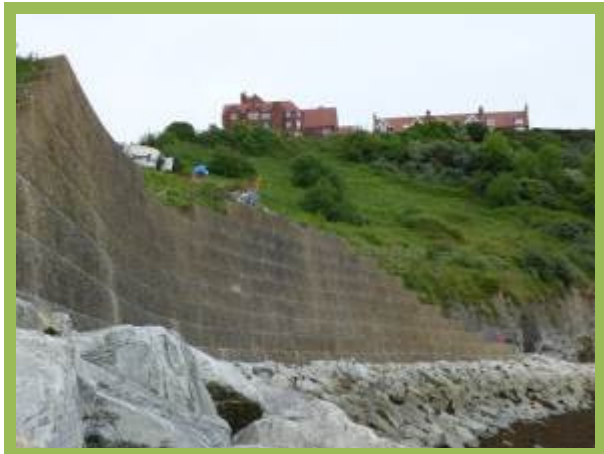
*Rock revetment fronting large sea wall (/1003C01)*
