## **Cell 1 Regional Coastal Monitoring Programme Walkover Inspection Surveys 2016**

**Scarborough  
Borough Council**

**September 2016**

## Walkover Inspection Surveys 2016

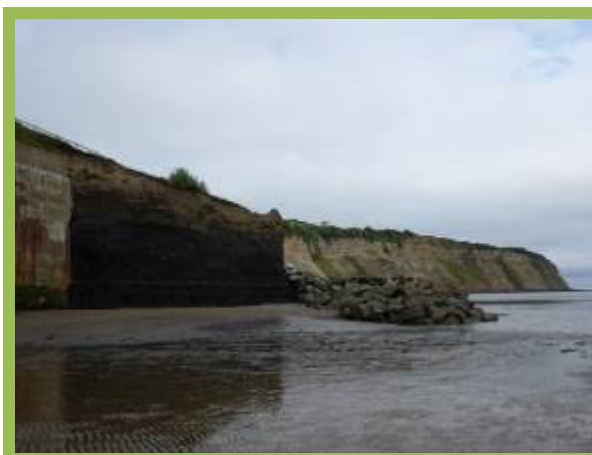
The rock armour extends south of the end of the wall, remaining in good condition, to protrude beyond the toe of the short length (~25m) of adjacent undefended shale cliffs. The cliffs (/1003C03) are generally eroding at slow rates, except for in one location at the cliff top near the interface with the southern large sea wall where a local slippage has occurred in the overlying till. The present minor outflanking at this location will worsen over time.

*Rock revetment protruding beyond undefended cliffs (/1003C01)*

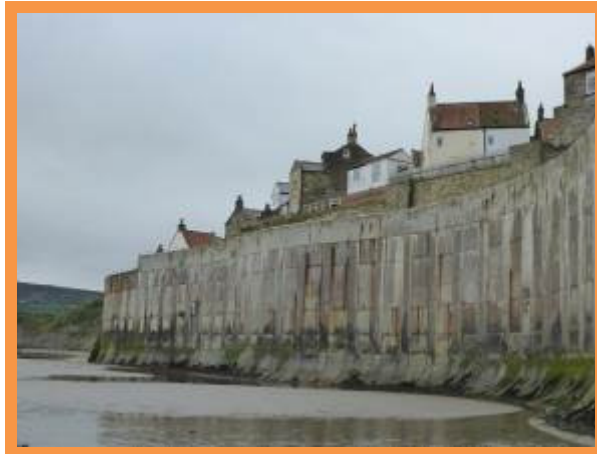
The large vertical pre-cast concrete panel wall that was constructed in 1975 (1003C02) is in poor condition, showing evidence of surface cracking, rust marks indicating corrosion of the reinforcement steel, mineral encrustation, seepage, and extensive cracking and repair work to the crest of the wall. Previous inspections have also noted some evidence of undercutting at the toe, but this was not visible at the time of inspection due to the beach levels. A recently developed Project Appraisal Report has proposed a capital scheme to repair and refurbish this wall.

*Large sea wall in poor condition will benefit from future planned capital scheme (/1003C02)*

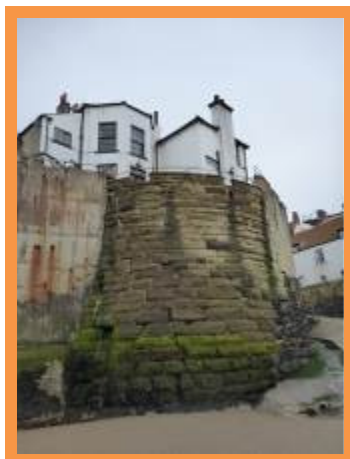
Immediately south of the large concrete sea wall, a private blockwork wall fronts the Bay Hotel (/1003C04). This wall extends south to the central slipway and is in overall poor condition with open joints between blocks despite obvious previous repairs having been undertaken (some of which are re-opening). Some of these align to form continuous near-vertical cracks down a significant extent of the wall's height. There is a particularly notable area of concern at the interface between the blockwork wall and the adjacent concrete panel wall. Above the blockwork wall there has been loss of the render to the upper property wall.

*Blockwork wall in poor condition fronting the Bay Hotel (/1003C04)*

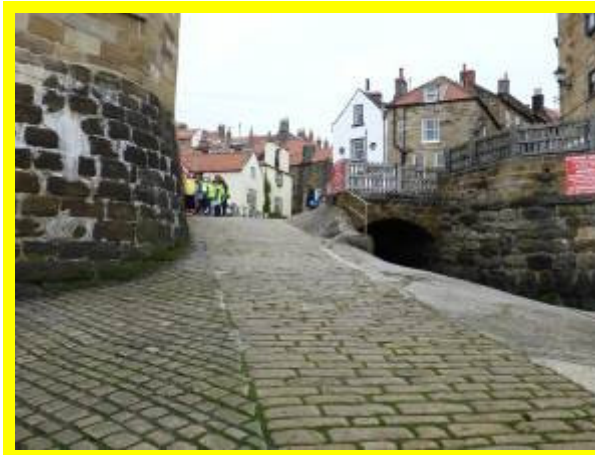
The adjacent central slipway (/1003C05) is in an overall fair condition, with minor damage to an area of previous concrete repairs near one corner.

*Slipway in fair condition (/1003C05)*

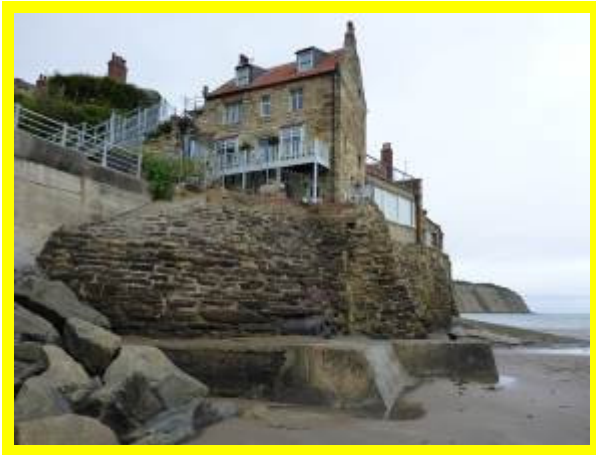
The mixed construction defence (/1003C06) on the south side of the slipway has mass concrete toe at the base with a variety of stone and blockwork above. The defence has a patchwork of previous repairs and repointing throughout but despite this a small number of open joints remain

(mostly in areas of previous repairs) and there is one area of cracking in the concrete at the apron. Overall the structure remains in fair condition, but it would benefit from some minor maintenance.

*Wall and apron in fair condition but minor maintenance needed (/1003C06)*

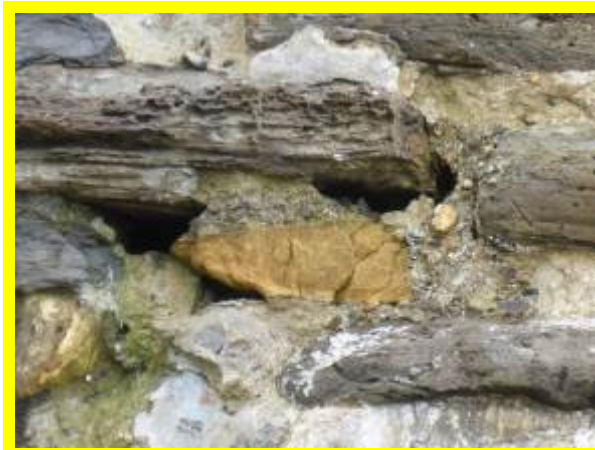
*Typical defects (gaps) on blockwork wall (/1003C06)*

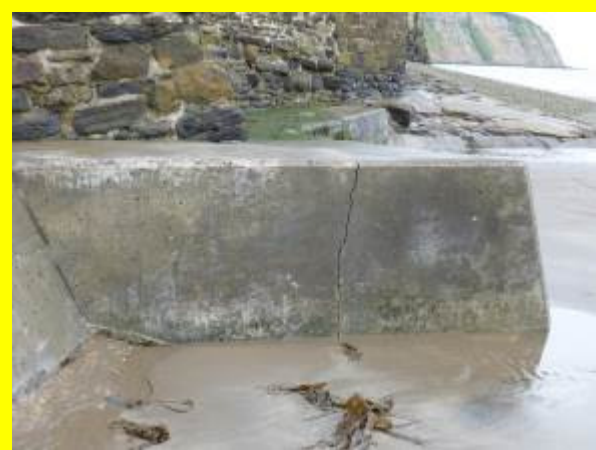
*Typical defects (cracking) on toe apron (/1003C06)*

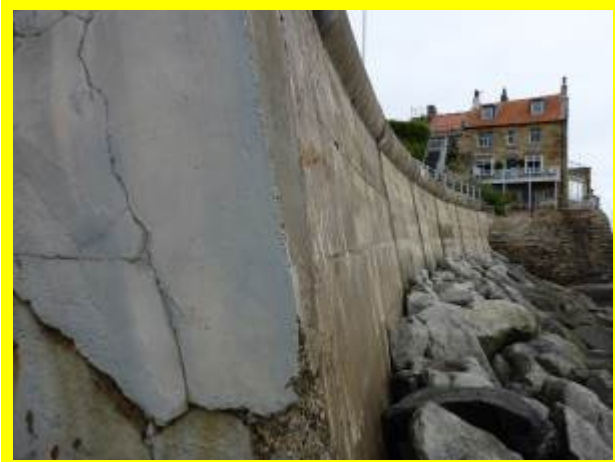
At the south of the village is the concrete sea wall at the Quarter Deck (/1003C10). This structure was given rock armour toe protection as part of the 2001 scheme. The rock armour remains in good condition with the sea wall in fair condition. There are some notable defects at the access steps at the southern end of the wall, with render cracking and falling away and abrasion of the concrete beneath. There is also some local abrasion and spalling at the coping and around joints, but the joints themselves remain well sealed.

*Concrete sea wall generally in fair condition (/1003C10)*

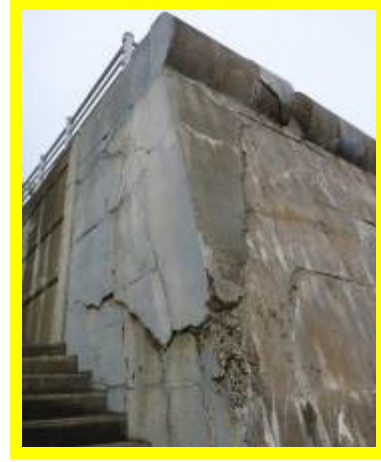
*Defects at access steps (/1003C10)*

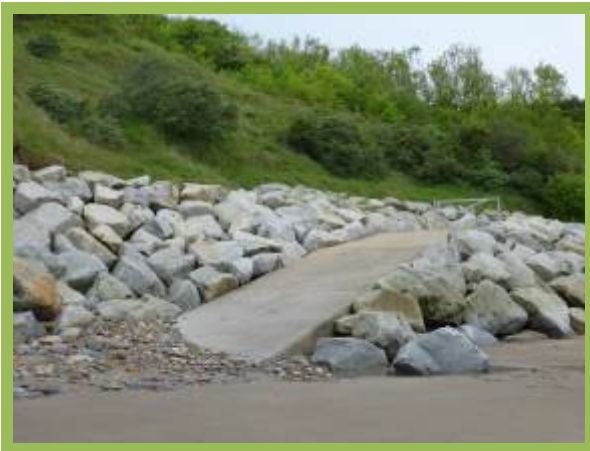
South of the Quarter Deck there is a length of rock armour defence with a slipway / ramp, both of which were constructed in 2001 and remain in good condition (/1003C09). One or two displaced armourstones from the revetment are now almost fully buried below beach level.

*Rock revetment and slipway remain in good condition (/1003C09)*

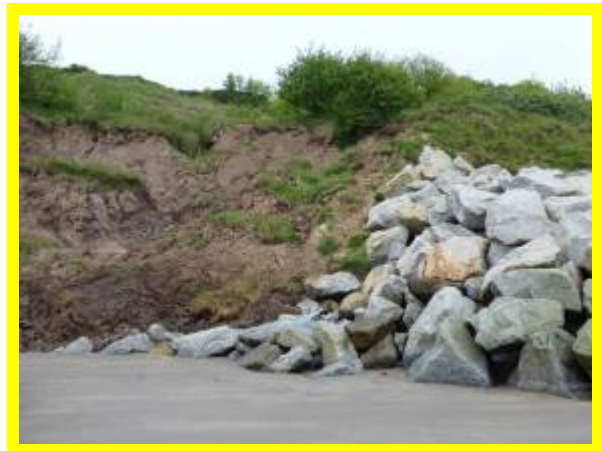
To the immediate south of the ramp is a short section of rock armour built in 2001 to stabilise the cliff (/1003C07). In one place the cliff is slumping behind this defence and there is further, pronounced, slumping immediately south of the structure's terminal end, although the defence remains fair and is not currently compromised.

*Slumping of cliffs immediately adjacent to southern end of rock armour (/1003C07)*

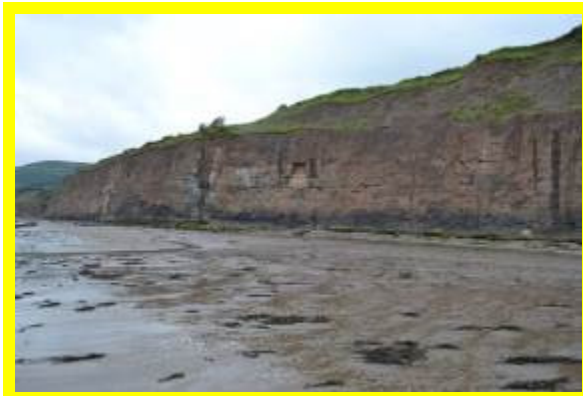
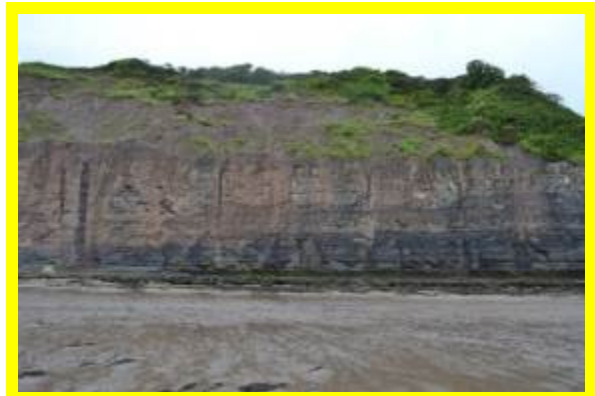
Units MU17/4 is located between Boggle Hole and just west of Stoupe Beck and has a near-vertical lower cliff formed in mudstone and an upper shallower part formed in glacial till. Due to lack of recent activity, this unit has a status of Locally Active in 2016, downgraded from Partly Active in 2014.

Steep composite cliff of mudstone overlain by till. MU17/4 Locally Active in June 2016

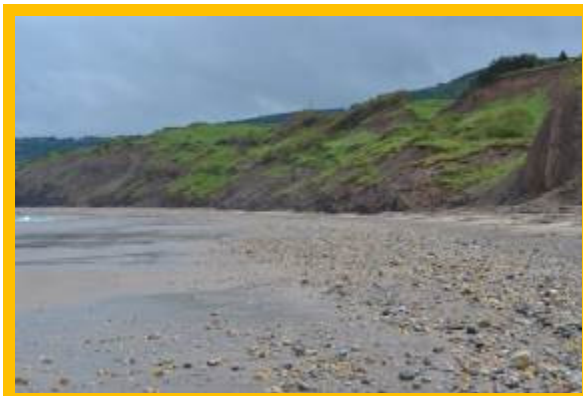
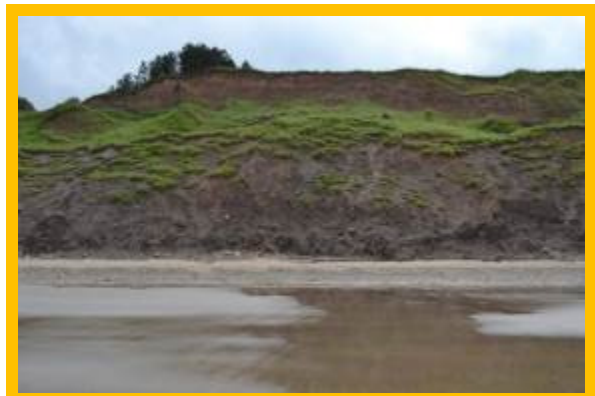
MU17/5 is located south of Stoupe Beck and is classified as Partly Active, same as 2014. The cliff toe is slumped till at beach level nearer Stoupe Beck becoming bedrock with overlying till to the southeast, which is regularly slumped over the cliff face and on to the beach. The mid and upper slopes of the composite cliff are shallower gradient.

Active till cliffs down to beach level in Robin Hood's Bay. MU17/5 Partly Active in June 2016

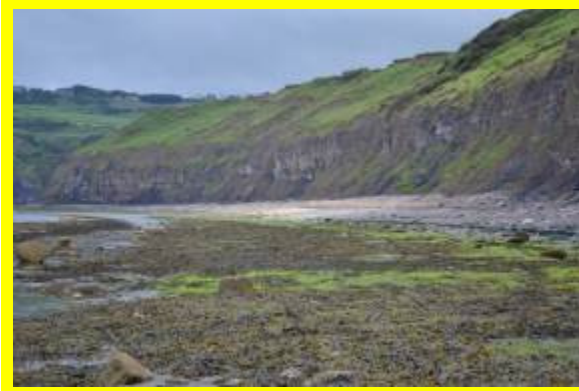
Further southeast, units MU17/6 and MU17/7 are classified as Locally Active, downgraded from Partly Active in 2014. The lower slopes are steep cliffs composed of mudstone overlain by shallower sloping till. The cliff face suffers localised rock falls and localised slumping of till from above.

Steep composite cliff of mudstone overlain by till. MU17/6 (right) and MU17/7 (left) (both Locally Active in June 2016)

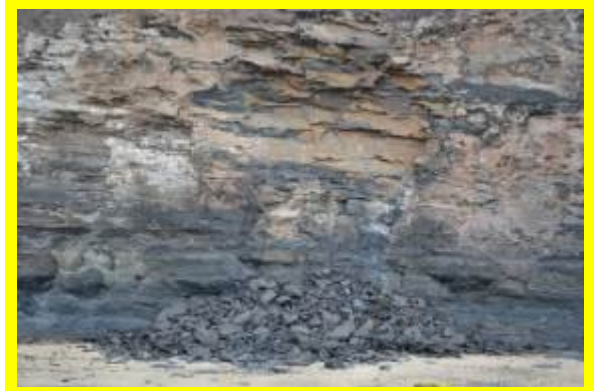
Recent local rock fall in the mudstone cliff. MU17/6 Locally Active in June 2016

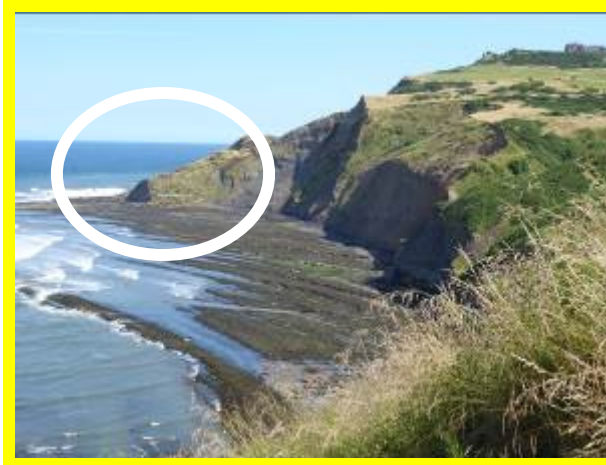
**Unit MU18/1** is located at Peak Steel, below Ravenscar. The cliffs in this region have a distinct two-tiered form. Much of the upper headscarp is densely vegetated with little evidence of recent activity. The lower headscarp, exposed to the sea, is more active and subject to episodic slides and falls evident. This unit is classified as Locally Active in 2016.

**MU18/1** Peak Steel (circled)  
(Locally Active)

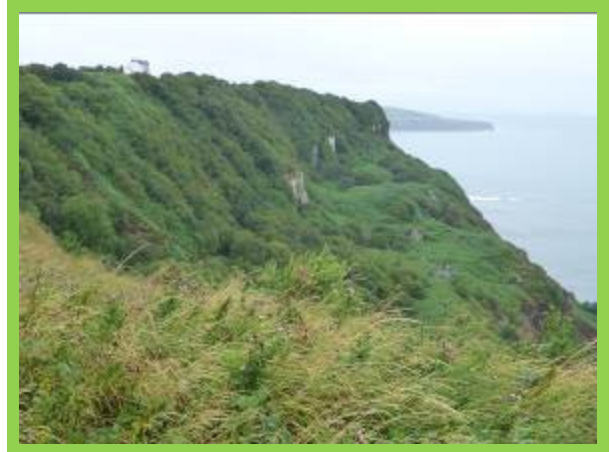
**Unit MU18/2** is a well vegetated, relict system with no signs of activity. As a result it is classified as Inactive.

**MU18/2** Distinct two-tiered cliffs  
(Inactive)

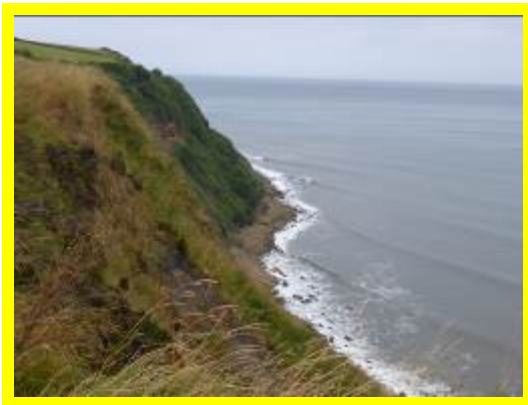
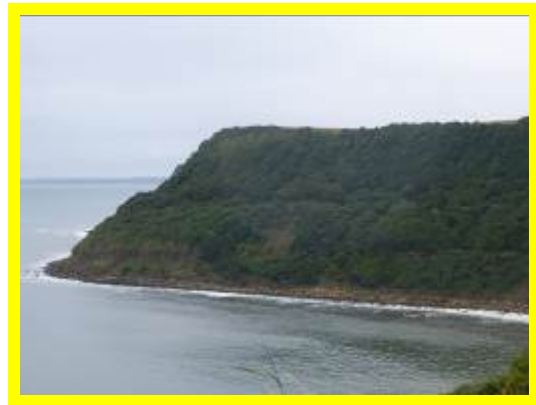
This Sub-Management Unit consists of **unit MU19/1** only. The cliffs are relatively stable and failures are localised, although a large failure in the upper cliff did occur ~ 5-10yrs ago. This unit is classified as Locally Active, and has not changed since the previous survey.

**MU19/1** well vegetated cliff face (Locally Active)

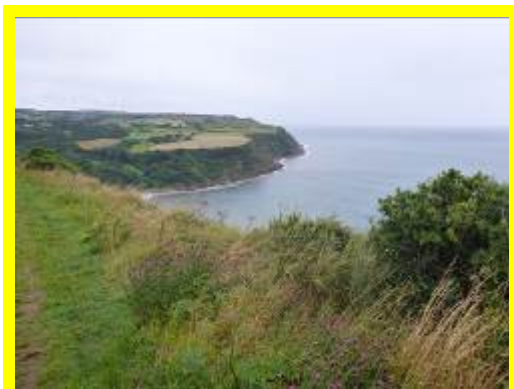
**Unit MU19/2** is located on the north side of Hayburn Wyke and is classified as Locally Active because of minor activity at the headscarp and some evidence of past rockfalls at the toe. The stabilisation works at the slopes around the footpath on the northern side of Hayburn Wyke were reported in the 2012 survey as being effective. However, it was noted during the 2014 survey that there was deformation of the steps here, indicating possible renewed movement. Despite this, the 2016 inspection showed no further deterioration or movement.

**MU19/2** Looking north across Hayburn Wyke at the vegetated cliffs (Locally Active)

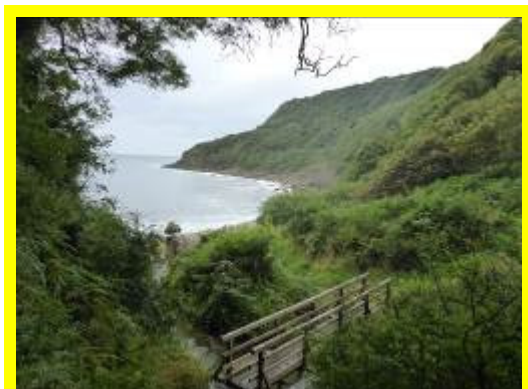
**Unit MU19/3** is located around and to the south of Hayburn Wyke. These cliffs are well vegetated, with localised erosion at the toe and headscarp. This unit remains classified as Locally Active.

**MU19/3** – Well vegetated undercliff on south side of Hayburn Wyke (Locally Active)

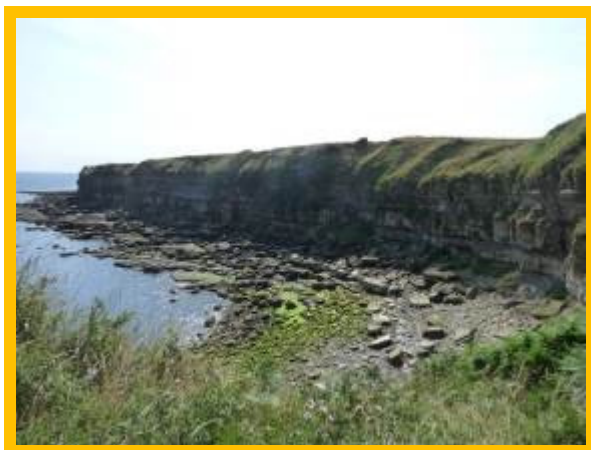
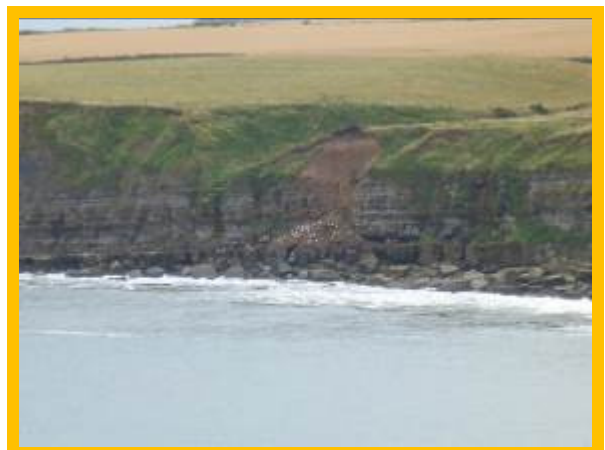
**MU19/6** Rockfall on southern side of Cloughton Wyke (Partly Active)

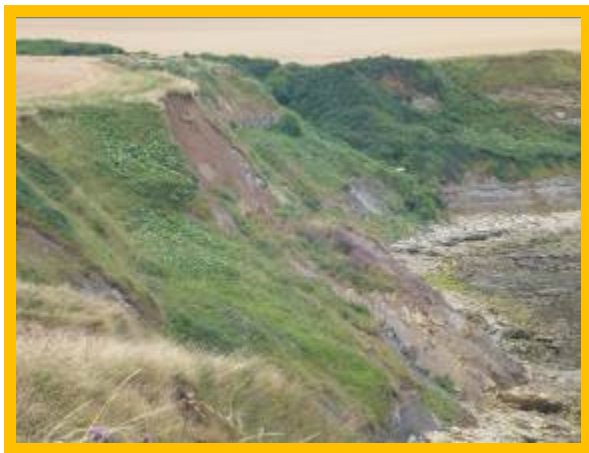
**Units MU19/9 and MU19/10** are located between Cromer Point and Scalby Ness. The toe of these units is subject to marine action and the headscarp is steep, exposed and actively retreating through slippages at numerous places throughout the units. The cliffs have been given a worsened status of Partly Active because of the extent of activity along their lengths being more than simply 'local'.

**MU19/9** Landsliding (Partly Active)

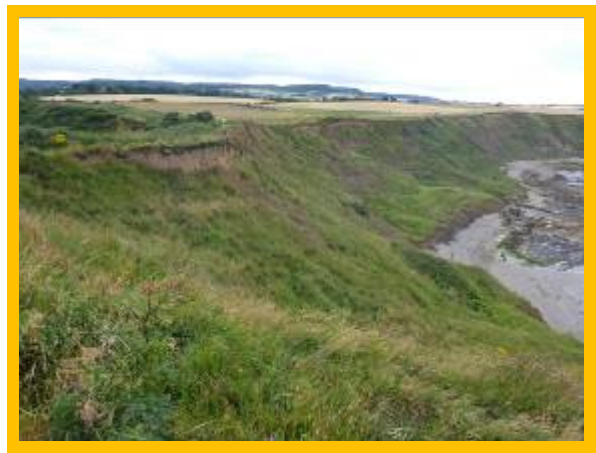
**MU19/10** Landsliding (Partly Active)

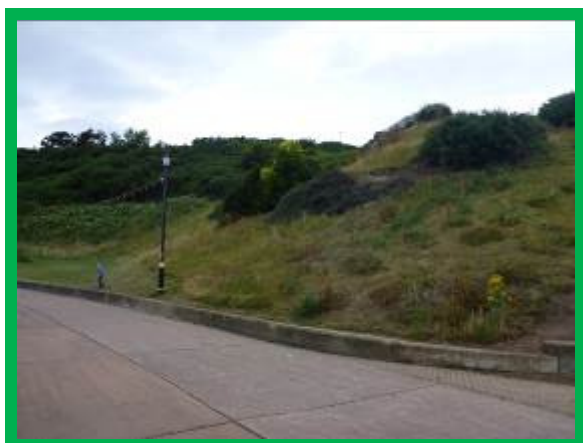
Both of these units are defended at the toe by the sea wall which runs the entire length of North Bay. The slopes are well vegetated, show no evidence of recent activity and are both classified as Dormant, as they were in previous surveys.

**MU20/1** Cliffs in northern North Bay (Dormant)

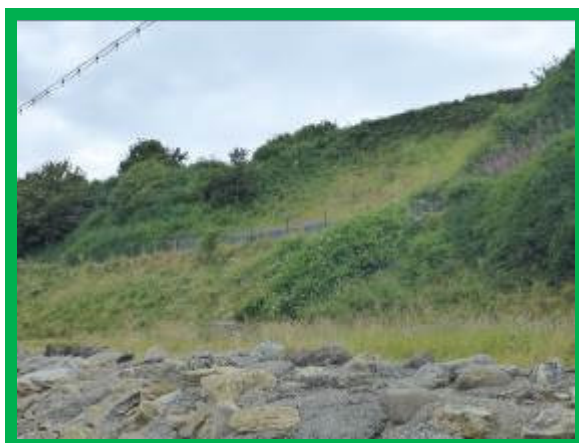
**MU20/2** Cliffs in northern North Bay (Dormant)

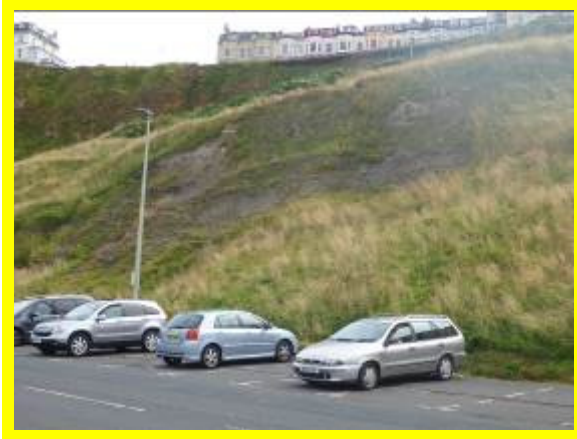
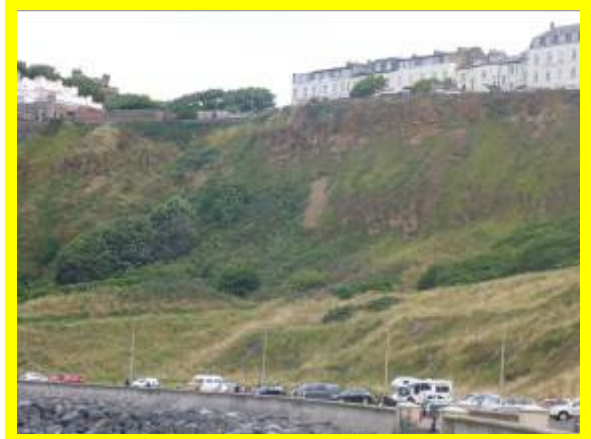
**Unit MU20/4b** covers the area of Clarence Gardens and has previously been slightly more active than the adjacent unit MU20/4a. However, remediation works have repaired cracks and the slopes are now well vegetated with exposed rock at the headscarp. This unit was downgraded to Inactive in 2012 and retained this status in 2014. However, because of evidence of some (very) shallow slips in one local area near to parking bays, it has been altered to Locally Active in 2016.

**MU20/4b** Cliffs in southern North Bay  
(Locally Active)

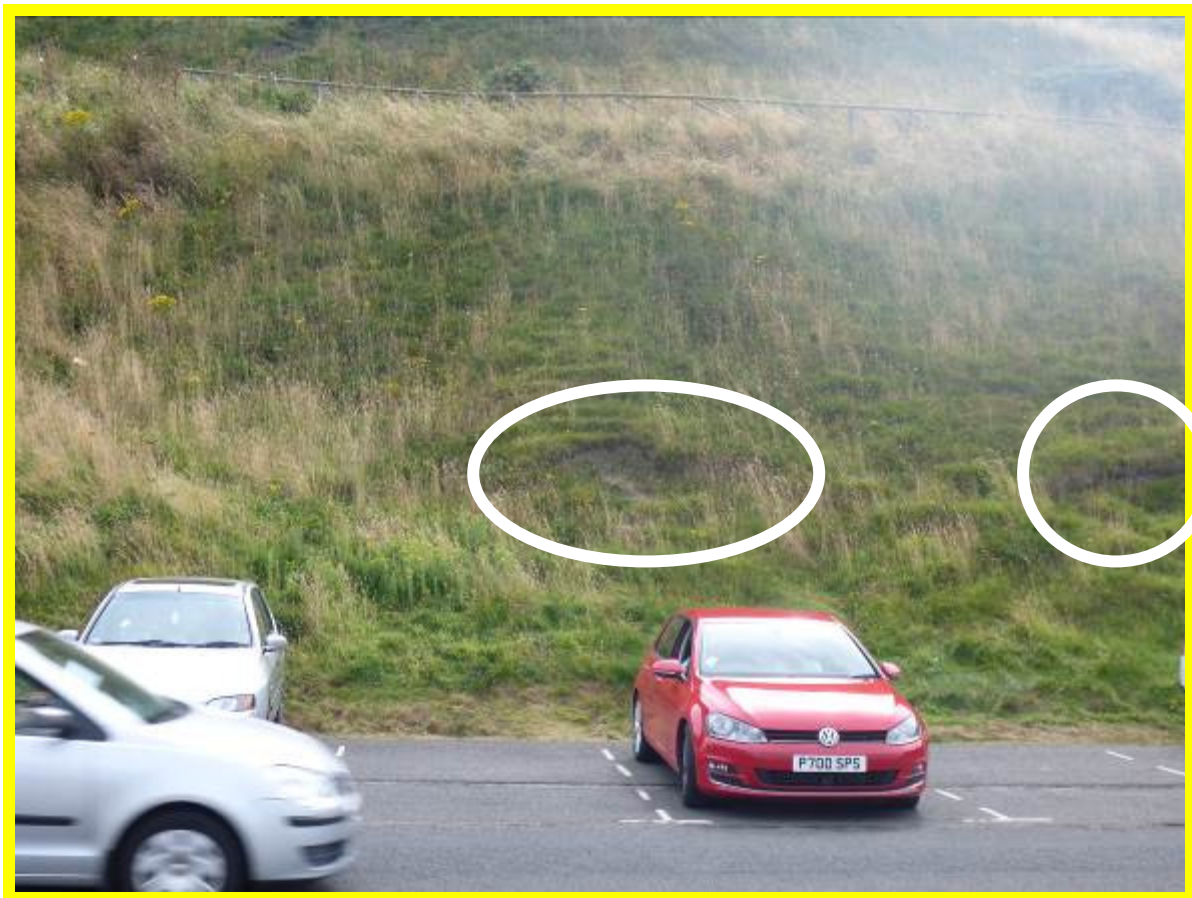
**MU20/4b** Cliffs in southern North Bay showing some signs of shallow slippage (Locally Active)

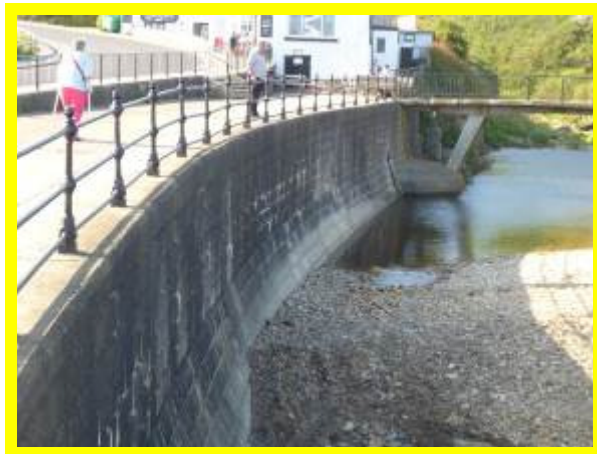
The most northerly seawall (/1201C01) starts adjacent to the footbridge at Scalby Mills and is in fair condition. Moving south the seawall (/1201C02), around the promontory on which the Sea Life centre is built is in overall fair condition, but with some local areas of abrasion. This is especially heavy around the access steps at the junction with the adjacent seawall to the south. Previous joint repairs are holding well.

Fair condition seawall at Scalby Beck (/1201C01)

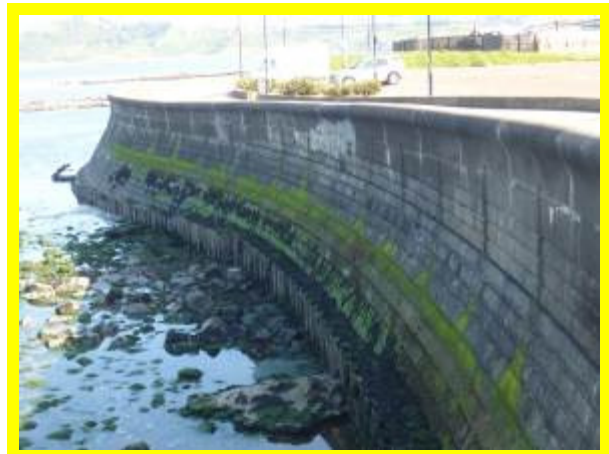
Fair condition seawall at Sea Life Centre (/1201C02)

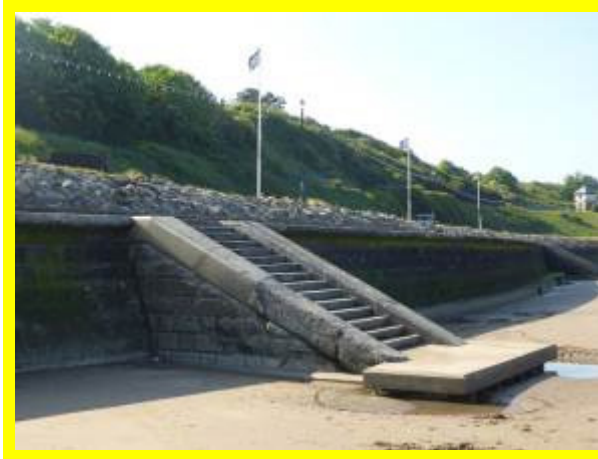
There is considerable abrasion damage to the front face, and spalling of the capping beam along the entire length of this frontage. The beach access steps are particularly heavily abraded and the southernmost set of steps have been subject to substantial repair which, to date, is holding well. However, there is a small crack between the repaired steps and the seawall which should continue to be monitored and beach levels were low at the time of the inspections, exposing the sheet piled foundations below the access steps landing. The concrete repairs extend northwards from the steps along the toe apron and remain effective.

*Fair condition seawall with recent repairs to access steps (/1201C24)*

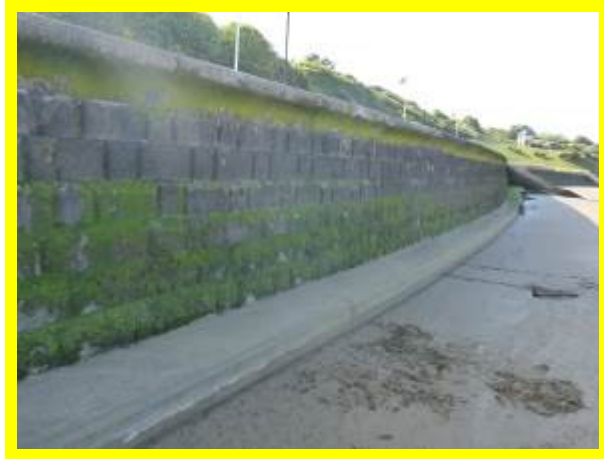
*Fair condition seawall with recent repairs to toe apron (/1201C24)*

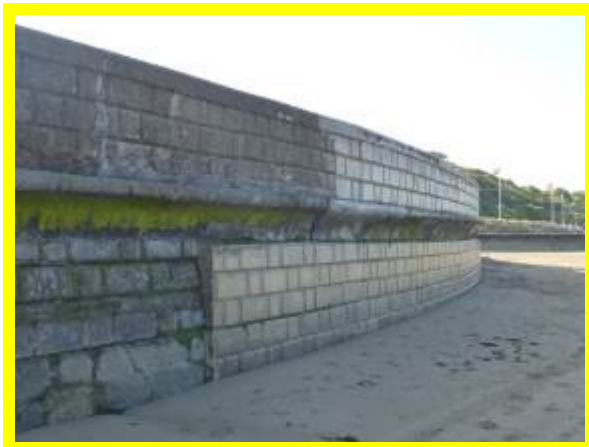
The wall around the promontory (/1201C04) is more exposed and has had relatively recent repairs to both the front face and the low crest wall, although abrasion damage remains heavy in other places (especially on the unrepaired sections of lower wall) and there is damage to the rear crest wall in two places. The new drainage outfall and entry guard are in good condition.

*Area of recent repairs to promontory wall (/1201C04)*

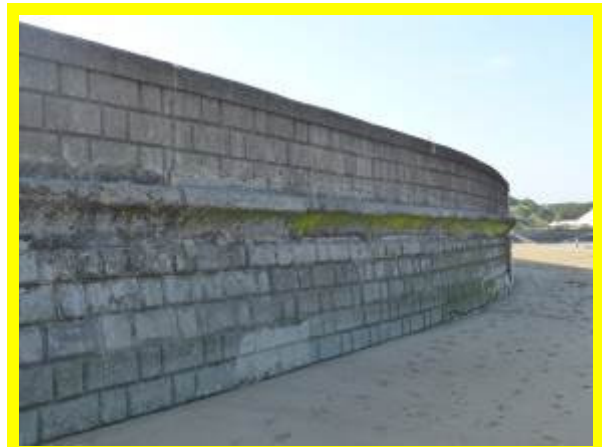
*Area of heavy abrasion damage to promontory wall (/1201C04)*

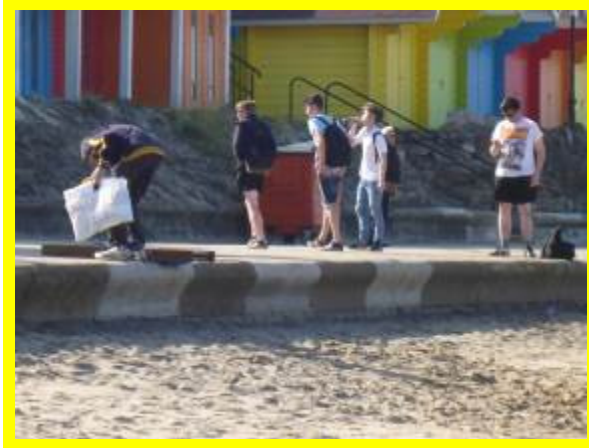
Between the promontory and Peasholm Gap, the frontage has been split into a series of asset lengths (/1201C10, C26, C11, C12, C13, C14, C15, C16, C05, C17, C18 and C06, running from north to south). The beach was relatively high along all this length, so only the upper wall and beach access steps were visible. In some areas only the capping beam was exposed, with areas of recent repairs clearly evident. Previous repairs to the grouted stone revetment to the rear of the promenade, below the beach huts, remained effective. Abrasion damage continues to be evident to the access steps along this section, although several sets have recently been repaired.

*Previous repairs to capping beam at rear of promenade (/1201C05)*

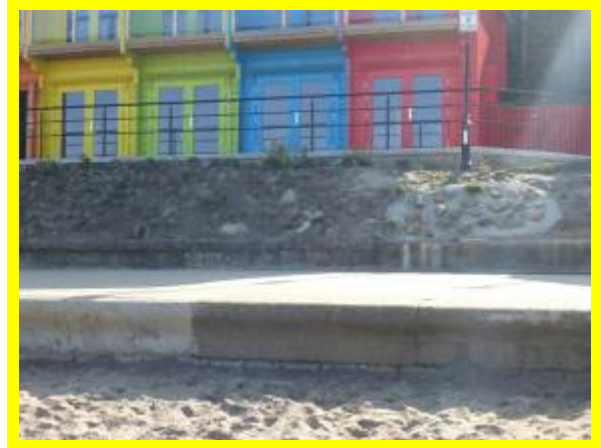
*Previous repairs to stone revetment at rear of promenade (/1201C05)*

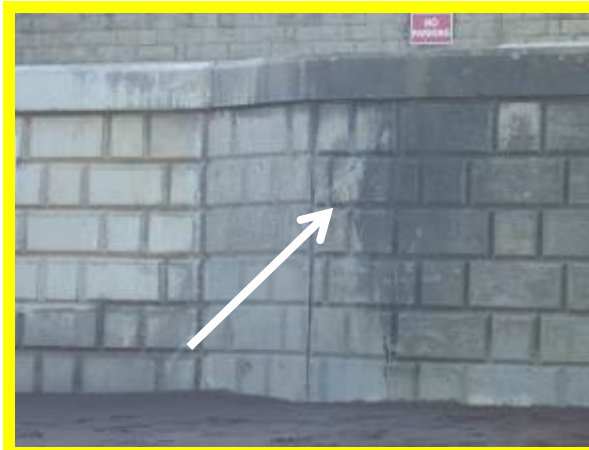
The wall to the north of the ramp at Peasholm Gap (/1201C06) continues to show several (currently minor) vertical cracks in the rear wall protecting the new development behind the wall, as well as one area of notable abrasion damage to the facing.

*Vertical cracks in wall protecting recent development (/1201C06)*

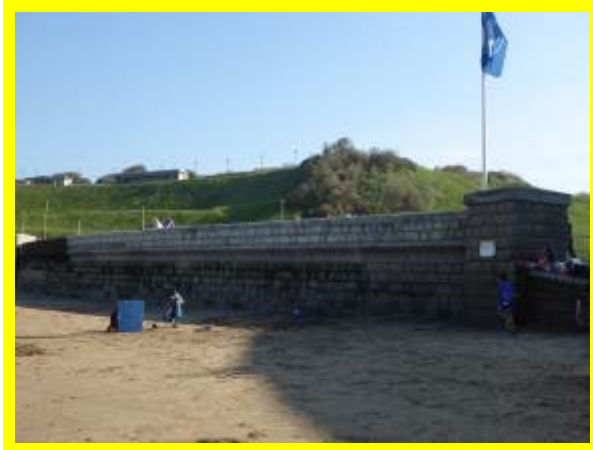
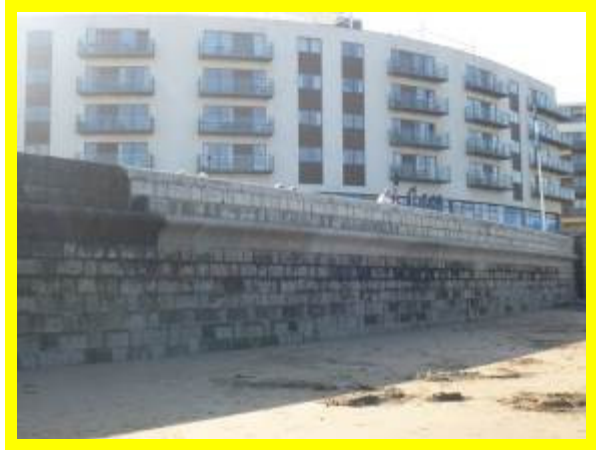
The wall at Peasholm Gap (/1201C19) has had an extensive number of significant repairs in 2014 which are holding well, with sections rebuilt or overlaid. However, there are still some damaged areas of blocks and spalling to the splash beam in areas not yet repaired. Overall, the wall remains in fair condition.

*Previous repairs to wall at Peasholm Gap (/1201C19)*

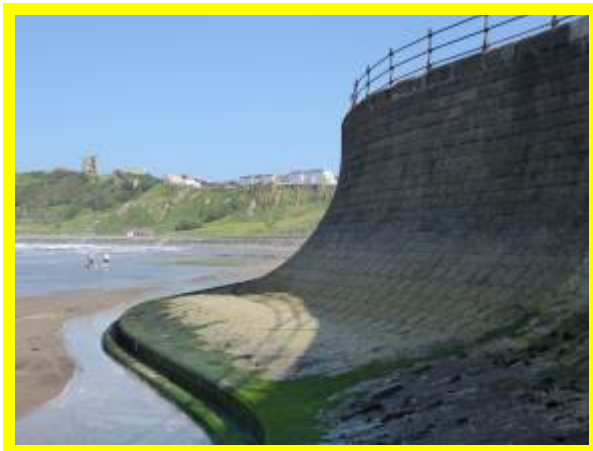
South of Peasholm Gap the beach levels drop and Royal Albert Drive is protected by an increasingly high curve-profiled blockwork wall (/1201C07 and C21) that runs south to the slight promontory at the ramp opposite the recently redeveloped Oasis Café. The previous repairs to joints, damaged wing-walls to beach access steps and entire sections of full height wall are holding well. However, one crack has opened in the wing-wall to the access ramp (which is closed off to the public) and another in the coping above the blockwork. The promenade along part of this section was re-laid in 2012 but remaining poor in other sections. Beach levels were relatively low at the time of the inspections, exposing the concrete apron which seems in fair condition although was subject to extensive algae growth.

*High curved-profile seawall (/1201C07)*

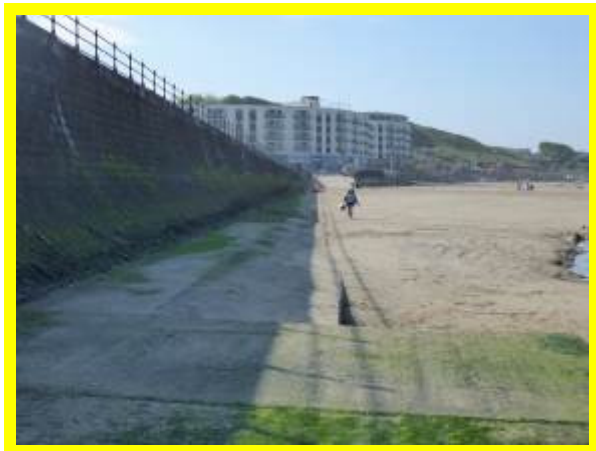
*Toe apron with algae growth (/1201C07)*

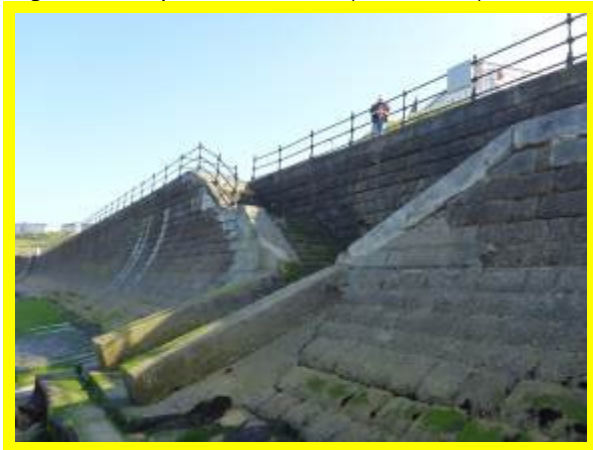
*Previous repairs to wing-wall (/1201C07)*

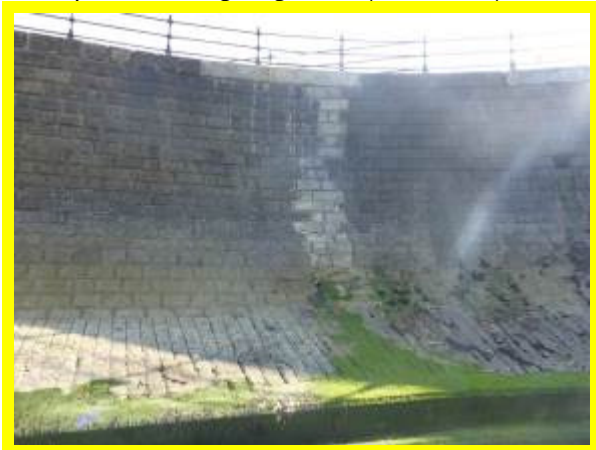
*Previous repairs to seawall (/1201C21)*

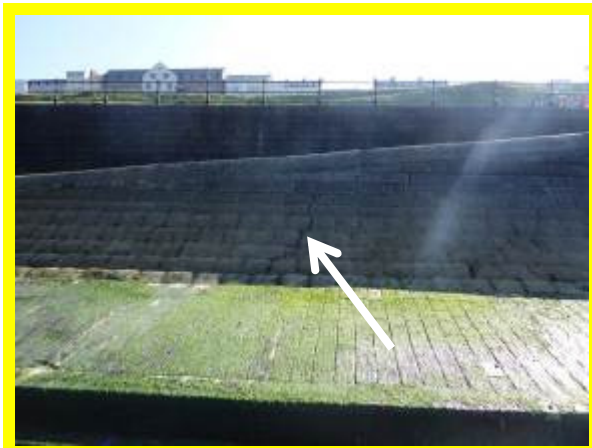
*One of two notable cracks visible in wing-wall at access ramp (/1201C21)*

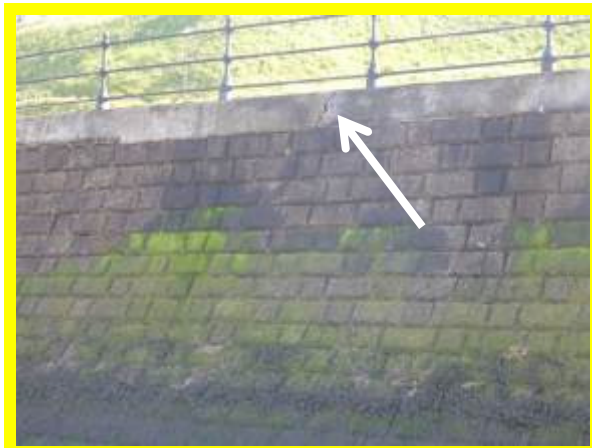
*Small crack in coping of seawall (/1201C21)*

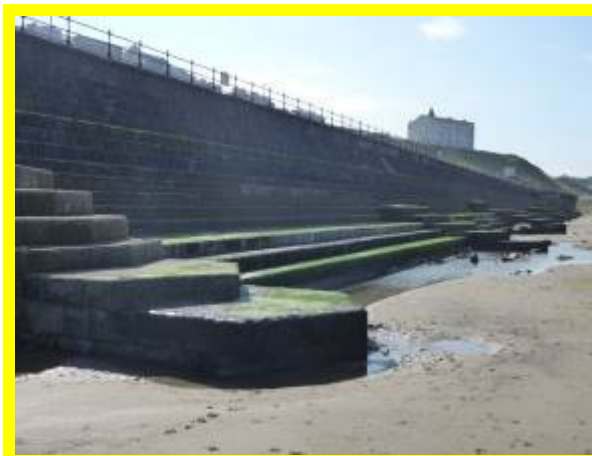
At the southern end of the North Bay, there is a large stepped concrete blockwork sea wall structure (/1201C08) constructed with nine large buttresses/bastions which protrude from the wall out onto the beach. The apron of the structure becomes increasingly exposed with progression north along the wall. There is one longitudinal crack in the blockwork across several adjacent blocks but otherwise the wall is in fair condition, although the promenade surface is poor in places.

*Concrete blockwall wall with buttresses (/1201C08)*

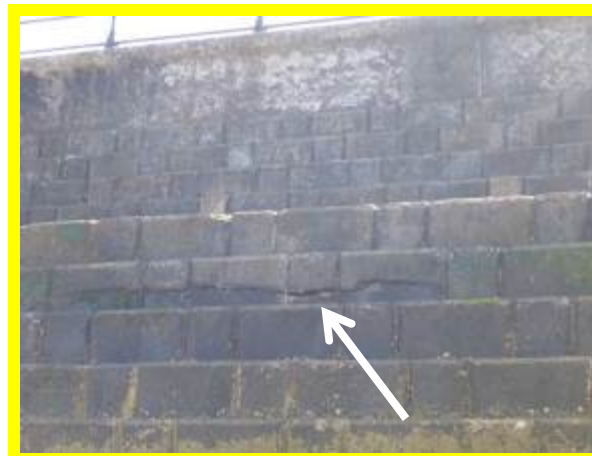
*Longitudinal crack in blockwall wall (/1201C08)*

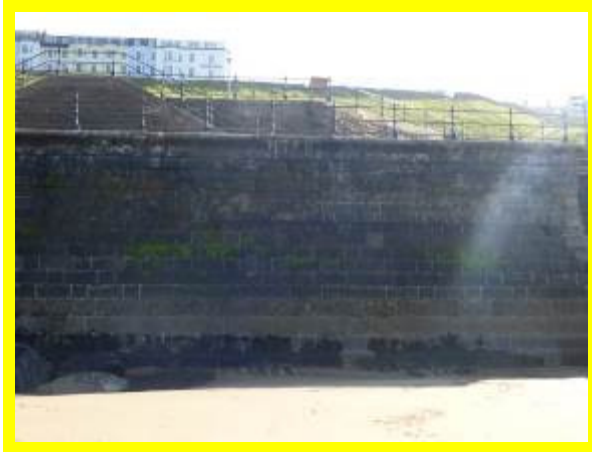
There is a short section of vertical blockwork wall (/1202C23) between the stepped concrete blockwork wall and the rock armour revetment to the south. This short wall is in fair condition and previously reported defects of cracking and missing blockwork have been rectified.

*Concrete blockwall wall in fair condition (/1202C23)*

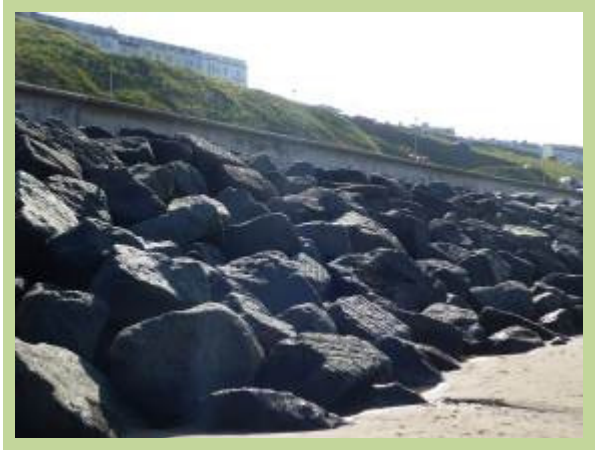
The southern-most section of defence in North Bay is the first section of the rock armour at Clarence Gardens that was constructed in 2004/5 (1202C01). This is in good condition, protecting the original wall behind.

*Rock revetment fronting seawall (/1202C01)*

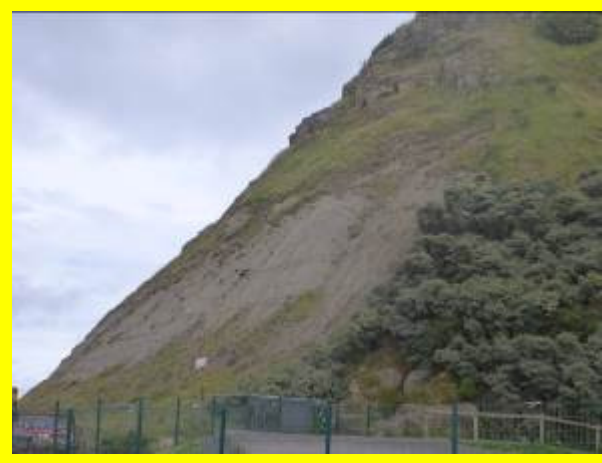
**Unit MU21/2** forms the Castle Cliff promontory and continues to be classified as Locally Active, unchanged from recent inspections. The cliffs are steep with extensive toe protection measures. Locally, bedrock is exposed where it is subject to ongoing weathering and erosion from rainfall.

**MU21/2** Castle Headland cliff (Locally Active)

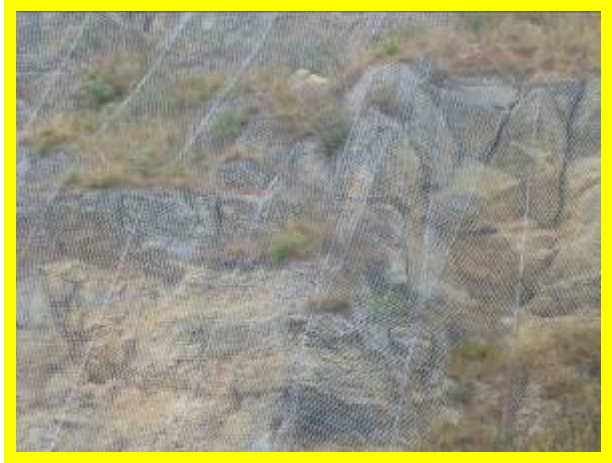
**MU21/2** Rock netting on parts of Castle Headland cliff (Locally Active)

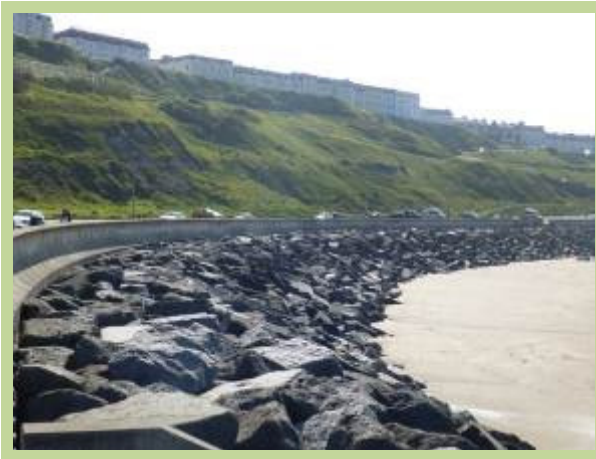
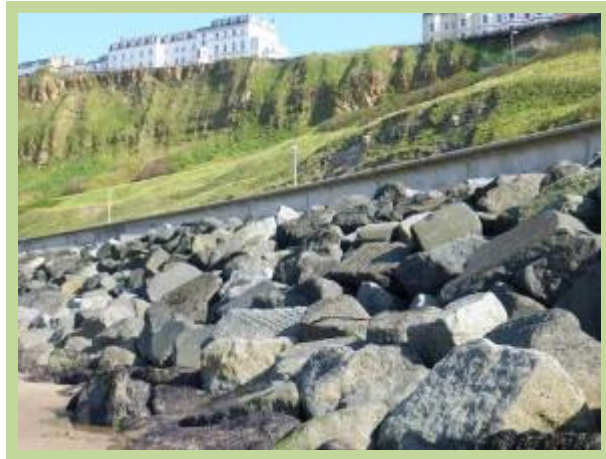
Part of the wider East Pier to the Holms Coast Protection Scheme, constructed between 2003 and 2005, protects this frontage with a rock armour revetment which extends from the southern end of North Bay (/1202C03). This continues through the Holms as rock armour with concrete toe piles to reduce the footprint of the defence, thus limiting encroachment into the foreshore SSSI (/1202C04). There is a continuous wave return wall along the crest of these defences, which remain in good condition along both of these asset lengths. Where there are beach access steps through the rock armour in the south part of North Bay (/1202C01), there is considerably more abrasion damage to the steps and locally scoured areas of the beach which leave a standing pool of water at low tide, making access to and from the beach difficult, but the structures themselves remain sound.

*Rock armour revetment and wave return wall (/1202C03)*

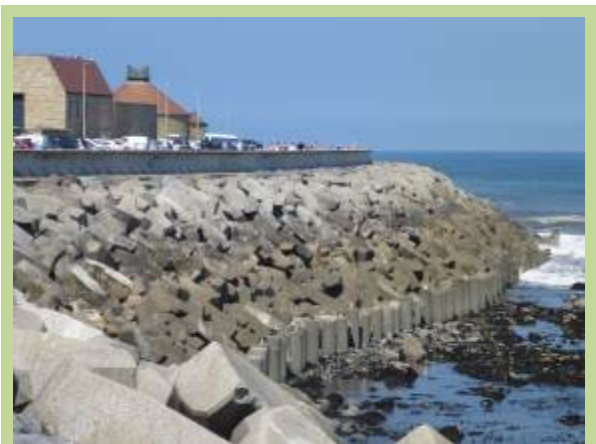
The section of defence continuing around the Castle Headland to the harbour is an Accropode revetment with concrete toe piles and a rock armourstone crest, with a concrete wave return wall (/1202C02). The inspection was limited to views from the crest wall and it was not possible to inspect the toe as along most of the length it is below water in all tide conditions. Overall, these defences remain in good condition with only localised evidence of concrete abrasion and cracks in the Accropodes. The crest wall is generally sound with only minor cracking and good joint seals. The promenade remains in overall good condition.

*Accropode revetment with concrete toe piles, rock crest and wave return wall (/1202C04)*

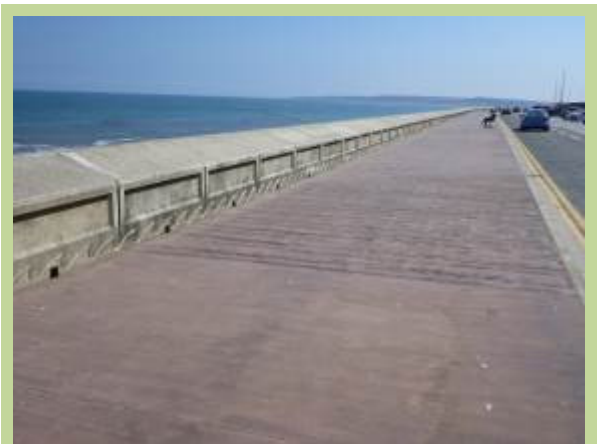
*Promenade deck and wave return wall around Castle Headland (/1202C04)*

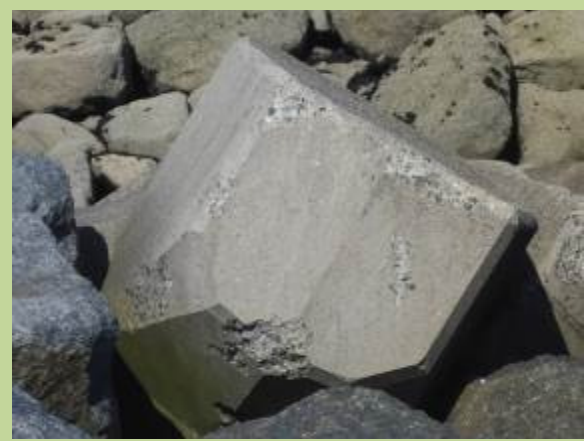
*Locally abraded Accropode unit but otherwise good condition revetment (/1202C04)*

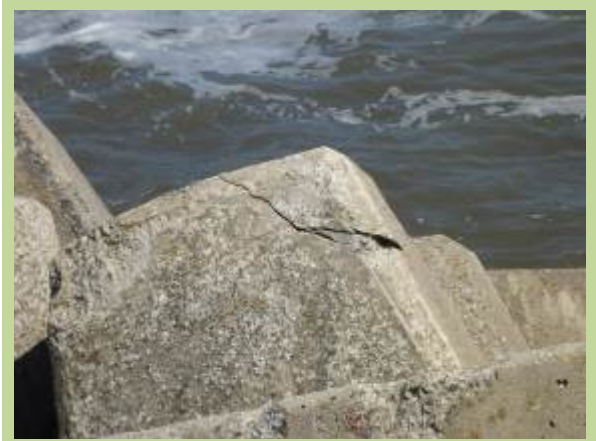
*Locally cracked Accropode unit but otherwise good condition revetment (/1202C04)*

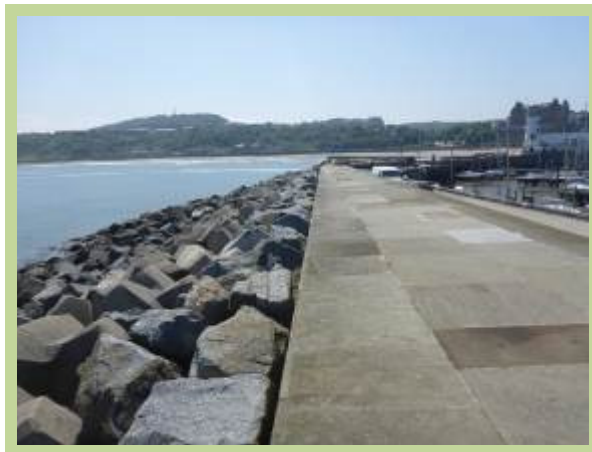
The outer facing pier of East Harbour's outer pier is protected by rock armour and Accropode units (/1301C01) and is in good overall condition. Towards the seaward end of the pier, many of the original wall blocks on the crest of the outer wall are heavily abraded and some are partially cracked.

*East Harbour outer pier (/1301C01)*

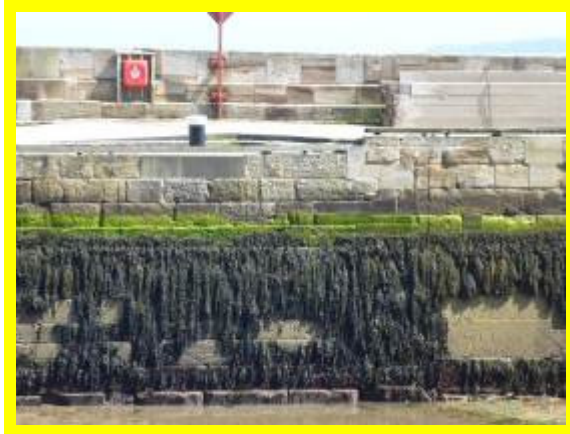
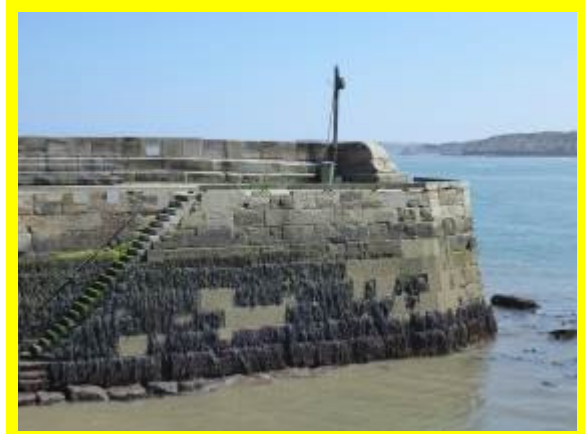
The inner facing wall of East Harbour's outer pier (/1301C16) was refurbished as part of the 2005 scheme, with missing blocks replaced and joints filled. Minor missing joints and cracks appear throughout the harbour masonry walls. The inner face remains in fair condition.

*Previous repairs to inner-facing wall of East Harbour outer pier (/1301C16)*

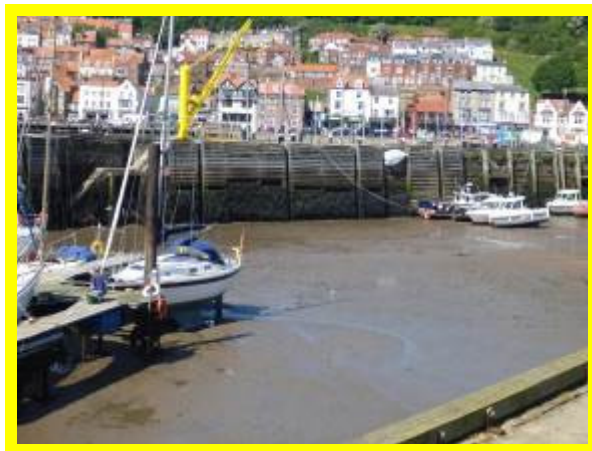
Vincent's Pier (/1301C04) separates East Harbour from Old Harbour and is in overall fair condition. The wall facing East Harbour is largely covered by timber boarding and algae growth, making inspection difficult, but where visible the blockwork and joints are sound. The pier deck is in good condition.

*Wall of Vincent Pier facing East Harbour covered by timber boarding and algae (/1301C04)*
