## **Cell 1 Regional Coastal Monitoring Programme Walkover Inspection Surveys 2016**

**Scarborough  
Borough Council**

**September 2016**

## Walkover Inspection Surveys 2016

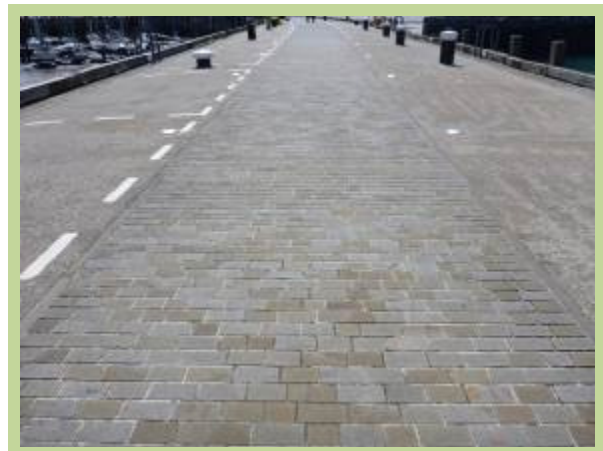
*Good condition pier deck on Vincent's Pier (/1301C04)*

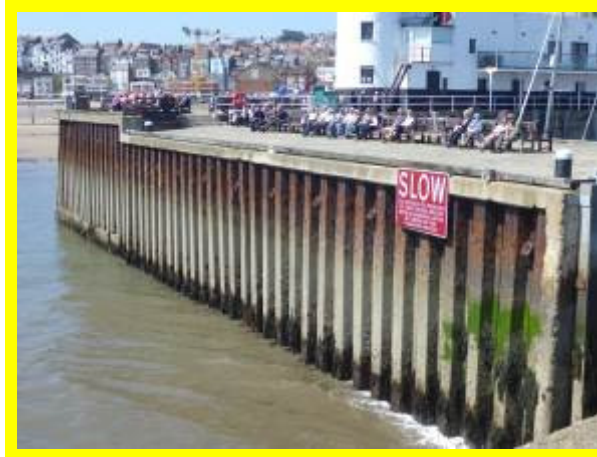
At the harbour arm beyond the Captain Sydney Smith Bridge, near the lighthouse, the steel sheet piling on the outer wall (/1301C17) is corroded but no holes were obviously apparent. However, it is notable that the blockwork walls at the end and inner facing walls (/1301C03) of this pier have open joints, although the overall condition of the pier remains fair.

*Corroded steel sheet piling (/1301C17)*

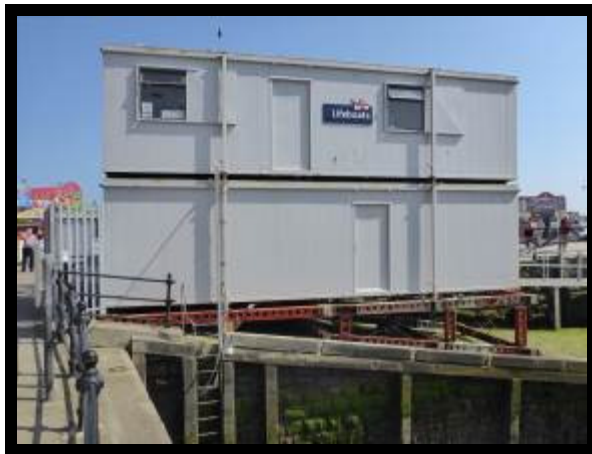
*Portable cabins used by the RNLi while a new lifeboat station is being built in South Bay (/1301C05)*

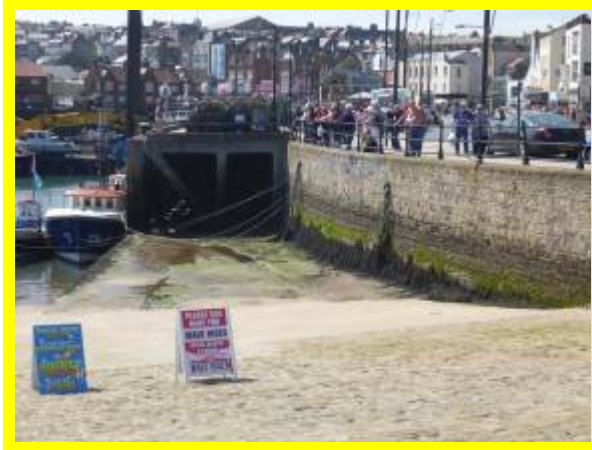
West of the arches, the quay wall leading to the slipway midway along Sandgate is formed by steel sheet piling (1301C12) which is corroded but otherwise appears in fair condition. The slipway (1301C11) is in fair condition, as is the short length of visible blockwork quay wall (1301C06) adjacent to the slipway. Immediately west of here is a concrete jetty which has been constructed to extend a suspended deck seaward of the wall. Previous inspections have reported signs of movement of the jetty and original quay wall, but this was not obviously apparent at the time of the present inspections and there was no sign of cracking in the deck. The slipway and wall at the western end of Sandgate (/1301C14), adjacent to the West Pier, is in fair condition.

*Slipway, quay wall and concrete jetty (/1301C11 and C06)*

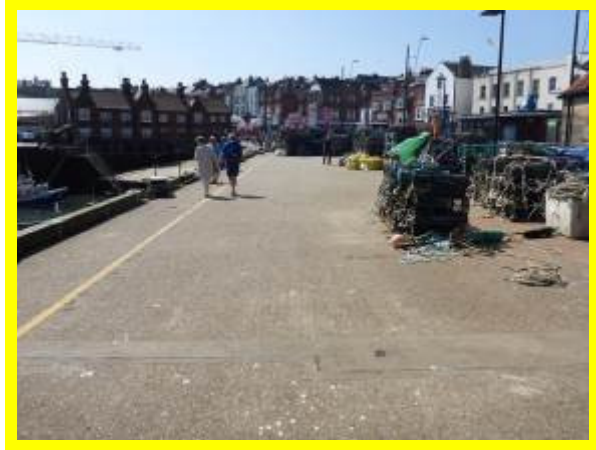
*Suspended deck of concrete jetty (/1301C6)*

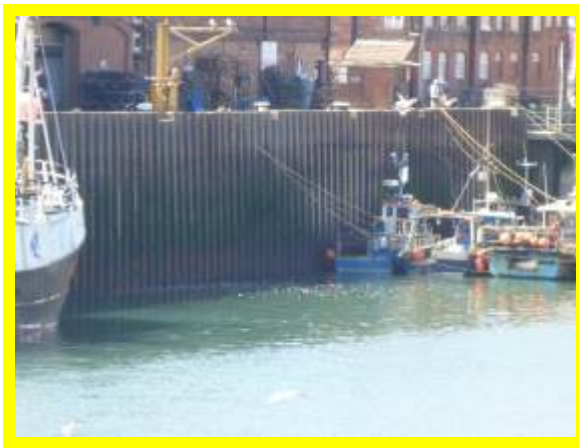
The inner face of the West Pier (/1301C13) appears to be mostly in fair condition, but the steel sheet piling is corroded. The seaward end (/1301C18) also has corroded steel sheet piling but the concrete capping beam at the crest is heavily abraded and suffers longitudinal cracks. Due to this, its condition has been downgraded to poor and repairs are recommended.

*Corroded steel sheet piling on inner face of West Pier (/1301C13)*

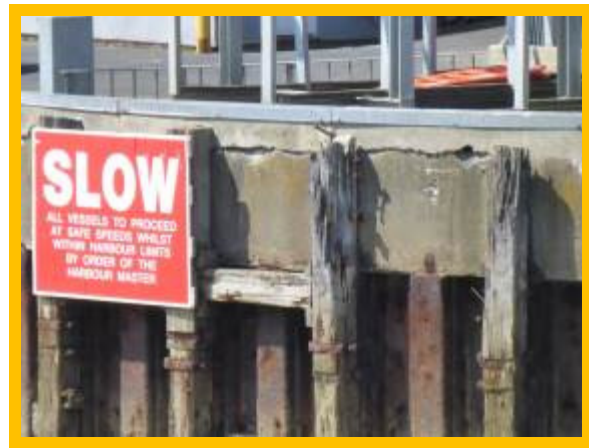
*Corroded steel and cracked capping beam on seaward end of West Pier (/1301C1718)*

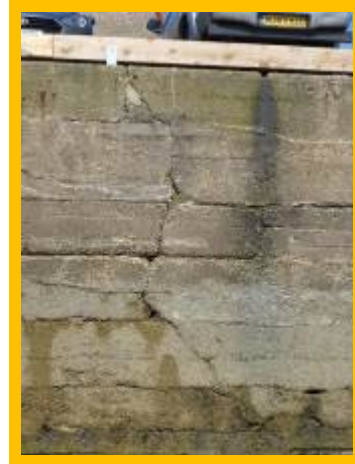
The outer face of West Pier (/1301C07) continues to show several significant defects including numerous longitudinal cold joints, several large full height cracks and exposure of aggregates. Its condition has been recorded as poor since 2009. Some previous repairs are obvious but in places cracks remain partly open. There is one area of voiding near the toe of the wall and spalling and loss of render near the seaward end of this southern face. Repairs are recommended.

*One of several full height cracks in south face of West Pier wall (/1301C07)*

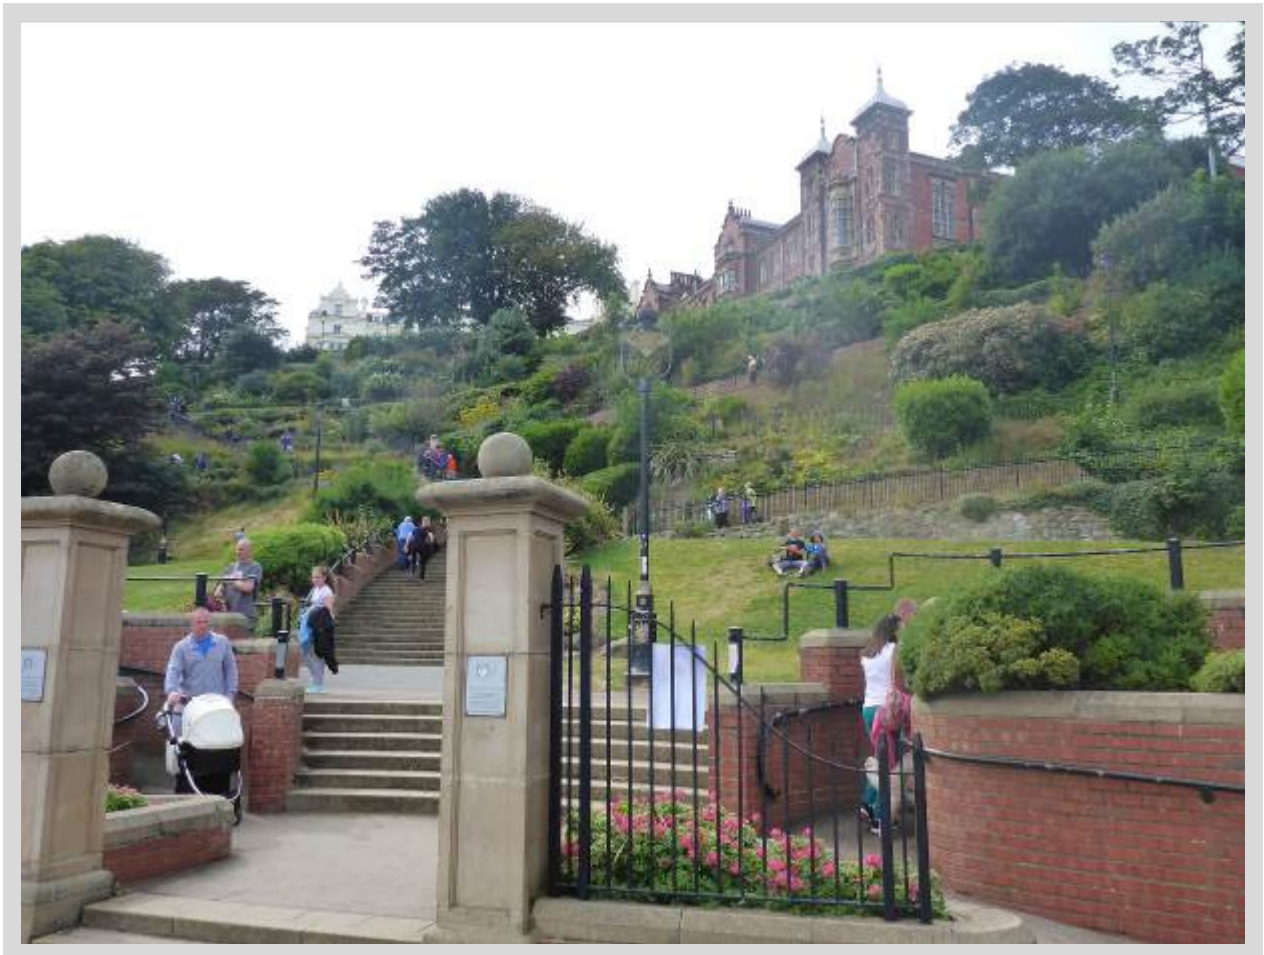
**Terraced gardens at St. Nicholas Cliff**

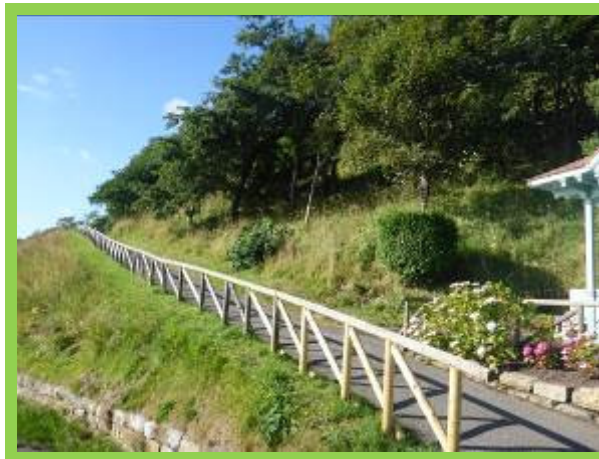
**MU22/2** Coastal slopes near the Spa (Inactive)

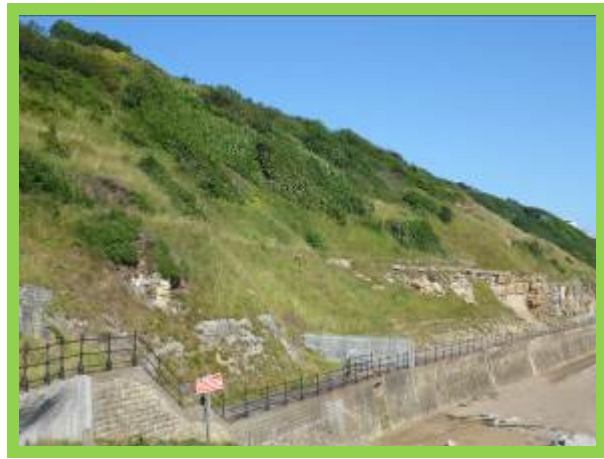
**Unit MU22/7** is located at Holbeck Gardens and is classified as Inactive in 2016, unchanged since 2012. A number of footpaths in have previously been closed due to cracking and ongoing instability. Otherwise, the slopes are well vegetated except for an area of exposed bedrock subject to small rockfalls at the cliff toe. The promenade at the base of the cliff is protected by a rockfall catch fence.

**MU22/7** Coastal slopes near Holbeck Gardens (Inactive)

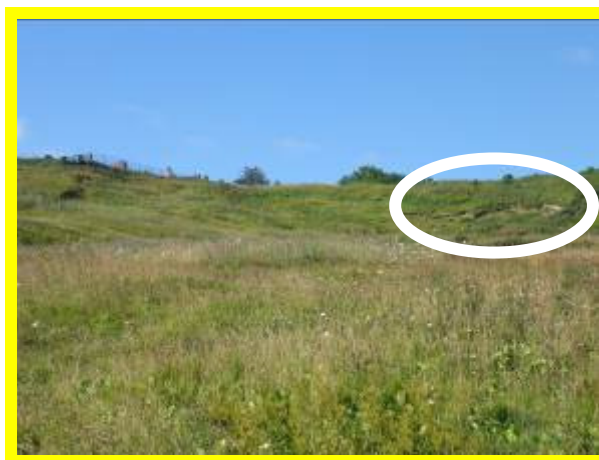
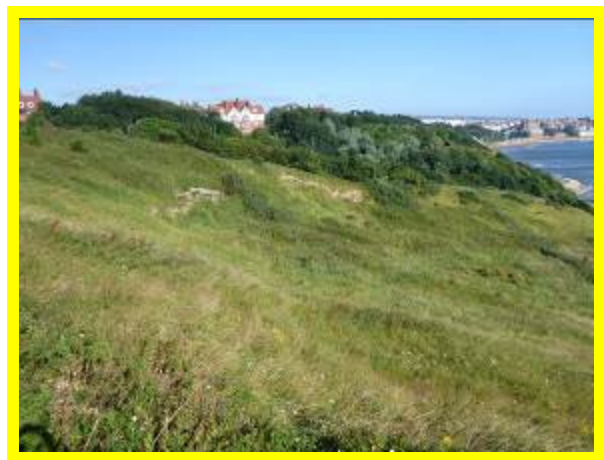
**Unit MU22/8** comprises the stabilised Holbeck Hall landslide run-out lobe and is protected at the toe by boulder armour. Localised sections near the headscarp are exposed. This unit is classified as Locally Active in 2016, unchanged.

**MU22/2** Coastal at Holbeck Hall landslide (Locally Active)

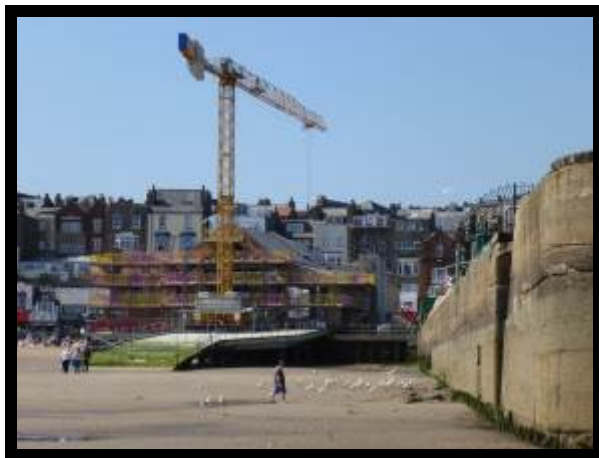
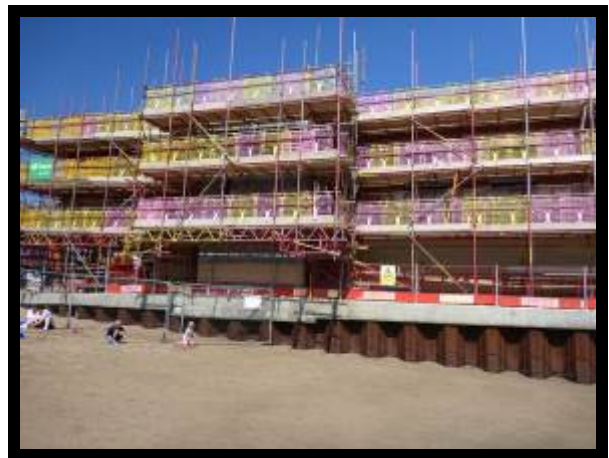
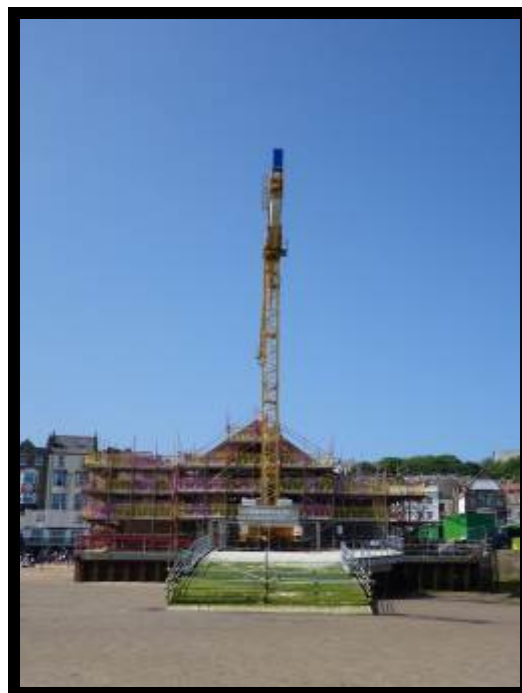
The South Bay defences start at the RNLI lifeboat station, adjacent to West Pier (/1301C08 and C20). At the time of the inspection the former lifeboat station and slipway had been demolished and the larger replacement station and slipway was being constructed by BAM Nuttall. Once complete, the assets will be in 'as built' condition.

*Construction of new RNLI lifeboat station and slipway (/1301C08 & C20)*

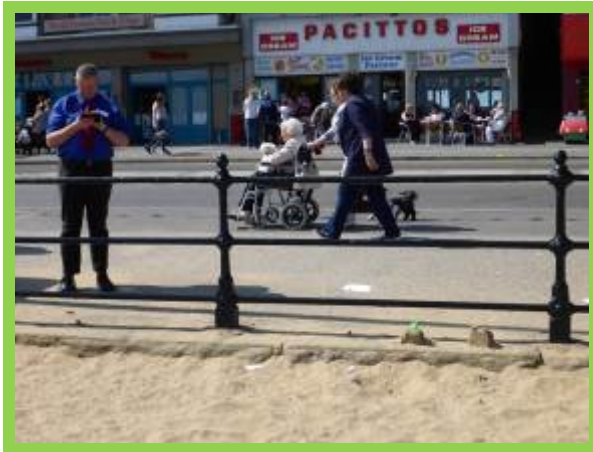
The low defence wall along the east side of Foreshore Road is split into a number of asset lengths between sets of access steps. These are, running from north to south /1301C15, C21, C22, C23, C24 and C25. Due to high beach levels at the time of inspections, sand was often flush with the promenade or, at best, only the top one or two courses of stone blocks were visible along most of this length. Due to the high beach levels, the northern section of frontage is classed as being in good condition, with the wall where exposed around the Olympia Leisure reducing to fair condition because of frequent washed out joints and abrasion to blocks, which would benefit from repair.

*Beach levels flush with promenade at north end of Foreshore Road seawall (/1301C15)*

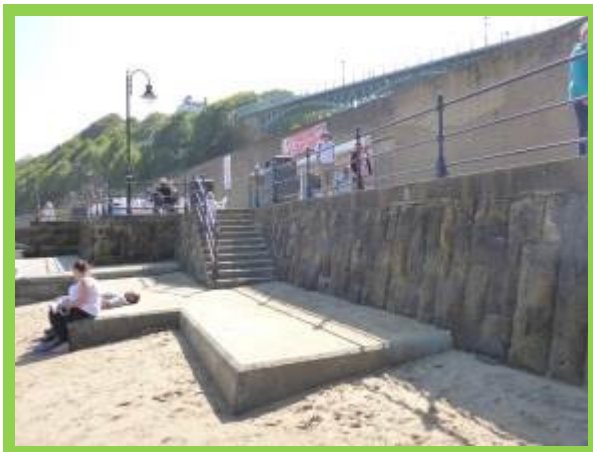
At the subway beach access in the vicinity of the Spa Bridge (1301C09), repairs have previously been made to the northern section of beach landing apron to the access steps and these remain in good condition. However, central and southern sections of the apron remain in fair condition. They are heavily abraded and in need of attention.

*Previous repairs remain in good condition locally, but overall asset condition is fair (/1301C09)*

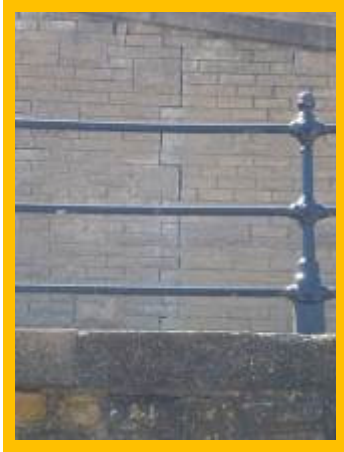
Immediately south of the beach access steps, this wall continues alongside a beach access ramp (1301C10) and there is a vertical crack in the brick retaining wall to the rear of the ramp which needs monitoring for further movement and repair. More significantly, there are major defects in the main wall (longitudinal and vertical cracks, gaps between the wall and its capping) and the lower wing-wall of the access ramp, especially around the Spa feature, which will need attention to prevent rapid further deterioration. Due to this, the wall is downgraded to poor condition. The seaward end of the ramp has been recently repaired and those works are holding well.

*Vertical crack in wall above access ramp (/1301C10)*

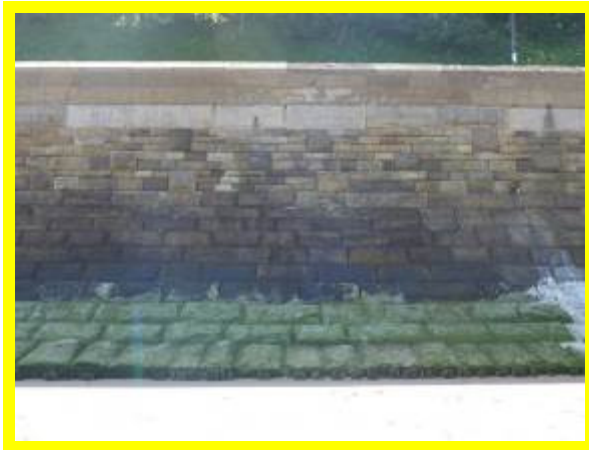
The recurved sea wall between Valley Road and the promontory at the Spa (/1301C26) continues to show occasional defects throughout, such as washout of joints and abrasion to the blockwork surface or coping, and some cracked blocks although they appear stable. It is in overall fair condition, with parts of the upper section having been rebuilt, but ongoing maintenance is needed. In one location, the timber piles at the toe of the structure were exposed and future inspections should check for signs of undercutting.

*Occasional minor defects but overall fair condition seawall (/1301C26)*

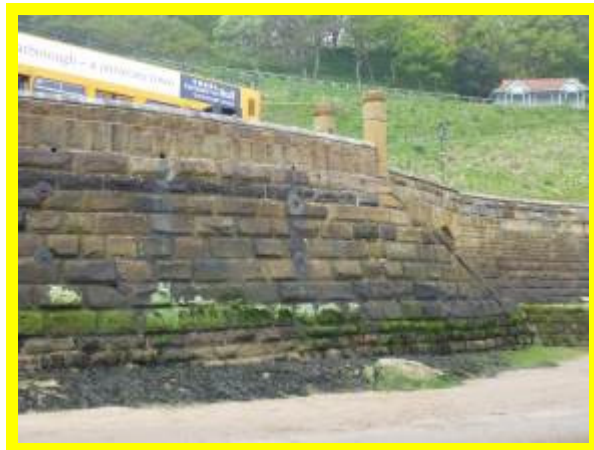
The masonry sea wall at the northern end of the Spa frontage (/1301C27) remains in fair condition following previous repairs, including reinstatement of a section of the masonry/concrete parapet after December 2013 storm damage. Previous repairs to fill joints between blocks in the wall's face also remain effective, but there are other occasional open joints between blocks which would benefit from filling and cracks are evident across the corners or full height of the face of some blocks. In front of the Spa building's entrance, one section of sea wall has longitudinal cracks across three adjacent masonry blocks, which is likely to be an area of potential weakness.

*Masonry sea wall at The Spaw access steps in fair overall condition (/1301C27)*

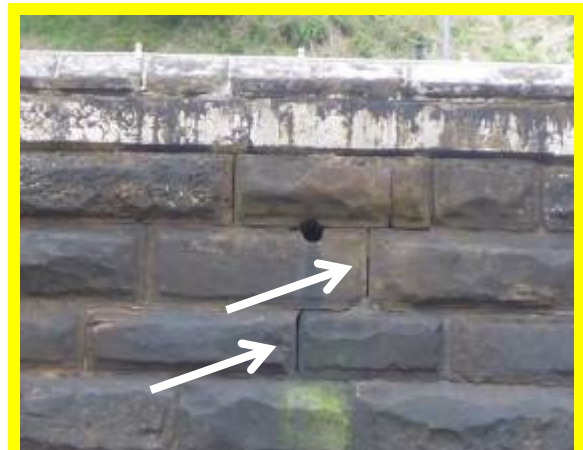
A small number of blocks near the toe of the sea wall at the apron section and to the immediate south appear slightly recessed within the wall and a few also have small gaps opening. The toe apron itself appears in fair condition, although there is a lot of marine growth on the concrete and sheet piling which may cover defects and the steel piling is corroded. Additionally, due to relatively high beach levels at the time of the inspections, previous observations of scour hole development under the concrete apron (following the December 2013 storm) could not be checked. The drainage holes appear mostly in working order and the local area of wall containing ties shows no obvious signs of deflection.

*Example of gaps between blocks in sea wall (/1301C27)*

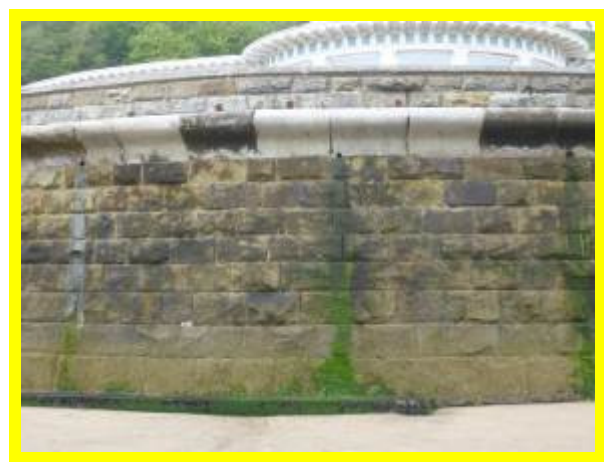
In front of the Sun Court (/1301C28), the wall has a concrete 'nosing' intended to act as a wave deflector below the parapet. Previous repairs to this element remain effective. The concrete toe beam was partially exposed along the length of the Sun Court and visible sections appeared in fair condition.

*Previous repairs to wave deflector wall in front of the Sun Court (/1301C28)*

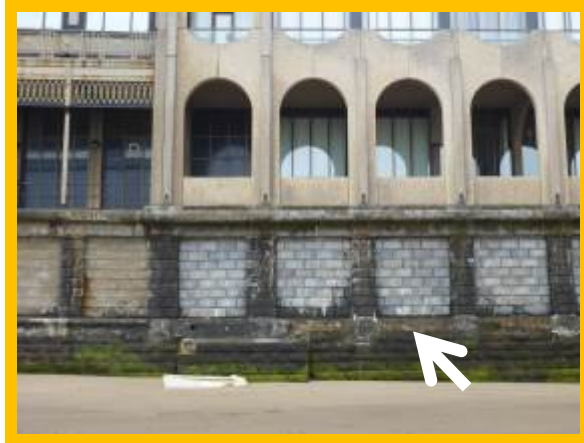
The wall between the Sun Court and the closed colonnade (/1301C29), remains in fair overall condition but has several small open joints. However, the closed colonnade section (/1301C29) has major spalling and loss of concrete to the lower splash beam below in-filled openings, tending towards poor condition. There is also an area of displacement in the blocks and loss of facing masonry at the toe near to the south end adjacent to the beach access steps between the closed and open colonnade sections. A large crack also runs down a section of the outer face of the access steps, just below its parapet. The pillars between adjacent in-filled openings show some minor cracking.

*Spalling to the lower splash beam at closed colonnade section (/1301C29)*

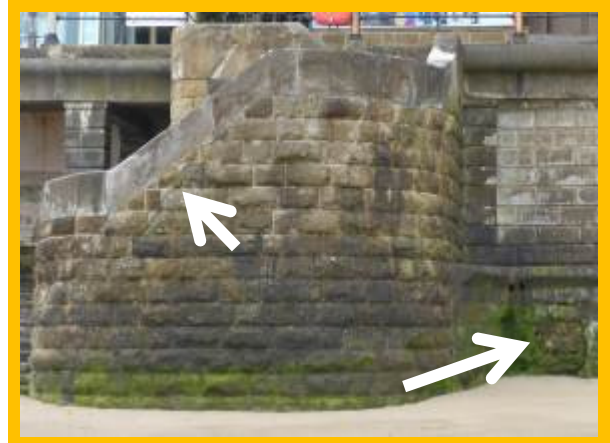
*Crack in wall and displacement/loss of facing masonry in blocks at toe (/1301C29)*

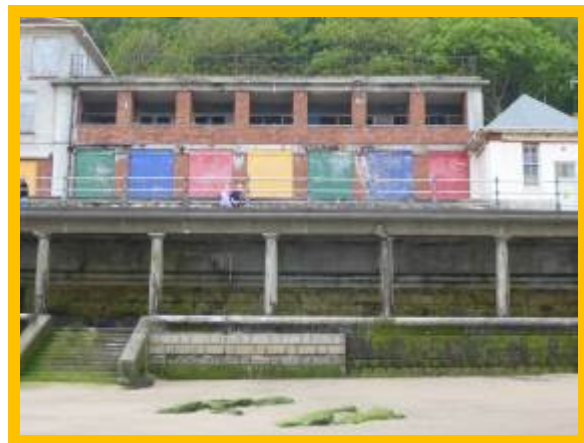
Along the open colonnade section (1302C01) there are three flights of access steps from the low level promenade to the beach, all of which are heavily abraded. The wall itself is in generally in poor condition despite previous December 2013 repairs remaining effective, with significant areas of open joints in other sections of the lower wall. The support pillars are heavily stained and in places there is some cracking. The access steps to the beach at the southern tie-in have been subjected to extensive repairs following previous damage in December 2013.

*Previous repairs (Dec 2013) at the open colonnade remain effective, but extensive open joints remain in lower wall (/1302C01)*

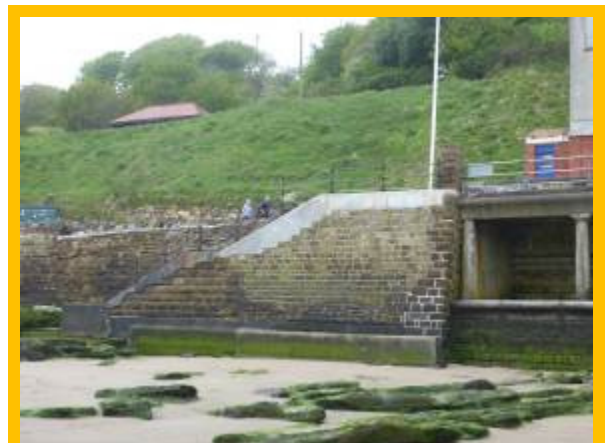
*Previous repairs at southern tie-in following December 2013 storm damage (/1302C01)*

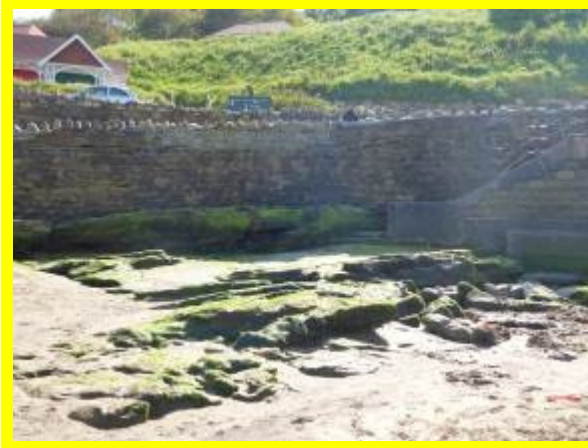
The low stone wall at South Cliff Gardens (/1302C03) has had a considerable number of repairs and rebuilding over the last few years, however notable cracks and gaps remain in need of further attention.

*Overall fair condition of low stone wall (/1302C03)*

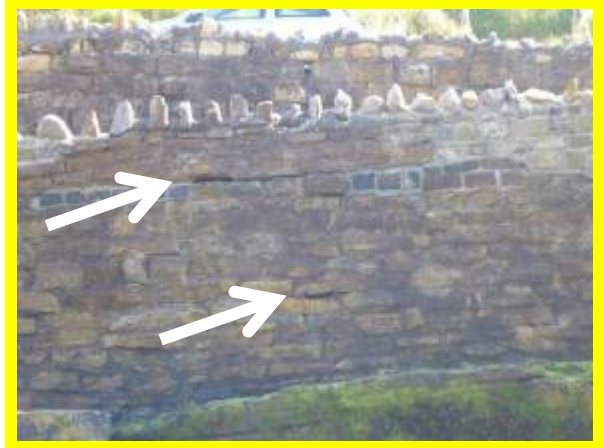
*Gaps in need of filling (/1302C03)*

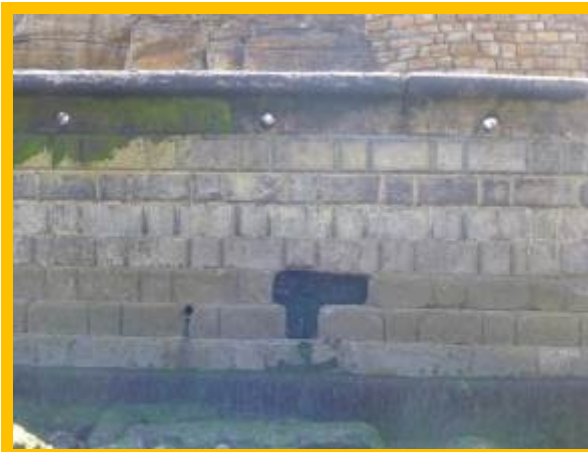
The low stone wall continues at the rear of the promenade around South Cliff Gardens with a seawall in front (/1302C02). The seawall has considerable previous repairs to the blocks and coping, but a group of three blocks is missing in one area. This needs to be addressed before more unravelling of the structure occurs. At the southern end of the wall, a short section of concrete bagwork is present at the tie-in to the South Bay Pool seawall to the south. Here one bag has been plucked from the wall, creating a small void which also needs attention. These defences have caused the structure to be regraded to poor.

*Overall fair condition of low stone wall (/1302C02)*

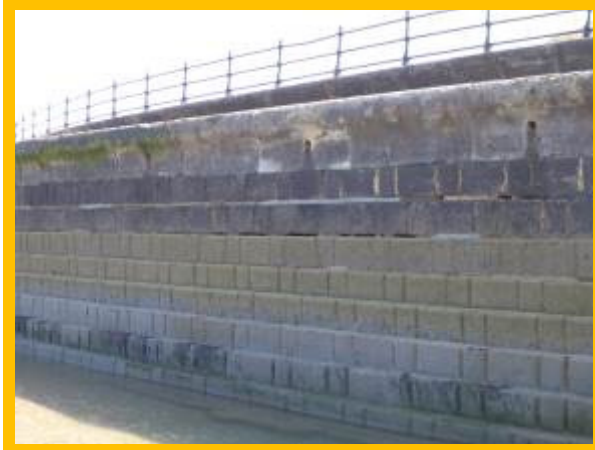
A concrete block wall (/1303C02) extends around the infilled lido pool, which is now used as a Star Disk. This wall has slightly stepped blocks on its face and these blocks and the wave return capping beam show continued signs of considerable abrasion. Some areas of the wall have been subject to beneficial repairs, but there are numerous other areas of open joints. In one location a failed outfall pipe extends across the foreshore. The wall's condition has previously been classed as poor and ongoing repairs/maintenance would be beneficial.

*Concrete block wall with open joints and heavy abrasion (/1303C02)*

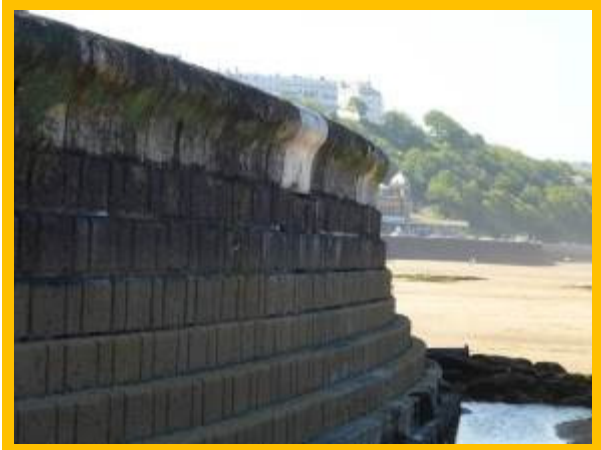
*Previous repairs to wave return coping (/1303C02)*

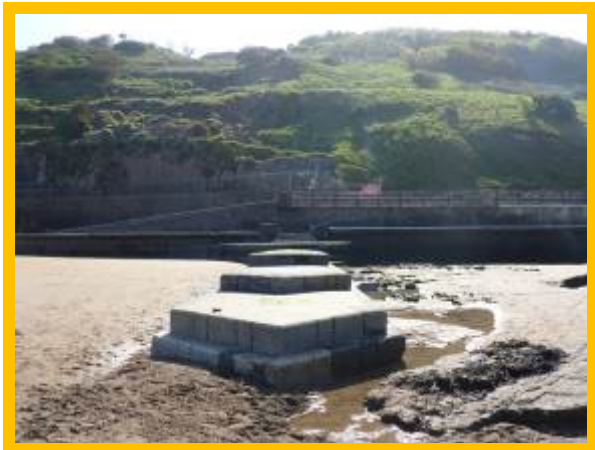
There is a bastion groyne at the north of this frontage (/1304C02) which has trapped sand between here and the rock revetment around the Hoilbeck Hall landslide to the south. The lower sections of the backing seawall have areas of previously repaired and currently heavily abraded coping, with previous repairs also evident on the upper wall. The backing promenade deck has some cracks.

*Bastion groyne in overall fair condition (/1304C02)*

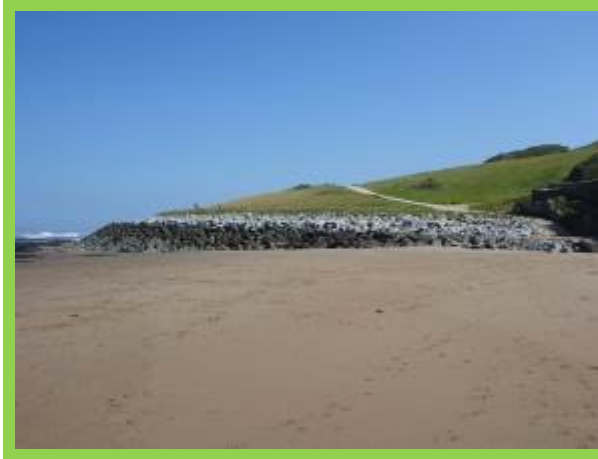
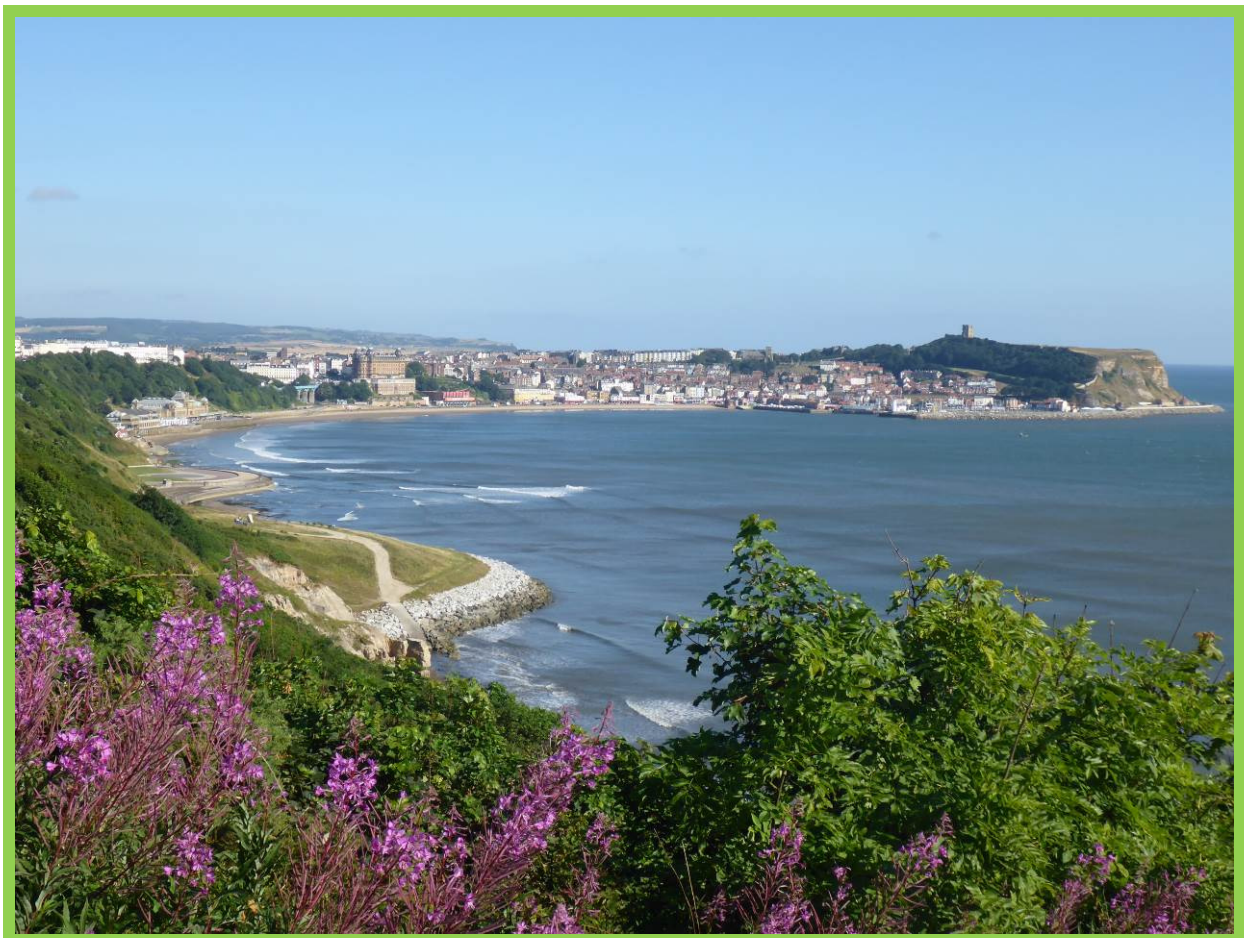
The rock armour revetment (/1304C01) defending the relict debris flow lobe at the site of the Holbeck Hall landslide remains in good condition, with the armour tightly packed and good coverage. At the southern end of the defence the beach access ramp has a short vertical drop to rocks at the end making its use slightly difficult and there is a minor crack in the most seaward concrete section which would benefit from repair.

*Rock revetment around debris lobe of Holbeck Hall landslide (/1304C01)*

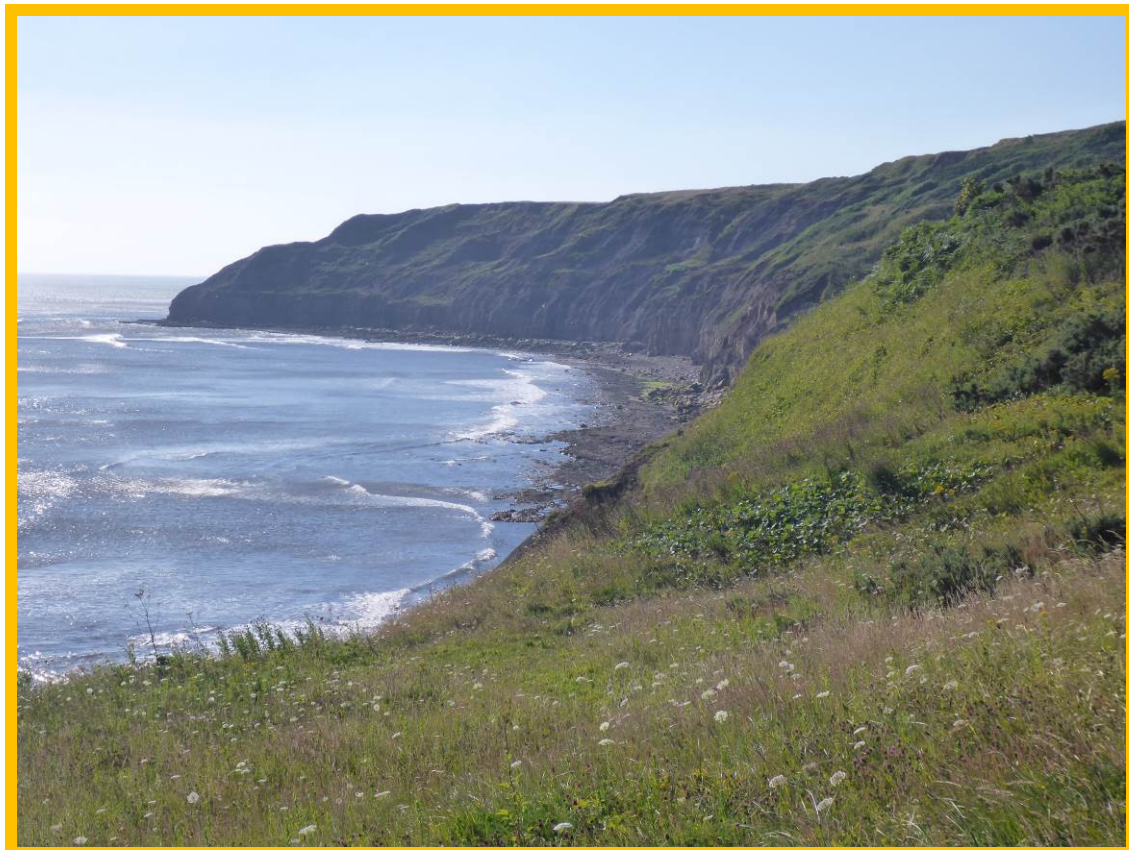
**Units MU23/D1, MU23/D2 and MU23/D3** are located at Wheatcroft Cliff above Black Rocks. These units are active down much of their length, with ongoing recession of the headscarp, slumping in the mid-slope and erosion of the toe. They are classified as Partly Active in 2016.

**View from MU23/A to MU23/D3 All Partly Active**

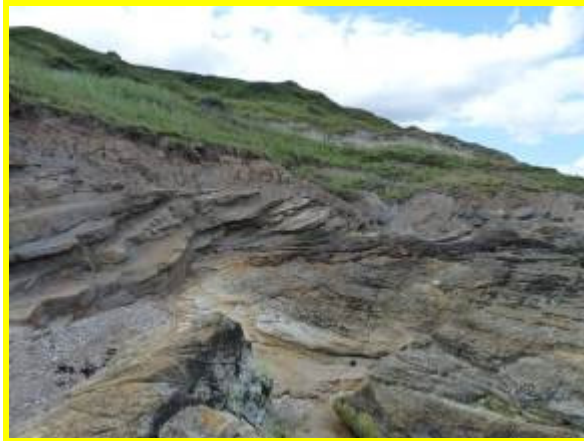
**Unit MU23/E** is located at White Nab and remains classified as Locally Active in 2016. The slopes of this unit support some vegetation cover with intermittent areas of more intense erosion mid-slope and at the unit toe.

**MU23/E** Vegetation and localised erosion (Locally Active). August 2014.

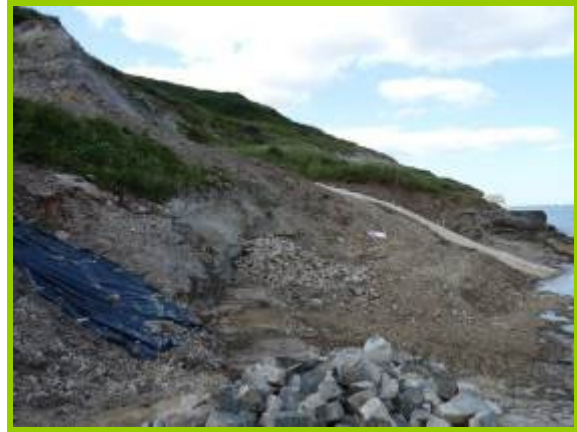
**Unit MU23/F** is a narrow, thin unit which follows a small valley occupied by an outflow channel for a pipeline and pumping station. The slopes inland are well vegetated and show very little evidence of recent activity. As a result, this unit is classified as Inactive in 2016. Works have recently been undertaken to repair the Yorkshire Water outfall at this site (with a replacement long sea outfall scheduled to be built in the future).

**MU23/F** Works encountered during the 2014 survey (Inactive). August 2014.

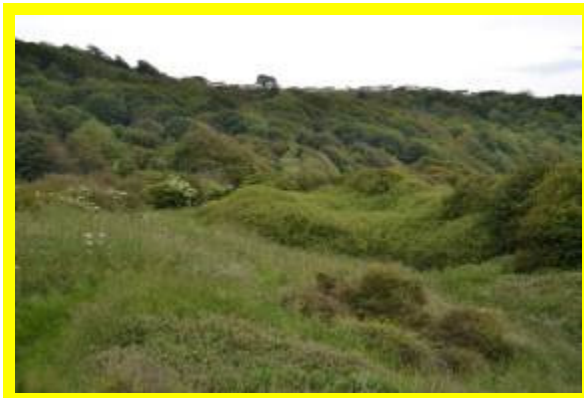
Immediately south of Osgodby Point, unit MU24/A comprises mudstone at beach level of the Cayton Cliff landslide complex. The wide expanse of Cayton Cliff is capped by till which is heavily vegetated. Significant recession of the head scarp occurred during an event in 2008-2009, resulting in the loss of land and properties at Knipe Point Drive. The cliff at the toe of the complex is steep and comprises uplifted debris from deep landslide movement. Only localised activity is evident at the toe and head scarp, with no evidence for movement in the body of the landslide, and so the unit is considered to be Locally Active in 2016, the same as 2014.

Heavily vegetated till of Cayton Cliff. MU24/A Locally Active in June 2016

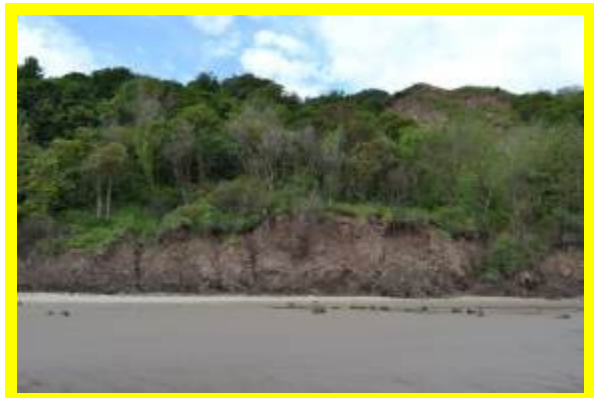
Toe of Cayton Cliff. MU24/A Locally Active in June 2016

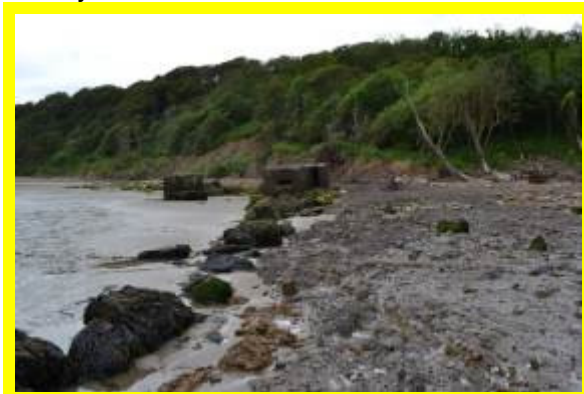
Toe of Cayton Cliff. MU24/A Locally Active in June 2016

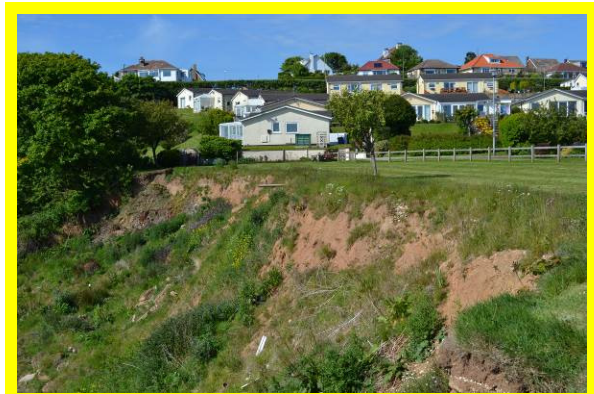
MU24/A Locally Active in June 2016

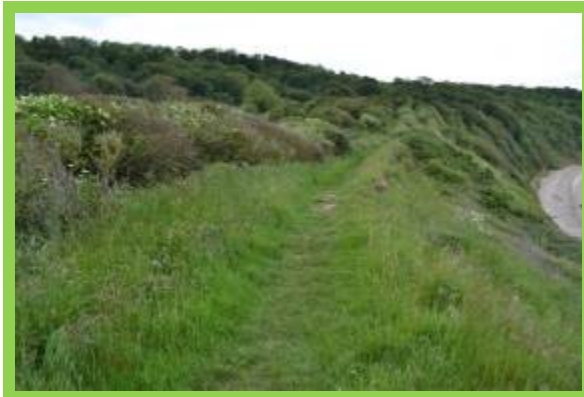
Tenants' Cliff is a complex of terraced landslips in mudstone and sandstone and is divided into 11 units. Unit MU24/B forms the main part of the Tenants' Cliff landslide and is classified as Inactive in 2016, no change from 2014. The toe of Tenants' Cliff is categorised into ten smaller landslide units comprised of massive displaced blocks of sandstone. Each of MU24/B1 to MU24/B10 is classified with a different level of activity in 2016. The more northerly units (MU24/B1 and MU24/B2) are classified as Locally Active, MU24/B3 to MU24/B8 as Partly Active and MU24/B9, where there is intense erosion of the unit toe, classified as Totally Active. All these units are classified the same as they were in 2014. MU24/B10 is protected by the seawall which extends northwards from the pumping station. During the 2016 survey it was completely vegetated and is classified as Inactive.

Heavily vegetated part of Tenants' Cliff complex. MU24/B Inactive in June 2016

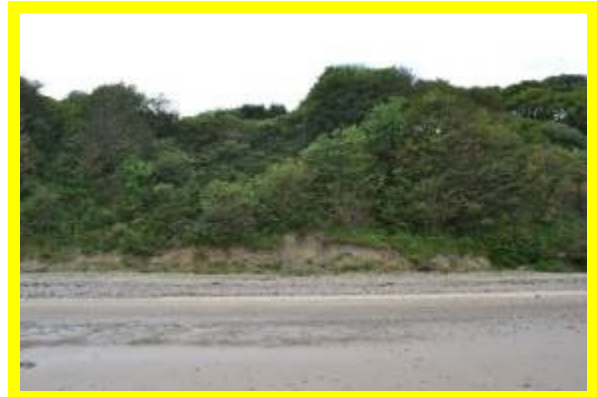
Toe of Tenants' Cliff complex. MU24/B1 Locally Active in June 2016

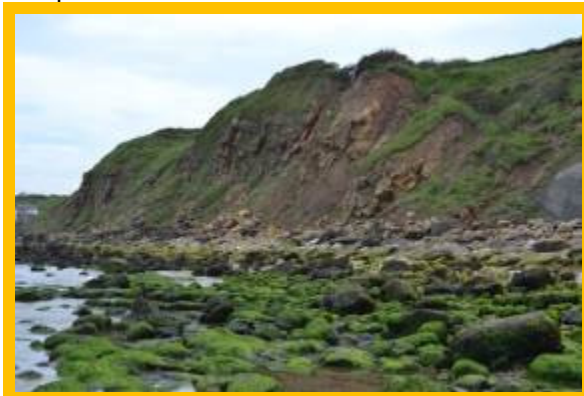
Toe of Tenants' Cliff complex. MU24/B4 (right) to MU24/B6 (left) Partly Active in June 2016

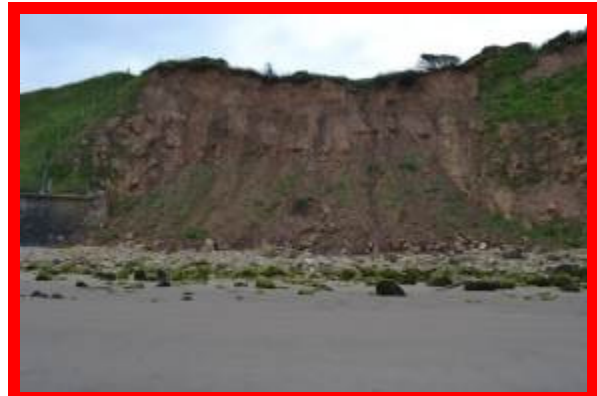
Intense erosion in MU24/B9 (Totally Active in June 2016)

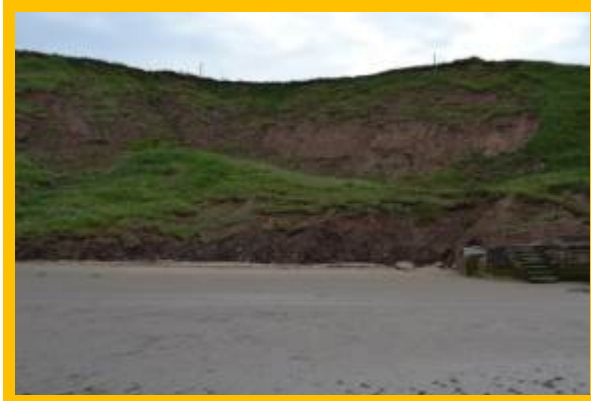
Units MU24/C to MU24/O are composed of glacial till down to beach level and stretch south from the pumping station as Killerby Cliffs. Apart from MU24/H and MU24/J, they are all classified as Partly Active in 2016, unchanged from 2014. The Partly Active units show active recession of the head scarp and slumping in mid and lower slopes. At the cliff toes there is evidence of instability through slumping and erosion. In the south-central units (MU24/K to MU24/O), the slumped till may be masking bedrock in the lower cliff. An exception to the Partly Active classification is MU24/H which comprises the access route to the beach. The slope of this unit is engineered and well vegetated, with no obvious signs of recent activity, and so is classified as Inactive. Also, although there is activity throughout much of the head scarp of MU24/J, there is less than in adjacent units, and so it is classified as Locally Active.

Till of Killerby Cliffs. MU24/C Partly Active in June 2016

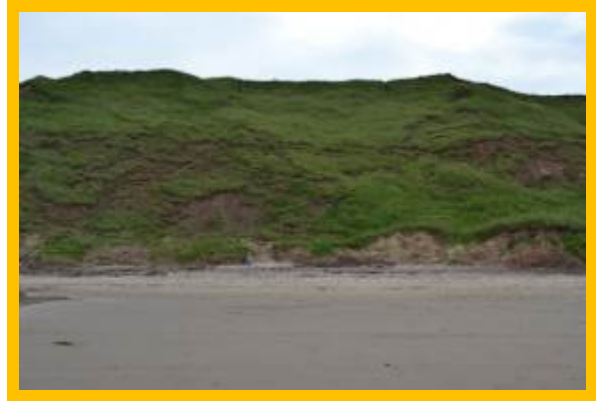
Till of Killerby Cliffs. MU24/F Partly Active in June 2016

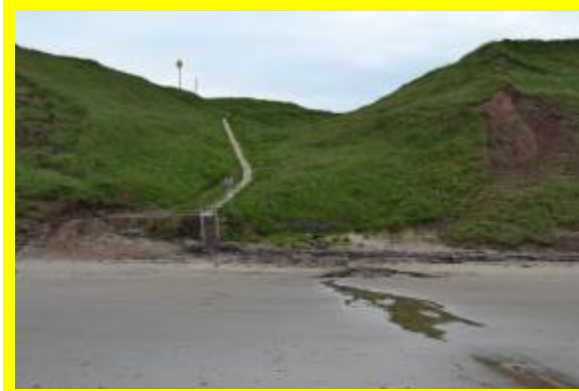
Vegetated till slopes of Killerby Cliffs. MU24/H Locally Active in June 2016

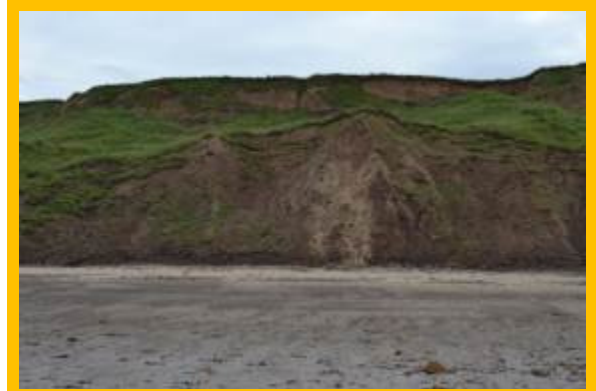
Till of Killerby Cliffs. MU24/I Partly Active in June 2016

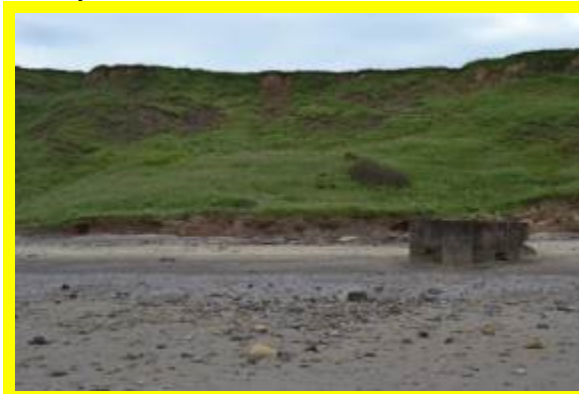
Vegetated till slopes of Killerby Cliffs. MU24/J Locally Active in June 2016

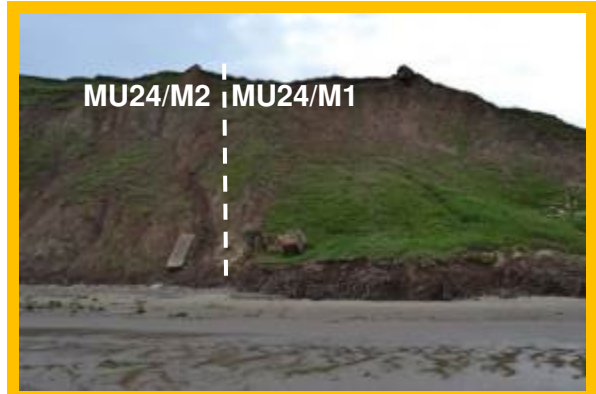
Till of Killerby Cliffs. MU24/M1 (right) and MU24/M2 (left) (both Partly Active in June 2016)

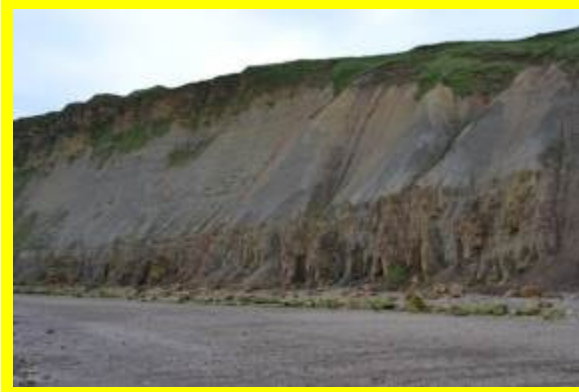
Units MU24/P to MU25/T are predominantly exposed near-vertical sandstone at the toe of a steep cliff overlain by mudstone with a thin capping of till. The sandstone is characterised by local rock falls on to the beach and platform with local small debris cones off the base of the mudstone. Given this level of activity, they are all classified as Locally Active in 2016, downgraded from Partly Active in 2014.

Composite sandstone and mudstone cliffs in south Cayton Bay. MU24/P (right) to MU24/S (left) (both Locally Active in June 2016)

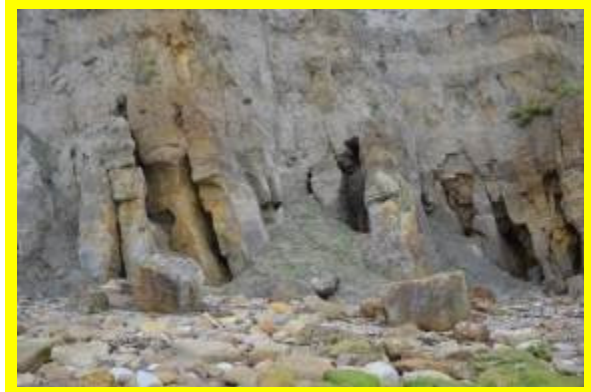
Local rock fall and debris cone in MU24/P (Locally Active in June 2016)

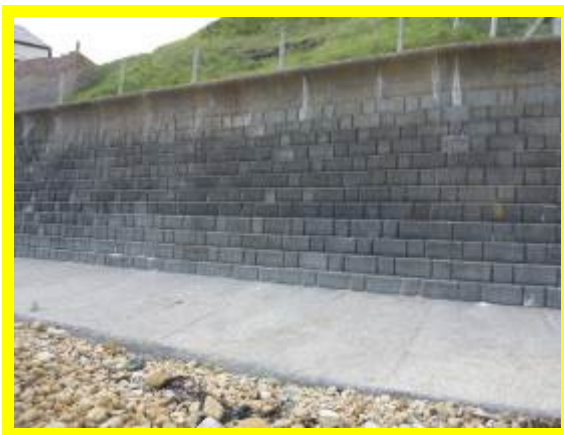
To the north of the pumping station (which is now converted to a private residence) is a private blockwork defence with concrete toe slab (/1402C02), which ties into the eroding cliffs to the north with a mixture of brick, stone blocks and concrete. The wall itself is in fair condition and appears newer than the wall to the south, although the toe apron is undermined. There was significant erosion of the undefended cliff immediately to the north of the tie-in between 2012 and 2014, but this has not significantly worsened since.

*Private sea wall in fair condition (/1402C02)*

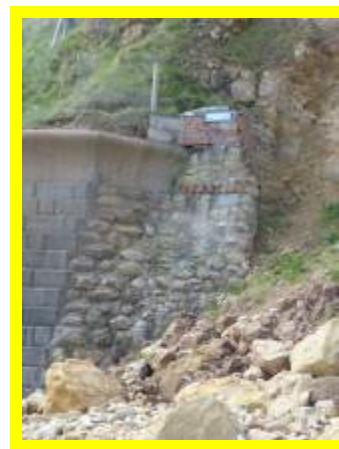
*Erosion of undefended cliffs at tie-in of sea wall private sea wall (/1402C02)*

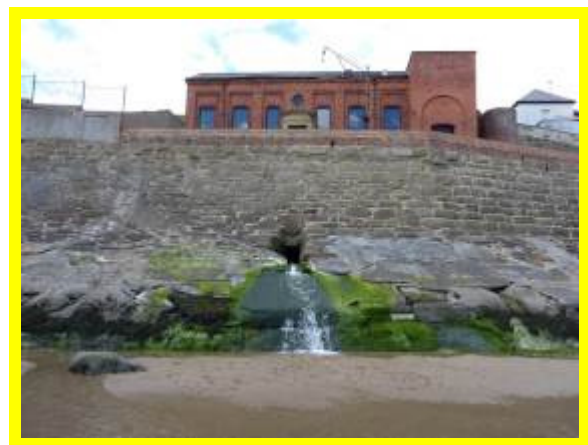
The condition of the defences varies with the higher, red brick walls appearing sound, the lower, concrete and sandstone blockwork remaining in fair condition but the apron at the toe being the worst affected.

Overall the structure remains in fair condition.

*Private sea wall in fair overall condition but with the toe apron subject to ad hoc repairs (/1402C05)*
