## **Cell 1 Regional Coastal Monitoring Programme Walkover Inspection Surveys 2016**

**Scarborough  
Borough Council**

**September 2016**

## Walkover Inspection Surveys 2016

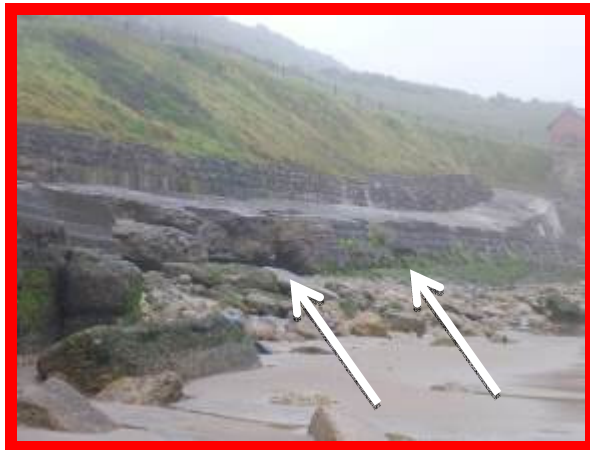
Between the southern end of the pumping station defences and the landing of the beach access steps, there is a length of defence (/1402C04) which exhibits major undercutting and blockwork loss leading to washout of backing material and the creation of large voids. Parts of the upper deck are badly cracked and breaking up and there is **very significant overall damage**.

The structure has deteriorated in condition since inspections undertaken in May 2015 as part of the *Filey & Cayton Bay Coastal Strategy*. In the northern section, concrete slurry appears to have been poured to cover previously identified defects, but there is one section below this with a void remaining at the toe. The greatest concern, however, is within the southern section which in one place has now been totally undermined at the toe and the material behind has entirely washed out leaving a large void below the deck. The deck has opened into a fairly large hole but the remainder of the undermined section is still covered by (now cracked) deck and this is likely to be subject to imminent failure and collapse. Adjacent to this section, an area of missing blockwork has expanded, with further block loss and washout of backing material. In its present condition, this structure should be deemed as 'dangerous' given that it is used by member of the public and is in such close proximity to the access steps.

*Sea wall in very poor condition with areas of significant undercutting and areas of missing blockwork leading to large voids (/1402C04)*

**The condition of the defences at the Cayton Bay pump house access is very poor and the structures present a significant health and safety risk to the general public. It is recommended that access arrangements to Cayton Bay at this location are re-evaluated at the earliest opportunity in line with the *Filey & Cayton Bay Coastal Strategy*.**

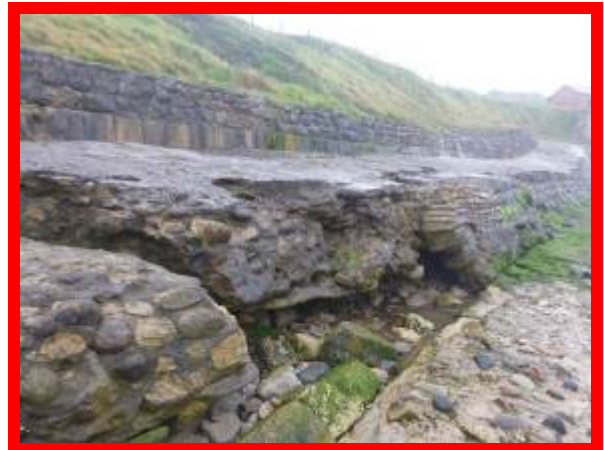
*Undercutting at toe leading to voiding behind and break-up of deck (/1402C04)*

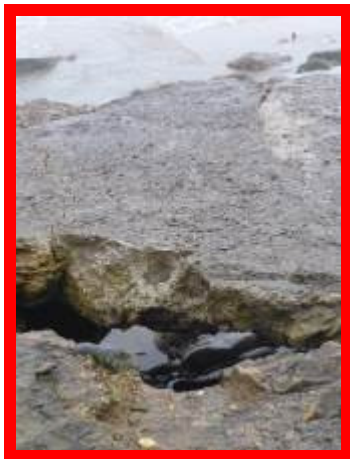
*Large hole in deck surface with visibility through to foreshore due to size of void underneath (/1402C04)*

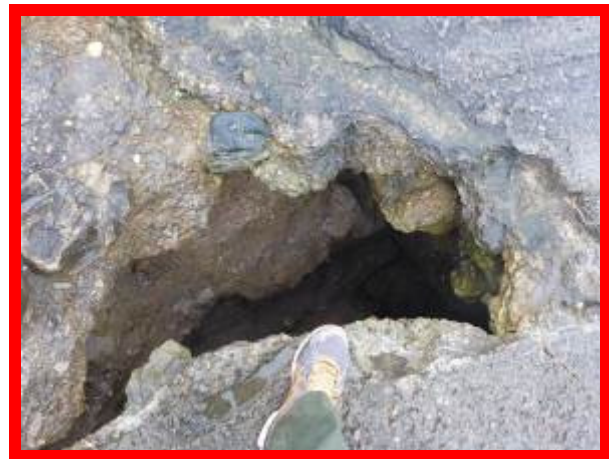
*Large hole in deck surface (/1402C04)*

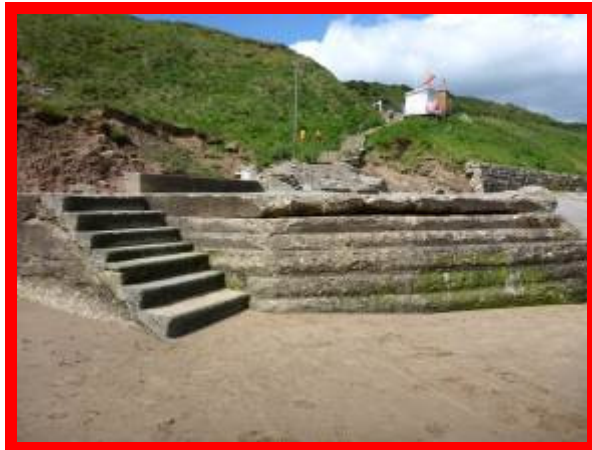
The concrete structure at the beach landing of the public access point is in a very poor condition with large cracks and voids throughout (/1402C06). Previous poured concrete skim has covered some voids on the deck to make the structure safer for pedestrians but slumps in the cliff behind are continuing to threaten the access and it is recommended that this structure is demolished and removed and replaced with a simple, safer and more adaptable public access.

*Landing at beach access and slumping cliffs adjacent to steps (/1402C06)*

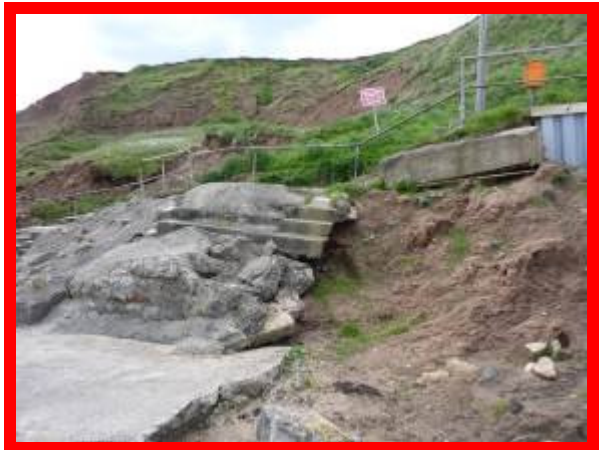
*Slumping cliffs adjacent to steps leading to outflanking – northern end (/1402C04)*

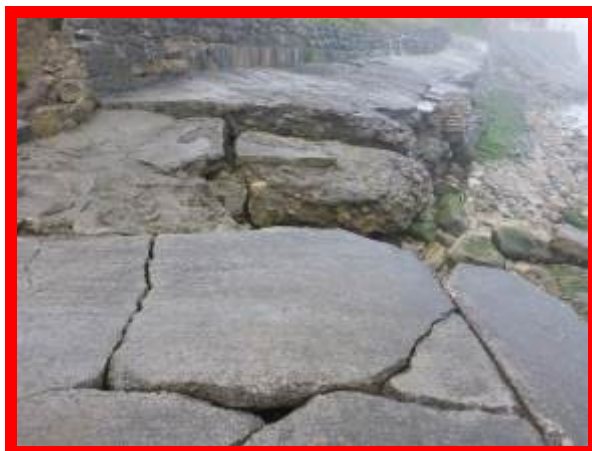
*Cracked concrete at landing at beach access (/1402C06)*

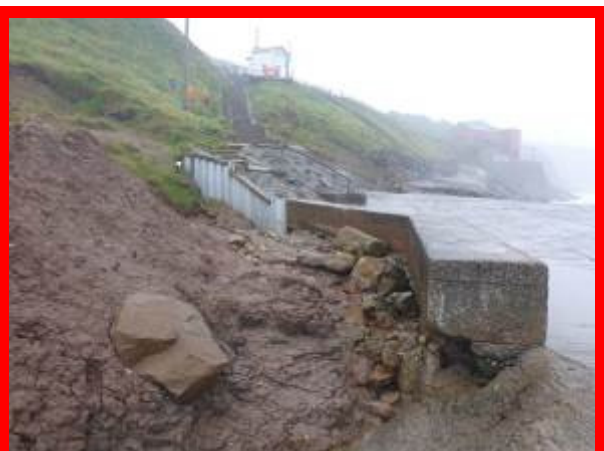
*Slumping cliffs adjacent to steps leading to outflanking – southern end (/1402C04)*

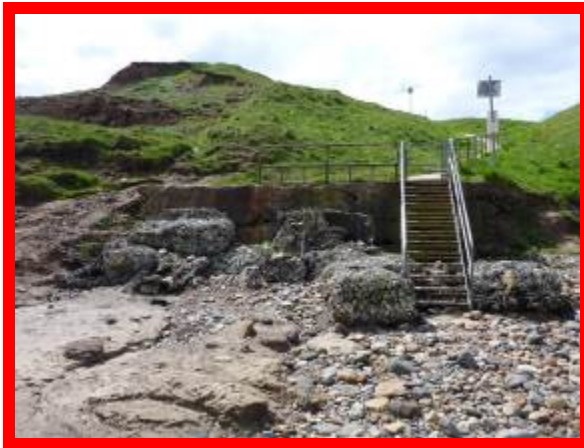
Around 300m south of the pumping station beach access, there is beach access point for the path from the public car park at the surf shop. There are a set of beach access steps that were previously protected by gabion baskets, which have distorted and split under wave action. This is not a formal coastal defence, so has no asset number.

*Failed gabion baskets at surf shop car park beach access (no asset reference)*

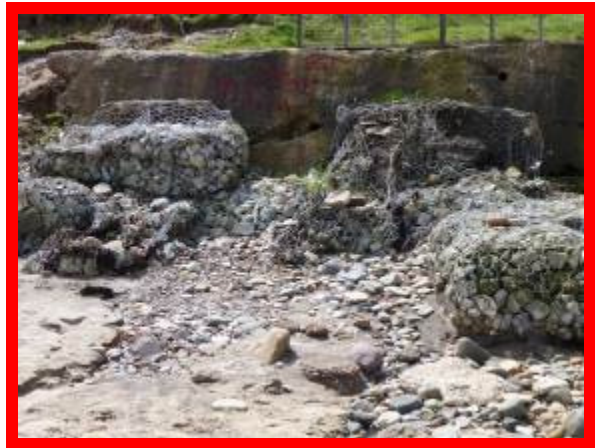
*Failed gabion baskets at surf shop car park beach access (no asset reference)*

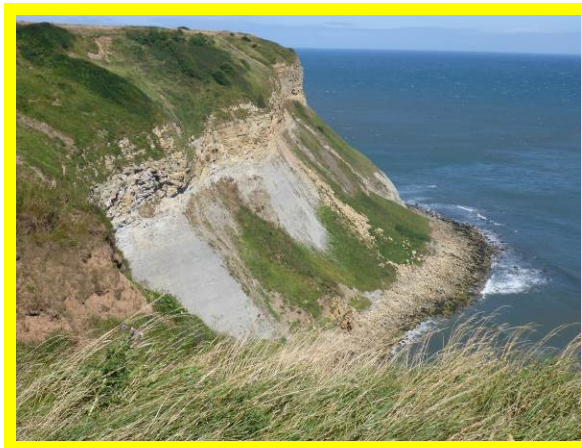
**MU26/AF** Soft till overlying resistant rock (Locally Active).

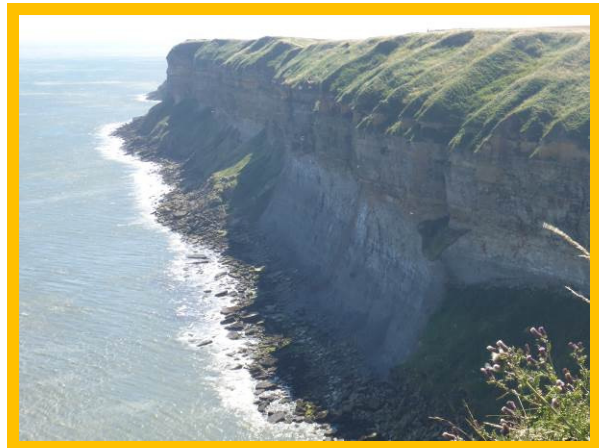
**MU26/AK and MU26/AL** are changed in grading to Partly Active, having experienced widespread rockfalls and mudslides along their length.

**MU26/AK and MU26/AL** Cliffs experiencing rockfalls and mudslides.

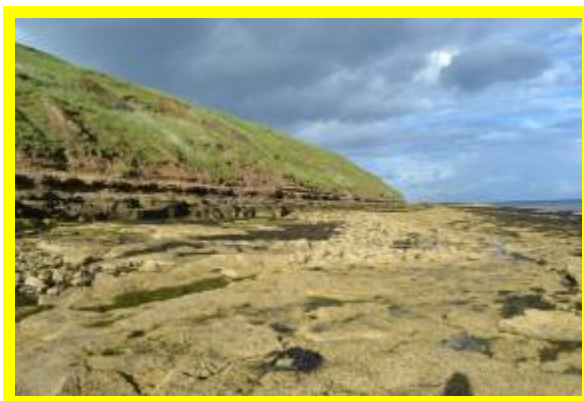
Composite cliffs on the south side of Filey Brigg. MU27/C (right) to MU27/G (left) (all Locally Active in June 2016)

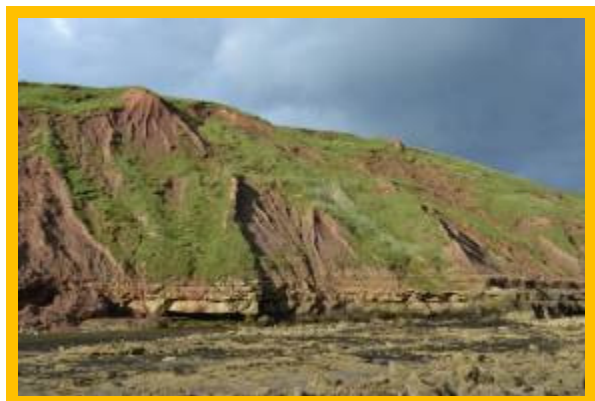
**MU27H to MU27/J** are located in the central part of the south side of Filey Brigg and are variously vegetated and unvegetated. These units comprise simple mudslides, each with an arcuate head scarp and elongate flow tracks. They are classified as Partly Active in 2016, the same as 2014.

Composite cliffs on the south side of Filey Brigg. MU27/I Partly Active in June 2016

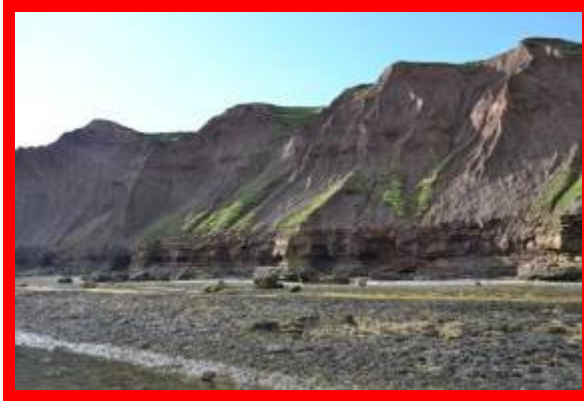
**Units MU27/K to MU27/O** are also located on the south side of the Brigg at its western end. They are predominantly unvegetated and are undergoing intense erosion and are therefore classified as Totally Active in 2016, the same as 2014.

Composite cliffs on the south side of Filey Brigg. MU27/K (right) to MU27/N (left) (all Totally Active in June 2016)

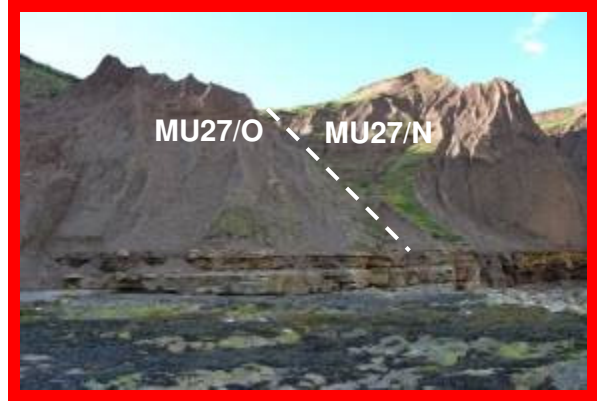
Composite cliffs on the south side of Filey Brigg. MU27/N (right) & MU27/O (left) (both Totally Active in June 2016)

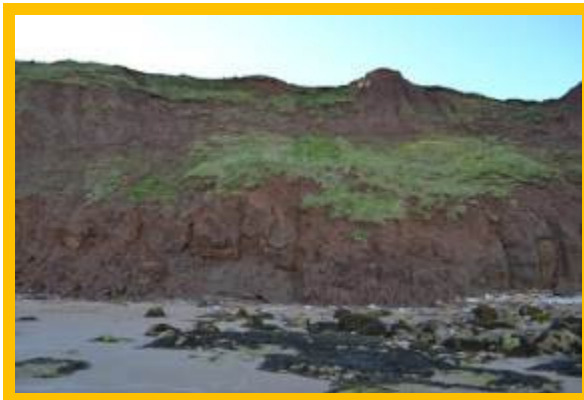
Till cliffs between Filey Brigg and Filey sailing club. MU27/Q Partly Active in June 2016

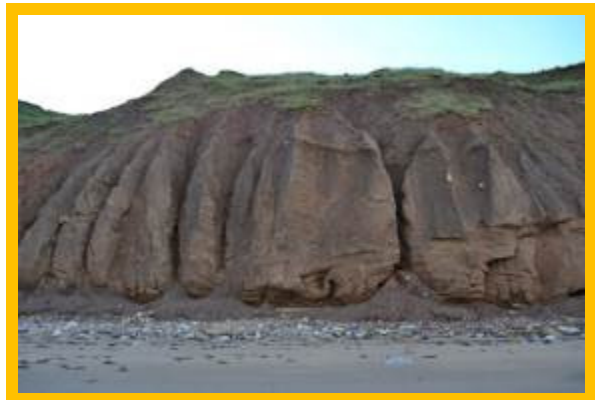
Till cliffs between Filey Brigg and Filey sailing club. MU27/R Partly Active in June 2016

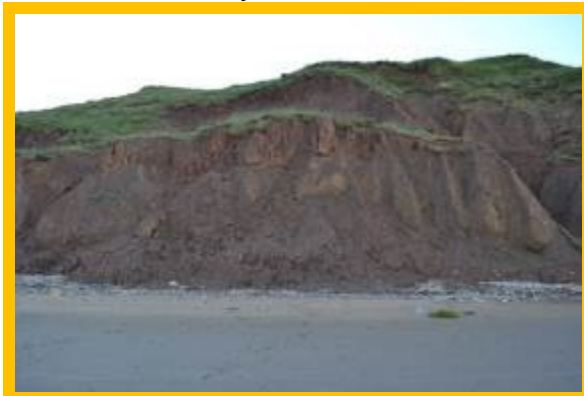
Till cliffs between Filey Brigg and Filey sailing club. MU27/S Partly Active in June 2016

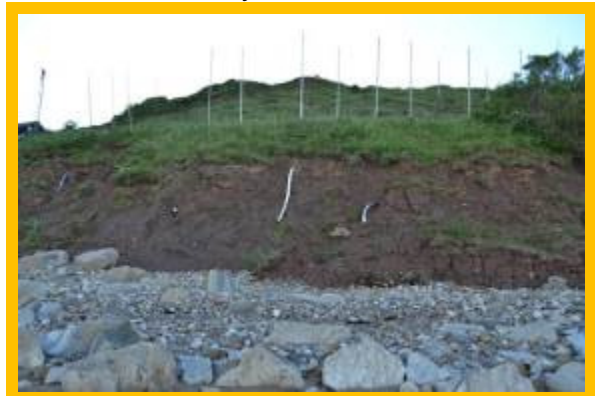
Till cliffs at Filey sailing club. MU27/T Partly Active in June 2016

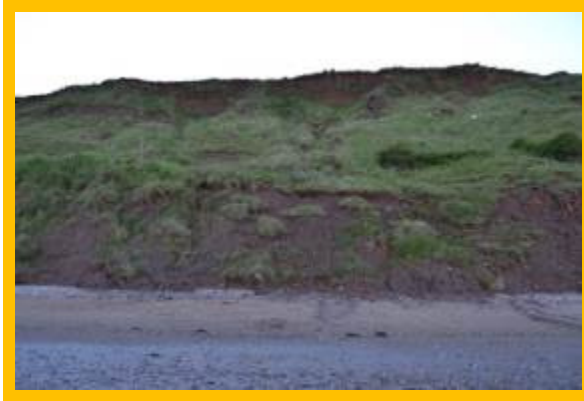
Unit MU27/V and MU27/W are located between the sailing club and the north end of Filey seawall. These units are classified as Partly Active in 2016 with large-scale head scarp recession, slumping throughout the profile and erosion at the toe.

Till cliffs between Filey sailing club and Filey town. MU27/V Partly Active in June 2016

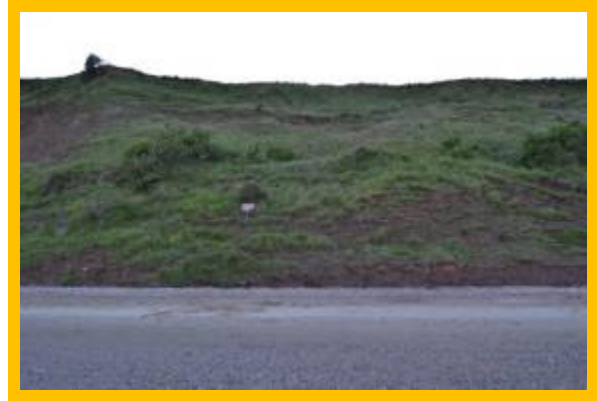
Till cliffs between Filey sailing club and Filey town. MU27/W Partly Active in June 2016

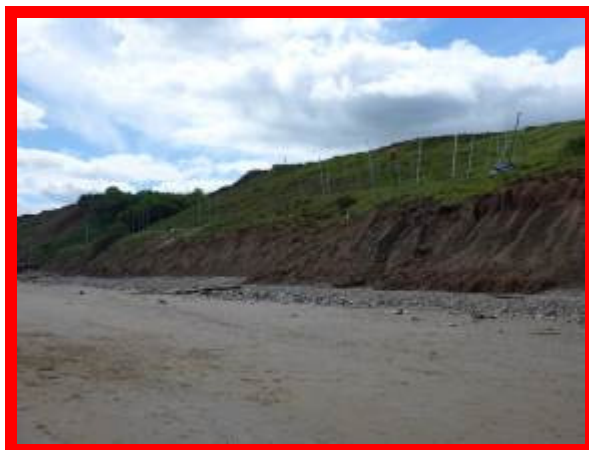
To the north of the town, Filey Sailing Club is located at the back of the beach and is partly protected by some coastal defences. However, the section of cliff below the boat park (which is located on a terrace part way up the cliff) north of the club building is undefended (/1601C01) and suffering active slumping along its length.

Undefended cliffs below boat storage yard (/1601C01)

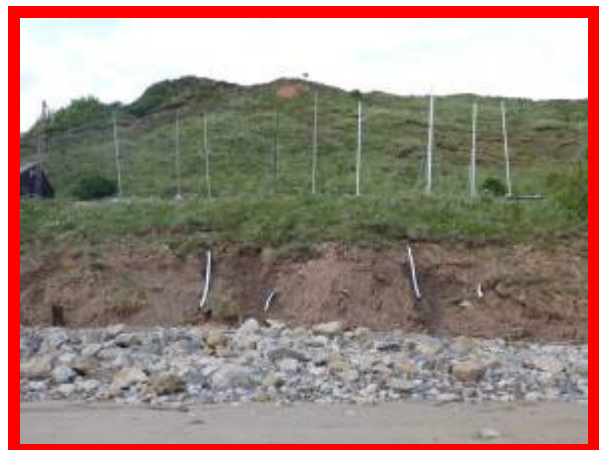
Immediately north of the club building there was formerly a defence structure (/1601C02) that consisted of timber breastwork retaining rock armour. However, all that remains of this now failed structure is the rock debris scattered on the beach.

Remnants of former defences north of club building (/1601C02)

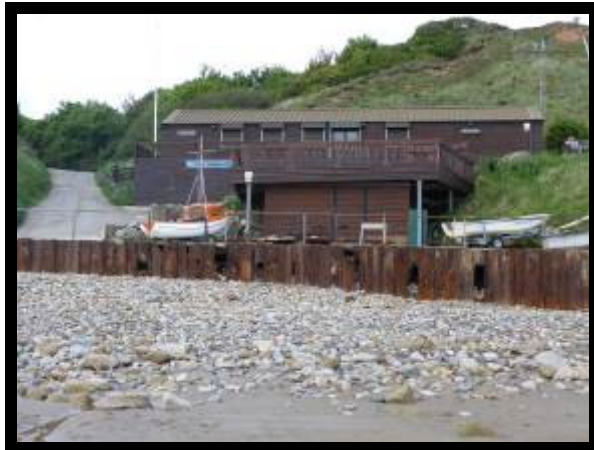
At the club building, there is a section of sheet piling (/1601C03) which showed significant corrosion leading to sizeable holes forming in the steel in the central section and voids behind due to wash out of material as recently as May 2015. At that time, the concrete slipway had been repaired not long before and the southern sections of steel piles had been replaced between 2009 and 2012. However, repairs have been made since May 2015 and the sheet piling is now in good condition.

*Failed central section of steel sheet piling as observed in May 2015 (/1601C01)*

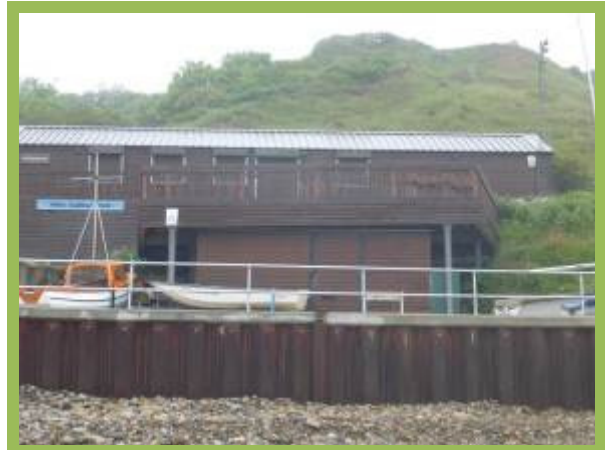
*Repaired central section of steel sheet piling as observed in June 2016 (/1601C02)*

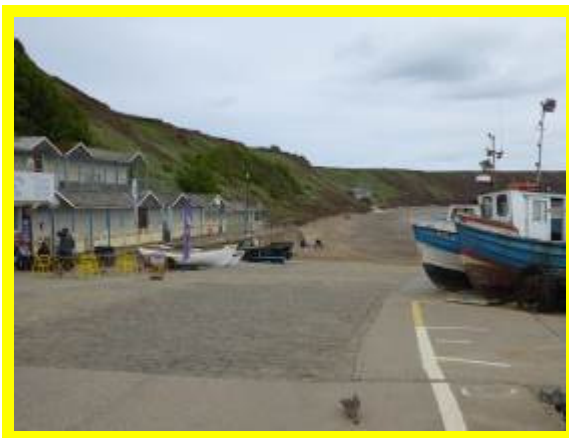
The most northerly asset in the defence system consists of the rear wall and slipway at Coble Landing (/1602C01). The slipway blockwork appeared in fair condition although, as noted during previous inspections, the rear wall below the chalets has a long horizontal crack in the wall and is in fair condition.

*Coble Landing slipway blockwork in fair condition (/1602C01)*

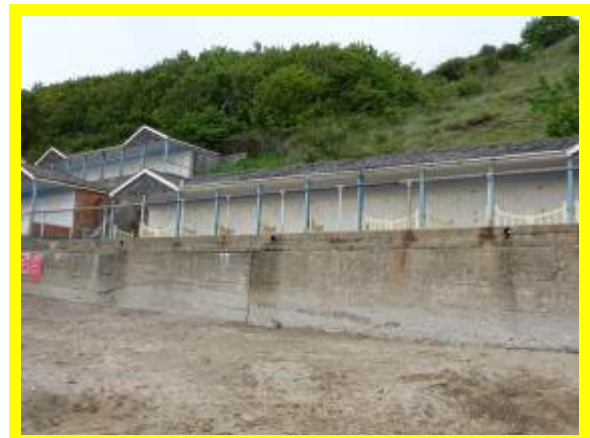
*Longitudinal cracks in rear wall (/1602C01)*

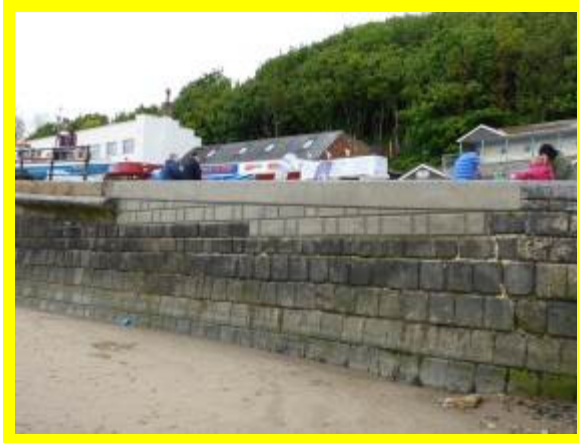
The next asset (/1602C09) is essentially a wing wall protecting the slipway. Repairs to this wall were made between 2012 and 2014 and are holding well and the overall asset condition remains as fair. However, the toe apron has some signs of abrasion damage and undercutting which need continued monitoring and likely future maintenance.

*Previous repairs to slipway 'wing-wall' holding well (/1602C09)*

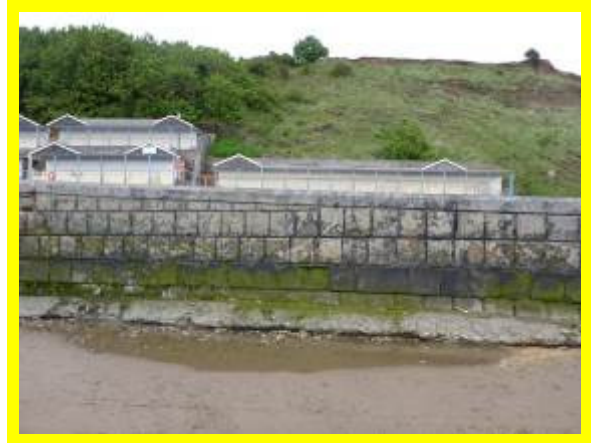
*Abrasion of concrete toe apron (/1602C09)*

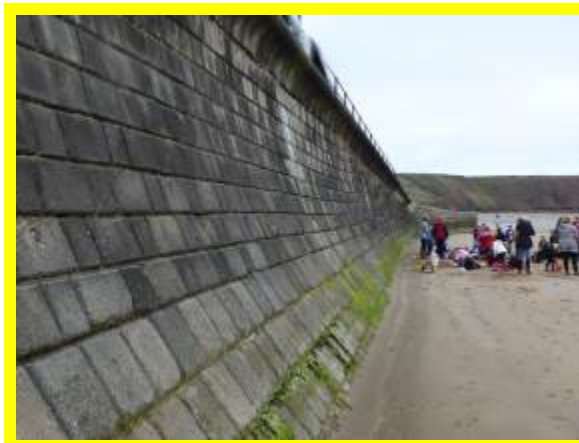
The wall located north of Ravine Road (/1602C06) is in fair overall condition, although there are areas of damage that have been previously repaired. There occasional remaining cracks, washed out joints / missing mortar between the masonry blocks in several locations both the wall and the slipway / beach access ramp next to the car park.

*Sea wall near Ravine Road in fair condition (/1602C06)*

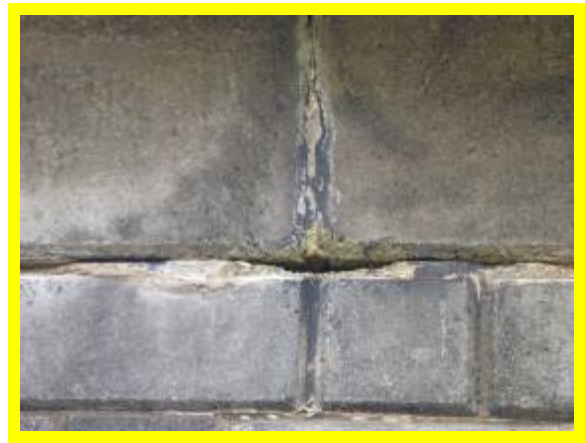
*Occasional open joints with missing mortar (/1602C06)*

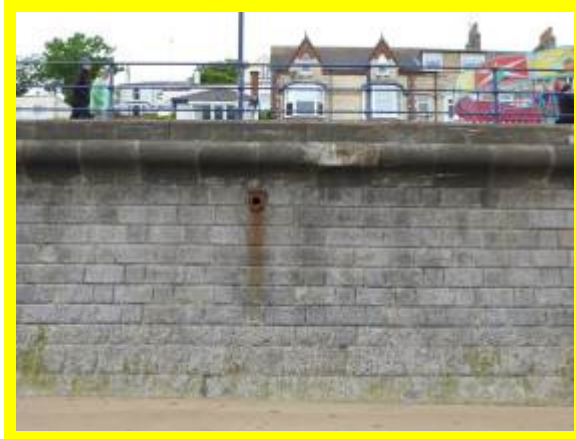
The sections of sea wall between Ravine Road and the access point east of Cargate Hill Road (/1602C08) and between Cargate Hill Road and Crescent Hill (/1602C03) are both in fair overall condition, although in some sections several blocks have abrasion damage to the front face, particularly just above beach level. Many of the splash coping blocks have been replaced along the length of these assets, but others are cracked or damaged. The damage appears to get worse with progression south and is mainly focused around the lower blockwork or upper splash wall / coping.

*Sea wall south of Ravine Road in fair condition but with damaged coping and lower blockwork abrasion (/1602C08)*

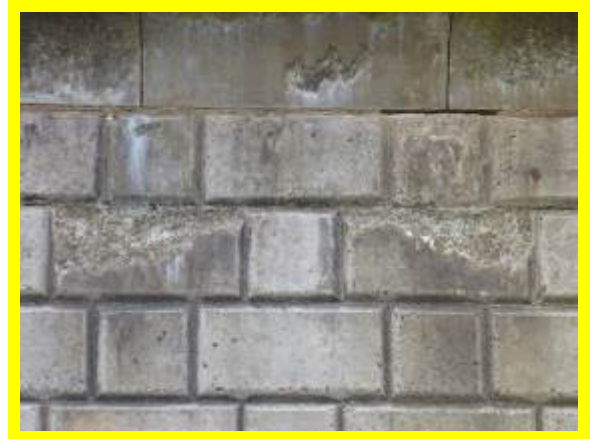
*Abrasion damage and open joint in sea wall south of Cargate Hill (/1602C03)*

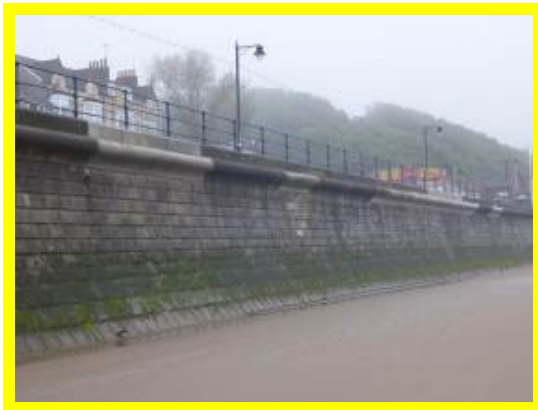
*Previous repairs to coping and wave return feature (/1602C08)*

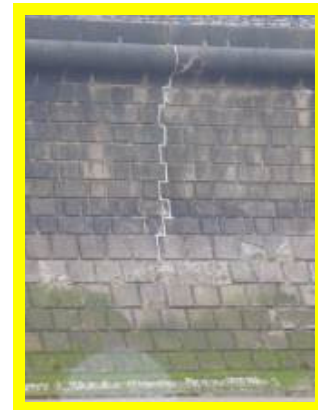
*Previous repairs to joints (/1602C03)*

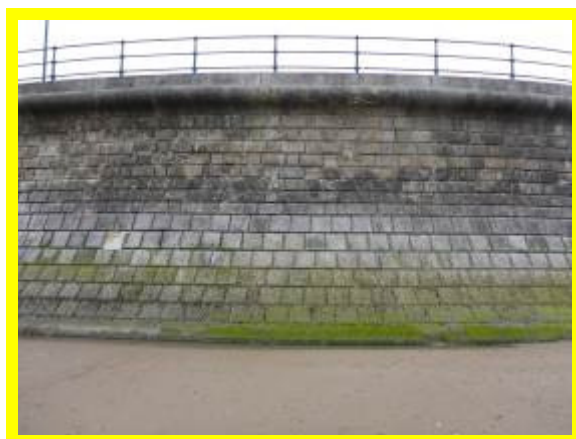
The next defence assets to the south are the wall around the Royal Parade promontory (/1602C04) and the wall between here and the southern-most promontory (/1602C07). These sections of wall are in fair overall condition (including previous repairs to one long vertical gap between adjacent blocks running over half the height of the wall), although there is cracking to the coping and numerous abraded, chipped or damaged blocks. Previous repairs to the lower section of the access steps at Royal Parade are holding well but the cracks and open joints in the southern set of access steps makes it vulnerable to damage during storms.

*Royal Parade sea wall in fair condition but with some blockwork abrasion (/1602C04)*

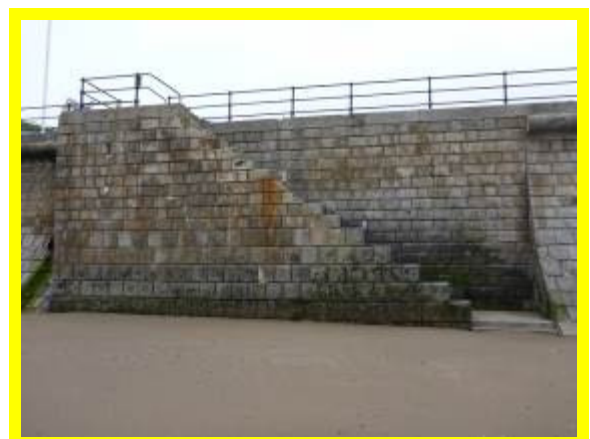
*Access steps at Royal Parade sea wall (/1602C04)*

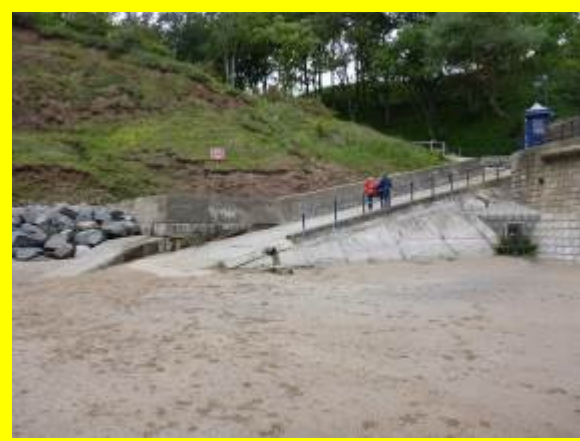
The southernmost section of the main wall includes the southern promontory and the return section to Martin's Gill (/1602C05). This structure is overall in fair condition, although there is chipping and cracking to the coping in small areas throughout length and numerous lower blocks area abraded. Cracks in the side wall to the slipway / access ramp at the southern end of the wall appear to have been filled.

*Slipway / access ramp at southern end of Filey Sea Wall (/1602C02)*

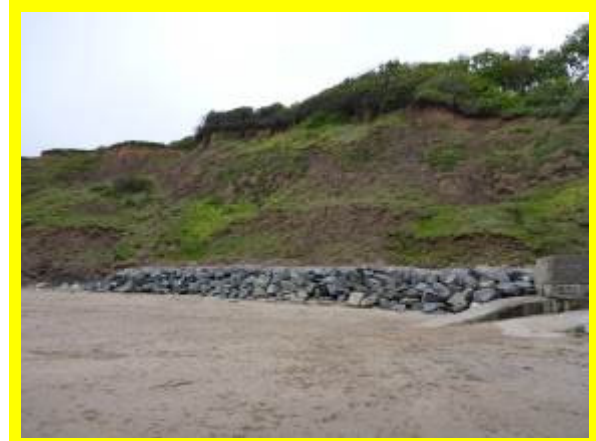
A short section of rock revetment with gabion baskets beneath is located at the southern end of the sea wall near Martin's Gill (/1602C02). This defence extends into Sub-Management Unit Mu29A and is intended to manage the interface between the hard defences to the north and eroding natural cliff to the south. The rock armour has been re-profiled on occasion after movement of some armourstones during storms. However, at the time of the inspections, the structure was in fair condition. Despite this, there coastal slopes behind the revetment still appear to be active and some form of improved outflanking defence remains necessary in the medium term.

*Rock revetment at southern end of Filey Sea Wall (/1602C02) – note active coastal slopes to rear*

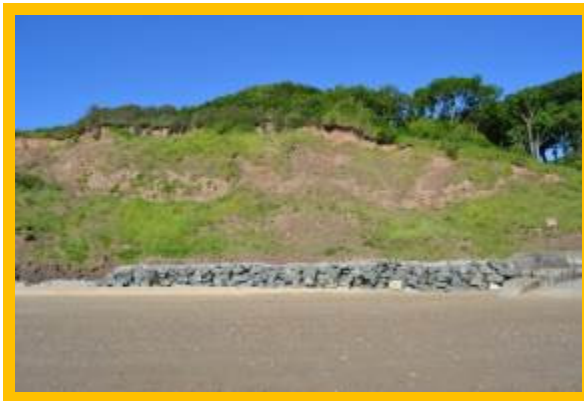
**Units MU29/AA and MU29/AI** which are composed of glacial till down to beach level and stretch south of Filey town are all classified as Partly Active in 2016. This is unchanged from 2014 for units **MU29/AA to MU29/AH**, but **MU29/AC and MU29/AI** are upgraded from Locally Active in 2014. The entire length of cliff is partly vegetated and suffers from head scarp erosion and slumps and slides are causing failure throughout the cliff face. The toes are undergoing various degrees of marine erosion.

Till cliffs adjacent to Filey town. MU27/AA Partly Active in June 2016

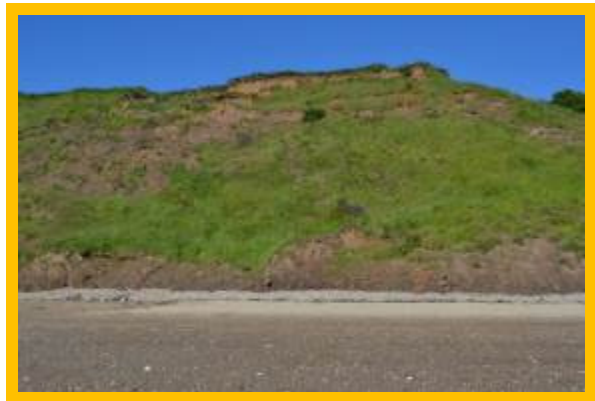
Till cliffs along Muston Sands. MU27/AD Partly Active in June 2016

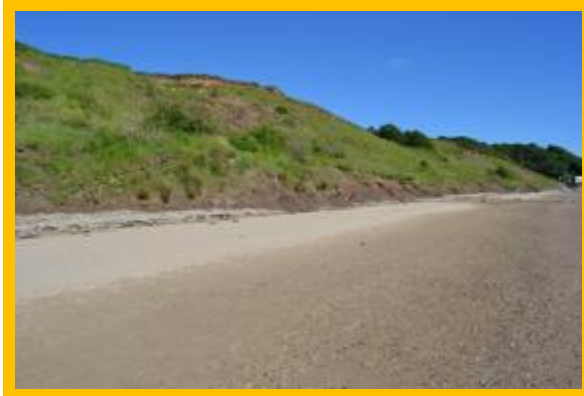
Till cliffs along Muston Sands. MU27/AA (right) to MU27/AD (left) (all Partly Active in June 2016)

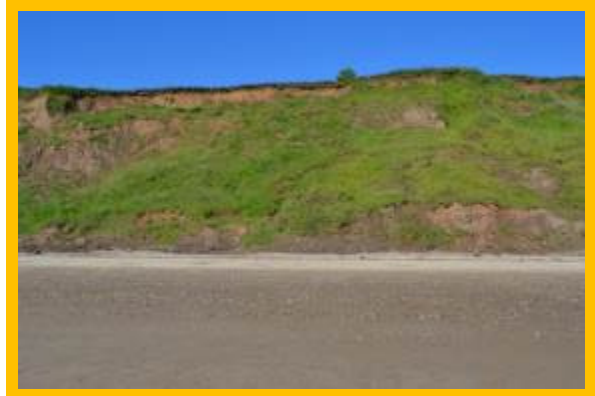
Till cliffs along Muston Sands. MU27/AF Partly Active in June 2016

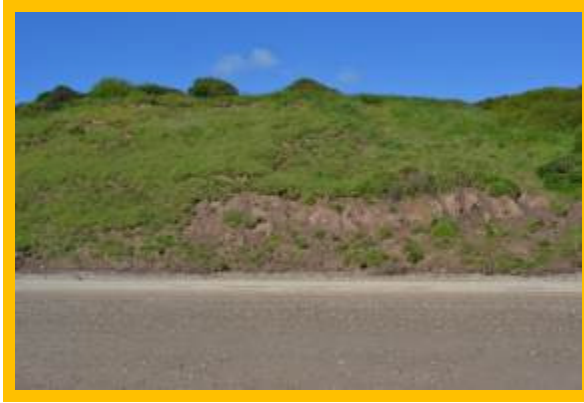
Till cliffs along Muston Sands. MU27/AH Partly Active in June 2016

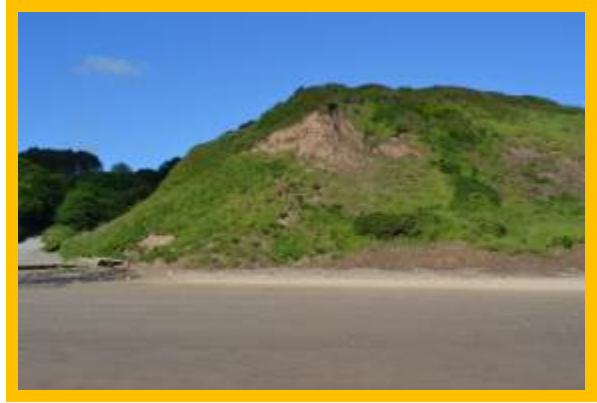
Till cliffs along Muston Sands. MU27/AI Partly Active in June 2016

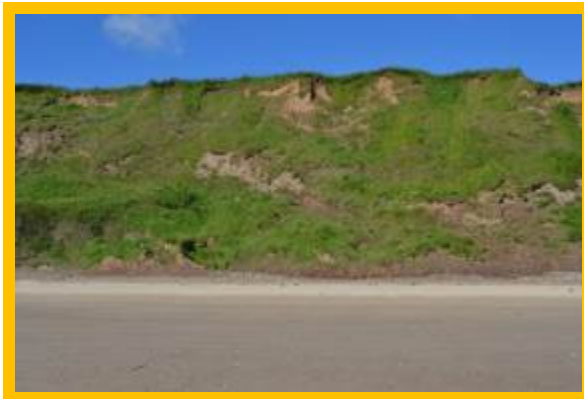
**Units MU29/AJ to MU29/AS** are all classified as Partly Active in 2016. This is an upgrade from Locally Active in 2014 for **MU29/AJ to MU29/AQ** and the same in 2014 for **MU29/AR and MU29/AS**. They all comprise glacial till down to beach level, which is partially vegetated and slumped throughout the cliff profiles, with active head scarp and toe erosion.

Till cliffs along Hunmanby Sands. MU27/AK Partly Active in June 2016

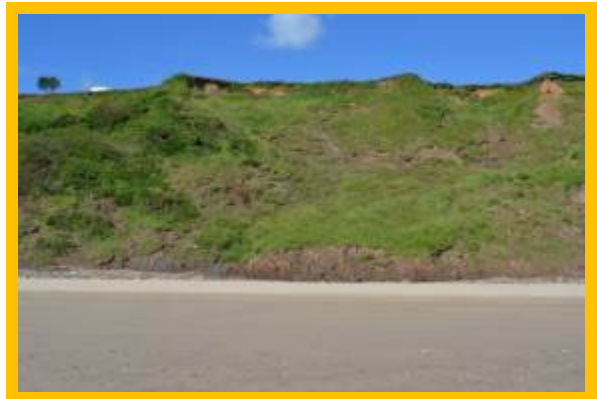
Till cliffs along Hunmanby Sands. MU27/AP Partly Active in June 2016

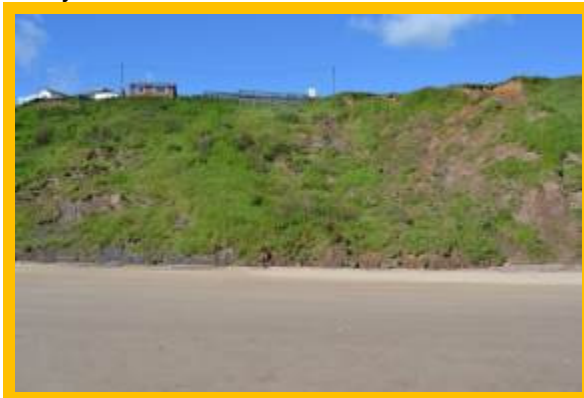
Toe of till cliffs at Flat Cliffs. MU27/AQ Partly Active in June 2016

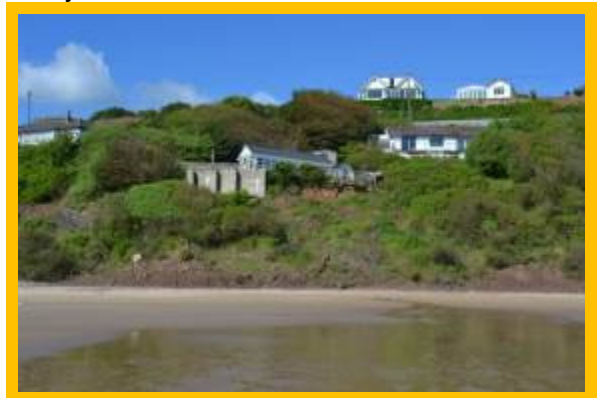
Toe of till cliffs at Flat Cliffs. MU27/AR Partly Active in June 2016

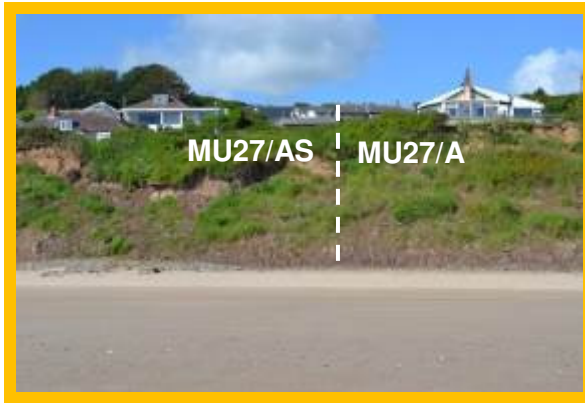
Toe of till cliffs at Flat Cliffs. MU27/AR (right) and MU27/AS (left) (both Partly Active in June 2016)

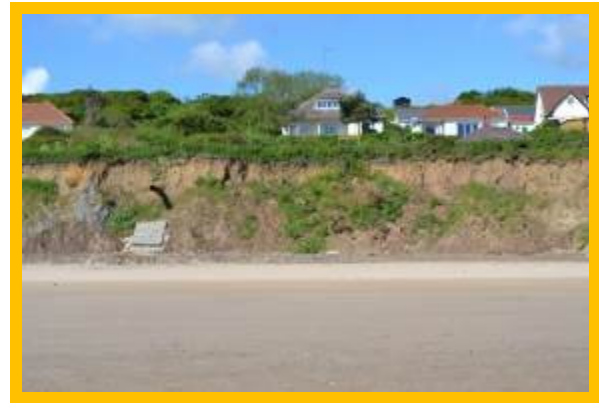
Toe of till cliffs at Flat Cliffs. MU27/AS Partly Active in June 2016

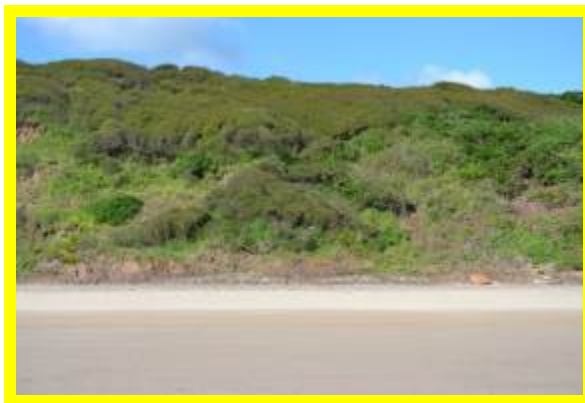
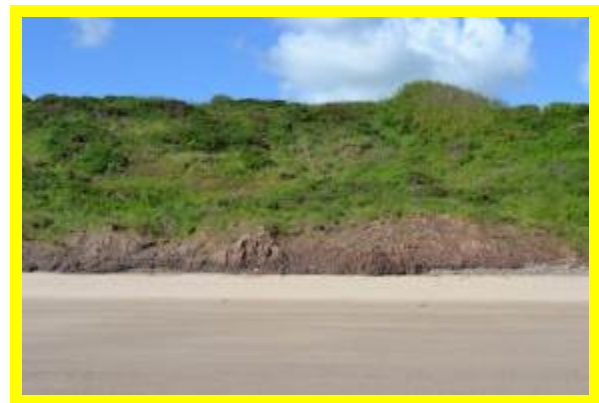
**MU29/AT** is classified as Locally Active in 2016 (unchanged from 2014) as it is generally well vegetated and there is only local evidence for toe erosion or activity at mid to upper levels.

Well vegetated till cliffs along Hunmanby Sands. MU27/AT Locally Active in June 2016

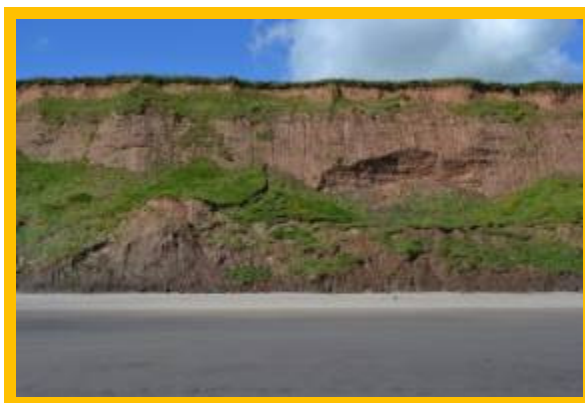
**Units MU29/BA to MU29/BE2** are located between Butcher Haven and Hunmanby Gap and are all classified as Partly Active, unchanged from 2014, apart from **MU29/BA and MU29/BE2** which are upgraded from Locally active. These cliffs are steeper than further north and are characterised by head scarp erosion and common areas of intense erosion. The toes are active with slumping and sliding on to the beach.

Till cliffs north of Hunmanby Gap. MU27/BB Partly Active in June 2016

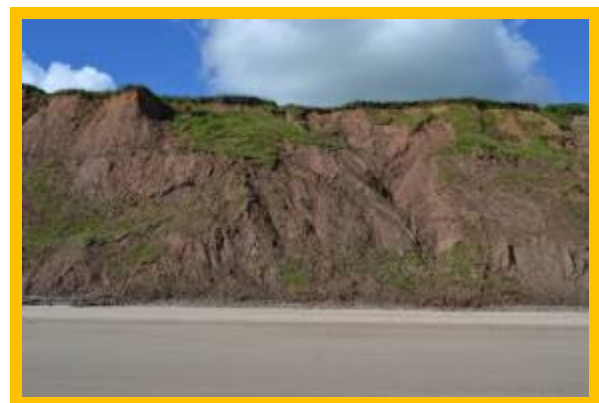
Till cliffs north of Hunmanby Gap. MU27/BD Partly Active in June 2016

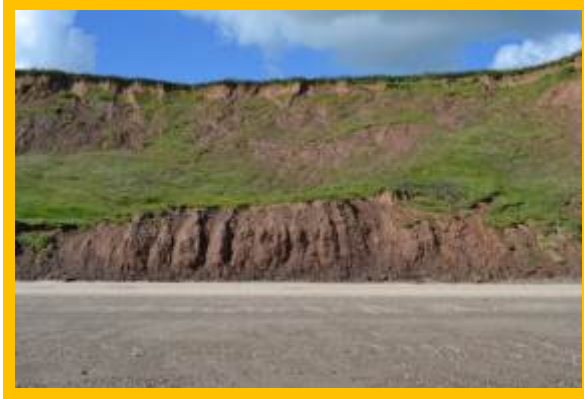
Till cliffs north of Hunmanby Gap. MU27/BE Partly Active in June 2016

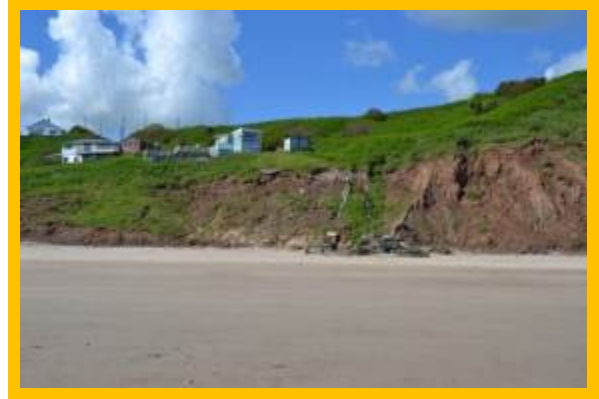
Till cliffs at Hunmanby Gap. MU27/BE2 Partly Active in June 2016

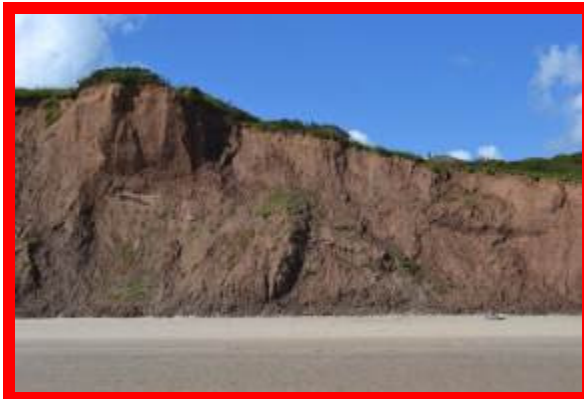
Unit MU29/BF includes Hunmanby Gap itself. This unit is partly shielded from wave erosion by unit MU29/BG and is classified as Locally Active in 2016, unchanged from 2014. MU29/BG to MU29/BJ are located south of Hunmanby Gap. These cliffs are steep and affected by intense erosion throughout most of their height. The head scarp is retreating and there is significant slumping on to the beach. MU/29BG to MU29/BJ are classified as Totally Active in 2016, unchanged from 2014.

Intense erosion of till cliffs south of Hunmanby Gap. MU27/BG Totally Active in June 2016

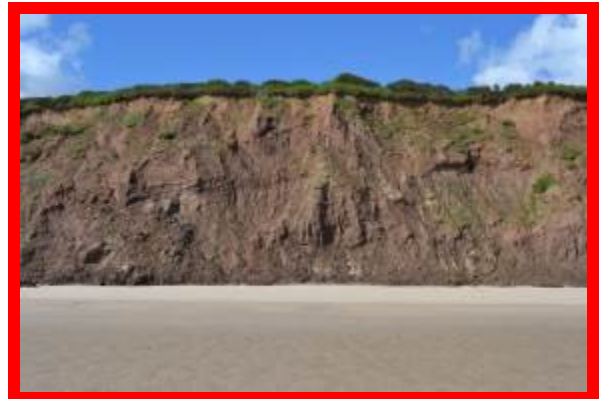
Intense erosion of till cliffs south of Hunmanby Gap. MU27/BH Totally Active in June 2016

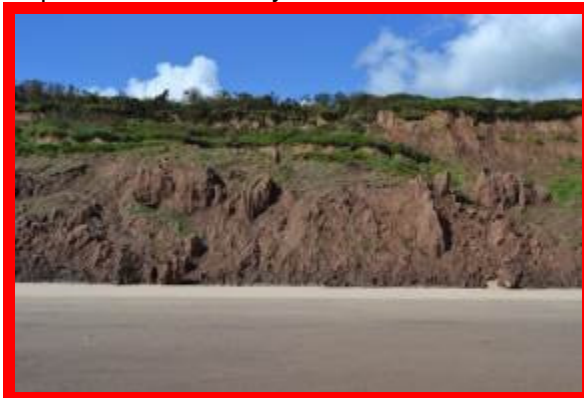
Intense erosion of till cliffs south of Hunmanby Gap. MU27/BI Totally Active in June 2016

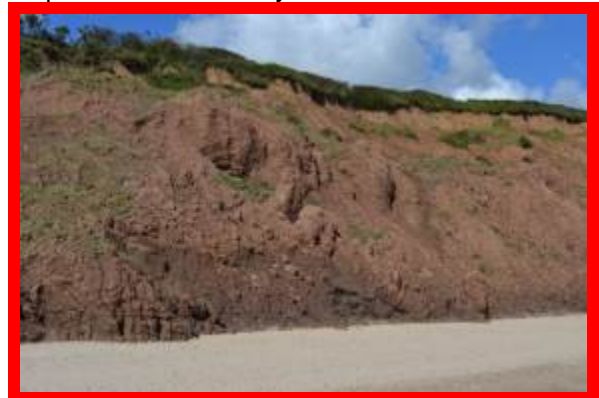
Intense erosion of till cliffs south of Hunmanby Gap. MU27/BJ Totally Active in June 2016

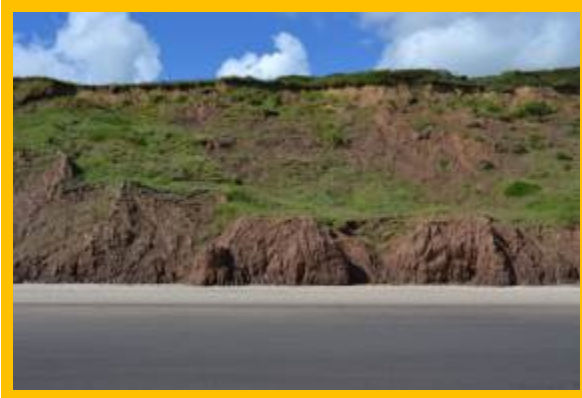
Further south, units MU29/BK to MU29/BQ are located above Reighton Sands. All of these units are classified as Partly Active in 2016, unchanged from 2014. They are characterised by steep slopes partially covered in vegetation. There is recession of the head scarp, common areas of erosion in the mid-slopes and slumping on to the beach. The toes are steep and eroding.

Till cliffs at Reighton Sands. MU27/BL Partly Active in June 2016

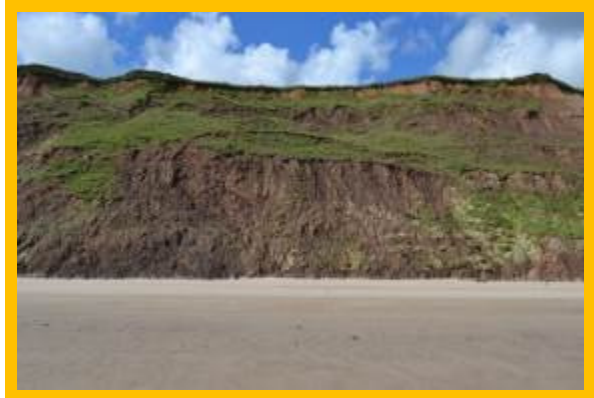
Till cliffs at Reighton Sands. MU27/BM Partly Active in June 2016

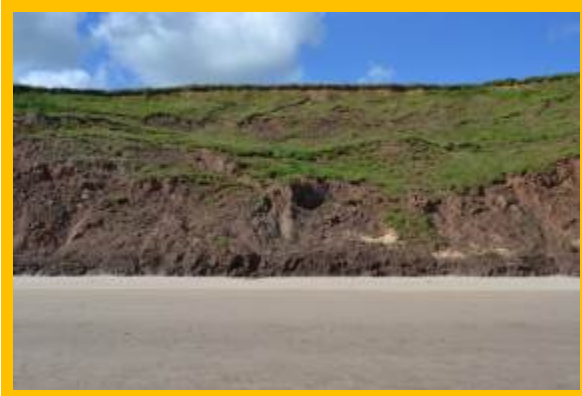
Till cliffs at Reighton Sands. MU27/BO Partly Active in June 2016

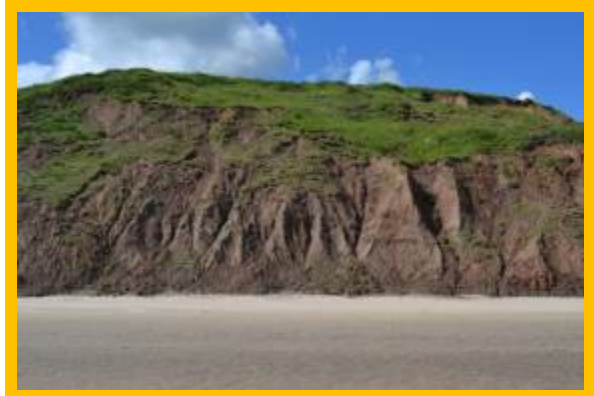
Till cliffs at Reighton Sands. MU27/BQ Partly Active in June 2016

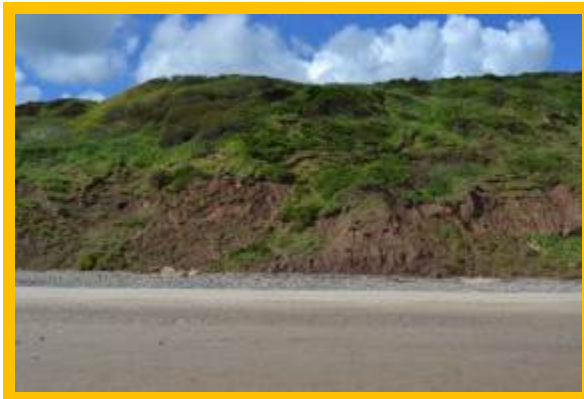
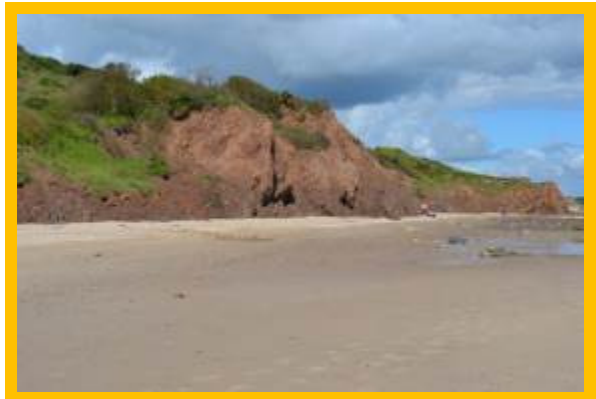
**Units MU29/BR, MU29/BS and MU29/CA** form the majority of this Sub-management Unit and are classified as Partly Active in 2016, unchanged from 2014. These units are partially vegetated, and contain large slumps and erosion at their head scarps.

Till cliffs beneath Reighton Sands Holiday Village. MU27/BR Partly Active in June 2016

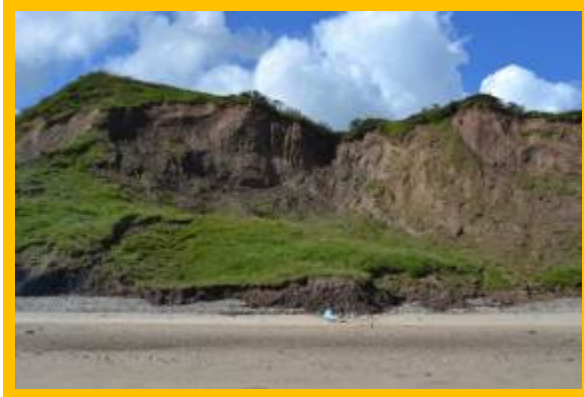
Till cliffs beneath Reighton Sands Holiday Village. MU27/BS Partly Active in June 2016

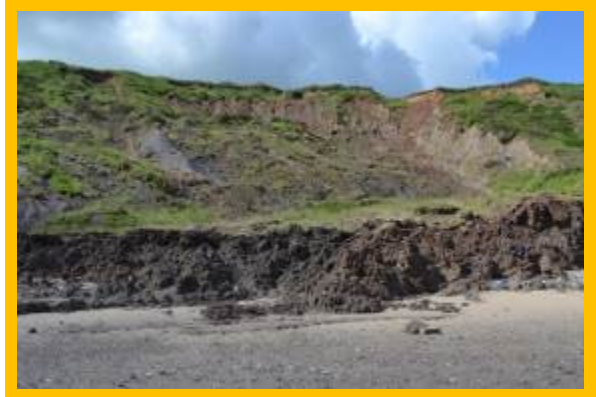
Till cliffs beneath Reighton Sands Holiday Village. MU27/CA Partly Active in June 2016

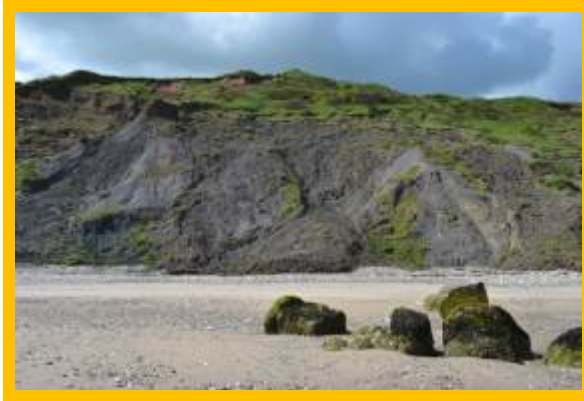
**Unit MU29/CB** is at the eastern end of the holiday village. The unit exhibits mudslides and an eroding head scarp, and is classified as Partly Active in 2016, the same as 2014. Unit **MU29/CCa** forms a shallow mudslide embayment extending on to the beach. The unit is classified as Partly Active, unchanged from 2014.

Till cliffs in MU27/CB  
(Partly Active in June 2016)

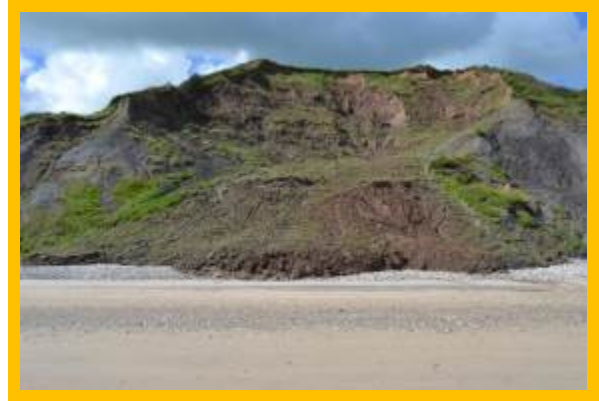
Mudslide embayment of MU27/CCa  
(Partly Active in June 2016)

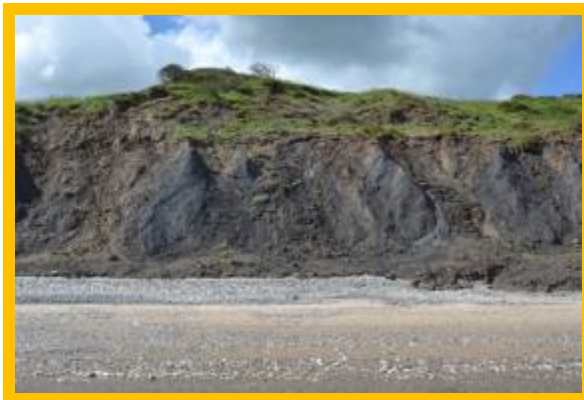
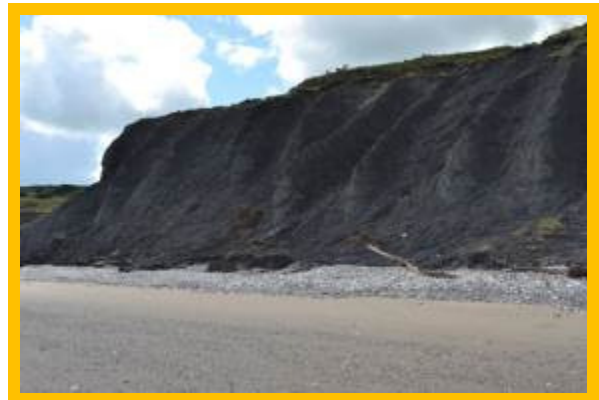
**Unit MU29/CC** forms a large, shallow, well vegetated embayment known as Middle Cliff with a steep well-defined eroding toe in mud. There is also activity at the unit head and mid slope. The unit is classified as Partly Active in 2016, the same as 2014.

Toe of mud cliff in MU27/CC  
(Partly Active in 2016)
