## **Cell 1 Regional Coastal Monitoring Programme Walkover Inspection Surveys 2016**

**Scarborough  
Borough Council**

**September 2016**

## Walkover Inspection Surveys 2016

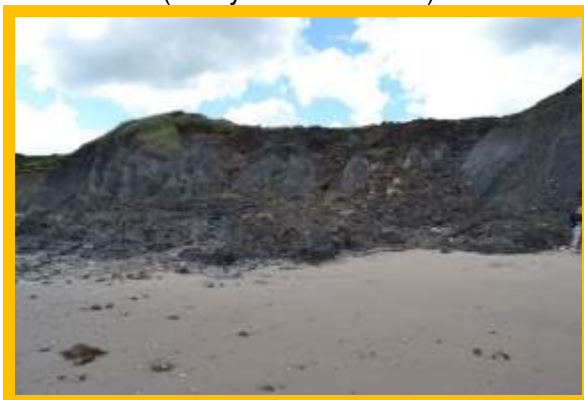
**Unit MU29/CD** is similar to MU29/CC but with more recent activity in the form of slumps, slides, block failures and mudflows at the toe. As a result this unit is classified as Partly Active, as it was in 2014.

Toe of mud cliff in MU27/CD  
(Partly Active in 2016)

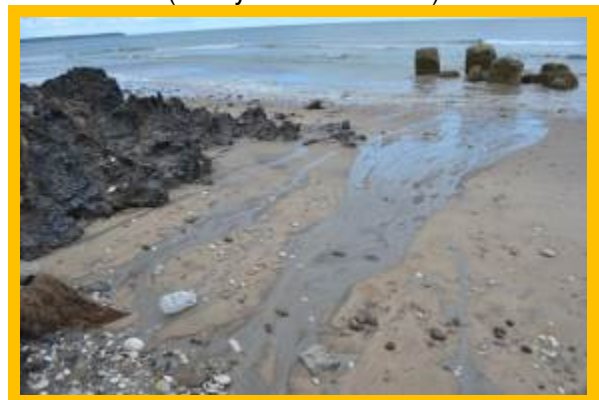
Mudflow from mud cliff in MU27/CD  
(Partly Active in 2016)
