Asset Inspection Document

Walk-over Visual Inspections of Assets

Scarborough Borough Council

NOVEMBER 2020

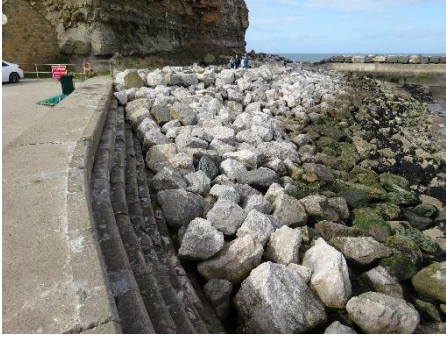
SBC Reference:	N/A		
NFCDD reference:	1221D901D0402C02

Asset Location:	NZ78301893, NZ78271901. South of Northern breakwater.	
	Asset Length:	91.4	
	Condition Assessment		
	Condition	Priority	Risk
	B	3	
	Brief Description		
	<p>Rock armour generally in good condition. Crest at northern extent appeared slightly lower (exposing concrete walkway behind). Rock armour on foreshore in front of toe – possibly displaced from crest.</p> <p>Concrete seawall at southern end in fair condition with exposed aggregate/abrasion and open joints, esp. close to crest. Minor cracking evident. Abrasion on wall crest and promenade.</p>		
	Recommendations		
	Continue to monitor. Reprofile rock at northern extent. Minor repairs to seawall (pointing/fill cracks).

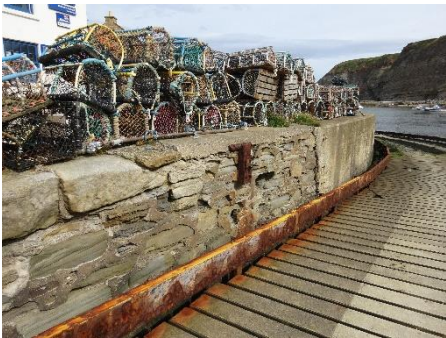
SBC Reference:	N/A		
NFCDD reference:	1221D901D0402C03

Asset Location:	NZ78251893, NZ78301893. RNLI slipway.	
	Asset Length:	55.3	
	Condition Assessment		
	Condition	Priority	Risk
	C	3	
	Brief Description		
	Abrasion / opening of horizontal construction joints in concrete wall. Slipway surface in good condition, but timber piles cracked and weathered. Gabion generally in good condition, but several baskets appear to have settled. Significant vegetation cover obscures much of gabions. Void in masonry river wall. Significant abrasion of masonry leaving mortar standing proud.		
	Recommendations		
Monitoring and repair cracks to wall. Infill void.

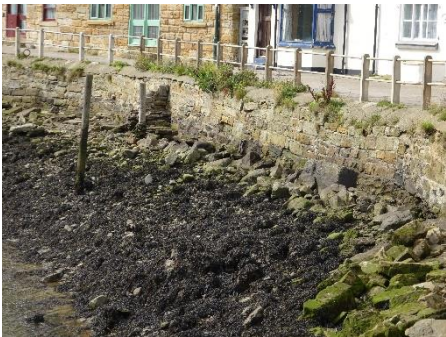
SBC Reference:	N/A		
NFCDD reference:	1221D901D0402C06

Asset Location:	Staithe, LB of River D/S of footbridge.	
	Asset Length:	100.3	
	Condition Assessment		
	Condition	Priority	Risk
	C	3	
	Brief Description		
	Promenade / road in fair condition. Wall has missing blocks and open joints locally. Vegetation growth at top of wall causing damage to concrete render. Voids in timber and masonry training wall – largely obscured by marine vegetation growth.		
	Recommendations		
Clear vegetation. Replace missing blocks and repoint open joints. Grout voids.

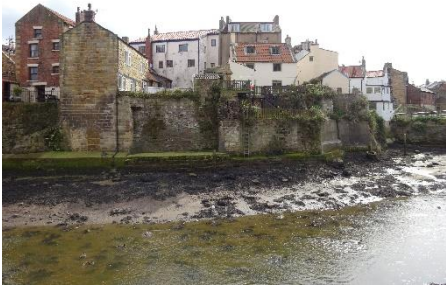
SBC Reference:	N/A		
NFCDD reference:	1221D901D0402C04

Asset Location:	NZ78261889, NZ78301886. South bank from bridge.	
	Asset Length:	117.1	
	Condition Assessment		
	Condition	Priority	Risk
	C	3	
	Brief Description		
	<p>Repair work to parts of wall evident. Vegetation growing in locally. Minor cracks evident throughout wall. Open joints and loose masonry blocks locally (two areas in property walls backing onto Staithes Beck in poor condition as a result).</p> <p>Undercutting of toe reported in 2014 partially visible in 2018 not observed in 2020 due to higher beach and marine vegetation growth.</p>		
	Recommendations		
Clear vegetation. Repair cracks, repoint masonry, fill voids. Continue to monitor.

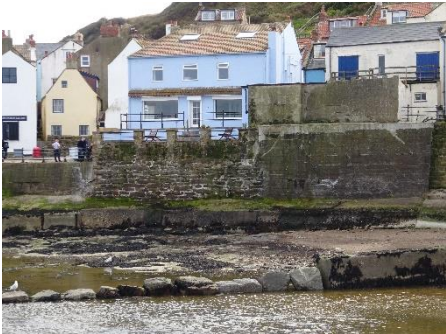
SBC Reference:	02-04-01		
NFCDD reference:	1221D901D0402C22

Asset Location:	Between slipway and groyne on South wall.	
	Asset Length:	47.7	
	Condition Assessment		
	Condition	Priority	Risk
	C	2	
	Brief Description		
	<p>Repairs evident to cracks and missing blocks replaced. Groyne in good condition (concrete and rock armour sections). Cracking and abrasion locally. Significant horizontal crack at base of structure wall on top of seawall. Vegetation growth throughout.</p>		
	Recommendations		
Clear vegetation. Repairs to walls joints, cracks and toe.

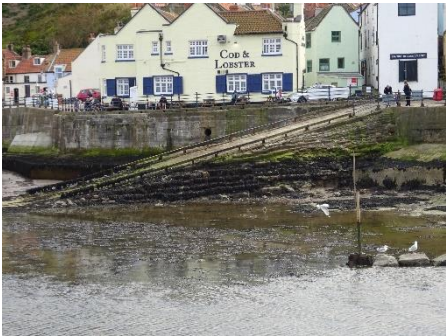
SBC Reference:	03-04-01		
NFCDD reference:	1221D901D0402C05

Asset Location:	NZ78301886, NZ78361882. Between east groyne and slipway.	
	Asset Length:	70.5	
	Condition Assessment		
	Condition	Priority	Risk
	B	3	
	Brief Description		
	Multiple cracks and spalling, but signs of multiple repair works. Some loose blocks to slip walls. Cracks along promenade. Additional toe berm placed along short length since 2012. Cope repair patches holding well.		
	Recommendations		
	Continue to monitor. Clear vegetation, repair cracks and joints.

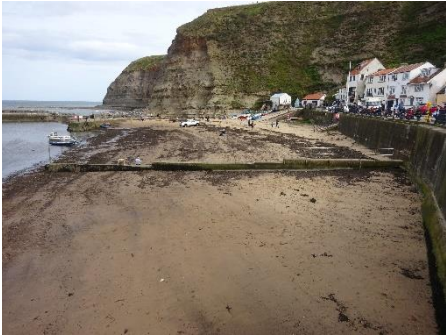
SBC Reference:	N/A		
NFCDD reference:	1221D901D0403C07

Asset Location:	NZ78361882, NZ78381885. In-between South slipways.	
	Asset Length:	32	
	Condition Assessment		
	Condition	Priority	Risk
	B	4	>5
	Brief Description		
	Groyne in good condition. Minor cracking to second "step". Vegetation cover at seaward end. Handrail in good condition.		
	Recommendations		
	Continue to monitor.

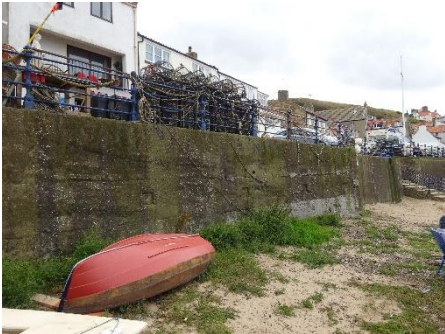
SBC Reference:	04-04-01		
NFCDD reference:	1221D901D0403C01

Asset Location:	NZ78361882, NZ78421880 South wall next to last slipway.	
	Asset Length:	73.1	
	Condition Assessment		
	Condition	Priority	Risk
	B	3	
	Brief Description		
	Vertical full height cracks through the wall between access steps and groyne has been filled although would benefit from further attention due to abrasion at surface. Exposure of aggregate throughout wall. Vegetation growing at top of wall. Cracking to promenade.		
	Recommendations		
Continue to monitor and repair crack to wall and promenade cracking.

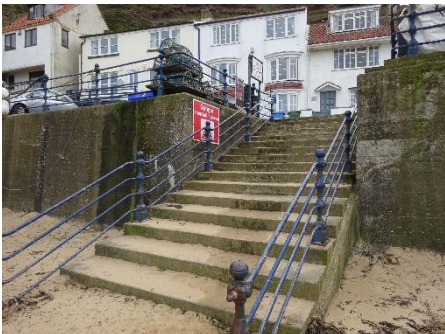
SBC Reference:	N/A		
NFCDD reference:	1221D901D0403C02

Asset Location:		
	Asset Length:	~5	
	Condition Assessment		
	Condition	Priority	Risk
	B	4	>5
	Brief Description		
	Concrete steps in fair condition. Handrails in fair condition.		
	Recommendations		
Continue to monitor

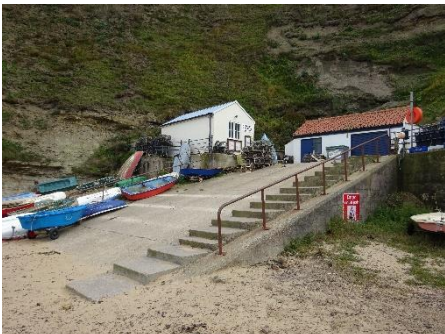
SBC Reference:	N/A		
NFCDD reference:	1221D901D0403C05

Asset Location:	NZ78421881, NZ78441881 Next to cliff.	
	Asset Length:	26.8	
	Condition Assessment		
	Condition	Priority	Risk
	B	4	>5
	Brief Description		
	Concrete ramp and steps in good to fair condition. Loss of joint filler and minor abrasion at exposed edges at construction joints.		
	Recommendations		
Continue to monitor. Replace joint filler.

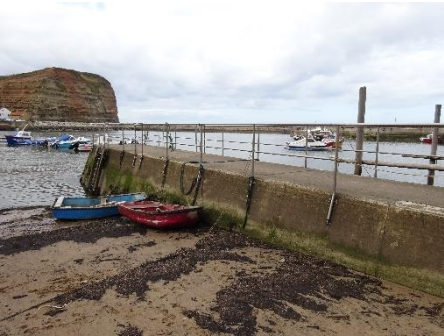
SBC Reference:	N/A		
NFCDD reference:	1221D901D0403C04

Asset Location:	NZ78431886, NZ78461884 Behind South breakwater.	
	Asset Length:	39	
	Condition Assessment		
	Condition	Priority	Risk
	B	3	
	Brief Description		
	Good condition concrete breakwater, some cracking in crest. Vegetation growth to vertical faces. Crack in vertical face at seaward end. At mid-length, vertical crack full width of deck and corresponding crack in vertical faces – appeared historic/stable. Handrails in good condition throughout.		
	Recommendations		
Fill cracks. Continue to monitor.

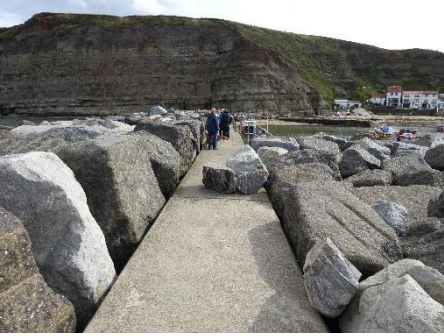
SBC Reference:	N/A		
NFCDD reference:	1221D901D0403C03

Asset Location:	NZ78491884, South Breakwater.	
	Asset Length:	327.5	
	Condition Assessment		
	Condition	Priority	Risk
	B	3	
	Brief Description		
	Concrete crest cracked in the middle of the length. Rock armour mostly tightly packed and maintaining good profile although some smaller rocks displaced and sitting on top of rock armour and four rocks on concrete deck (at seaward end). Opening of construction joints to the old part of the wall (visible on inner face). Notable construction joint between wall concrete and crest concrete look to be widening esp. around historic ladders. Local cracking and loose concrete locally at crest on inside face at approx. Mid-length possibly as a result of vessel impact. Minor deformation of handrails in same location.		
	Recommendations		
Continue to monitor. Repair cracked/loose concrete at crest. Move smaller rock armour pieces from concrete crest.

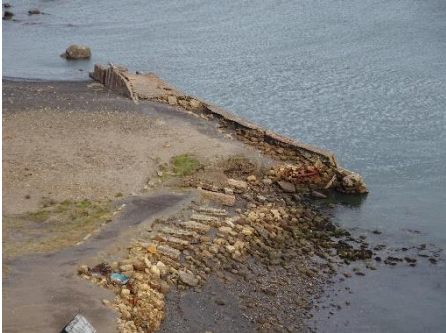
SBC Reference:	N/A		
NFCDD reference:	1221D901D0502C01

Asset Location:	NZ79871763, NZ79941769. Port Mulgrave Pier.	
	Asset Length:	161.4	
	Condition Assessment		
	Condition	Priority	Risk
	D	1	
	Brief Description		
	The structure is considered redundant however still provides limited protection to the fishermen huts and base of the cliff.		
	Recommendations		
Not inspected - redundant

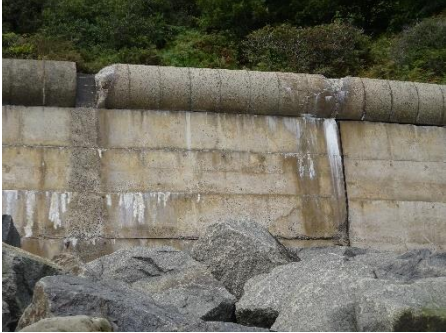
SBC Reference:	07-07A-01		
NFCDD reference:	1221D901D0601C01

Asset Location:	NZ81081614, NZ81111619. Next to Upgarth Hill	
	Asset Length:	72.4	
	Condition Assessment		
	Condition	Priority	Risk
	B	3	
	Brief Description		
	Previously reported defects (erosion/abrasion & undercutting to the wall toe) were repaired via local concrete repairs in advance of construction of rock armour fillet as part of Coastal Protection Scheme (July 2018). Rock armour extends approx. 15m west of seawall to tie-in at Cauldron Cliff.		
	Wash out of the joints under the capping beam. Local cracking and abrasion/spalling of reinforced concrete coping/capping beam continues to worsen. Brittle/missing joint filler on promenade parallel to capping beam (up to 20mm wide joint). Vegetation growth in joints. Route for surface water to enter backfill – increased risk of freeze-thaw action. Differential settlement of promenade slabs. 10-

Recommendations		
	Local repairs to concrete coping, fill open joints. Remove vegetation. Replace joint filler. Continue to monitor.

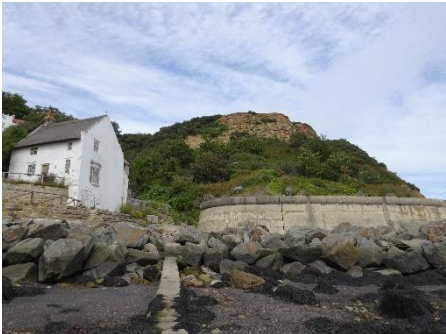
SBC Reference:	07-07A-02		
NFCDD reference:	1221D901D0601C01001

Asset Location:	Runswick Beck	
	Asset Length:	2	
	Condition Assessment		
	Condition	Priority	Risk
	B	4	>5
	Brief Description		
	Former Yorkshire Water (YW) gravity combined sewer connection into longshore outfall, redundant / filled with concrete during YW realignment works in 2017. YW manhole between rock armour fillets remains live - combined gravity sewer runs south to pumping station (beneath rock armour). Bag work and ad hoc concrete wall/repairs running up into Runswick Beck are generally in fair to poor condition but are protected to some extent by the rock armour. Provides informal access/egress to beach. Local damage to concrete manhole cover slab.		
	Recommendations		
	Continue to monitor. Remove vegetation and infill cracks.

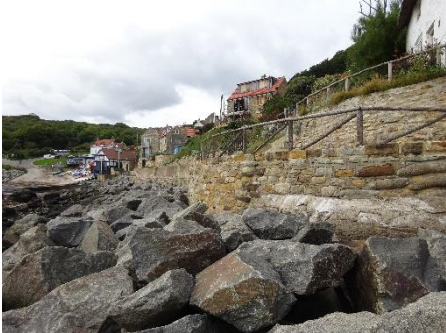
SBC Reference:	07-07A-03		
NFCDD reference:	1221D901D0601C06

Asset Location:	North side of Runswick Bay	
	Asset Length:	25.3	
	Condition Assessment		
	Condition	Priority	Risk
	B	4	>5
	Brief Description		
	Rock armour fillet constructed as part of Coastal Protection Scheme (July 2018). Local repointing and repairing of cracks to masonry sea wall and concrete apron in advance of rock placement. Rock armour maintains good interlock and consistent profile throughout.		
	Recommendations		
Continue to monitor.

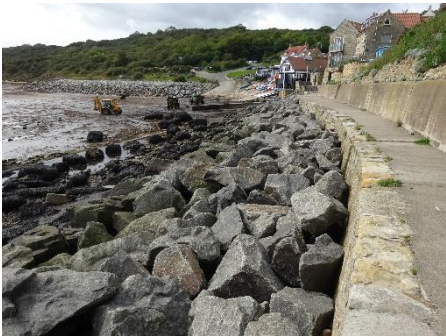
SBC Reference:	08-07A-01		
NFCDD reference:	1221D901D0601C03

Asset Location:	NZ81001604, NZ81081614. North of breakwater.	
	Asset Length:	91.3	
	Condition Assessment		
	Condition	Priority	Risk
	B	4	>5
	Brief Description		
	Rock armour fillet constructed as part of Coastal Protection Scheme (July 2018). Local repointing of masonry sea wall and repairs to coping in advance of rock placement. Minor cracking in concrete of promenade. Recessed mortar in structure and slope protection above seawall, to eastern extent of asset. Brittle/missing joint filler to promenade and concrete retaining wall to rear. Rock armour maintains good interlock and consistent profile throughout. Rock armour maintains good interlock and consistent profile throughout.		
	Recommendations		
Continue to monitor. Repair cracks, replace joint filler, repoint masonry of structures and slope protection.

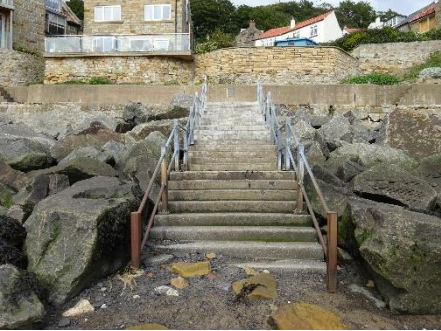
SBC Reference:	08-07A-02		
NFCDD reference:	1221D901D0601C03 001

Asset Location:	North of breakwater	
	Asset Length:	~7	
	Condition Assessment		
	Condition	Priority	Risk
	A	4	>5
	Brief Description		
	Reinforced concrete access steps constructed as part of Coastal Protection Scheme (July 2018). Precast RC step and landing units grouted onto mass concrete fill in advance of placing rock armour to both sides. Handrailing installed by SBC in August 2018. Flexible construction joints in good condition.		
	Recommendations		
Continue to monitor.

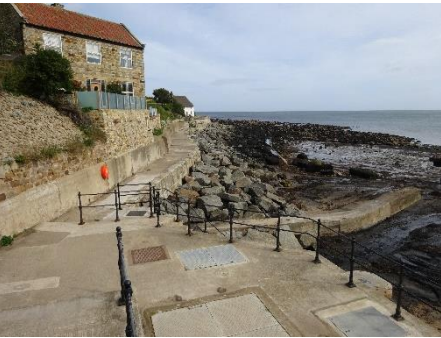
SBC Reference:	08-07A-03		
NFCDD reference:	1221D901D0601C03 002

Asset Location:	North of breakwater	
	Asset Length:	~35	
	Condition Assessment		
	Condition	Priority	Risk
	B	4	>5
	Brief Description		
	Cracks, abrasion and voids previously reported in lower concrete seawall repaired through Yorkshire Water realignment work (2017) and local concrete repairs in advance of construction of rock armour fillet (July 2018). Repointing/repairs to masonry wall and coping locally. Minor cracking in concrete of promenade. Recessed mortar in structure and slope protection above seawall, to eastern extent of asset. Brittle/missing joint filler to promenade and concrete retaining wall to rear.		
	Recommendations		
Continue to monitor. Repair cracks, replace joint filler, repoint masonry of structures and slope protection.

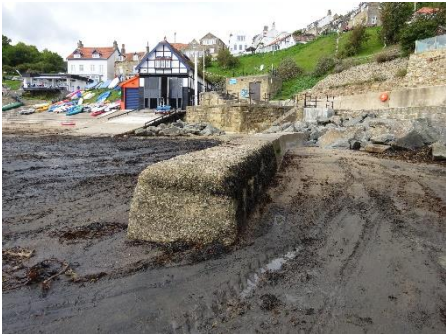
SBC Reference:	08-07A-04		
NFCDD reference:	1221D901D0601C02

Asset Location:	NZ81011606, NZ81031605.	
	Asset Length:	26.1	
	Condition Assessment		
	Condition	Priority	Risk
	C	2	
	Brief Description		
	<p>Breakwater / groyne in poor condition overall. Landward section of structure covered by rock armour fillet (approx. 4m length of crest & 10m length on both faces). Smaller vertical cracks to breakwater at seaward end. Section of breakwater around elbow broken out temporarily to allow access for construction of Coastal Protection Works (this section was previously in very poor condition). Reinstated with 16m³ of in situ cast concrete in July 2018. Crack/displacement of concrete in crest of existing structure at seaward end of infill section.</p> <p>Extensive vegetation coverage. Significant abrasion. Opening of joint between crest and walls. Higher beach levels obscuring potential undercutting reported in 2018.</p>

Recommendations		
	Continue to monitor. Consider removal.

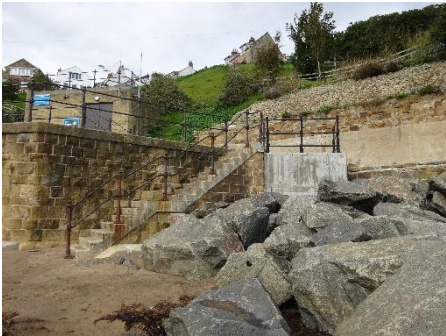
SBC Reference:	08-07A-05		
NFCDD reference:	1221D901D0601C07001

Asset Location:	Runswick Bay Pumping Station	
	Asset Length:	7	
	Condition Assessment		
	Condition	Priority	Risk
	B	4	>5
	Brief Description		
	<p>Yorkshire Water constructed concrete manhole chamber immediately to north in advance of Coastal Protection Scheme (July 2018). Remains in good condition as are handrails.</p> <p>Minor local damage/abrasion to surface and edges of concrete access steps. Several steps buried beneath sand. Minor loss of mortar locally.</p>		
	Recommendations		
	Continue to monitor.

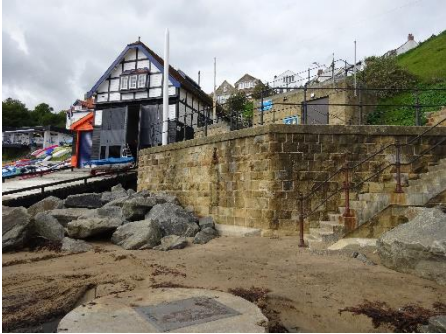
SBC Reference:	08-07A-06		
NFCDD reference:	1221D901D0601C07

Asset Location:	Runswick Bay. Pumping station.	
	Asset Length:	33.3	
	Condition Assessment		
	Condition	Priority	Risk
	B	4	>5
	Brief Description		
	Pumping station with masonry cladding in good condition. Rock armour fillet constructed as part of Runswick Bay Coastal Protection Scheme completed July 2018. Minor loss of mortar locally. Small flap valve no longer operational and in need of replacement. Rock fillet in good condition – no evidence of global displacement.		
	Recommendations		
	Continue to monitor. Replace flap valve.

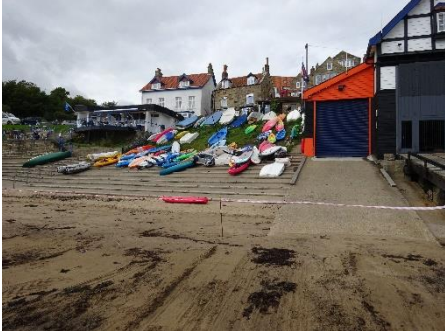
SBC Reference:	09-07A-01		
NFCDD reference:	1221D901D0601C04

Asset Location:	NZ81011601. Lifeboat slipway.	
	Asset Length:	43.8	
	Condition Assessment		
	Condition	Priority	Risk
	B	3	
	Brief Description		
	Rotting timber supports to historic lifeboat slipway. Deck timbers in good condition. Cracks/open joints to side walls of Runswick Rescue slipway. Southern slipway / beach access ramp concrete in good condition with local abrasion at construction joints and minor longitudinal crack in top two panels. Concrete revetment including timber steps in good condition.		
	Recommendations		
	Repair cracks to slipway, replace rotten/missing timbers. Continue to monitor.

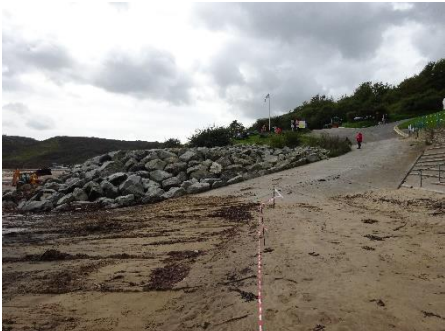
SBC Reference:	09-07A-02		
NFCDD reference:	1221D901D0601C04 001

Asset Location:		
	Asset Length:	~30	
	Condition Assessment		
	Condition	Priority	Risk
	B	4	>5
	Brief Description		
	Concrete ramp in good condition. Minor damage / abrasion locally at concrete edges at construction joints. Minor longitudinal crack in centre of top two panels.		
	Recommendations		
	Continue to monitor.

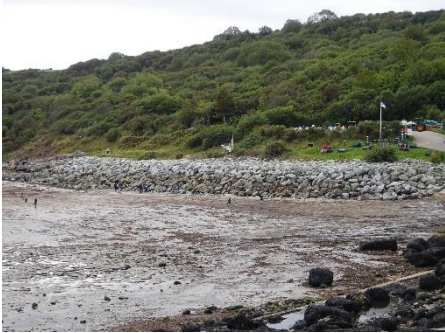
SBC Reference:	10-07A-01		
NFCDD reference:	1221D901D0602C01

Asset Location:	NZ81051591, NZ81011601	
	Asset Length:	290	
	Condition Assessment		
	Condition	Priority	Risk
	B	4	>5
	Brief Description		
	<p>Rock armour generally in good condition. Consistent crest and slope profile. No evidence of significant global movement / displacement. Toe rocks well buried in sand. High level access ramp (Cleveland Way) well protected – armour stone “edging” remains in place. Backfill/surfacing (smaller rocks and sand) in poor condition (washed away). Understood this is regularly replaced.</p>		
Recommendations			
Continue to monitor.

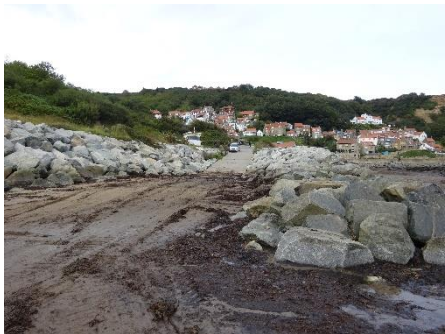
SBC Reference:	10-07B-01		
NFCDD reference:	1221D901D0602C01001

Asset Location:	NZ81051591, NZ81011601	
	Asset Length:	~50	
	Condition Assessment		
	Condition	Priority	Risk
	B	4	>5
	Brief Description		
	<p>Concrete slipway in good condition. Vegetation growth associated with Nettle Beck which outfalls through the rock armour and over the ramp surface in high flows.</p>		
Recommendations			
Continue to monitor.

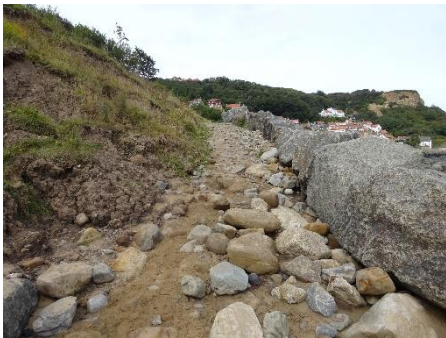
SBC Reference:	10-07B-02		
NFCDD reference:	1221D901D0602C01002

Asset Location:		
	Asset Length:	~48	
	Condition Assessment		
	Condition	Priority	Risk
	B	3	
	Brief Description		
	<p>Southern extent of revetment refurbished in June 2018 using surplus rock armour from CPS. Rock is generally 8-10t. Seaward edge of high-tide access ramp lined with single row of rock armour and revetment bolstered with rock armour (previously smaller armour and beach-won boulders were used). Rock armour extends approx. 30m to the south to form fillet at toe of active coastal slopes. High level access ramp (Cleveland Way) well protected – armour stone “edging” remains in place. Backfill/surfacing (smaller rocks and sand) in poor condition (washed away). Understood this is regularly replaced.</p>		
	Recommendations		
Continue to monitor. Replace smaller backfill as required.

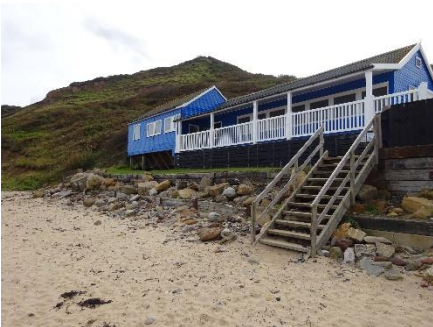
SBC Reference:	N/A		
NFCDD reference:	1221D901D0602C05

Asset Location:	South end of bay.	
	Asset Length:	56.2	
	Condition Assessment		
	Condition	Priority	Risk
	B	3	
	Brief Description		
	<p>North: Rock armour slope protection at mouth of stream. Concrete seawall and apron above timber toe beams (likely permanent formwork). South: Boulders and concrete blocks placed informally on/in front of retaining wall formed from timber sleepers fixed between vertical steel columns. Boulders and large concrete tank blocks to tie into coastal slope.</p>		
	Recommendations		
Continue to monitor. Replace/reprofile rock to protect timber retaining wall.

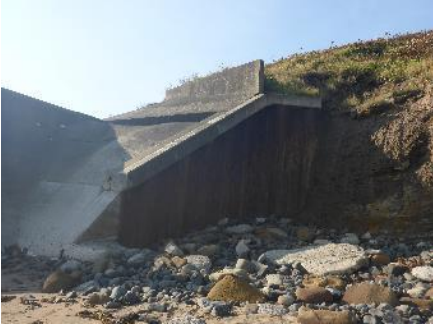
SBC Reference:	13-09A-01		
NFCDD reference:	1221D901D0701C02 001

Asset Location:	NZ86061286, NZ85981297. Wall protecting car park.	
	Asset Length:	~5	
	Condition Assessment		
	Condition	Priority	Risk
	C	3	
	Brief Description		
	Heavily corroded sheet pile retaining wall tied into the unprotected cliff. No deflection / movement of the pile noticeable. Concrete capping appears in good condition. It has previously been observed that minor abrasion at toe has caused some exposed reinforcement, but this was covered by beach sand.		
	Recommendations		
	Continue to monitor corrosion of piles and erosion of undefended cliff at tie-in.

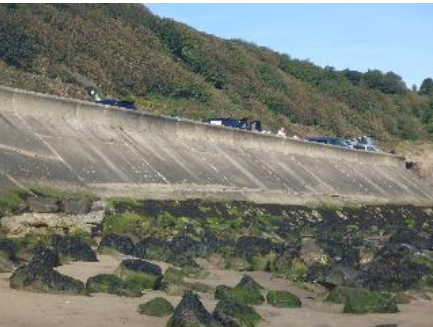
SBC Reference:	13-09A-02		
NFCDD reference:	1221D901D0701C02

Asset Location:	NZ86061286, NZ85981297. Wall protecting car park.	
	Asset Length:	174.5	
	Condition Assessment		
	Condition	Priority	Risk
	B	3	
	Brief Description		
	Sloping concrete revetment with a recurve crest wall. The concrete wall remains in fair condition with minimal damage to the surface, however the revetment has lost thickness of concrete at the base through abrasion, with exposure of reinforcement bars previously reported (not seen during present inspections due to high beach levels).		
	Recommendations		
	Encasement of this reinforcement is advised from a structural perspective, as well as preventing any Health & Safety incidents occurring due to sharp edges of the exposed bars on this popular amenity beach. Cracks towards southern end (near slipway) need filling.

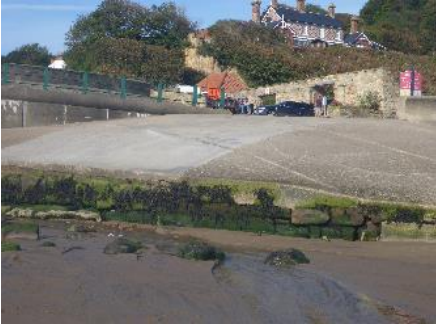
SBC Reference:	13-09A-03		
NFCDD reference:	1221D901D0701C02002

Asset Location:		
	Asset Length:	~15	
	Condition Assessment		
	Condition	Priority	Risk
	B	3	
	Brief Description		
	Missing filler in joints to slipway's blockwork wing-wall. Toe at interface of slipway and adjacent seawall previously reported as being locally poor but covered during inspections due to high beach levels.		
	Recommendations		
Continue to monitor toe and fill gaps in joints on wing-wall.

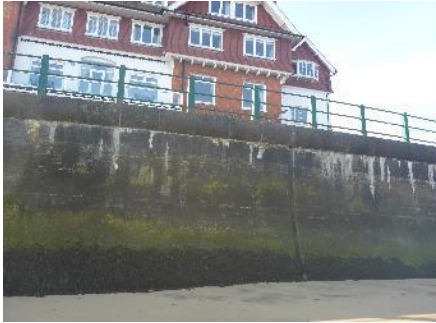
SBC Reference:	14-09B-01		
NFCDD reference:	1221D901D0702C01

Asset Location:	NZ86061286, NZ86241268	
	Asset Length:	259.1	
	Condition Assessment		
	Condition	Priority	Risk
	C	2	
	Brief Description		
	Groynes derelict. Apron fully buried so not observed, but previously recorded as being very poor with adjacent timber planks and stakes missing and rotten. Missing joint filler under capping beam. Some sections of missing sealant in most joints in wall, with minor abrasion around joints.		
	Recommendations		
Re-seal joints where missing between poured sections of sea wall and replace/encase apron. Whilst not yet 'urgent' the structure would benefit from works within a few years.

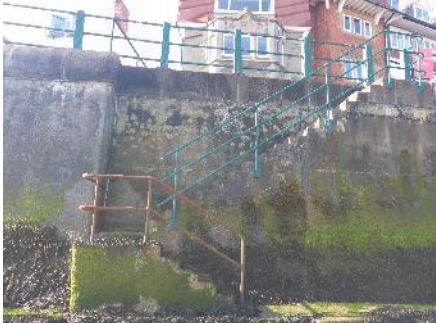
SBC Reference:	14-09B-02		
NFCDD reference:	1221D901D0702C01001

Asset Length:	~4	
	Condition Assessment		
	Condition	Priority	Risk
	B	3	
	Brief Description		
	Steps abraded on lower sections. Handrail replaced or painted since 2018, with lowest section corroded.		
	Recommendations		
	Continue to monitor.

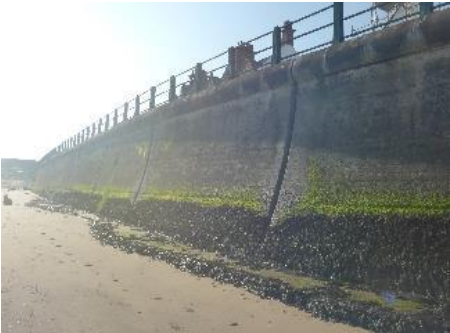
SBC Reference:	14-09B-03		
NFCDD reference:	1221D901D0702C01002

Asset Location:	Same as 14-09B-01	
	Asset Length:	Incl. in 14-09B-01	
	Condition Assessment		
	Condition	Priority	Risk
	C	2	
	Brief Description		
	Groynes derelict. Apron fully buried so not observed, but previously recorded as being very poor with adjacent timber planks and stakes missing and rotten. Some sections of missing sealant in most joints in wall, with minor abrasion around joints.		
	Recommendations		
Re-seal joints where missing between poured sections of sea wall and replace/encase apron. Whilst not yet 'urgent' the structure would benefit from works within a few years.

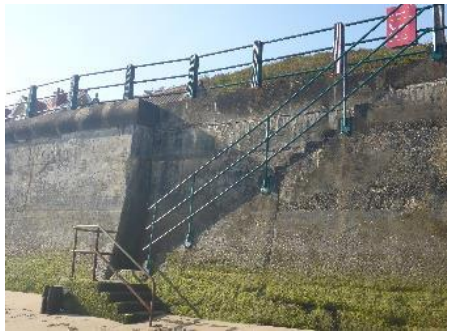
SBC Reference:	14-09B-04		
NFCDD reference:	1221D901D0702C01003

Asset Location:		
	Asset Length:	~4	
	Condition Assessment		
	Condition	Priority	Risk
	B	3	
	Brief Description		
	Steps abraded on lower sections. Handrail replaced or painted since 2018, with lowest section corroded.		
	Recommendations		
Continue to monitor.

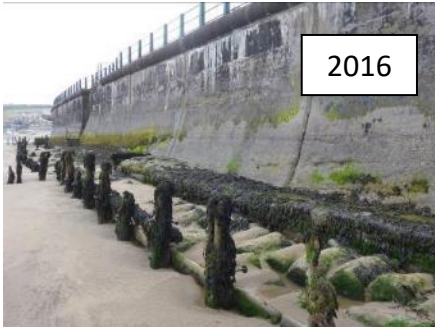
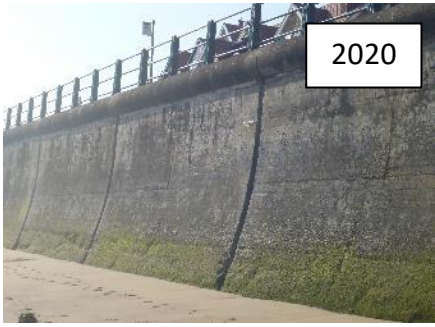
SBC Reference:	14-09B-05		
NFCDD reference:	1221D901D0702C01004

Asset Location:	Same as 14-09B-01	
	Asset Length:	Incl. in 14-09B-01	
	Condition Assessment		
	Condition	Priority	Risk
	C	2	
	Brief Description		
	Groynes derelict. Apron fully buried so not observed, but previously recorded as being very poor with adjacent timber planks and stakes missing and rotten. Missing joint filler under capping beam. Some sections of missing sealant in most joints in wall, with minor abrasion around joints.		
	Recommendations		
Re-seal joints where missing between poured sections of sea wall and replace/encase apron. Whilst not yet 'urgent' the structure would benefit from works within a few years.

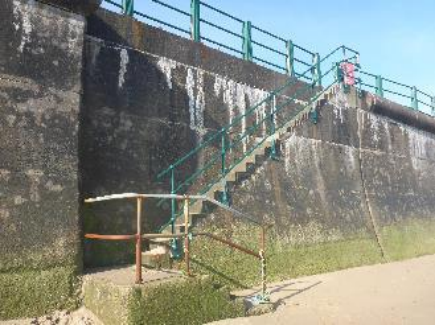
SBC Reference:	14-09B-06		
NFCDD reference:	1221D901D0702C01005

Asset Location:		
	Asset Length:	~4	
	Condition Assessment		
	Condition	Priority	Risk
	B	3	
	Brief Description		
	Steps abraded on lower sections. Handrail replaced or painted since 2018, with lowest section corroded.		
	Recommendations		
Continue to monitor.

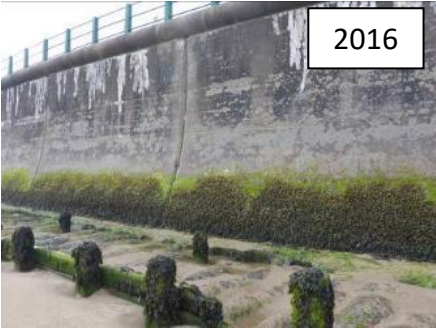
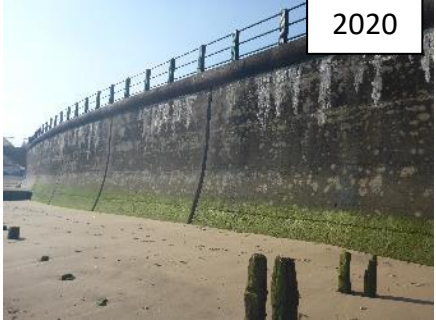
SBC Reference:	14-09B-07		
NFCDD reference:	1221D901D0702C01006

Asset Location:	Same as 14-09B-01	
	Asset Length:	Incl. in 14-09B-01	
	Condition Assessment		
	Condition	Priority	Risk
	C	2	
	Brief Description		
	Groyne derelict. Apron fully buried so not observed, but previously recorded as being very poor with adjacent timber planks and stakes missing and rotten. Missing joint filler under capping beam. Some sections of missing sealant in most joints in wall, with minor abrasion around joints.		
Recommendations			
Re-seal joints where missing between poured sections of sea wall and replace/encase apron. Whilst not yet 'urgent' the structure would benefit from works within a few years.

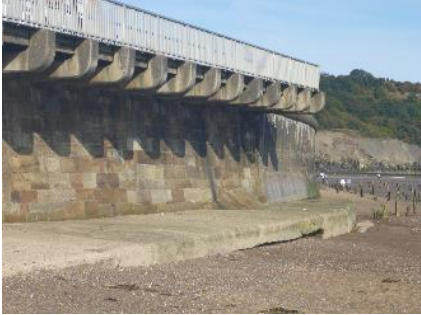
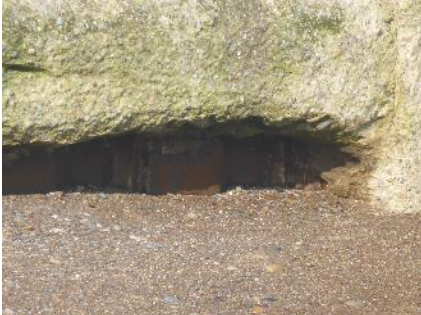
SBC Reference:	15-09B-01		
NFCDD reference:	1221D901D0702C04

Asset Location:	NZ86251264, NZ86241268. NE of East Row Bridge.	
	Asset Length:	42.1	
	Condition Assessment		
	Condition	Priority	Risk
	B	3	
	Brief Description		
	Steel toe piles exposed in 2016 and looked very corroded but buried/submerged by ponded water in 2018 and only one small section exposed in 2020 (showing corrosion). Groyne derelict. Vertical crack to masonry wall near pipe at centre of wall. Some mortar missing in some joints in masonry wall. Timber walkway in good condition.		
Recommendations			
Expose and repair voids under toe apron.

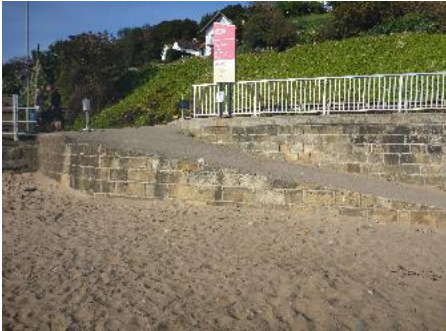
SBC Reference:	15-09B-02		
NFCDD reference:	1221D901D0702C03

Asset Location:		
	Asset Length:	~10	
	Condition Assessment		
	Condition	Priority	Risk
	B	3	
	Brief Description		
	Slipway in good condition overall. One or two gaps in the blockwork wing wall recorded in 2018 have now been infilled.		
	Recommendations		
Continue to monitor.

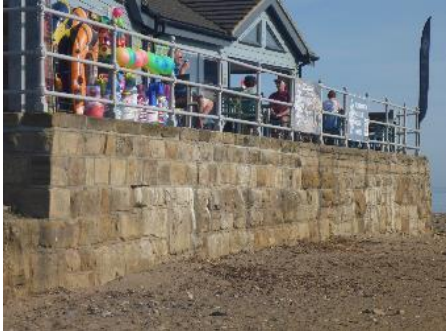
SBC Reference:	15-09B-03		
NFCDD reference:	1221D901D0702C03 001

Asset Location:	NZ86211252, NZ86251264. Wall extending from East Row Bridge	
	Asset Length:	232.4 total (15-09b-03 to 15-09b-05)	
	Condition Assessment		
	Condition	Priority	Risk
	B	3	
	Brief Description		
	Masonry blockwork wall to channel sides increasing in height at café. Overall, in fair to good condition. Minor abrasion to a few blocks, missing mortar in occasional joints near cafe.		
	Recommendations		
Repoint wall on 'as needs' basis. Continue to monitor.

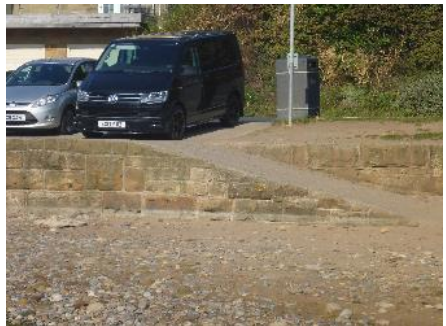
SBC Reference:	15-09B-04		
NFCDD reference:	1221D901D0702C03 002

Asset Location:		
	Asset Length:	~4	
	Condition Assessment		
	Condition	Priority	Risk
	B	3	
	Brief Description		
	Fair overall condition. Edge capping stone missing. Toe below beach level.		
	Recommendations		
Repair capping edge. Continue to monitor.

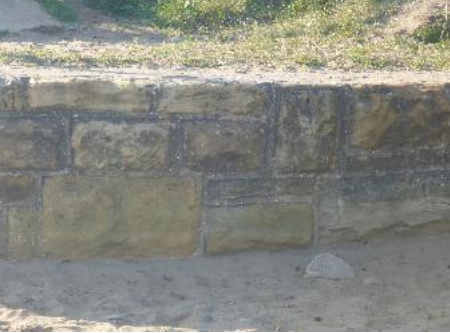
SBC Reference:	15-09B-05		
NFCDD reference:	1221D901D0702C03003

Asset Location:		
	Asset Length:	232.4 total (15-09b-03 to 15-09b-05)	
	Condition Assessment		
	Condition	Priority	Risk
	B	3	
	Brief Description		
	Masonry blockwork wall to channel sides in fair to good condition.		
	Recommendations		
Continue to monitor.

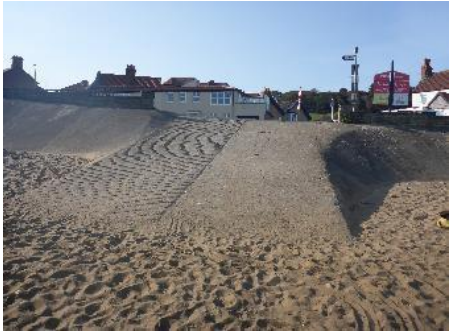
SBC Reference:	15-09B-07		
NFCDD reference:	1221D901D0702C02001

Asset Location:		
	Asset Length:	774.5 total (15-09b-06 to 17-10-02)	
	Condition Assessment		
	Condition	Priority	Risk
	B	4	>5
	Brief Description		
	Slipway in good condition with toe below beach level. Adjacent concrete tie-ins to either side of slipway in good condition.		
	Recommendations		
Continue to monitor

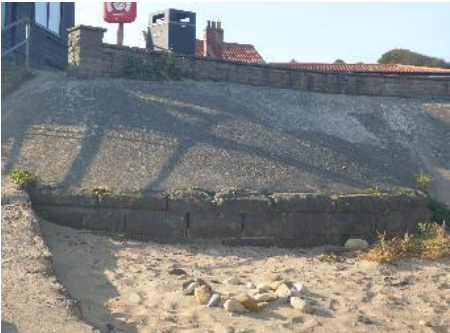
SBC Reference:	16-09C-01		
NFCDD reference:	1221D901D0702C02002

Asset Location:		
	Asset Length:	774.5 total (15-09b-06 to 17-10-02)	
	Condition Assessment		
	Condition	Priority	Risk
	B	4	5
	Brief Description		
	Good overall condition. Sloping revetment with blockwork wall. Toe of wall below beach level but some open joints in exposed sections.		
	Recommendations		
Repoint joints in blockwork wall below revetment.

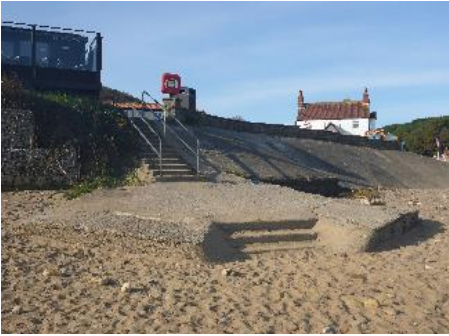
SBC Reference:	16-09C-02		
NFCDD reference:	1221D901D0702C02003

Asset Location:		
	Asset Length:	774.5 total (15-09b-06 to 17-10-02)	
	Condition Assessment		
	Condition	Priority	Risk
	B	3	
	Brief Description		
	Steps in fair overall condition. Concrete revetment on the landing is abraded in places.		
	Recommendations		
Continue to monitor.

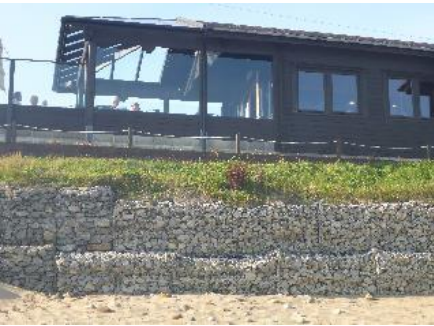
SBC Reference:	16-09C-04 to 17-10-02		
NFCDD reference:

Asset Location:		
	Asset Length:		
	Condition Assessment		
	Condition	Priority	Risk
	B	2	
	Brief Description		
	The gabion baskets have not filled completely with visible sagging on the bottom row. The top row has remained vertical. Seems to be holding at the moment. Baskets founded on stone blocks but these were buried at the time of the inspections (Previously have been exposed along its length to 3 or 4 courses of blocks in height, showing 1 block missing and plugged with a beach boulder and large cobbles being used as a plug at the toe in the western end adjacent to the gabions).		
	Recommendations		
Continue to monitor.

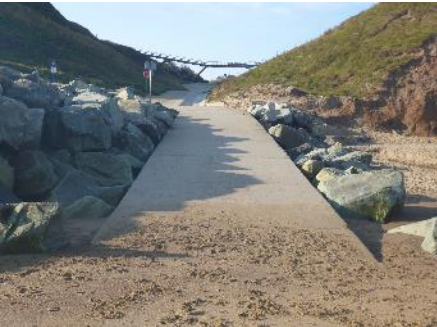
SBC Reference:	18-11A-01		
NFCDD reference:	1221D901D0801C01001

Asset Location:	NZ88161194, NZ88541185	
	Asset Length:	~10	
	Condition Assessment		
	Condition	Priority	Risk
	B	4	>5
	Brief Description		
	Concrete edge of slipway chipped at construction joint. Overall good condition. Toe below beach level. Rock armour both sides tightly packed.		
	Recommendations		
Continue to monitor.

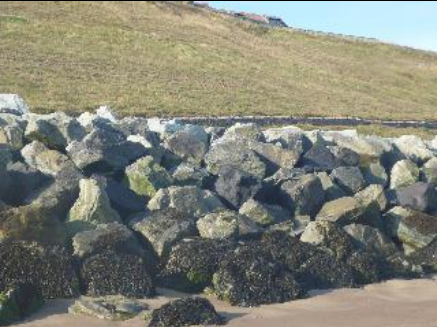
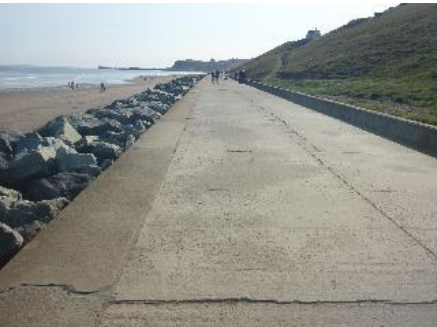
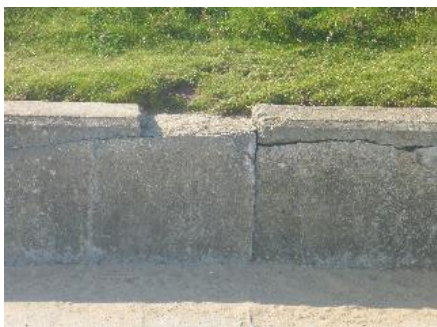
SBC Reference:	18-11A-02		
NFCDD reference:	1221D901D0801C01

Asset Location:	NZ88161194, NZ88541185	
	Asset Length:	439.3	
	Condition Assessment		
	Condition	Priority	Risk
	B	3	
	Brief Description		
	Rock armour generally good, well packed but movement in several local areas. Some smaller armour loosely packed on crest.		
	Promenade has occasional minor open joints / cracks / missing sealant, but nothing appears to have worsened since previous inspections.		
Localised damages to rear 'splash' wall observed.			
Recommendations			
Continue to monitor surface cracking in promenade and reactive repairs on an 'as needs' basis.

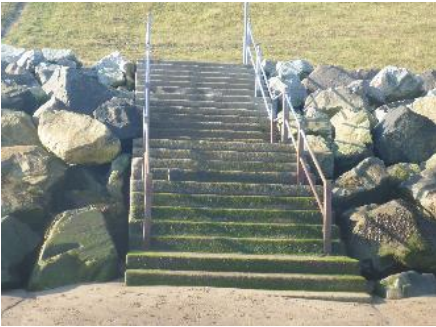
SBC Reference:	18-11A-03		
NFCDD reference:	1221D901D0801C01002

Asset Location:		
	Asset Length:	~5	
	Condition Assessment		
	Condition	Priority	Risk
	C	3	
	Brief Description		
	Steps with algae on lower courses. Heavy abrasion on lower sections of steps.		
	Recommendations		
Continue to monitor.

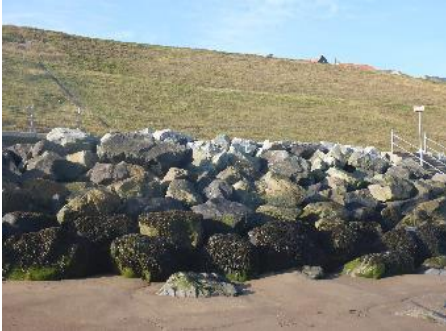
SBC Reference:	18-11A-04		
NFCDD reference:	1221D901D0801C01003

Asset Location:	Part of 18-11A-02	
	Asset Length:		
	Condition Assessment		
	Condition	Priority	Risk
	B	3	
	Brief Description		
	Rock revetment – remainder of 18-11A-02 - appears in generally good condition.		
	Recommendations		
Continue to monitor.

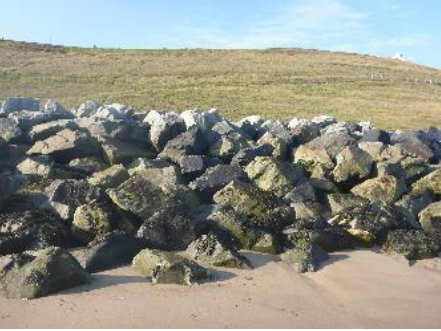
SBC Reference:	70-11A-01		
NFCDD reference:	1221D901D0802C02

Asset Location:	NZ88671180, NZ88861170	
	Asset Length:	216.1 (incl. 70-11a-01 to 70-11a-04)	
	Condition Assessment		
	Condition	Priority	Risk
	B	3	
	Brief Description		
	Rock armour in good condition, closely packed, and good coverage. Some smaller rocks on crest lost interlock. Promenade surface showing some signs of cracking and sealant loss between concrete sections.		
	Recommendations		
	Continue to monitor.

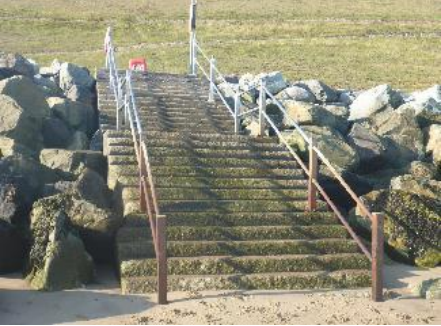
SBC Reference:	70-11A-02		
NFCDD reference:	1221D901D0802C02 001

Asset Location:	Western promenade, Whitby	
	Asset Length:	216.1 (incl. 70-11a-01 to 70-11a-04)	
	Condition Assessment		
	Condition	Priority	Risk
	B	3	
	Brief Description		
	Steps with algae on lower courses. Heavy abrasion on lower sections of steps.		
	Recommendations		
Continue to monitor

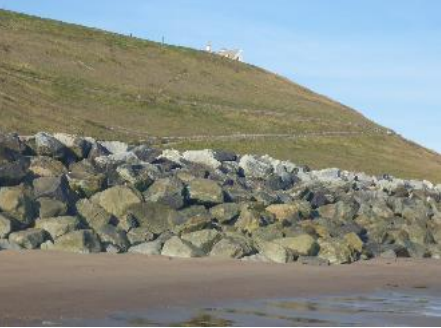
SBC Reference:	70-11A-03		
NFCDD reference:	1221D901D0802C02 002

Asset Location:	Western promenade, Whitby	
	Asset Length:	216.1 (incl. 70-11a-01 to 70-11a-04)	
	Condition Assessment		
	Condition	Priority	Risk
	B	3	
	Brief Description		
	Rock armour in good condition, closely packed, and good coverage. Some smaller rocks on crest lost interlock. Promenade surface showing some signs of cracking and sealant loss between concrete sections.		
	Recommendations		
Continue to monitor.

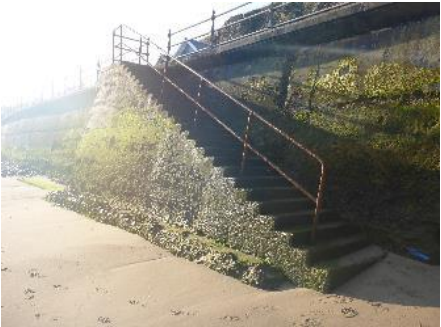
SBC Reference:	70-11A-04		
NFCDD reference:	1221D901D0802C02 003

Asset Location:	Western promenade, Whitby	
	Asset Length:	216.1 (incl. 70-11a-01 to 70-11a-04)	
	Condition Assessment		
	Condition	Priority	Risk
	C	3	
	Brief Description		
	Tread of steps in fair condition. Side wall corner is heavily abraded. Handrail corroded and missing bolt fixing at the bottom. Heavy abrasion on lower sections of steps.		
	Recommendations		
Treat or replace handrails.

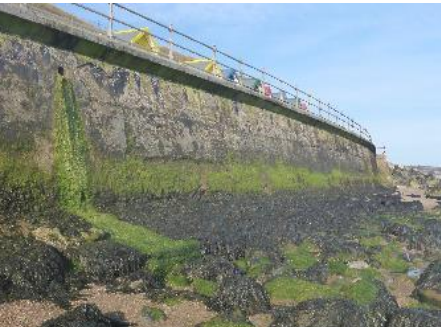
SBC Reference:	71-11A-01		
NFCDD reference:	1221D901D0802C03

Asset Location:	NZ88861170, NZ89231154	
	Asset Length:	166.8	
	Condition Assessment		
	Condition	Priority	Risk
	C	2	
	Brief Description		
	Lower half of wall abraded/eroded. Toe apron exposed along whole length due to low sand level but heavily covered by seaweed. Previous records of apron missing locally and in poor condition. Promenade fair, signs of wave overtopping causing damage. Handrails anchor bolts corroding. The concrete toe has been repaired at the eastern end.		
	Recommendations		
Consider extending rock armour along this section.

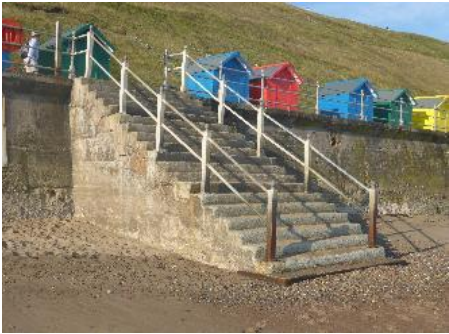
SBC Reference:	71-11A-02		
NFCDD reference:	1221D901D0802C13 001

Asset Location:	Western promenade, Whitby	
	Asset Length:	~ 4	
	Condition Assessment		
	Condition	Priority	Risk
	B	3	
	Brief Description		
	Tread repaired half way up the steps. Sheet pile toe is only slightly exposed with steel capping. The steel rise 'facing' on the bottom step was exposed in the previous inspections and had moved seaward and was coming away on 'corner' (but was covered by beach levels in present inspections). Handrail in generally good condition. Heavy abrasion on lower sections of steps.		
	Recommendations		
Continue to monitor

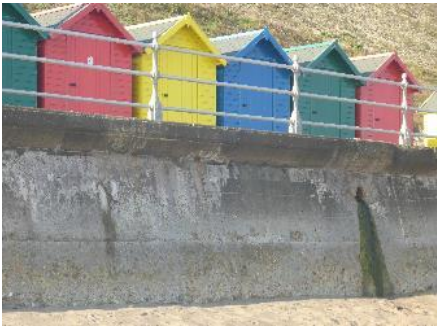
SBC Reference:	71-11A-03		
NFCDD reference:	1221D901D0802C13

Asset Location:	NZ88861170, NZ89231154	
	Asset Length:	158.4	
	Condition Assessment		
	Condition	Priority	Risk
	C	2	
	Brief Description		
	Horizontal cracks to wall visible near slipway, east of Beach Management Centre and North Beach cafe. Beach level high and wall's toe not exposed. Handrail is relatively new. Some anchor bolts showing signs of corrosion. Concrete facing weathered/abraded.		
	Recommendations		
Repair cracks (likely cold joints) to wall near slipway.

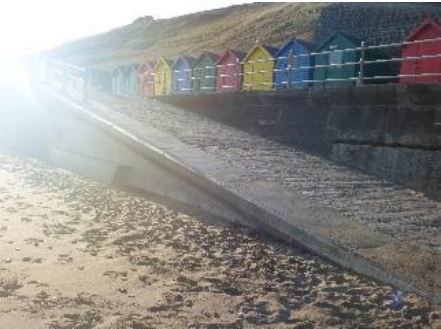
SBC Reference:	71-11A-04		
NFCDD reference:	1221D901D0802C13002

Asset Location:	Western promenade, Whitby	
	Asset Length:	~12	
	Condition Assessment		
	Condition	Priority	Risk
	C	2	
	Brief Description		
	Lower section of slipway has been repaired since previous inspection, but wing wall still has abrasion.		
	Recommendations		
Continue to monitor

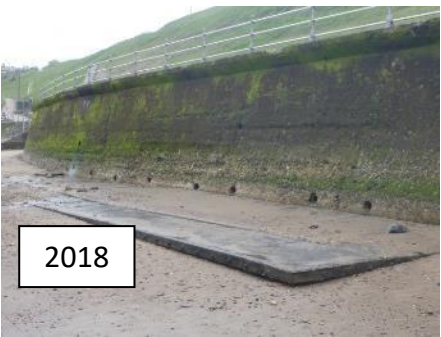
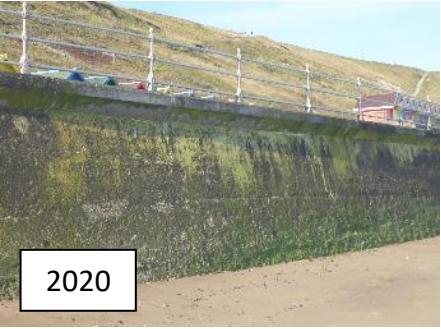
SBC Reference:	71-11A-05		
NFCDD reference:	1221D901D0802C14

Asset Location:	NZ88861170, NZ89231154	
	Asset Length:	86.2	
	Condition Assessment		
	Condition	Priority	Risk
	C	2	
	Brief Description		
	Erosion/abrasion to lower half of wall. Minor damage throughout. Apron buried (was partly exposed in 2018). Minor cracking to promenade throughout. Areas of chipping/cracking along top edge. Handrails have been replaced relatively recently.		
	Recommendations		
Repair chipped areas approx. 0.5m from edge throughout.

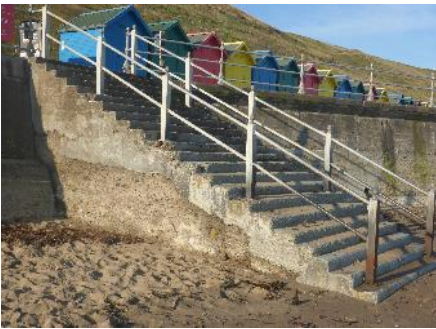
SBC Reference:	20-11A-01		
NFCDD reference:	1221D901D0802C04 001

Asset Location:	Western promenade, Whitby	
	Asset Length:	~7	
	Condition Assessment		
	Condition	Priority	Risk
	C	3	
	Brief Description		
	Steps. Weathered concrete with exposed aggregates. Abraded side walls with large cracks. Handrail in fair condition. Heavy abrasion on lower sections of steps.		
	Recommendations		
Repair cracks. Continue to monitor.

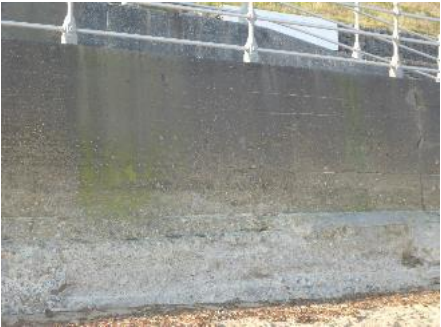
SBC Reference:	20-11A-02		
NFCDD reference:	1221D901D0802C04

Asset Location:	NZ89231154, NZ89291153	
	Asset Length:	65.4	
	Condition Assessment		
	Condition	Priority	Risk
	C	3	
	Brief Description		
	<p>One minor vertical crack / joint in eastern third of wall. Concrete coping replaced at western end. Erosion/abrasion to lower half of wall, including exposed sections of apron. Lower handrails have been replaced relatively recently (set back from edge). Minor cracking to promenade.</p>		
	Recommendations		
	Repair abraded front face. Infill crack.

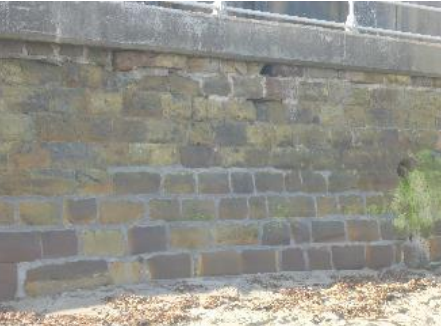
SBC Reference:	21-11A-01		
NFCDD reference:	1221D901D0802C07

Asset Location:	NZ89291153, NZ89361152	
	Asset Length:	71.9	
	Condition Assessment		
	Condition	Priority	Risk
	C	3	
	Brief Description		
	<p>Blockwork wall - cracking/loss of mortar and abraded blocks in places. Joints missing locally. Generally stable although these points of weakness could cause failure. Higher concrete wall in a fair condition. Minor cracking in promenade. New coping beam since 2014.</p>		
	Recommendations		
	Repair/replace damaged blocks and grout joints.

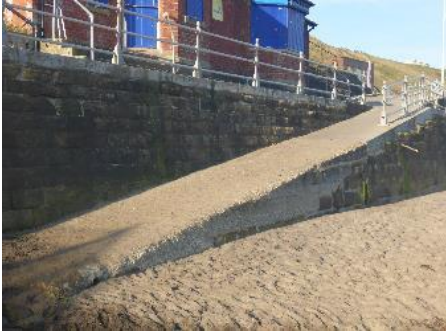
SBC Reference:	21-11A-02		
NFCDD reference:	1221D901D0802C07 001

Asset Location:		
	Asset Length:	~30	
	Condition Assessment		
	Condition	Priority	Risk
	C	3	
	Brief Description		
	Slipway. Concrete deck replaced on the top half of the structure - bottom half abraded.		
	Recommendations		
Continue to monitor.

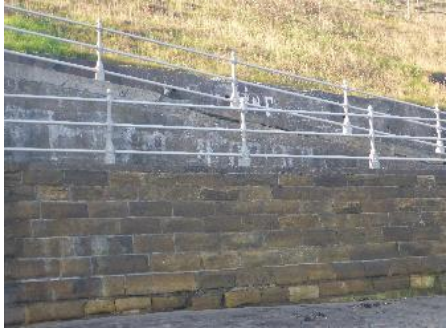
SBC Reference:	22-11A-01		
NFCDD reference:	1221D901D0802C06

Asset Location:	NZ89361152, NZ89401152	
	Asset Length:	37.5	
	Condition Assessment		
	Condition	Priority	Risk
	C	3	
	Brief Description		
	Blockwork wall with many previously open joints now repointed. High beach levels covered previously reported abrasion and loss of blocks and mortar in lower section and under ramp. No water seen seeping through wall as observed in 2012 and 2016. Cracks in coping of upper wall behind sea wall.		
	Recommendations		
Repair or encase toe. Repair cracking in masonry wall.

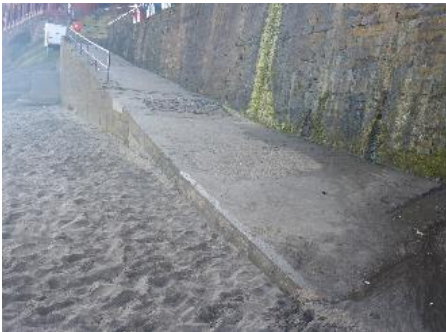
SBC Reference:	22-11A-02		
NFCDD reference:	1221D901D0802C06 001

Asset Location:		
	Asset Length:	30	
	Condition Assessment		
	Condition	Priority	Risk
	C	3	
	Brief Description		
	Slipway. Mixed construction. Settlement of toe remediated with concrete transition slope. Open joints between blocks revetment and occasional cracks and voids. Toe covered by high beach levels, but previously reported as being heavily abraded. Wing walls in fair condition.		
	Recommendations		
Repair joints, cracks and voids. Continue to monitor.

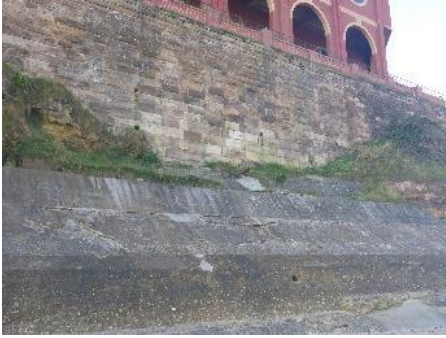
SBC Reference:	22-11A-03		
NFCDD reference:	1221D901D0802C15

Asset Location:	Beneath red brick building (Whitby Pavilion).	
	Asset Length:	71.8	
	Condition Assessment		
	Condition	Priority	Risk
	C	3	
	Brief Description		
	Concrete toe showing signs of cracking, abrasion and loss of concrete and undercutting. Evidence of previous repairs. Blockwork walls below Pavilion appear sound but some loss of mortar. Slips in cliff between upper wall and toe structure. One block missing from smaller blockwork wall just west of Pavilion.		
	Recommendations		
	Stabilise and repair cliff. Repair toe.

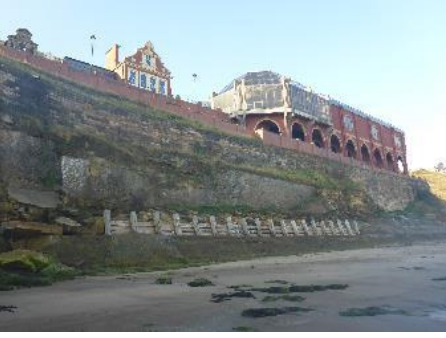
SBC Reference:	N/A		
NFCDD reference:	1221D901D0802C05

Asset Location:	NZ89401152, NZ89511152	
	Asset Length:	43.1	
	Condition Assessment		
	Condition	Priority	Risk
	C	3	
	Brief Description		
	Concrete apron seaward of timber breastwork was buried at its toe, but previous inspections reported undercutting with large voids beneath and part of the lower section of apron breaking up. Blockwork walls below Pavilion and its access road appear sound but slips / falls in cliff below and some loss of mortar.		
	Recommendations		
	Repairs to toe.

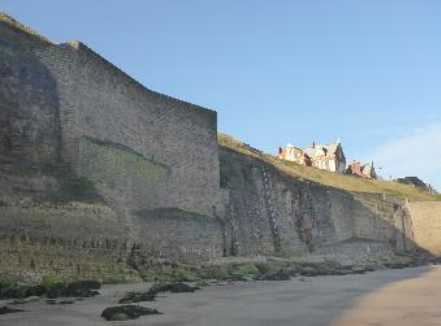
SBC Reference:	24-11B-01		
NFCDD reference:	1221D901D0802C09

Asset Location:	NZ89541152, NZ89651151	
	Asset Length:	115.8	
	Condition Assessment		
	Condition	Priority	Risk
	B	3	
	Brief Description		
	High sections of blockwork sea wall facing in between in-situ rock outcrops. Sections of masonry appear sound condition, some mortar loss, but not worse than noted previously. In several locations tie-in of edges into cliff is getting outflanked / abraded.		
	Recommendations		
Repair edges of panels where tie- in to cliff

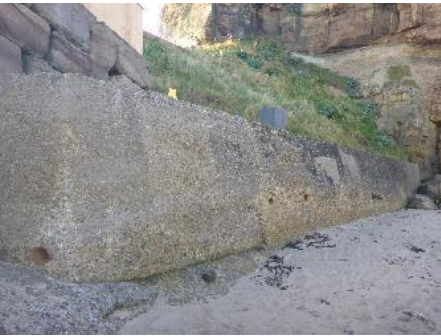
SBC Reference:	25-11B-01		
NFCDD reference:	1221D901D0802C10

Asset Location:	NZ89771147, NZ89781150. West side of West Pier.	
	Asset Length:	26.8	
	Condition Assessment		
	Condition	Priority	Risk
	B	3	
	Brief Description		
	In situ concrete retaining wall. Abrasion has led to areas of exposed aggregates. Fair condition overall despite abraded face. Minor slip in cliff above wall has not worsened since previous inspections.		
	Recommendations		
Continue to monitor.

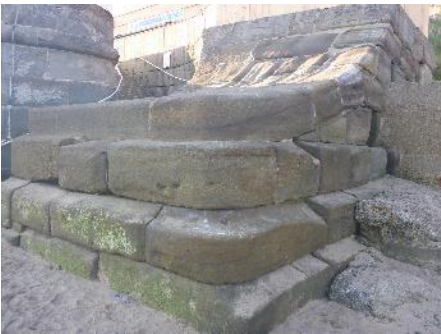
SBC Reference:	25-11B-02		
NFCDD reference:	1221D901D0802C12002

Asset Location:	NZ89781150, NZ89861150	
	Asset Length:	~7	
	Condition Assessment		
	Condition	Priority	Risk
	B	3	
	Brief Description		
	Landing area has evidence of repairs and repointing to upper blocks. Open gaps between blocks on wing wall (west face).		
	Recommendations		
Continue to monitor.
