Asset Inspection Document

Walk-over Visual Inspections of Assets

Scarborough Borough Council

NOVEMBER 2020

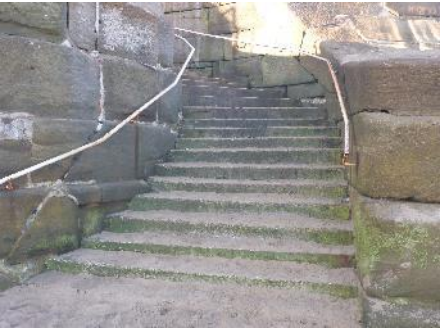
SBC Reference:	25-11B-03		
NFCDD reference:	1221D901D0802C12 003

Asset Location:	NZ89781150, NZ89861150	
	Asset Length:	~7	
	Condition Assessment		
	Condition	Priority	Risk
	B	3	
	Brief Description		
	Toe and lower steps covered by high beach levels. Steps in fair condition, with abrasion on lower courses.		
	Recommendations		
	Continue to monitor.

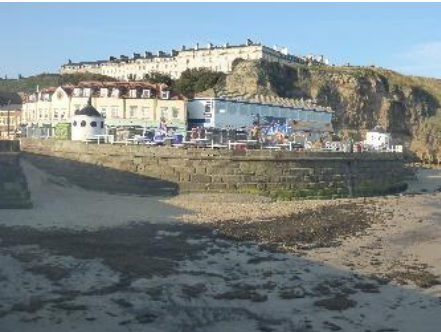
SBC Reference:	26-11B-01		
NFCDD reference:	1221D901D0802C12

Asset Location:	NZ89781150, NZ89861150 Start of west pier at slipway.	
	Asset Length:	87.7	
	Condition Assessment		
	Condition	Priority	Risk
	B	2	
	Brief Description		
	Battery wall. Deep voids between blockwork, with a few blocks vertically cracked. Voids between corners of blocks. Slipway wall capping beam and wall to west is abraded, with a displaced block. Damaged apron. Promenade in fair condition.		
	Recommendations		
	Continue to monitor and repair deep voids and cracks.

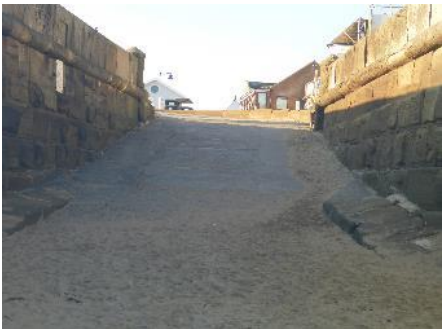
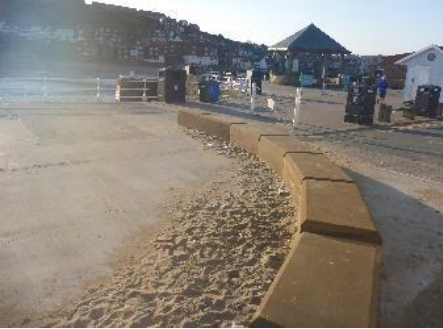
SBC Reference:	26-11B-02		
NFCDD reference:	1221D901D0802C12001

Asset Location:	NZ89781150, NZ89861150	
	Asset Length:	~12	
Condition Assessment			
Condition		Priority	Risk
B		3	
Brief Description			
<p>Slipway in fair condition. Toe below beach level.</p> <p>Wall built at top of slipway as part of capital scheme in 2019 to deflect wave run-up back into the harbour. Some sand accumulating on seaward side of wall should be periodically cleared.</p>			
Recommendations			
<p>Continue to monitor condition of slipway and start to record the performance of the wave deflector wall during surge and storm events.</p>

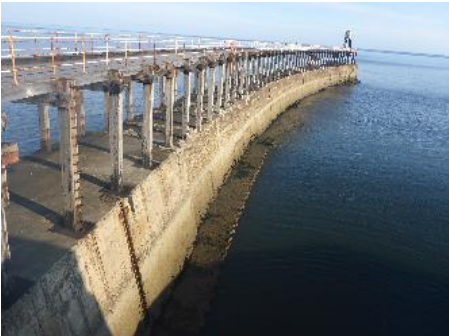
SBC Reference:	N/A		
NFCDD reference:	1221D901D0803C01

Asset Location:	NZ89921172, NZ89921187 West breakwater arm.	
	Asset Length:	315.5	
	Condition Assessment		
	Condition	Priority	Risk
	B	3	
	Brief Description		
	Overall fair condition but limited inspection as toe is covered in water even at low tide. Abrasion to edges of concrete structure and exposure of aggregate. Timber supporting structure weathered.		
Recommendations			
Continue to monitor and replace planks in promenade deck as necessary. Detailed low water inspection from vessel recommended every 10 years.

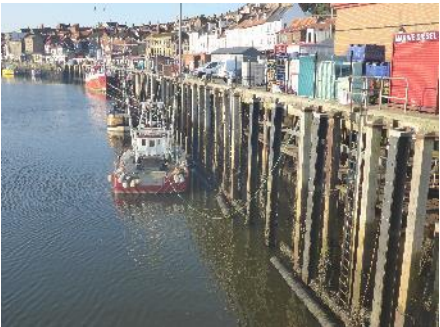
SBC Reference:	N/A		
NFCDD reference:	1221D901D0803C06

Asset Location:	West bank, Whitby Harbour	
	Asset Length:	215.4	
	Condition Assessment		
	Condition	Priority	Risk
	B	4	5
	Brief Description		
	Timber edge beam and fenders recently replaced. Metal deck support piles to suspended quay deck are corroding. Original sandstone blockwork wall viewed from ends only but looks fair. Some voids to blockwork.		
	Recommendations		
Detailed inspection of supporting piles to deck required

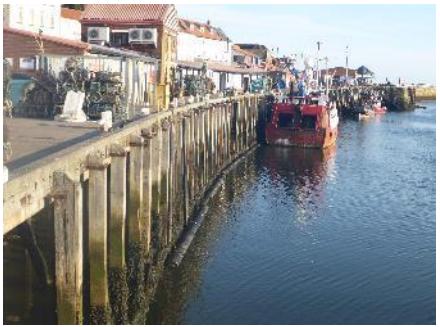
SBC Reference:	N/A		
NFCDD reference:	1221D901D0803C07

Asset Location:	West bank, Whitby Harbour	
	Asset Length:	157.4	
	Condition Assessment		
	Condition	Priority	Risk
	C	3	
	Brief Description		
	Timber fenders along length, vegetation to upper part of wall. Promenade in good condition. Lower wall obscured by seaweed. Steps cracked and open joints at mid-length. Concrete steps repaired but cracking and abrasion still evident. No handrail.		
	Recommendations		
Repair and repoint joints at steps.

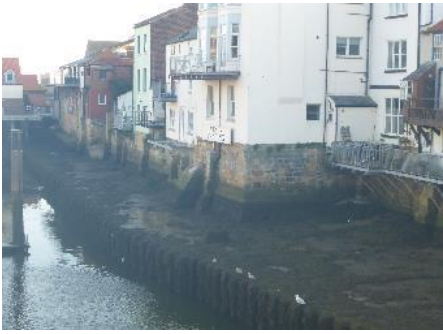
SBC Reference:	N/A		
NFCDD reference:	1221D901D0803C10

Asset Location:	East bank, D/S of Whitby Bridge	
	Asset Length:	135.2	
	Condition Assessment		
	Condition	Priority	Risk
	B	3	
	Brief Description		
	No direct access but appears in fair condition when viewed from distance (limited access, visual inspection from RNLI and bridge). Some joint washout to riparian walls. Area of damage to blocks 20m downstream of bridge. Concrete apron near to the bridge appears in fair condition including		
	Recommendations		
Continue to monitor – repair washed out joints to wall

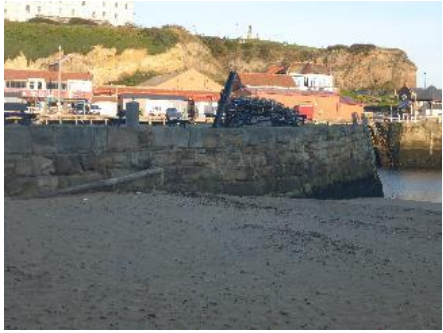
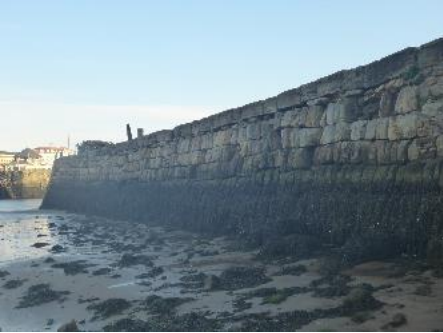
SBC Reference:	N/A		
NFCDD reference:	1221D901D0803C08

Asset Location:	West bank, Whitby Harbour RNLI Station and Pier.	
	Asset Length:	391.3	
	Condition Assessment		
	Condition	Priority	Risk
	B	3	
	Brief Description		
	Very weathered blocks with gaps on east side of old RNLI pier but overall fair.		
	High levels of abrasion, marine growth and steel sheet pile corrosion to old Boathouse 'block'		
	Coping damage on the slipway but fair overall condition.		
	Walls between piers of mixed construction, fair to poor condition. Missing mortar between blocks and cracked blocks.		
Tate Hill Pier has deep joints and block eroding. Steps weathered with corroding handrail at bottom section. Top revetment in fair condition. Healthy beach sand on north side of pier.			
Recommendations			
Fill voids, cracks and open joints.

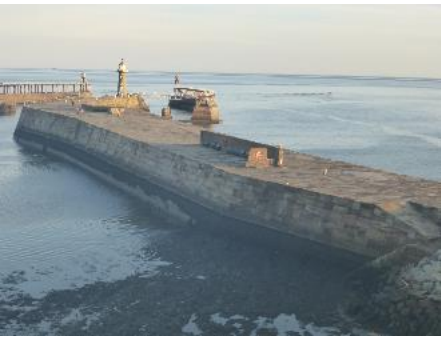
SBC Reference:	N/A		
NFCDD reference:	1221D901D0803C03

Asset Location:	NZ90161146, NZ90001174. East Pier.	
	Asset Length:	637	
	Condition Assessment		
	Condition	Priority	Risk
	A	4	
	Brief Description		
No visible defects following capital works to walls, toe, deck. Signs erected warning users of winds, wave overtopping, trips, edges.			
Recommendations			
Major refurbishment undertaken in 2018/19.

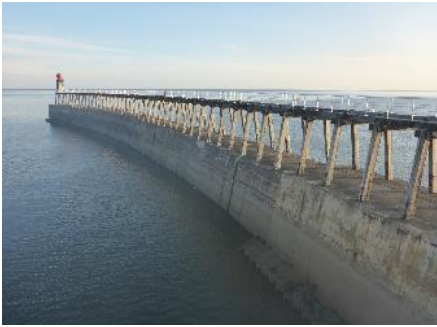
SBC Reference:	N/A		
NFCDD reference:	1221D901D0803C04

Asset Location:	NZ90041172, NZ89971186. East breakwater.	
	Asset Length:	330.9	
	Condition Assessment		
	Condition	Priority	Risk
	B	3	
	Brief Description		
	Access now possible due to replacement bridge erected in 2019.		
	Overall fair condition but limited inspection as toe is covered in water even at low tide.		
	Recommendations		
	Continue to monitor and replace planks in promenade deck as necessary. Detailed low water inspection from vessel recommended every 10 years.

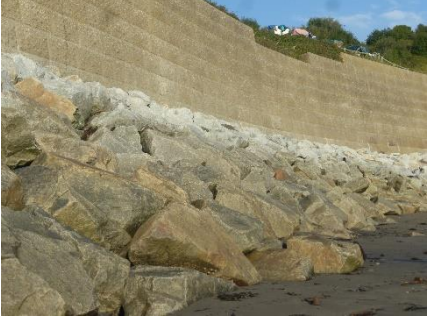
SBC Reference:	33-16A-01
----------------	------------------

Asset Location:	NZ95340504, NZ95270520	
	Asset Length:	183.4

Condition Assessment		
	Condition	Priority	Risk
	B	4	>5
	Brief Description		
	<p>Wall was built in 2001. Rock armour in good condition with good coverage, profile and interlock. Slipway ramp in good condition, some abrasion to slab and joints near toe. Fence / edge protection repaired since previous inspection as indicated above.</p>		
<p>Precast concrete sea wall in good condition. Short section of blocks missing from along the crest of the wall. This is assumed to be a historic defect. There is a small accumulation of material on the revetment crest, this does not appear to have changed since 2018.</p>			
Recommendations			
Continue to monitor.

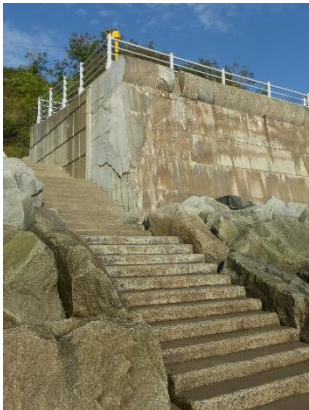
SBC Reference:	36-16B-03		
NFCDD reference:	1221D901D1003C09 ⁰⁰¹

Asset Location:	NZ95320468, NZ95310481	
	Asset Length:	~10	
	Condition Assessment		
	Condition	Priority	Risk
	B	4	5
	Brief Description		
	Steps in good overall condition. No handrail.		
	Recommendations		
Continue to monitor

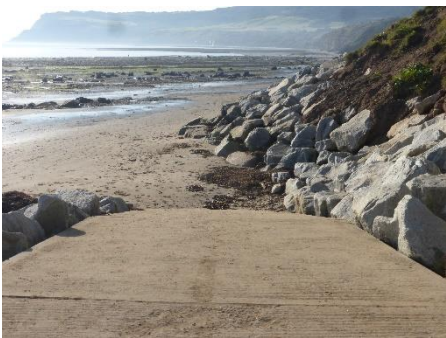
SBC Reference:	37-16C-02		
NFCDD reference:	1221D901D1003C07 001

Asset Location:	NZ95320468, NZ95310481	
	Asset Length:	~20	
	Condition Assessment		
	Condition	Priority	Risk
	B	4	>5
	Brief Description		
	Slipway in good condition.		
Recommendations			
Continue to monitor

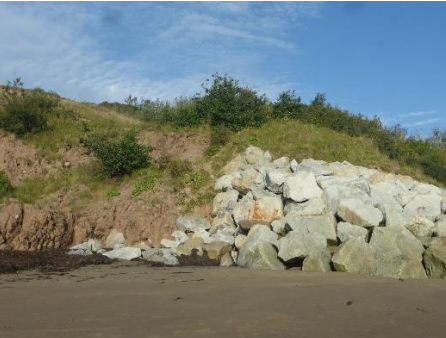
SBC Reference:	37-16C-03		
NFCDD reference:	1221D901D1003C07

Asset Location:	NZ95320468, NZ95310481	
	Asset Length:	54.3	
	Condition Assessment		
	Condition	Priority	Risk
	C	2	High
	Brief Description		
	Rock armour mostly well packed, but cliffs slumping from rear over top of revetment continues to damage and displace rock, particular just South of slipway / ramp and at the southern end of revetment (see photo).		
Recommendations			
Continue to monitor rock armour and cliff. Considerations should be made for the revetment to be realigned when the cliff has retreated sufficiently.

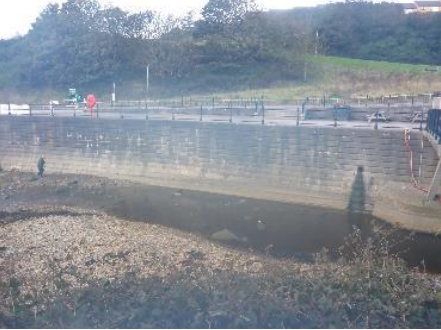
SBC Reference:	39-20A-01		
NFCDD reference:	1221D901D1201C01

Asset Location:	TA03569082, TA03569085 North of the Sea Life Centre.	
	Asset Length:	37.4	
	Condition Assessment		
	Condition	Priority	Risk
	B	4	>5
	Brief Description		
	Promenade in good condition. Wall in fair condition. No change identified in 2020.		
	Recommendations		
	Continue to monitor

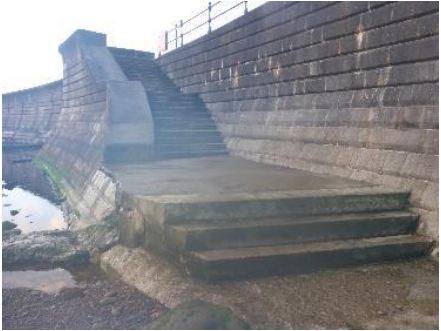
SBC Reference:	39-20A-01		
NFCDD reference:	1221D901D1201C02001

Asset Location:	TA03549057, TA03569082 next to Sea Life Centre.	
	Asset Length:	~10	
	Condition Assessment		
	Condition	Priority	Risk
	B	4	>5
	Brief Description		
	Steps. Localised concrete abrasion with chipped tread but overall remains in fair condition in 2020.		
	Recommendations		
	Continue to monitor.

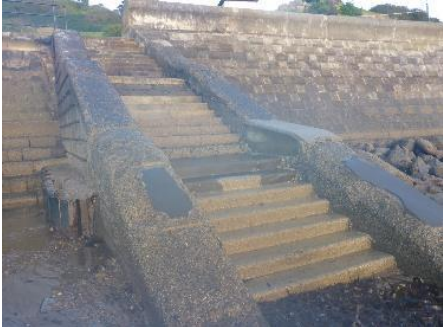
SBC Reference:	40-20A-01		
NFCDD reference:	1221D901D1201C02004

Asset Location:		
	Asset Length:	~5	
	Condition Assessment		
	Condition	Priority	Risk
	C	3	
	Brief Description		
	2016: Partly rebuilt steps. 2018: Steps themselves generally in fair condition though cracks remain through older steps. Abrasion to capping and side walls with cracks through side walls between various repairs. Piles at toe of side walls severely corroded with water seeping out at low tide. 2020: No significant change. Remain in poor condition.		
	Recommendations		
	Continue to monitor. Repair cracks and pile toes.

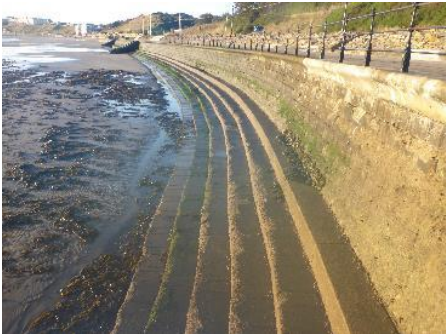
SBC Reference:	40-20A-02		
NFCDD reference:	1221D901D1201C03

Asset Location:	TA03589031, South of Sea Life Centre.	
	Asset Length:	120.6	
	Condition Assessment		
	Condition	Priority	Risk
	C	2	
	Brief Description		
	Abrasion of external blockwork throughout sea wall, particularly to the north of the asset where reinforcement is exposed. Stepped concrete toe is heavily abraded. Corroded handrails. As reported in 2018, there is cracking and spalling to prom slabs and some missing sealant between slabs. Sections of rear splash wall and revetment have been repaired since previous inspection.		
	Recommendations		
Undertake repairs to northern extents of seawall face where reinforcement is exposed.

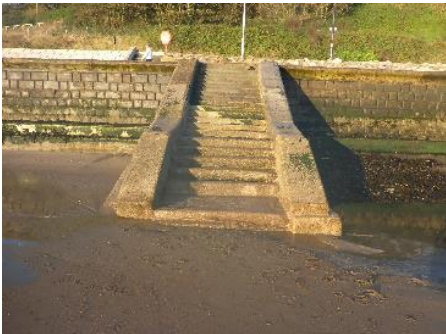
SBC Reference:	40-20A-03		
NFCDD reference:	1221D901D1201C03 ⁰⁰¹

Asset Location:	TA03589031, South of Sea Life Centre.	
	Asset Length:	~5	
	Condition Assessment		
	Condition	Priority	Risk
	B	4	
	Brief Description		
	As reported in 2018, the capping to north and south abutment walls have both been repaired. The capping to the lower half (that was not repaired) is showing signs of abrasion. Treads in fair condition although some rounding has occurred. Beach levels lower in 2020 exposing final tread of steps.		
	Recommendations		
Continue to monitor

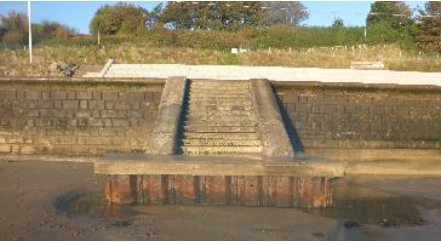
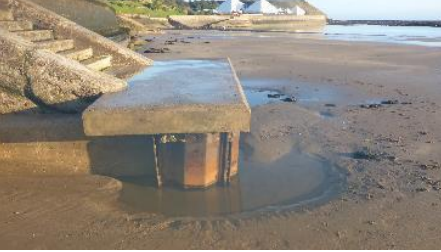
SBC Reference:	40-20A-05		
NFCDD reference:	1221D901D1201C24001

Asset Location:		
	Asset Length:	~5	
	Condition Assessment		
	Condition	Priority	Risk
	B	3	
	Brief Description		
	Beach levels locally approx. 500mm lower than previous inspection. Sheet piles heads. Side sheet piles appeared to be leaning seaward suggesting possible lateral movement - this should be monitored. Step abutments heavily abraded.		
	Recommendations		
Continue to monitor

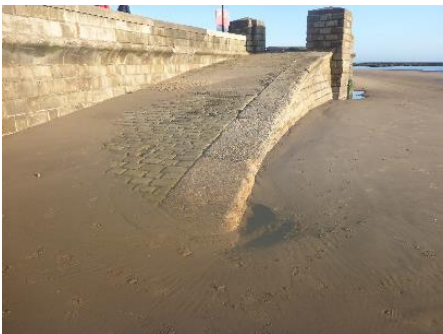
SBC Reference:	41-20A-03		
NFCDD reference:	1221D901D1201C10001

Asset Location:	TA03599020, TA03589031	
	Asset Length:	~4	
	Condition Assessment		
	Condition	Priority	Risk
	B	3	
	Brief Description		
	Slipway - No significant change observed in 2020. As reported previously joints to block paving missing Capping beam to side wall abraded and chipped		
	Recommendations		
Replace joints. Continue to monitor.

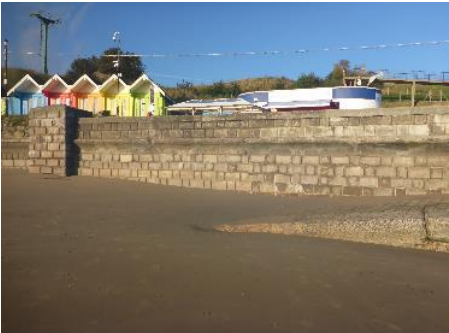
SBC Reference:	41-20A-04		
NFCDD reference:	1221D901D1201C10

Asset Location:	TA03599020, TA03589031	
	Asset Length:	13	
	Condition Assessment		
	Condition	Priority	Risk
	B	3	
	Brief Description		
	No significant change observed in 2020. As reported previously few cracks appear on capping beam, adjacent to N ramp to prom. Damage to recurve splash wall. Promenade in good condition.		
	Recommendations		
Repoint missing mortar to sea wall.

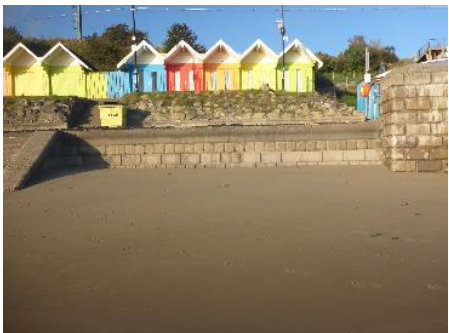
SBC Reference:	42-20A-02		
NFCDD reference:	1221D901D1201C26

Asset Location:	TA03758981, TA03599020	
	Asset Length:	13.7	
	Condition Assessment		
	Condition	Priority	Risk
	B	4	5
	Brief Description		
	Unchanged. Spalling in poured concrete capping to wall. Promenade in this section largely covered in debris deposited by tide, but no evidence to suggest any significant change. Toe not visible due to beach level.		
	Recommendations		
Continue to monitor and maintain.

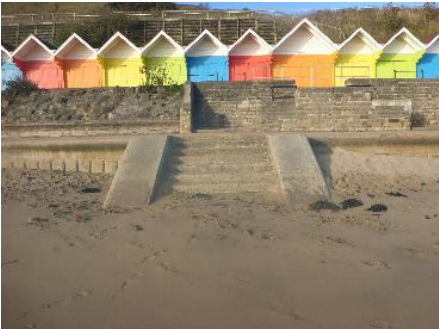
SBC Reference:	42-20A-05		
NFCDD reference:	1221D901D1201C11001

Asset Location:	TA03758981, TA03599020	
	Asset Length:	~3	
	Condition Assessment		
	Condition	Priority	Risk
	B	4	5
	Brief Description		
	New abutments constructed in 2015 remain in good condition. Minor damage to steps including rounding and chipping of treads. Beach levels significantly higher concealing lower steps.		
	Recommendations		
Continue to monitor.

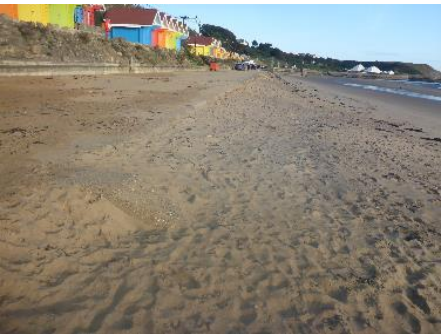
SBC Reference:	42-20A-08		
NFCDD reference:	1221D901D1201C13

Asset Location:	TA03758981, TA03599020	
	Asset Length:	58.2	
	Condition Assessment		
	Condition	Priority	Risk
	B	4	>5
	Brief Description		
	Beach levels very high during the inspections, coming to the crest of the wall. Some spalling to joints between sections of capping, erosion to capping exposing aggregate. Some abrasion to blockwork was reported in 2018. Mature vegetation in revetment.		
	Recommendations		
Repair cracks to capping and inspect when toe visible. Remove mature vegetation from revetment.

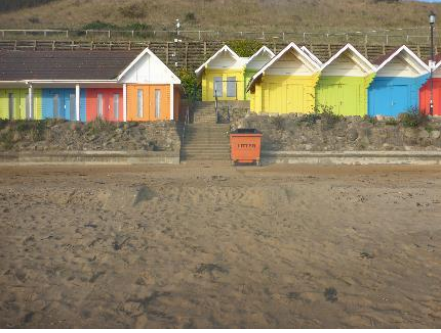
SBC Reference:	42-20A-09		
NFCDD reference:	1221D901D1201C13001

Asset Location:	TA03758981, TA03599020	
	Asset Length:	~3	
	Condition Assessment		
	Condition	Priority	Risk
	B	4	>5
	Brief Description		
	Beach levels very high during the inspections, almost completely burying the steps. Abrasion visible to abutment. 2018 Inspection reported steps rounded but in fair condition. Both abutments in fair condition.		
	Recommendations		
Continue to monitor

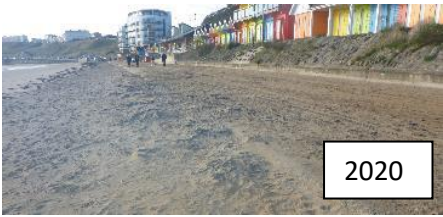
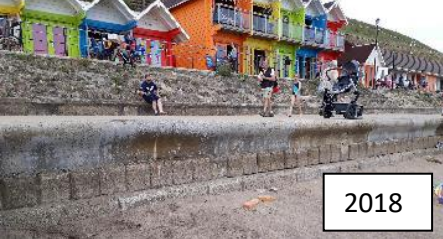
SBC Reference:	42-20A-10		
NFCDD reference:	1221D901D1201C14

Asset Location:	TA03758981, TA03599020	
	Asset Length:	58.4	
	Condition Assessment		
	Condition	Priority	Risk
	B	4	5
	Brief Description		
	Beach levels very high during the inspections, almost overtopping crest. Previous inspections have noted cracks to capping with some erosion exposing aggregate in places, some capping slabs repaired, but remaining showing signs of damage. Rear revetment fair condition with recent repairs – although mature vegetation growth noted in crest.		
	Recommendations		
Monitor and repair spalling to wall capping.

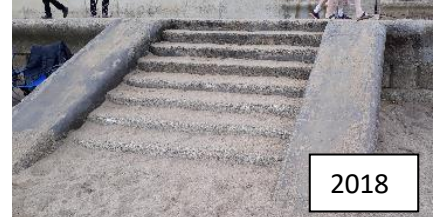
SBC Reference:	42-20A-11		
NFCDD reference:	1221D901D1201C14001

Asset Location:	TA03758981, TA03599020	
	Asset Length:	~3	
	Condition Assessment		
	Condition	Priority	Risk
	B	4	>5
	Brief Description		
	Beach levels very high during the inspections, coming to the crest of the wall. Previous inspections have noted Rounded and chipped steps but fair condition. Abutments walls in good condition		
	Recommendations		
Continue to monitor.

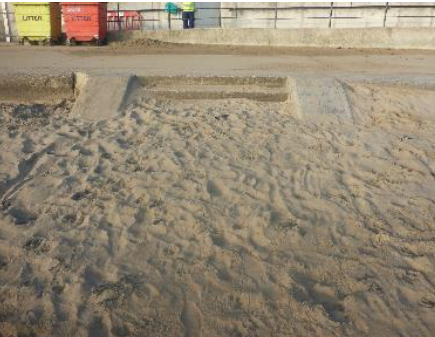
SBC Reference:	42-20A-13		
NFCDD reference:	1221D901D1201C15001

Asset Location:	TA03758981, TA03599020	
	Asset Length:	~3	
	Condition Assessment		
	Condition	Priority	Risk
	B	3	
	Brief Description		
	Beach levels very high during the inspections, coming to the crest of the wall. Previous inspection noted fair condition overall. Rounded steps. Abutment walls built in 2015. Spalling to southern abutment wall at joint with capping again noted in 2020.		
	Recommendations		
Repair southern abutment wall. Continue to monitor

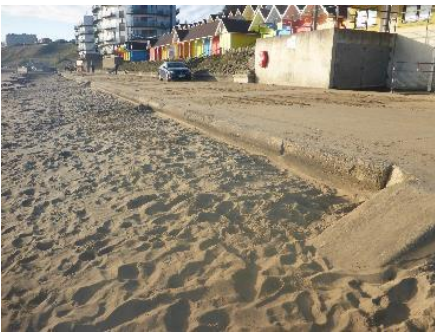
SBC Reference:	42-20A-14		
NFCDD reference:	1221D901D1201C16

Asset Location:	TA03758981, TA03599020. In front of Beach Management Centre.	
	Asset Length:	32	
	Condition Assessment		
	Condition	Priority	Risk
	B	4	5
	Brief Description		
	Beach levels very high during the 2020 inspection, coming to the crest of the wall. Promenade in good condition. Some cracks to capping. It was previously reported that there is missing mortar to blockwork.		
Recommendations			
Repair cracks to capping and repoint blockwork. Inspect when toe of wall visible.

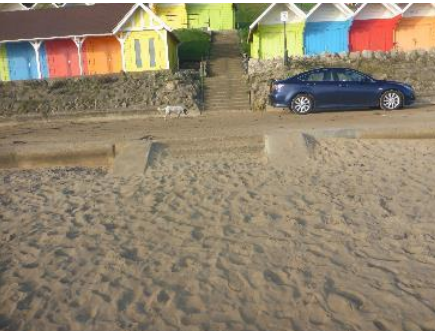
SBC Reference:	42-20A-15		
NFCDD reference:	1221D901D1201C16001

Asset Location:	TA03758981, TA03599020.	
	Asset Length:	~3	
	Condition Assessment		
	Condition	Priority	Risk
	B	4	5
	Brief Description		
	Beach levels very high during the inspections, coming to the crest of the wall. Previous inspection noted treads rounded but in fair condition. Southern abutment spalling at joint with promenade, again noted in 2020.		
Recommendations			
Repair southern abutment. Continue to monitor.

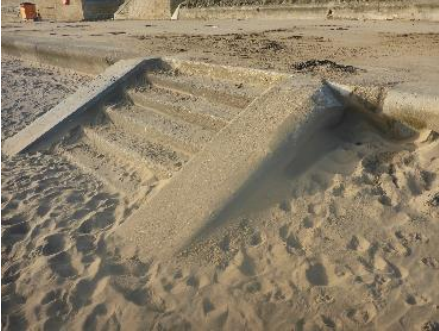
SBC Reference:	42-20A-17		
NFCDD reference:	1221D901D1201C05001

Asset Location:	TA03758981, TA03599020	
	Asset Length:	~3	
	Condition Assessment		
	Condition	Priority	Risk
	A	4	5
	Brief Description		
	Fair condition overall. Some spalling to lower section of northern abutment reported in 2018 but not visible in 2020. Treads rounded. Damaged abutment at joint on northern side.		
	Recommendations		
Repair northern abutment. Continue to monitor

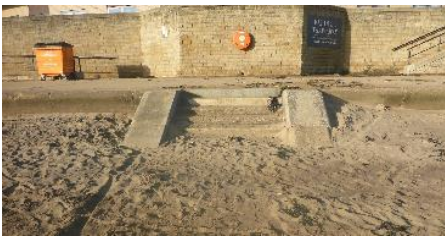
SBC Reference:	42-20A-19		
NFCDD reference:	1221D901D1201C17001

Asset Location:		
	Asset Length:	~3	
	Condition Assessment		
	Condition	Priority	Risk
	B	4	5
	Brief Description		
	Unchanged since 2018. Steps: Fair overall condition Penultimate step replaced from the top in 2015. Upper part of abutments appears to have previous repairs. Unable to inspect lower part fully due to beach levels but showing signs of abrasion on southern abutment.		
	Recommendations		
	Continue to monitor.

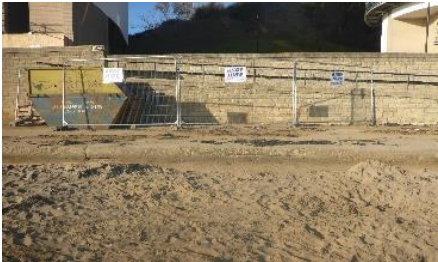
SBC Reference:	42-20A-20		
NFCDD reference:	1221D901D1201C18

Asset Location:	In front of new apartments.	
	Asset Length:	43	
	Condition Assessment		
	Condition	Priority	Risk
	B	4	5
	Brief Description		
	Cracking and spalling to wall capping has deteriorated since 2018. Beach level covering most of wall. Promenade in good condition.		
	Recommendations		
	Repair/replace damaged capping/coping beams.

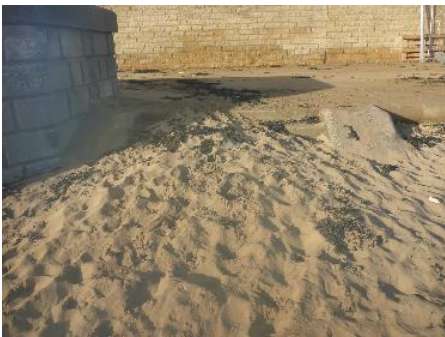
SBC Reference:	42-20A-21		
NFCDD reference:	1221D901D1201C18001

Asset Location:		
	Asset Length:	~3	
	Condition Assessment		
	Condition	Priority	Risk
	B	4	5
	Brief Description		
	Beach levels very high during the inspections, coming to the crest of the wall. Previous inspection reported steps in Fair condition .		
	Recommendations		
	Continue to monitor.

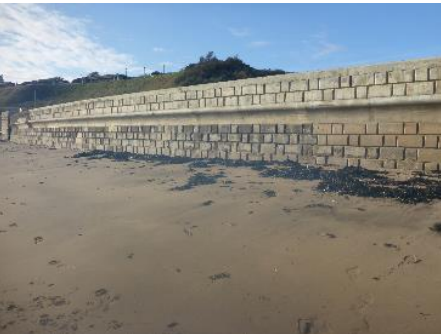
SBC Reference:	43-20B-03		
NFCDD reference:	1221D901D1201C19

Asset Location:	TA03818971, TA03758981. In front of new development.	
	Asset Length:	93.2	
	Condition Assessment		
	Condition	Priority	Risk
	B	3	
	Brief Description		
	Unchanged since 2018. Higher beach level concealed much of the toe. Upper wall has been rebuilt at North end. Some missing joints and chipping of capping beam and splash beam.		
	Recommendations		
Repair missing joints and chipped parts of capping and splash beams.

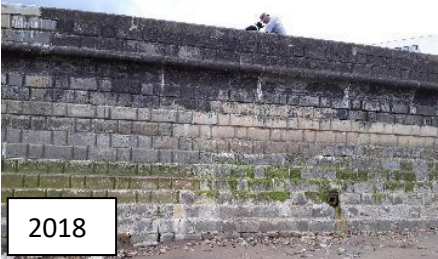
<p>2020</p>	Asset Location:	TA03818971, TA03758981. In front of new development.	
	Asset Length:	~10

<p>2018</p>	Condition Assessment		
	Condition	Priority	Risk
	B	3	
	Brief Description		
	Beach levels approx. 1.5m higher than 2018 concealing toe and outlets. Previously reported that missing mortar between blockwork at toe Broken edge to construction joints. Missing sealant. Overall Fair condition. Cracks in upper wall.		
	Recommendations		
	Replace sealant in joints and mortar between blockwork. Repair cracks in upper wall. Continue to monitor.

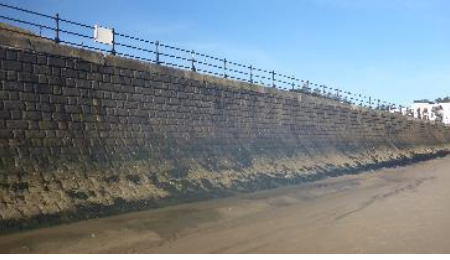
SBC Reference:	44-20B-02		
NFCDD reference:	1221D901D1201C07

Asset Location:	TA03818971, TA04078946 east of Alexandra Gardens.	
	Asset Length:	158.9	
	Condition Assessment		
	Condition	Priority	Risk
	C	2	
	Brief Description		
	<p>Wall overall appeared in fair condition. Lower course of blockwork abraded. As are section of cope stone. Handrails corroded. As reported in 2018, Leaking evident through previous crack repairs with oily residue, likely from road runoff. Prom re-laid in concrete in 2012 in good cond. Two blocks missing in seawall adjacent to southern access steps exposing reinforcement.</p>		
Recommendations			
Cracks need repointing throughout sea wall. Repair damage to coping and toe. Repair missing blocks.

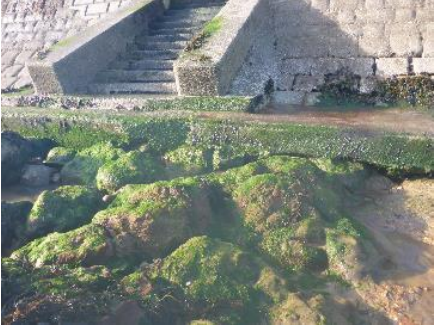
SBC Reference:	44-20B-03		
NFCDD reference:	1221D901D1201C07001

Asset Location:		
	Asset Length:	~7	
	Condition Assessment		
	Condition	Priority	Risk
	B	3	
	Brief Description		
	<p>Lower steps in fair condition with some rounding. Toe visible and now showing some signs of undercutting. Large full height crack from middle platform to prom level. Upper steps (north) in fair condition. Repairs carried out to step treads and abutments. Corroded handrail discontinuous seaward.</p>		
Recommendations			
Treat corroded handrail. Continue to monitor crack and undercutting

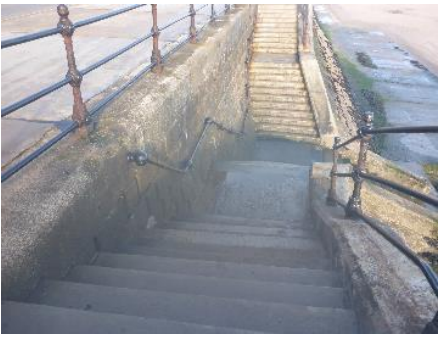
SBC Reference:	44-20B-04		
NFCDD reference:	1221D901D1201C07002

Asset Location:		
	Asset Length:	~7	
	Condition Assessment		
	Condition	Priority	Risk
	B	3	
	Brief Description		
	No significant change to upper steps (south) since 2018. Fair condition. Corroded handrail and discontinuous seaward.		
	Recommendations		
Treat corroded handrail. Continue to monitor

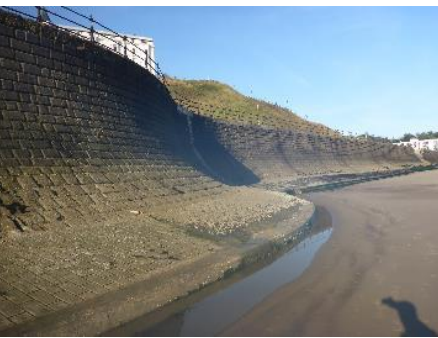
SBC Reference:	44-20B-05		
NFCDD reference:	1221D901D1201C21

Asset Location:	TA03818971, TA04078946 East of Alexandra Gardens.	
	Asset Length:	211.1	
	Condition Assessment		
	Condition	Priority	Risk
	B	3	
	Brief Description		
	No significant change since 2018. Prom surface replaced in 2012 at N and S ends, but centre still to do. Erosion to capping at edge of prom, patch repairs carried out with tarmac.		
	Recommendations		
Continue to monitor.

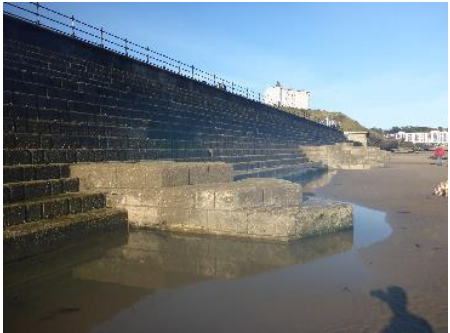
SBC Reference:	45-20B-02		
NFCDD reference:	1221D901D1201C08

Asset Location:	TA04078945, TA04288930	
	Asset Length:	206.9	
	Condition Assessment		
	Condition	Priority	Risk
	B	3	
	Brief Description		
	No significant change since 2018. Some prom slabs have been repaired but significant abrasion to surface of many slabs remains. Repair / replacement work on some of the steps / toe in 2011/2013, but some horizontal cracks in original blocks remain.		
	Recommendations		
	Continue to monitor and repair cracks and resurface rest of prom.

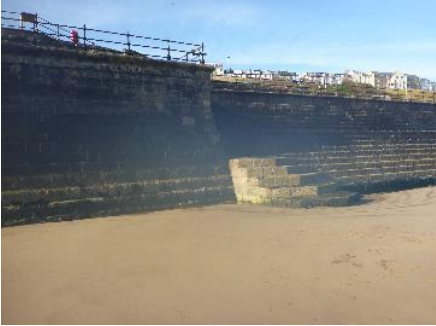
SBC Reference:	45-20B-03		
NFCDD reference:	1221D901D1202C23

Asset Location:	North of Albert Road.	
	Asset Length:	31.5	
	Condition Assessment		
	Condition	Priority	Risk
	C	3	
	Brief Description		
	Fair condition. Missing blockwork at southern end identified in 2018 has been repaired. Lower courses remain heavily abraded. Full height crack through wall at back of prom to south of steps. Cracks through prom slabs and coping to abutments either side of steps.		
	Recommendations		
	Undertake repairs and continue to monitor.

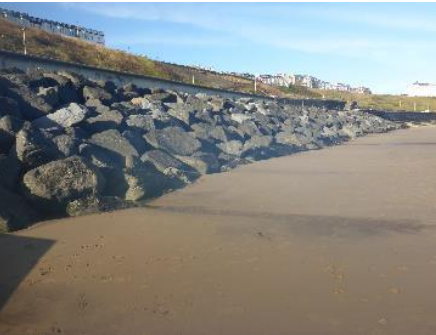
SBC Reference:	46-20B-01		
NFCDD reference:	1221D901D1202C01

Asset Location:	TA04288929, TA0493895. East of Albert Road.	
	Asset Length:	124.8	
	Condition Assessment		
	Condition	Priority	Risk
	B	4	>5
	Brief Description		
	No significant change since 2018. Original wall mostly hidden by rock armour; splash wall seems to be in good condition. Tightly packed rock armour with good coverage. Scour pool at toe of steps makes use at low tide difficult. Missing mortar to wall at rear of prom. Prom slab abraded where not replaced.		
	Recommendations		
	Replace mortar to wall at rear of prom. Continue to monitor. Look to replace remaining sections of prom.

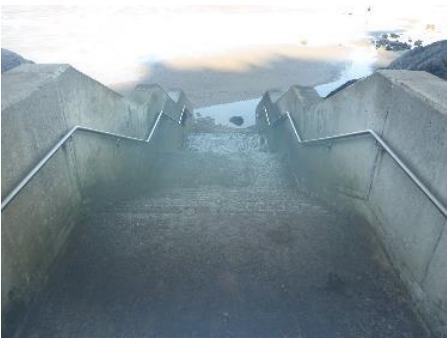
SBC Reference:	46-20B-06		
NFCDD reference:	1221D901D1202C03 001

Asset Location:	Part of 46-20B-04	
	Asset Length:	~4	
	Condition Assessment		
	Condition	Priority	Risk
	A	4	
	Brief Description		
	Steps: Upper flight in good condition throughout. Steps combine with SBC Ref: 46-20B-05 with single flight to beach level. Steps to lower part of flight to each level rounded.		
	Recommendations		
Continue to monitor.

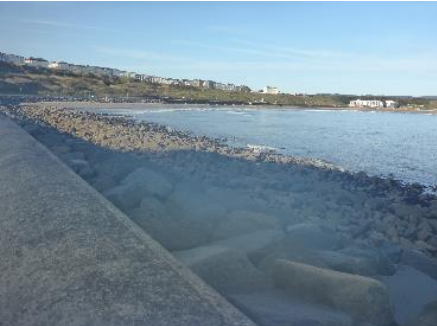
SBC Reference:	46-20B-07		
NFCDD reference:	1221D901D1202C04

Asset Location:		
	Asset Length:	219.9	
	Condition Assessment		
	Condition	Priority	Risk
	B	4	>5
	Brief Description		
	Original wall hidden by armour; splash wall seems to be in good condition. Tightly packed rock armour appears stable, no loose rocks. Toe piling appears to be working well, although could only be inspected from the promenade. Healthy levels of natural rock against piling offering further protection. . Prom good condition.		
	Recommendations		
Continue to monitor.

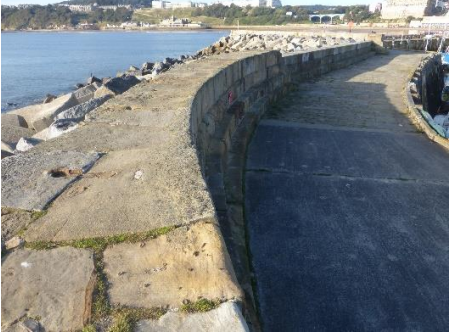
SBC Reference:	N/A		
NFCDD reference:	1221D901D1301C01

Asset Location:	TA04958849, TA05178883 North Harbour Breakwater.	
	Asset Length:	444.9	
	Condition Assessment		
	Condition	Priority	Risk
	B	3	
	Brief Description		
	Crest wall good. Rock armour & accropodes generally in good condition, well packed. Less tightly packed or missing armour units at south end of wall. Several cracked pieces of armour. Evidence of lateral voids at seaward end of breakwater visible during inspection from the beach to the south.		
	Recommendations		
Continue to monitor. Inspection of seaward end of structure required from boat.

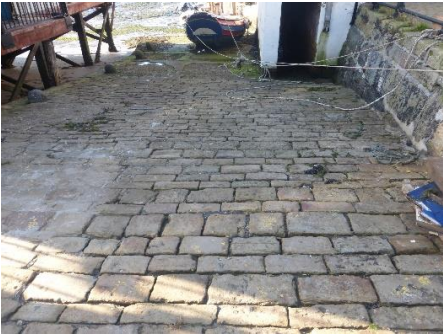
SBC Reference:	N/A		
NFCDD reference:	1221D901D1301C02

Asset Location:	TA05108874, TA05148874. Next to and under fairground.	
	Asset Length:	77.9	
	Condition Assessment		
	Condition	Priority	Risk
	B	3	
	Brief Description		
	Wall unable to be inspected due to fair ground. Render breaking away.		
Recommendations			
Report missing joints to spillway wall and repair slipway surfacing.

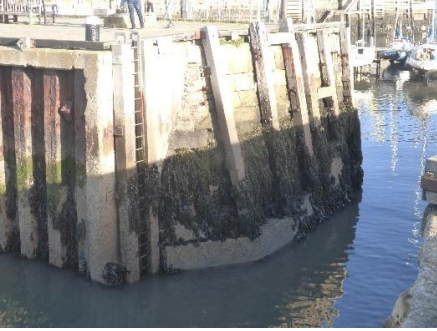
SBC Reference:	N/A		
NFCDD reference:	1221D901D1301C03

Asset Location:	TA04958853, TA04938860. Lighthouse island.	
	Asset Length:	83.5	
	Condition Assessment		
	Condition	Priority	Risk
	C	3	
	Brief Description		
	Inner wall at entrance breakwater. Numerous cracks to blocks and missing mortar in joints. Vegetation and fenders obscuring most of walls. Only inspected from distance.		
Recommendations			
Continue to monitor and repoint cracks and joints.

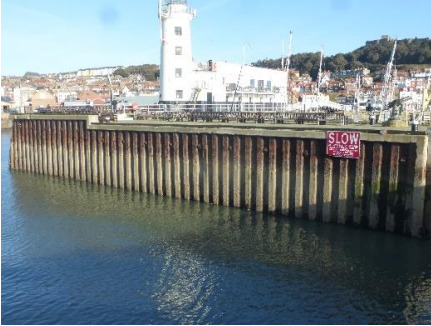
SBC Reference:	N/A		
NFCDD reference:	1221D901D1301C17

Asset Location:	TA04958853, TA04938860. Wall at south side of Lighthouse island	
	Asset Length:	97	
	Condition Assessment		
	Condition	Priority	Risk
	B	3	
	Brief Description		
	Outer face. Sheet piles heavily corroded, although obscured by vegetation growing on the bottom of the piling. Cracks to concrete side wall to steps. Only inspected from distance.		
Recommendations			
Repair cracks. Continue to monitor.

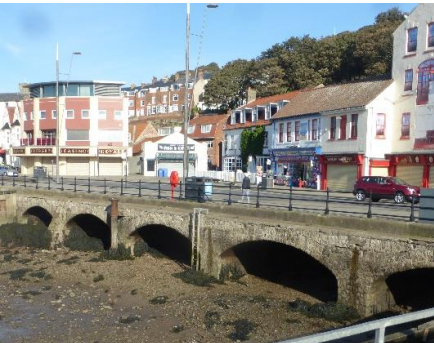
SBC Reference:	N/A		
NFCDD reference:	1221D901D1301C05

Asset Location:	TA05048878, TA05088877. South of roundabout opposite arcade.	
	Asset Length:	43.2	
	Condition Assessment		
	Condition	Priority	Risk
	B	3	
	Brief Description		
	Cracking and missing joints to top of capping, arches look structurally sound. Promenade in good condition.		
Recommendations			
Repair cracks and damage to coping.

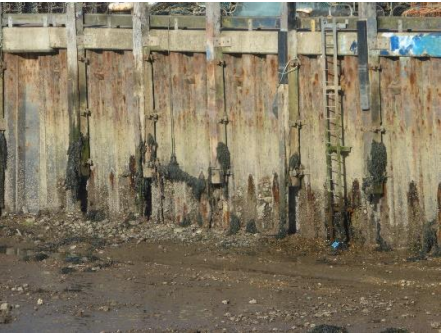
SBC Reference:	N/A		
NFCDD reference:	1221D901D1301C12

Asset Location:	TA04998877, TA05048878. West of masonry arches.	
	Asset Length:	51.7	
	Condition Assessment		
	Condition	Priority	Risk
	C	3	
	Brief Description		
	Corrosion evident sheet piles, especially lower part, but appear fair. Promenade in good condition.		
	Recommendations		
Continue to monitor.

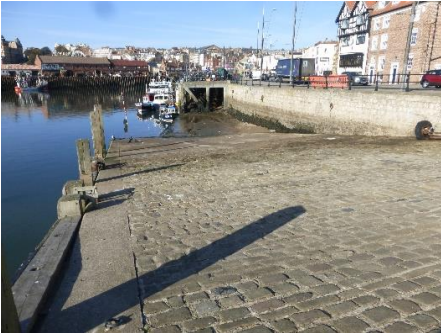
SBC Reference:	N/A		
NFCDD reference:	1221D901D1301C11

Asset Location:	TA04958876, TA04998877, Opposite Subway restaurant.	
	Asset Length:	47	
	Condition Assessment		
	Condition	Priority	Risk
	B	3	
	Brief Description		
	Few minor cracks to wall, spalling to capping. Promenade in good condition. Upper wall good. Slipway fair. Concrete piles at lower wall appear to have rotated in past but appear to be stable. Cracks to lower slabs in slipway. Damage to handrailing noted during 2020 inspection.		
	Recommendations		
Continue monitoring, repair cracks/joints. Repair damaged section of handrailing.

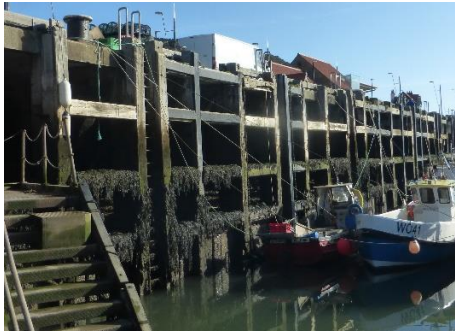
SBC Reference:	N/A		
NFCDD reference:	1221D901D1301C06

Asset Location:	TA04768876, TA04958876. Opposite Information centre.	
	Asset Length:	195.8	
	Condition Assessment		
	Condition	Priority	Risk
	B	3	
	Brief Description		
	Back wall difficult to view, appears to be fair, where visible, some cracks and missing joints in places. Suspended quay appears to be fair condition, some cracks in protective coating. Promenade good. Timber edging rail decaying.		
	Recommendations		
Monitor cracks to wall.

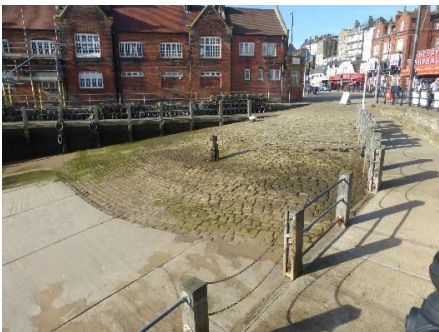
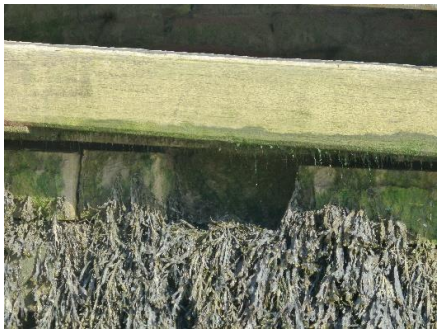
SBC Reference:	N/A		
NFCDD reference:	1221D901D1301C14

Asset Location:	TA04758875, TA04768876. West of Information centre.	
	Asset Length:	19.5	
	Condition Assessment		
	Condition	Priority	Risk
	B	3	
	Brief Description		
	Fair overall, only minor gaps. Damaged section of blockwork wall beneath coping stone on low northern tie in wall.		
	Recommendations		
Continue active monitoring. Repoint missing joints and damaged section of blockwork wall.

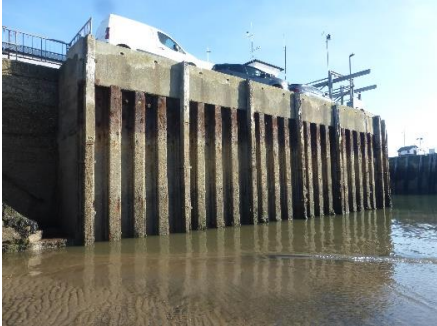
SBC Reference:	N/A		
NFCDD reference:	1221D901D1301C18

Asset Location:	West Pier, Scarborough South Bay.	
	Asset Length:	115.6	
	Condition Assessment		
	Condition	Priority	Risk
	C	2	
	Brief Description		
	Section remains in poor condition. Heavily corroded piles throughout. Cracking evident in coping beam.		
	Recommendations		
Continue to monitor. Inspect piles, repair cracks.

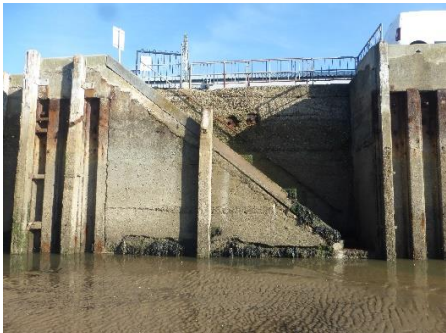
SBC Reference:	49-21B-05		
NFCDD reference:	1221D901D1301C18 001

Asset Location:	West Pier, Scarborough South Bay.	
	Asset Length:	~5	
	Condition Assessment		
	Condition	Priority	Risk
	C	2	
	Brief Description		
	Cracking and missing render at steps. Treads in good condition. Back wall heavily abraded with exposed aggregates and missing capping block in places. Heavily corroded handrail. Large crack above toe of side wall on seaward side.		
	Recommendations		
Treat or replace handrail. Replace missing capping block and concrete skim the back wall. Repair cracks in seaward wall.

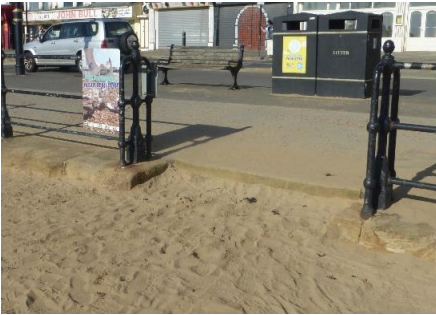
SBC Reference:	51-22A-03		
NFCDD reference:	1221D901D1301C15001

Asset Location:	TA04538856, TA04698873	
	Asset Length:	~3	
	Condition Assessment		
	Condition	Priority	Risk
	B	4	5
	Brief Description		
	Fair condition overall. Chipped concrete steps. High beach levels covered the full set of steps.		
	Recommendations		
Continue to monitor.

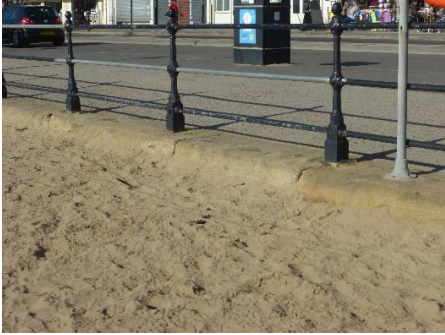
SBC Reference:	51-22A-04		
NFCDD reference:	1221D901D1301C21

Asset Location:	TA04538856, TA04698873	
	Asset Length:	57.8	
	Condition Assessment		
	Condition	Priority	Risk
	B	3	
	Brief Description		
	Only the coping stone and occasionally the top course of blockwork was visible during the 2020 inspection. What was visible was in fair condition with some joints missing mortar and some spalling around the base of the iron fence posts.		
	Recommendations		
Repoint when necessary.

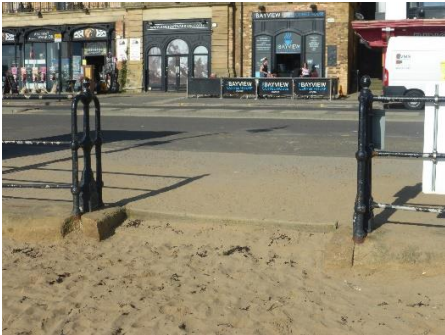
SBC Reference:	51-22A-05		
NFCDD reference:	1221D901D1301C21001

Asset Location:	TA04538856, TA04698873	
	Asset Length:	~3	
	Condition Assessment		
	Condition	Priority	Risk
	B	4	5
	Brief Description		
	Fair condition overall. High beach levels mean steps now visible.		
	Recommendations		
Continue to monitor

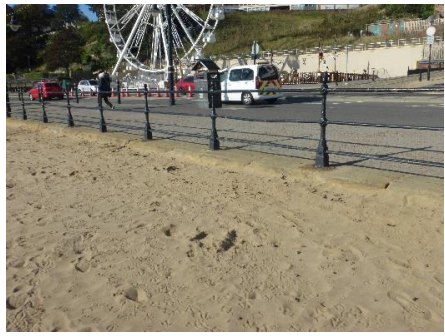
SBC Reference:	51-22A-06		
NFCDD reference:	1221D901D1301C22

Asset Location:	TA04538856, TA04698873	
	Asset Length:	114.9	
	Condition Assessment		
	Condition	Priority	Risk
	B	3	
	Brief Description		
	Limited height of wall visible due to beach level.		
	Recommendations		
Repair handrails. Repoint blocks.

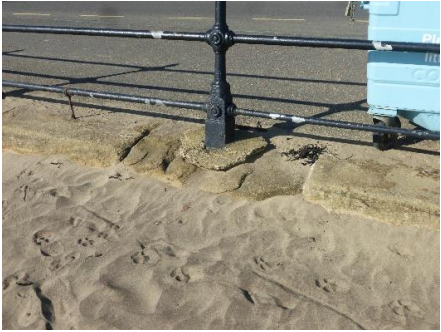
SBC Reference:	51-22A-08		
NFCDD reference:	1221D901D1301C23

Asset Location:	TA04538856, TA04698873	
	Asset Length:	101.8	
	Condition Assessment		
	Condition	Priority	Risk
	B	3	
	Brief Description		
	Only upper wall inspected due to beach level. Wall appears in fair to good condition although missing joints in places with some failing repairs around bases of railing posts.		
	Recommendations		
Repoint as required. Ensure historic repairs to posts are still effective.

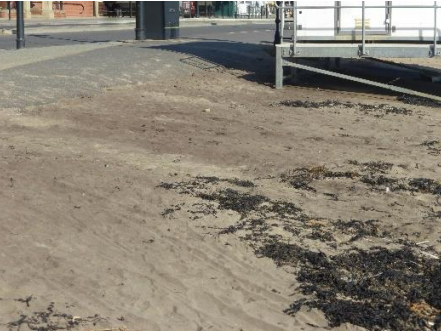
SBC Reference:	51-22A-09		
NFCDD reference:	1221D901D1301C23 001

Asset Location:	TA04538856, TA04698873	
	Asset Length:	~10	
	Condition Assessment		
	Condition	Priority	Risk
	B	4	5
	Brief Description		
	Partly covered by sand and by the lifeguard station. Section visible in fair condition, some missing mortar between blocks.		
	Recommendations		
Repoint as required and continue to monitor.

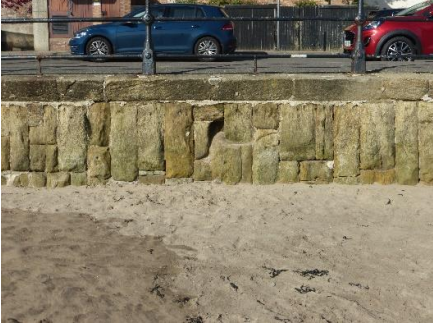
SBC Reference:	51-22A-10		
NFCDD reference:	1221D901D1301C24

Asset Location:	TA04538856, TA04698873	
	Asset Length:	109.7	
	Condition Assessment		
	Condition	Priority	Risk
	B	3	
	Brief Description		
	Some missing mortar between blocks, cracks, missing blocks and previous repairs. Promenade good.		
	Recommendations		
	Monitor, replace blocks, seal cracks and repoint when

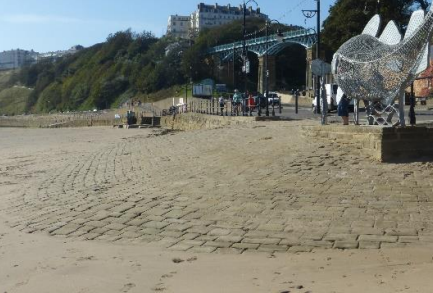
SBC Reference:	51-22A-11		
NFCDD reference:	1221D901D1301C24 ⁰⁰¹

Asset Location:		
	Asset Length:	~10	
	Condition Assessment		
	Condition	Priority	Risk
	B	3	
	Brief Description		
	Slipway. Missing mortar in gaps between blocks.		
	Recommendations		
	Fill gaps between blocks. Continue to monitor.

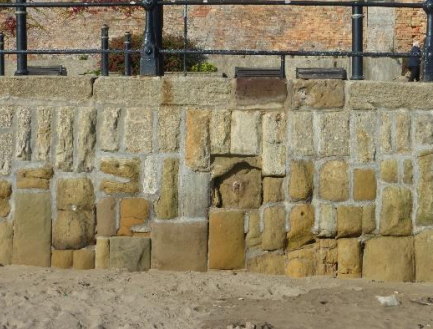
SBC Reference:	51-22A-12		
NFCDD reference:	1221D901D1301C25

Asset Location:	TA04538856, TA04698873. In front of Hotel.	
	Asset Length:	99.1	
	Condition Assessment		
	Condition	Priority	Risk
	B	2	
	Brief Description		
	Missing mortar in joints in places and signs of abrasion. Repairs suggested.		
	Recommendations		
	Continue to monitor and repair joints, inspect at low beach level.

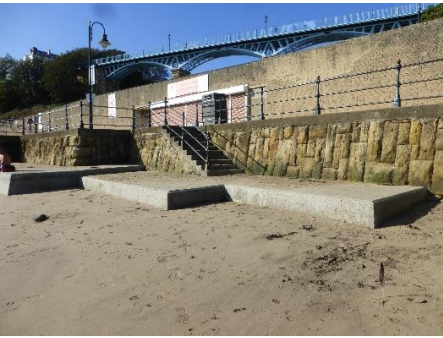
SBC Reference:	52-22A-01		
NFCDD reference:	1221D901D1301C09 001

Asset Location:		
	Asset Length:	~4	
	Condition Assessment		
	Condition	Priority	Risk
	B	4	5
	Brief Description		
	Steps in fair condition. New concrete apron in good condition.		
	Recommendations		
Continue to monitor.

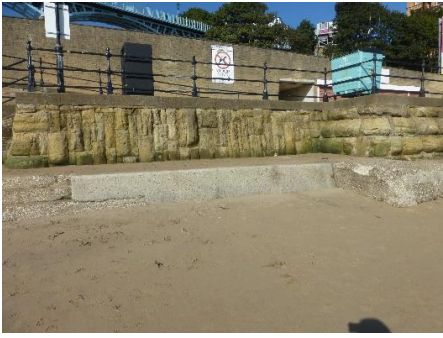
SBC Reference:	52-22A-02		
NFCDD reference:	1221D901D1301C09

Asset Location:	TA04428822, TA04438827. Wall at underground tunnel entrance.	
	Asset Length:	41.5	
	Condition Assessment		
	Condition	Priority	Risk
	B	3	
	Brief Description		
	Toe apron has been repaired / overlaid repairs in good condition. Elsewhere, localised missing mortar in joints to wall, signs of abrasion and cracking & abrasion to unrepaired sections of original apron. Several full height vertical cracks to upper road wall. Promenade in good condition.		
	Recommendations		
Continue to monitor and repair joints and cracks.

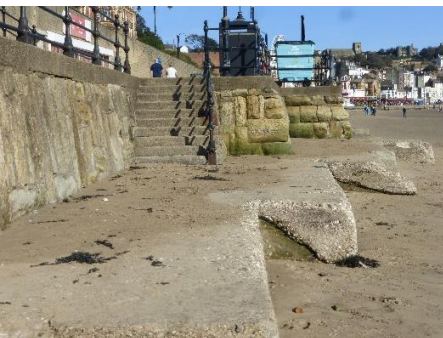
SBC Reference:	52-22A-03		
NFCDD reference:	1221D901D1301C09 002

Asset Location:		
	Asset Length:	~4	
	Condition Assessment		
	Condition	Priority	Risk
	B	4	5
	Brief Description		
	Fair condition overall, lower steps and apron visible due to lower beach level. Apron generally in fair condition.		
	Recommendations		
Continue to monitor.

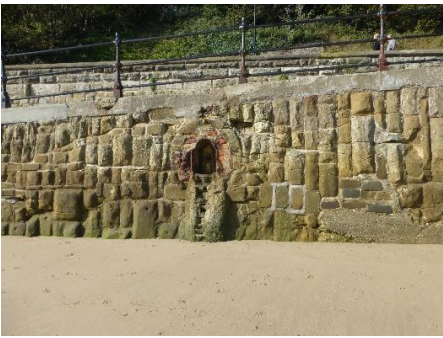
SBC Reference:	52-22A-04		
NFCDD reference:	1221D901D1301C10

Asset Location:	TA04508772, TA04428822. North of slipway.	
	Asset Length:	100.7	
	Condition Assessment		
	Condition	Priority	Risk
	C	1	
	Brief Description		
	Missing mortar joints to wall, occasional cracked blockwork and missing blocks to lower part of wall, vegetation near slipway. Cracking in upper retaining wall between prom and slipway. Recent repairs to slipway toe and sections of replaced mortar are holding. A large number of defects remain including missing blocks which require filling, particularly around Spa feature and longitudinal cracks.		
	Recommendations		
Continue to monitor, repair cracks, replace blocks and joints.

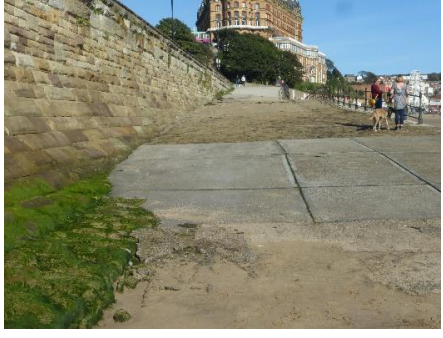
SBC Reference:	53-22B-01		
NFCDD reference:	1221D901D1301C10 001

Asset Location:	South of 52-22A-04	
	Asset Length:	~12	
	Condition Assessment		
	Condition	Priority	Risk
	B	3	
	Brief Description		
	Repairs to slipway toe holding. Mixed revetment construction testimony of previous repairs undertaken.		
	Recommendations		
Continue monitoring, repair joints as required.

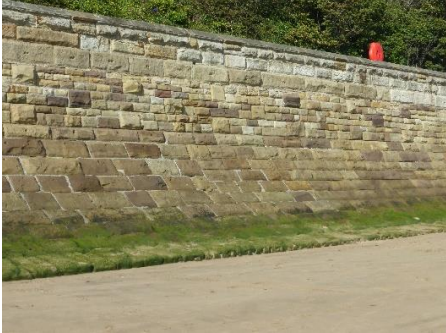
SBC Reference:	53-22B-02		
NFCDD reference:	1221D901D1301C26

Asset Location:	TA04508772, TA04428822. South of slipway.	
	Asset Length:	162.1	
	Condition Assessment		
	Condition	Priority	Risk
	B	3	
	Brief Description		
	Wall in fair condition. Some cracked blocks but seem stable. Missing mortar / open joints here and there. Crest wall repairs evident with some sections of coping repaired but others abraded.		
	Recommendations		
Grout joints. Continue to monitor.

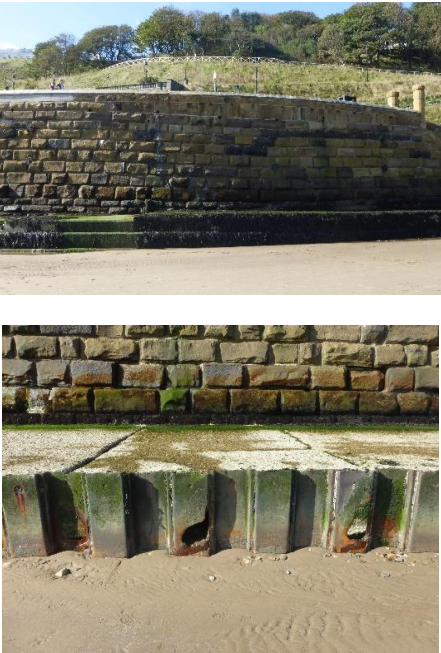
SBC Reference:	53-22B-05		
NFCDD reference:	1221D901D1301C27

Asset Location:	TA04508772, TA04428822. North of The Spa.	
	Asset Length:	158.1	
	Condition Assessment		
	Condition	Priority	Risk
	B	2	
	Brief Description		
	Multiple repairs. Repaired section of crest wall rebuilt after Dec 13 storm, in fair condition. Wall remains in poor condition elsewhere. Many cracks, open joints and displaced blocks in main wall. New toe constructed to northern section of wall June-August 2018 remains in good condition.		
	Sheetpiles at edge of toe constructed previously severely corroded with holes in places with evidencing of voids beneath concrete toe.		
	Recommendations		
	Repair cracks, joints and sheetpile toe.

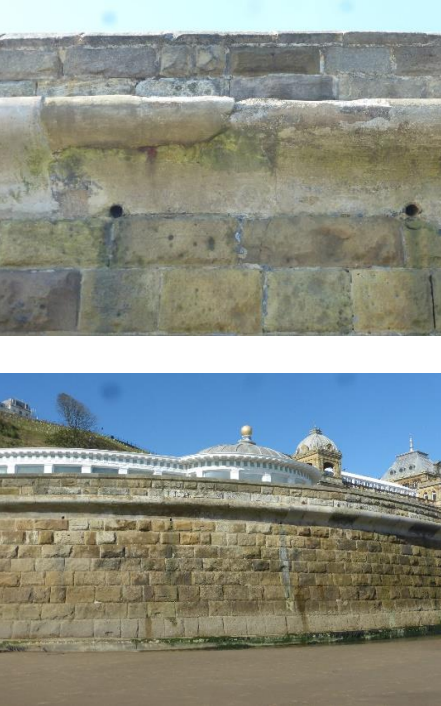
SBC Reference:	53-22B-06		
NFCDD reference:	1221D901D1301C28

Asset Location:	TA04508772, TA04428822 Opposite The Spa	
	Asset Length:	76.4	
	Condition Assessment		
	Condition	Priority	Risk
	B	3	
	Brief Description		
	Repairs undertaken in 2017 to install new concrete toe. Concrete toe only partially visible, appears in fair condition. Bullnose wave return feature is heavily abraded and cracked in places. Some recent repairs to the feature appear to be in fair condition.		
	Recommendations		
	Continue to monitor, repoint as necessary, repair damaged section of bullnose.

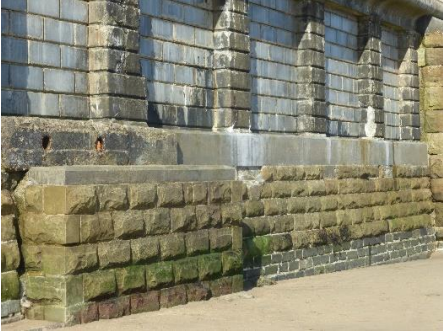
SBC Reference:	53-22B-07		
NFCDD reference:	1221D901D1301C29

Asset Location:	TA04508772, TA04428822. South of The Spa.	
	Asset Length:	57.4	
	Condition Assessment		
	Condition	Priority	Risk
	C	2	
	Brief Description		
	Open joints in main wall. Repairs to lower splash beam in good condition. Beach levels generally higher than in 2018 burying undercutting to stepped out section of wall. Promenade in good condition.		
	Recommendations		
	Continue to repair joints and monitor.
