Asset Inspection Document

Walk-over Visual Inspections of Assets

Scarborough Borough Council

NOVEMBER 2020

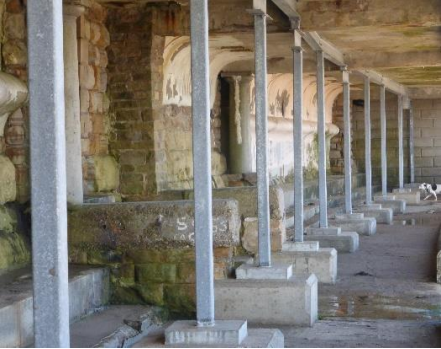
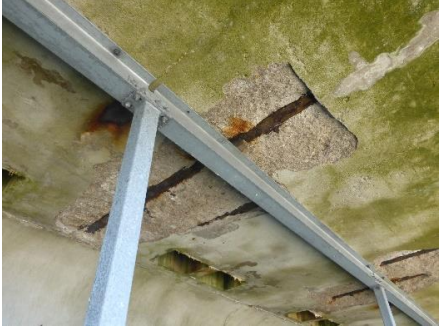
SBC Reference:	54-22B-01		
NFCDD reference:	1221D901D1302C01

Asset Location:	TA04538765, TA04508772. Next to cliff railway.	
	Asset Length:	77.5	
	Condition Assessment		
	Condition	Priority	Risk
	C	2	
	Brief Description		
	<p>Lower wall has repairs to 2 large areas which remain in good condition. A framework of steel supports and horizontal I-section support beam beneath upper prom has been constructed and appears in good condition. The condition of the promenade remains unchanged in a poor state of repair. There are numerous cracks and extensive corrosion/rust staining to beams supporting upper prom near stairs. Cracking & rust staining to cols. Major weathering loss of stone blocks in rear splash wall.</p>		
	Recommendations		
<p>Monitor steel support structure. Capitol scheme to improve long term resilience of the asset.</p>

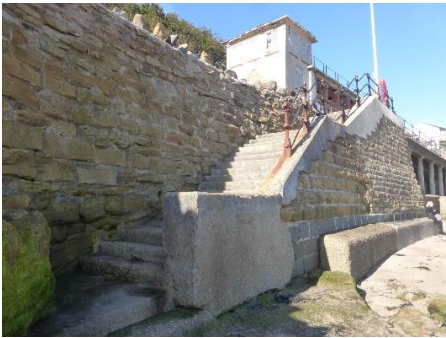
SBC Reference:	54-22B-02		
NFCDD reference:	1221D901D1302C01002

Asset Location:		
	Asset Length:	~4	
	Condition Assessment		
	Condition	Priority	Risk
	C	2	
	Brief Description		
	Steps worn out. Cracks visible across a number of steps. Some have already been repaired. Corroded handrail.		
	Recommendations		
Repair steps. Treat handrail. Continue to monitor.

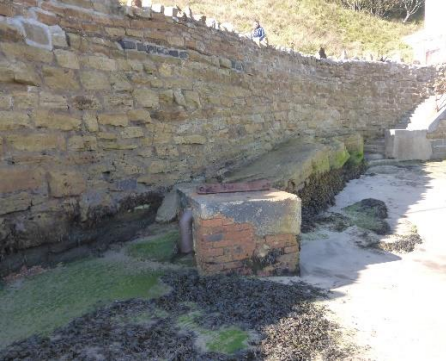
SBC Reference:	54-22B-03		
NFCDD reference:	1221D901D1302C03

Asset Location:	TA04628752, TA04538765. South of cliff railway.	
	Asset Length:	19.2	
	Condition Assessment		
	Condition	Priority	Risk
	B	3	
	Brief Description		
	Repairs evident with blocks replaced and joints filled.		
	Recommendations		
Regular repair to joints, particularly on steps.

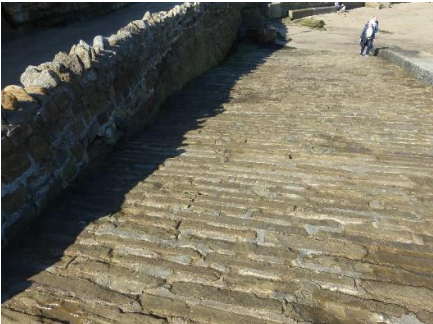
SBC Reference:	56-22B-04		
NFCDD reference:	1221D901D1302C02001

Asset Location:		
	Asset Length:	~10	
	Condition Assessment		
	Condition	Priority	Risk
	B	3	
	Brief Description		
	Slipway in fair overall condition. Uneven cobbles with some missing mortar requiring repointing in places.		
	Recommendations		
Repoint joints. Continue to monitor

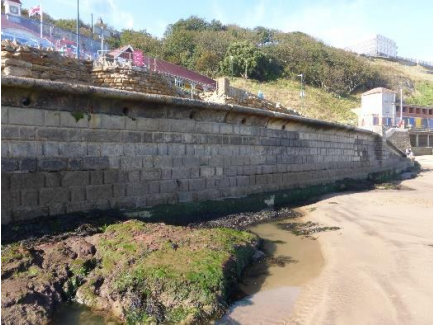
SBC Reference:	55-22B-01		
NFCDD reference:	1221D901D1302C02

Asset Location:	TA04628752, TA04538765. In front of Beach Chalets.	
	Asset Length:	231.8	
	Condition Assessment		
	Condition	Priority	Risk
	C	2	
	Brief Description		
	Numerous historic and recent repairs in varying conditions Generally the condition of the asset is in a fair condition with recent repairs to the main wall, coping and wave wall in good condition. Some evidence of spalling and open joints throughout structure.		
	Recommendations		
Replace missing filler in joints in promenade.

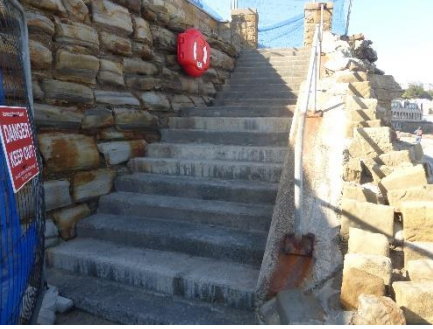
SBC Reference:	56-22B-02		
NFCDD reference:	1221D901D1302C02002

Asset Location:		
	Asset Length:	~4	
	Condition Assessment		
	Condition	Priority	Risk
	B	3	
	Brief Description		
	Cracks between the capping beam and the steps. Some steps have been refurbished. Fixings to handrail corroded. Overall fair condition.		
	Recommendations		
Treat handrail fixings. Continue to monitor.

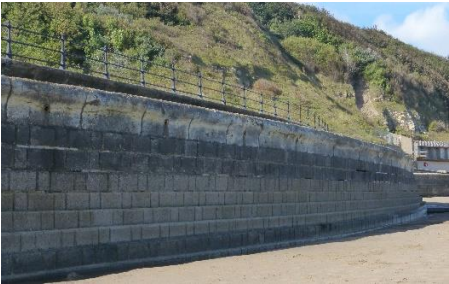
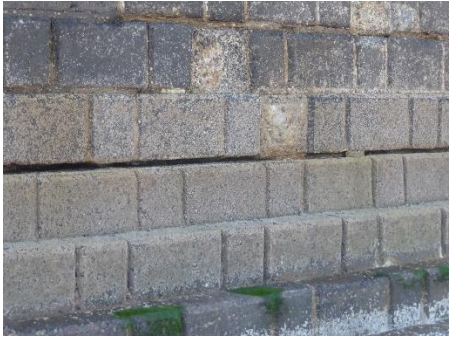
SBC Reference:	56-22B-03		
NFCDD reference:	1221D901D1302C02003

Asset Location:	Wall south of steps	
	Asset Length:	231.8 (with 55-22b-01)	
	Condition Assessment		
	Condition	Priority	Risk
	C	2	
	Brief Description		
	Repairs evident. Several sections of rebuilt facing and sine prom slabs have been replaced. However, large areas of missing joints in prom slabs remain, particularly at north end. Scour of the toe with deep holes over a 20m section. Open joints in lower wall.		
	Recommendations		
	Repoint blockwork, replace joints in slabs and on lower wall. Continue with any outstanding repair work

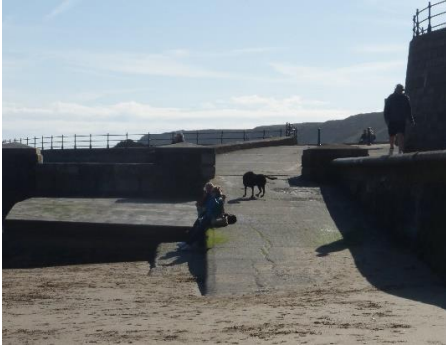
SBC Reference:	56-22B-04		
NFCDD reference:	1221D901D1302C02004

Asset Location:		
	Asset Length:		~5
	Condition Assessment		
	Condition	Priority	Risk
	B	3	
	Brief Description		
	Top section behind defence wall has been re-built although cracks have started to appear. Slipway leading to beach - large cracks with damaged side walls (especially the concrete bag work and mass concrete screed).		
	Recommendations		
	Repair cracks and screed.

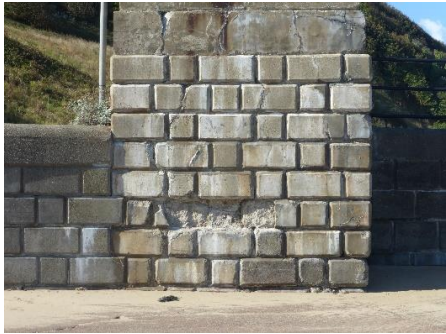
SBC Reference:	56-22B-05		
NFCDD reference:	1221D901D1303C02

Asset Location:		TA04828723, TA04668746.Wall at Dickinson's Point.
	Asset Length:		308.2
	Condition Assessment		
	Condition	Priority	Risk
	B	2	
	Brief Description		
	Still some missing joints in blockwork in lower wall. Repairs undertaken since last inspection to scour holes, coping and deck slabs. Many open joints between concrete slabs in lower prom remain. Ongoing damage and loss of facing to upper wall, cracks/spalling to splash beam.		
	Recommendations		
	Repair missing joints in lower blockwork wall and open joints in lower prom. Continue to monitor.

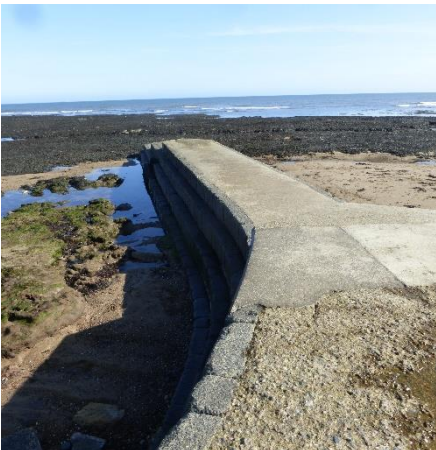
SBC Reference:	56-22B-06		
NFCDD reference:	1221D901D1303C02 001

Asset Location:		
	Asset Length:	~12	
	Condition Assessment		
	Condition	Priority	Risk
	B	3	
	Brief Description		
	Groyne in fair condition. Ramp - Visible resin repair to side wall Concrete slab revetment repaired with flexible asphalt filler, but repairs have failed and need redoing.		
	Recommendations		
	Replace asphalt filler.

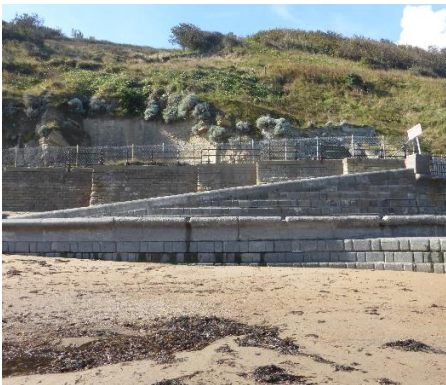
SBC Reference:	56-22B-07		
NFCDD reference:	1221D901D1304C02

Asset Location:	TA04868713, TA04828723. East of Holbeck Gardens.	
	Asset Length:	112.5	
	Condition Assessment		
	Condition	Priority	Risk
	C	3	
	Brief Description		
	Cracks to bastion throughout. Missing pointing / open joints and damaged parts of upper and lower capping beam. Limited height of lower wall visible due to beach level. Mortar missing between blockwork in lower wall. Corroded handrail with missing sections. Upper prom has been fenced off and is in poor condition. Full height cracks through uppermost wall.		
	Recommendations		
	Repair facing and copings. Replace mortar. Seal cracks. Replace broken handrails.

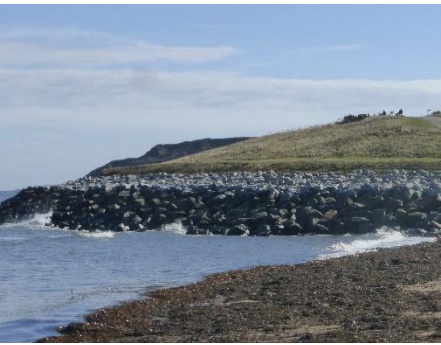
SBC Reference:	56-22B-08		
NFCDD reference:	1221D901D1304C01

Asset Location:	TA05038695, TA04868713. Land slip.	
	Asset Length:	294.7	
	Condition Assessment		
	Condition	Priority	Risk
	B	4	>5
	Brief Description		
	Rock armour tightly packed, good cover and looks in good condition. Toe in good condition, rock socketed into wave cut platform of soft rock. Top of sheetpiles just visible at toe of revetment with concrete behind.		
	Recommendations		
Continue to monitor, monitor stability of cliffs.

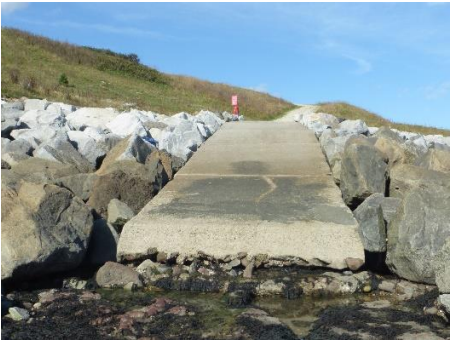
SBC Reference:	56-22B-09		
NFCDD reference:	1221D901D1304C01001

Asset Location:	Part of 56-22b-08	
	Asset Length:	~10	
	Condition Assessment		
	Condition	Priority	Risk
	B	3	
	Brief Description		
	Southern ramp has vertical drop to rocks and crack in bottom slab. Missing sealant between slab joints		
	Recommendations		
Repair cracks. Seal joints. Provide safe access from base of ramp onto foreshore. Continue to monitor.

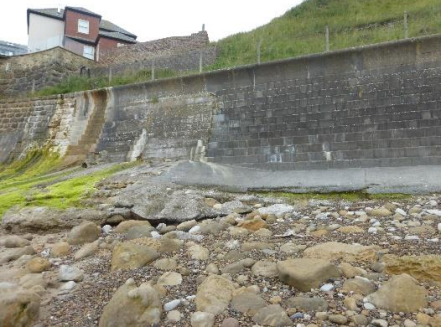
SBC Reference:	58-24B-01		
NFCDD reference:	1221D901D1402C02

Asset Location:	TA06618455, TA06648454	
	Asset Length:	34	
	Condition Assessment		
	Condition	Priority	Risk
	C	3	
	Brief Description		
	<p>North of old PS. Poured concrete and concrete blockwork toe below a stepped seawall with curved coping stone. More recent construction than adjacent walls. Cliff cutting back adjacent to North. Wall generally fair, but toe undercut at South. A large void beneath the apron of the structure is partially concealed by higher beach levels in 2020. Evidence of leaching and moisture seemingly draining from the cliff unit above.</p>		
	Recommendations		
	<p>Repair to voids. Investigate source of moisture at the southern end of the defence. Monitor recession of beach level along toe of structure. Monitor for outflanking.</p>

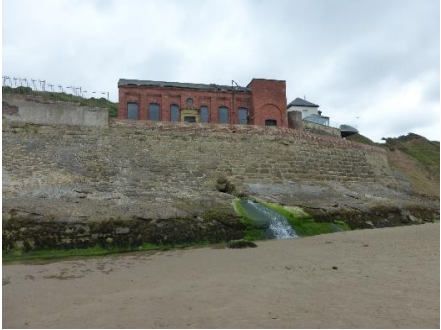
SBC Reference:	59-24B-01		
NFCDD reference:	1221D901D1402C05

Asset Location:	TA06698449, TA06658454	
	Asset Length:	67.3	
	Condition Assessment		
	Condition	Priority	Risk
	B	3	
	Brief Description		
	<p>Private wall to old PS in Poor condition. Lower apron has multiple patch repairs with poured concrete but has cracks. Recent pointing to main wall joints. Higher wall slightly better than lower. Higher beach levels in 2020 have in part concealed localised undercutting of the toe of the lower wall apron. Numerous voids visible in concrete apron.</p>		
	Recommendations		
	<p>Private maintenance.</p>

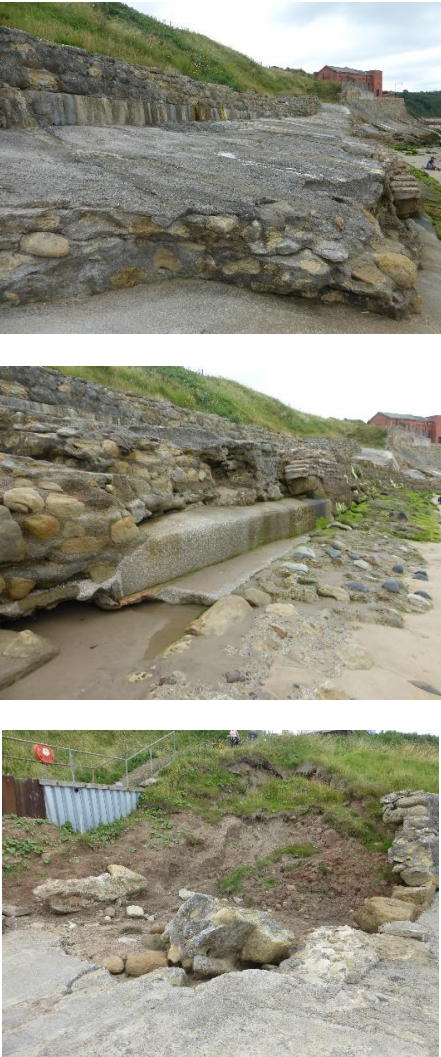
SBC Reference:	60-24B-01		
NFCDD reference:	1221D901D1402C04

Asset Location:	TA06698449, TA06758445	
	Asset Length:	32.6	
	Condition Assessment		
	Condition	Priority	Risk
	D	1	
	Brief Description		
	<p>Southern section of apron is missing, lower sea wall has been undercut and failed. Blockwork missing and displaced. Some repairs to deck with concrete. Upper wall missing southern section. Toe undermined. Crest breaking up.</p> <p>Ongoing slip failure behind higher wall with access steps consolidated with trench sheets. Loss of material from behind upper wall caused by slip failure. Large voids in the lower wall at beach level. Further undermining of the footpath. Defence is at significant risk of washout in the event of significant rainfall event coupled with tidal surge. Runoff from slope to the rear of upper wall could lead to instability of the structure and cause collapse of access footpath. Repairs performed following 2016 inspection appear in fair condition however the mass concrete toe repair is now itself undercut and being undermined from its southern end.</p>

Recommendations		
	<p>Repair or remove/make safe. Adapt long term strategic approach as defined in Filey and Cayton Bay Coastal Strategy.</p>

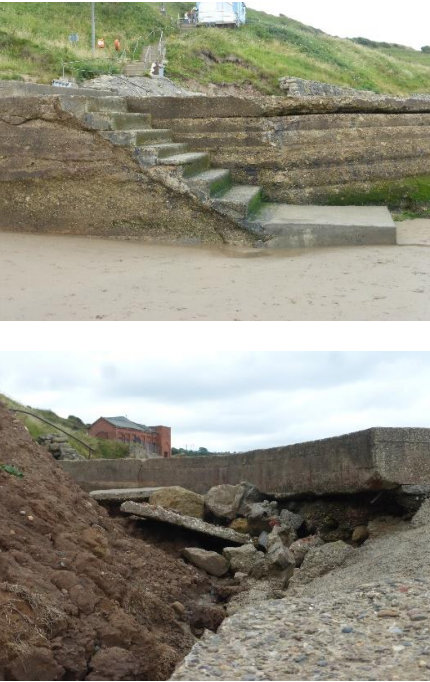
SBC Reference:	60-24B-01		
NFCDD reference:	1221D901D1402C06

Asset Location:	Nr Pumping Station in Cayton Bay.	
	Asset Length:	19.9	
	Condition Assessment		
	Condition	Priority	Risk
	D	1	
	Brief Description		
	<p>Mass concrete wall has failed and is breaking up. More patch repair work has been done to make safer for pedestrians. Large voids beneath deck structure. Needs removing and replacing with safer beach pedestrian access.</p> <p>Significant damage to the rear of the structure, washout out of fill material evidenced by undercutting and settlement of the structure.</p> <p>Higher beach levels have concealed the base of the structure. Repairs to step (addition of larger bottom step) made following 2018 inspection are in good condition.</p> <p>Repairs undertaken to make safe in July 2016 noted as being in fair condition. Concrete skim on deck of structure noted as being in good condition and has temporarily filled open surface voids.</p>

Recommendations		
	<p>Repair or remove/make safe beach access. Adapt long term strategic approach as defined in Filey and Cayton Bay Coastal Strategy.</p>

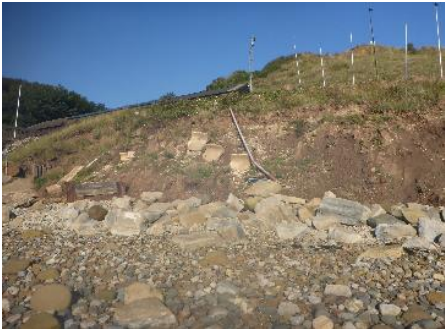
SBC Reference:	N/A		
NFCDD reference:	1221D901D1601C02

Asset Location:	TA12248126, TA12278130	
	Asset Length:	18.3m	
	Condition Assessment		
	Condition	Priority	Risk
	D	4	
	Brief Description		
	Rock armour scattered and totally ineffective. Timber breastwork no longer evident. Coastal slope appears to be actively eroding. Rock armour originally placed in failed breastwork. No significant change in 2020.		
	Recommendations		
	Consider reprofiling rock to slow erosion at boat club.

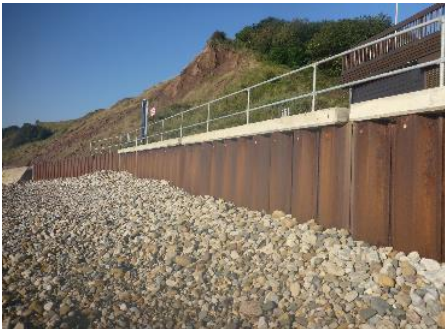
SBC Reference:	64-28A-02		
NFCDD reference:	1221D901D1601C03

Asset Location:	TA12228121, TA12248126	
	Asset Length:	55.8m	
	Condition Assessment		
	Condition	Priority	Risk
	B	4	
	Brief Description		
	Sheet piling remains in good condition although surface corrosion present. High beach levels concealed much of the lower sheet piles, including outlet. Scour hole at north end of promenade identified in 2018 has been repaired.		
	Recommendations		
	Continue to inspect.

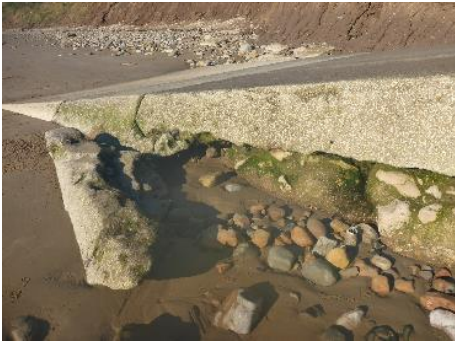
SBC Reference:	64-28A-01		
NFCDD reference:	1221D901D1601C03 001

Asset Location:	TA12228121, TA12248126	
	Asset Length:	~15m	
	Condition Assessment		
	Condition	Priority	Risk
	C	3	
	Brief Description		
	Fair to poor condition overall, concrete encasement abraded, open joints, cracks in the middle part with patch repairs carried out. Significant undercutting of slipway toe on the seaward side. Drainage outlet on seaward side not observed but reported previously to be blocked. Previous earth movements onto slipway have been cleared.		
	Recommendations		
Repair undercutting slipway.

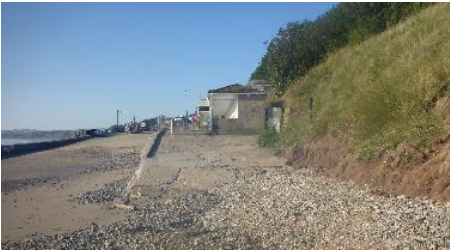
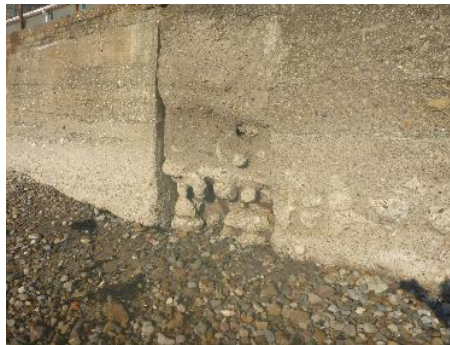
SBC Reference:	N/A		
NFCDD reference:	1221D901D1602C09 002

Asset Location:	TA12118095, TA12128100	
	Asset Length:	~10m	
	Condition Assessment		
	Condition	Priority	Risk
	D	2	
	Brief Description		
	Concrete rear ramp/wing wall in poor condition. Seaward side is heavily abraded with several missing sections of capping beam. Several holes in deck towards toe. A large scour hole has developed since 2018 at the wall joint exposing reinforcement – condition reduce to very poor as a result.		
	Recommendations		
Repair scour hole

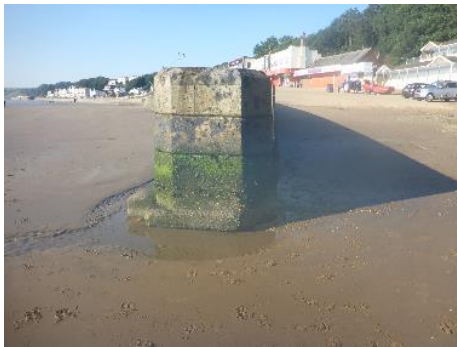
SBC Reference:	N/A		
NFCDD reference:	1221D901D1602C09

Asset Location:	North of promenade, Filey.	
	Asset Length:	38.8m	
	Condition Assessment		
	Condition	Priority	Risk
	C	2	
	Brief Description		
	Horizontal cracks and open joints throughout structure. Degradation of front faces of blocks and capping. Crest section repaired locally. Toe of wall abraded/undermined at bottom of slipway. Large crack through wingwall approx. 7m from extremity of wall possibly due to settlement. No significant change in 2020.		
	Recommendations		
Repair undermining at slipway, monitor and repair damage.

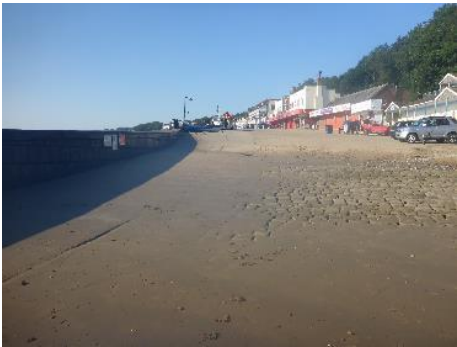
SBC Reference:	N/A		
NFCDD reference:	1221D901D1602C09 001

Asset Location:	North of promenade, Filey.	
	Asset Length:	10m	
	Condition Assessment		
	Condition	Priority	Risk
	B	4	
	Brief Description		
	Slipway blockwork remains in fair to good condition. Much of lower slipway concealed by beach sediment.		
	Recommendations		
Continue to monitor

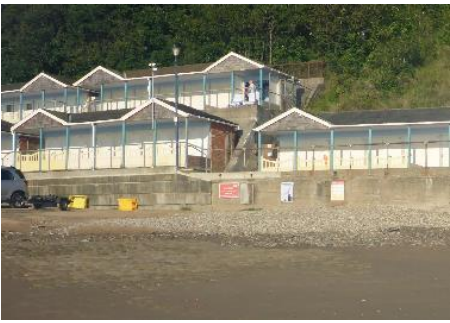
SBC Reference:	N/A		
NFCDD reference:	1221D901D1602C01

Asset Location:	TA12118095, TA12128100	
	Asset Length:	49.6m	
	Condition Assessment		
	Condition	Priority	Risk
	C	2	
	Brief Description		
	The concrete cope beam, observed being replaced in the 2018, remains in good condition. Abrasion of wall. Concrete block wall adjacent in poor condition – leans seaward, open joints, damaged blocks.		
	Recommendations		
Repair damaged wall. Monitor leaning wall.

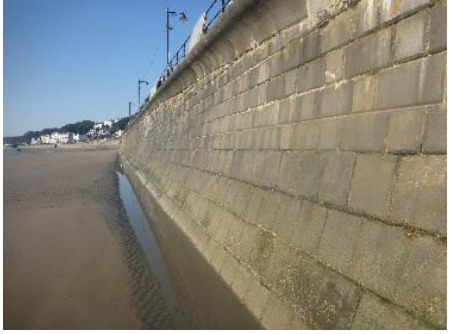
SBC Reference:	67-28B-01		
NFCDD reference:	1221D901D1602C06

Asset Location:	North of promenade	
	Asset Length:	109.8m	
	Condition Assessment		
	Condition	Priority	Risk
	B	2	
	Brief Description		
	No significant change in 2020. Missing pointing between blocks on wall. Damage to front face of several blocks. Concrete toe apron exposed locally. High beach levels buried several outlets in 2020 – water pooling against face.		
	Recommendations		
Repointing. reseal cracks below coping.

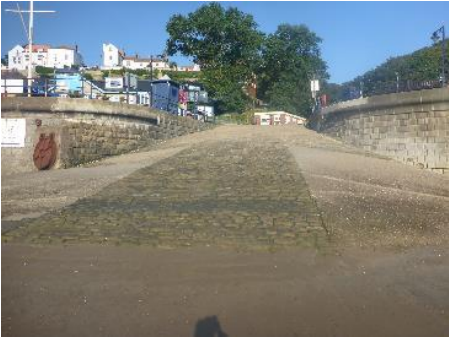
SBC Reference:	67-28B-02		
NFCDD reference:	1221D901D1602C08 001

Asset Location:		
	Asset Length:	~6m	
	Condition Assessment		
	Condition	Priority	Risk
	B	3	
	Brief Description		
	Mixed construction from blockwork and mass concrete. Recent blockwork repair towards toe. Several open joints between blockwork, cracked concrete. High Beach levels concealed concrete toe apron previously reported to be undermined.		
	Recommendations		
Repair/reseal joints and repair cracks. Continue to monitor.

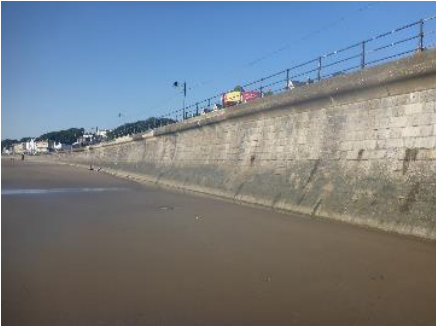
SBC Reference:	67-28B-03		
NFCDD reference:	1221D901D1602C08

Asset Location:	TA11978020, TA12068082	
	Asset Length:	301.6m	
	Condition Assessment		
	Condition	Priority	Risk
	B	2	
	Brief Description		
	Abrasion to front face, particularly just above beach level appeared to have worsened slightly. As reported in 2018, Many bullnose blocks have been repaired, but others are cracked/damaged. Several open joints leaking water. Water again observed bubbling on beach approx. 1m off toe of wall, it is believed this is due to a buried outfall pipe. Handrails corroded.		
	Recommendations		
Replace/repair cracked coping and repair damaged blocks. Repair handrails. Confirm "bubbling" is due to buried outlet.

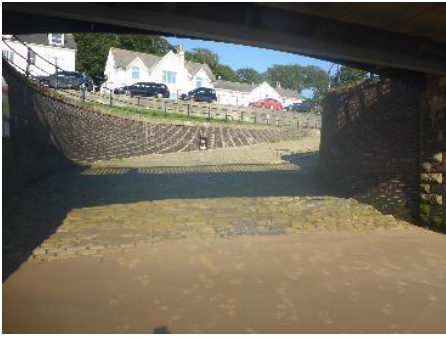
SBC Reference:	67-28B-04		
NFCDD reference:	1221D901D1602C03002

Asset Location:		
	Asset Length:	12m	
	Condition Assessment		
	Condition	Priority	Risk
	B	3	
	Brief Description		
	Several open/missing joints in slipway, occasional settled blocks although none noted missing. Missing blocks and mortar joints on abutment walls. Handrails corroded.		
	Recommendations		
Repair/replace missing blocks and joints. Treat/replace handrail.

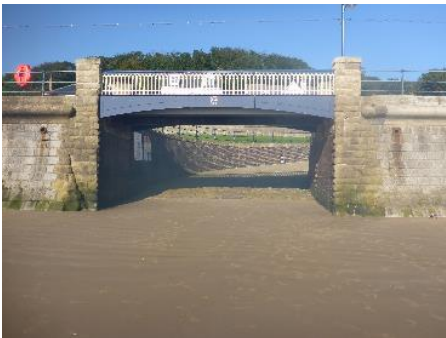
SBC Reference:	67-28B-04		
NFCDD reference:	1221D901D1602C03003

Asset Location:		
	Asset Length:	6m	
	Condition Assessment		
	Condition	Priority	Risk
	B	3	
	Brief Description		
	No significant change in 2020. Painted steel bridge in good condition overall. No issues noted to slabs on underside of deck, surface corrosion noted to pipework. Several cracks/open joints in both abutments and brickwork in need of localised repointing.		
	Recommendations		
Repair cracks in abutment walls.

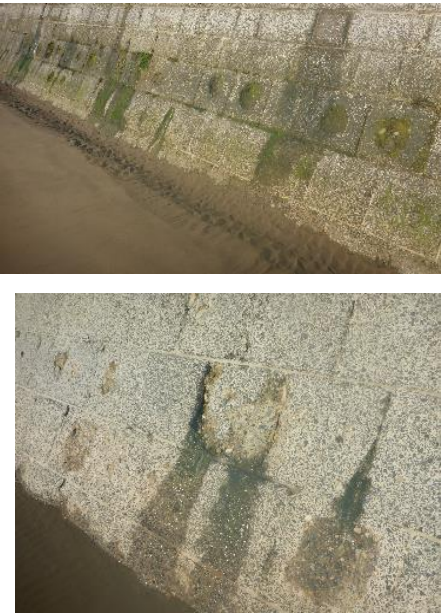
SBC Reference:	67-28B-05		
NFCDD reference:	1221D901D1602C03

Asset Location:	TA11978020, TA12068082	
	Asset Length:	318.8m	
	Condition Assessment		
	Condition	Priority	Risk
	C	3	
	Brief Description		
	Chipped / abraded areas of blocks continued to have deteriorated since 2018. Loss of face to many blocks throughout, particularly at lower levels at South end. Water observed sipping out abraded blocks in area. Several new / repaired coping blocks. Handrails corroding at many joints. Cracked splash beam and missing joints in several places. High beach levels burying several outlets.		
	Recommendations		
Monitor abrasion and reface in blocks. Repair/replace handrails. Repair missing joints.

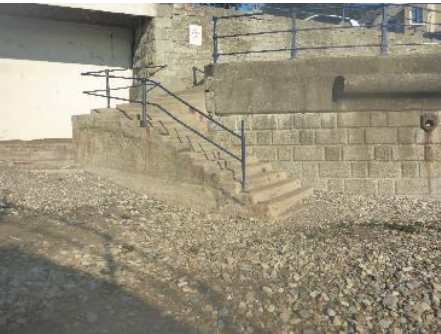
SBC Reference:	N/A		
NFCDD reference:	1221D901D1602C03 001

Asset Location:		
	Asset Length:	5m	
	Condition Assessment		
	Condition	Priority	Risk
	B	3	
	Brief Description		
	No significant change in 2020. Corroded handrail and cracking joints below treads on side wall. Step nosing lightly		
	Recommendations		
Repair joints. Treat handrails. Continue to monitor.

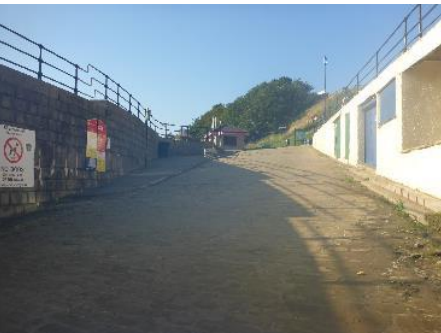
SBC Reference:	67-28B-06		
NFCDD reference:	1221D901D1602C04 002

Asset Location:	TA11968012, TA11978020	
	Asset Length:	20m	
	Condition Assessment		
	Condition	Priority	Risk
	B	3	
	Brief Description		
	Several open/missing joints between stone blocks Toe of structure covered by shingle, 2015 inspection reports 'scour hole near the toe stabilised with mass concrete infill but still depressed' although this was again not observed in 2020.		
	Recommendations

Recommendations		
	Replace/repair missing joints. Continue to monitor.

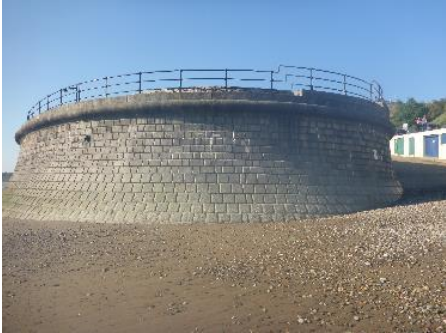
SBC Reference:	67-28B-07		
NFCDD reference:	1221D901D1602C04

Asset Location:	TA11968012, TA11978020	
	Asset Length:	91.8m	
	Condition Assessment		
	Condition	Priority	Risk
	B	3	
	Brief Description		
	Overall fair condition, some abrasion to facing of blocks, open/missing joints between a few blocks. No change in 2020.		
	Recommendations		
	Seal open joints, repair abrasion damage to facing of blocks.

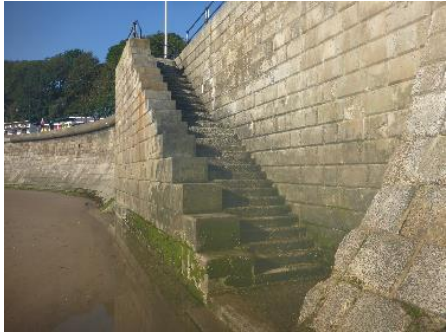
SBC Reference:	67-28B-08		
NFCDD reference:	1221D901D1602C04 001

Asset Location:		
	Asset Length:	~6m	
	Condition Assessment		
	Condition	Priority	Risk
	B	3	
	Brief Description		
	Abrasion/ chipping to steps, coping cracked locally. Deep scour in beach sediment adjacent to landing step makes access at low tide difficult due to pooling water.		
	Recommendations		
	Repair chipped steps and cracked coping, continue to monitor.

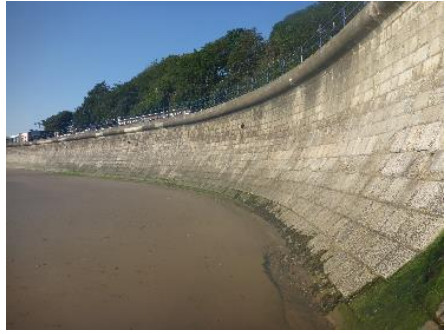
SBC Reference:	67-28B-09		
NFCDD reference:	1221D901D1602C07

Asset Location:		
	Asset Length:	98m	
	Condition Assessment		
	Condition	Priority	Risk
	B	3	
	Brief Description		
	Cracking to splash beam in a few places, other areas have been repaired. Numerous chipped / damaged blocks, but overall fair. Cracks and open joints in blockwork of Southern steps buttress. Promenade fair to good. Potholes in asphalt reported in 2018.		
	Recommendations		
	Repair cracks and loose blocks. Fill joints. Continue to monitor.

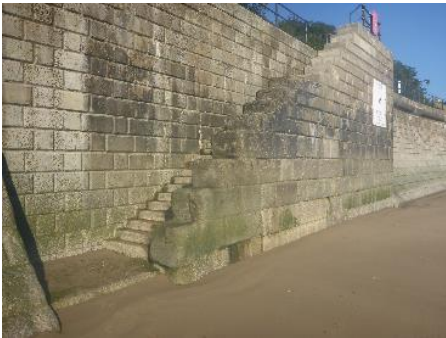
SBC Reference:	67-28B-10		
NFCDD reference:	1221D901D1602C05 001

Asset Location:		
	Asset Length:	10m	
	Condition Assessment		
	Condition	Priority	Risk
	B	3	
	Brief Description		
	Spalling and abrasion of concrete blocks on seaward side with missing joints in places. Steps abraded and beginning to round although in fair condition.		
	Recommendations		
	Replace missing joints, repoint steps. Continue to monitor

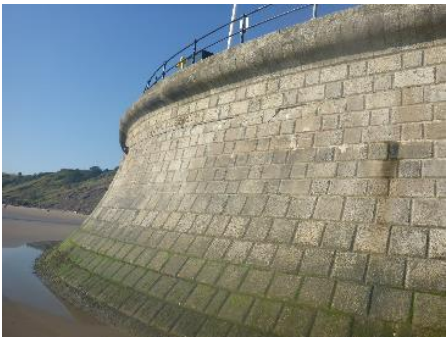
SBC Reference:	67-28B-11		
NFCDD reference:	1221D901D1602C05

Asset Location:	TA11957997, TA11968012	
	Asset Length:	103.9m	
	Condition Assessment		
	Condition	Priority	Risk
	B	3	
	Brief Description		
	Some damage to seaward edge of prom. Repairs to splash beam by outfall holding (reported in 2018). Numerous lower blocks damaged on front face between beach level and 2m height not significantly worsened. Horizontal crack on seaward section as 2012. Cracks in retaining wall to slipway. Outfall discharging on day of inspection. Outfall grate corroded.		
	Recommendations		
	Monitor damage to blocks and repair where necessary. Treat/replace handrailing.

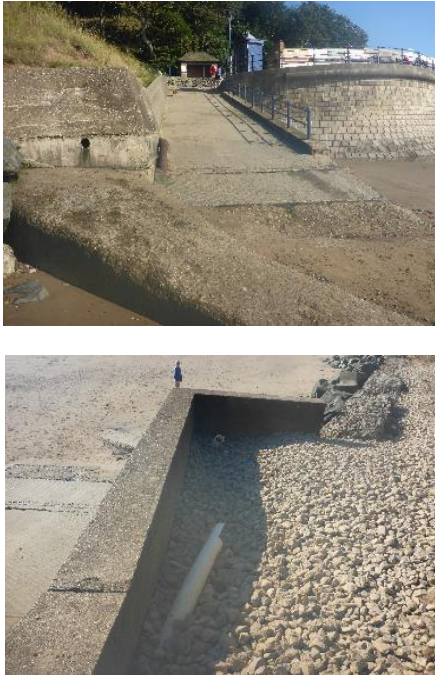
SBC Reference:	67-28B-12		
NFCDD reference:	1221D901D1602C02001

Asset Location:	TA12248126, TA12278130	
	Asset Length:	15m	
	Condition Assessment		
	Condition	Priority	Risk
	B	3	
	Brief Description		
	Spalling of concrete near base. Crack on side wall at mid-section. Fair condition overall. Handrail corroded. Toe of slipway abraded causing open joints between concrete sections. Washout of material behind slipway has caused outlet pipe to break.		
	Recommendations		
Repair spalling and cracking. Repaint/replace handrailing. Repair outlet pipe behind structure.

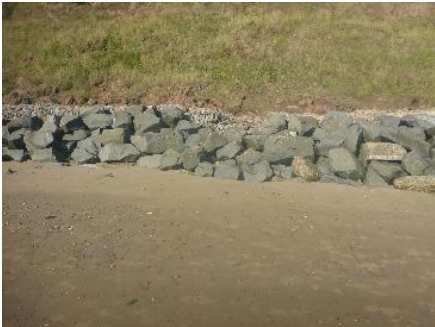
SBC Reference:	67-28B-13		
NFCDD reference:	1221D901D1602C02

Asset Location:	TA12068082, TA12118035	
	Asset Length:	18.3m	
	Condition Assessment		
	Condition	Priority	Risk
	C	2	
	Brief Description		
	Gabion baskets fronted by rock armour and concrete blocks, with gravel/stone infill to rear. Slumping cliffs behind may be pushing rock onto beach highlighted by the depression in the crest of the gabion baskets and rock armour		
	Recommendations		
Continue to monitor and reposition rocks as required. Consider placement of larger rock armour.

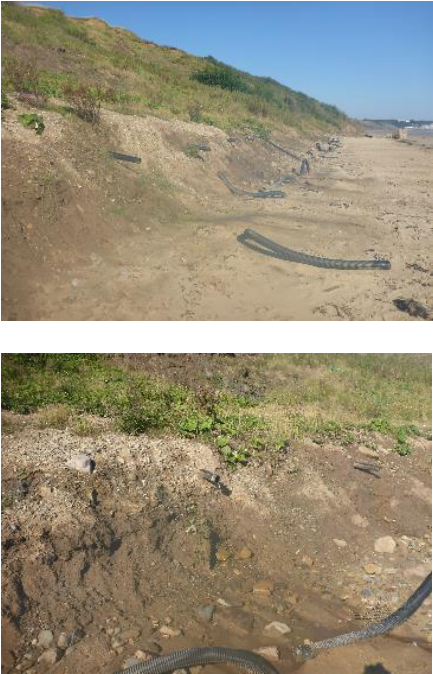
SBC Reference:	To be allocated by SBC to this new defence length		
NFCDD reference:	To be allocated by SBC to this new defence length

Asset Location:		
	Asset Length:	75m	
	Condition Assessment		
	Condition	Priority	Risk
	C	3	
	Brief Description		
	<p>Flat cliffs stabilisation scheme was complete in 2018 to provide temporary (20 year design life) protection to the hamlet access road. The works involved installing sand filled geotextile bags along the toe of the till cliffs, kerb drainage units along the access road at the crest of the cliffs and sub-horizontal slope drainage installed at the base of the cliff.</p> <p>The geotextile bags at the toe of the cliff were mostly fully buried by beach sediment. The toe of the cliff has continued to slowly retreat, exposing drainage pipes along the full length which in many places have come separated at their terminal end. It was noteworthy that several of the drainage pipes were discharging water at the time of inspection suggesting they are still operating as expected</p>

Recommendations		
	<p>It is recommended that the pipes are not reconnected due to the ongoing erosion of the toe making it highly likely for the issues rearise. Remove any unused pipework from foreshore.</p> <p>As the works are designed as a temporary measure, it is recommended that an alternative access arrangement into the hamlet is made [Urgent].</p> <p>Monitor performance of drainage units, ensuring outfalls behave as designed.</p> <p>In the longer term, it is recommended that the Council, residents and other local stakeholders start planning for 'adaptation to coastal change' in the medium to longer term. This may involve relocating inland.</p>
