**Walk-over Visual Inspections of Assets  
including Coastal Slopes**

**Scarborough Borough Council  
Final Report**

**October - November 2012**

## Coast Protection Assets and Coastal Slope Condition Analysis

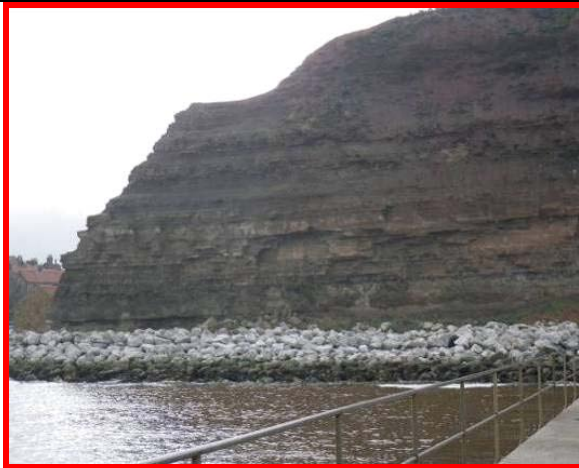
**MU4/1a** - Exposed and active end of Cowbar Nab, the southern half (Totally Active).

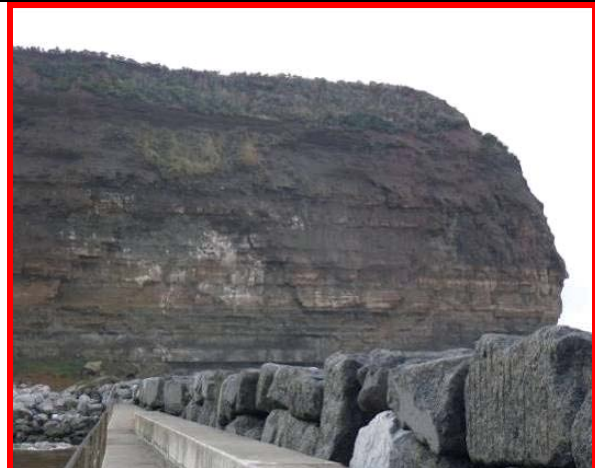
**E60/1a** - The northern half of Cowbar Nab. The cliff face is showing signs of erosion (Totally Active)

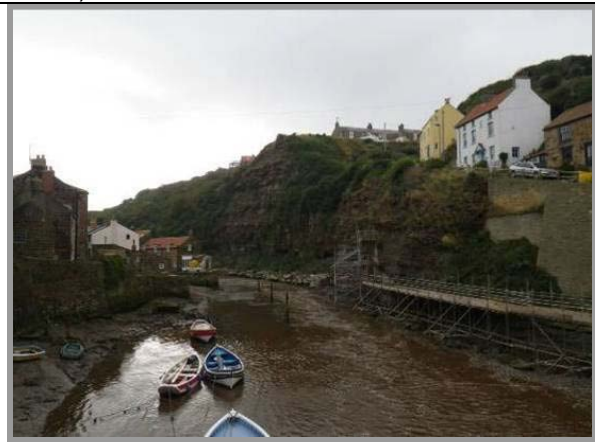
**(No unit)** - Further up Staithes Beck a rockfall occurred in the cliffs during February 2012. The site was remediated in September 2012.

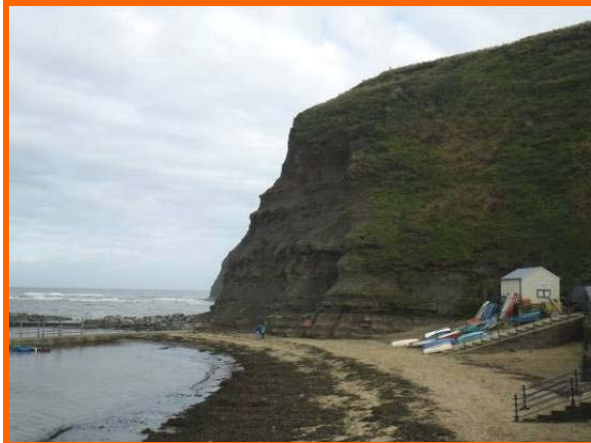
**MU4/2** –Vegetated cliff with localised erosion, behind Staithes harbour (Partly Active).

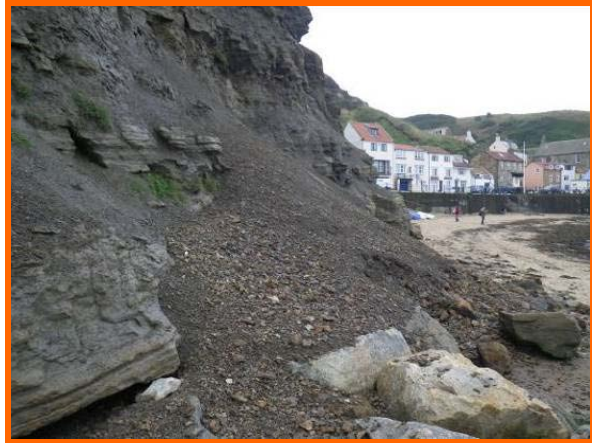
more exposed than the rest of the unit because of its position in the bay and is more prone to erosion. Failed material is evident in at the toe of the cliff and recent activity has been reported by residents of the eastern part of High St. The unit has been re classified from Locally Active to Partly Active to reflect this recent phase activity, which was likely to have been triggered by the exceptionally wet weather of 2012.

**MU4/2** – There have been a number of recent failures in this management unit, which is now classed as Partly Active.

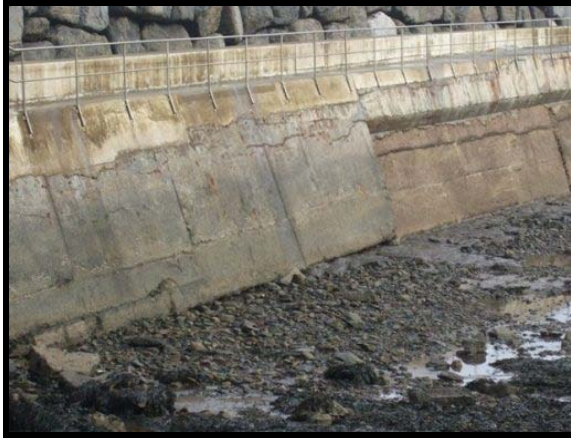
Undercutting to landward facing of north breakwater (photo from 2009 inspection) (Asset Ref. 1221D901D0402C01)

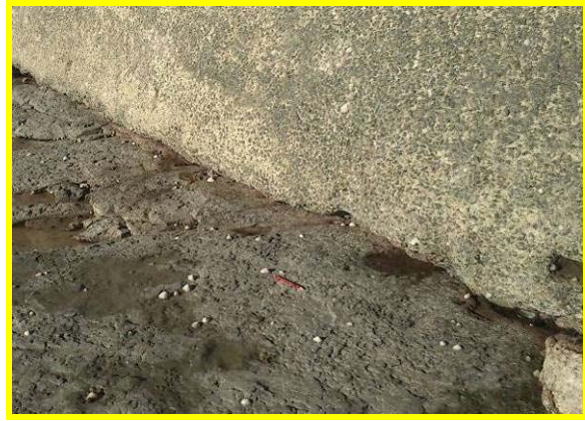
Undercutting at landward facing of north breakwater (30/12/2012) (Asset Ref. 1221D901D0402C01)

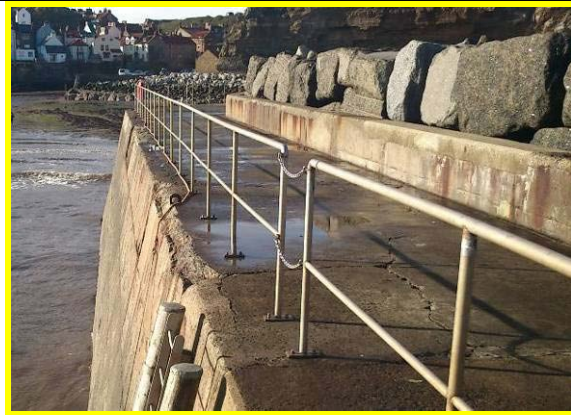
There is cracking in the promenade deck slab on the north breakwater, see below left, and loss of concrete at the top of the inner face. There is also extensive horizontal cracking of the outer section of the crest wall, below right.

North breakwater promenade and inner face showing cracking in slab and damage to coping. (Asset Ref. 1221D901D0402C01)

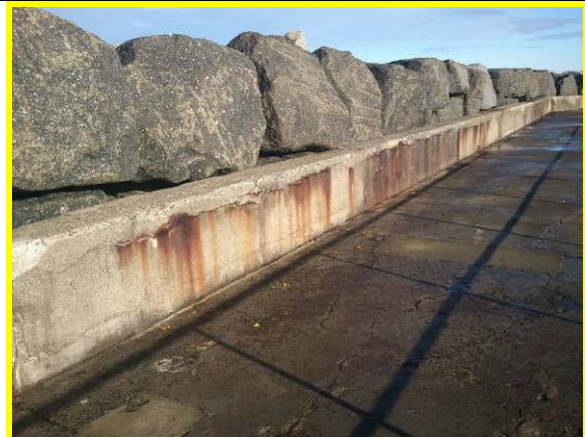
North breakwater outer crest wall showing horizontal cracking and rust staining. (Asset Ref. 1221D901D0402C01)

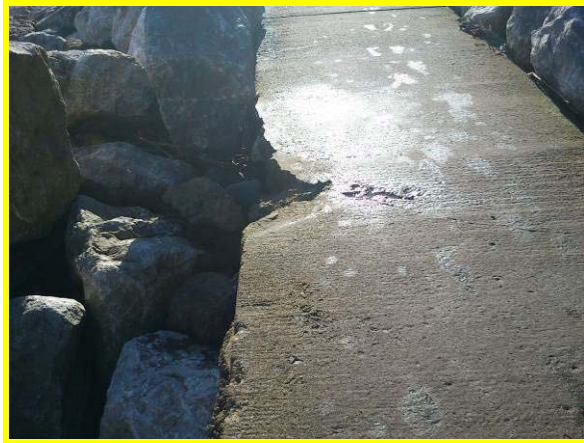
The rock armour defence running south from the north breakwater to the end of Cowbar Lane (Asset Ref. 1221D901D0402C02) was constructed after the 2002 upgrade to the main breakwaters and remains in overall good condition. It appears that some armour stones may have been displaced at the toe. At the north end there is cracking and spalling of the concrete walkway / promenade, possibly related to placement of or movement of the rock armour. At the south end the original promenade at the end of Cowbar Lane has surface erosion and exposed aggregate, and there is cracking and spalling to the blockwork wall, see below right.

Damage to the walkway / promenade, as also noted in 2009 inspection  
(Asset Ref. 1221D901D0402C02)

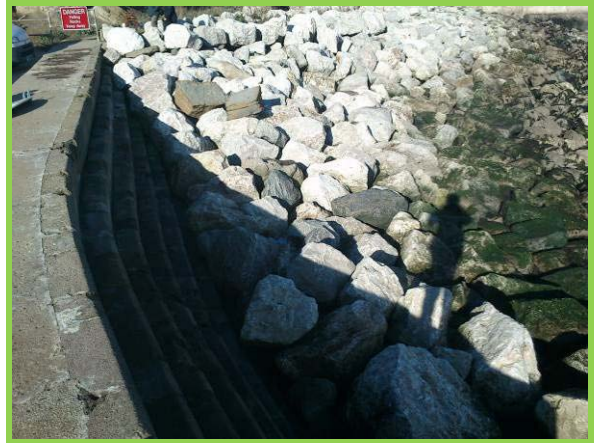
Rock armour which is in good condition adjacent to stepped wall at end of Cowbar Lane. (Asset Ref. 1221D901D0402C02)

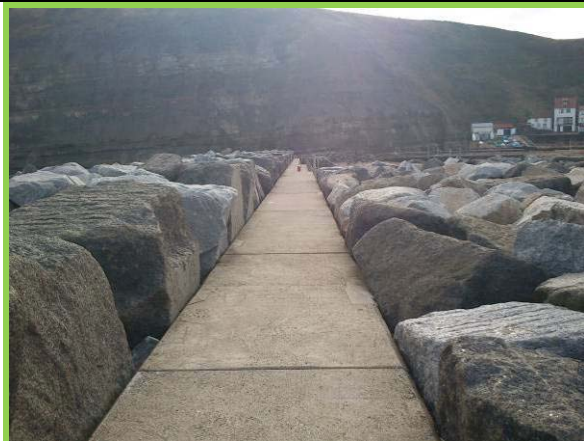
The main Staithes south breakwater (Asset Ref No.1221D901D0403C03), originally had a spur at the northern tip, but the section between main breakwater and the spur is filled with rock armour. The breakwater is in good overall condition. The rock armour is in very good condition. It was noted that there was cracking in concrete crest units in the middle of the breakwater length and exposure to aggregate and concrete joints to the old part of the wall (inner face).

South breakwater promenade and rock armour  
(Asset Ref. 1221D901D0403C03)

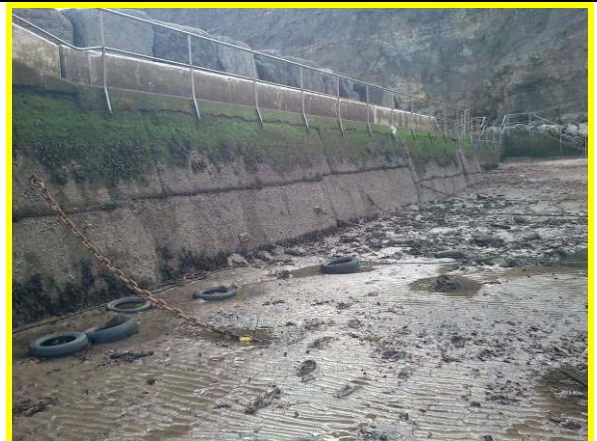
Exposure of aggregate and construction joints in south breakwater inner face.  
(Asset Ref. 1221D901D0403C03)

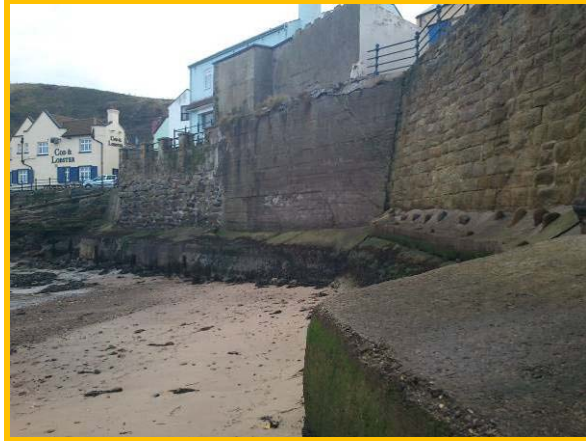
sections of the wall, towards the west side of the harbour and into Staithes beck, consist of masonry blockwork and are often exterior walls of private properties, these display visible loss of mortar and missing blocks, see below right. There is also undercutting of the toe in several locations, exposing timber piling. The defects observed were again similar to the previous inspection. Although there is evidence of previous repairs, maintenance needs to be implemented at regular intervals (Asset Ref. 1221D901D0402C22). Should these repairs continue to fail, replacement of the assets should be considered.

Cracks throughout wall and undercutting of toe (Asset Ref. 1221D901D0402C22)

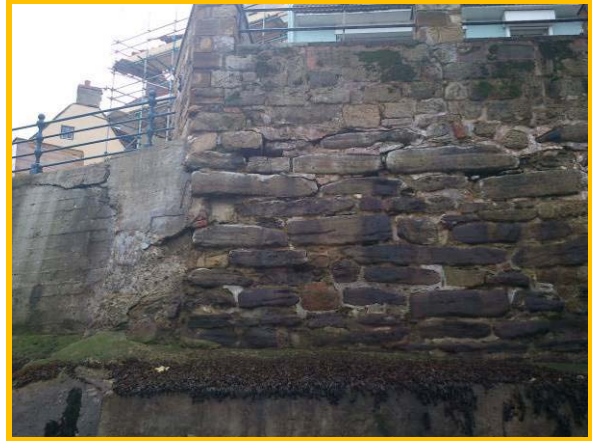
Older sections of harbour wall in need of regular maintenance (Asset Ref. 1221D901D0402C22)

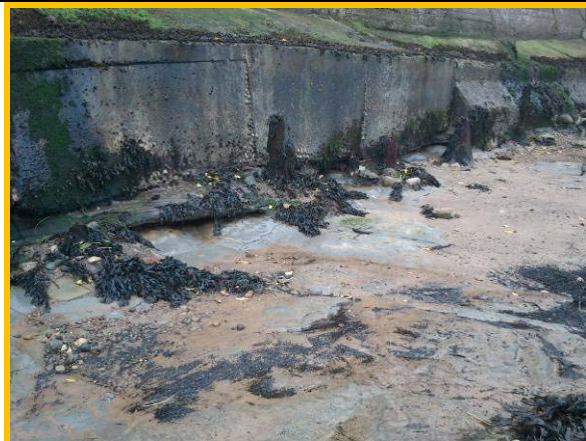
Undercutting at the toe of some parts of the harbour wall (no change since 2009) (Asset Ref. 11221D901D0402C22)

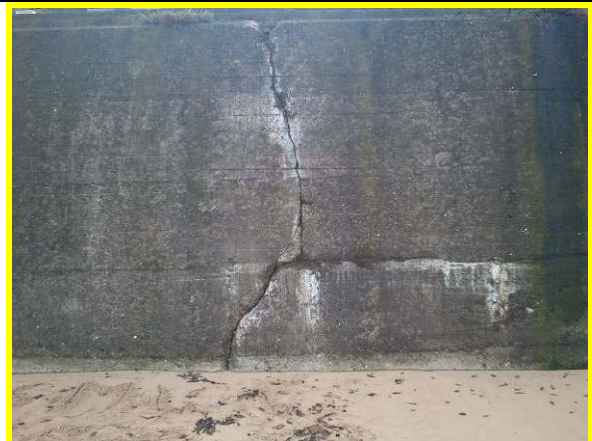
Vertical crack through wall (no change since 2009) (Asset Ref. 1221D901D0403C01)

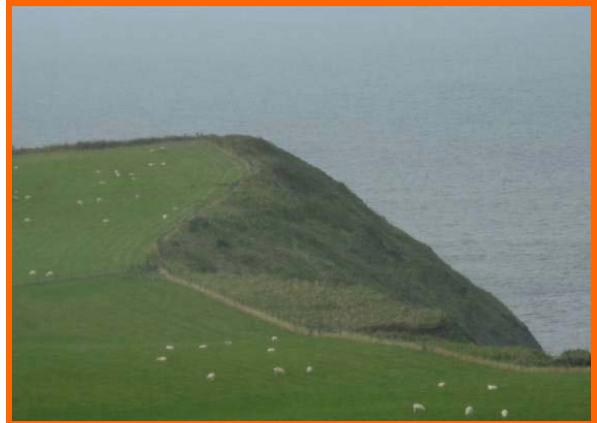
**MU5/1** – The more stable, vegetated slope close to Penny Steel (Partly Active).

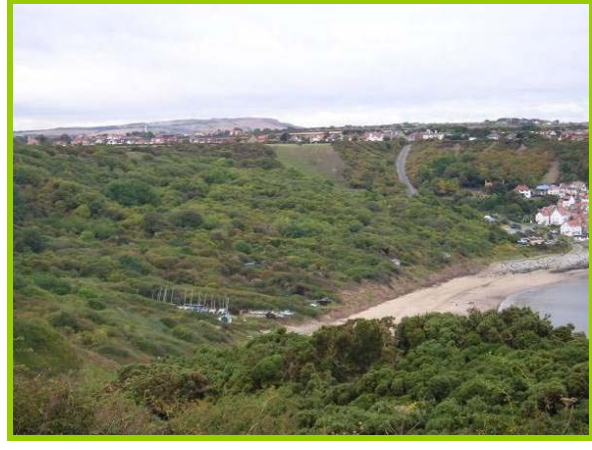
**MU7/2** (right of image with rock armour at toe - Inactive) **MU7/3** (left with eroding toe – Locally Active).

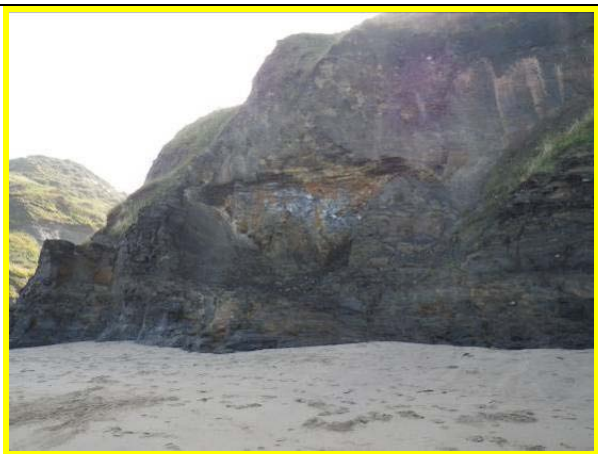
**Units MU7/3 and MU7/4** are located behind Runswick Sands. The cliffs here are vegetated and of a shallow gradient, similar to those within unit MU7/2. The units do not have any protection at the toe and therefore are subject to continual marine activity. The toe is generally steep as a result, does not support any vegetation cover, and shows evidence of recent slumping. As a result, both units are classified as Locally Active.

**MU7/4** – Toe erosion at the base of the cliff  
(Locally Active)

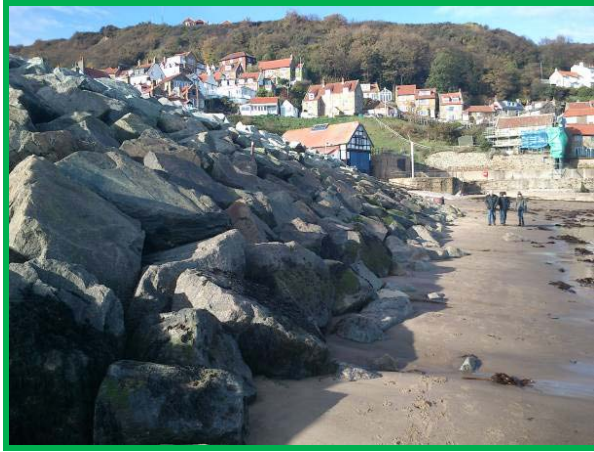
The rock armour defences (Asset ref: 1221D901D0602C01) remain in very good condition, with the rocks tightly packed with good coverage and no evidence of significant deformation. The associated slipway towards the south from the end of the road and boat park is also in good condition. Beach levels appeared relatively high at the time of the inspection, so the toe was not visible. There is ongoing erosion of the undefended cliff at the southern end of the defence and some of the locally sourced smaller rock used at the tie in has been scattered, see below right, however this is not a cause for concern at present.

Runswick Bay village rock armour defences (Asset Ref. 1221D901D0602C01)

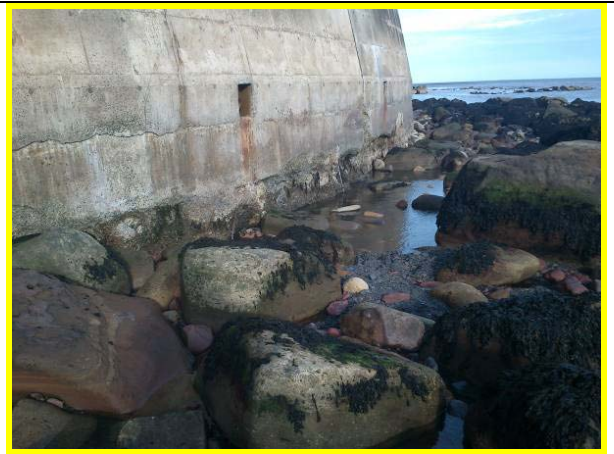
Foreshore scour at toe of seawall, photo from 30/10/2012 (Asset Ref. 1221D901D0601C01)

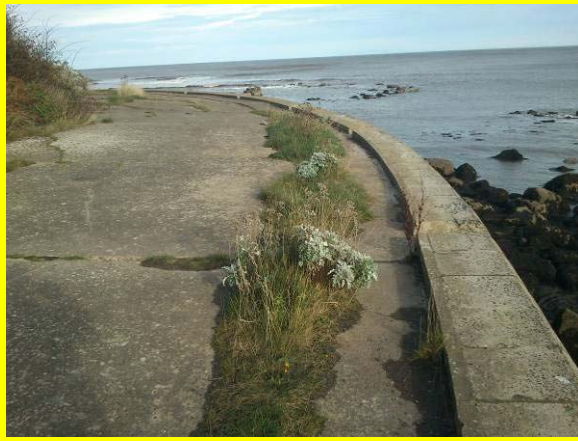
Promenade on top of northern seawall,  
30/10/2012 (Asset Ref. 1221D901D0601C01)

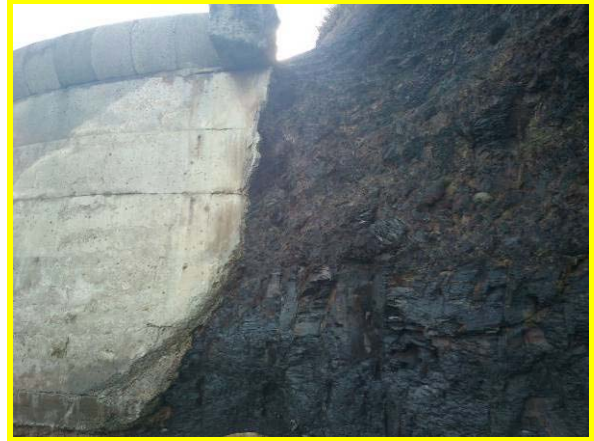
Erosion of cliff adjacent to north end of seawall,  
30/10/2012 (Asset Ref. 1221D901D0601C01)

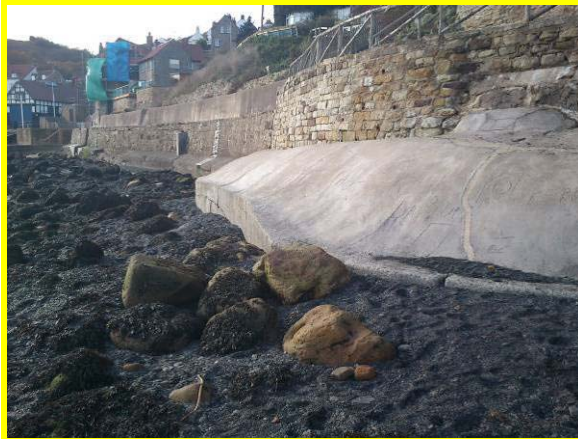
Moving south, the protruding section of wall (1221D901D0601C06) protecting the individual property is in fair condition. There are signs of repairs to the large vertical cracks in the wall and toe apron. However there are cracks in the top of the concrete bagwork part of the wall.

Repaired vertical cracks to toe of wall, and  
horizontal cracks holding  
(Asset Ref. 1221D901D0601C06)

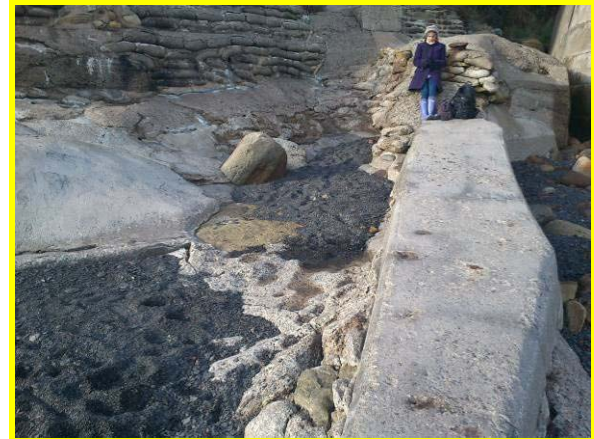
View of northern end of wall with cracked concrete  
bagwork.  
(Asset Ref. 1221D901D0601C06)

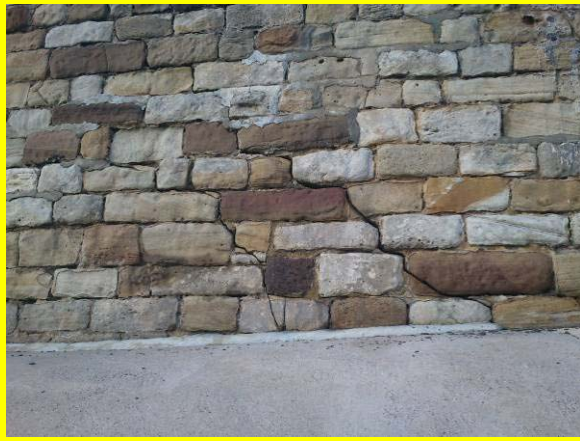
The main length of wall below the properties, Asset Ref. 1221D901D0601C03 is in variable condition. Although there are signs of repair work there are significant cracks in the wall and undercutting of the toe in several locations, see photos below. The beach level has recovered here since the 2009 inspection with a small accumulation of coarse grey shale sand from the eroding landslip to the north of the village.

Diagonal cracks in wall (Asset Ref. 1221D901D0601C03)

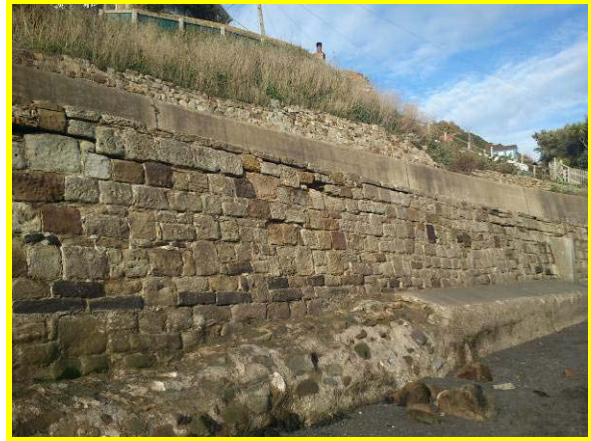
Gaps at joints and missing blocks (Asset Ref. 1221D901D0601C03)

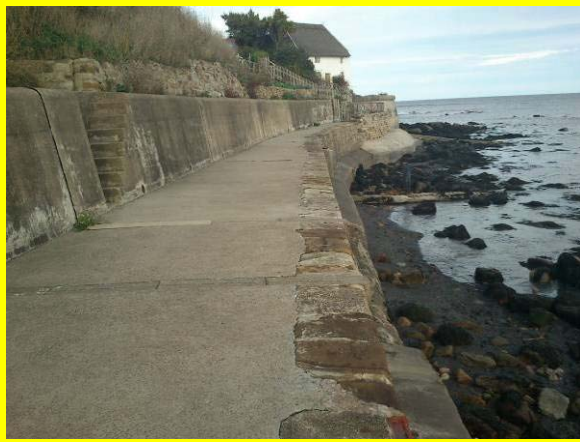
Overview of wall (Asset Ref. 1221D901D0601C03)

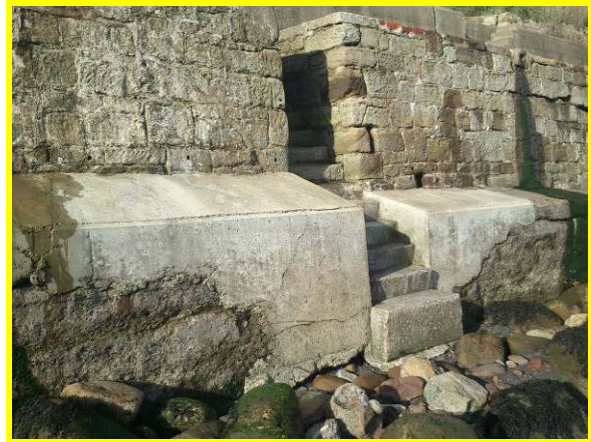
Undercutting of toe adjacent to steps (Asset Ref. 1221D901D0601C03)

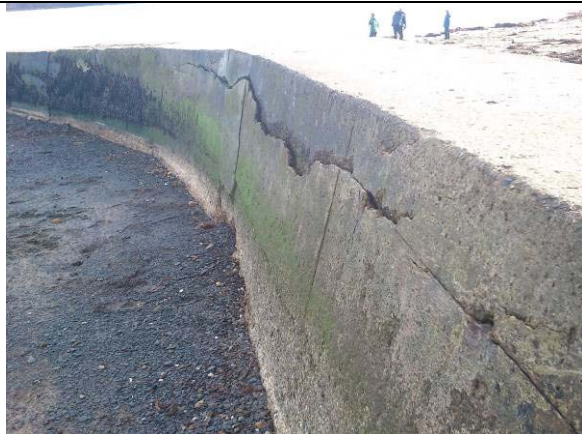
The concrete breakwater or groyne (Asset Ref. 1221D901D0601C02) to the north of the pumping station and lifeboat slip was noted to be in need of repair during the 2009 survey, with large horizontal and vertical cracks on both sides propagating through the defence. The condition at the time of the 2012 inspections seems to be similar or worse. It is recommended that forthcoming strategy study should consider the need for this asset in terms of sheltering to the RNLI Slip and pumping station seawall, and the retention of sand and gravel beaches in the area.

Large horizontal crack to breakwater (Asset Ref. 1221D901D0601C02)

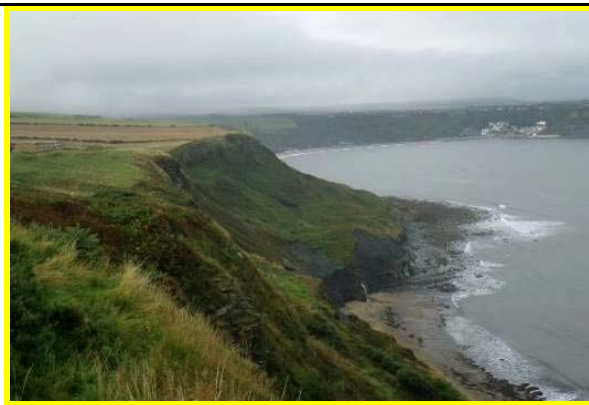
**MU8/2** Relict debris run out lobe adjacent to Runswick Sands (Locally Active)

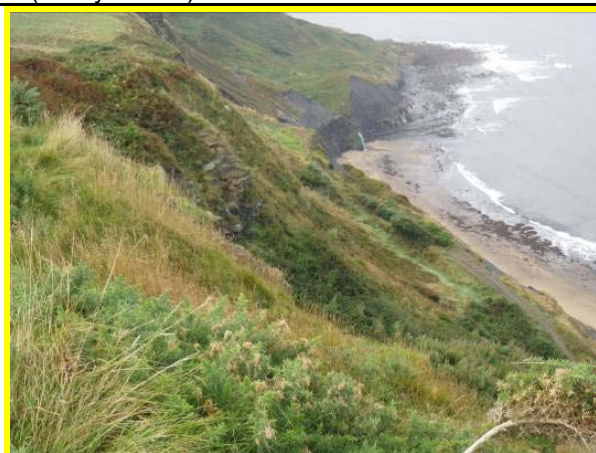
**MU8/3** is located behind Kettleness Sand and is classified as Locally Active, having been downgraded from Partly Active. The slopes are steep and free from vegetation down much of their length. There is intense weathering occurring along much of the unit, especially at the toe which is subject to marine action.

**MU8/3** The vegetated upper cliffs and eroding sea cliffs above Kettleness Sands (Locally Active)

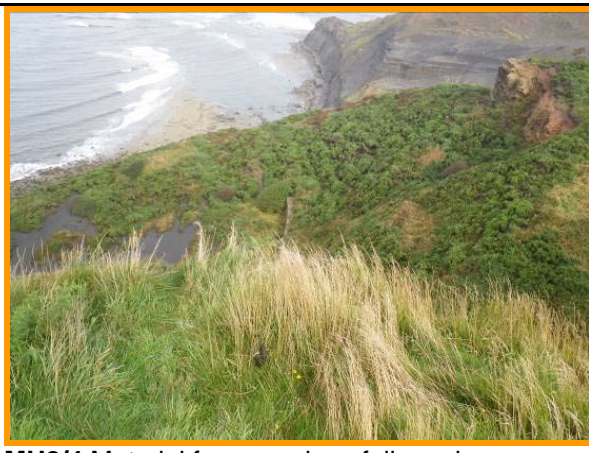
**MU8/4** is small unit, just west of Kettle Ness. . Regular, marine erosion is indicated by the absence of vegetation and the unit remains classified as Partly Active.

**MU8/4** Material from previous failures have stabilised and become vegetated above the level of wave attack (Partly Active)

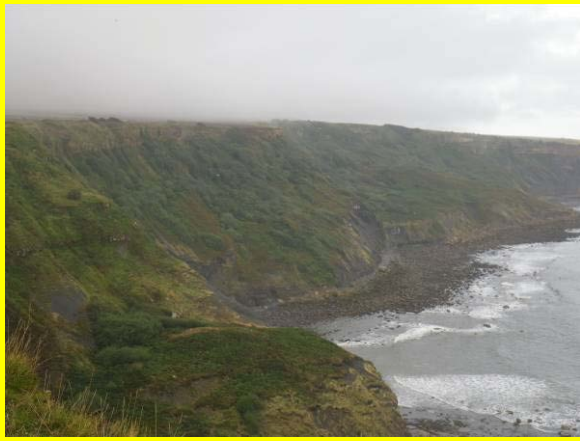
**MU8/7 and MU8/8** The well vegetated relict debris flow lobe at Seaveybog Hill (Locally Active)

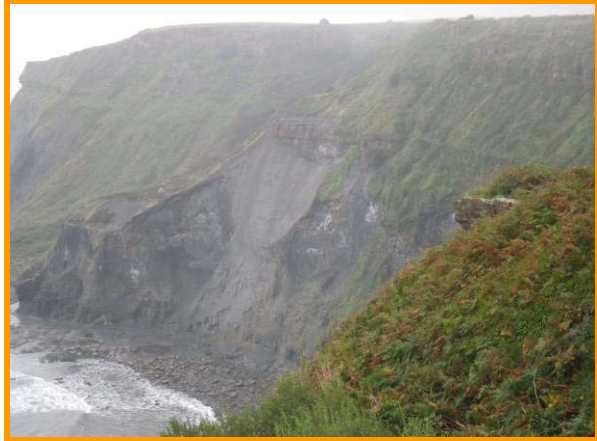
**Unit MU8/9** is located at Loop Wyke and is classified as Partly Active. The upper slopes of this unit support some vegetation cover. Lower down the slopes are very steep, support no vegetation cover and have failed recently. The base of the cliff is subject to ongoing marine erosion.

**MU8/9** has recently failed in the lower two-thirds of the cliff slope. As a result the unit is classified Partly Active.

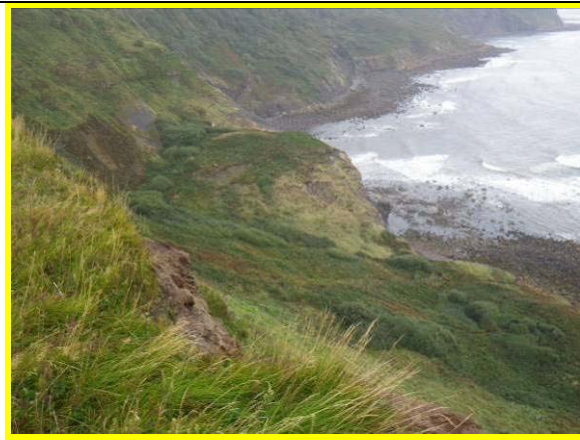
**MU8/10** The lobe of material at Tellgreen Hill is being eroded by coastal processes but appears to be stable overall (Locally Active).

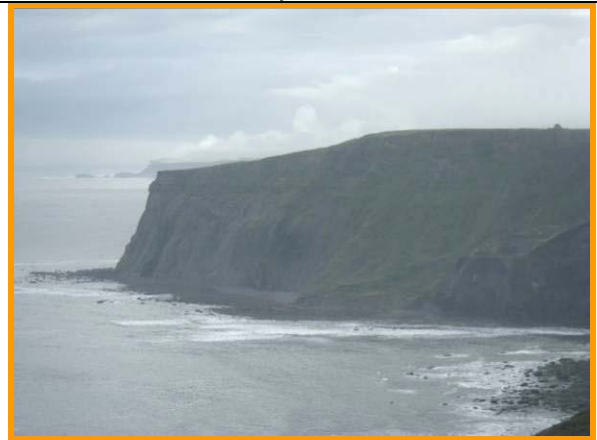
**MU8/11** Some of the slopes are stable enough to support vegetation but a greater proportion of the cliff face is exposed rock (Partly Active).

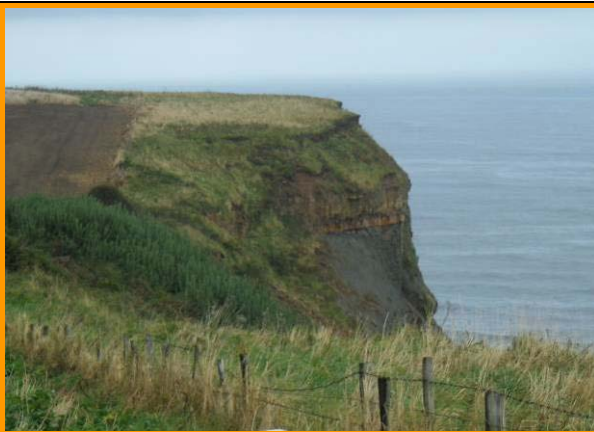
**Unit MU8/12** is immediately south of Keldhowe Steel. The lower slopes are steep and subject to on-going marine erosion. The backscarp also has localised erosion and the unit is classified as Partly Active.

**MU8/12** the cliff is showing signs of regular erosion in the lower two-thirds of the face (Partly Active).

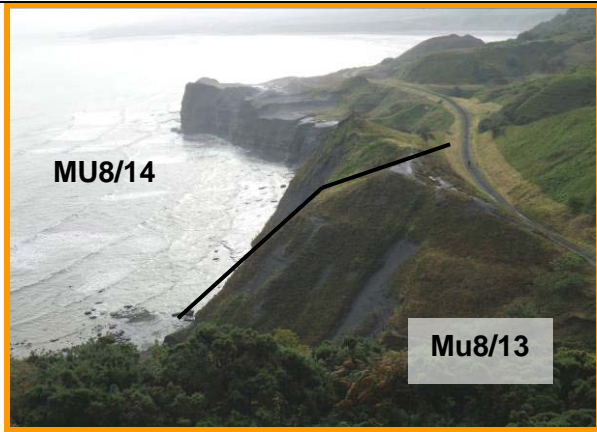
**Units MU8/13, MU8/14 and MU8/15** form the headland of Sandsend Ness and the adjacent cliffs. All units remain classified as Partly Active. The toes of these cliffs are subject to on-going marine erosion and there is evidence for erosion on the upper slopes. The disintegration of abandoned sea defences within Unit MU8/15 are resulting in exposure and erosion of the lower cliff face.

**MU8/13 and MU8/14** Erosion at the toe of the units causes instability to propagate up the face of the cliff (Partly Active) (approx. extents shown).

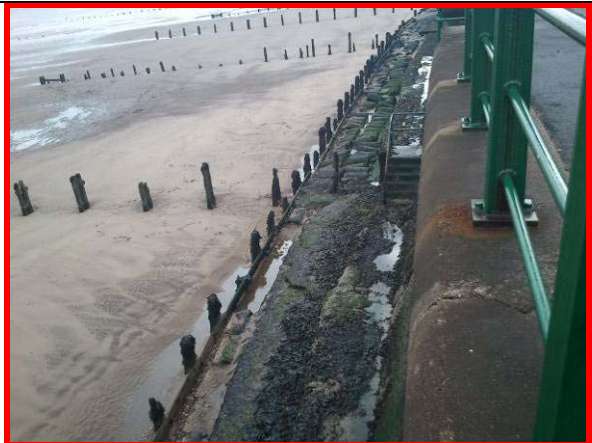
Similarly to the 2009 inspection, the beach was low in front of the main concrete seawall in front of Sandsend village (Asset Ref. 1221D901D0702C01). The groyne field is derelict and the remains have no significant impact on sand movement. The toe of the seawall was showing evidence of significant damage and movement in 2009 and the defence appears to have worsened over the last three years, with the timber breastwork deteriorating and allowing the ad hoc toe protection units to move. There are cracks in the wall and significant abrasion at the steps.

Failed timber groynes and timber breastwork at toe of wall in front of Sandsend (Asset Ref. 1221D901D0702C01)

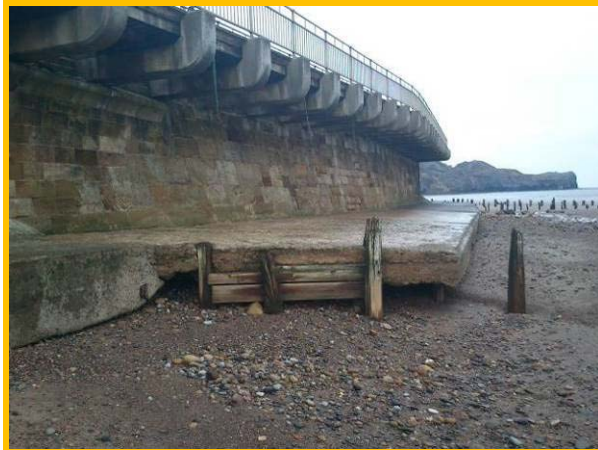
The newer short section of masonry blockwork sea wall (Asset Ref. 1221D901D0702C04) that supports a cantilevered promenade just north of East Row Beck was noted in the 2008 inspection to suffer from undercutting of the toe of the structure with steel sheet piling in need of repair. Although the main wall is in fair condition the defence has an overall rating of poor. The steel toe piling was visible in several locations during the 2012 inspection and is corroded and abraded. There are holes through the piles and voids behind under the apron. There is a particularly large void under the southern end of the apron, see below left.

Masonry blockwork sea wall with cantilevered footway, showing large void under toe apron and failed groynes. (Asset Ref. 1221D901D0702C04)

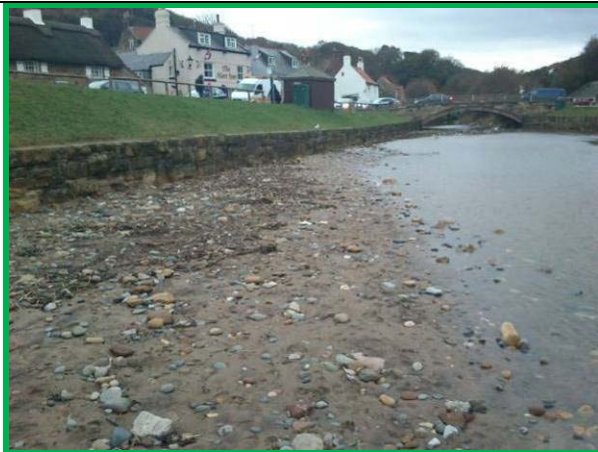
The low masonry wall (Asset Ref. 1221D901D0702C03), below left and right, that returns into both sides of East Row Beck adjacent to the road bridge is in overall good condition, although there is minor abrasion damage to some blocks and locally missing sections of mortar.

Low masonry wall at east Row Beck, south bank. (Asset Ref. 1221D901D0702C03)

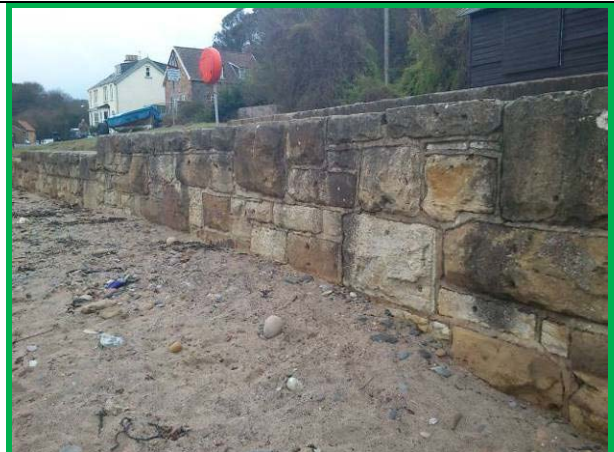
Low masonry wall at east Row Beck, north bank. (Asset Ref. 1221D901D0702C03)

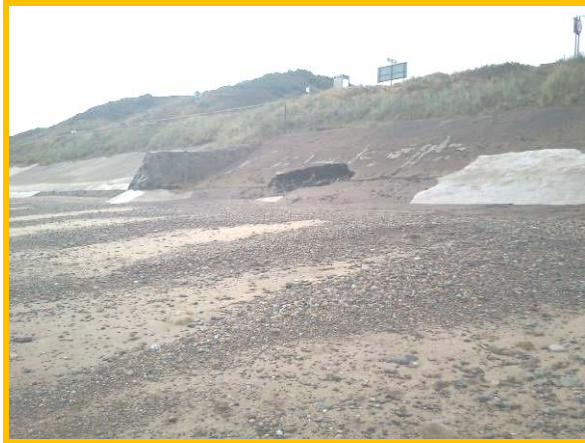
Southeast of Sandsend, a large sloping concrete revetment covering light weight rock armour / rubble runs parallel to the coastal road (Asset Ref. 1221D901D0702C02). This 800m long defence features many significant defects throughout. There was a large void > 1.5m across where the revetment had failed and the underlying rubble was being actively eroded, see photo below top left. There is frequent surface cracking and localised spalling and undercutting and erosion of the toe. There was evidence of several significant repairs since the previous inspection at the east end of the revetment (below top right) and several other areas. The whole asset is in poor condition and it is understood that a capital improvement scheme planned to be undertaken in the near future.

Large void in revetment adjacent to recent patch repair (Asset Ref. 1221D901D0702C02)

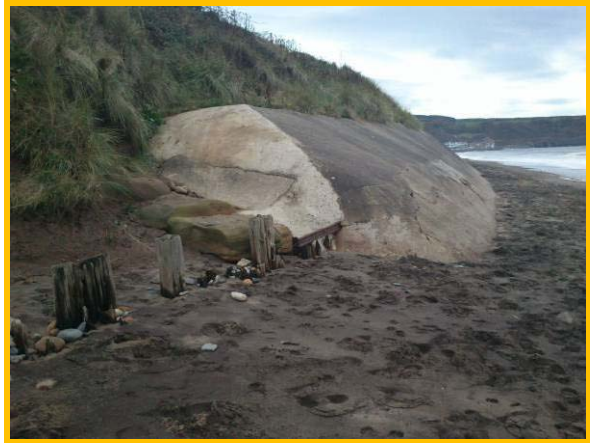
Repair at east end of the concrete revetment since 2009 inspection (Asset Ref. 1221D901D0702C02)

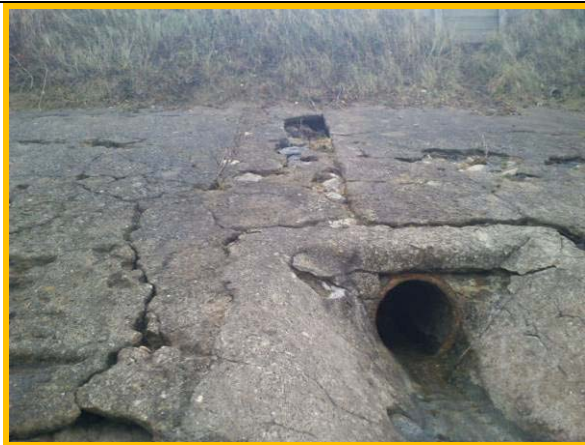
Cracks and voids in surface of concrete revetment (Asset Ref. 1221D901D0702C02)

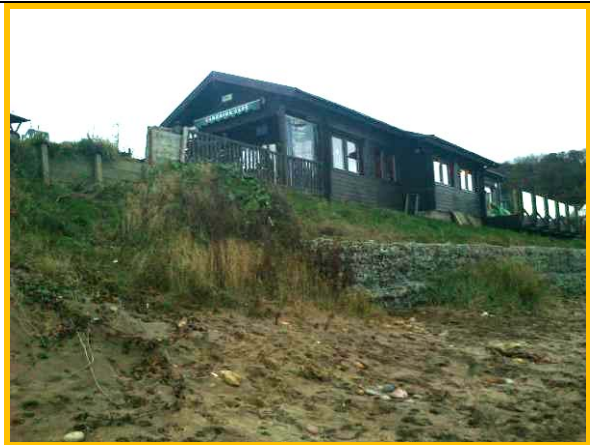
Gabions protecting café at NW end of revetment (Asset Ref. 1221D901D0702C02)

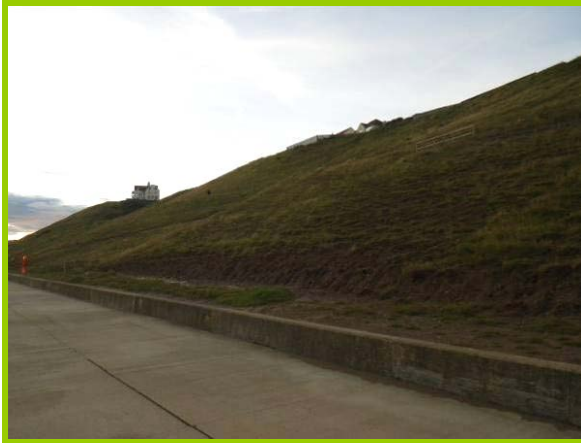
These units are comprised of re-graded slopes which are largely protected by the sea wall and promenade. As a result there is very little evidence of activity. Unit MU11/1 is classified Inactive.

**MU11/1** Regraded, stabilised slopes (Inactive)

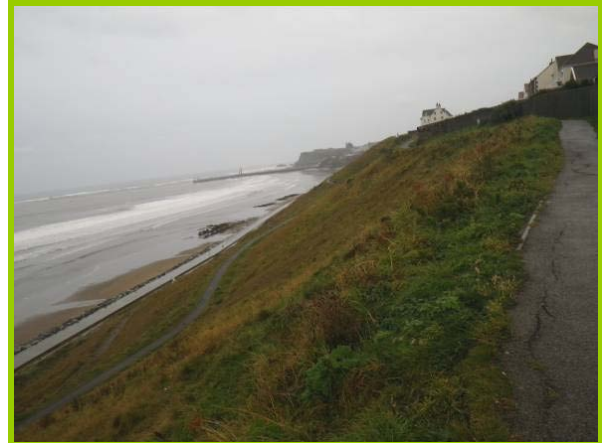
**MU11/1** The upper sections of the slopes are in good condition (Inactive)

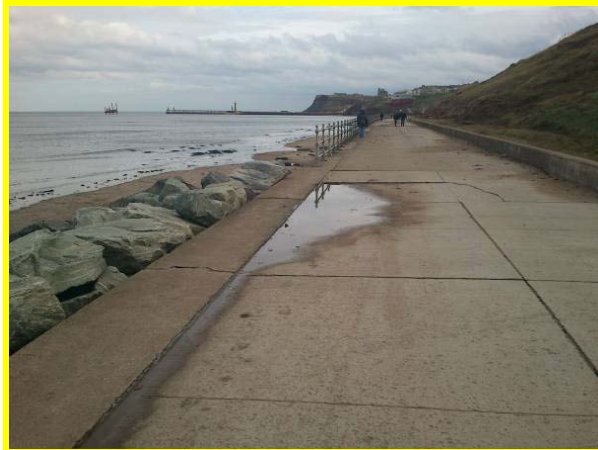
The most westerly defence at Whitby is a rock armour defence fronting the promenade (Asset Ref. 1221D901D0801C01). As in the 2009 inspection the armour is in good condition with only minor movement visible. The asset is in overall good condition although the promenade

is rated as fair as some slabs appear to be sinking with cracks and standing water, which may be a sign of loss of fill and voids beneath - further investigation and monitoring is needed.

Promenade looking south east showing cracks in slabs and standing water (Asset Ref. 1221D901D0801C01)

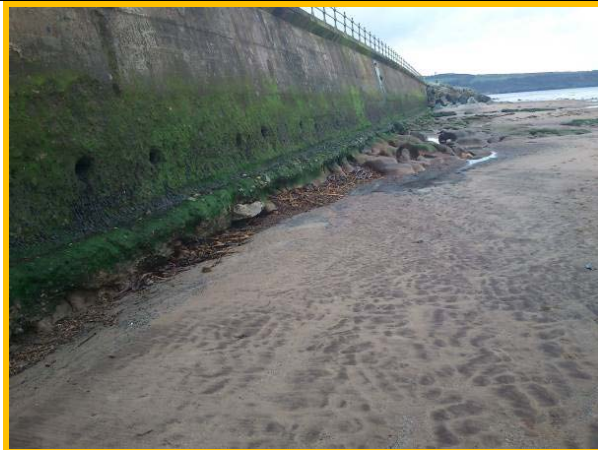
The sections of seawall along the frontage west of the North Beach Café with no protective rock armour, Asset Ref. 1221D901D0802C01, and 1221D901D0802C03 have in many places lost the concrete surface over whole lower half of wall due to abrasion. The toe is exposed and there is undercutting, below left and right. There is also local damage to the wall capping beam and promenade slabs in a number of locations from wave overtopping damage where there is no rock revetment. The large concrete wall structure (Asset Ref. 1221D901D0802C03) is similar to the wall to the north west, but has no rock armour. The toe is exposed and eroded along its length, leading to significant undercutting, although the beach was higher at the time of inspection than during the previous, 2009 inspection. This defence is currently in a poor condition. Repairs to toe are required to prevent future instability of wall and it is recommended that consideration is given to extending the rock armour to this section. Adjacent sections of wall show similar defects although toe is often less visible here

Undermining of toe in section with no rock armour (Asset Ref. 1221D901D0802C01)

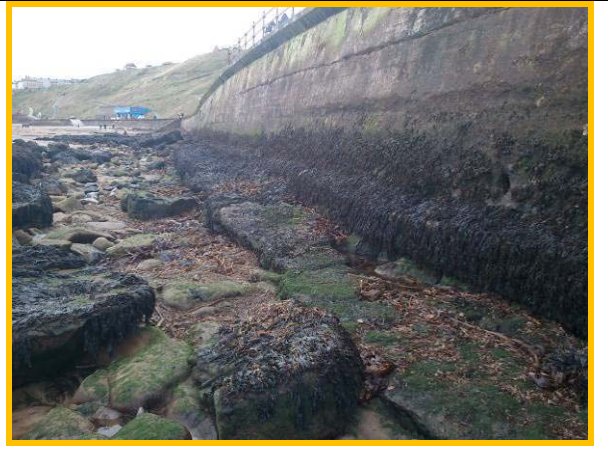
Undermining of toe in section with no rock armour (Asset Ref. 1221D901D0802C03)

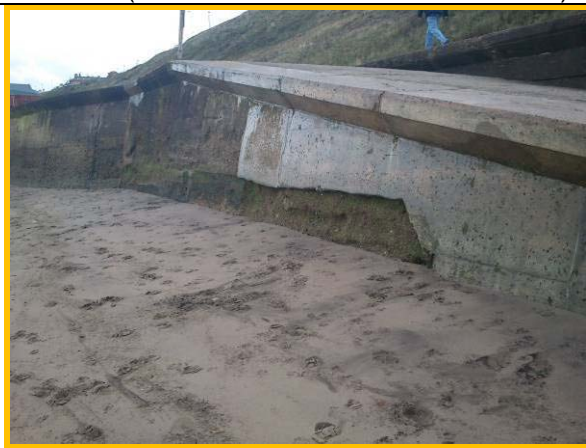
Loss of wall facing and damage to encasement repair (Asset ref. 1221D901D0802C14)

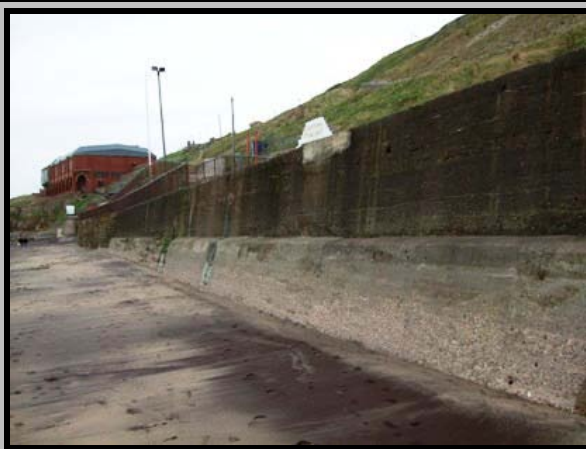
The wall adjacent to Argyle Road is in fair condition, and is intact with no toe exposed at the time of the site visit. However, the front face shows extensive abrasion and erosion and there are significant cracks both through the capping and directly beneath it. Although in some places patch repairs are visible, these defects should be monitored and repaired when possible to prevent further degradation in the future.

Overview of asset, looking south. Patchwork repairs to capping visible – photo from 2009. (Asset Ref. 1221D901D0802C04)

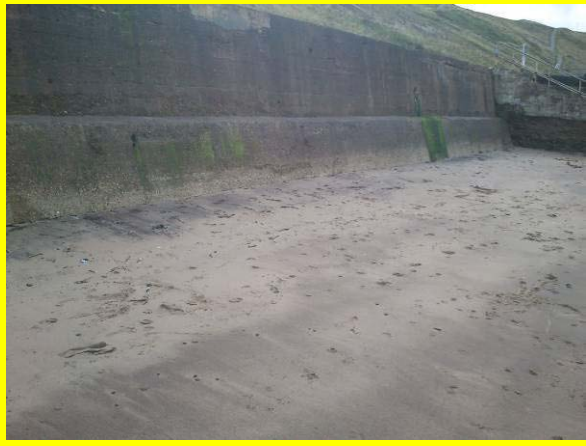
Patchwork repairs to capping holding  
(Asset Ref. 1221D901D0802C04)

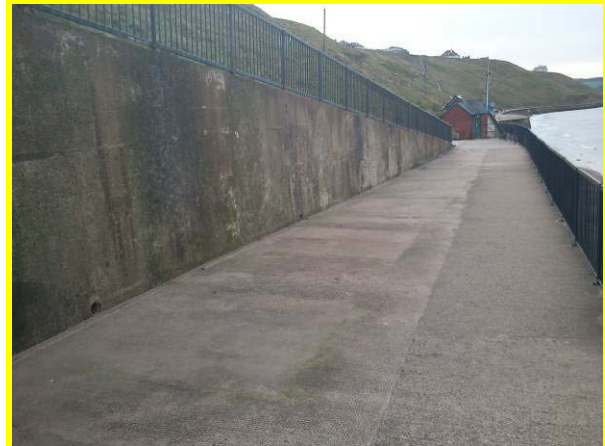
Promenade ramp above seawall  
(Asset Ref. 1221D901D0802C04)

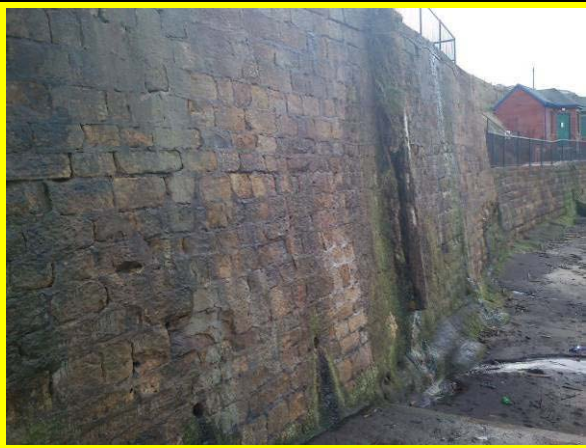
Between Argyle Road and the Royal Crescent, two sections of blockwork separated by a ramp show further defects. There appear to have been some repairs to the blockwork since 2009 and both Assets Ref. 1221D901D0802C07 and 1221D901D0802C06 are in fair condition, but here are cracks through blocks, washout along joints and the capping shows damage. Both assets lengths have pipes exiting through front face, seepage from which has attracted vegetation growth.

Cracking, mortar loss and vegetation growth due to leaking pipe  
(Asset Ref. 1221D901D0802C06)

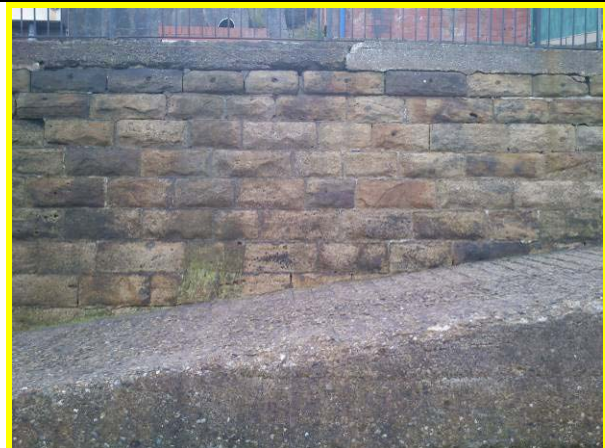
Cracking, mortar loss, damage to capping and localised repairs  
(Asset Ref. 1221D901D0802C07)

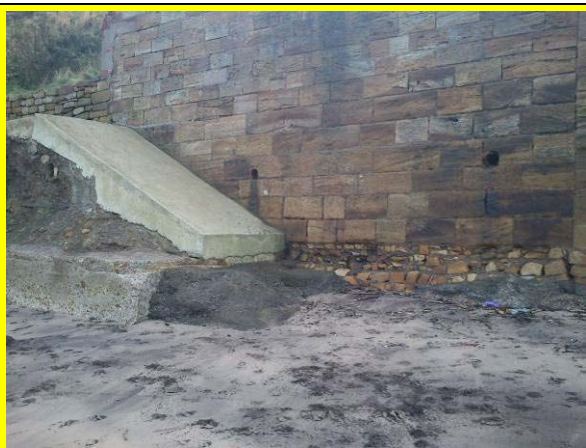
Visible joint washout and seepage  
(Asset Ref. 1221D901D0802C06)

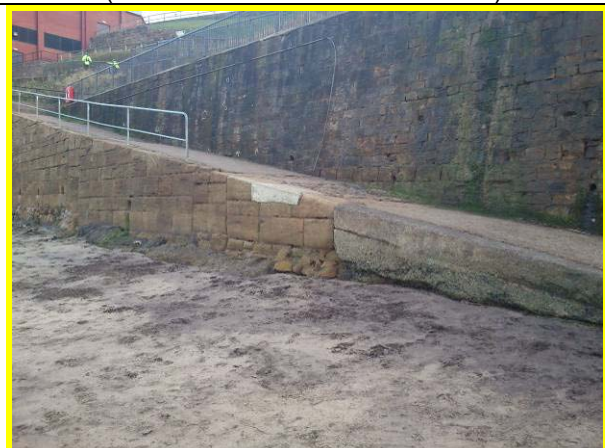
Cracking, mortar loss and damaged blocks (Asset Ref. 1221D901D0802C06)

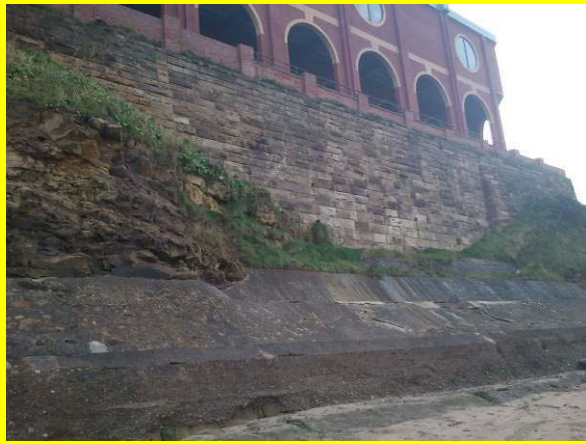
Cracking in concrete revetment toe.  
(Asset Ref. 1221D901D0802C15)

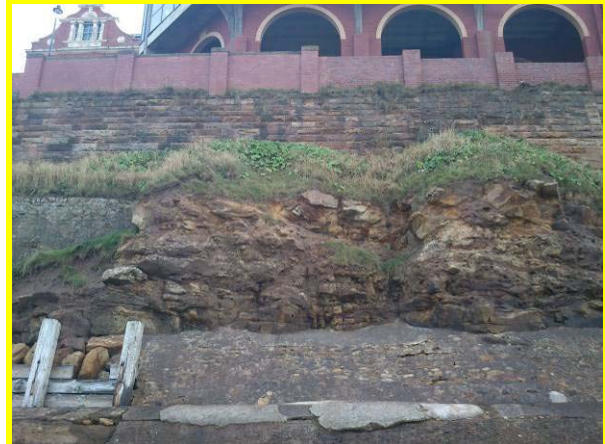
Mortar loss and vegetation growth on upper wall  
(Asset Ref. 1221D901D0802C15)

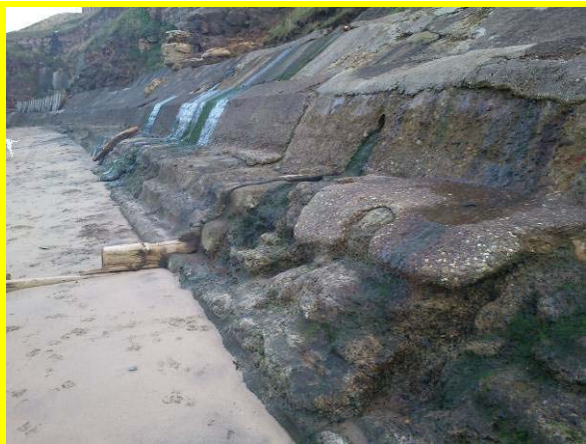
Defence toe suffering abrasion and weathering  
(Asset Refs. 1221D901D0802C05)

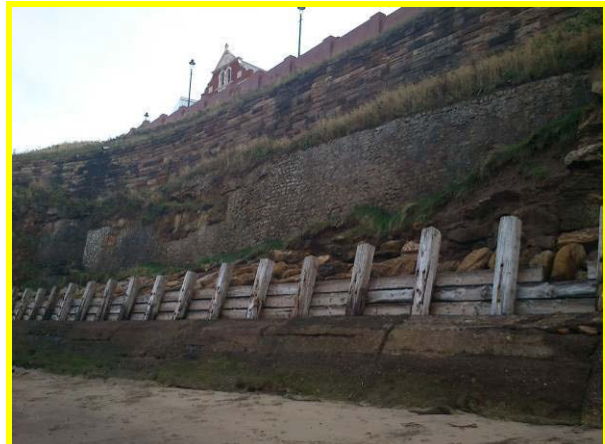
Mortar loss and surface erosion to middle and upper wall  
(Asset Ref. 1221D901D0802C05)

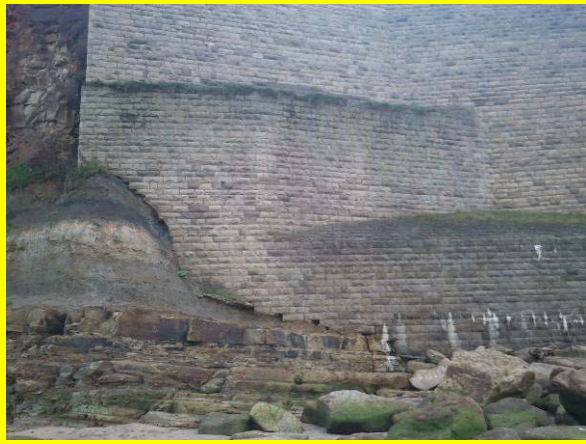
To the east of the theatre the natural cliff is intermittently defended with a series of blockwork and brickwork sections. These vary in construction and are generally in good condition, but there are areas of undercutting and erosion at the interface between the blocks and the natural cliff, which require repair and lowers the condition to a 'fair' grading.

Cliff protected with block/brickwork undercutting at interface with cliff requires repair (Asset Refs. 1221D901D0802C09)

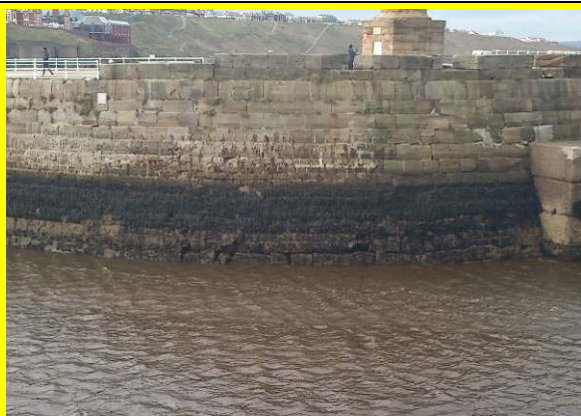
Missing blocks at LW line NE corner of West Breakwater (Asset Ref. 1221D901D0803C02)
