**Walk-over Visual Inspections of Assets  
including Coastal Slopes**

**Scarborough Borough Council  
Final Report**

**October - November 2012**

## Coast Protection Assets and Coastal Slope Condition Analysis

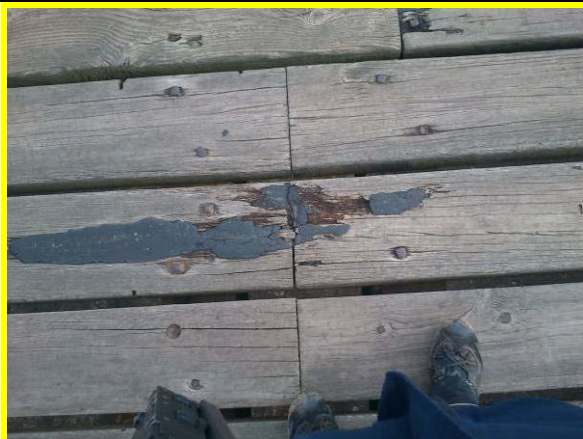
There is a new access bridge, opened in July 2012 between the main and outer western breakwaters. The timber deck of the western outer breakwater (C01) was in a fair condition, with evidence of rot to some ends of some planks, below left, and it is slippery when wet so may present a possible H&S issue. The supporting timber structure was not inspected due to limited access.

Evidence of rot in ends of timber desk on West Pier extension (Asset Ref. 1221D901D0803C01)

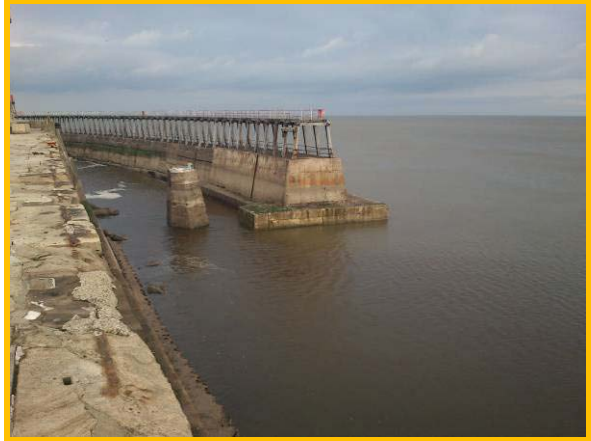
An urgent works scheme was undertaken recently to repair the southern end of the outer east breakwater where a large void had formed in the structure behind the sheet pile toe which had failed following corrosion and abrasion. Despite the repair the asset remains in overall poor condition due to corroded toe piling and rotting timber deck structure. This asset was only inspected from the main east breakwater as there is no access on foot even at low water.

South end of outer east breakwater extension arm, where failed toe piling has been replaced with precast concrete panels. (Asset Ref. 1221D901D0803C04)

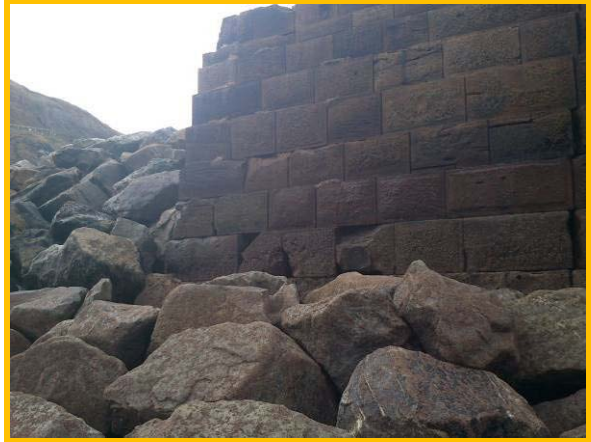
Loose blocks at south outer end of east breakwater (Asset Ref. 1221D901D0803C03)

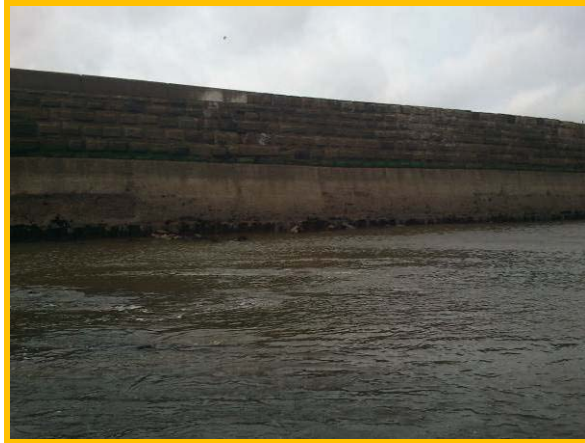
Area of displaced blocks on outer face of east pier (Asset Ref. 1221D901D0803C03)

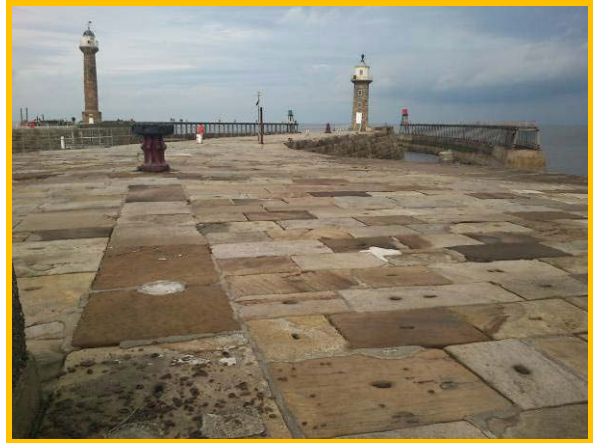
Open gaps between sandstone slabs in deck of east pier (Asset Ref. 1221D901D0803C03).

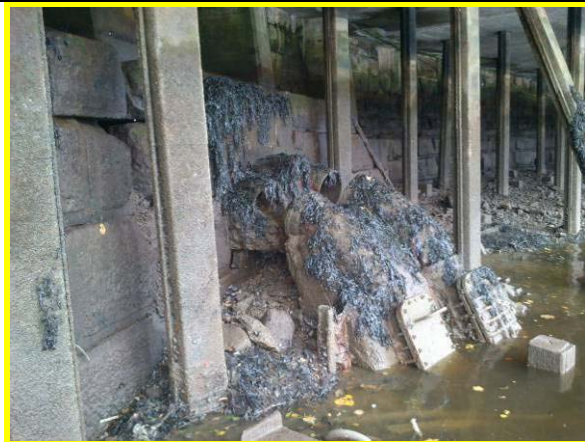
Broken outfall between promenade supports under pier (Asset Ref. 1221D901D0803C06)

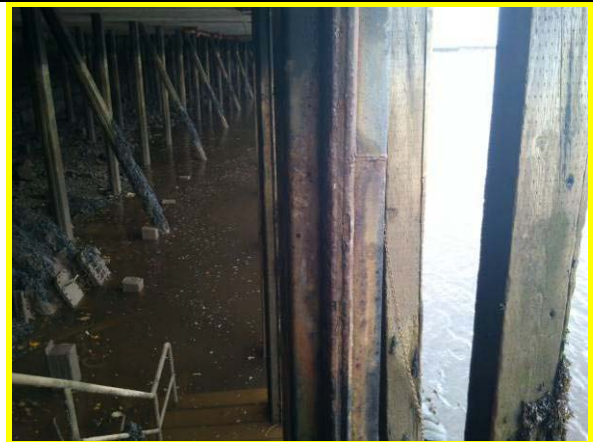
The west harbour pier at the fish quay consists of a concrete slab suspended over the original quay wall with concrete filled vertical and raking steel pile supports, see photos below. There is corrosion to the steel piles, which look rather slender and susceptible to damage. It was not possible to inspect the underside properly as this would require a boat even at low tide. There is a broken outfall under the pier at the south end, see below right. There were broken vertical timber fender piles at the fuel berth that need repairing urgently as they provide protection to the main pier support piles.

Corrosion to deck support columns (Asset Ref. 1221D901D0803C06)

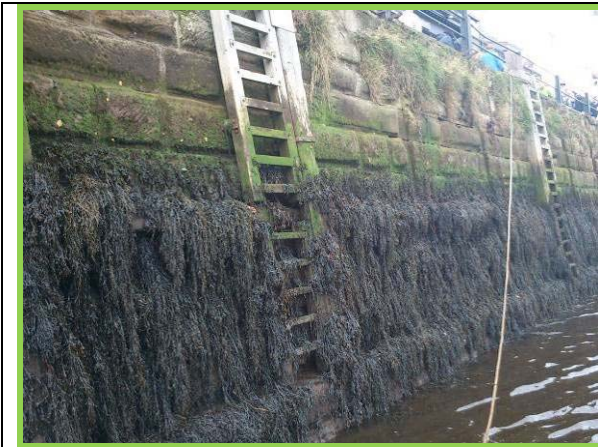
The inner section of the west harbour quay wall (Asset Ref. 1221D901D0803C07), near the swing bridge was largely obscured by seaweed on the lower wall and vegetation growth to the upper wall, see below left. The promenade is in good condition. There is wash out of joints at the set of stairs at middle of wall length.

Inner west quay wall near swing bridge, (Asset Ref. 1221D901D0803C07)

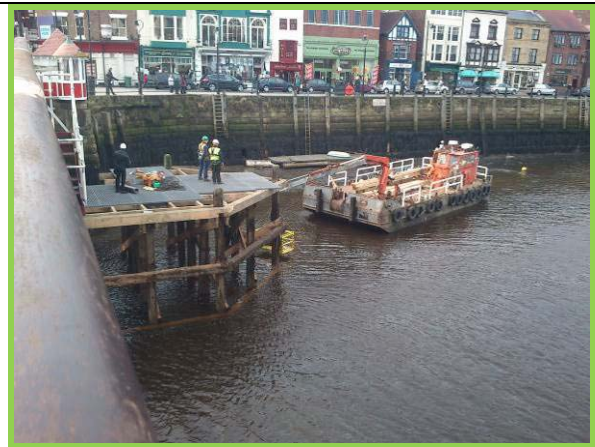
Repairs underway to swing bridge fendering

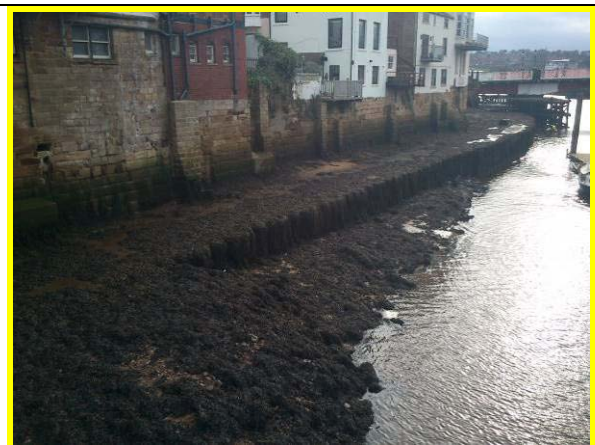
The inner wall on the east side, between the swing bridge and the RNLI berth consists of a variety of riparian property walls, which are protected by concrete apron and a sheet pile toe, below top right (Asset Ref. 1221D901D0803C10). Access is difficult so inspection was from the RNLI berth and swing bridge.

Sheet piling and toe apron protecting property walls (Asset Ref. 1221D901D0803C10)

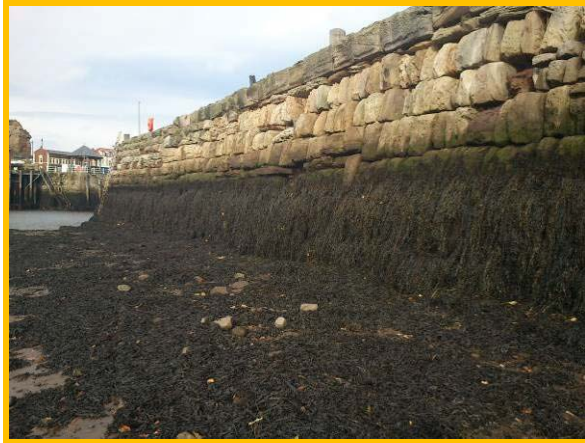
Heavily weather blocks on south side of Tate Hill pier (Asset Ref. 1221D901D0803C08)

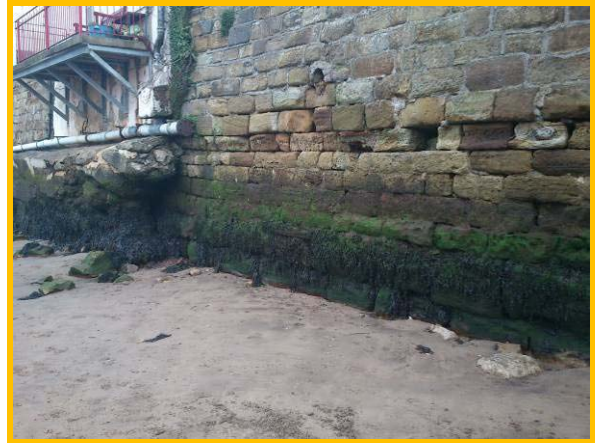
Wall at east side of harbour south of Tate Hill pier (Asset Ref. 1221D901D0803C08)

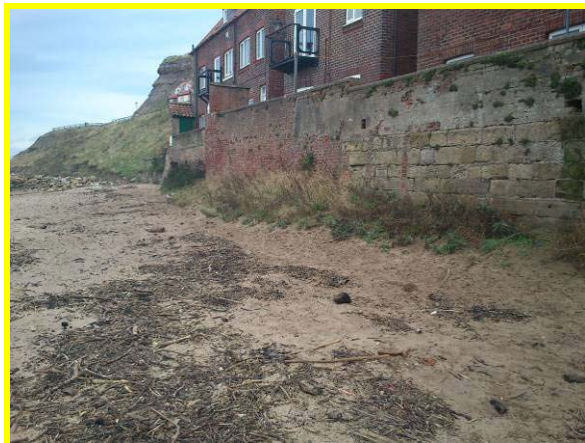
Riparian walls backing sandy beach in east side of harbour, (Asset Ref. 1221D901D0803C09)

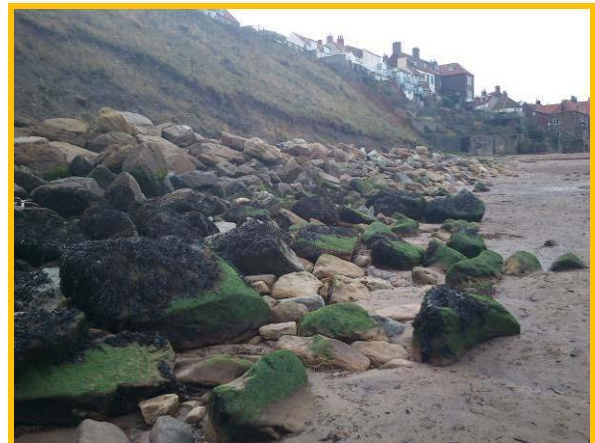
North of Tate Hill pier, the harbour wall is fronted by a sand beach, with a variety of riparian walls at the back, Asset ref. 1221D901D0803C09, below left. Between here and the main harbour East Pier there is a rock revetment protecting the toe of the slope at the Haggerlythe, 1221D901D0803C05. This was constructed in 2001, but is in poor condition. The same asset reference continues outside the East Pier below the abbey for about 200m, and here larger rock was used in the 2001 scheme. Within the harbour the revetment is showing signs of significant damage, with displacement of the armour and exposure of the geotextile netting stabilising the slope above, see photo below right. This armour needs re-profiling and topping up with larger armour.

Displaced rock armour and damaged revetment at the Haggerlythe inside harbour adjacent to east pier (Asset Ref. 1221D901D0803C05)

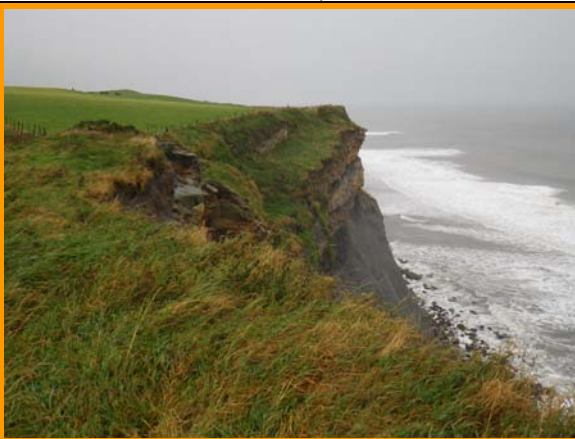
**Unit MU13/5** is formed by the shallow, relict debris flow lobe at Black Nab. The slopes of this unit are well vegetated, with localised activity evident at the toe and headscarp. This unit was classified as Locally Active in 2009 but the activity noted at the headscarp and toe means it is classified as Partly Active in 2012.

**MU13/5** The cliff is showing signs of erosion in the lower half of the face (Partly Active).

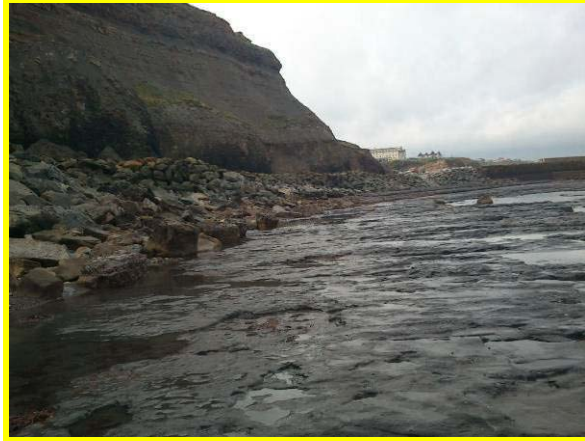
There is a section of rock armour protecting the eastern side of the harbour and toe of Abbey cliff directly to the east of Whitby harbour East Pier. The rock armour varies in size from 1-4

tonnes to 5-8 tonnes. (Asset Ref No.1221D901D0803C05) and is in fair condition, below left and right, although there are areas that would benefit from topping up with additional armour stone.

Rock armour protection to toe of Abbey Cliff (Asset Ref. 1221D901D0803C05)

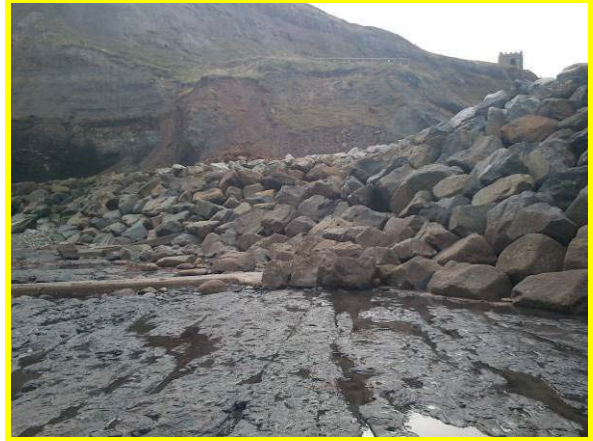
Rock armour at interface between east pier and Abbey cliff (Asset Ref. 1221D901D0803C05)

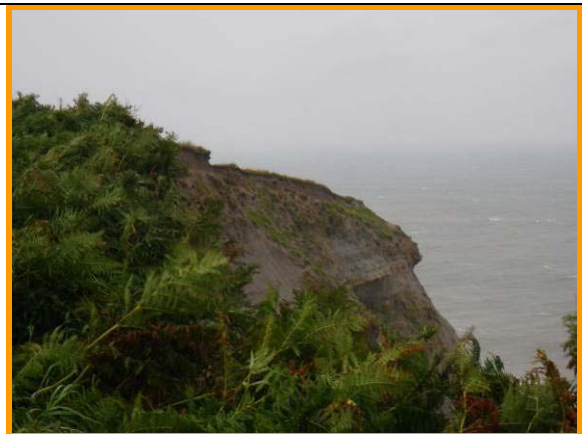
**MU15/2** An area of intense erosion (Partly Active)

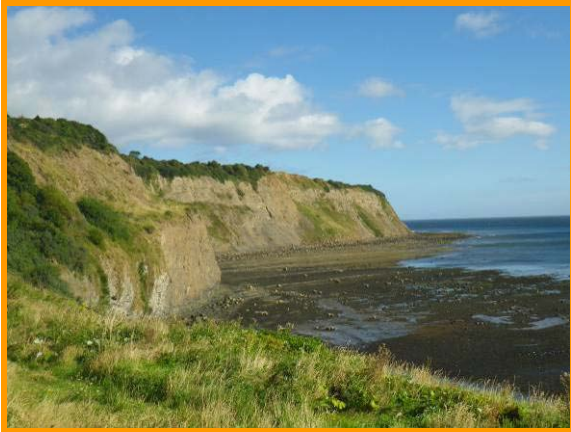
**MU15/3** The cliff face supports patchy vegetation  
(Partly Active)

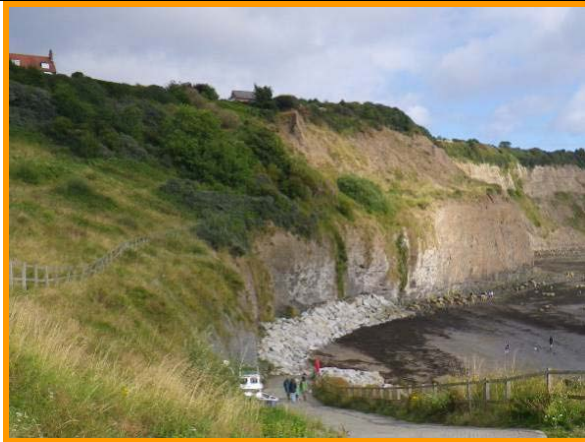
**MU16/1** Cliffs below the upper part of Robin Hood's Bay Village (Partly Active)

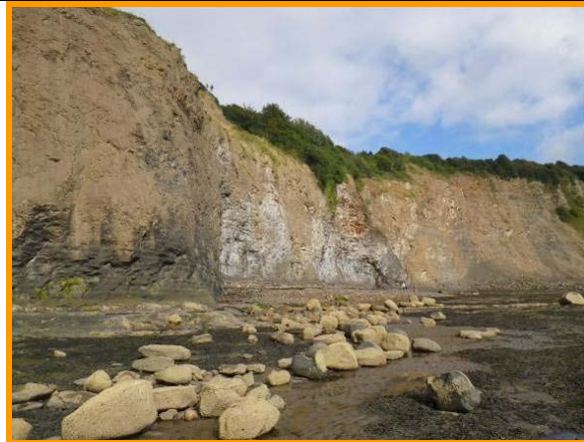
**MU16/1** the base of the cliff continues to erode. The undercutting of the cliff is evident in the left side of the photograph (Partly Active)

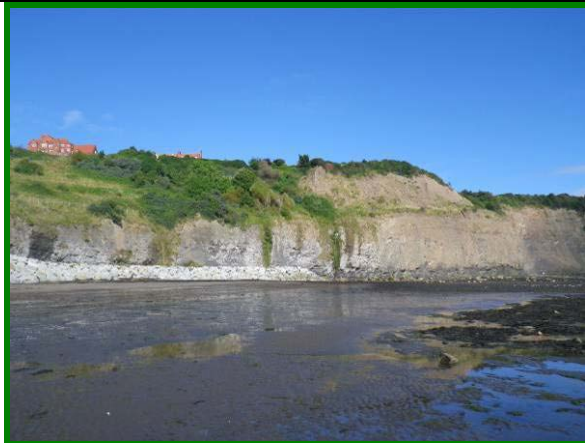
**Units MU16/2 and MU16/3** are stabilised landslides that form the lower parts of Robin Hood’s Bay Village and are both classified as Dormant. The units are protected by sea defences and show no evidence of recent activity.

**MU16/2** The cliffs have been stabilised at the toe but show some signs of erosion on their face (Dormant).

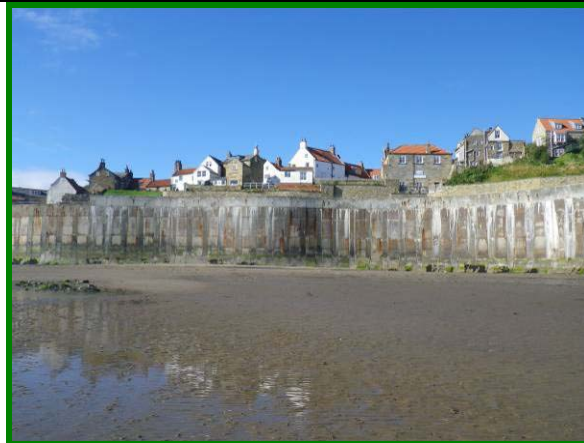
**MU16/3** The cliff at this location has been stabilised and is not visible through much of the unit (Dormant).

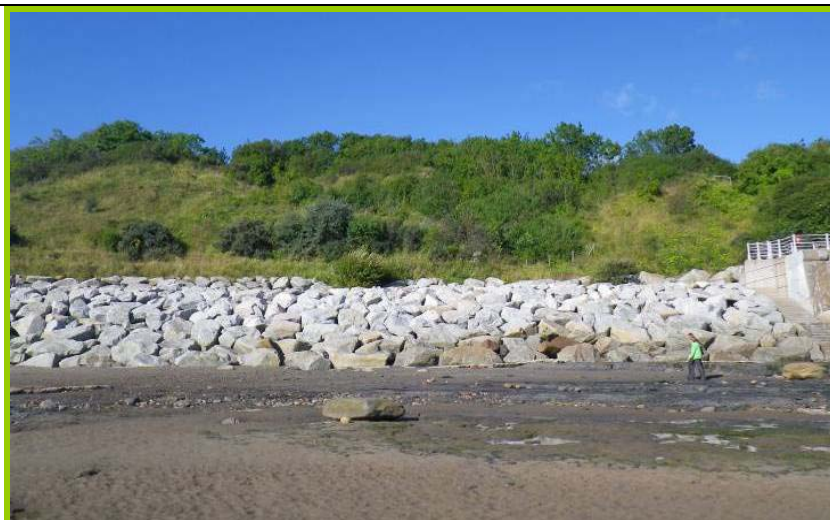
This Sub-Management Unit consists of **unit MU17/1** only. This unit is defended at the toe by a sea wall and rock armour. The slopes are densely vegetated with trees and shrubs and show little evidence of recent activity. As a result this unit is classified as Inactive, as it was in 2008.

**MU17/1** The defended toe and heavily vegetated slopes show that the unit has been stable (Inactive)

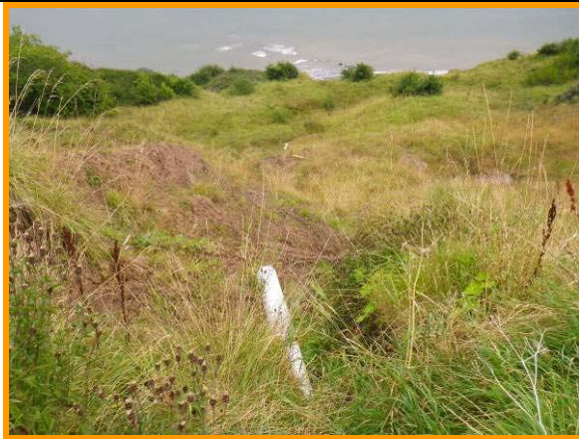
**Unit MU17/2** is protected in part by rock armour at the toe. The slopes are generally well vegetated with some exposed areas at the head and mid-slope where evidence of sliding and gullies are present. A tension crack has opened at the back of the cliff so the instability is continuing and propagating landward. This unit classified as Locally Active 2009, but is now considered to be Partly Active, due to the evidence of instability throughout the unit.

**MU17/2** The land drains from the adjacent fields are draining on to the cliff and causing instability (Partly Active).

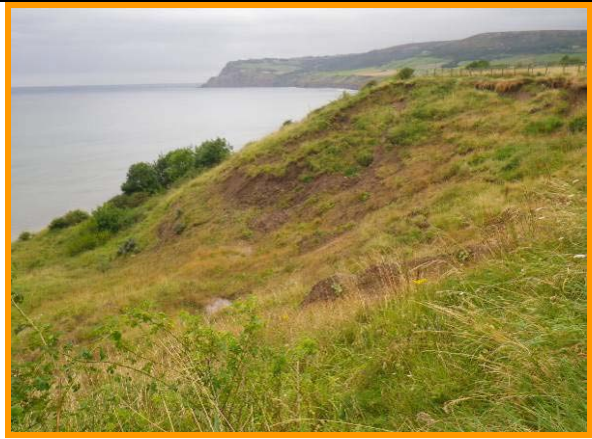
**MU17/2** The slope is showing evidence of ground movement (Partly Active).

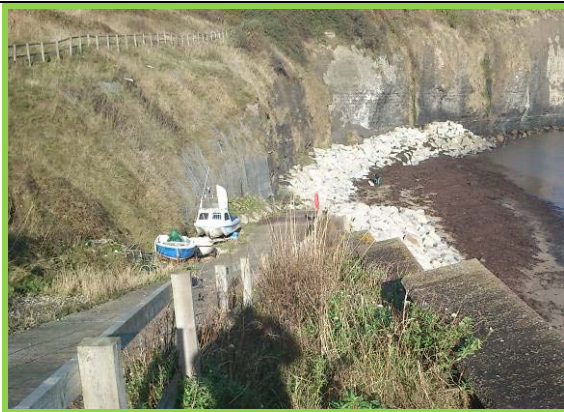
The most northern defence at Robin Hoods Bay is a section of rock armour protecting the cliff toe to the north of the northern slipway, Asset Ref. 1221D901D1002C02. This rock armour constructed as part of the 2001 scheme is in good condition, see photo below, top left.

Rock armour at north end of defence system (Asset Ref. 1221D901D1003C02)

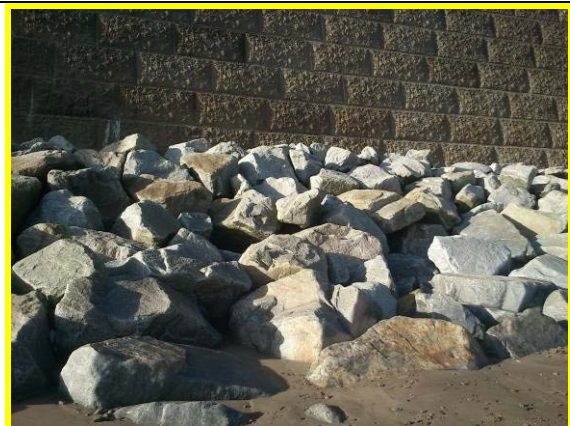
The large sea wall (Asset Ref. 1221D901D1003C01) that was built in 2001 is fronted by rock armour and incorporates a slipway / ramp to its northern end. The wall is in very good condition. Joints and sealant show no signs of damage or minor defects. The rock armour at the toe is also very good, apart from one area near the centre where there are several gaps indicating displaced armour units. The timber fence adjacent to the ramp, see photo below top left, has some rotten / broken rails that need replacing. The northern slipway has some abrasion damage near the toe and missing joint filler, but is overall in good condition

Section of rock armour with gaps / displaced units in front of 2001 seawall. (Asset Ref. 1221D901D1003C01)

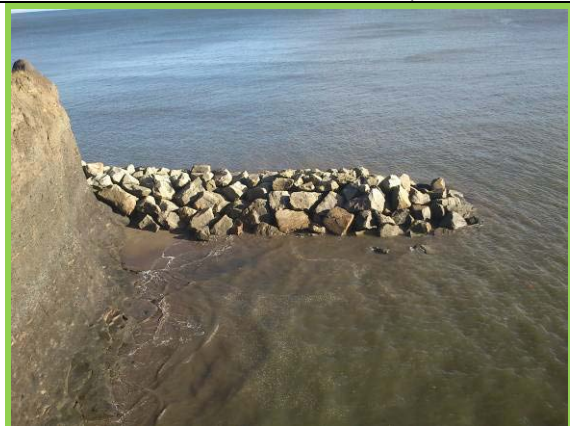
Rock armour extension at the interface between defended and undefended section. (Asset Ref. 1221D901D1003C01)

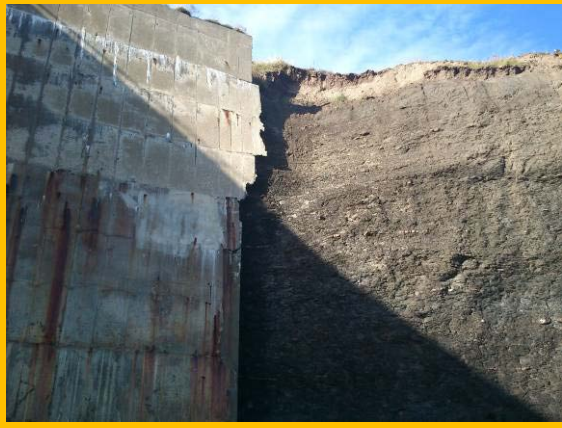
Large vertical wall at Robin Hood's Bay  
(Asset Ref. 1221D901D1003C02)

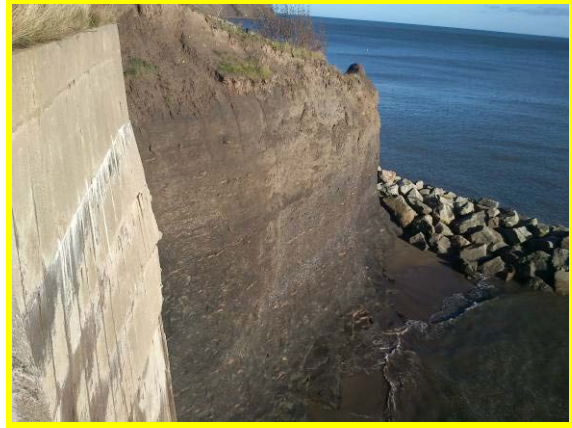
Between the 2001 seawall and the large vertical defence wall built in 1975 further south there is a short 25m length of undefended shale cliff, Asset Ref. 1221D901D1003C03, which is slowly eroding, see photo below right and threatens to undermine the north end of the vertical wall.

Short section of undefended cliff  
(Asset Ref. 1221D901D1003C03)

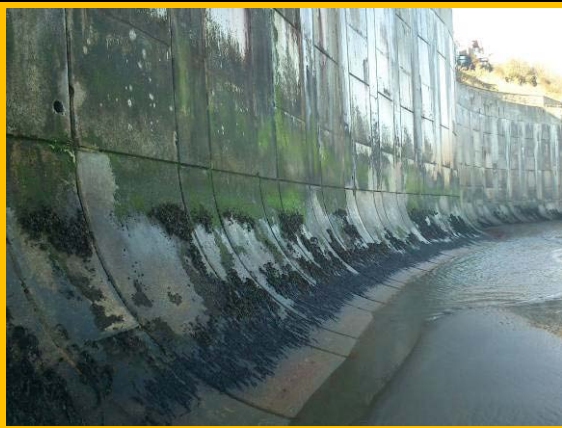
The large vertical concrete wall that was constructed in 1975 (Asset Ref. 1221D901D1003C02) is in poor condition, showing evidence of surface cracking, rust marks indicating corrosion of the reinforcement steel, mineral encrustation, seepage, and extensive cracking and repair work to the crest of the wall. Previous inspections have also noted some evidence of undercutting at the toe, but this was not visible at the time of inspection due to the beach levels. The recently developed strategy has proposed a capital scheme to repair and refurbish this wall.

Large vertical wall at Robin Hood's Bay in poor condition  
(Asset Ref. 1221D901D1003C02)

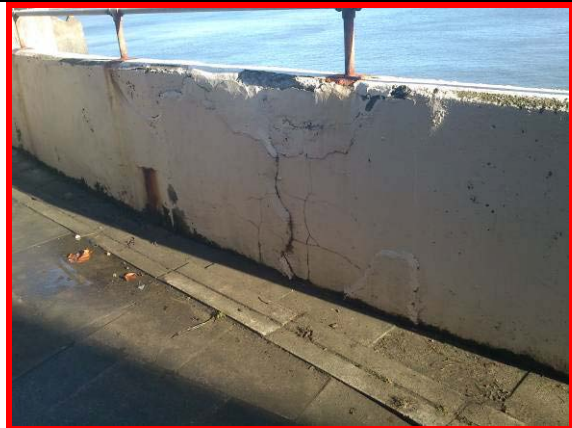
Crest wall in locally very poor condition  
(Asset Ref. 1221D901D1003C02)

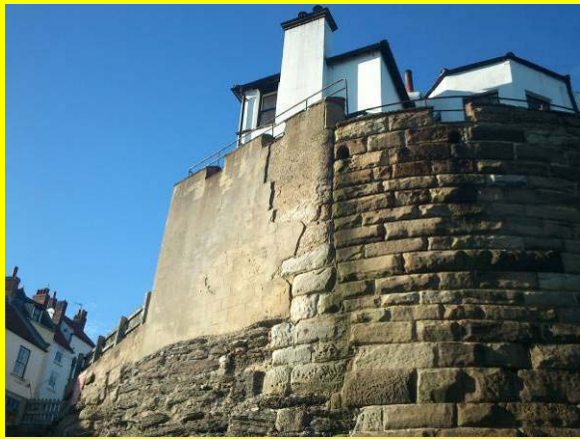
The short section of defence between the central slipway and the vertical wall (Asset Ref. 1221D901D1003C04) has an exposed toe at the north and evidence of large cracks at its southern end. There are large voids in the masonry wall, >0.5m deep as evidenced by water pouring out as the tide receded. Above the wall there is loose spalling blockwork style render to upper property wall that could fall on pedestrians. There is some evidence of repair work and re-pointing to the joints but further repairs are needed, including grouting the deep voids.

Loose render on property wall to north side of slipway (Asset Ref. 1221D901D1003C04)

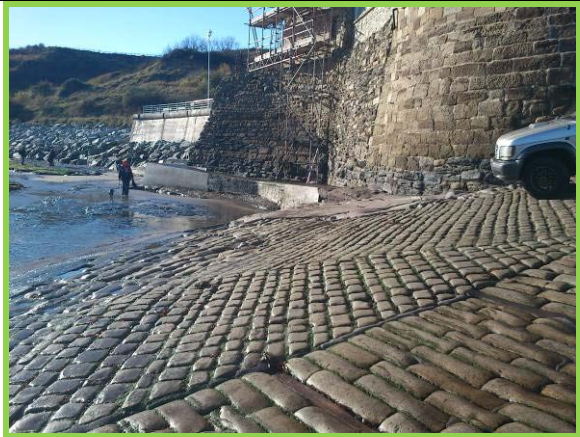
The adjacent central slipway (Asset Ref. 1221D901D1003C05) is in an overall good condition, with signs of wear, minimal cracking and limited loss of cobble stones, see photos below, lower left and right. This structure needs regular inspections and minor repairs to keep it in good order.

Central Slipway in overall good condition (Asset Ref. 1221D901D1003C05). (Masonry wall forming property foundations to rear in fair condition -1221D901D1003C06).

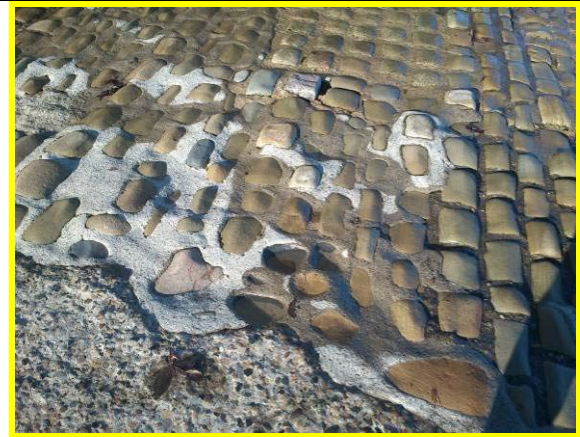
Missing cobbles and mortar in slipway, with evidence of previous repair work with contrasting colour mortar. (Asset Ref. 1221D901D1003C05)

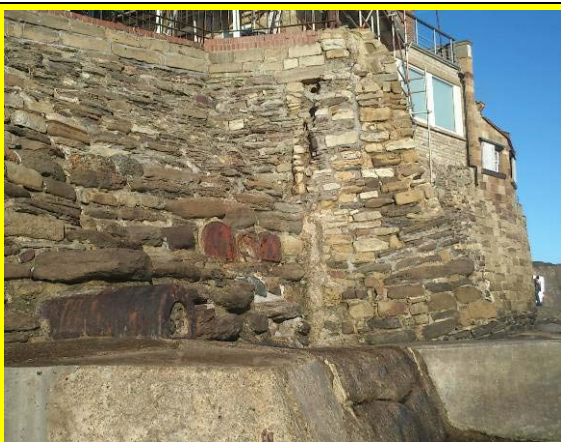
The mixed construction defence (Asset Ref. 1221D901D1003C06) on the south side of the slipway has mass concrete toe at the base with a variety of stone and blockwork above. The defence has a patchwork of previous repairs and repointing throughout but further work is needed. There is a large crack visible in south end of the concrete toe and some undermining of the toe was apparent. There were some missing stone blocks in return end at south.

Cracks and missing stonework in upper wall (Asset Ref. 1221D901D1003C06)

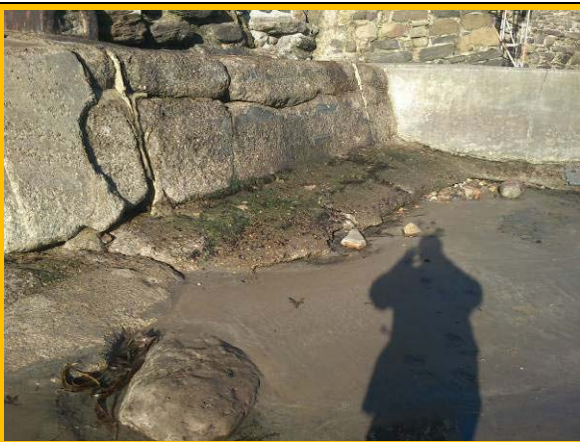
Wide cracks to toe of wall and undermining (Asset Ref. 1221D901D1003C06)

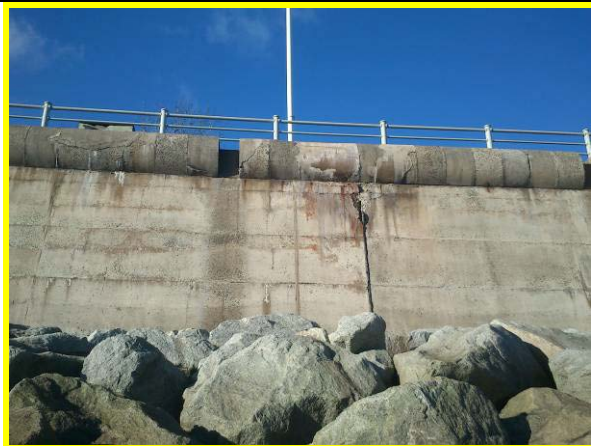
At the south of the village is the concrete sea wall at the Quarter Deck (Asset Refs. 1221D901D1003C10). This was given rock armour toe protection as part of the 2001 scheme. The rock armour is tightly packed and is providing good protection to the toe of the sea wall behind. The upper sections of the sea wall itself show some evidence of seepage through the blockwork joints, and cracking and erosion to the capping beam and spalling, although there is evidence of repairs since the 2009 inspection. The promenade above the sea wall is in a good condition, with only minor defects present. The timber access stairs down onto the Quarter Deck are worn and show signs of previous repairs and will need replacing in future.

Quarter Deck sea wall with cracked capping beam with previous repairs (Asset Ref. 1221D901D1003C10)

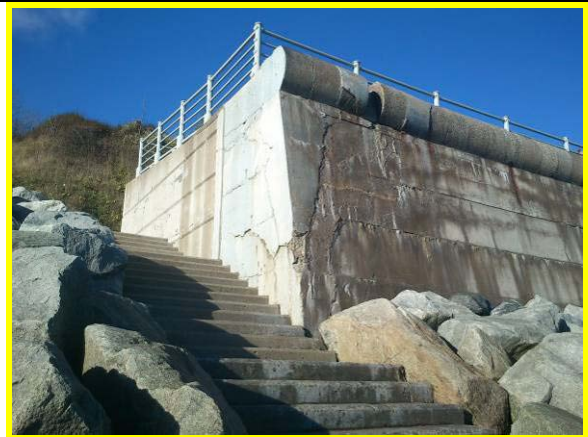
Failing previous repairs at south end of Quarter Deck (Asset Ref. 1221D901D1003C10)

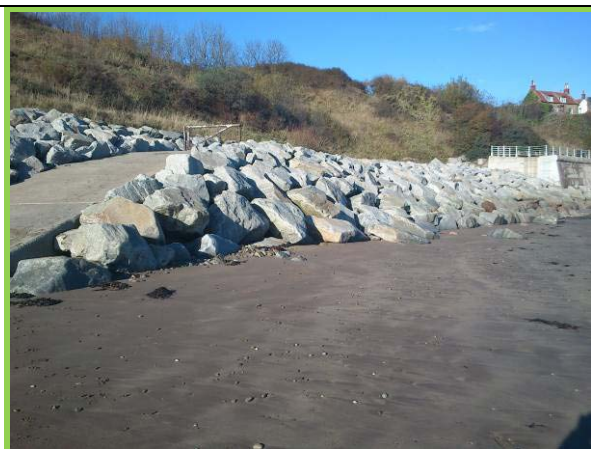
At the south of the Quarter Deck there is a length of rock armour defence with a slipway / ramp, both of which were constructed in 2001, see photo below left. The rock armour is in very good condition, is tightly packed and performing well, although there are two armour units that have been displaced near the centre (Asset Ref. 1221D901D1003C09). The barrier gate on the ramp is rusted and needs repainting. There was evidence of fire / barbeque damage to the plastic geotextile mesh in the concrete deck north of the barrier.

Rock armour and ramp south of Quarter Deck (Asset Ref. 1221D901D1003C09)

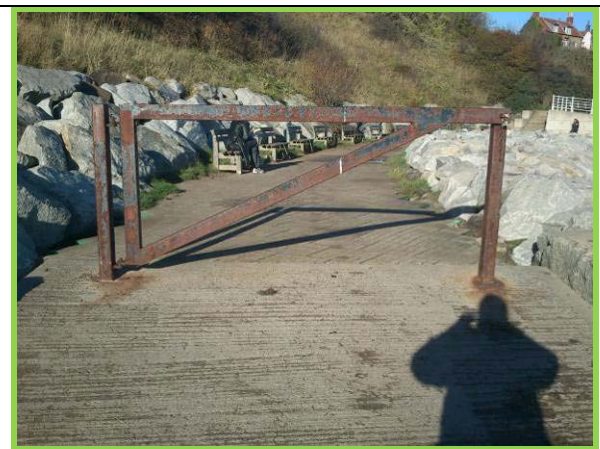
Promenade above rock armour. (Asset Ref. 1221D901D1003C09)

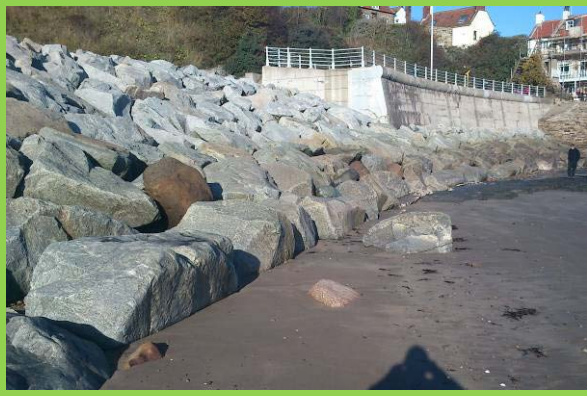
Apparently displaced rock armour units (Asset Ref. 1221D901D1003C07)

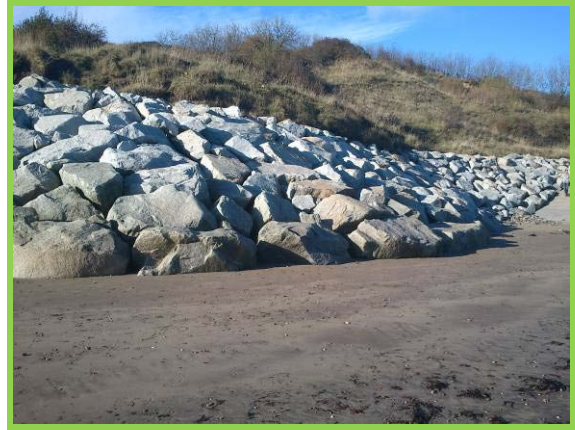
Tightly packed rock armour (Asset Ref. 1221D901D1003C07)

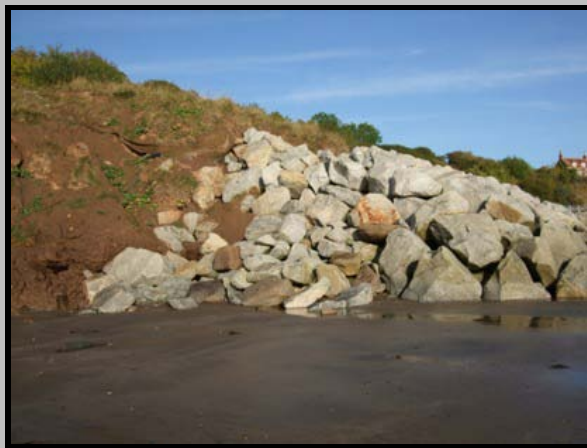
Southern extent of rock armour - photo from 2009 inspection (Asset Ref. 1221D901D1003C07)

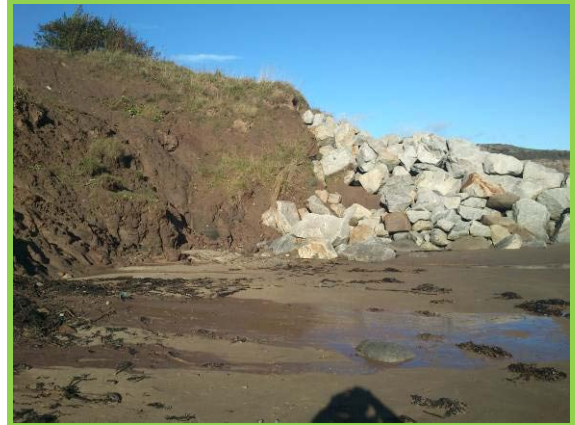
To the south of the southern ramp is a short section of rock armour built in 2001 to stabilise the cliff and prevent outflanking of the Quarter Deck wall, Asset Ref 1221D901D1003C07. At the south end the eroding adjacent cliff is starting to cause some unravelling and it is suggested that in future after further erosion the rock armour should be reprofiled to form a double sided defence, in a similar way to the transition at the south end of the northern section of rock armour (Asset 1221D901D1003C03).

Erosion adjacent to south end of rock armour. November 2012 (Asset Ref. 1221D901D1003C07)

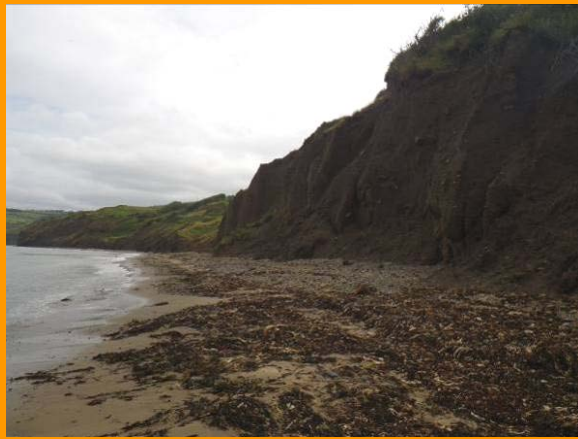
**MU175** has been subject to marine erosion at the toe of the cliff (Partly Active)

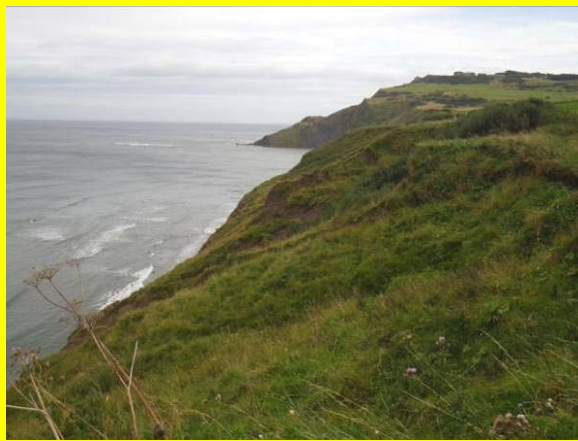
**MU176** Locally Active the slopes in the foreground are well vegetated with some signs of movement on the face (Locally Active).

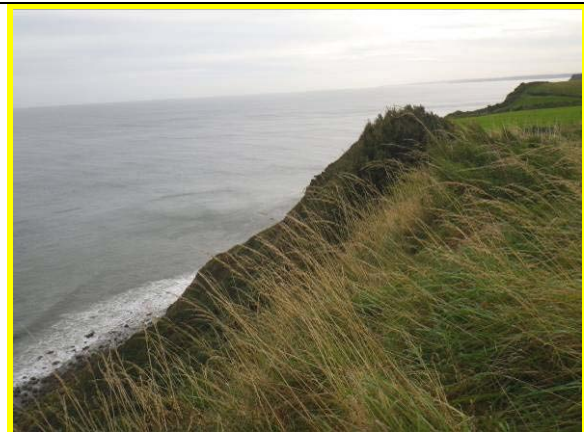
This Sub-Management Unit consists of **units MU18/3 and MU18/4**, both of which are classified as Locally Active. The cliffs have a distinct ‘undercliff’, formed by seepage erosion and landsliding conditioned by variations in the geology. The slopes are well vegetated with only localised patches of activity evident at the slope toe. These units have not changed activity status since 2009.

**MU18/4** Vegetated overall but with localised erosion (Locally Active)

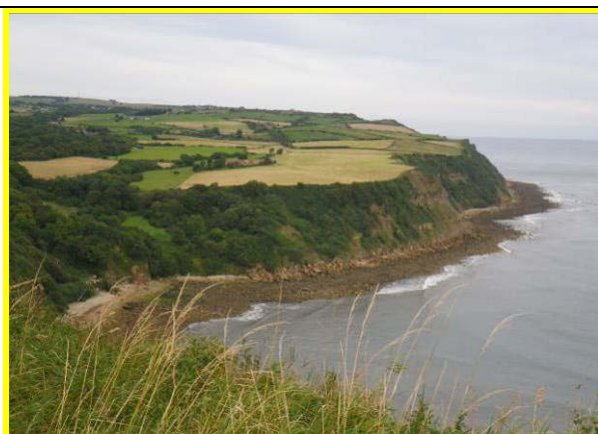
**MU19/2** Looking north across Hayburn Wyke at the vegetated cliffs (Locally Active).

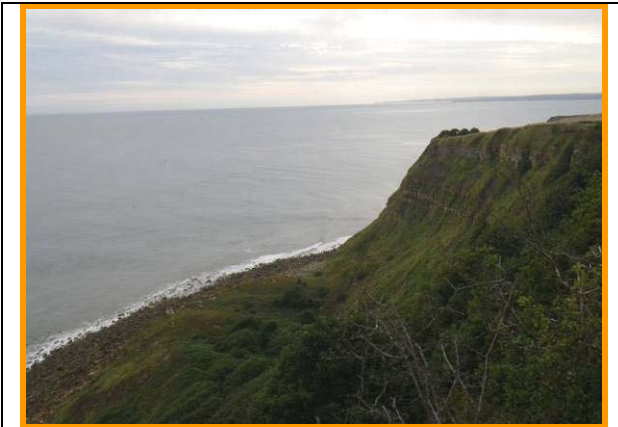
**Unit MU19/4** is located immediately to the north of Cloughton Wyke. The unit is characterised by high, steep cliffs which are more active than those cliffs further north. There is some recession of the headscarp. This unit continues to be classified as Partly Active.

**Mu19/4** The upper slopes are vegetated but the lower slopes are (Partly Active)

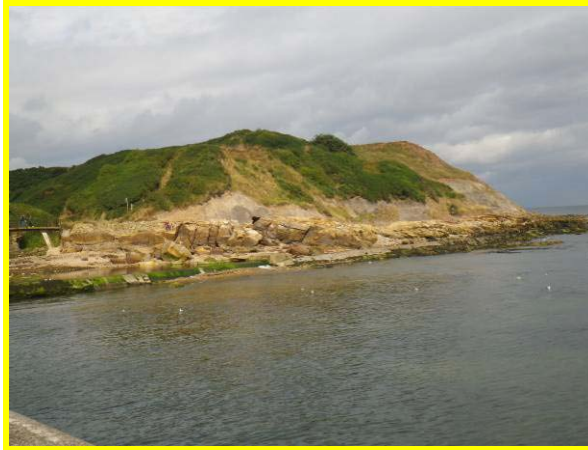
The Scalby Ness headland comprises **unit MU19/11**. This area is well vegetated with only localised activity evident at the toe and some recession at the headscarp. This unit is classified as Locally Active.

**MU19/11** Long Nab is eroding at the toe but the cliff face is well-vegetated and stable (Locally Active)

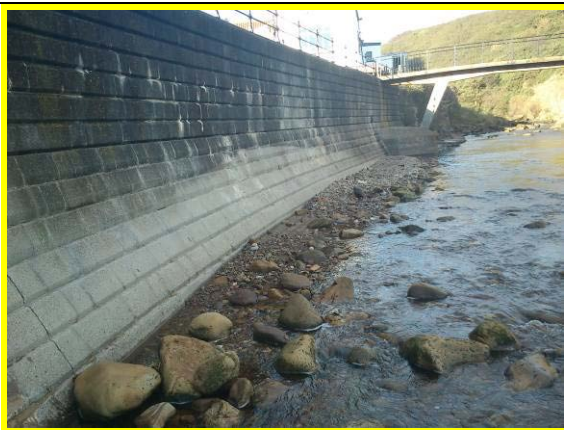
The most northerly defence in the system, Asset Ref. 1221D901D1201C01, starts adjacent to the footbridge at Scalby Mills and is in fair condition, see below left. There are small cracks throughout and some holes and damage near the bridge where it ties into the river bank.

Wall on south side of Scalby Beck in fair condition (Asset Ref. 1221D901D1201C01)

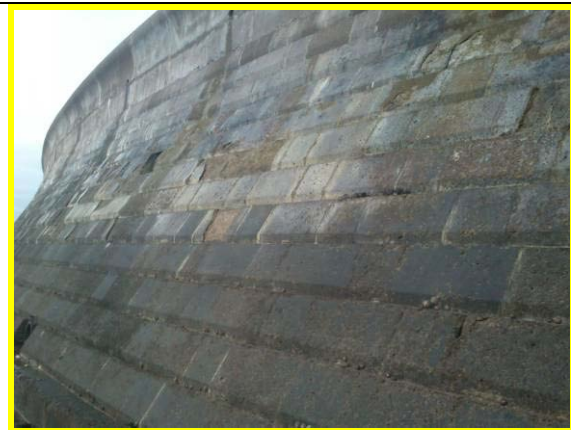
Moving south the wall, Asset Ref. 1221D901D1201C02, around the promontory on which the Sea Life centre is built is in less good, but still overall fair condition, see below top right and bottom left. There is evidence of toe scour and abrasion damage to the face of the wall. At the southern end of this defence there is a beach access ramp / slipway that is unusable due to the low beach levels leaving a large drop and boulders at the bottom. The Promenade in this area is in good condition, below lower right, although in places there is evidence of wave overtopping damage to the vegetation in the Sea Life centre gardens behind.

Damage to face of blocks on wall at Sea Life Centre (Asset Ref. 1221D901D1201C02)

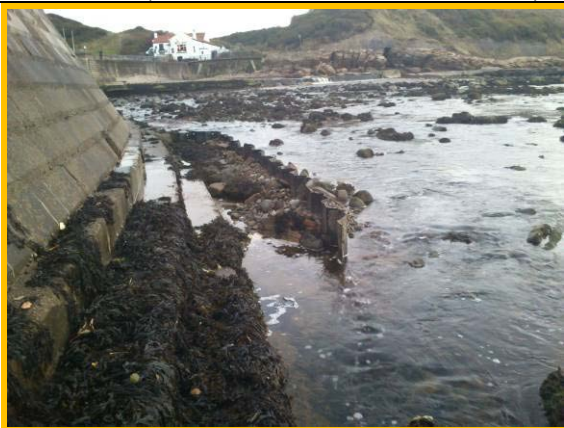
Exposed toe at Sea Life Centre. Note missing infill apron behind end of sheet pile toe. (Asset Ref. 1221D901D1201C02)

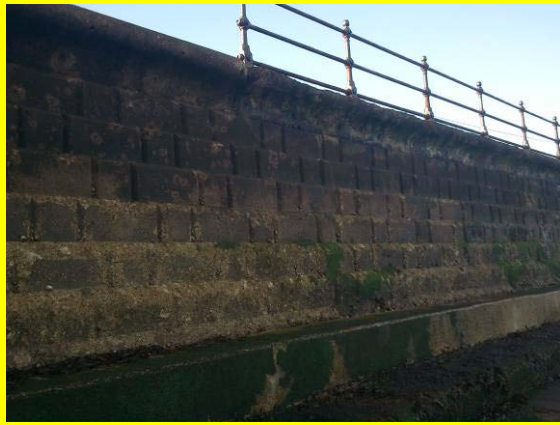
Sea walls (Asset Refs. 1221D901D1201C03, C24, C25, and C04, lie between the Sea Life Centre and the small promontory at the south of the mini golf course. These are formed of blockwork with a concrete crest wall with a promenade beyond, backed by a grouted stone revetment, see below lower right. There is considerable abrasion damage to the front face, and spalling of the capping beam along this length, see below top left. The beach was very low at the north, as on previous surveys, and in places the sheet pile toe (Asset Ref. 1221D901D1201C02) or concrete toe (Asset Ref. 1221D901D1201C24) has been exposed

Erosion and spalling of front face of wall and exposed toe. Asset Ref. 1221D901D1201C03

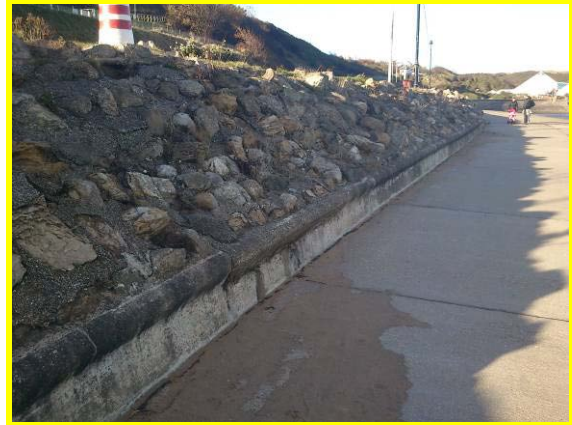
Grouted revetment behind prom has missing infill and voids in several locations Asset Refs. 1221D901D1201C25 & C04

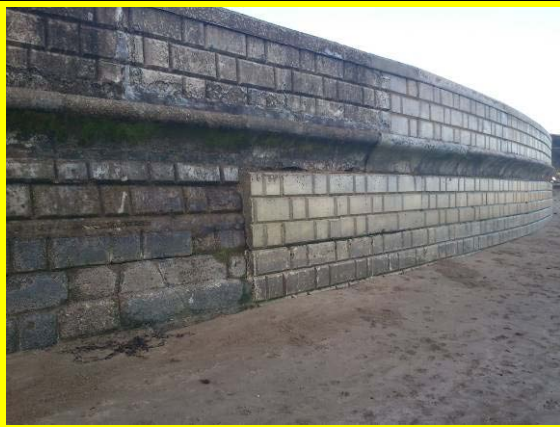
and is corroded or eroded. The promenade shows signs of heavy wave overtopping damage with loss of filler from joints. The steps mid way along are abraded with rounded steps near the toe. The wall around the promontory, Asset ref 1221D901D1201C04, which is more exposed has had relatively recent repairs to both the front face and the low crest wall at this section, below, bottom left and right. It is recommended that repairs are considered to reface the northern part of the wall to the in future.

Recent repairs to areas of front face of wall. Asset Ref. 1221D901D1201C04

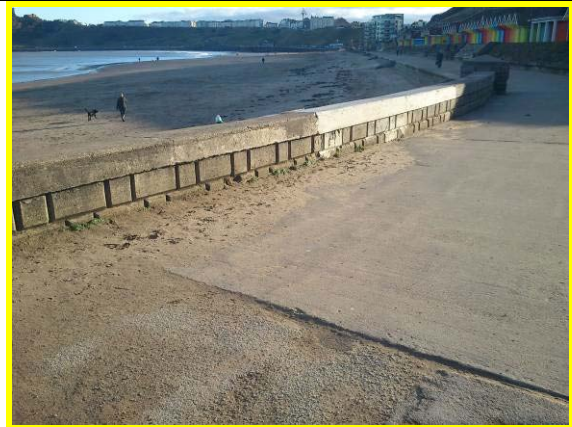
Recent repairs to low crest wall at promontory. Asset Ref. 1221D901D1201C04

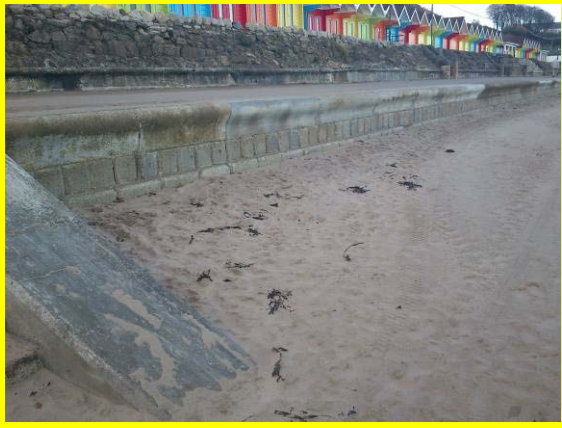
High beach levels, repairs to capping beam holding. (Asset Ref. 1221D901D1201C12)

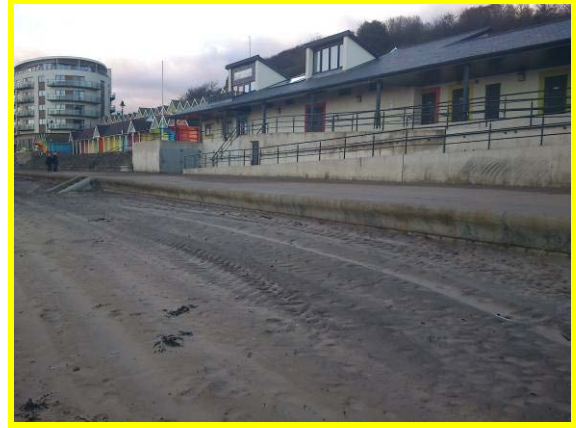
High beach in front of new rear wall at beach management centre, (Asset Ref. 1221D901D1201C15)

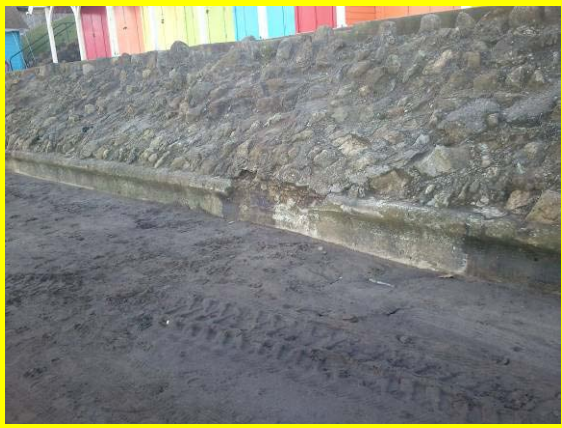
Damage to rear wall and grouted revetment (Asset Ref. 1221D901D1201C05)

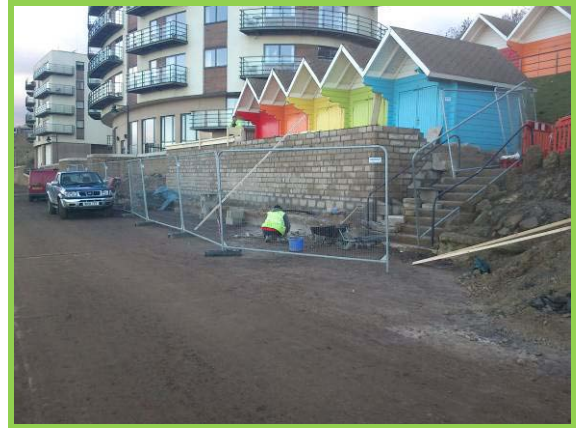
New rear property boundary wall under construction at south end of Asset Ref. 1221D901D1201C05

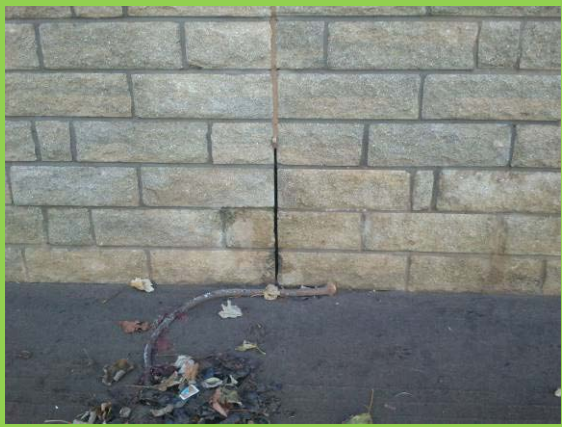
The wall to the north of the ramp at Peasholm Gap has several vertical cracks, see below bottom right. The beach is higher at this location, but there is occasional wave action and this has caused loss of expansion joint filler in the new rear wall protecting the new development behind the wall.

Missing filler in construction joint in new wall north of Peasholm Gap (Asset Ref. 1221D901D1201C06)

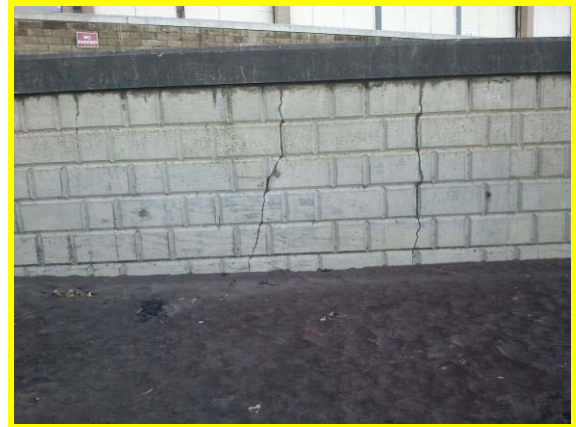
Full height cracks in wall north of Peasholm Gap ramp (Asset Ref. 1221D901D1201C06)

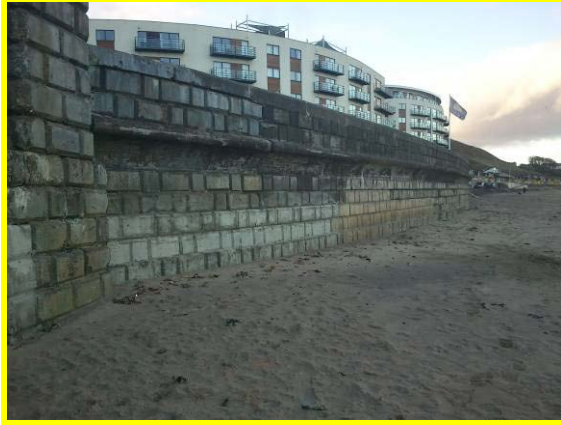
The wall at Peasholm Gap, Asset ref. 1221D901D1201C19 has missing mortar at joints, damage to the front face of many blocks and spalling to the splash beam between the lower and upper sections, see below upper left photo. There was evidence of localised repairs, but much more significant work is required. The promenade and slipway / ramp appeared in fair to good condition.

Abraded / eroded blocks and splash beam at Peasholm Gap.  
(Asset Ref. 1221D901D1201C19)

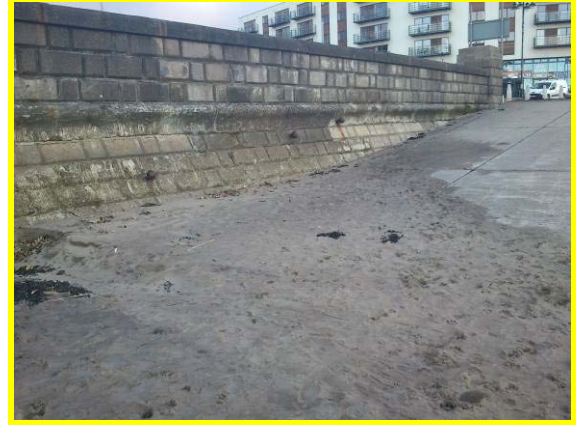
Slipway and sloping wall with splash beam  
(Asset ref. 1221D901D1201C20)

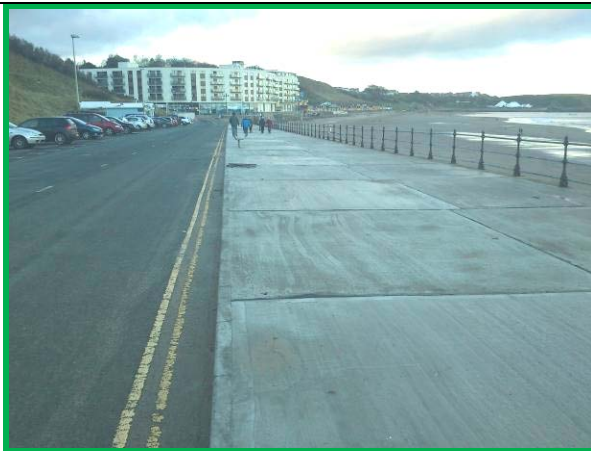
Recently replaced promenade slabs  
(Asset Ref. 1221D901D1201C07)
