**Walk-over Visual Inspections of Assets  
including Coastal Slopes**

**Scarborough Borough Council  
Final Report**

**October - November 2012**

## Coast Protection Assets and Coastal Slope Condition Analysis

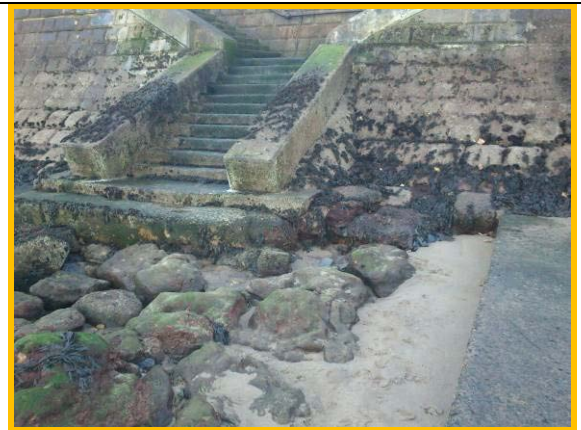
Erosion and undermining at steps at south end of  
Asset Ref. 1221D901D1201C07

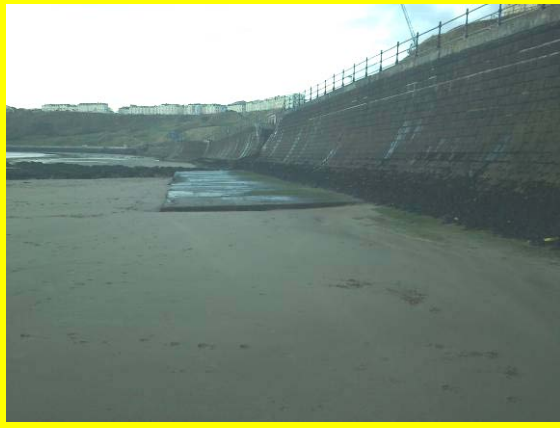
Low beach levels exposing toe apron  
(Asset Ref. 1221D901D1201C07)

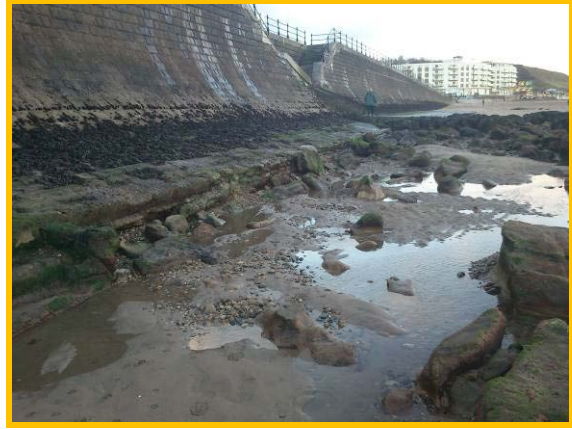
Low beach levels exposing toe apron  
(Asset Ref. 1221D901D1201C21)

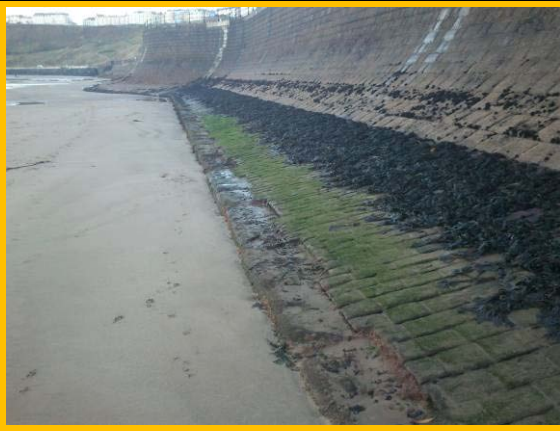
Exposed toe – with missing blocks  
(Asset Ref. 1221D901D1201C21)

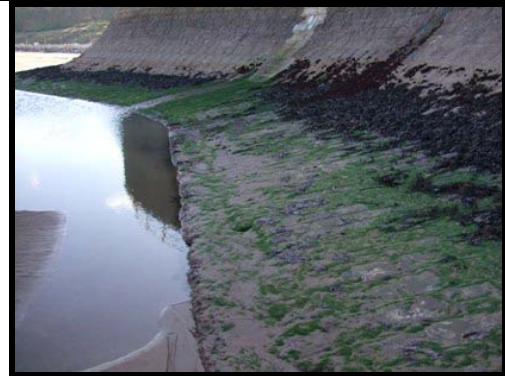
Exposed toe – photo from 2009  
(Asset Ref. 1221D901D1201C21)

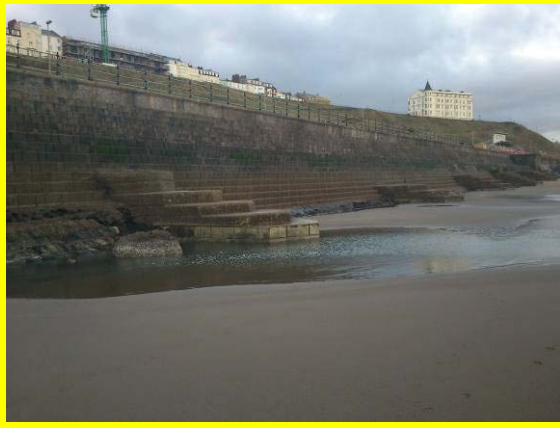
To the southern end of the North Bay, opposite Clarence Gardens to the north of the rock armour there is a large stepped concrete blockwork sea wall structure (Asset Ref. 1221D901D1201C08 – just north of Albert Road) constructed with eight large buttresses/bastions which protrude from the wall out onto the beach. The buttresses/bastions vary in height and length. As noted in the 2009 inspections the toe of the wall is severely eroded and there is severe cracking to out-built sections particularly at north end. There is a concrete berm above the buttresses, which is in good condition. Above this are the sea wall and promenade, and a second wall at the back of the promenade as the road, Albert Drive, is at higher level here. Both the promenade and the second wall show cracking. There are localised signs of repair to eroded faces of blockwork and to buttresses, however, additional repairs are now required. It is understood that a capital works scheme is under consideration to repair this section of wall.

Looking north from south end  
(Asset Ref. 1221D901D1201C08)

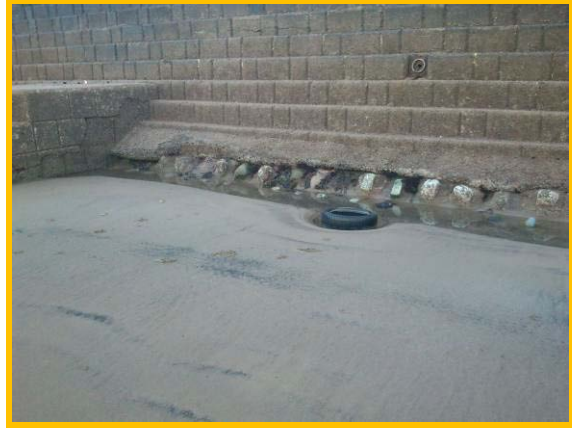
Looking north, showing eroded undermined toe  
(Asset Ref. 1221D901D1201C08)

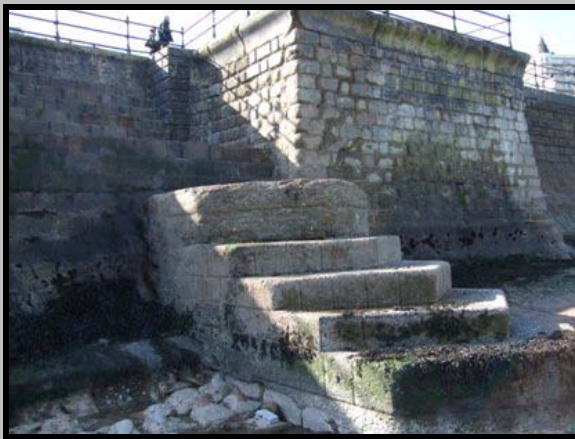
Cracking outbuilt section at north of defence –  
photo from 2009.  
(Asset Ref. 1221D901D1201C08)

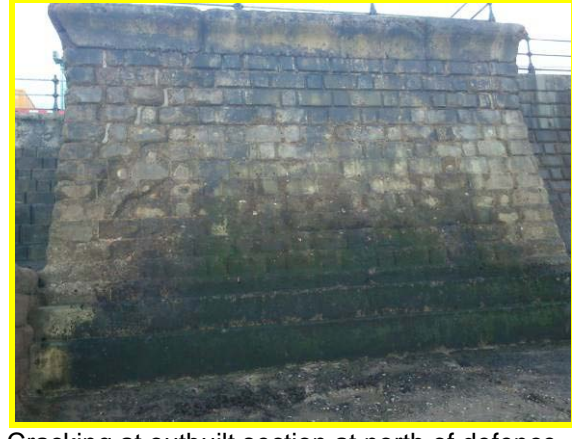
Cracking at outbuilt section at north of defence –  
photo from 07/11/2012.  
(Asset Ref. 1221D901D1201C08)

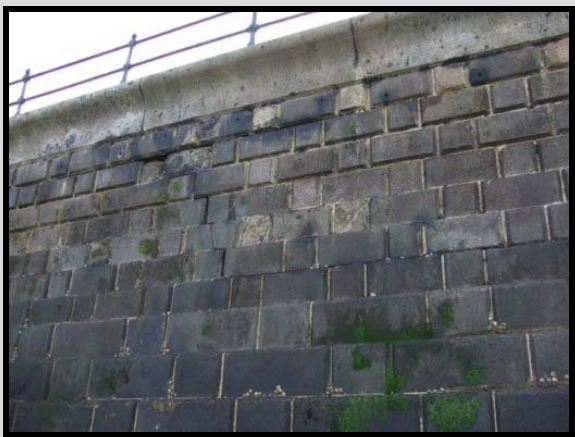
There is a short section of stepped blockwork wall (Asset Ref. 1221D901D1202C23) between this wall and the rock armour section. This short wall two large vertical cracks with one crack extending through the capping beam. There is another crack extending half way up the wall. There is missing blockwork in localised areas and the lower part of wall is eroded with exposed aggregate. The secondary wall beyond the promenade and the promenade itself are also cracked. These issues were identified in the 2009 inspections but had changed very little when inspected in 2012, see photos below.

Example of cracking Photo from 2009  
(Asset Ref. 1221D901D1202C23)

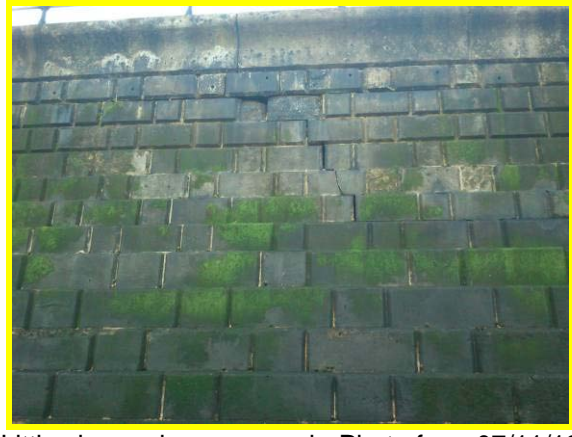
Little change is same crack- Photo from 07/11/12  
(Asset Ref. 1221D901D1202C23)

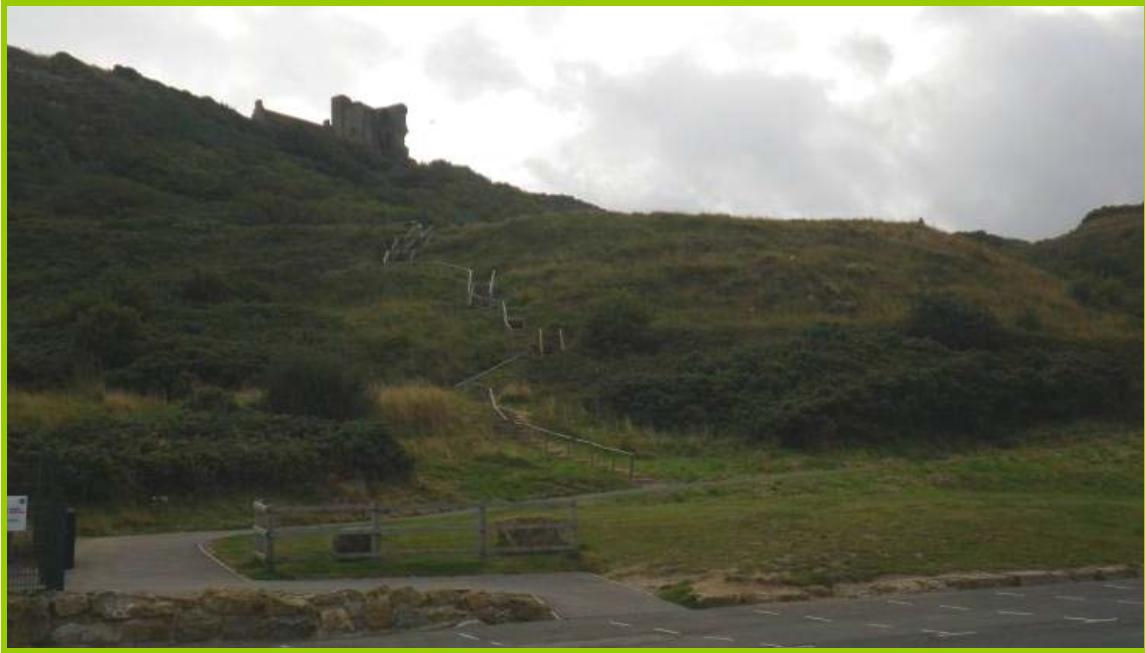
**Unit MU21/1** is located at The Holms and continues to be classified as Inactive. In this unit the rock is prone to rockfalls and there are patches of rock on the face where small cliffs are exposed. There was no evidence of recent rockfalls and the majority of the unit is well vegetated.

**MU21/1** Well jointed hard rock has a thick cover of vegetation (Inactive).

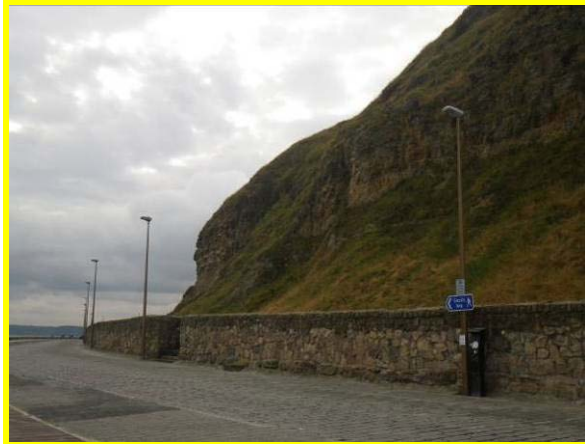
**Unit MU21/2** forms the Castle Cliff promontory and continues to be classified as Locally Active. The cliffs are steep with variable vegetation cover and extensive toe protection measures. Locally, bedrock is exposed where it is subject to ongoing weathering and erosion from rainfall

**MU21/2** Well jointed hard rock (Locally Active)

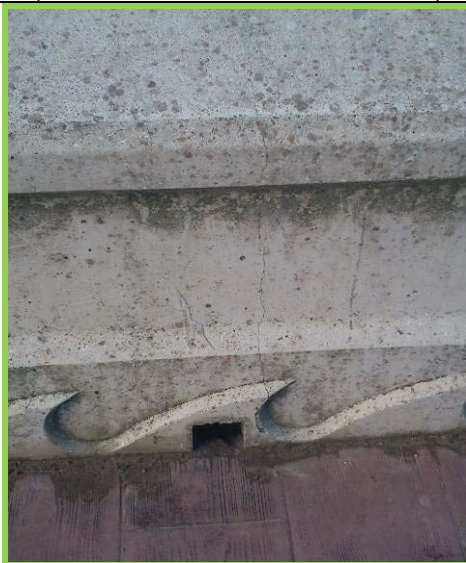
Example of crack through centre of wave wall –  
(Asset Ref. 1221D901D1202C03)

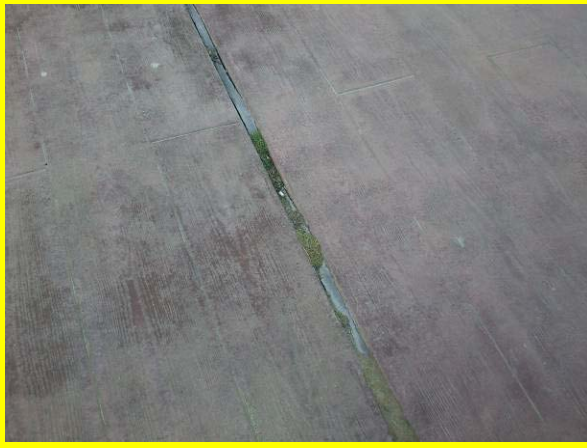
deterioration. There has been some deterioration of through wear and tear to parts of the promenade and some expansion joints in both promenade slabs and wave wall need resealing.

Joints in promenade slab needing re-sealing  
(Asset Ref. 1221D901D1202C02)

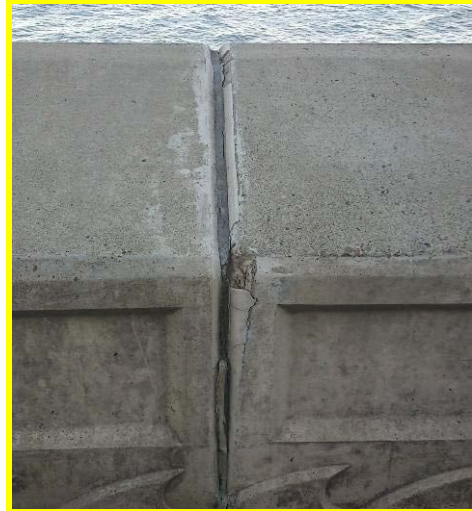
Expansion joint in crest wall needs repair  
(Asset Ref. 1221D901D1202C02)

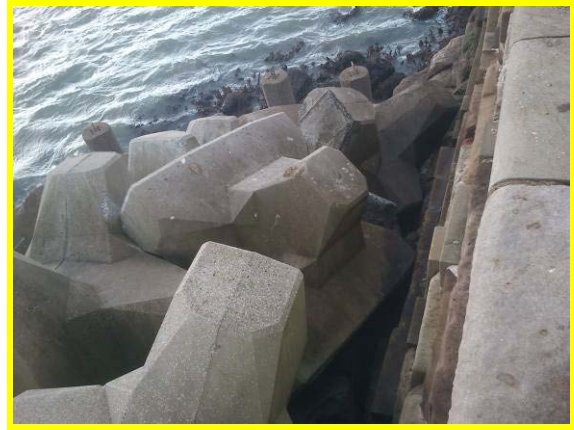
South end of harbour arm showing potential lack of armour fill Photo taken 16/10/2012 (Asset Ref. 1221D901D1301C01)

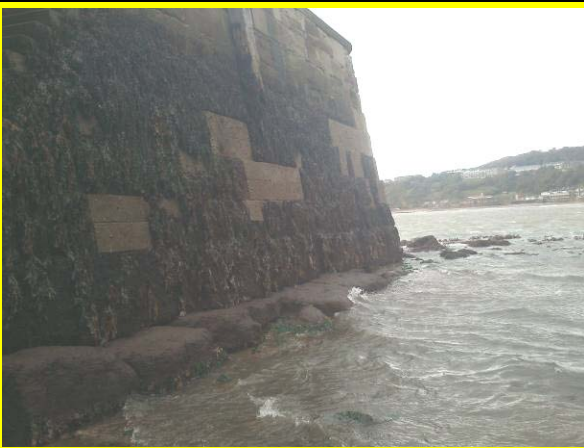
The faces of many blocks are missing or cracked at the seaward end of the original East Pier wall. The inner face of East Pier, Asset ref 1221D901D1301C16 was refurbished as part of the 2005 scheme, with missing blocks replaced and joints filled. Minor missing joints and cracks appear throughout the harbour masonry walls with recent maintenance work visible to the landward part of the harbour arms. The inner wall was inspected on a very low tide and it was noted that there are open joints and voids at the toe, see photos below left and right.

Erosion at toe, south end of East Pier. (Asset Ref. 1221D901D1301C16)

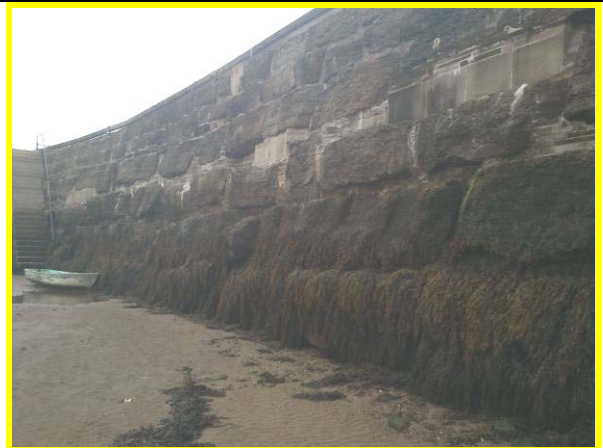
Open joints between blocks in inner face of east Pier below repaired section. (Asset Ref. 1221D901D1301C16)

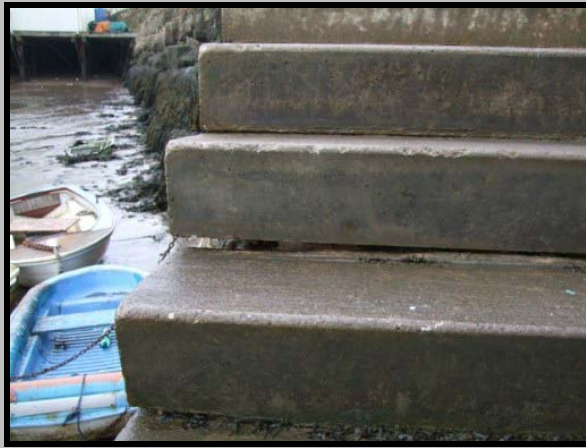
Washout behind steps – photo from 2009  
(Asset Ref. 1221D901D1301C16)

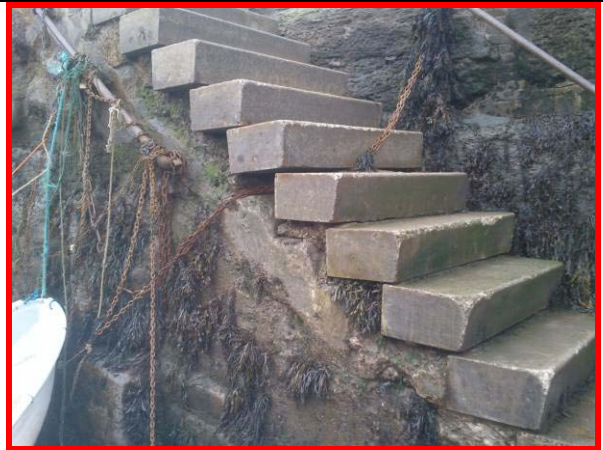
The stone stairs set into this defence are loose and in need of repair, see lower photos below. The washout of the joints at this set of steps was noted in the 2009 report and this has deteriorated, threatening collapse of the stone treads.

Washout behind steps – 16/10/2012  
(Asset Ref. 1221D901D1301C16)

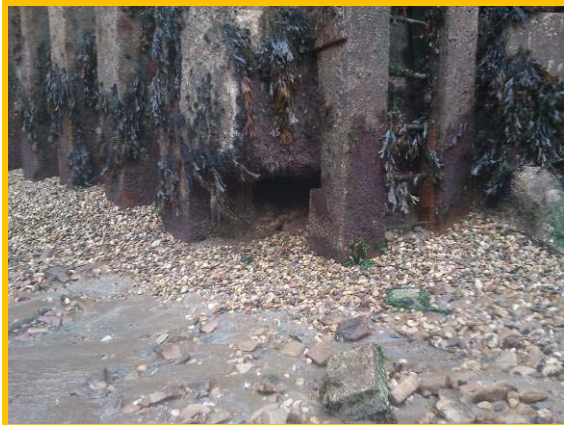
A number of defences in the harbour area show corrosion to the steel piling of varying degrees (Asset Ref. 1221D901D1301C13 and 1221D901D1301C17), as would be expected in an environment such as this. Locals report the piles to be up to 50 years old. Significant corrosion is evident in the photo below located on the harbour arm near the lighthouse, and there is a large void in the SE corner visible on very low tides (Asset Ref. 1221D901D1301C17).

Void under SE corner of breakwater by lighthouse  
(Asset Ref. 1221D901D1301C17)

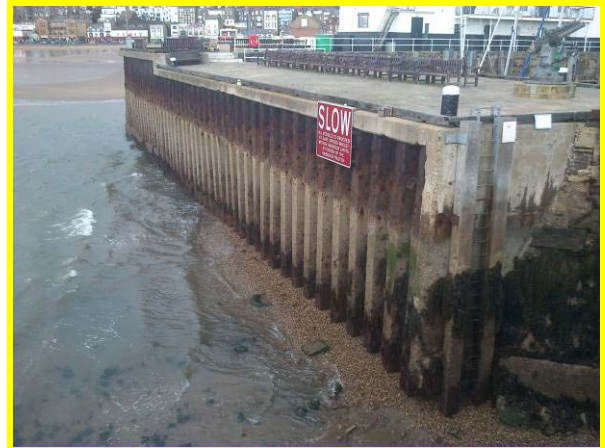
Corroded sheet piles, but overall fair condition  
(Asset Ref. 1221D901D1301C17)

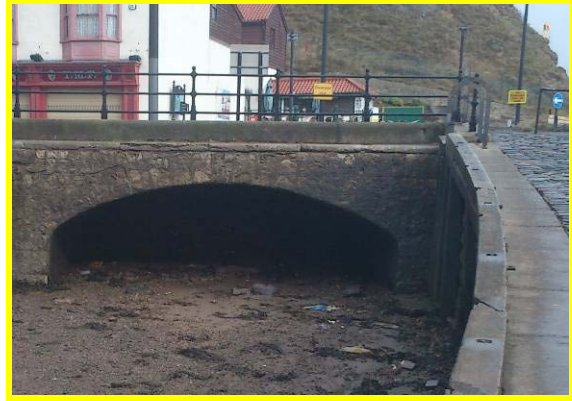
Spalling concrete capping to arched suspended quay at east end of Sandside (Asset Ref. 1221D901D1301C05)

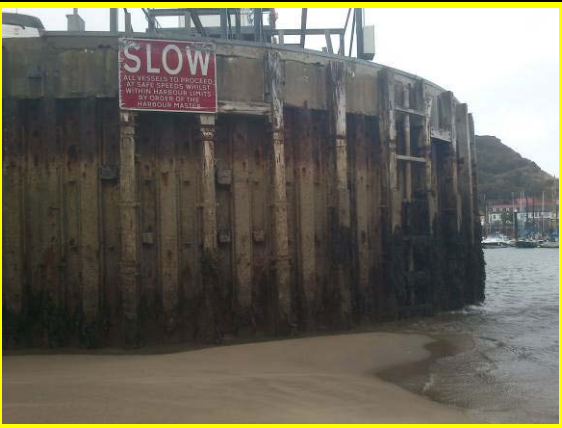
The west pier appears to be in fair condition, the steel sheet piling on the inner side of the harbour wall and at the seaward end is corroded, although intact (Asset Ref. 1221D901D1301C13 and C18). The outer side (Asset Refs. 1221D901D1301C07 and Asset Ref. 1221D901D1301C19) shows several significant defects including large full height cracks and exposure of aggregates. During the inspection at low tide the toe, which has a variety of constructions was exposed. This shows potential undercutting in a number of places with low beach levels. Erosion to the wall and minor cracks to the promenade were also noted during the inspection (Asset Ref. 1221D901D1301C19). These cracks require repair and monitoring to ensure that the structural integrity of the defence is maintained.

Corroded sheet piling and damaged timber fenders at end of West Pier (Asset Ref. 1221D901D1301C18)

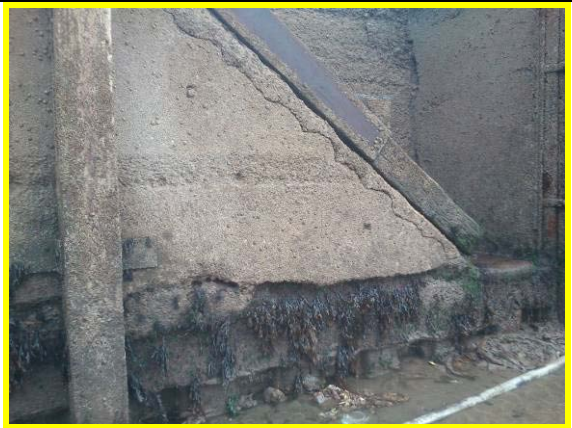
Cracks to concrete facing and exposed toe to steps on West Pier (Asset Ref. 1221D901D1301C18)

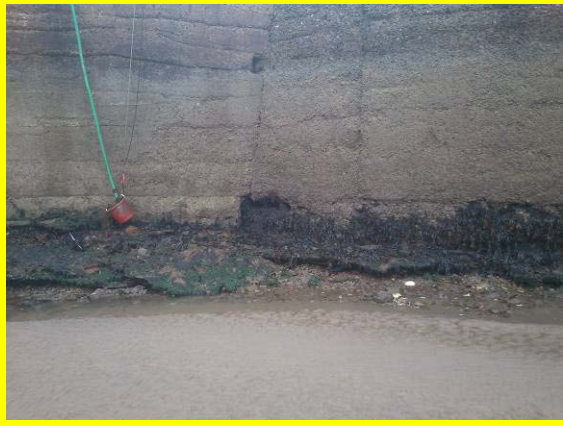
The beach level at the west side of west pier (Asset Ref. 1221D901D1301C19 and C07, see photos below) was lower than during the 2009 inspections, see photos below, exposing the timber toe piles. If the lower levels persist the toe piles may become further undercut so additional toe protection should be considered.

Undermining of toe of concrete encased section at bend where West Pier narrows (Asset Ref. 1221D901D1301C07)

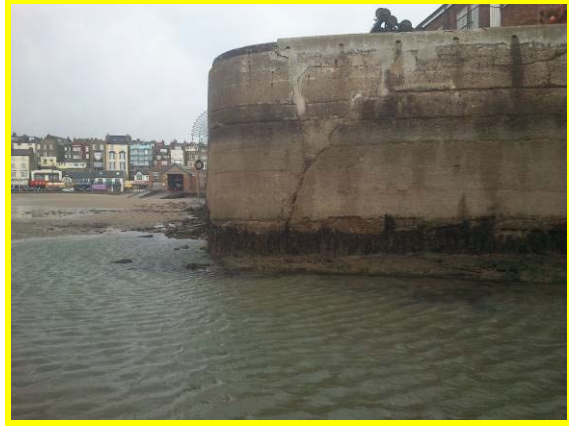
Cracks and repairs in concrete encasement section at narrowing of West Pier (Asset Ref. 1221D901D1301C07)

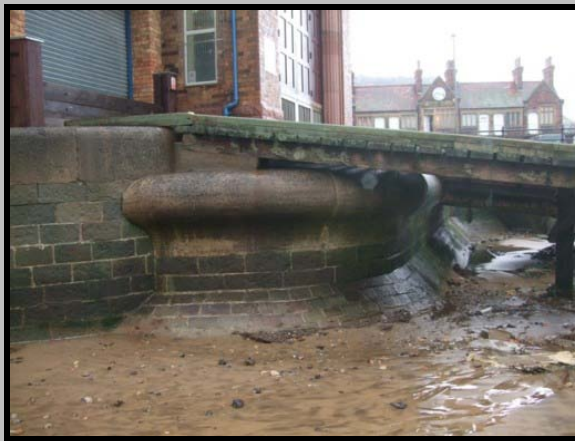
The South Bay defences start at the RNLI station, adjacent to West Pier. As in the 2009 inspection the sea wall protecting the Lifeboat Station is in fair to good condition with minor mortar loss of joints and erosion (Asset Ref No.1221D901D1301C08).

View of blockwork wall beneath life boat station  
 Photo from 2009 (Asset Ref. 1221D901D1301C08)

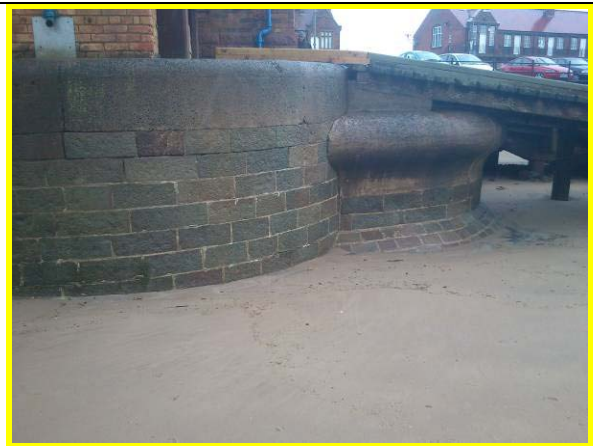
Minimal change to wall since 2009  
 (Asset Ref. 1221D901D1301C08)

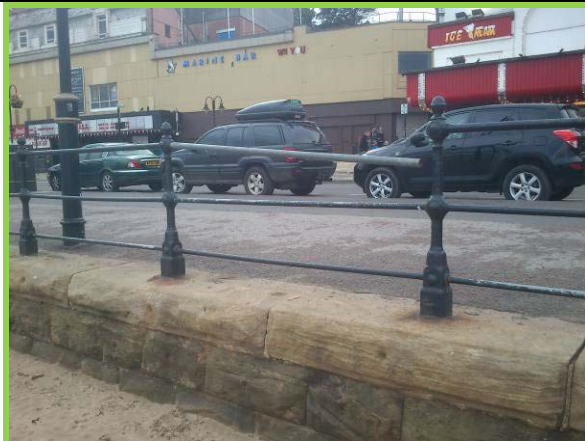
Damaged handrail above wall (Asset Ref. 1221D901D1301C22)

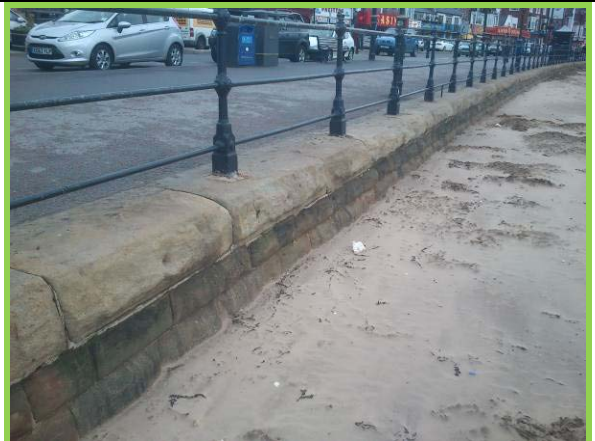
The low defence wall along the east side of Foreshore Road, is split into different NFCDD assets at each of the sets of access steps. These are running from north to south Asset Refs. 1221D901D1301C15, C21, C23, C24 and C25. Due to high beach levels only the top two courses of stone blocks were visible along most of this length. However, where

visible, the sea wall is in good condition with only occasional minor missing joints and erosion evident and occasional defects to the hand railing needing repair.

High beach level along sea wall running in front of Foreshore Road, South Bay (Asset Ref. 1221D901D1301C15)

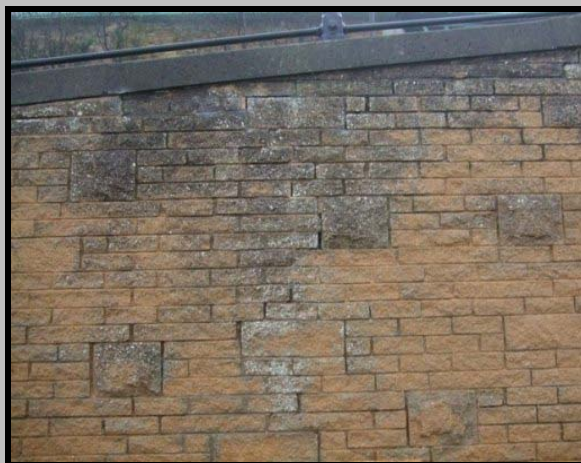
The two stage wall at the end of Valley Road / Aquarium Top has a vertical crack in the wall at the back of the promenade (Asset Ref. 1221D901D1301C09). This was observed in 2009, but does not appear to have deteriorated. Repair work to the vertical cracks is advised to prevent further cracking to the wall.

Vertical crack to second wall protecting road. Photo from 2009 (Asset Ref. 1221D901D1301C09)

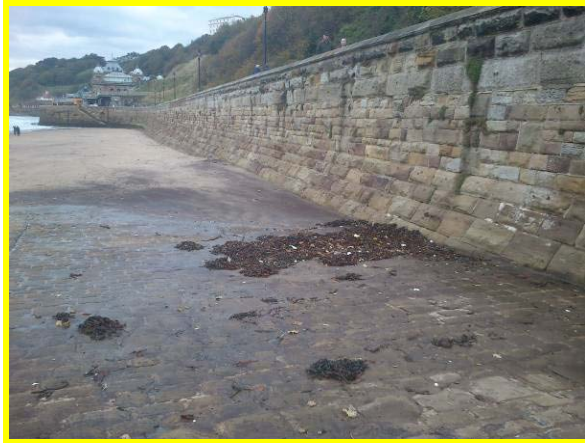
The recurved sea wall between Valley Road and the promontory at the Spa (Asset Ref. 1221D901D1301C26) shows occasional defects throughout, such as washout of joints and erosion to the blockwork surface and some cracked blocks although they appear stable. It is recommended that repointing is undertaken to prevent future washout and further damage. The crest wall, photo below right, has weathering / abrasion damage to some stone blocks that requires attention and missing mortar or cracks in joints.

General view of defence at Spa Chalet  
(Asset Ref. 1221D901D1301C26)

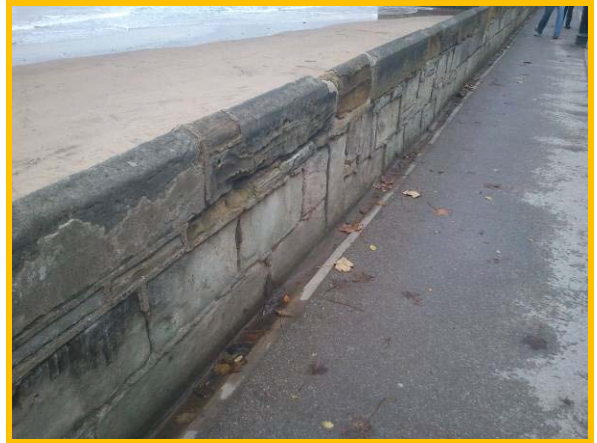
Erosion and weathering to limestone blocks in  
crest wall  
(Asset Ref. 1221D901D1301C26)

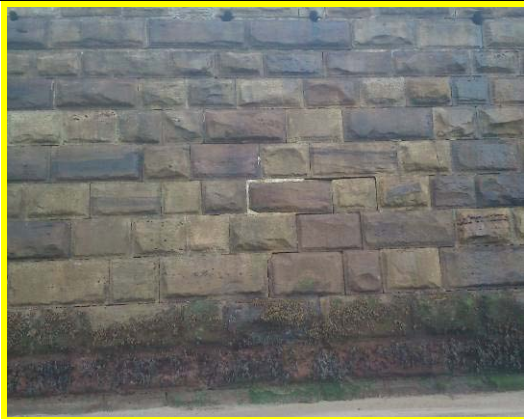
The beach was relatively high for the inspection of the stone blockwork sea wall at “The Spa”, possibly due to beach management operations moving sand to this area from the Foreshore Road beach earlier in the year. However, the toe apron, which is in locally poor condition was still exposed. A capital improvement works scheme is under development for this frontage, although further deterioration should be closely monitored and action taken if necessary until the scheme can be implemented.

Loose blocks and open joints with failed previous  
repairs blockwork wall  
(Asset Ref. 1221D901D1301C27)

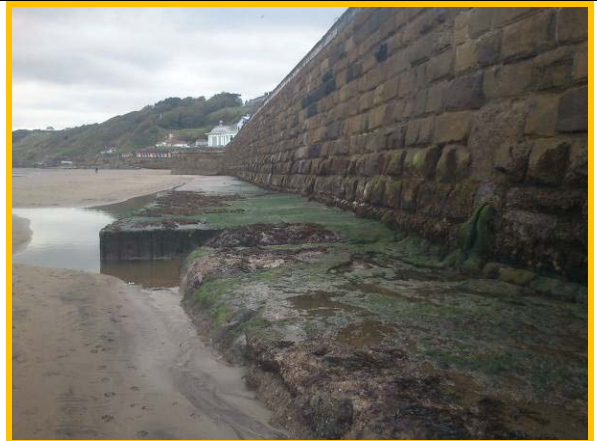
Exposed and abraded toe apron at the Spa  
(Asset Ref. 1221D901D1301C27)

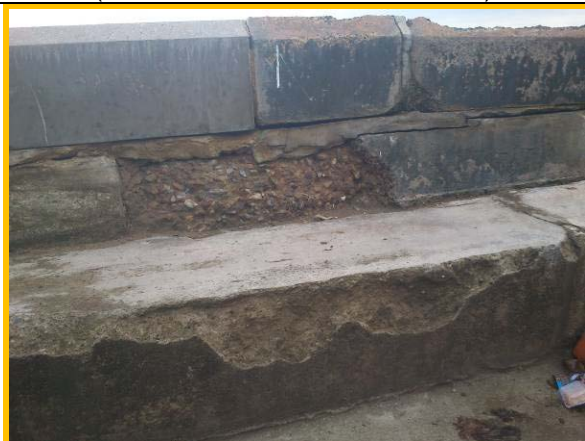
Loose blocks and cracking in crest wall previous  
repairs (Asset Ref. 1221D901D1301C27)

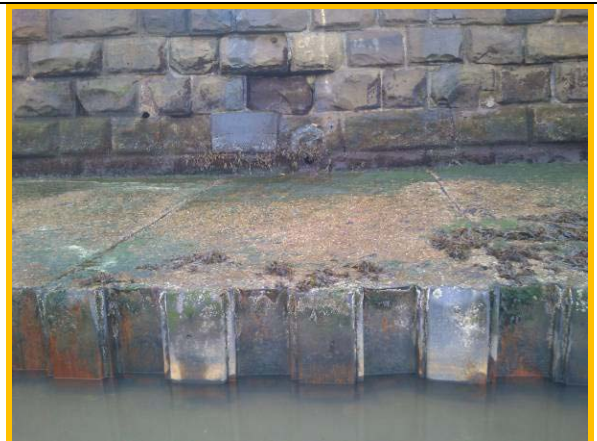
Loose blocks set back in void at toe of wall  
(Asset Ref. 1221D901D1301C27)

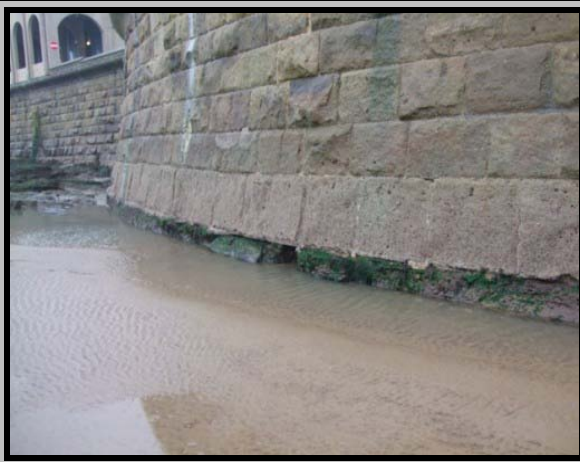
The curved plan section of wall, (Asset Ref. 1221D901D1301C28) is in a similar state to the main blockwork wall to the north. There are open joints and cracked blocks throughout especially in south, although there had been repairs to the cracked splash beam since the previous inspection.

Undercutting to the sea wall – photo from 2009 (Asset Ref. 1221D901D1301C28)

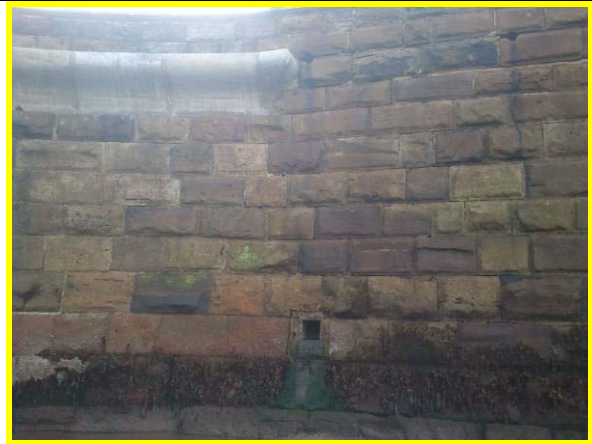
Repaired splash beam, but cracks in blockwork below (Asset Ref. 1221D901D1301C28)

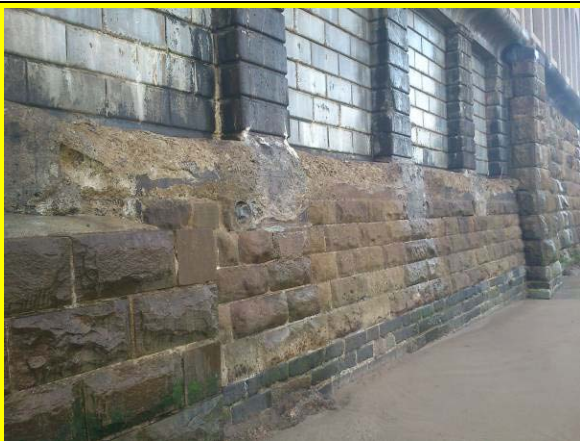
The wall at Spa Colonnade, Asset ref 1221D901D1301C29, while in fair overall condition has major spalling and loss of concrete to lower splash beam below infilled openings, see below left. There is also a small void at the toe near to South end.

Abraded and spalling concrete capping to original wall below infilled openings (Asset Ref. 1221D901D1301C29)

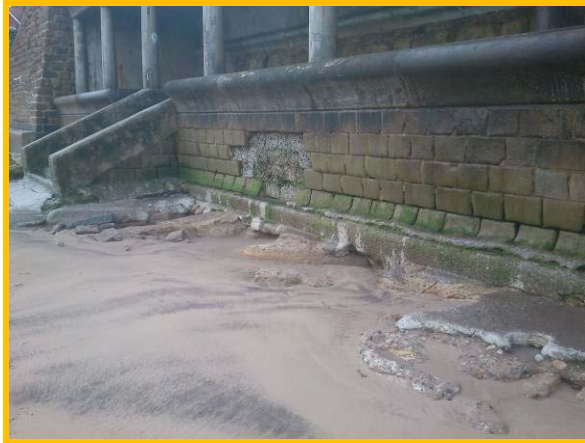
Loss of stone facing and undermining of the toe on lower level wall  
(Asset Ref. 1221D901D1302C01)

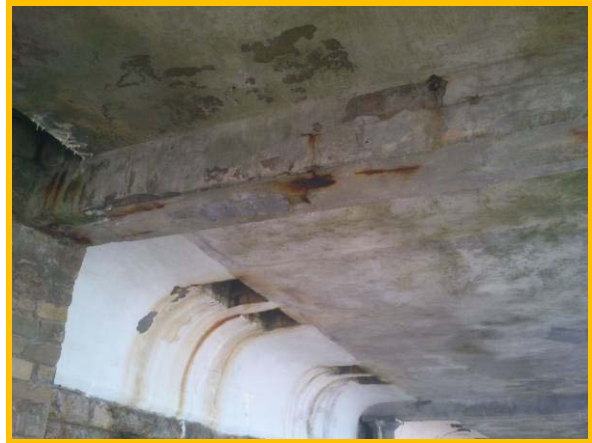
Cracking and corrosion to beams supporting upper level prom.  
(Asset Ref. 1221D901D1302C01)

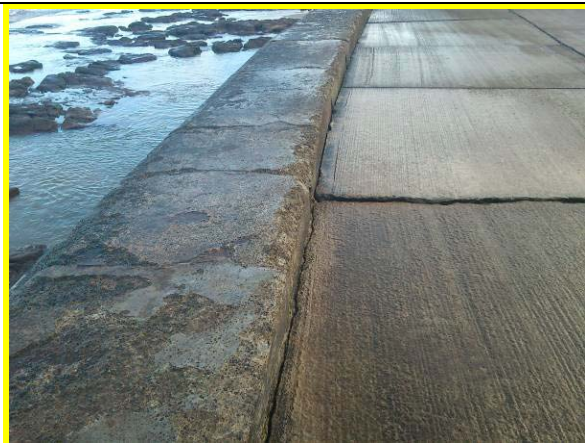
Missing joint sealant in gaps promenade slabs  
(Asset Ref. 1221D901D1303C02)

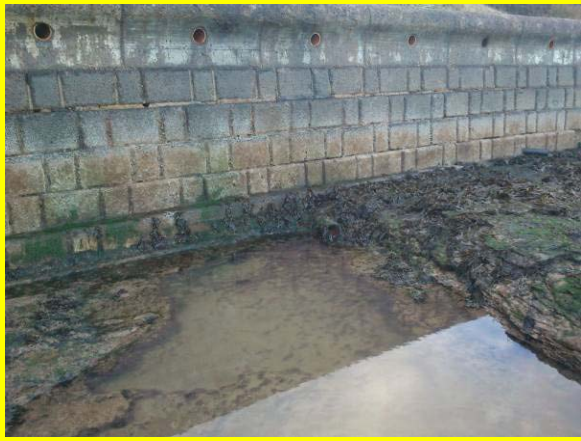
The lower section of the concrete block wall which has offset, slightly stepped blocks, and that capping beam is showing evidence of significant surface erosion exposing aggregate throughout the defence. It was only possible to inspect parts of the lower wall due to the low tide level, but there were deep voids/ missing joints in the blockwork that need attention. The lower promenade, which is subject to regular heavy wave overtopping, is missing filler between slabs in places. It was apparent that some new slabs had been placed during recent significant repairs, but others are eroded. There was also loss of facing to set back second wall and cracks/spalling to splash beam, although it is noted that a section of the middle level wall had been rebuilt recently. Ongoing repairs and maintenance will be necessary in future due to the age and overall condition of this asset.

Undermining of wall, with voids at South Bay Pool (Asset Ref. 1221D901D1303C02)

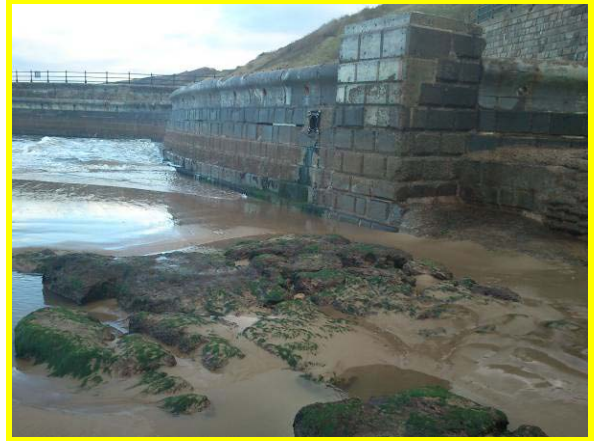
Repaired upper section of upper wall adjacent to re-constructed concrete ramp. (Asset Ref. 1221D901D1303C02)

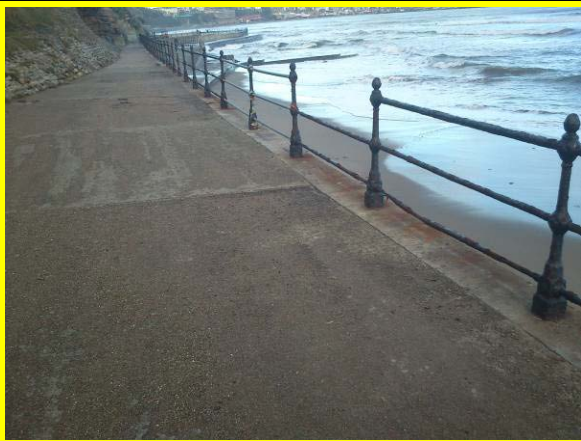
The beach at the Holbeck Gardens defence, was high covering the lower promenade in the centre. This is probably due to its relatively enclosed location between South Bay Pool and the Holbeck cliff landslide lobe. The bastion groyne at the north has cracks throughout the concrete, although there were repairs evident at head of bastion. There are missing / damaged parts of the capping beam to the lower wall. The handrail to the upper promenade is very corroded with missing sections.

Corroded handrail with missing section on upper level prom (Asset Ref. 1221D901D1304C02)

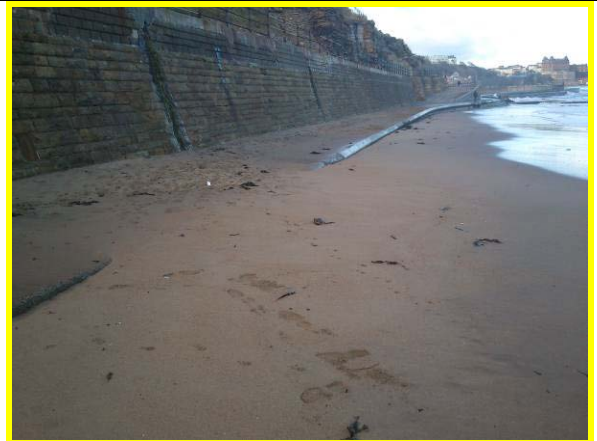
High beach covering lower wall at Holbeck Gardens (Asset Ref. 1221D901D1304C02)

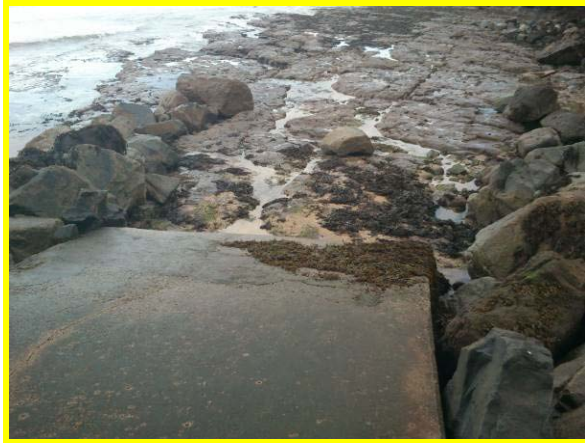
The relatively new rock armour revetment (Asset Ref. 1221D901D1304C01) defending the relict debris flow lobe at the site of the Holbeck Hall landslide remains in good condition, with the armour tightly packed and good coverage. The rock toe was not all inspected due to tide cover. At the southern end of the defence there has been erosion leaving the beach access ramp with a vertical drop to rocks at the end and a crack in the bottom slab.

Vertical drop off ramp at south end of Holbeck revetment (Asset Ref. 1221D901D1304C01)

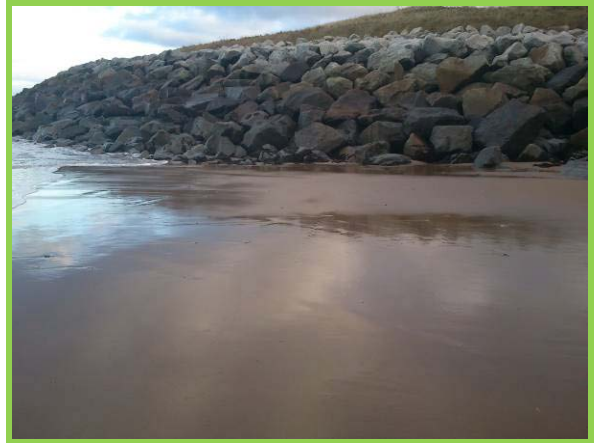
Rock armour revetment at Holbeck landslide (Asset Ref. 1221D901D1304C01)

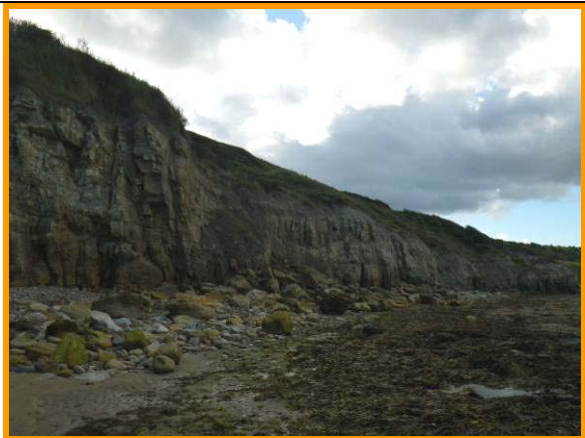
**MU23/A** Erosion of the toe (Partly Active)

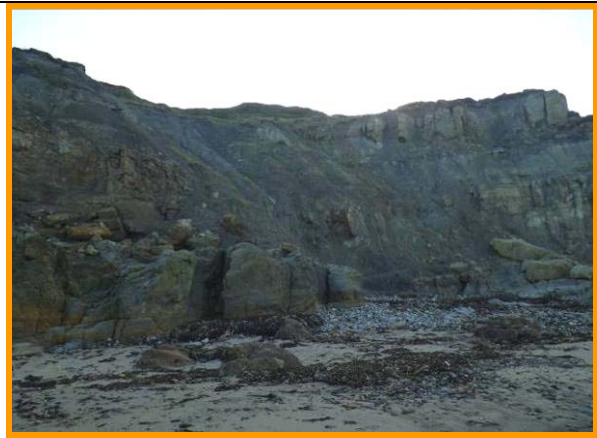
**Units MU23/B** is also classified as Partly Active, having been upgraded from Locally Active in 2009. A failure had recently occurred in this unit, with mudslide debris cascading from the top of the cliff to the beach. The cliffs tend to be steep and in some cases undercut by marine erosion.

**MU23/B** Recent failure of the cliff (Partly Active)

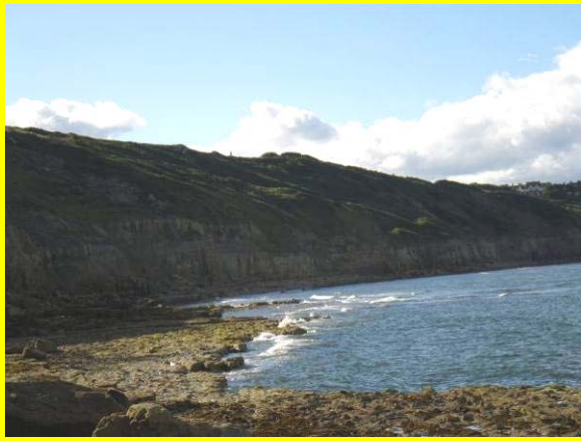
**Unit MU23/C** remains classified as Locally Active. The unit is well-vegetated with only localised patches of erosion. The cliff toe is steep and eroding.

**MU23/C** Ongoing marine driven erosion is evident on this unit (Locally Active)

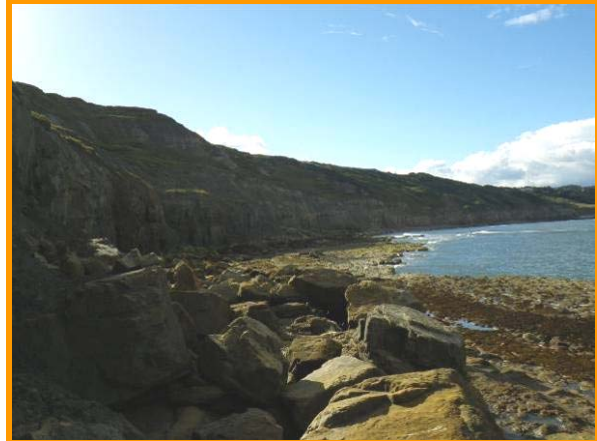
**Units MU23/D1, MU23/D2 and MU23/D3** are located at Wheatcroft Cliff above Black Rocks. These units are active down much of their length, with on-going recession of the headscarp, slumping in the mid-slope and erosion of the toe. All three units were classified as Partly Active in 2009. **MU23/D2 and 23/D3** have been downgraded to Locally Active in 2012 as activity is more localised than previously seen.

**MU23/D1** failed blocks at the toe of the cliff (Partly Active)

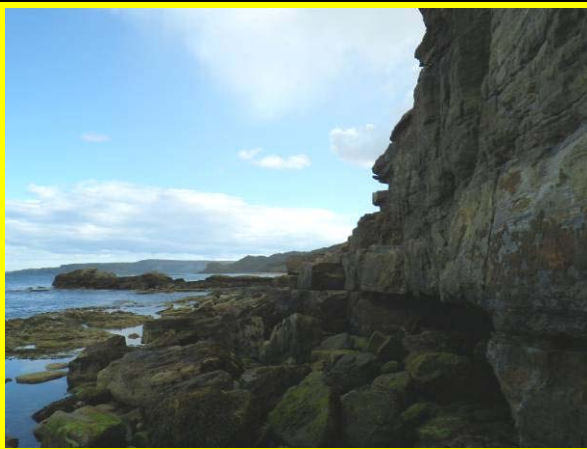
**MU23/D2** The failed material is evident on the shore (Partly Active)

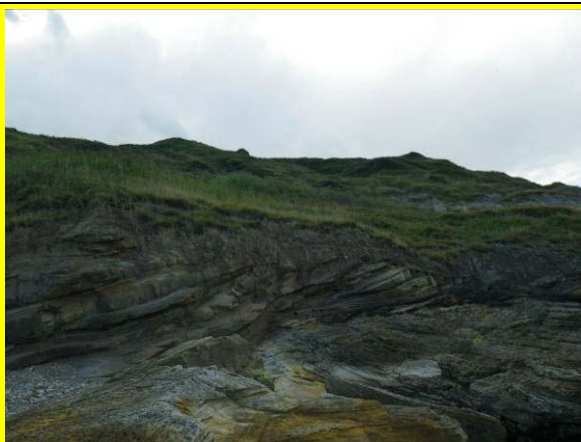
**Unit MU23/E** is located at White Nab and remains classified as Locally Active. The slopes of this unit support some vegetation cover with intermittent areas of more intense erosion mid-slope and at the unit toe.

**MU23/E** Vegetation and localised erosion (Locally Active)

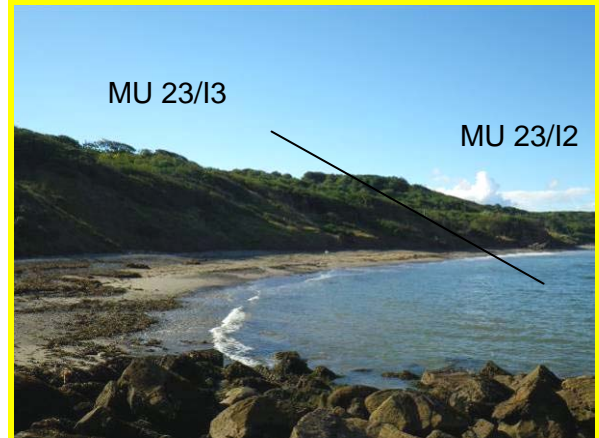
recent activity at the headscarp, which has experienced localised slumps. **Units MU23/I1, MU23/I2 and Mu23/I3** form smaller mudslides at the toe of unit 23/I. MU23/I1 is Partly Active while MU23/I2 and I3 are Locally Active.

**MU23/I2 and I3** Less active toe unit within Cornelian Bay (Locally Active)

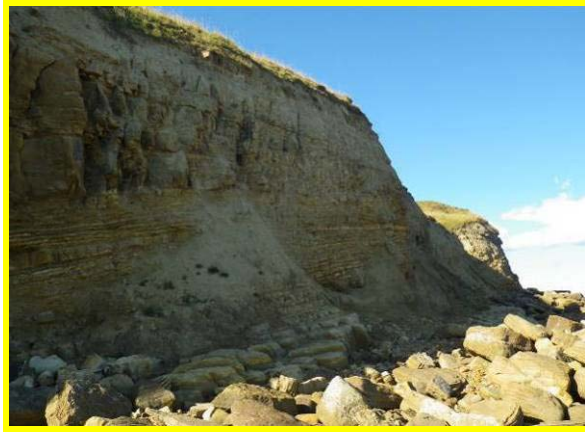
**Unit MU23/J** is also located on the north side of Knipe Point. This unit is composed of hard, well jointed rock and is classified as Locally Active. There has been a small recent fall, which is shown in the photograph.

**MU23/J** Rock face of the north side of Knipe Point (Locally Active)

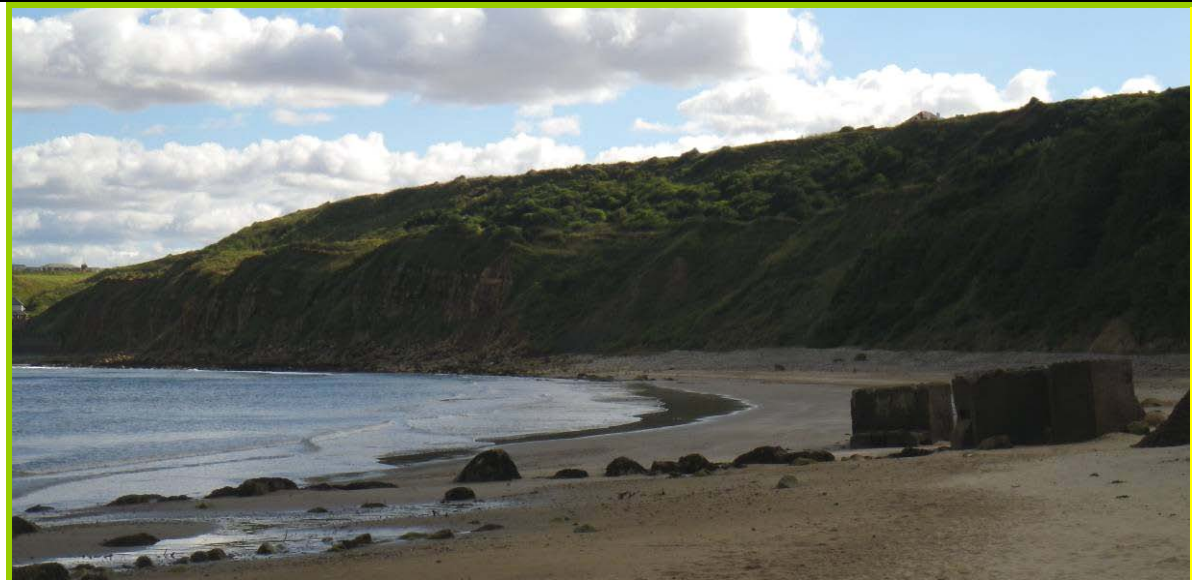
**MU24/B and B1 to 10** Tenants' Cliff upper slopes are inactive. Units at the toe are Locally Active.

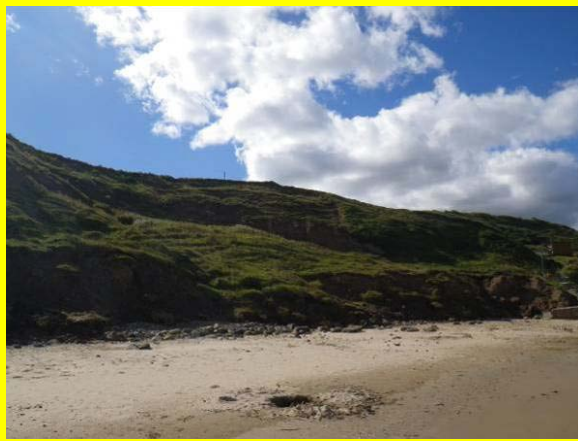
**Units MU24/C, MU24/D and MU24/E** are located just southeast of the Pumping Station in Cayton Bay and are cut into the soft till cliffs. All units show active recession of the headscarp and slumping and cracking mid-slope. At the unit toes there is evidence of slumping and erosion. These units have had their classification changed from Partly Active to Locally Active.

**MU24/C** A slump of material which is becoming more vegetated and stable (Locally Active)

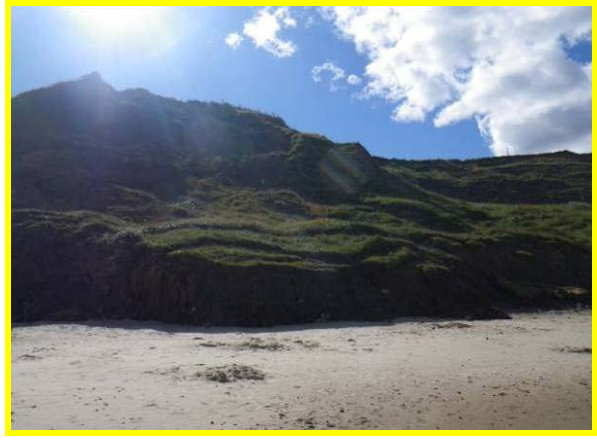
**MU24/D** Toe slumping which is more stable than during the last inspection (Locally Active)

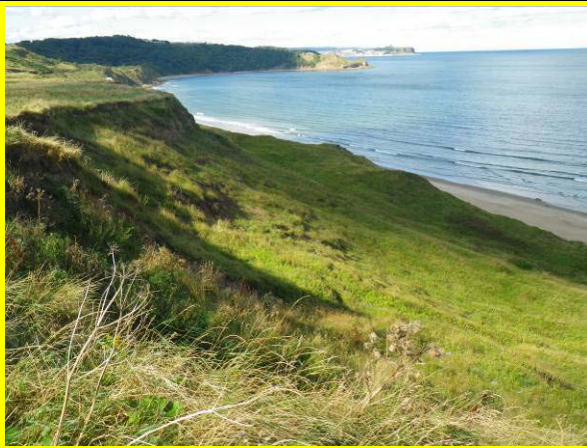
**MU24/K** The slope has patchy vegetation (Locally Active)

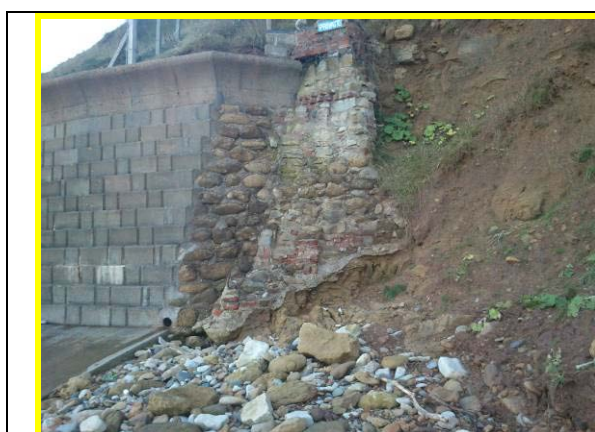
To the north of the pumping station (which is now converted to a private residence) is a private blockwork defence with concrete toe slab, Asset Ref. 1221D901D1402C02, which ties into the eroding cliffs to the north with a mixture of brick, stone blocks and concrete, see below left. This wall is in fair condition and appears newer than the wall to the south, although the toe apron is undermined with voids beneath that need attention.

Tie in of Pumping station defences at north end  
(Asset Ref. 1221D901D1402C02)

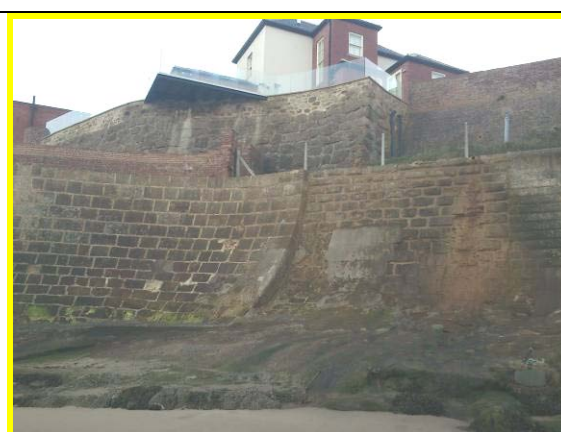
There are a complex series of private blockwork and concrete sea walls (Asset Ref. 1221D901D1402C05) protecting the main pumping station building. The condition of the defences varies from good to very poor and relates to the height from the high water mark. The higher, red brick walls appear sound. The lower, concrete and sandstone blockwork is in fair condition with evidence of quite recent repairs to joints. A patchwork of repair work is visible to the blockwork (see photo below right). The lower apron has had recent cosmetic repairs with poured concrete that appears to have been tipped from above. However, the toe appears undercut in places. There appear to have been many repairs since the last inspection but due to the age, exposure and patchwork nature of the defence there will be a need for ongoing maintenance repairs to prevent defects expanding and destabilising the overall wall.

Walls protecting former pumping station  
(Asset Ref. 1221D901D1402C05)
