**Walk-over Visual Inspections of Assets  
including Coastal Slopes**

**Scarborough Borough Council  
Final Report**

**October - November 2012**

## Coast Protection Assets and Coastal Slope Condition Analysis

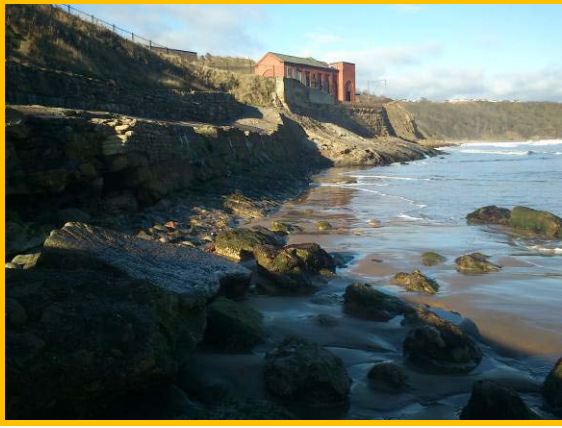
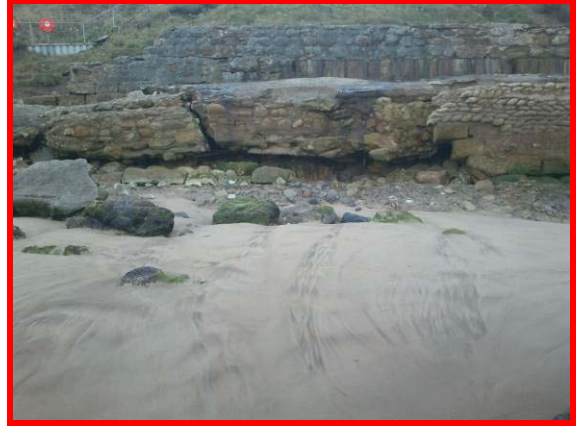
Between the southern end of the pumping station defences and the beach access point there is a derelict length of defence, Asset Ref. 1221D901D1402C04, which exhibits major undercutting, blockwork washout, parts of upper wall missing and significant damage. It is advised that the failed southern part of this defence should be made safe or removed in accordance with the SMP policy.

Large voids to makeshift defences to the south of the pumping station (Asset Ref. 1221D901D1402C04)

South end defence of the pumping station (Asset Ref. 1221D901D1402C04)

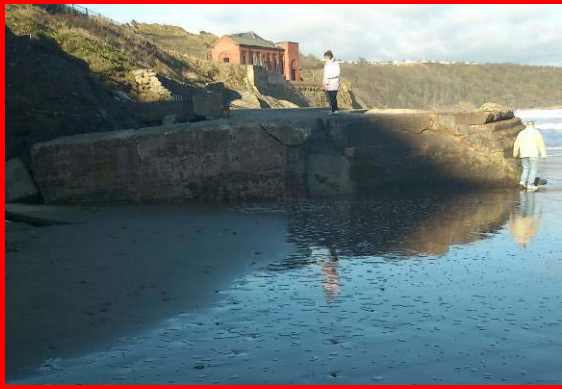
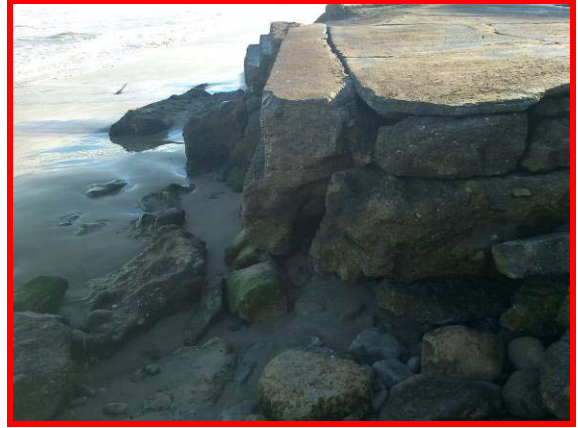
The last defence to the south is the concrete structure at the public beach access point. This is in a failed condition with large cracks and voids throughout (Asset Ref. 1221D901D1402C06). Repair work consisting of a concrete skim over the voids on the deck is apparent, although the structure remains unsafe. It is recommended that this structure is demolished and removed and replaced with a simple safe public access ramp set further back.

Difficult public access at failing beach defence (Asset Ref. 1221D901D1402C06)

Voids beneath and failing front face at defence at beach access south of the pumping station (Asset Ref. 1221D901D1402C06)

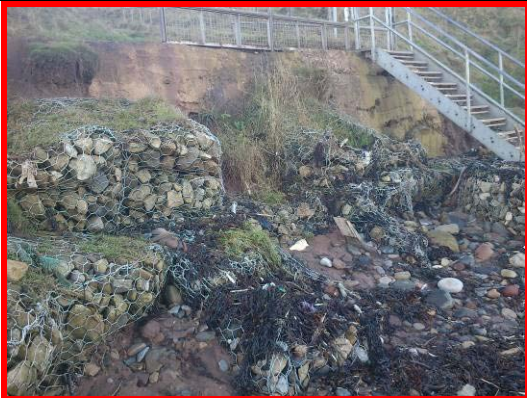
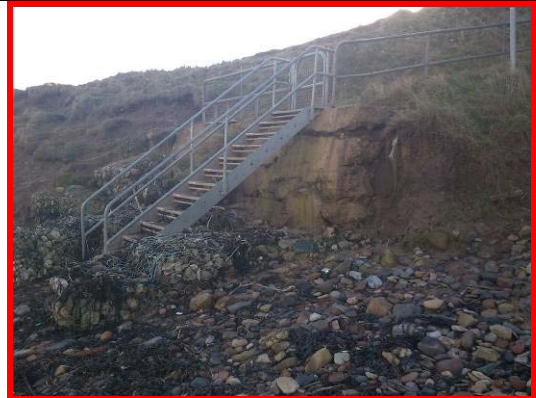
Around 300m south there is a beach access point for the path from the public car park at the surf shop. There are a set of beach access steps that were previously protected by gabion baskets, which distorted and split under wave action and / or cliff movement, see below left and right. This is not a formal coastal defence, so has no asset number.

(Failed gabion baskets at south beach access)

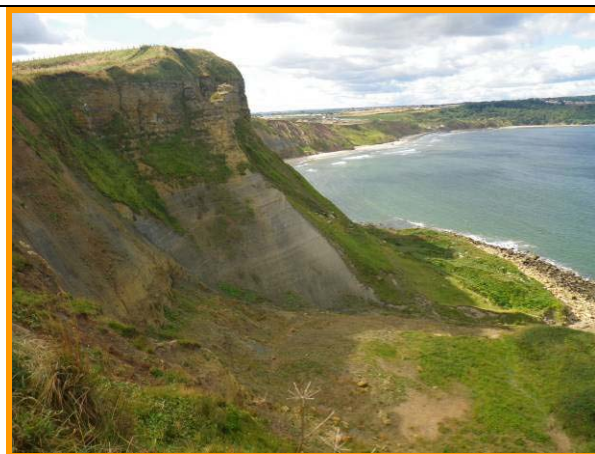
**Unit MU25/V** is located at Lebberston Cliff and comprises a large, periodically active mudslide system. The unit appears to be prone to regular change and recession, although it appears to have stabilised somewhat since the 2009 walkover. This unit was Totally Active in the 2009 walkover but it has now been downgraded to Partly Active.

**MU25/V** Upper part of active mudslide system (Partly Active)

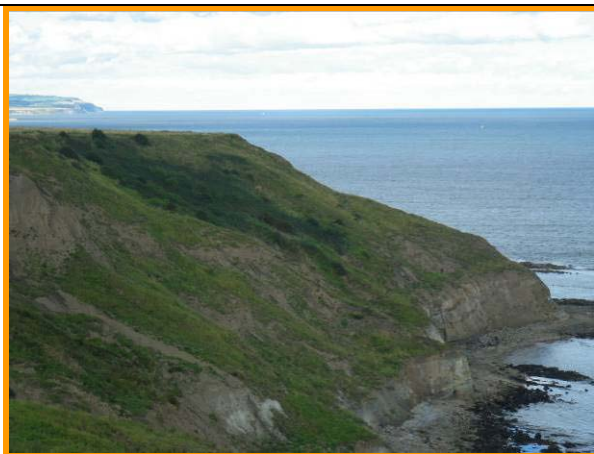
**Unit MU25/X** is classified as Partly Active, as it was in 2009. Despite being well vegetated, the slopes of this unit appear to be subject to ongoing instability, with evidence of mudsliding and recession at the headscarp.

**MU25/X** Toe erosion and shallow slumping (Partly Active)

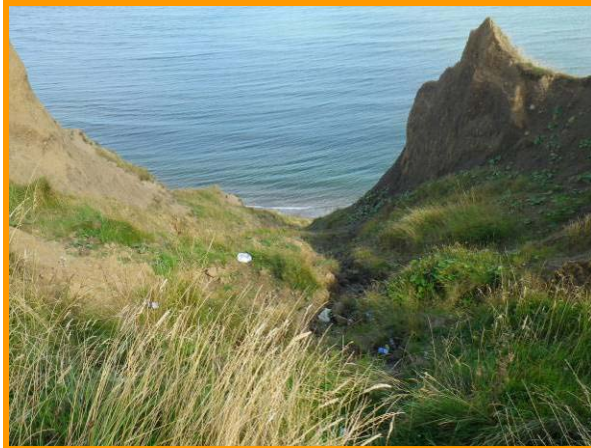
**MU25/Z** Mudslide head formed on the cliff top following heavy rainfall (Partly Active)

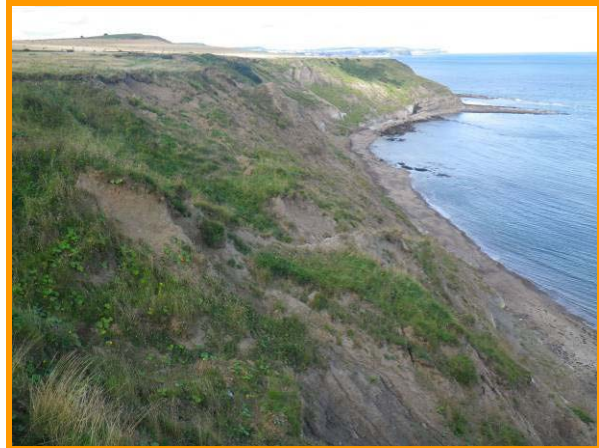
**Unit MU25/AA** was previously an area of mudslide activity and headscarp recession and was classified as Totally Active in 2009. In 2012 the activity has less marked and the unit is now classed as Partly Active. The soft till cliff is being eroded at the headscarp with slumping and sliding mid-slope. Marine erosion is apparent at the cliff toe.

**MU25/AA** Mudsliding and patchy vegetation cover (Partly Active)

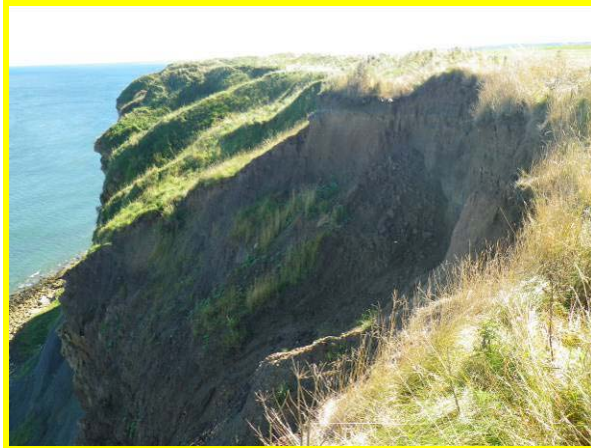
**Units MU25/AD and MU25/AE** are similar in form to adjacent units MU25/AB and AC. However, the lower slopes of these units appear more stable than those of the adjacent units, and support more continuous vegetation cover. There is some erosion of the headscarp and localised areas of more intense erosion on the lower slopes. These units are classified as Locally Active, with no change since 2009.

**MU25/AD** Erosion affecting the top of the cliff (Locally Active).

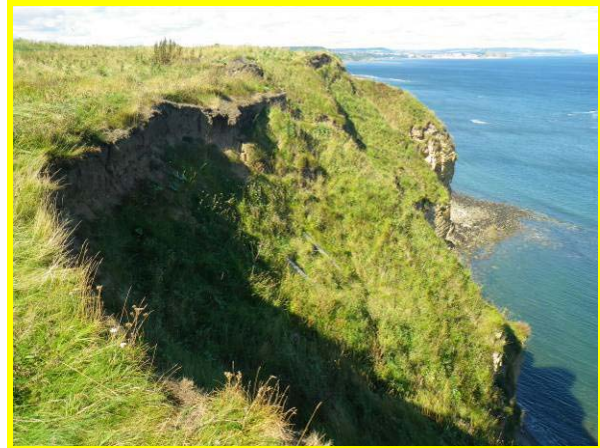
**MU25/AE** A vegetated cliff with only localised signs of erosion (Locally Active).

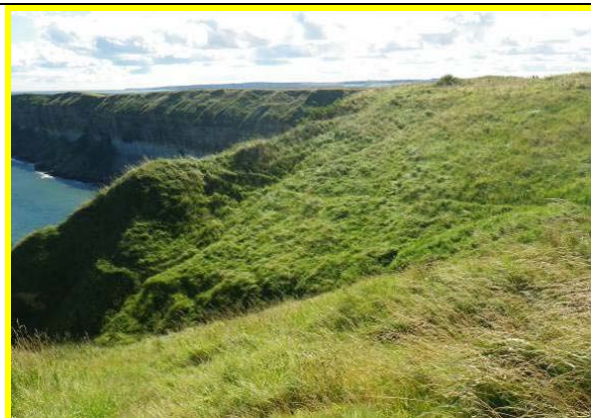
**MU26/AG** Rockfall evidence at the unit toe (Locally Active)

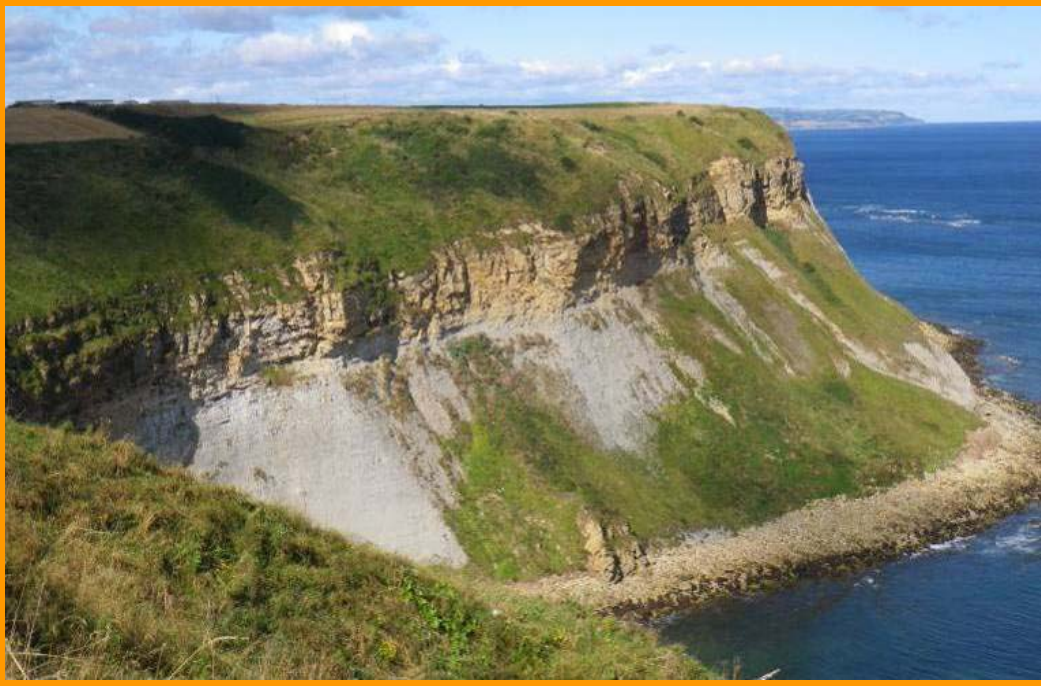
**Units MU26/AI and MU26/AJ**, form the western part of Newbiggin Cliff and are both classified as Partly Active, as they were in 2009. These units are of a similar form to the adjacent Locally Active units, described above. However, they are characterised by a greater level of activity within both the upper and lower cliff layers and less continuous vegetation cover.

**MU26/AI and AJ** large vegetated debris aprons dominate these units. There is activity in these aprons and the overlying cliffs. Localised toe erosion is also seen (Partly Active)

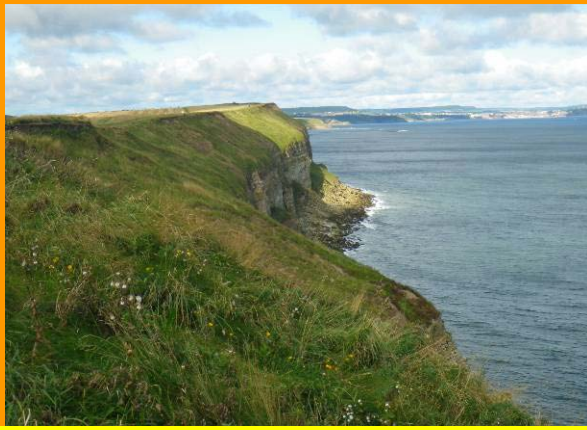
**MU27/AY and AZ** Well vegetated upper slopes  
(Locally Active and Partly Active)

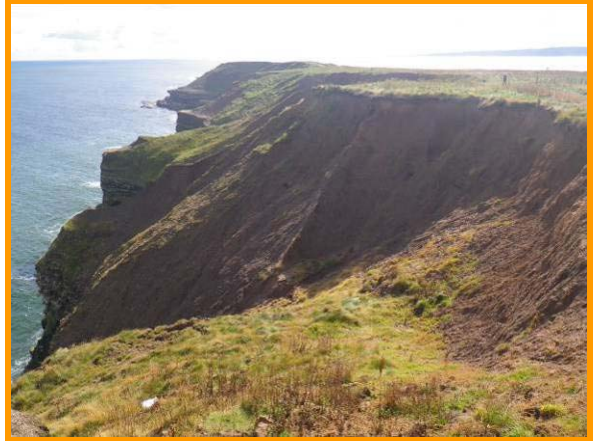
**MU27/BA** The failure which had been observed in 2009 is now beginning to stabilise (Partly Active).

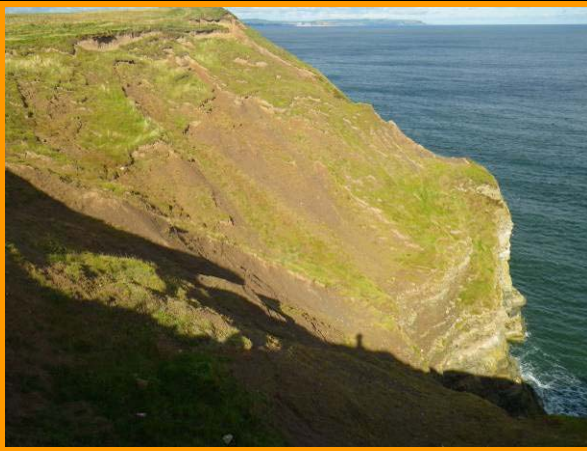
**MU27/BB** Mass failure of upper layer  
(Partly Active)

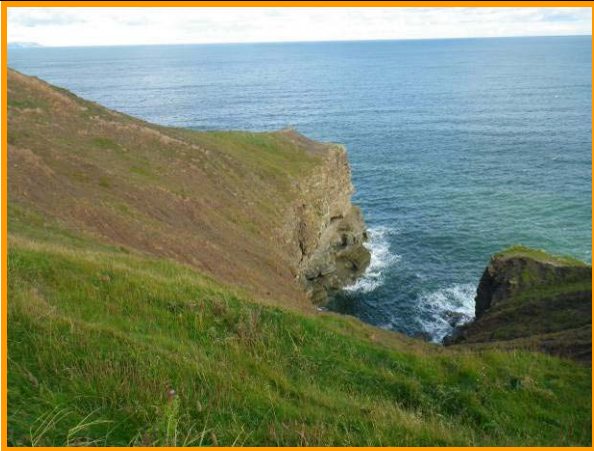
**MU27/BC** Slumping, sliding and rilling  
(Partly Active)

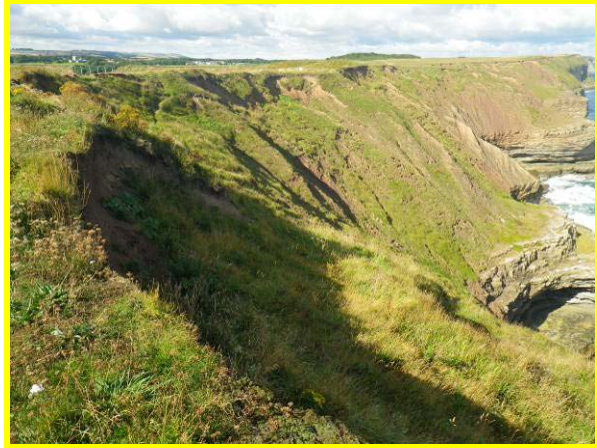
**MU27/BE** The vegetated slopes are showing signs of slippage and ongoing coastal erosion (Locally Active)

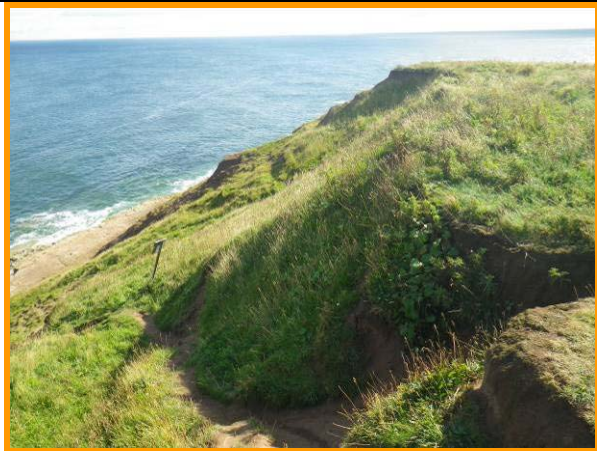
**MU27/A** Cracking and slumping activity (Partly Active)

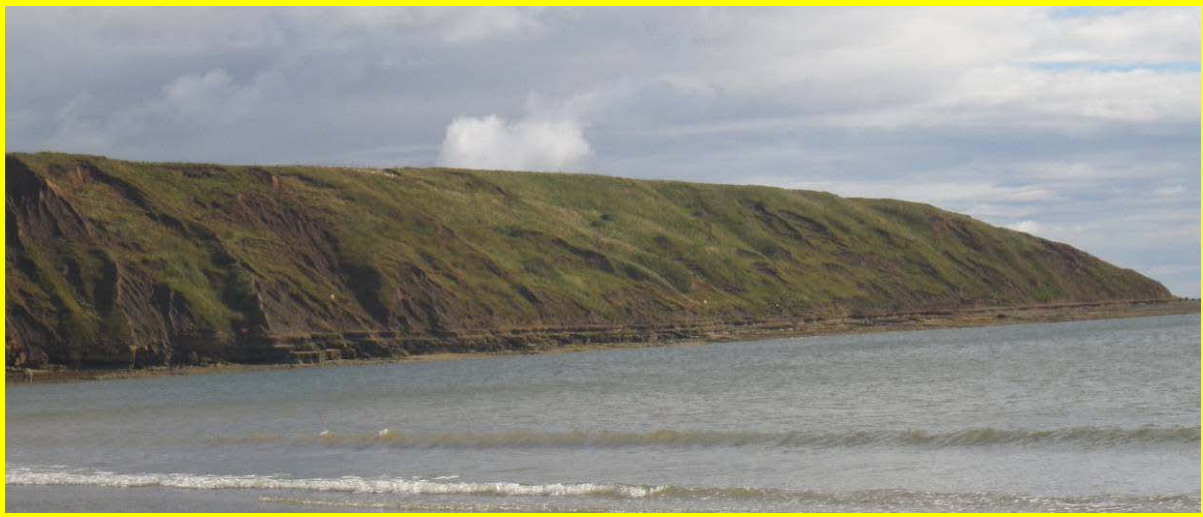
**MU27/C to I** Vegetated upper slopes on the south side of Filey Brigg (Locally Active)

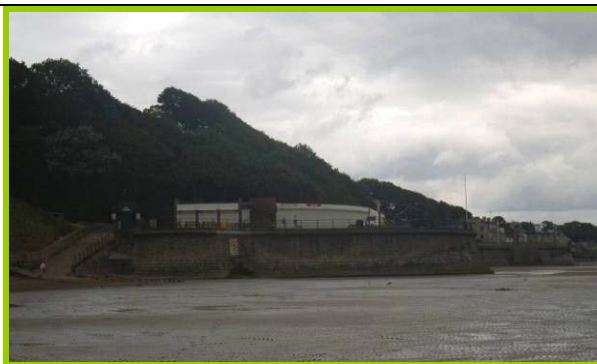
Much of the town frontage lies within **unit MU28/Y**. There are no signs of activity on the coastal slopes and this unit continues to be classified as Inactive.

**Unit MU28/Z** is located at the southern end of Filey and is also classified as Inactive. Recently, significant slope stabilisation works have been undertaken within the ravine. This unit was downgraded from Locally Active, its classification in 2009.

**MU28/Y and Z** The Filey frontage does not show any signs of slope failure (Inactive).

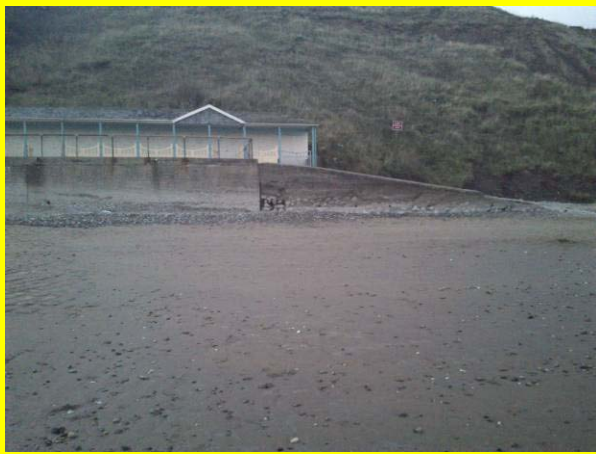
The most northerly asset in the defence system consists of the rear wall and slipway at Cobble landing (Asset Ref. 1221D901D1602C01). There are some areas missing or eroded joints in slipway blockwork. In the rear wall below the chalets there is a long horizontal crack in wall and a large void in centre of wall near the ramp at the north end of chalets.

Rear wall set back behind slipway at Cobble Landing (Asset Ref. 1221D901D1602C01)

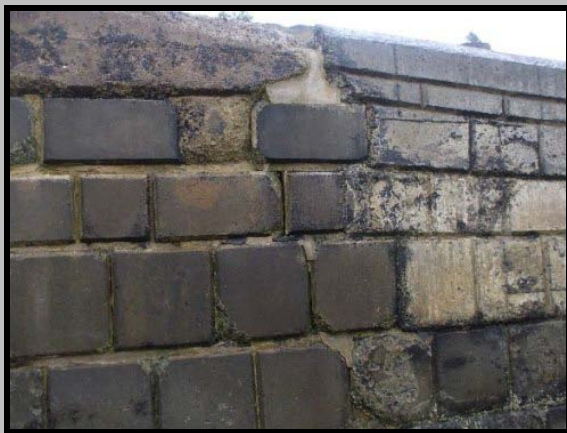
Between the northern slipway at Cobble Landing and the slipway at the end of Ravine Road the seawall is split into two assets. The northern asset, 1221D901D1602C09, is essentially a breakwater or wing wall protecting the slipway. This section of wall is in need of repair as it has a major crack and section of loose blocks, see photo below right. The toe apron is also exposed and appears to be undercut, below top left, although the foundation details are not know.

Photo from 2009 inspection of crack at Cobble Landing – (Asset Ref. 1221D901D1602C09)

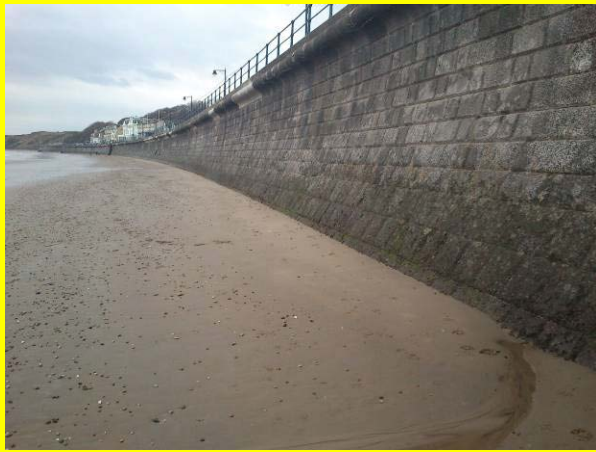
The section of wall between Ravine Road and the access point east of Cargate Hill Road is Asset ref. 1221D901D1602C08. This section is in fair overall condition, although some blocks have abrasion damage to the front face, particularly near beach level. Several of the coping blocks are cracked, and drainage flap valves are partly covered with sand due to the beach level. At both slipway access points there are open joints in the slipway blocks that need re-pointing.

General view of wall showing repaired coping wave return blocks and abrasion damage to blocks near beach level. (Asset Ref. 1221D901D1602C08)

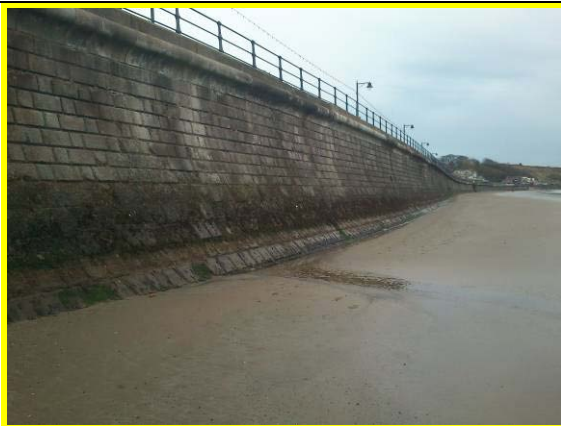
From the promenade pedestrian bridge at Cargate Hill to the next access point at Crescent Hill the wall (Asset Ref. 1221D901D1602C03) is in fair condition. There are several new or repaired coping splash beam blocks, but more are cracked. The lower handrail is loose where it joins the footbridge and needs re-fixing. The upper coping near the handrail up-stands is chipped and damaged in many locations. There is abrasion damage to the front face of many blocks and several of the drainage outlets are blocked due to beach levels

General view of wall looking north. (Asset Ref. 1221D901D1602C03)

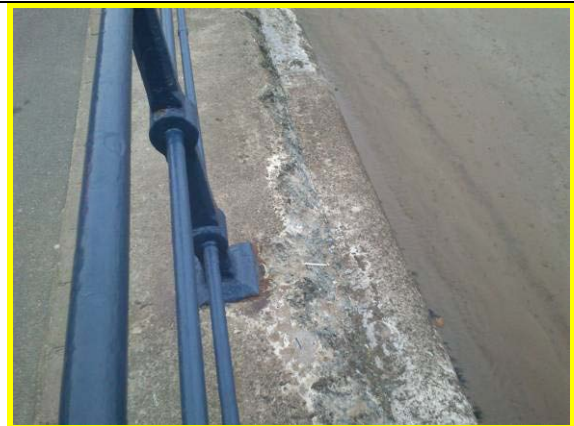
Damaged coping and splash beam (Asset Ref. 1221D901D1602C03)

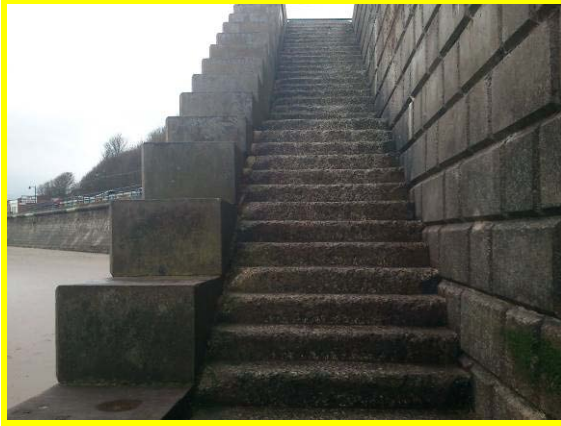
The next defence asset to the south is the wall around the promontory, Royal Parade, Asset ref. 1221D901D1602C04. This section of wall is again in fair overall condition, although it is slightly more exposed to wave action than the wall to the north. There was noted to be missing mortar at some of the joints in the coping blocks and between some of the blocks in the main wall and some of the block faces are damaged. There was evidence of some temporary repair works to cracks and joints with what appeared to be mastic. The treads on the access steps are becoming abraded and will require attention in future.

Exposed aggregate on access steps (Asset Ref. 1221D901D1602C04)

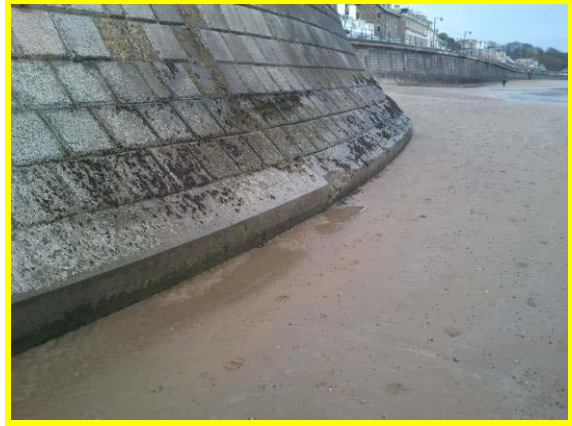
Repaired section of toe with chipped block adjacent. (Asset Ref. 1221D901D1602C04)

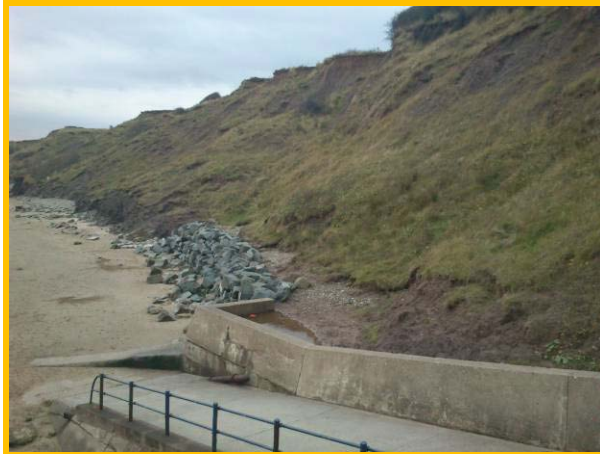
General view of rock armour at interface with natural cliff (Asset Ref. 1221D901D1602C02)

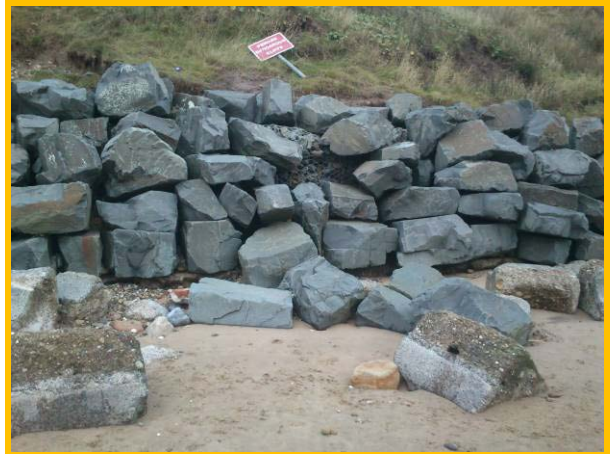
Collapsed section of rock and slumping cliff behind. (Asset Ref. 1221D901D1602C02)

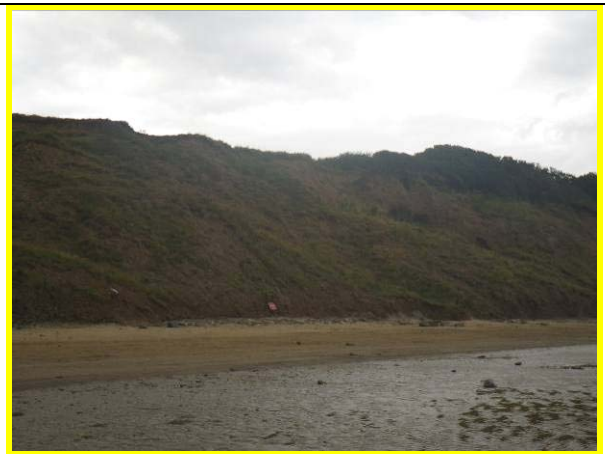
**MU29/AB** Eroding toe and sliding mid-slope (Locally Active)

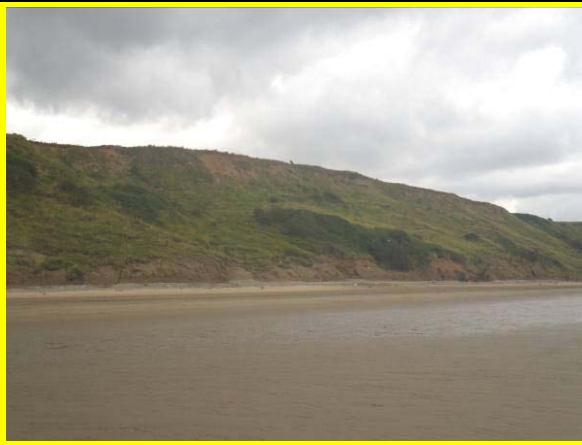
**MU29/AE** The slope is well vegetated with erosion at the toe and headscarp (Locally Active)

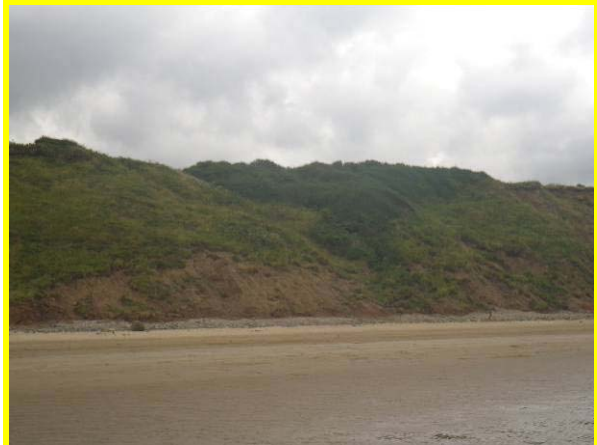
**MU29/AH** Heavily vegetated with toe erosion, which is severe in places (Locally Active)

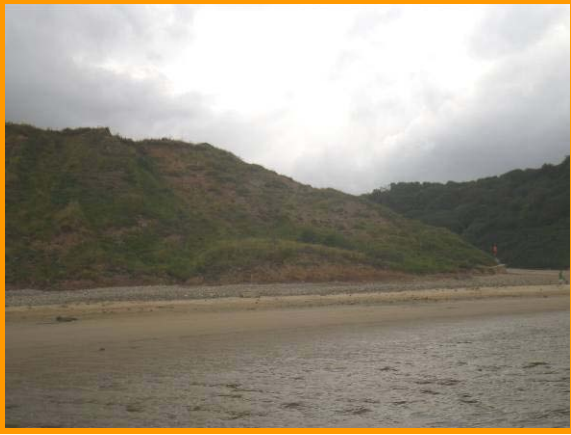
**MU29/AJ** Areas of intense erosion at the toe and headscarp (Partly Active).

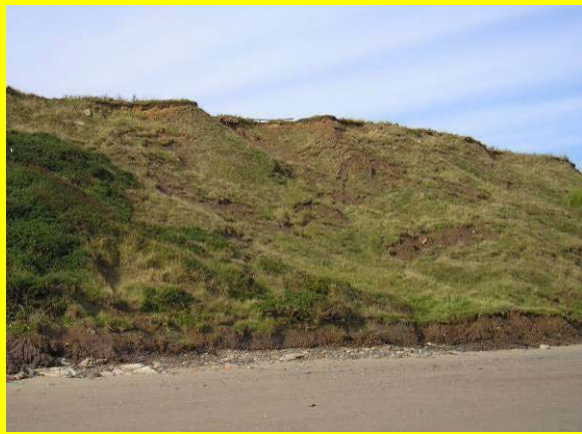
**MU29/AL and M** Erosion at the toe and headscarp, sliding mid-slope (Locally Active).

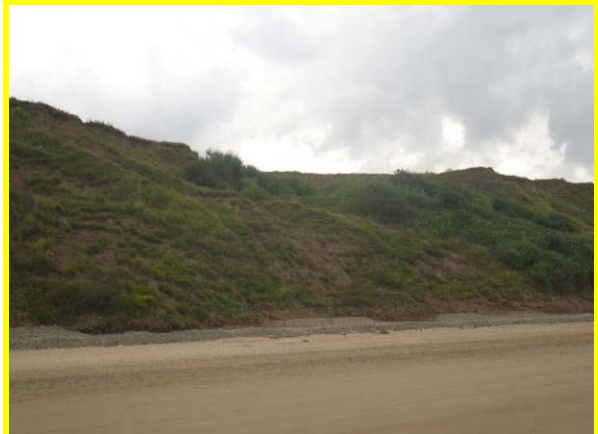
**MU29/AN** Toe erosion on an otherwise vegetated slope (Locally Active).

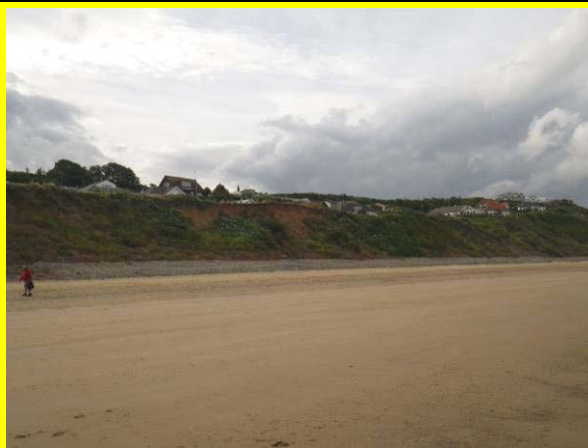
**MU29/AR** Continuing mudslide activity and toe erosion at Flat Cliffs (Locally Active).

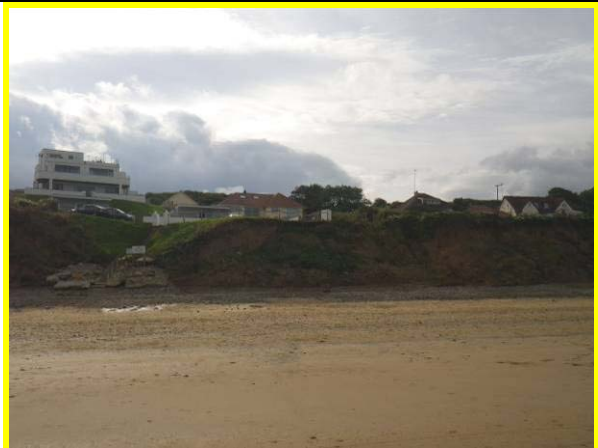
**MU29/AS** Continuing mudslide activity and toe erosion at Flat Cliffs (Locally Active).

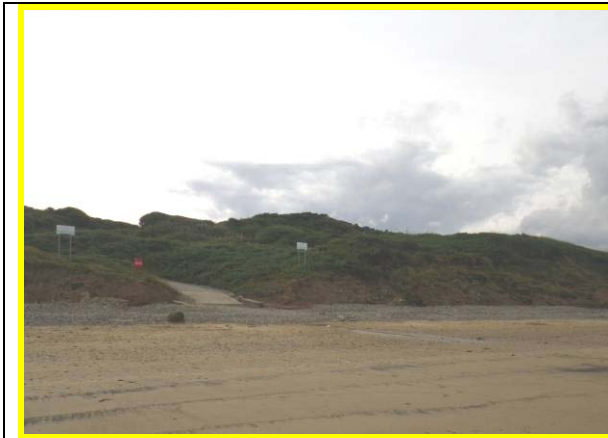
**MU29/AT** this large unit is showing eroding at the toe with thick vegetation higher up the unit (Locally Active).

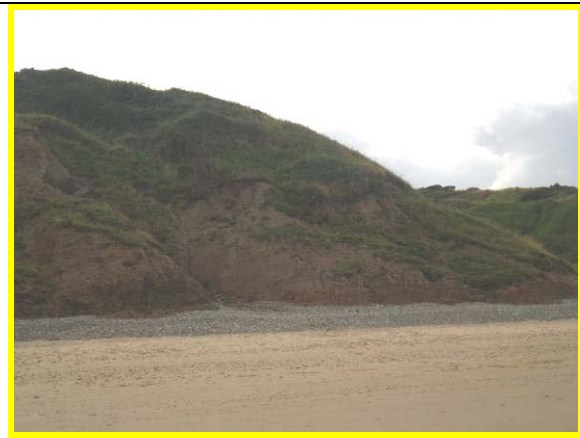
**MU29/BA** The small unit at Butcher Haven does not support vegetation on its lower slopes and is undergoing erosion. (Locally Active).

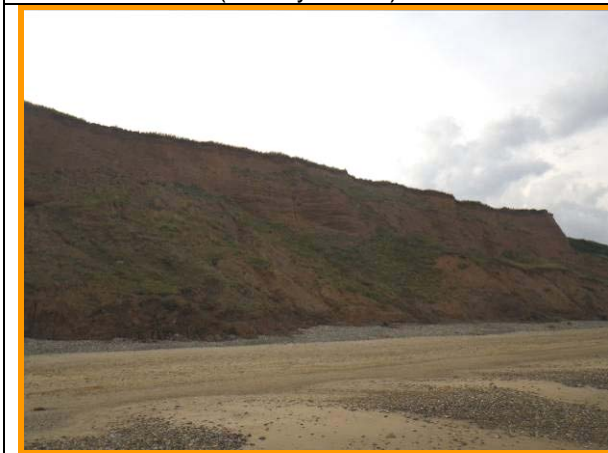
**MU29/BB and BC** Steeper cliffs with very common areas of intense erosion (Partly Active).

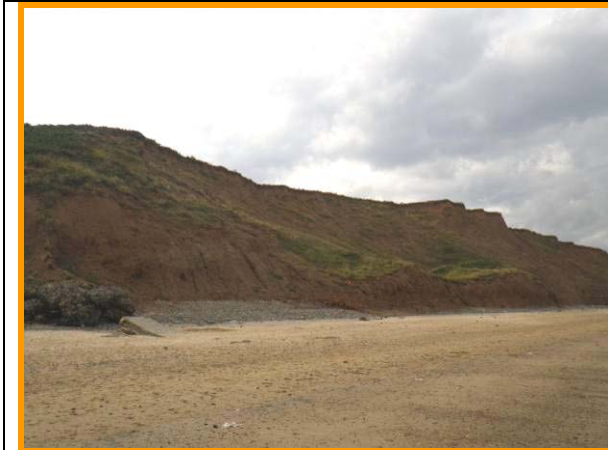
**MU29/BE** Headscarp and toe erosion (Partly Active).

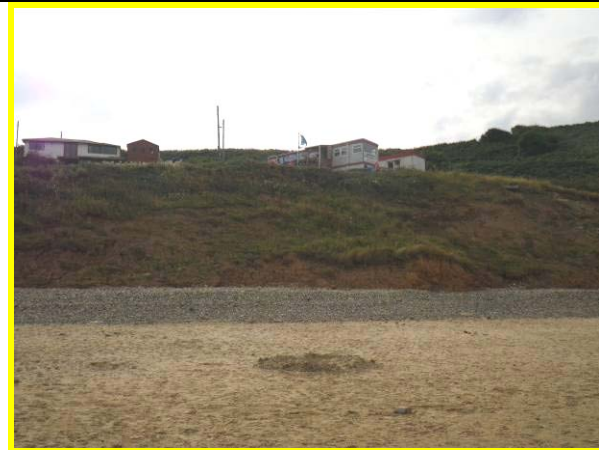
**MU29/BE2** The Hunmanby Gap unit is more stable than the units to the NW (Locally Active).

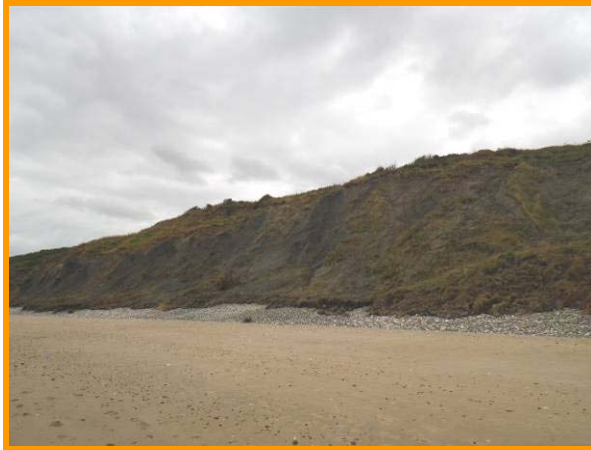
**MU29/CC** Erosion and mudsliding at Middle Cliff (Partly Active)

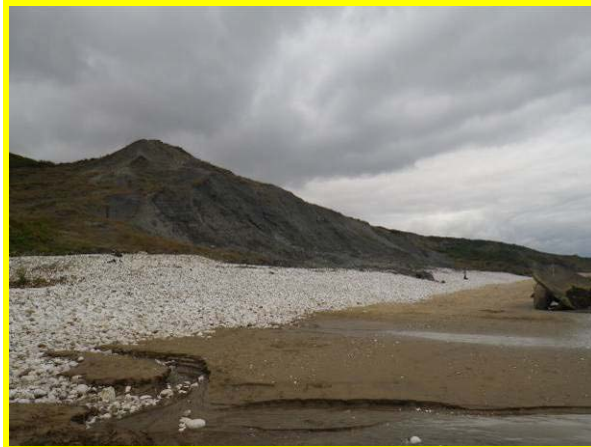
**MU29/CE** Actively eroding cliff toe (Locally Active)

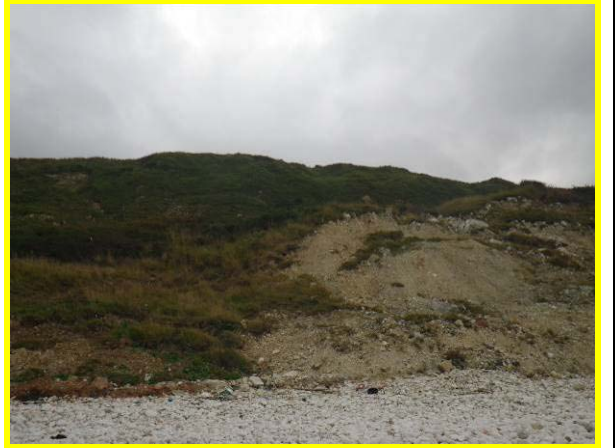
**MU29/CI** Actively eroding cliff toe (Locally Active)
