Analysis and Interpretation of Coastal Monitoring Data

Geotechnical Interpretative Report

Document Ref No 721228/001/GR/01/FINAL
February 2009

Scarborough Borough Council
Town Hall
St. Nicholas Street
Scarborough
N. Yorkshire
YO11 2HG

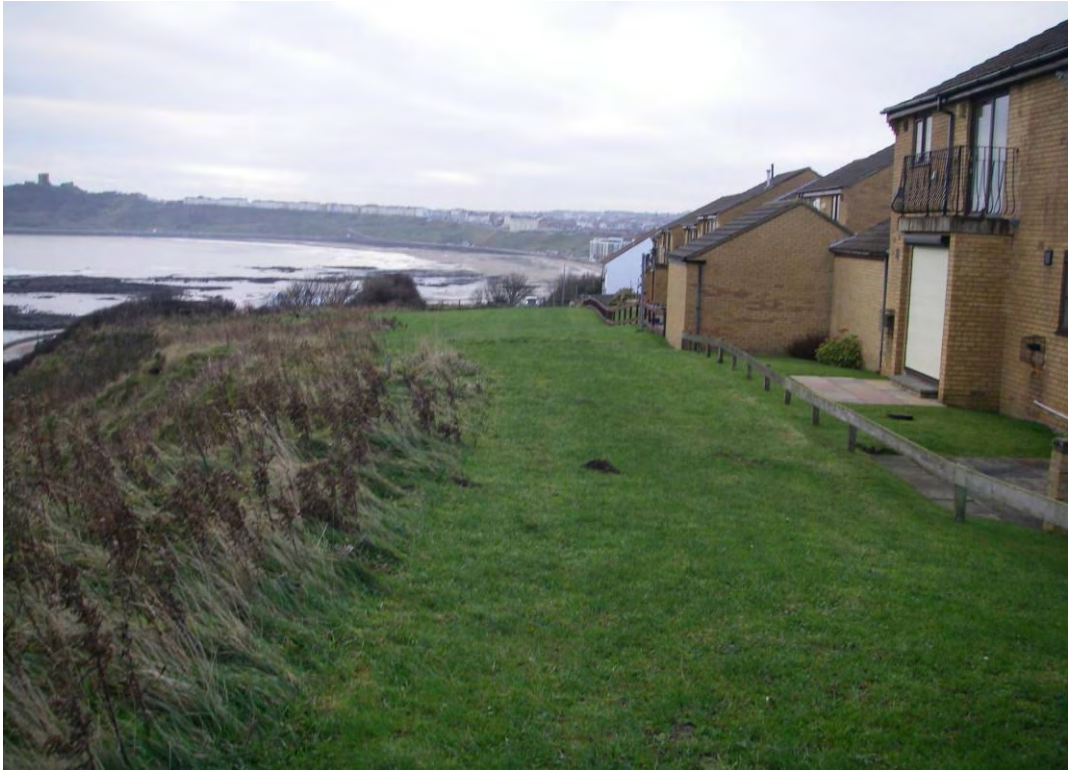
Plate 11. Site view looking south across Upper Plateau showing slope crest and residential properties.

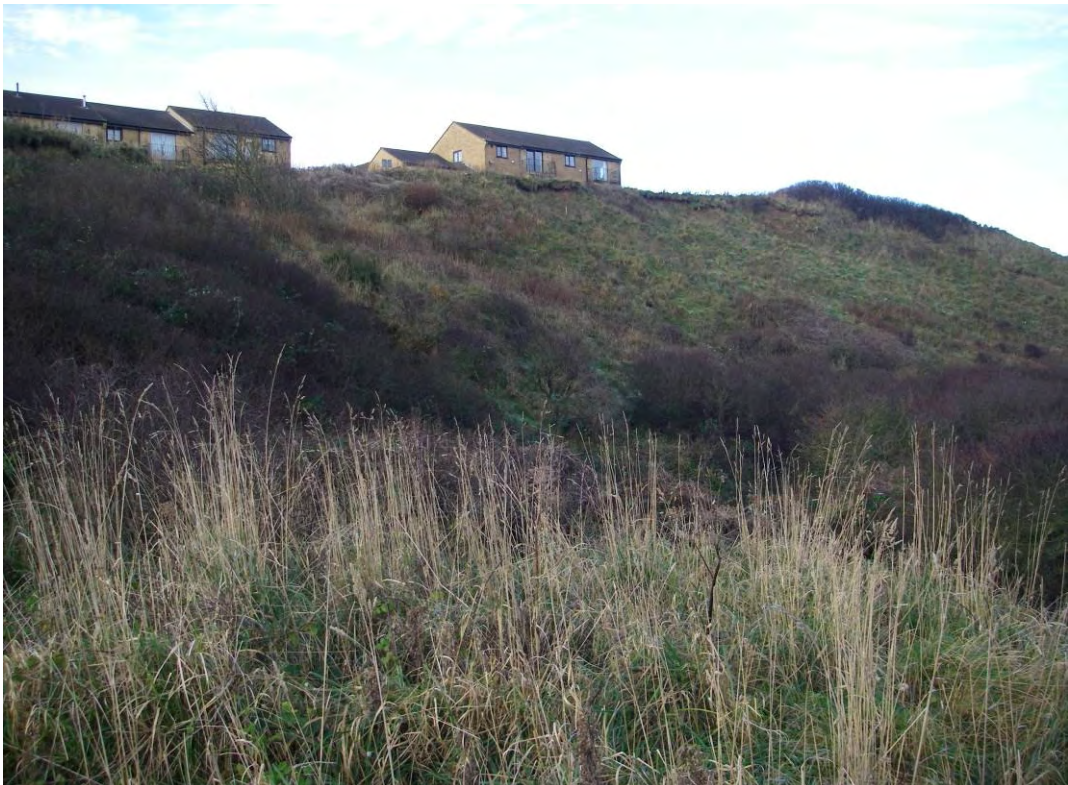
Plate 12. Site view of Behaviour Unit II showing over steepened back-scarp below Upper Plateau.

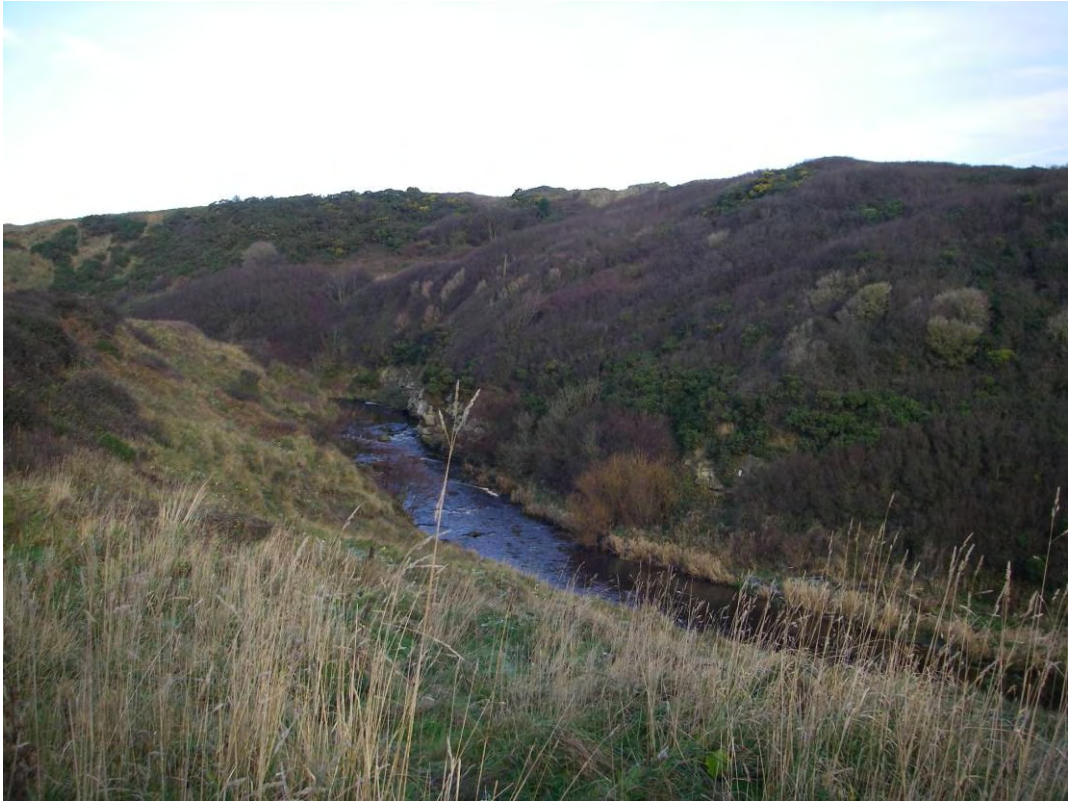
Plate 13. Site view looking north at Scalby Beck showing rock outcrops.

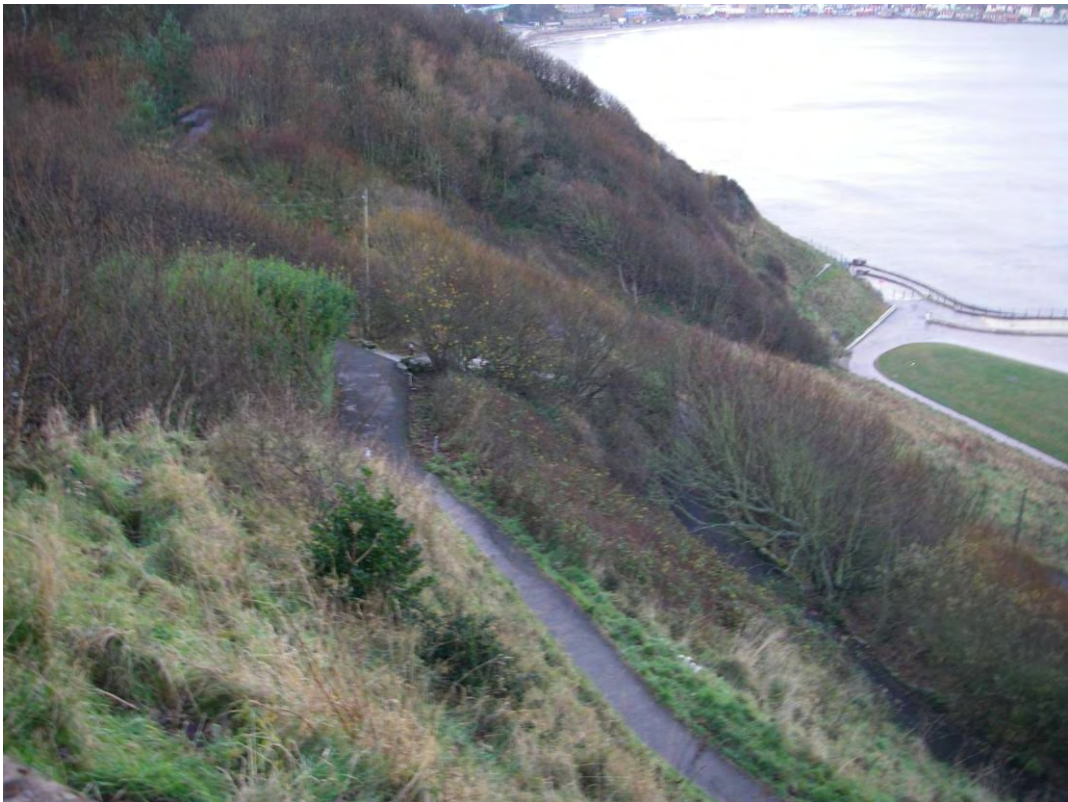
Plate 22. Site view of steep slope angles above South Bay Pool Cliff.

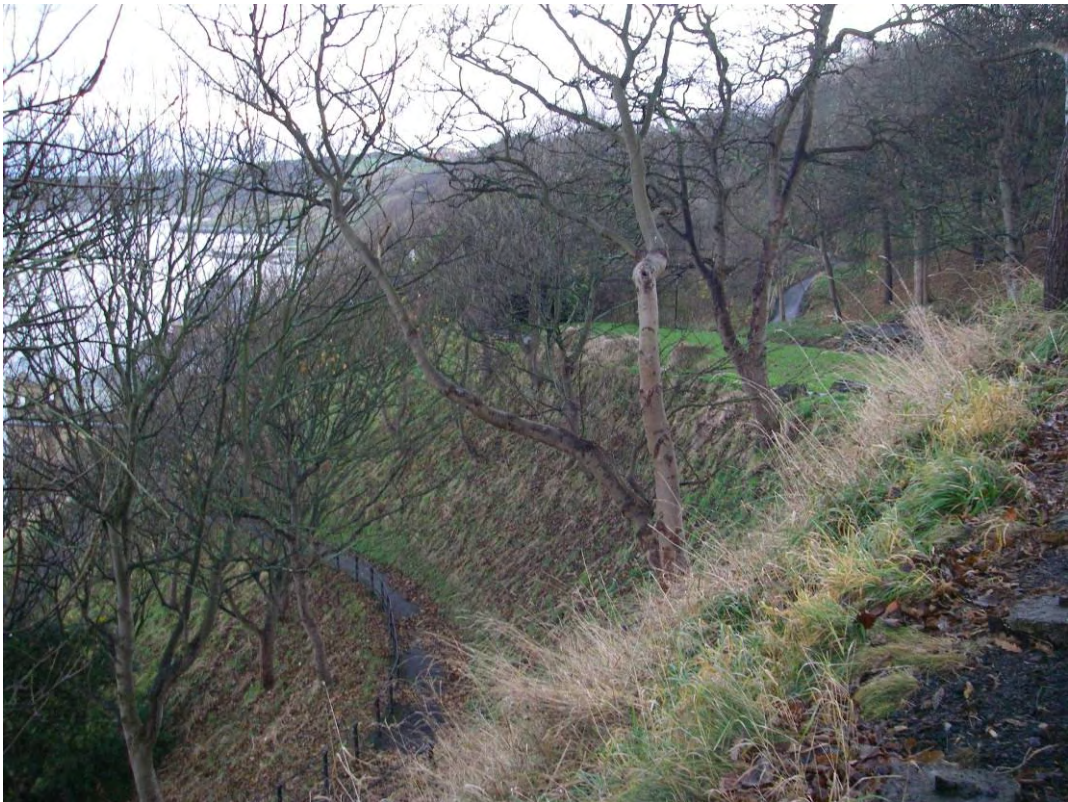
Plate 28. Site view looking south across Spa Cliff showing steep slope angles and bench-cut paths.

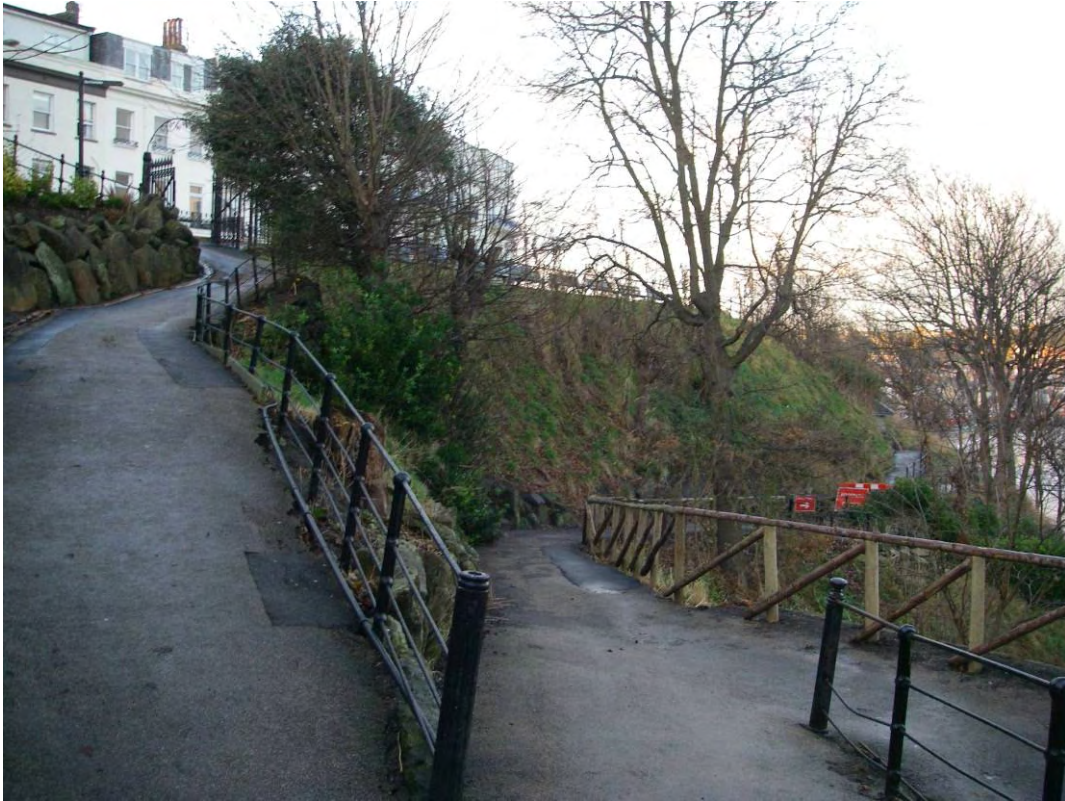
Plate 29. Site view looking north across Spa Chalet Cliff showing steep slope angles and bench-cut paths.

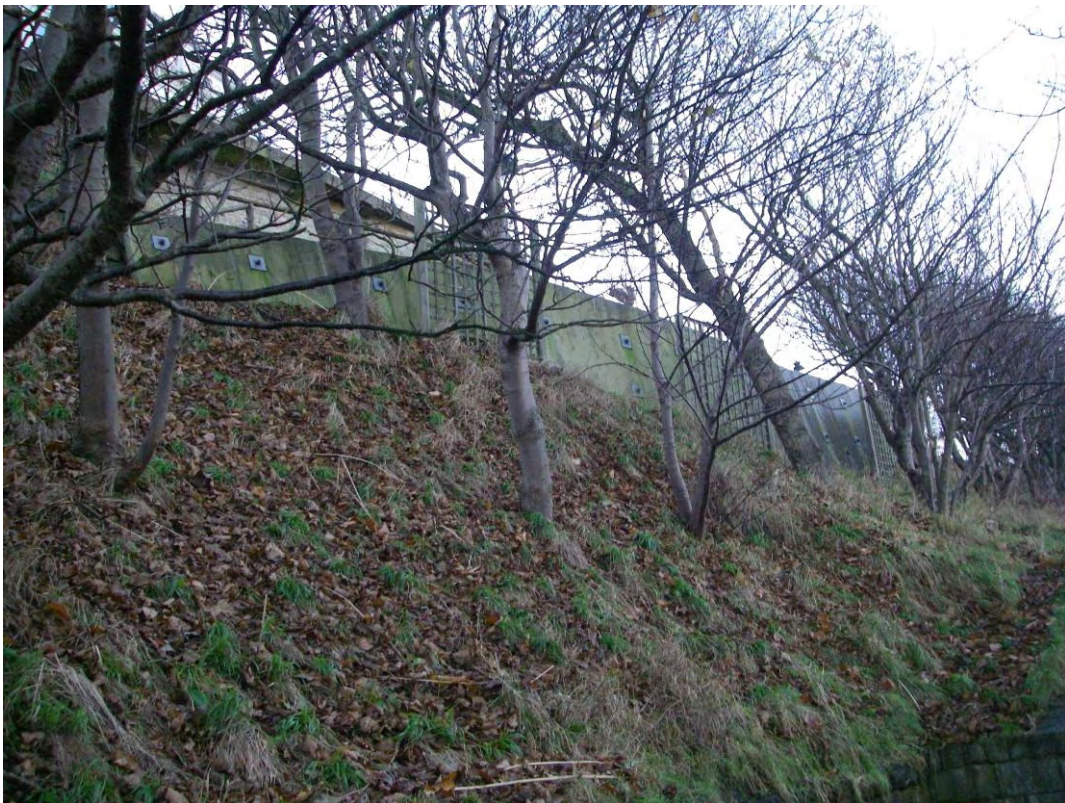
Plate 30. Site view of slope crest retaining walls at Prince of Wales Cliff.

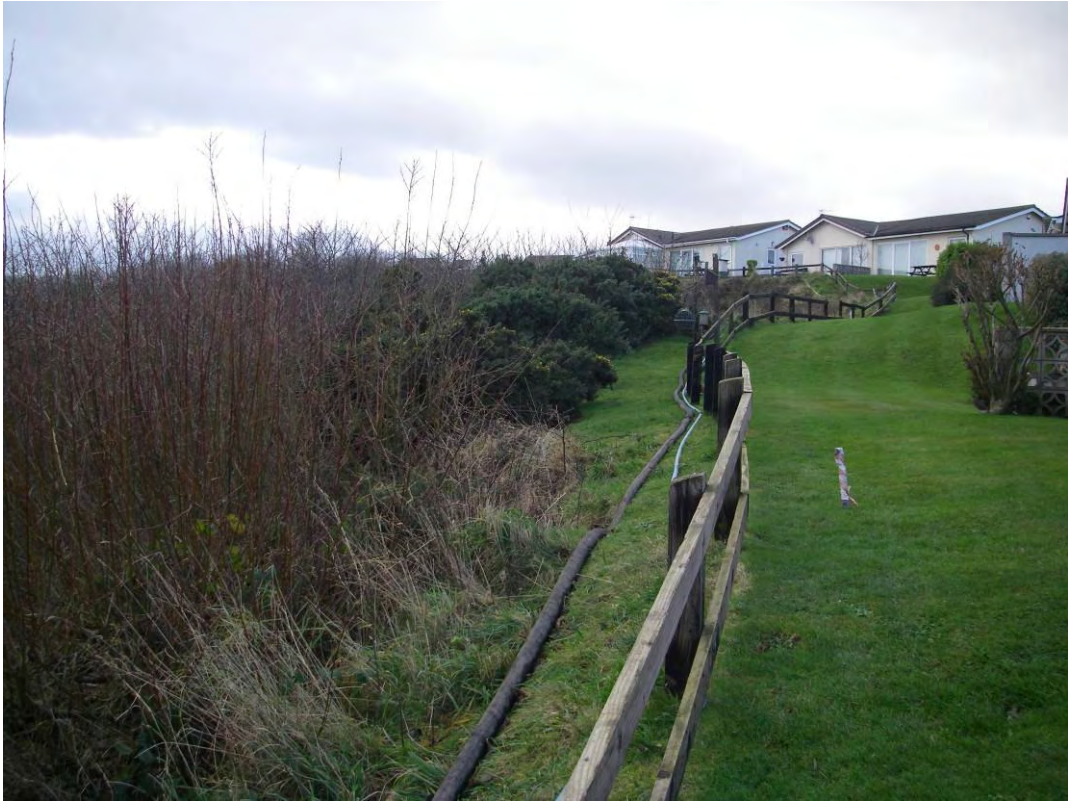
Plate 31. Site view looking south west along crest of Cayton Cliff.

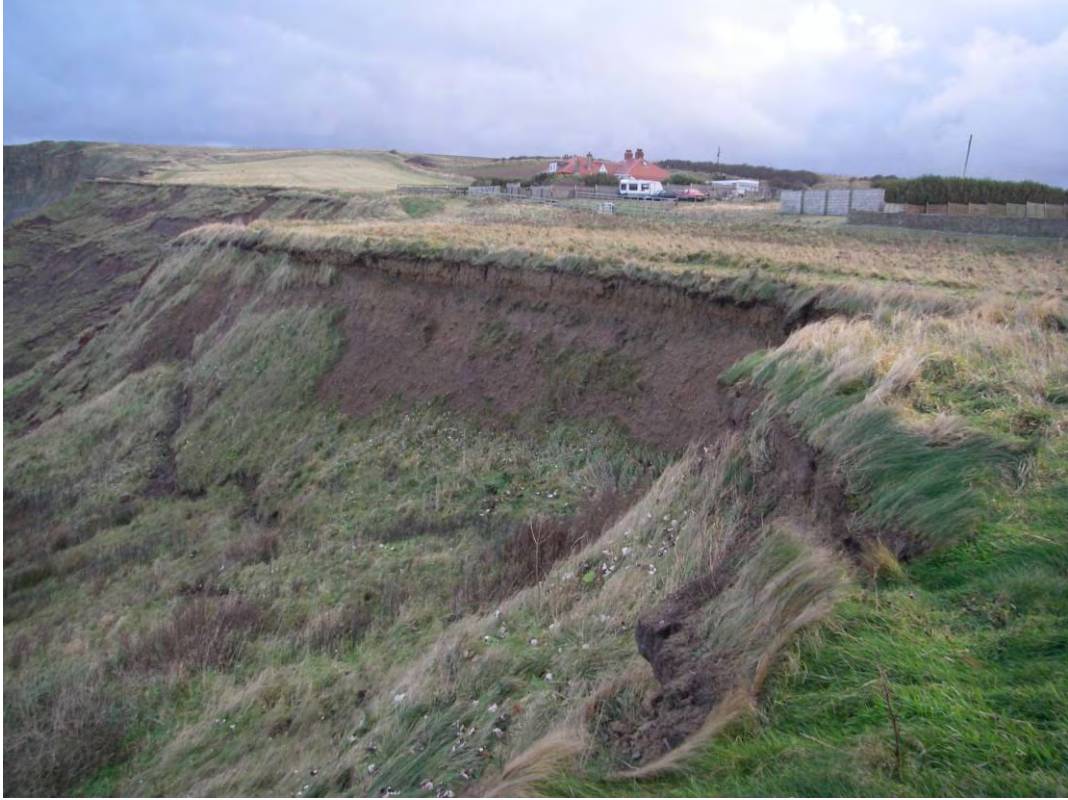
Plate 40. Site view looking south across Killerby Cliffs.

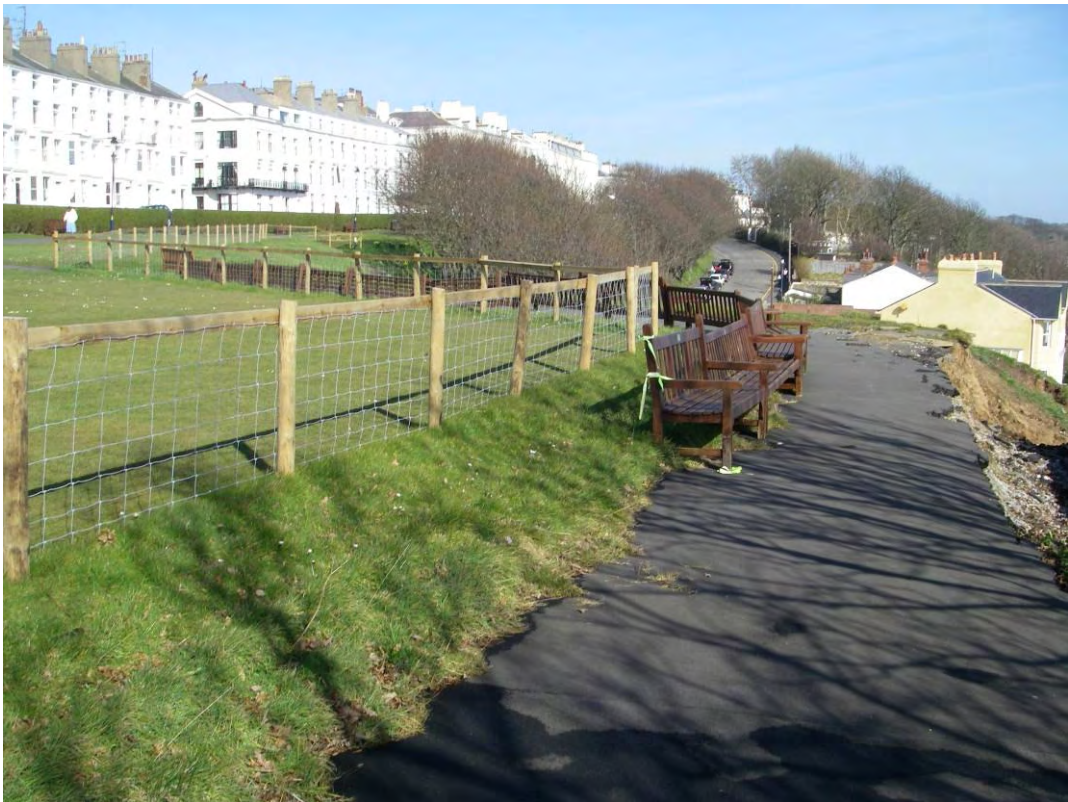
Plate 44. Site view looking north across Glen Gardens.

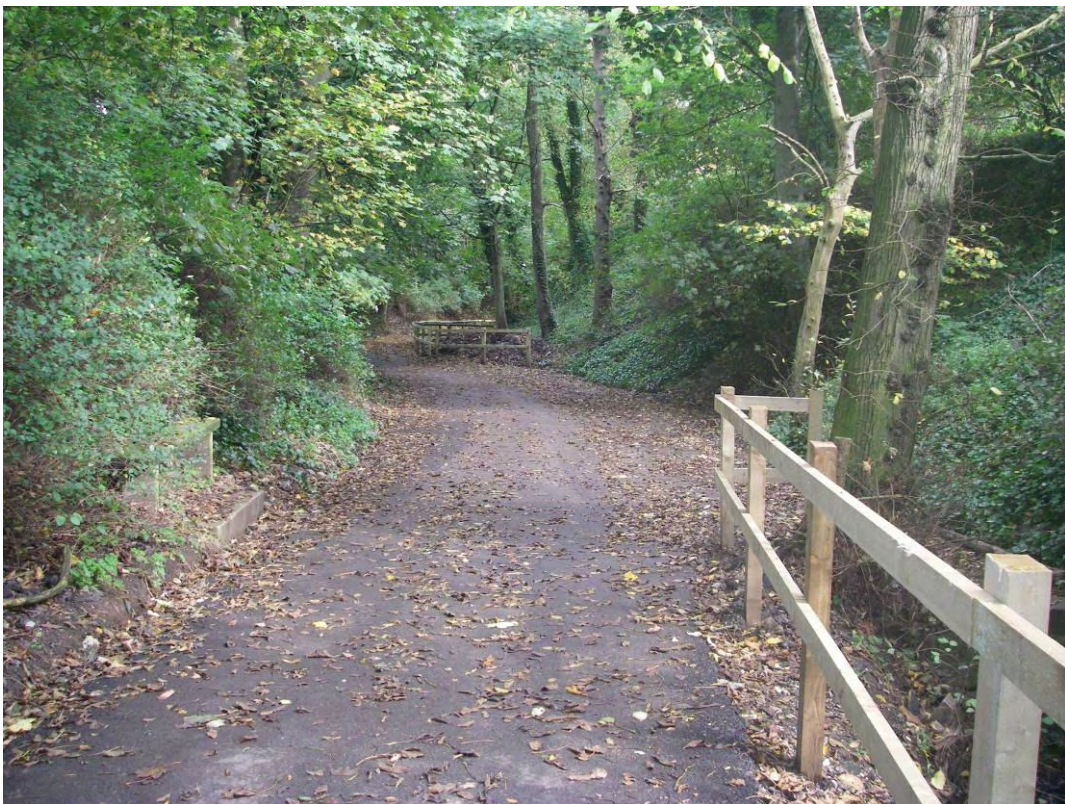
Plate 46. Site view looking down Martin's Ravine. Note stream on the right side.

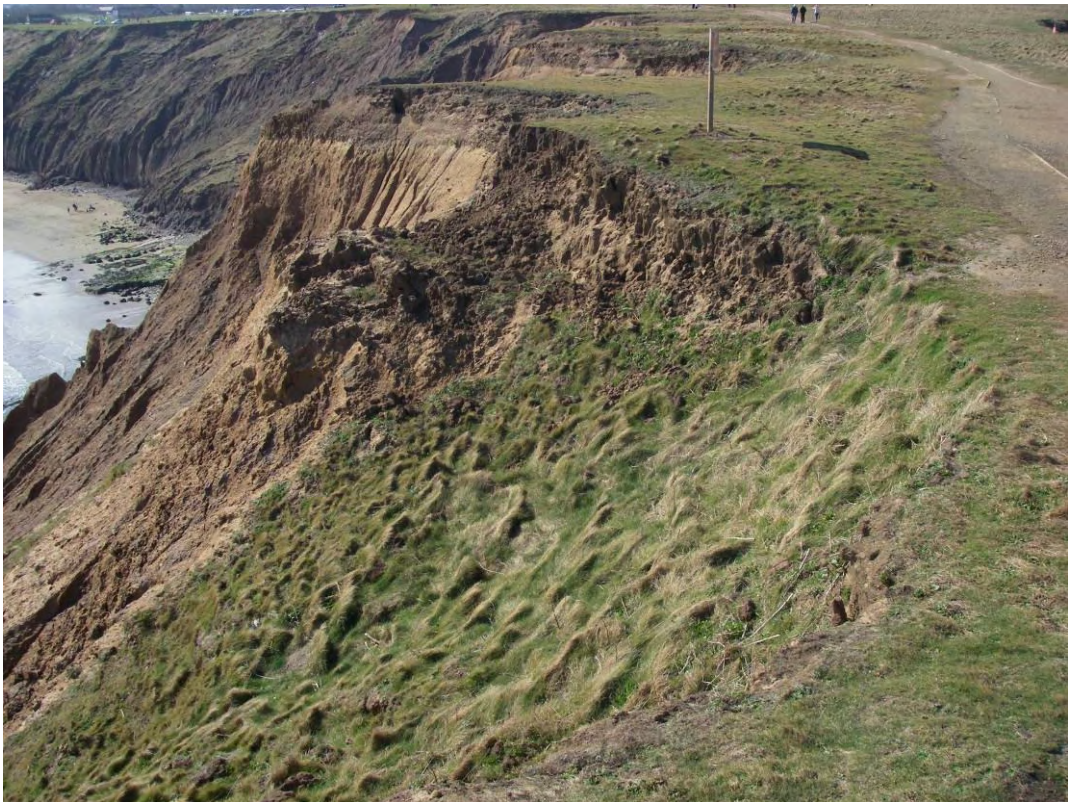
Plate 50. Site view of gullying and slumping of glacial tills at Filey Brigg.

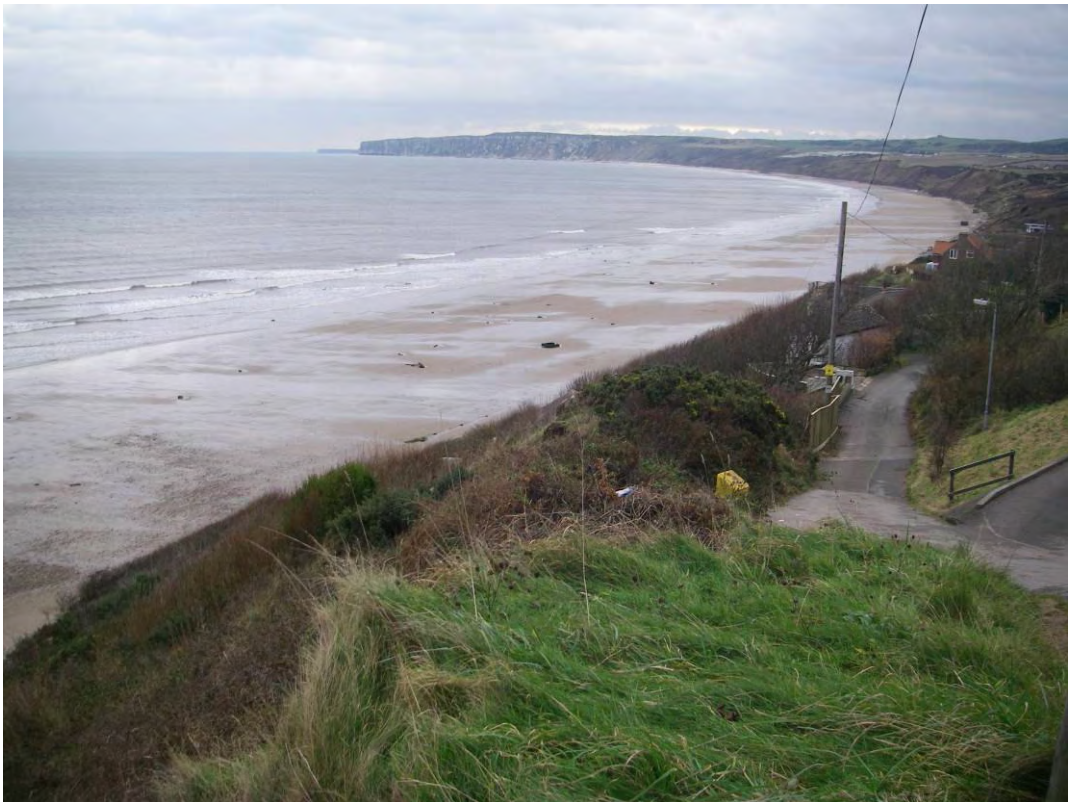
Plate 54. Site view looking south across Filey Bay towards Flamborough Head.

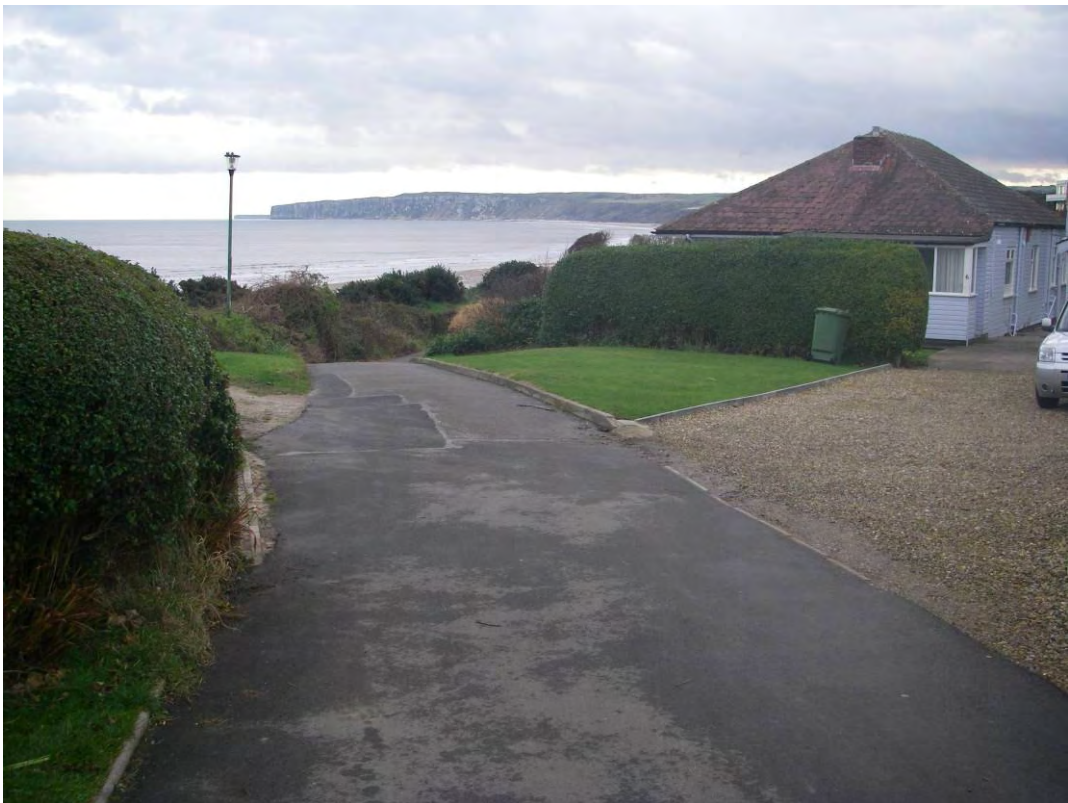
Plate 58. Site view looking down slope from 'level' mid-slope bench.
