Ongoing Analysis and Interpretation of Coastal Monitoring Data

Initial Review of Full Suite Monitoring

Geotechnical Interpretative Report

Document Ref. No. 721229/002/GIR/002/Final

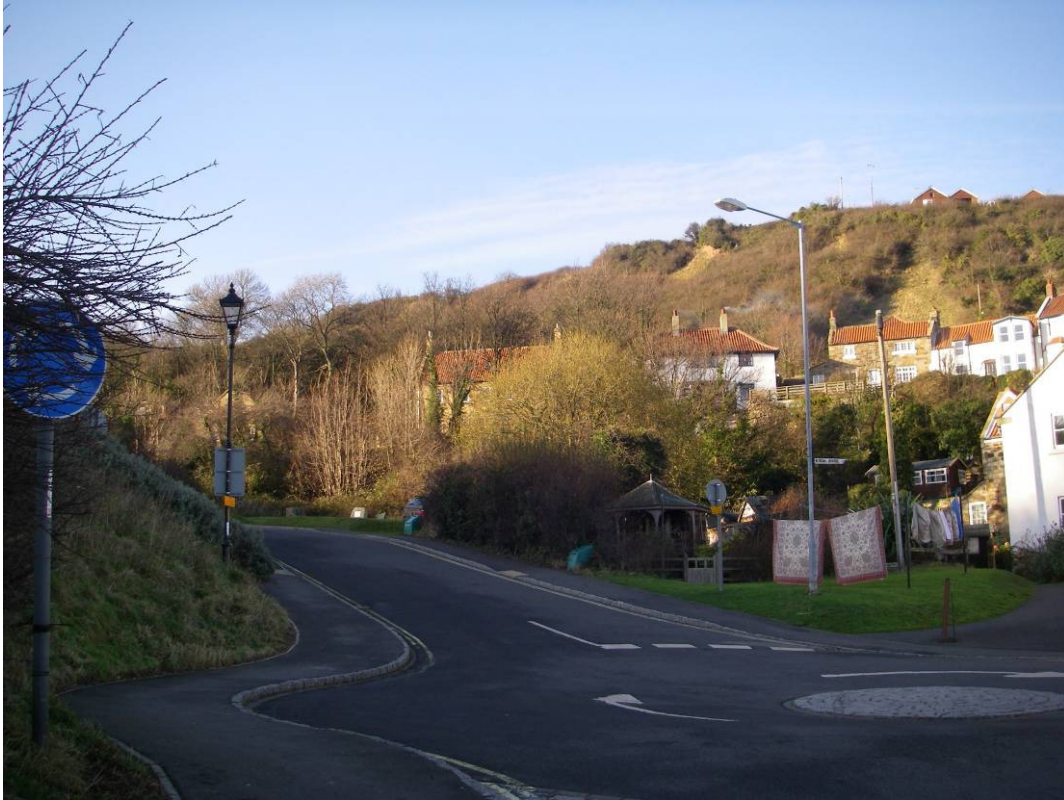
Plate 3 Site view looking towards only access road.

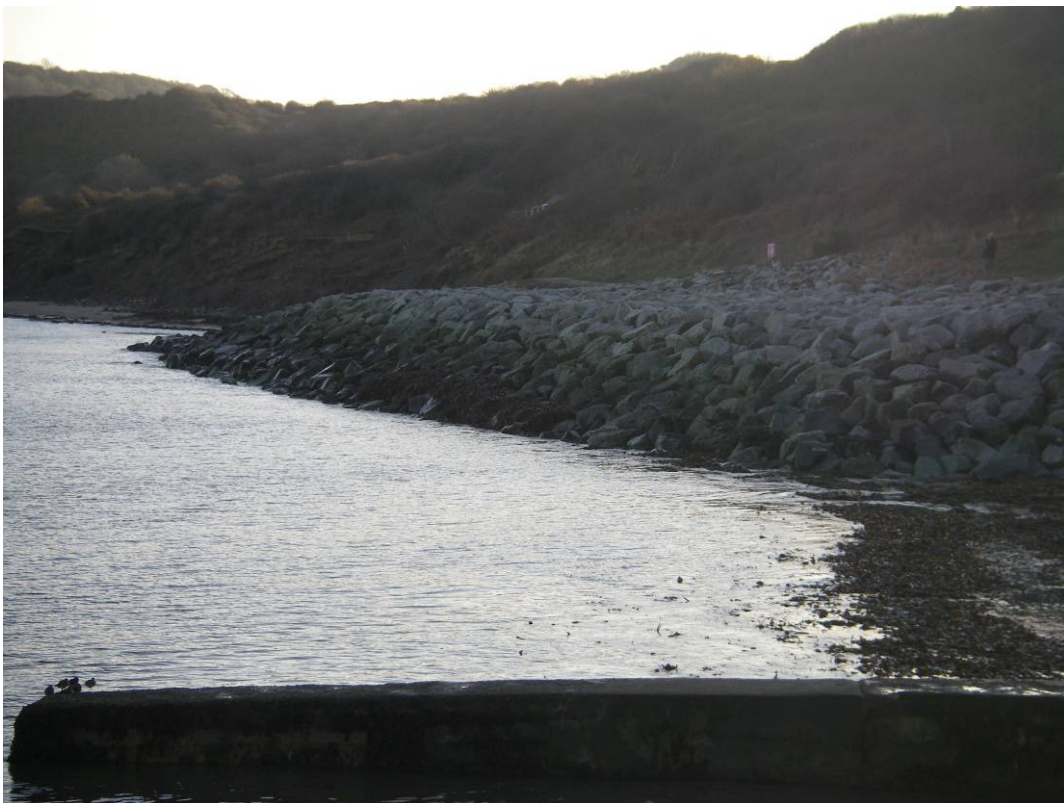
Plate 4 Site view looking south-south east across rock armour revetment towards Dother Pits.

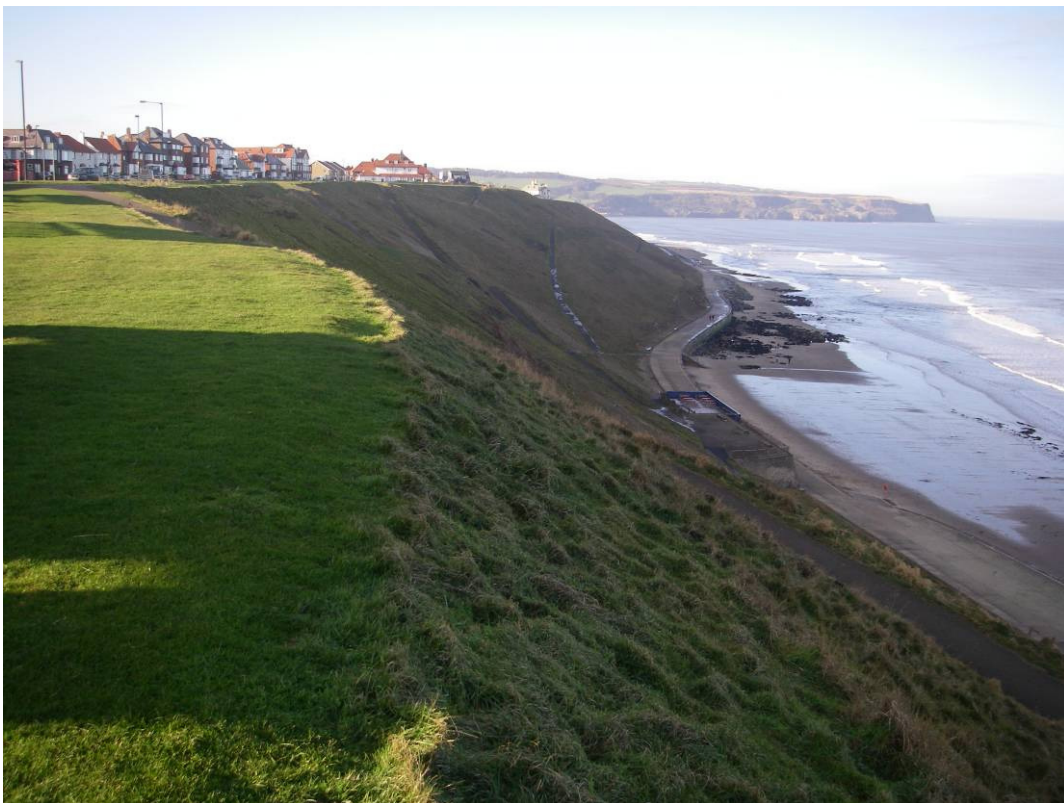
Plate 6 Site view looking west along West Cliff towards Sandsend.

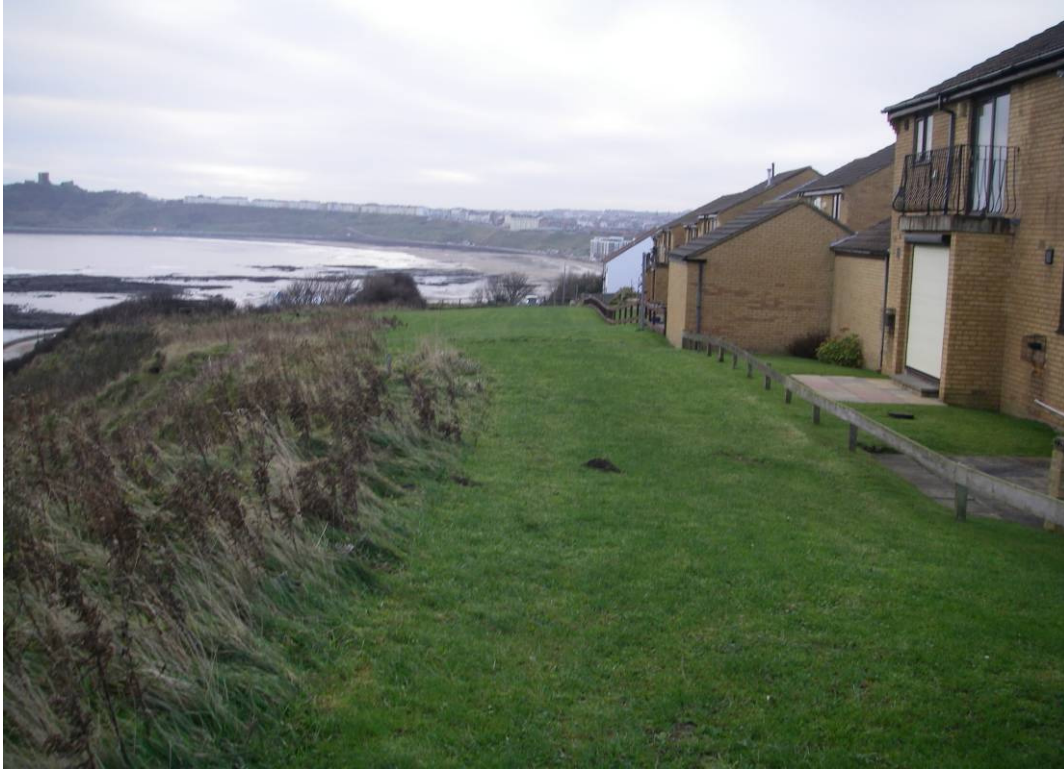
Plate 11 Site view looking south across Upper Plateau showing slope crest and residential properties.

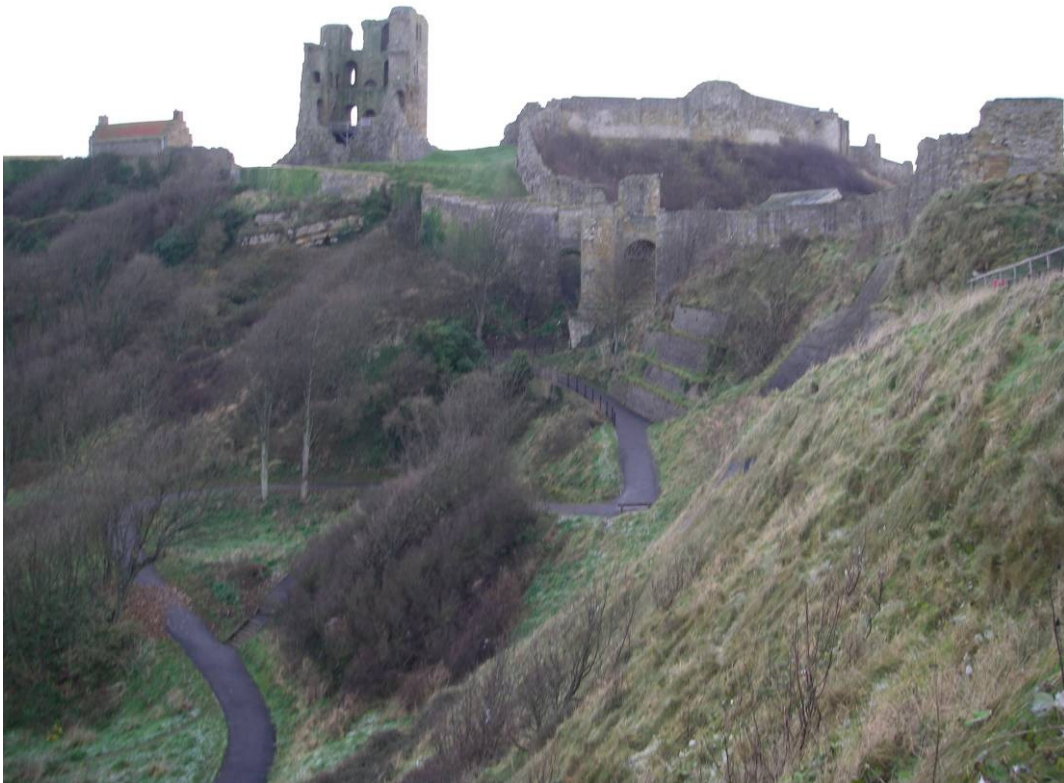
Plate 18 Site view of the Castle from Castle by The Sea. (Note retaining walls in the mid-ground).

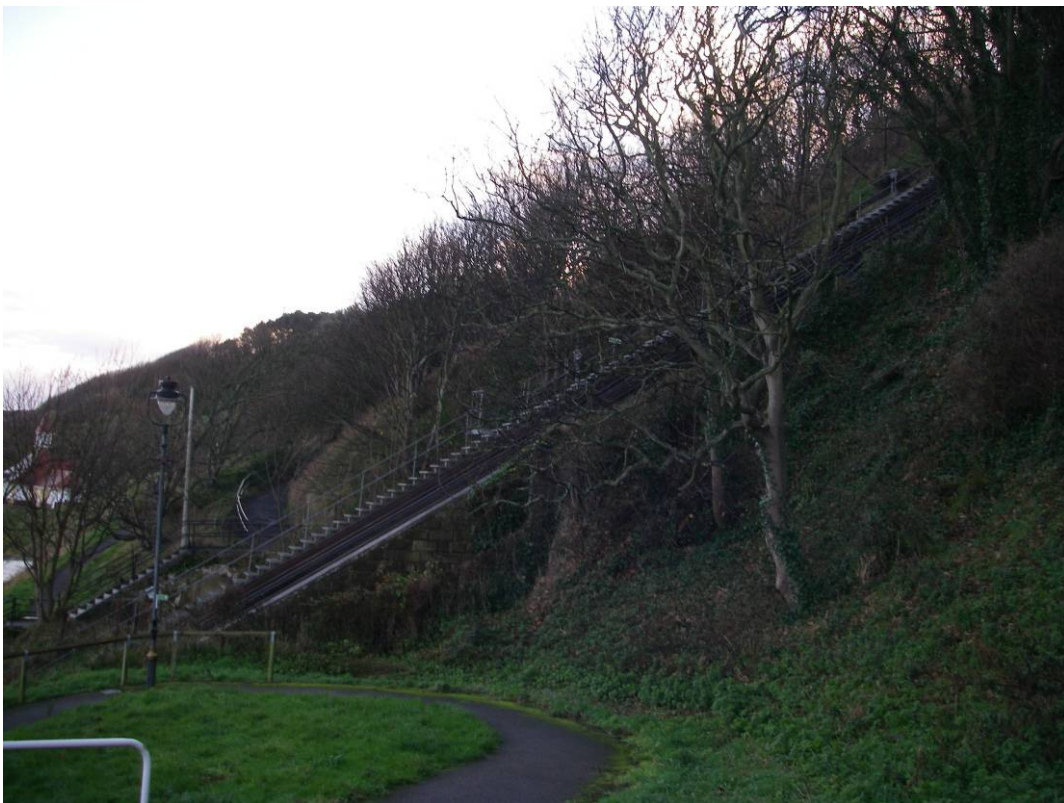
Plate 26 Site view looking south at the cliff railway and slopes of Prince of Wales Cliff.

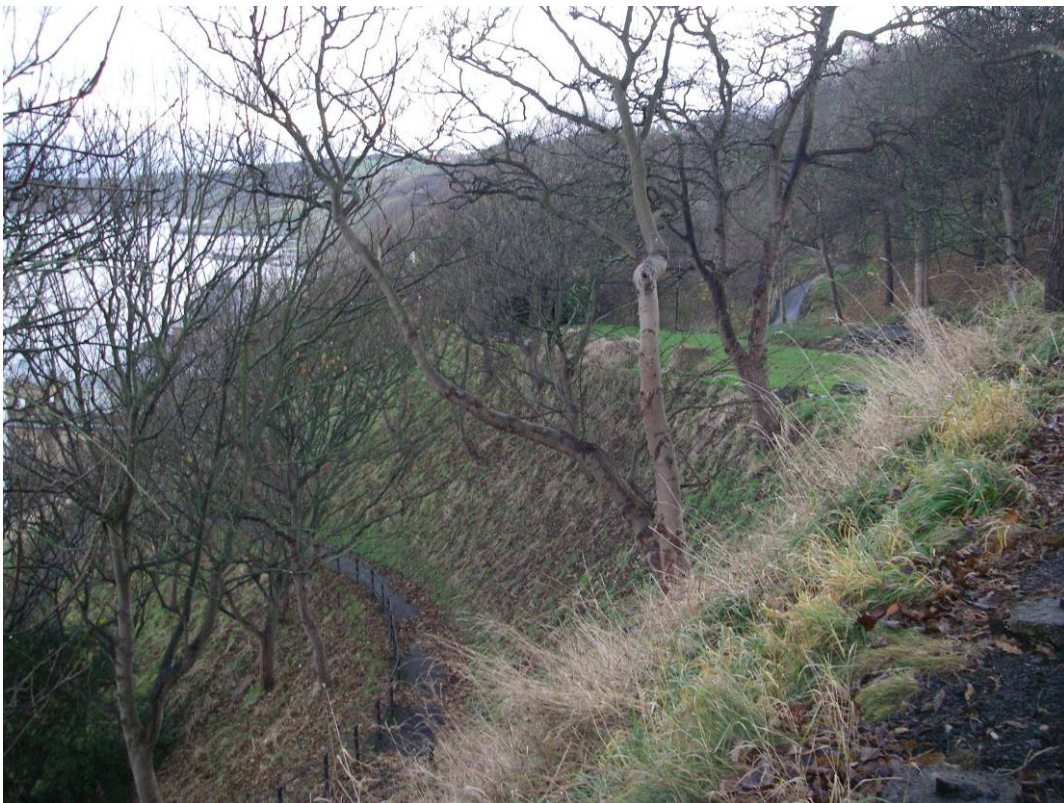
Plate 28 Site view looking south across Spa Cliff showing steep slope angles and bench-cut paths.

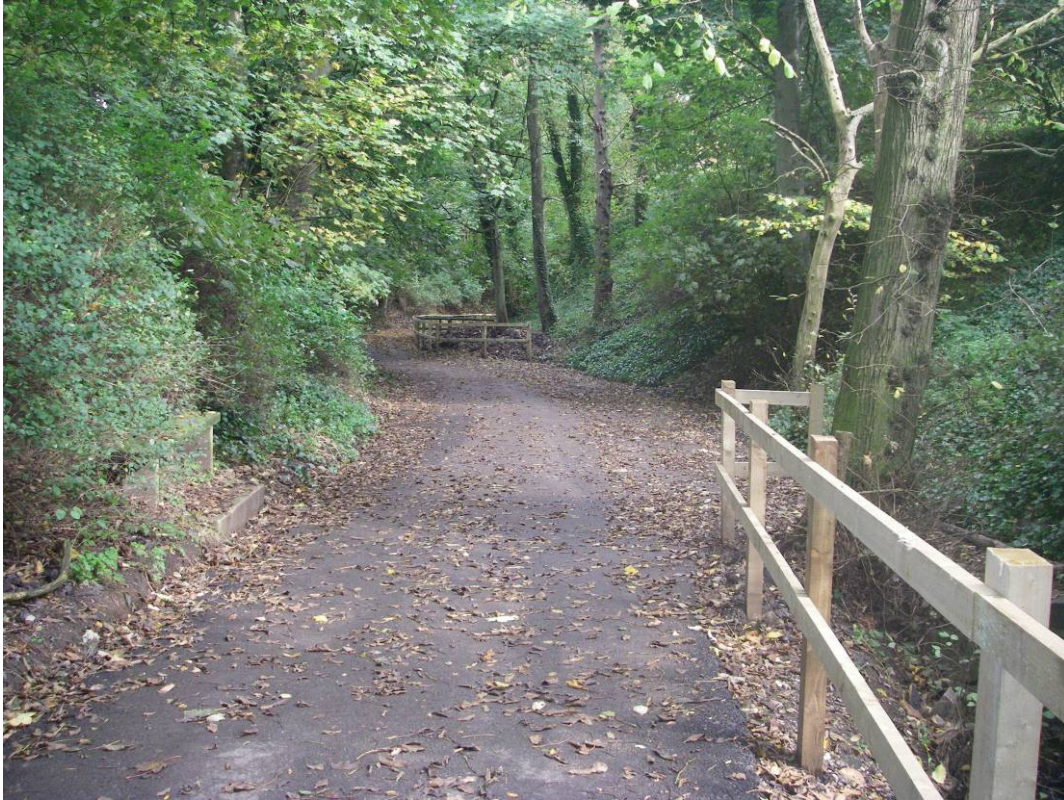
Plate 45 Site view looking down Martin's Ravine. (Note stream on the right side).

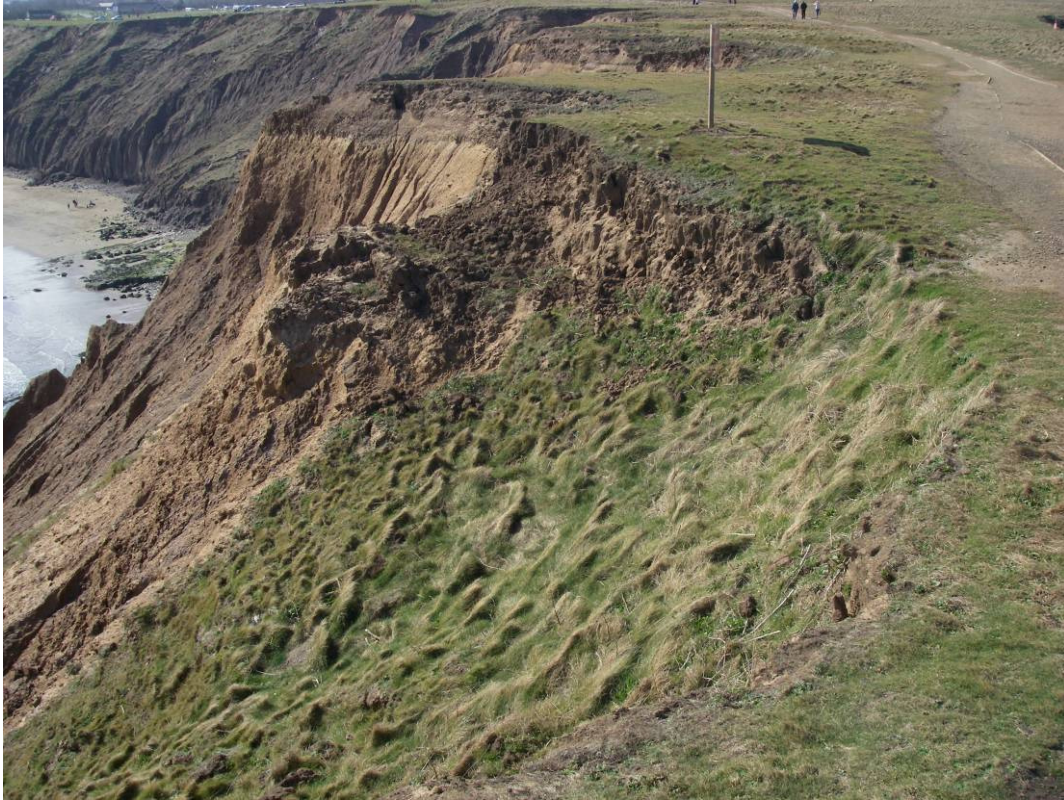
Plate 49 Site view of gullying and slumping of glacial tills at Filey Brigg.

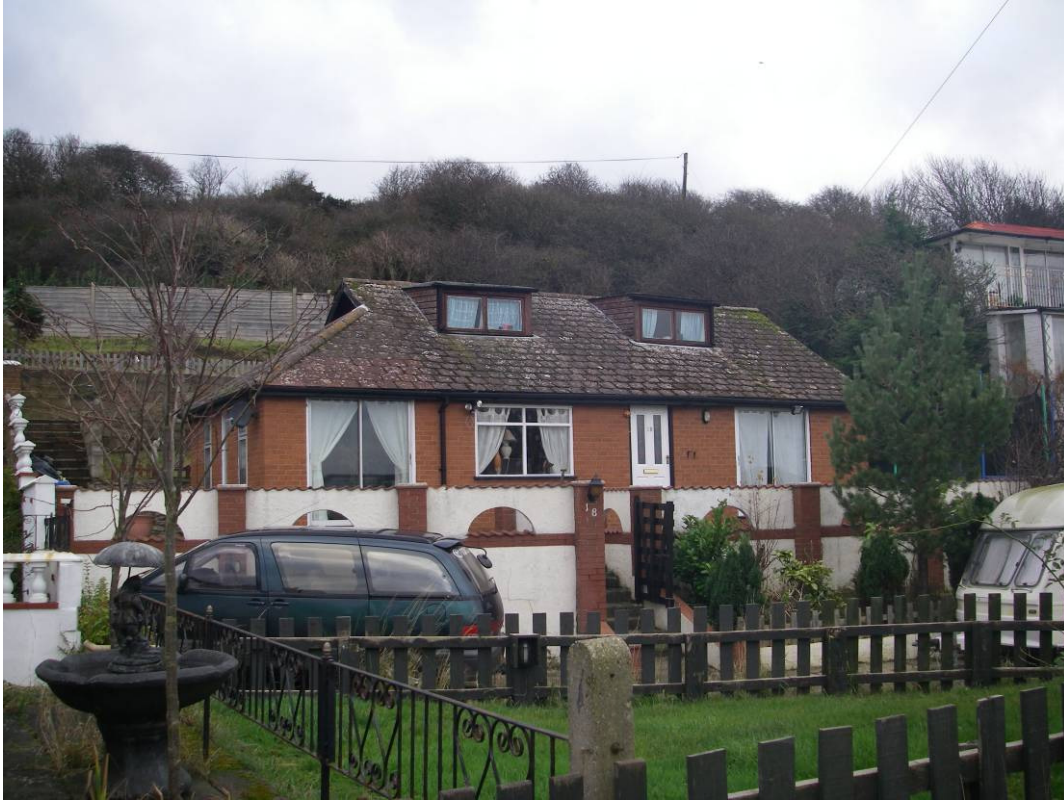
At Flat Cliffs there is evidence of active slope erosion, cliff-top recession and slope instability. Slope instability is particularly apparent at this site where an active landslide (rotational failures forming a benched slope profile) now threatens to breach the only vehicle access route into the area.

Plate 57 Site view of property on 'level' mid-slope bench with steep back slopes in background.
