# Ongoing Analysis and Interpretation of Coastal Monitoring Data

Third Review of Restricted Suite Monitoring

## Geotechnical Interpretative Report

Document Ref. No. 721229/002/GIR/005/Final

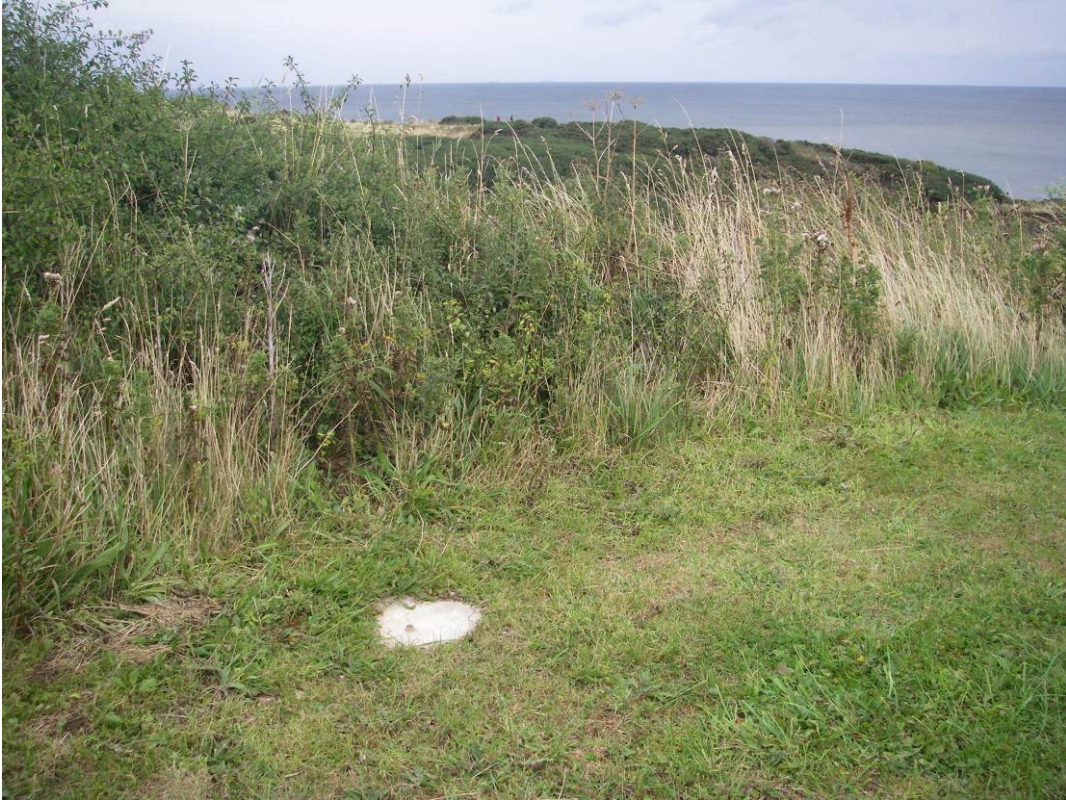
Plate 2 Scalby Ness MP1

The survey pins were measured at monthly intervals from July to October 2009. A comparison of the measurements taken from stations (MP1, MP2, MP3 and MP4) showed that zero cliff recession rates had occurred during the period August to October. At recession point MP3 a cliff recession rate of 10mm was noted to have occurred between July and August, though zero recession rates have been recorded from August onwards. The results of monitoring indicate both slopes are relatively stable although the on-set of wetter autumn / winter months may lead to some increased activity of slope recession.
