Ongoing Analysis and Interpretation of Coastal Monitoring Data

Sixth Review of Restricted Suite Monitoring

Geotechnical Interpretative Report

Document Ref. No. 721229/002/GIR/009/Final

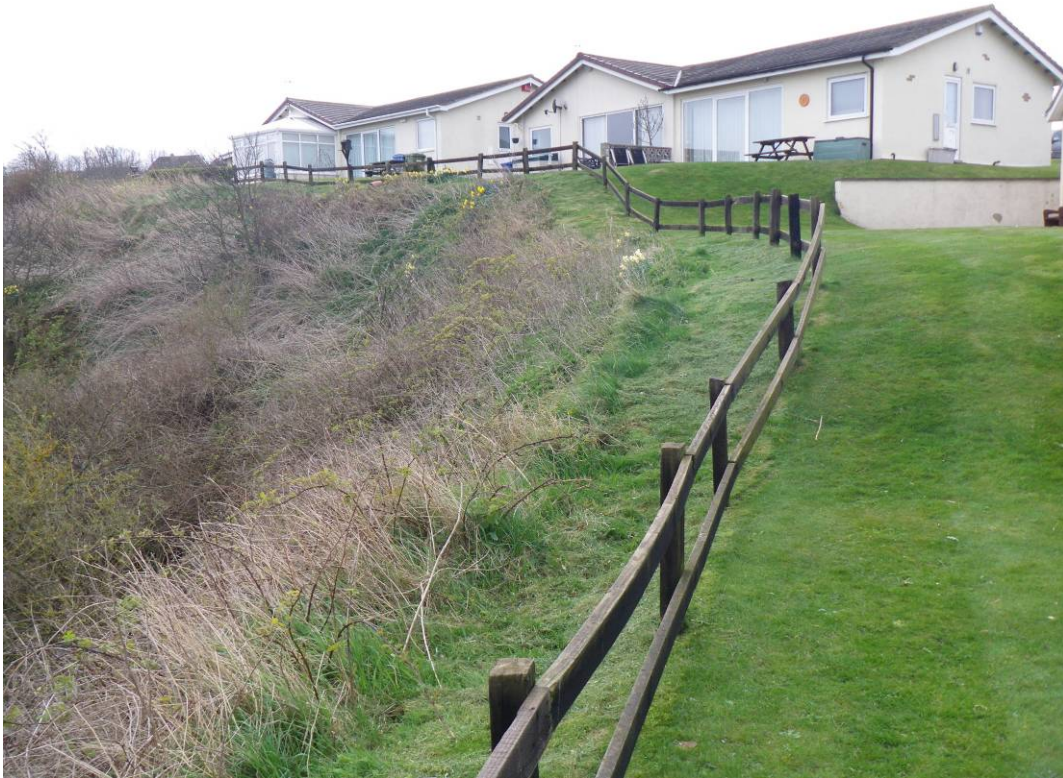
Plate 4 Slope failures on Cornelian Bay side looking east (14th April 2010)

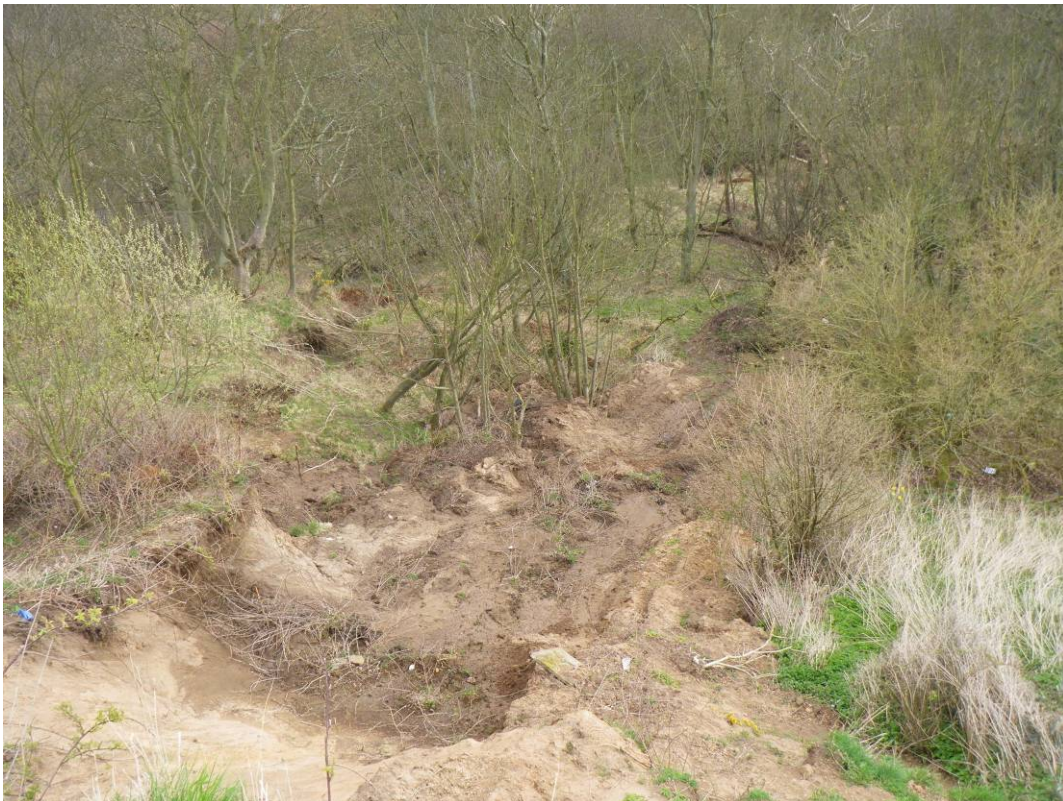
Plate 5 View of Knipe Point Headscarp at Monitoring Pin H4 (14th April 2010)

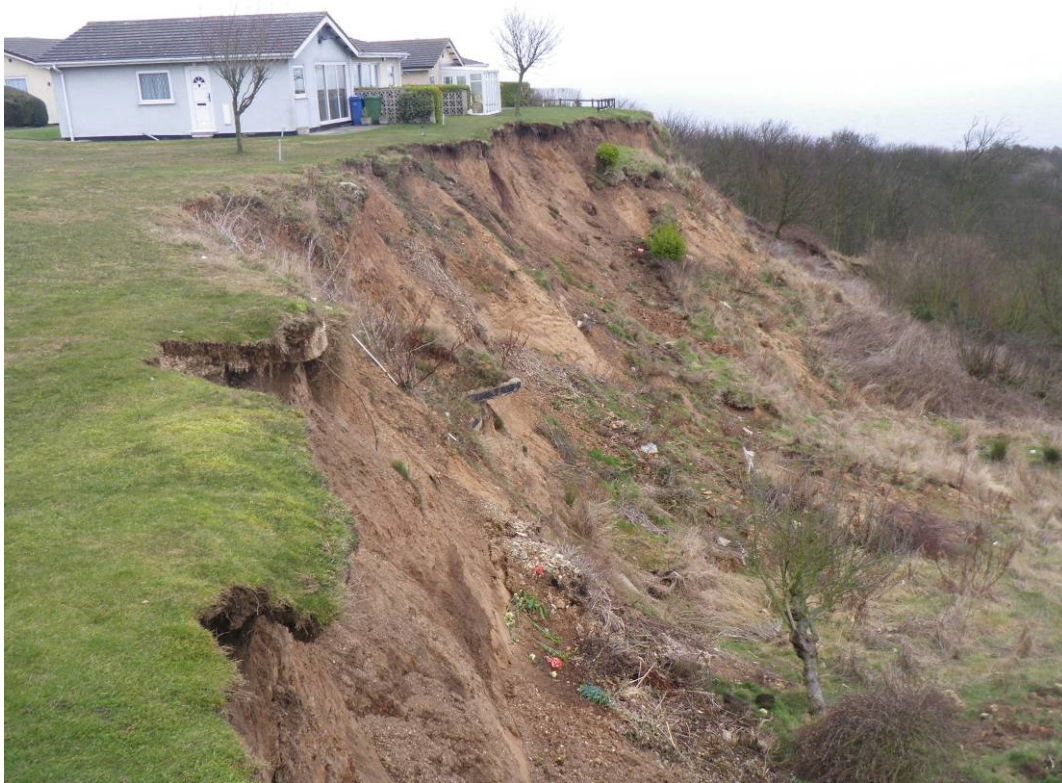
Plate 11 Cliff recession at Knipe Point Headscarp (8th March 2010) looking east
