Ongoing Analysis and Interpretation of Coastal Monitoring Data

Review of Runswick Bay / Knipe Point Monitoring

Geotechnical Interpretative Report

Document Ref. No. 721229/023-024/GIR/001/Final

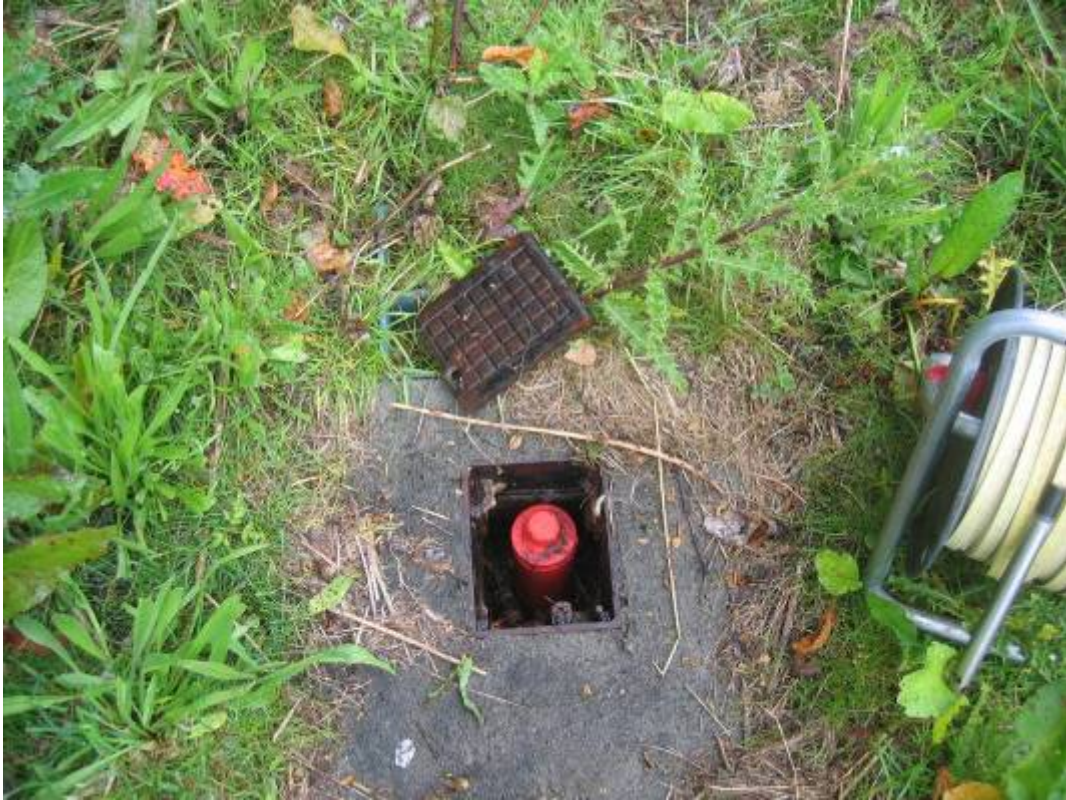
Plate 1 Runswick Bay A001

Runswick Bay has been included for monitoring from February through to July 2010 due to suspected ground movements observed within inclinometers A001

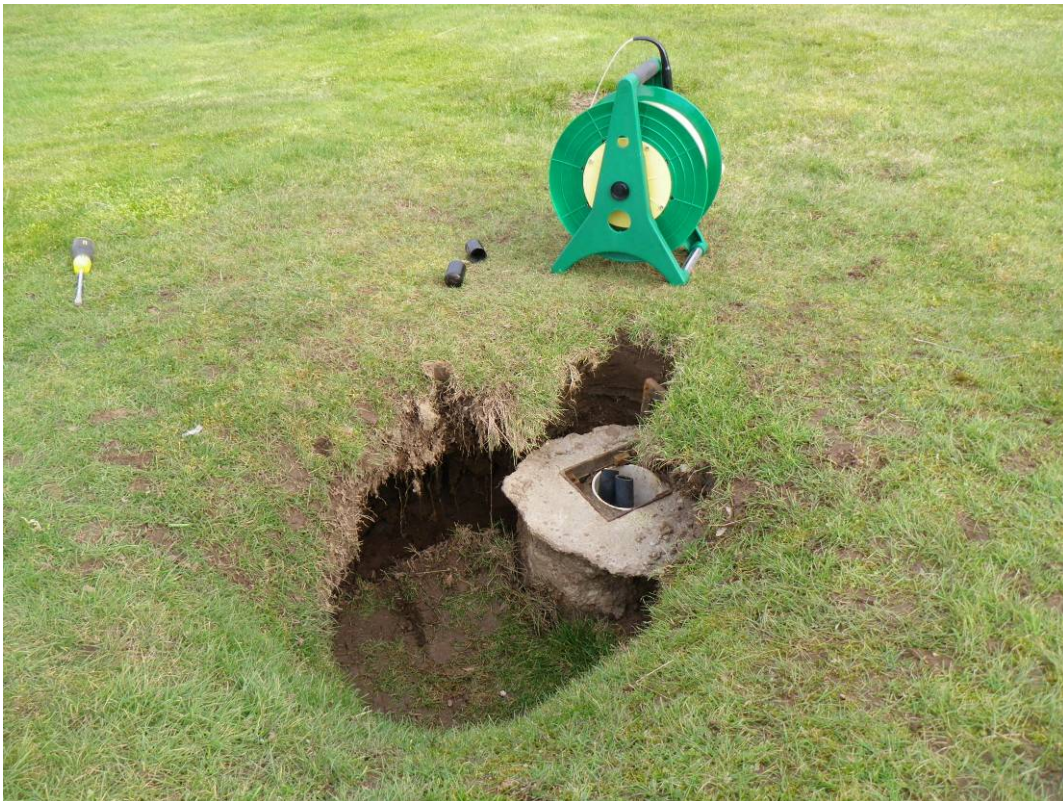
Plate 8 Knipe Point BH04 (4th March 2010)

³ - Borehole collapsed at ground level creating a depression 0.50m depth, 1.20m diameter (See Plates 8 & 9, Appendix F).

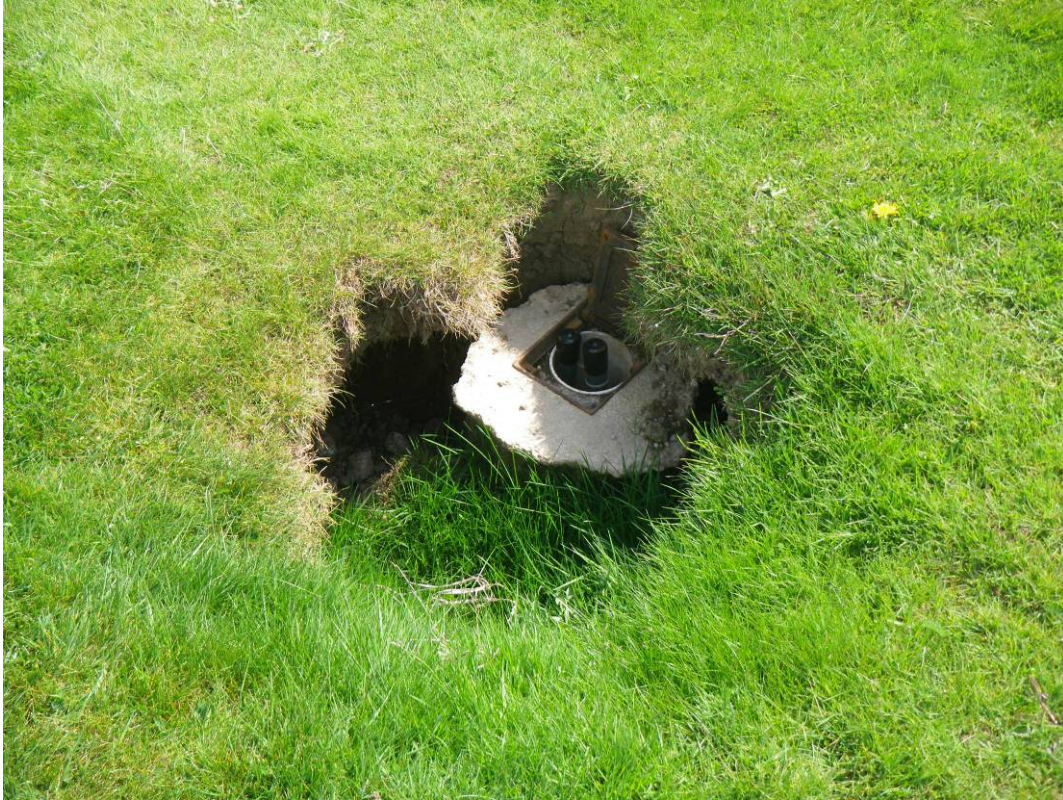
Plate 9 Knipe Point BH04 (5th May 2010)

³ - Borehole collapsed at ground level creating a depression 0.50m depth, 1.20m diameter (See Plates 8 & 9, Appendix F).
