Interpretation Report 10: December 2017 to May 2018

Prepared for
Scarborough
Borough Council

August 2018

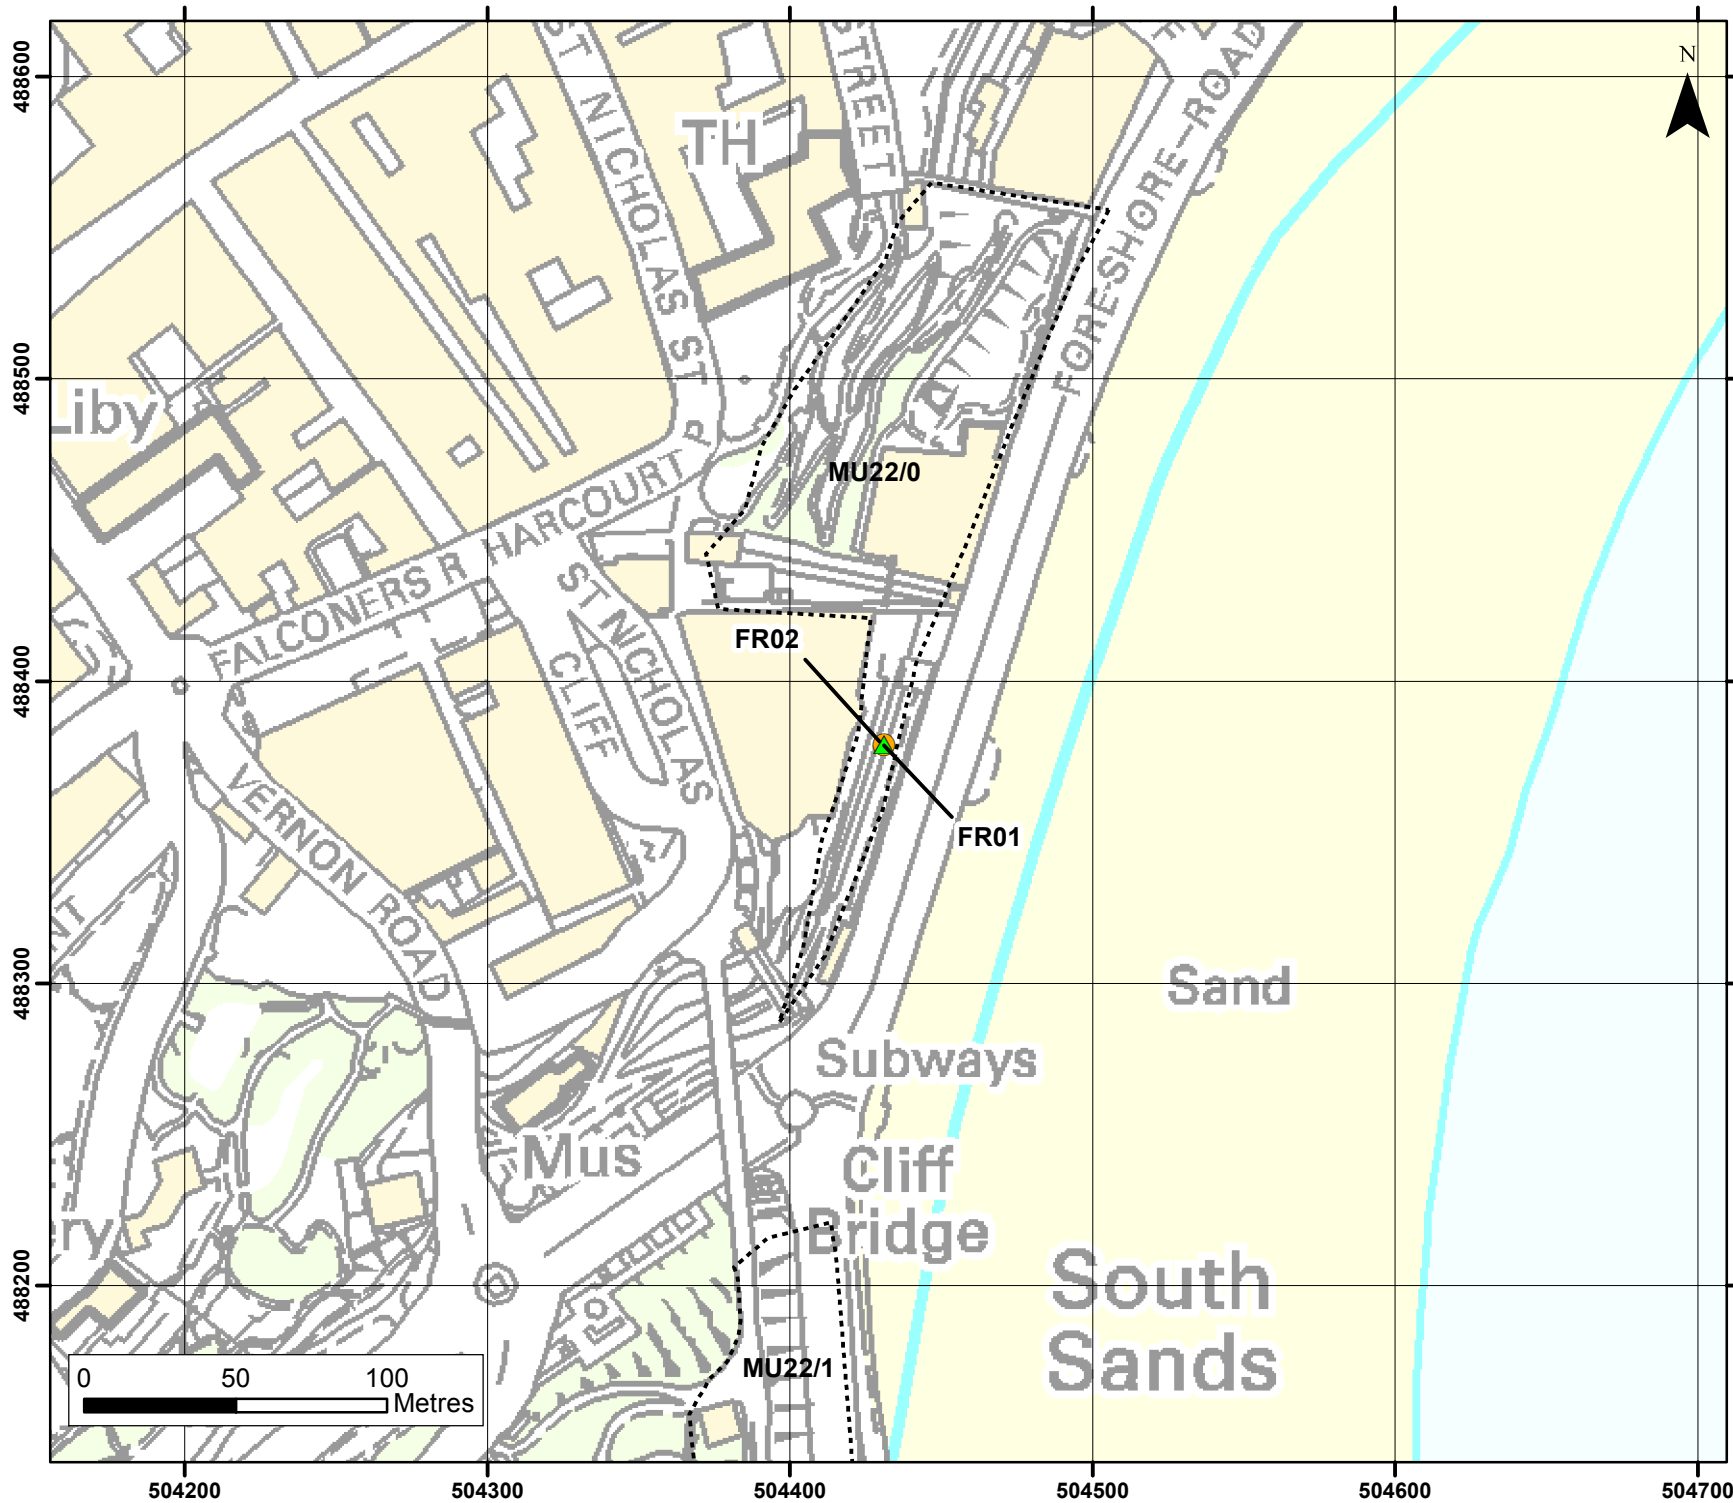
Figure 9.1A Location of monitoring at Scarborough South Bay

The cliff here is around 30m high and heavily landscaped with terraces and footpaths and formed in fine-grained glacial sediments (Figure 9.1A). Average slope angle is 20 to 30° but is locally steeper with sections supported by retaining walls. The cliff is crossed by a cliff lift and the cliff top is occupied by the Grand Hotel. There is no history of instability in recent years and this CBU was not reported on by Mouchel.

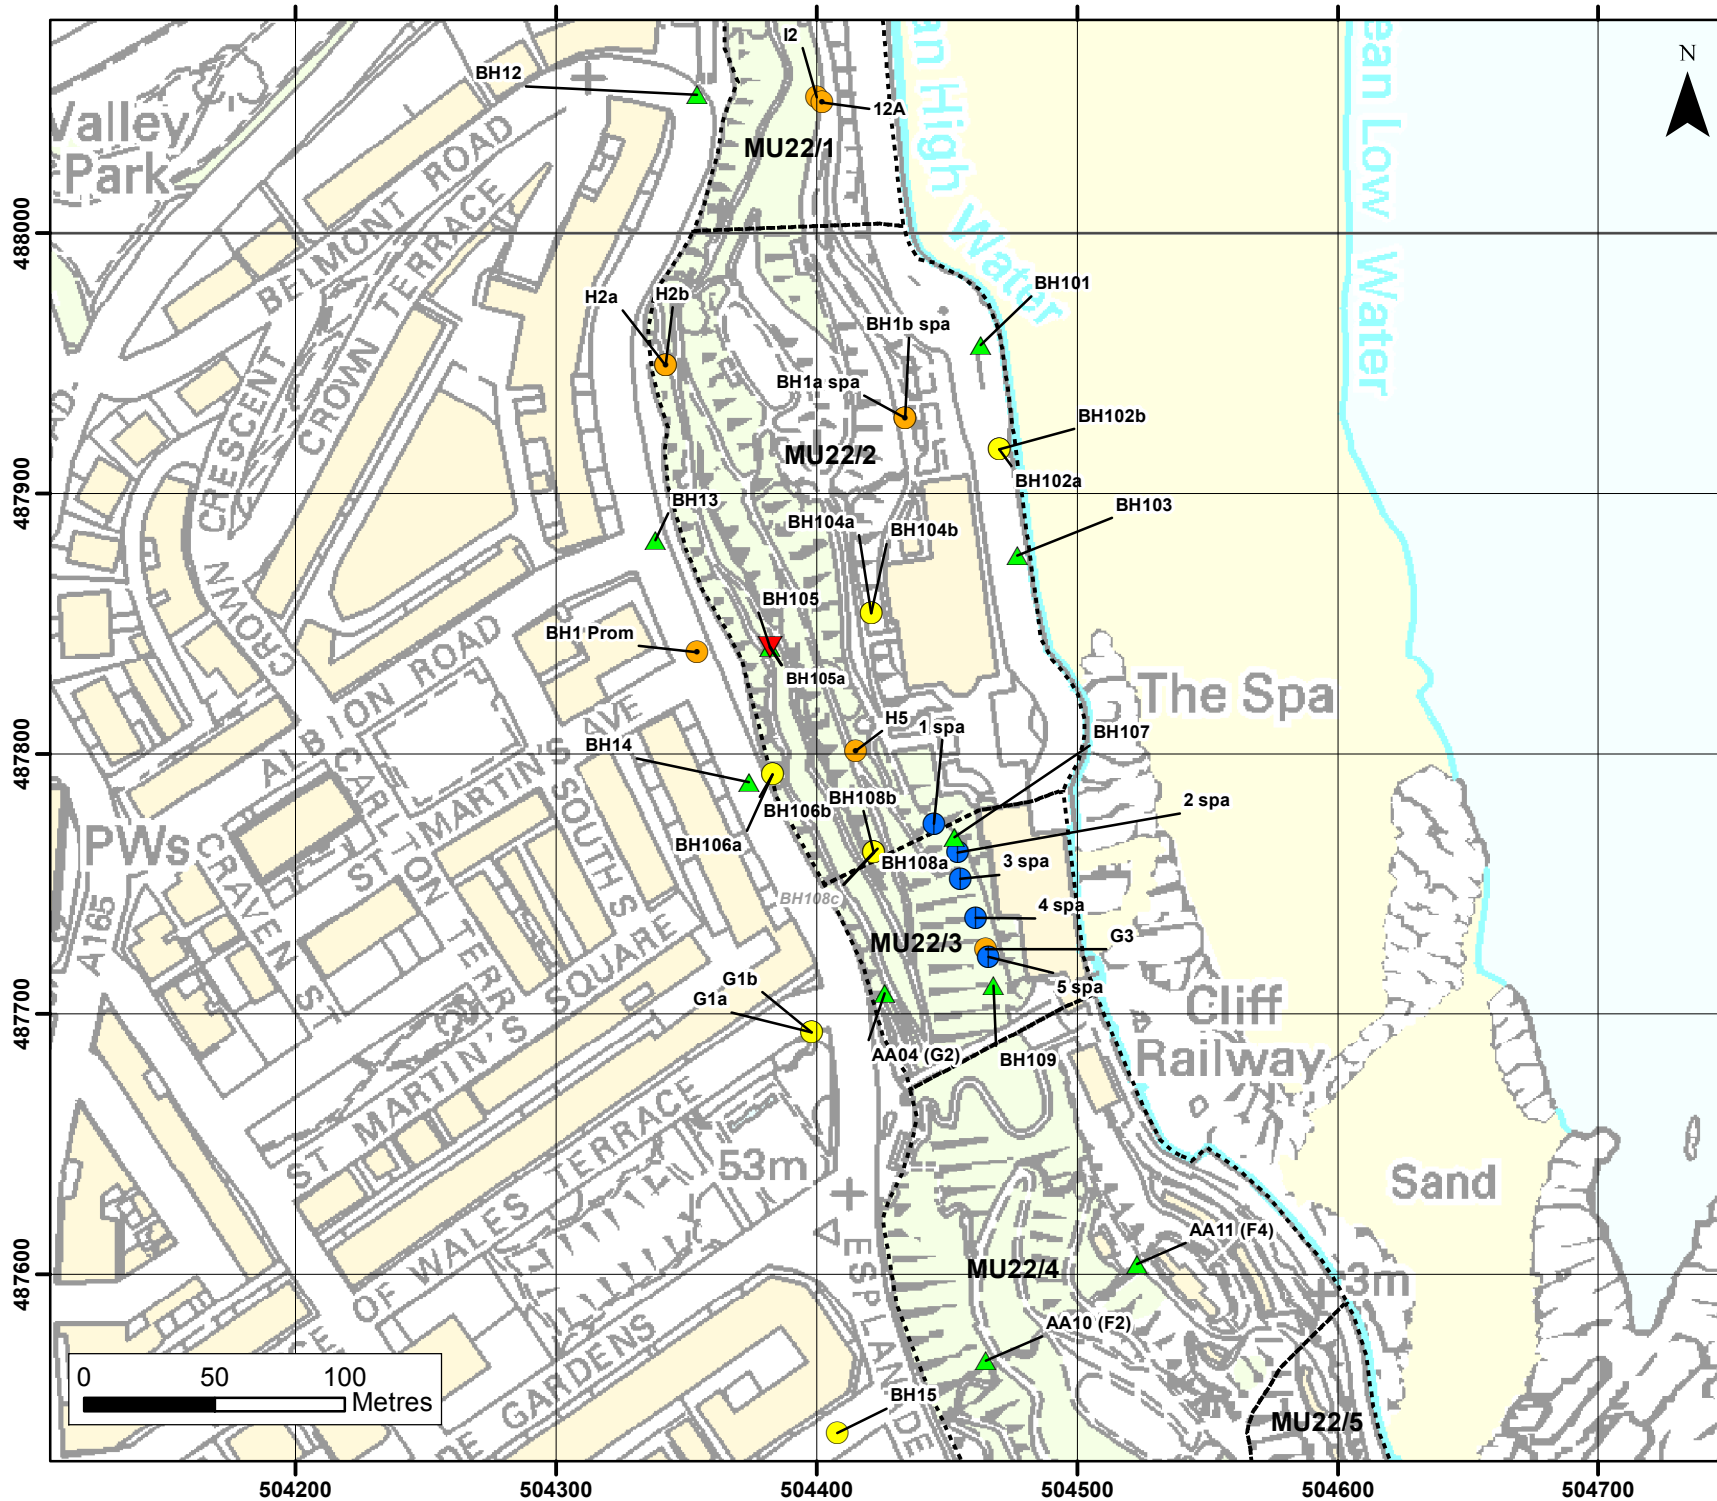
Figure 9.1B Location of monitoring at Scarborough South Bay

The Spa is the focus of monitoring in South Bay, with eight inclinometers and 21 piezometers installed in the area (Figure 9.1B). The cliffs are generally steep and formed in glacial sediment. Shallower cliff sections are associated with a deep-seated landslide seen immediately north of the Spa Centre and localised shallow landslides. The monitoring results are described in Tables 9.6 and 9.7.

Monitoring at the Clock Café comprises a line of three boreholes from the promenade (BH15) to the midslope (AA10 F2) and lower slope (AA11 F4) (Table 9.8, Figure 9.1B).

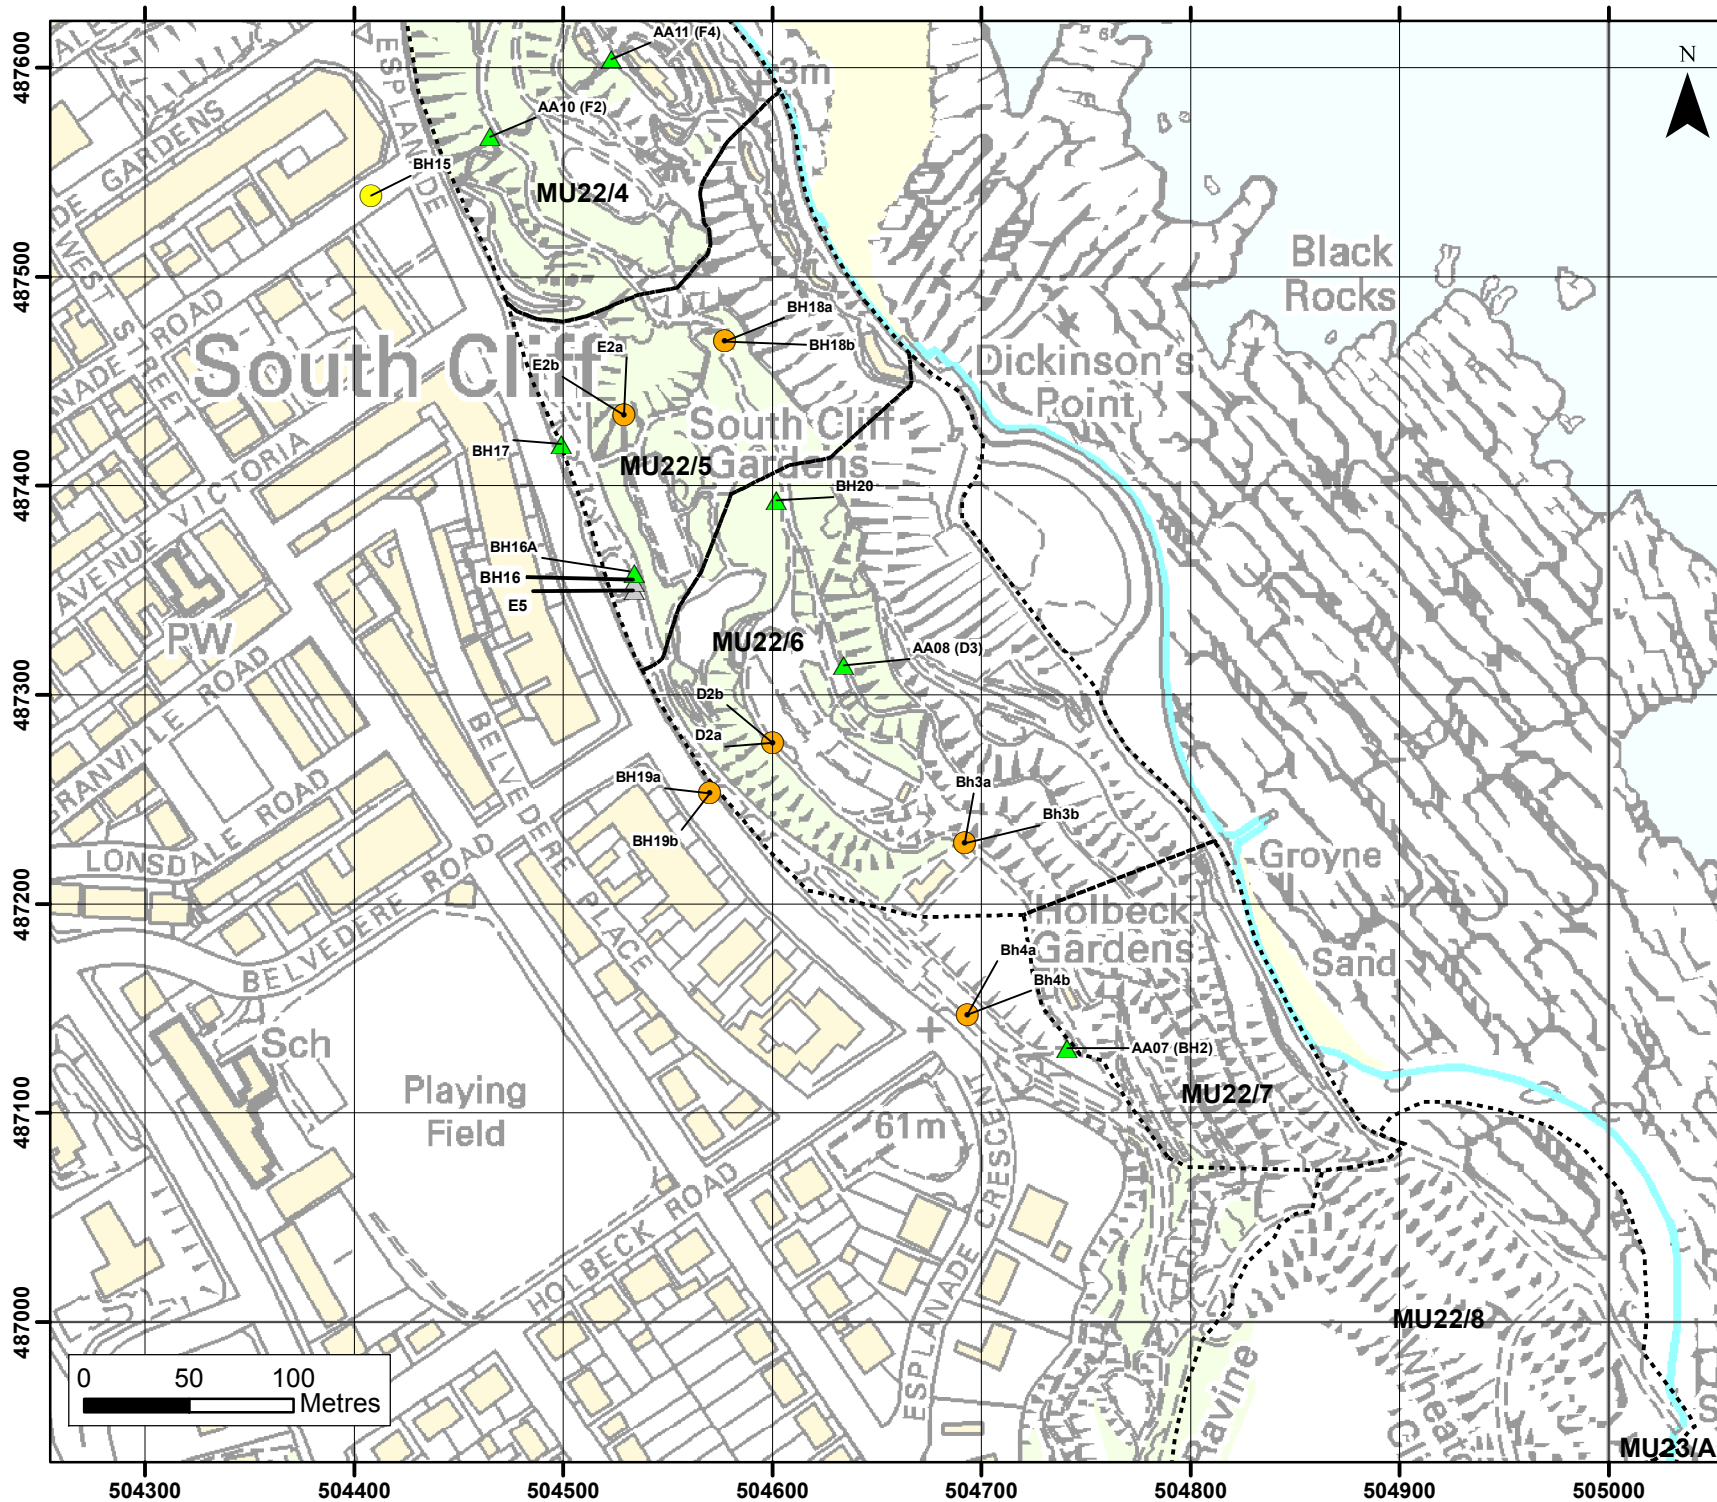
Figure 9.1C Location of monitoring at Scarborough South Bay

The South Cliff Gardens area comprises landscaped public areas and the former South Bay Pool, which lies at the foot of a relict landslide complex (the South Bay Pool landslide). There are three transects of monitoring locations (Tables 9.10 and 9.11; Figure 9.1C).

This area comprises two monitoring locations (Figure 9.1C); water levels are monitored at two depths along the promenade and ground movements are recorded by an inclinometer on the upper slope (Tables 9.12 and 9.13).

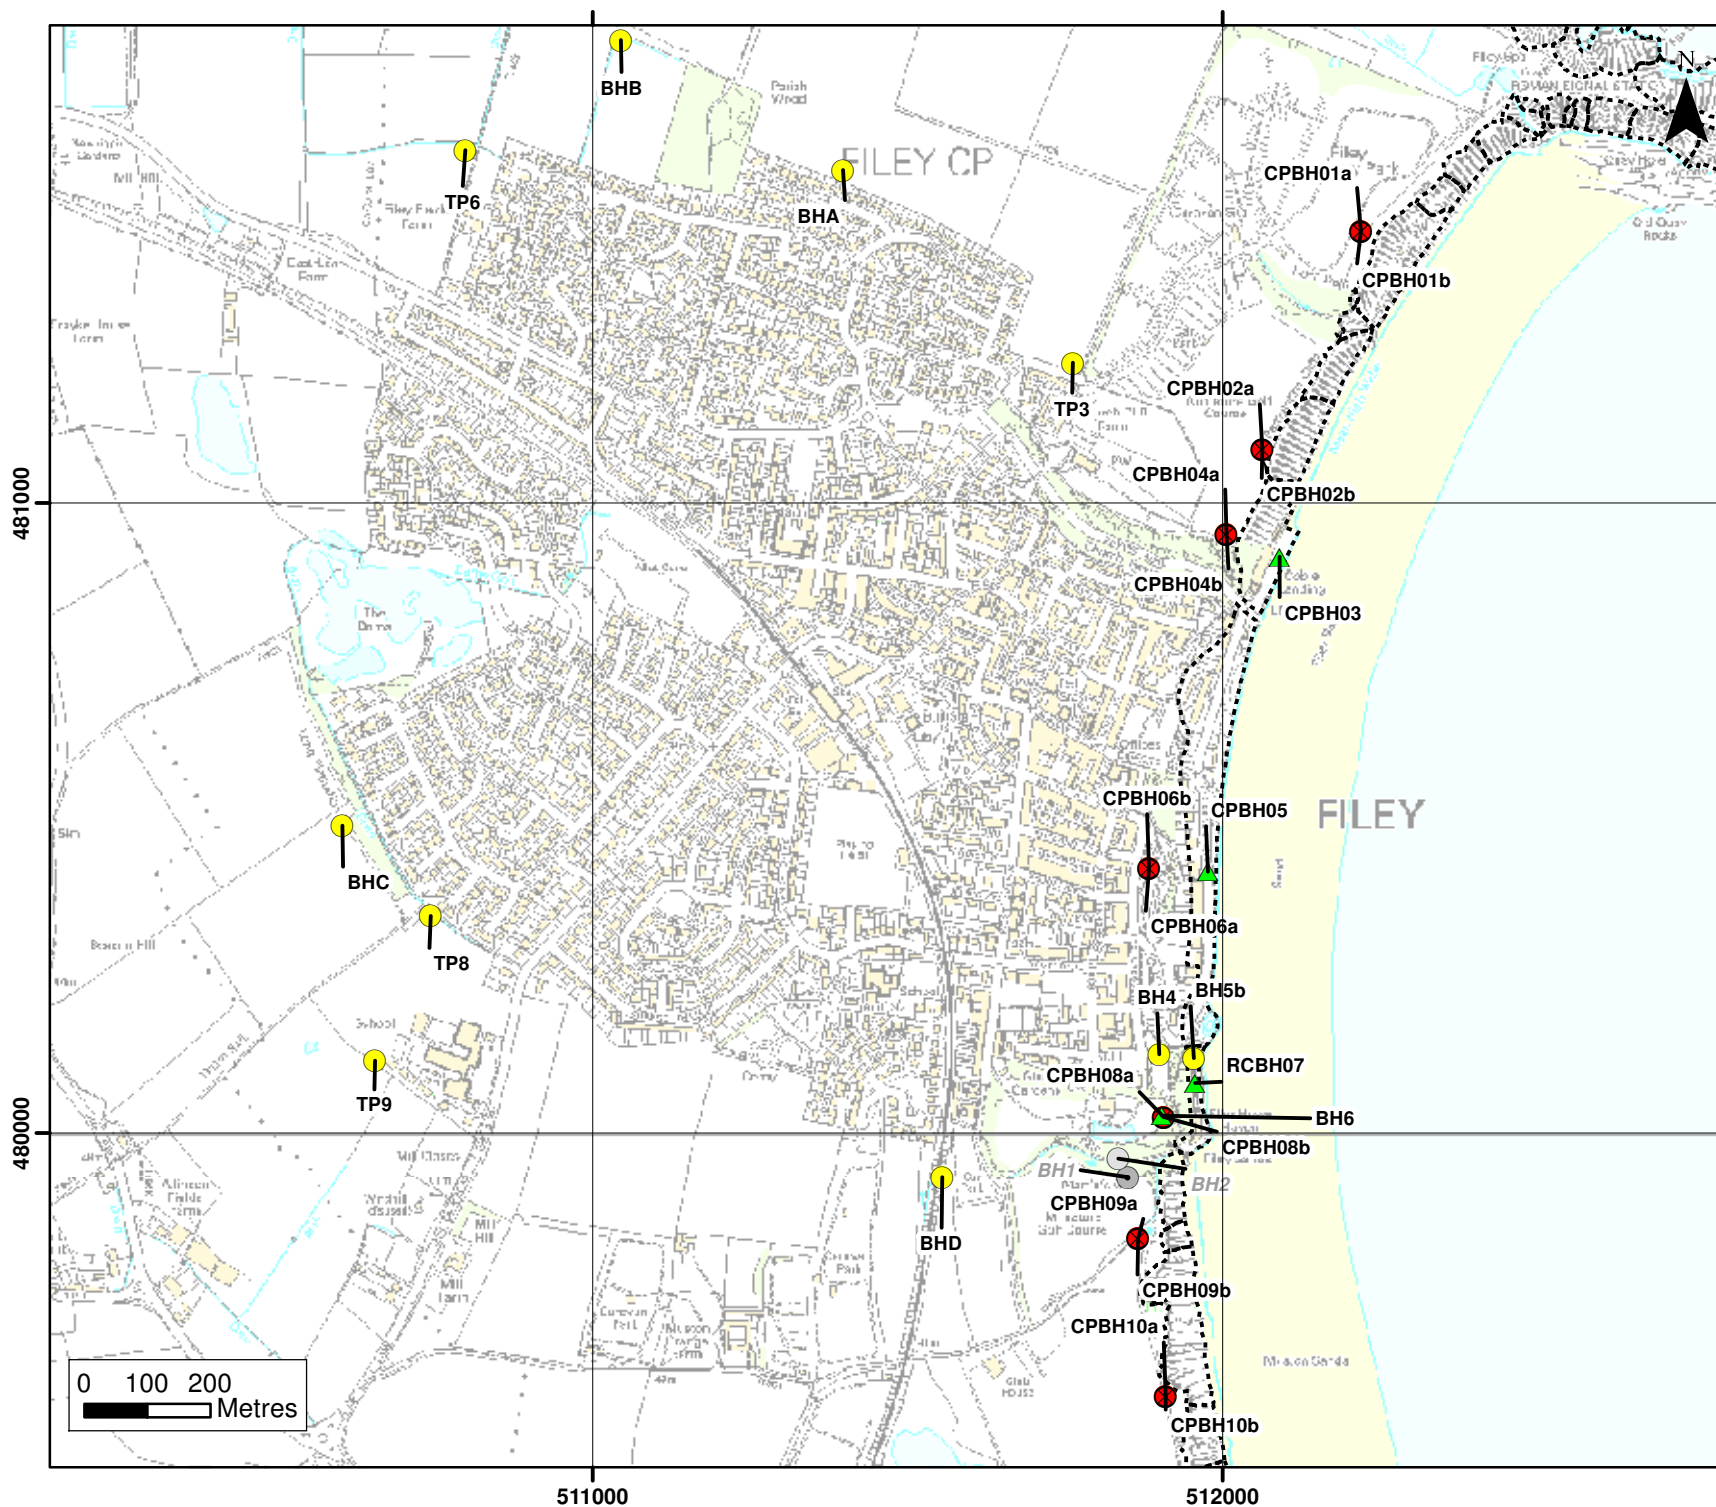
Figure 10.1. Location of slope monitoring at Filey

Cliff behaviour units, reflecting individual mudslides and areas of relict cliff protected by the seawall, have been mapped for the frontage (Figure 10.1):
