Interpretation Report 12: December 2018 to May 2019

Prepared for
Scarborough
Borough Council

September 2019

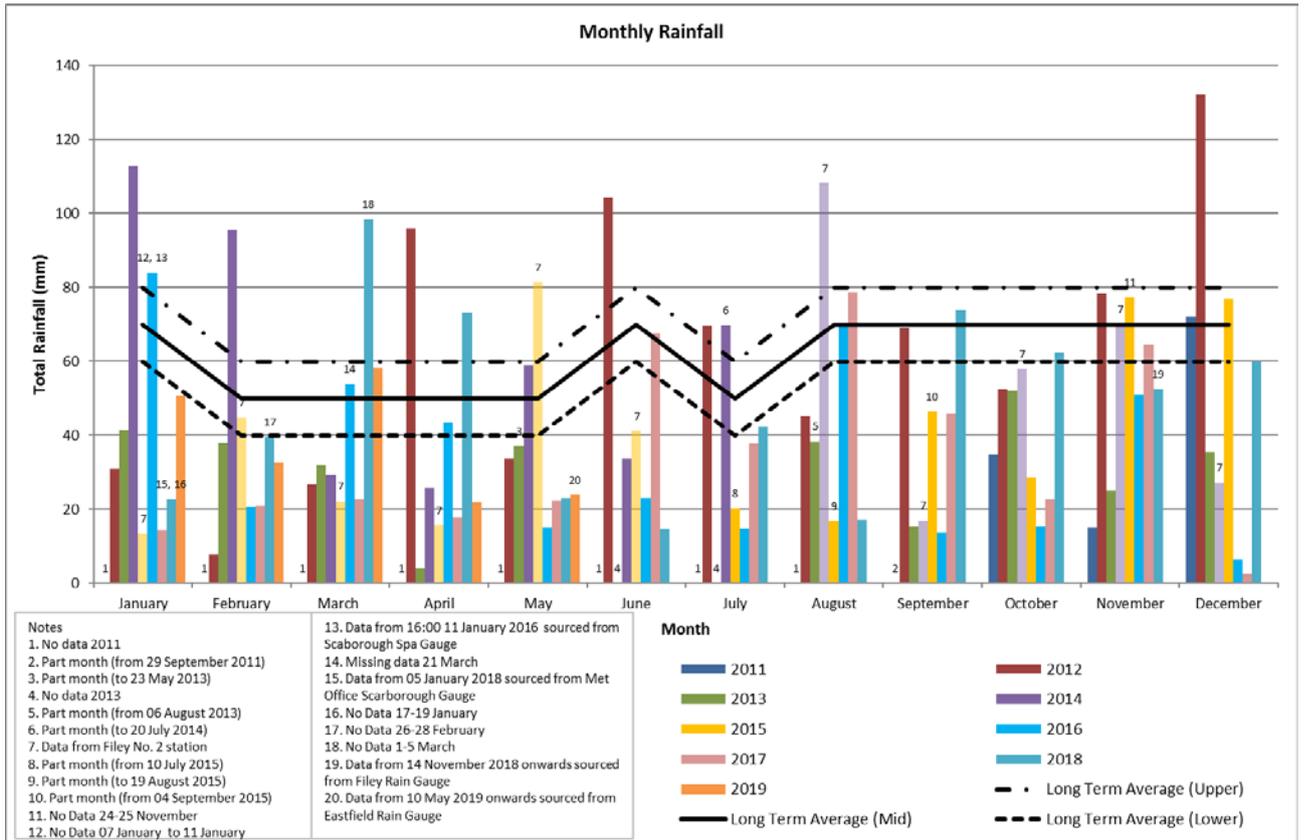
Figure 2.1 Comparison of monthly rainfall records (2011 to 2019).

Data from all sources are summarised in Table 2.1 and Figure 2.1. The records for the last six months show that Winter 2018/19 was marginally wetter when compared to past records, but that Spring 2019 was drier on average. However, March had close to the long-term mean rainfall (upper range).

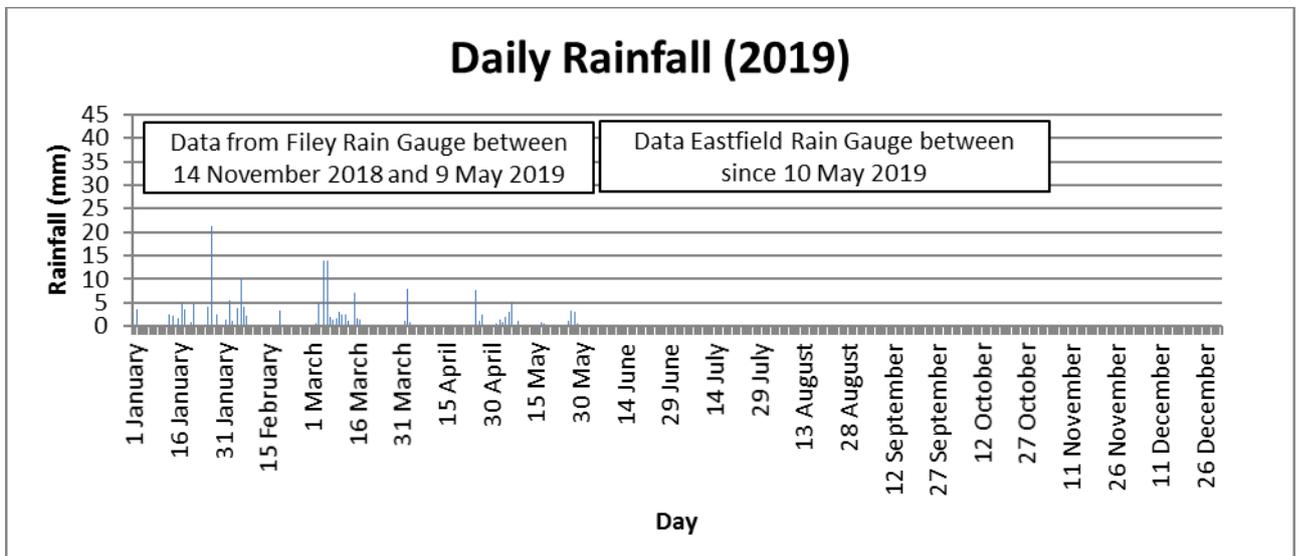
Figure 2.2 Daily rainfall recorded at Scarborough Spa during 2019.

Daily rainfall totals recorded by the Scarborough Spa weather station are presented in Figure 2.2, which shows peaks on 15 December, 27 January, and 5 to 6 March. The events in December and March had daily peak rainfall totals of between 12 and 14 mm. These events were storms Deirdre and Freya, respectively, which resulted in persistent heavy rainfall and strong winds over Yorkshire. Persistent heavy rainfall on 27 January resulted in a daily peak rainfall total of 21.2 mm, the highest over this monitoring period.

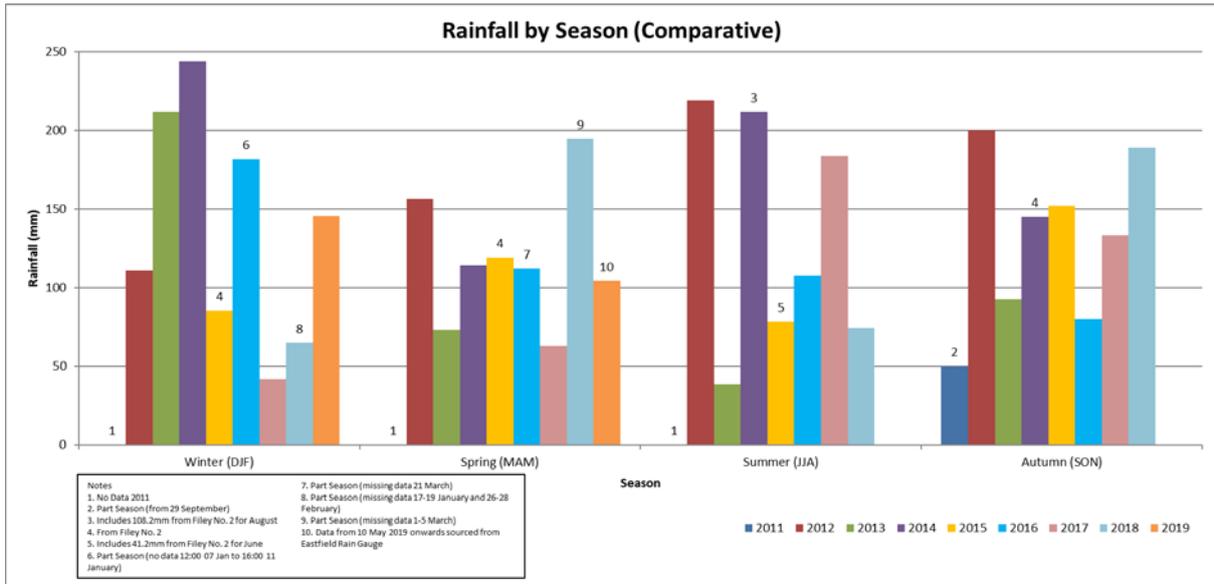
Figure 2.3 Seasonal rainfall comparison (2011-2019)

Seasonal totals are shown in Figure 2.3, which shows that the wettest seasons tend to be winter and summer and that the spring is the driest. The wettest season on record was winter of 2013/14 (i.e. December 2013, January and February 2014) that received a total of 244mm rainfall. The summers of 2012 and 2014 were also very wet, receiving 219mm and 211mm respectively. The winter of 2015/16 received around double the rainfall of 2014/5, but the spring was marginally drier. The winter of 2016/17 and spring 2017 have been the driest on record. The summer of 2017 was relatively wetter than previous years, receiving 183mm of rainfall, whereas slightly drier conditions occurred through autumn 2017 and into the winter of 2017/2018. The spring of 2018 was the wettest on record, receiving a total of 195mm rainfall. However, the summer was especially dry and

hot. Autumn to Winter 2018/2019 was relatively wet compared to past years. Spring 2019 was slightly drier than average.
