**Local Coastal Slope Monitoring Analysis**  
**Interpretation Report 16: December 2020 to June 2021**

7 December 2021

**Scarborough Borough Council**

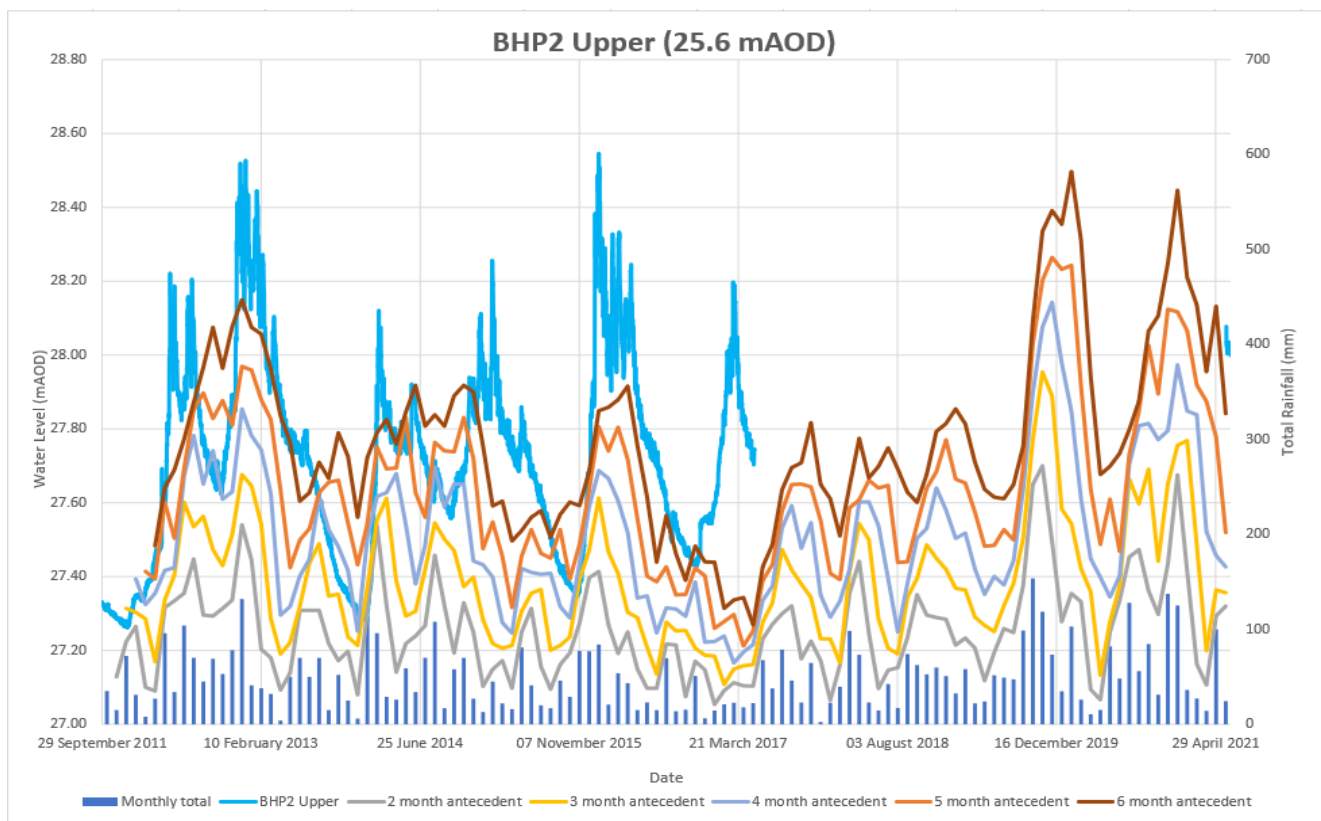
Winter 2020 and spring 2021 were exceptionally wet. This pattern closely mirrors the conditions observed in the previous year. With the collection of nearly 10 years of data it is possible to establish relationships between rainfall and groundwater response. An example from Scalby Ness is presented below, which illustrates groundwater levels recorded by piezometer BHP2 Upper and antecedent rainfall. The data reveal groundwater responses to 4-5 month antecedent rainfall and intense rainstorms, both of which are known to trigger ground movement and landslides

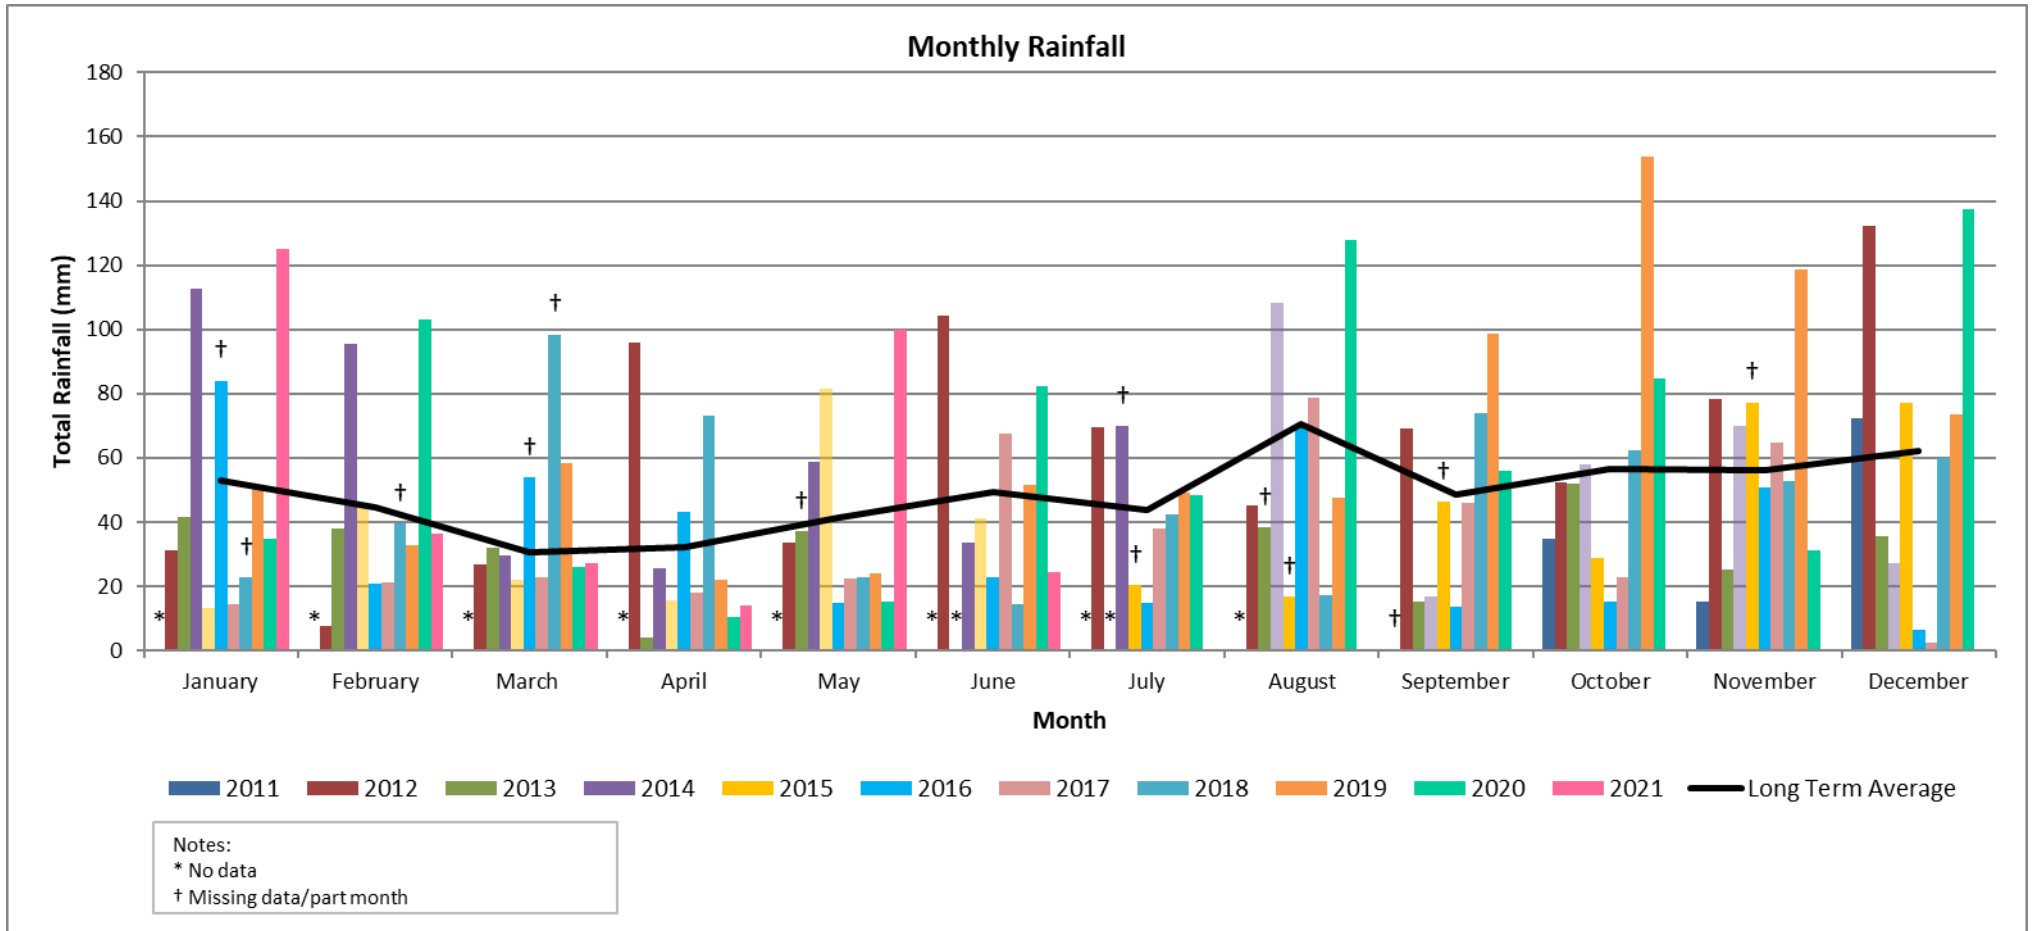
Data from all sources are summarised in Table 2-1 and Figure 2.1. Weather data for this monitoring period includes January to June 2021 (mid-winter to early summer).

Figure 2.1 Comparison of monthly rainfall records (2011 to 2021).

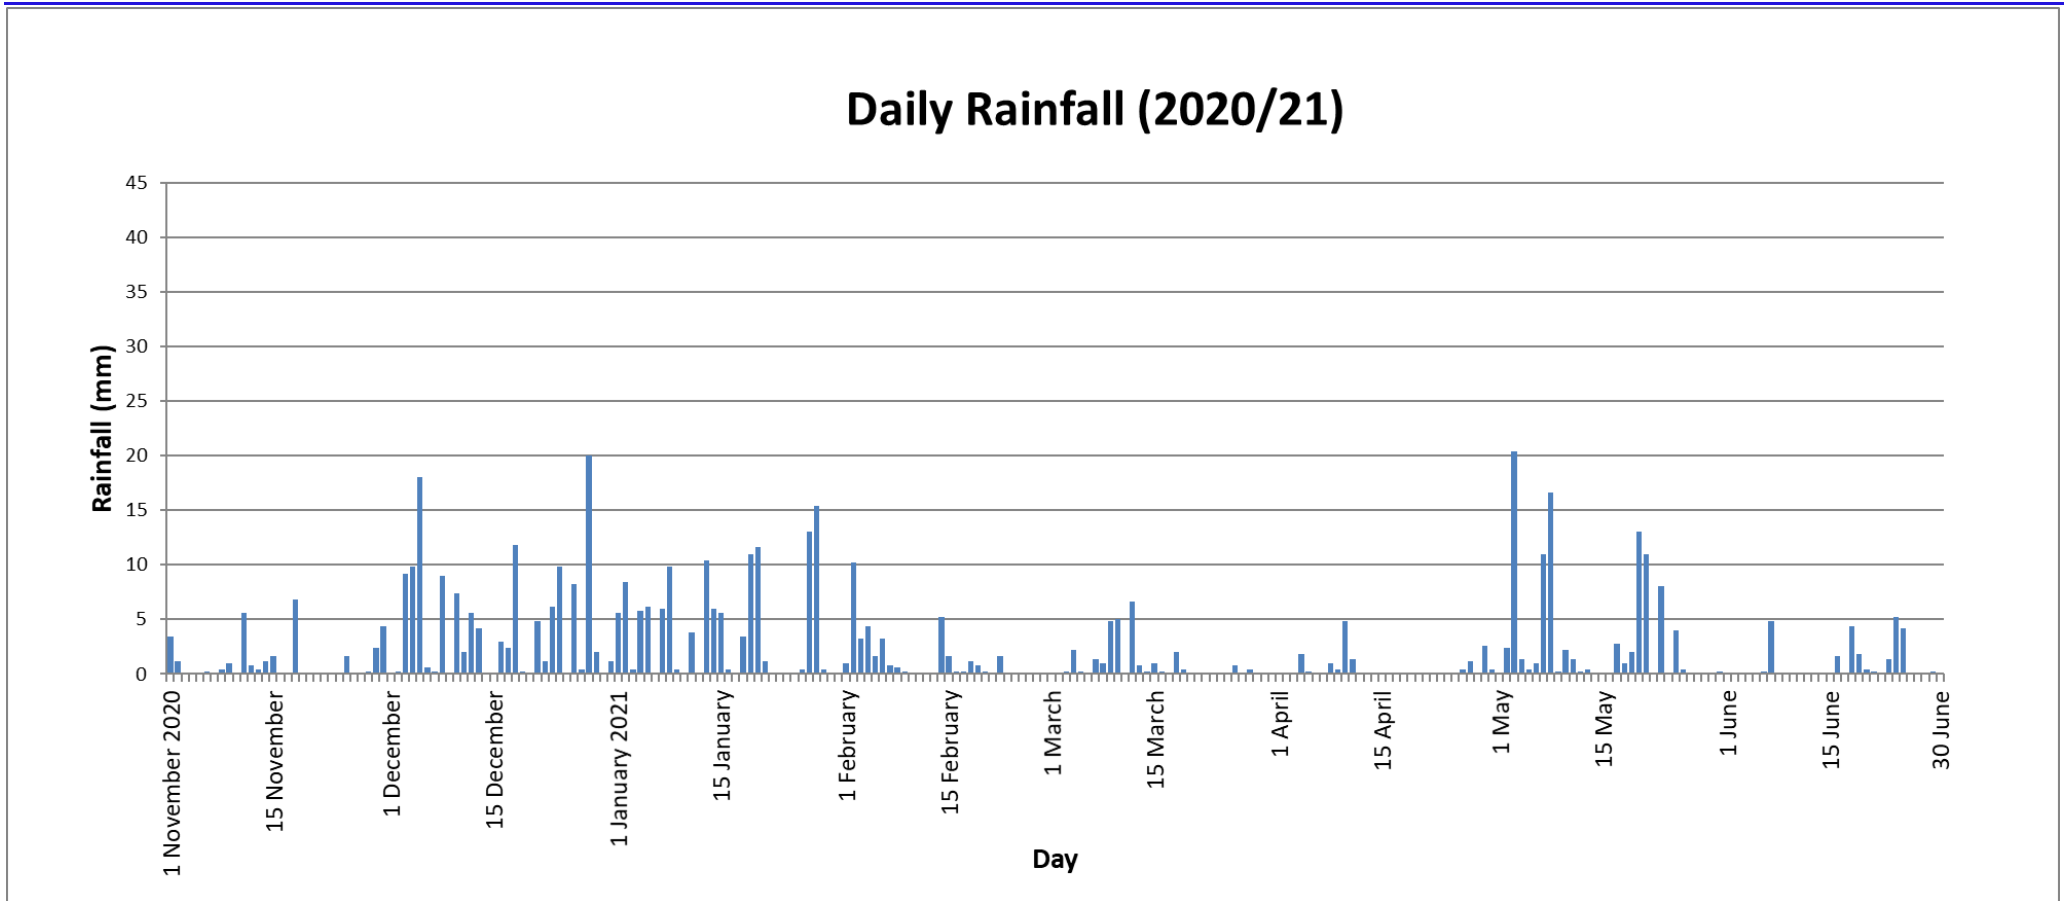
Daily rainfall totals recorded by the Scarborough South Bay weather station are presented in Figure 2.2, which highlights peaks in daily rainfall over 10 mm occurring in December 2020 to February 2021 and May 2021. During the winter, rainfall peaked between 18 to 20 mm on 5<sup>th</sup> December and 18<sup>th</sup> December. The highest daily rainfall total over this monitoring period equalled 20.4 mm on 3<sup>rd</sup> May.

Figure 2.2 Daily rainfall recorded at Scarborough Spa from November 2020 to June 2021.

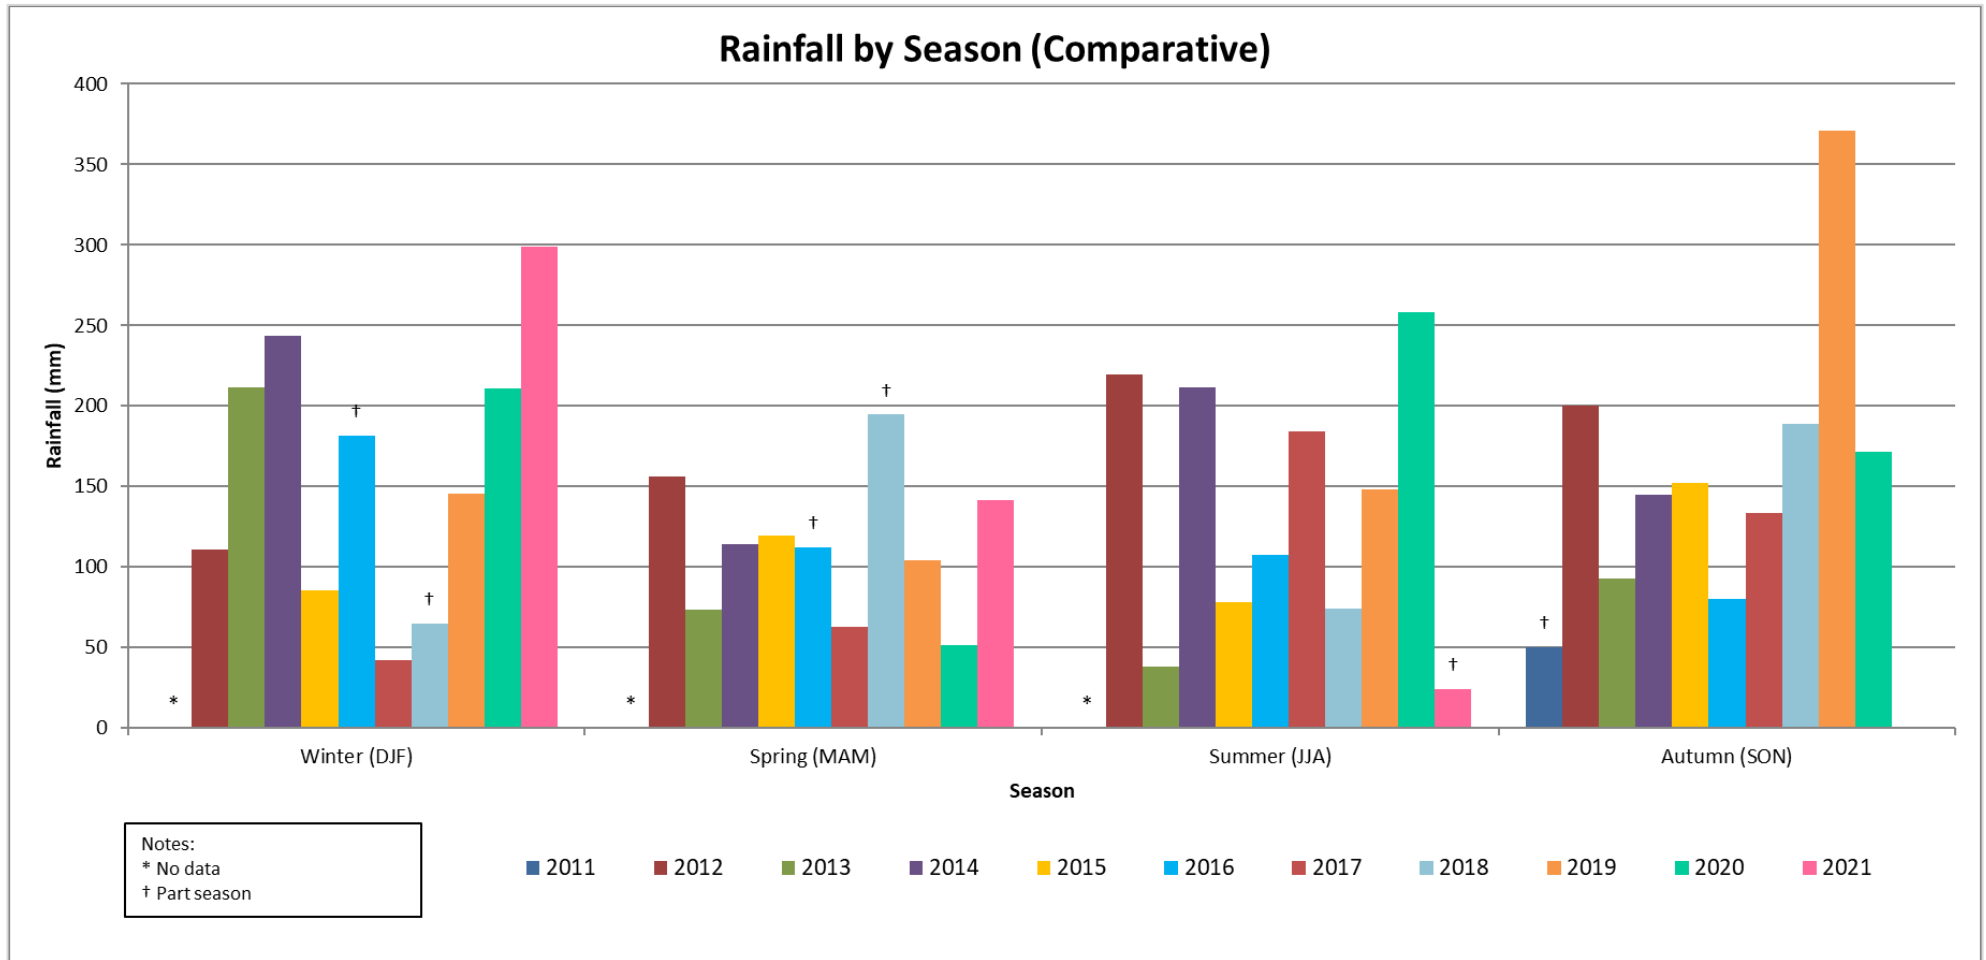
Seasonal totals are shown in Figure 2.3, which shows that the wettest season tends to be winter, and that the summer is the driest, though data from this season is partially missing. The wettest season on record was autumn of 2019 (i.e. September, October and November) that received a total of 371mm rainfall, which is exceptional when compared to previous years. The next wettest season is the winter of 2020/2021 (i.e. December, January and February), totalling 298.8 mm of rainfall. When overlooking the part season of summer 2021, the winter of 2016/17 and summer 2013 were the driest on record.

Figure 2.3 Seasonal rainfall comparison (2011 to 2021).

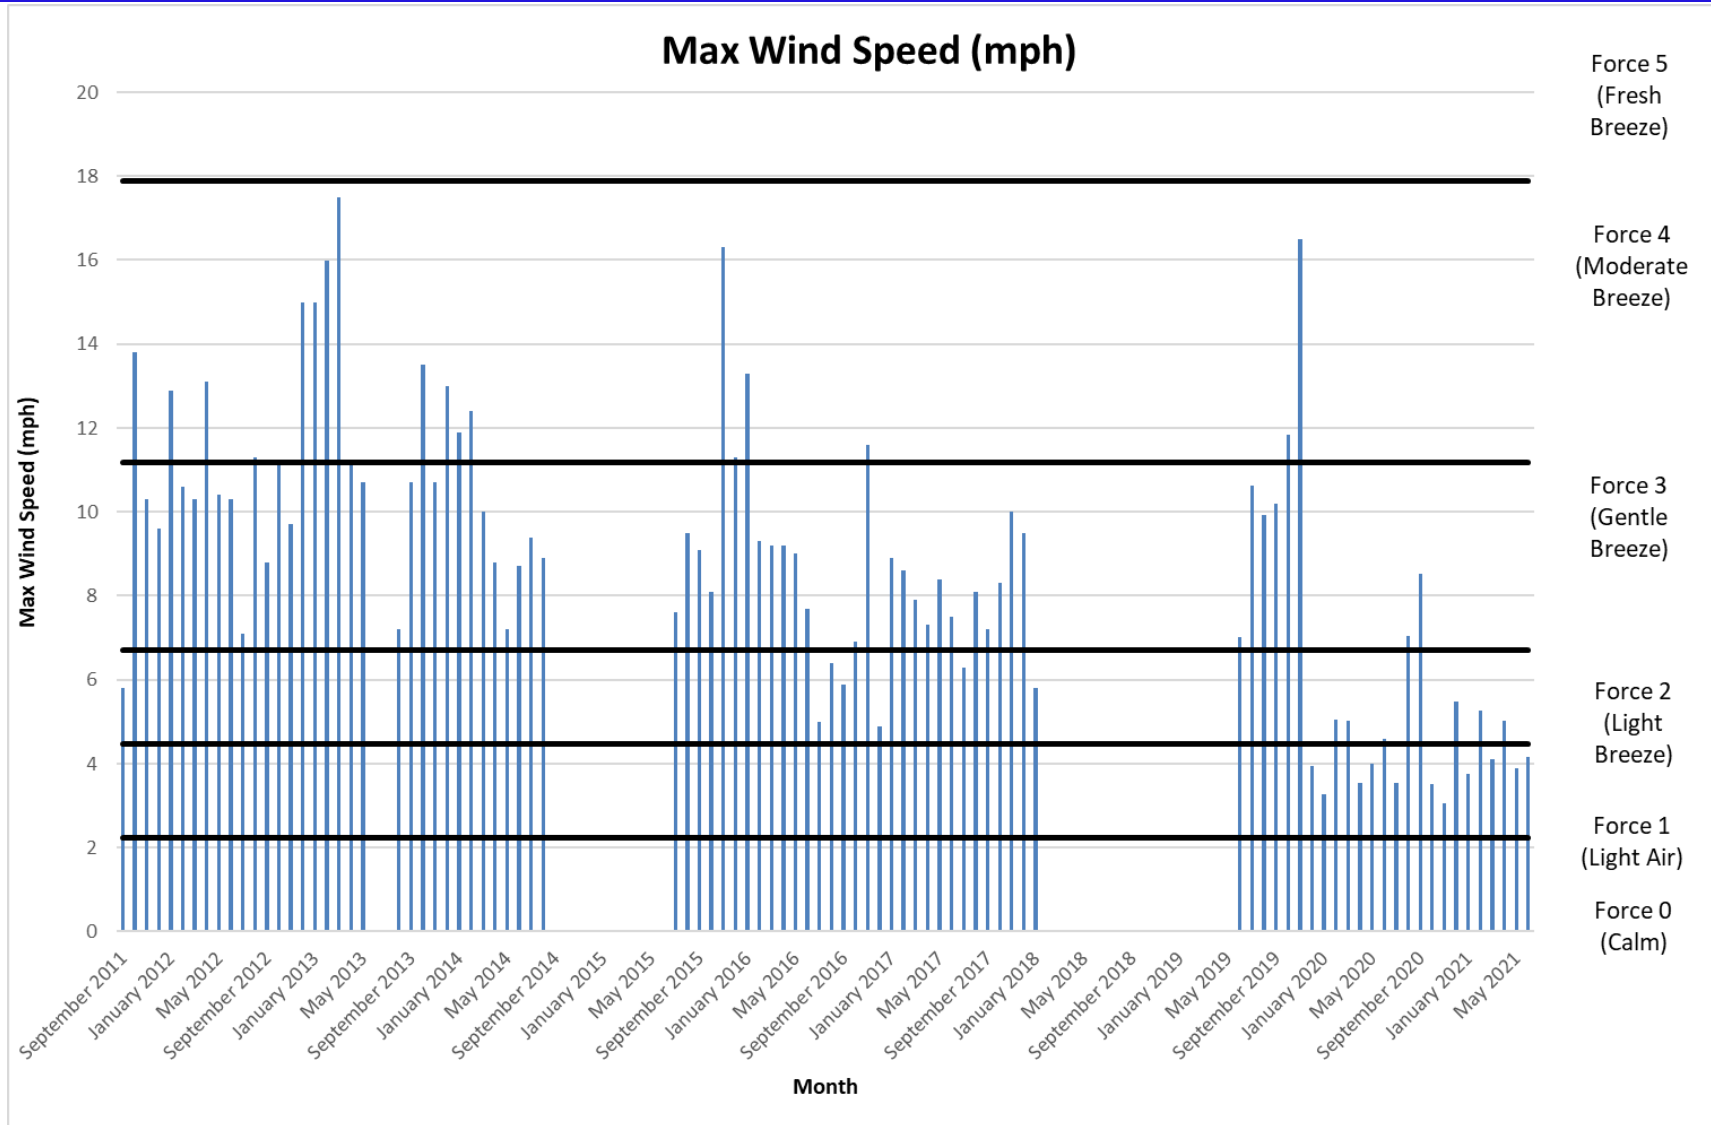
Wind speed and air temperature records are presented in Figure 2.4 and Figure 2.5. Occasional failure of the Scarborough South Bay met station means there are no data for some of the previous monitoring periods.

Figure 2.4 Maximum daily wind speed (2011 to 2021).

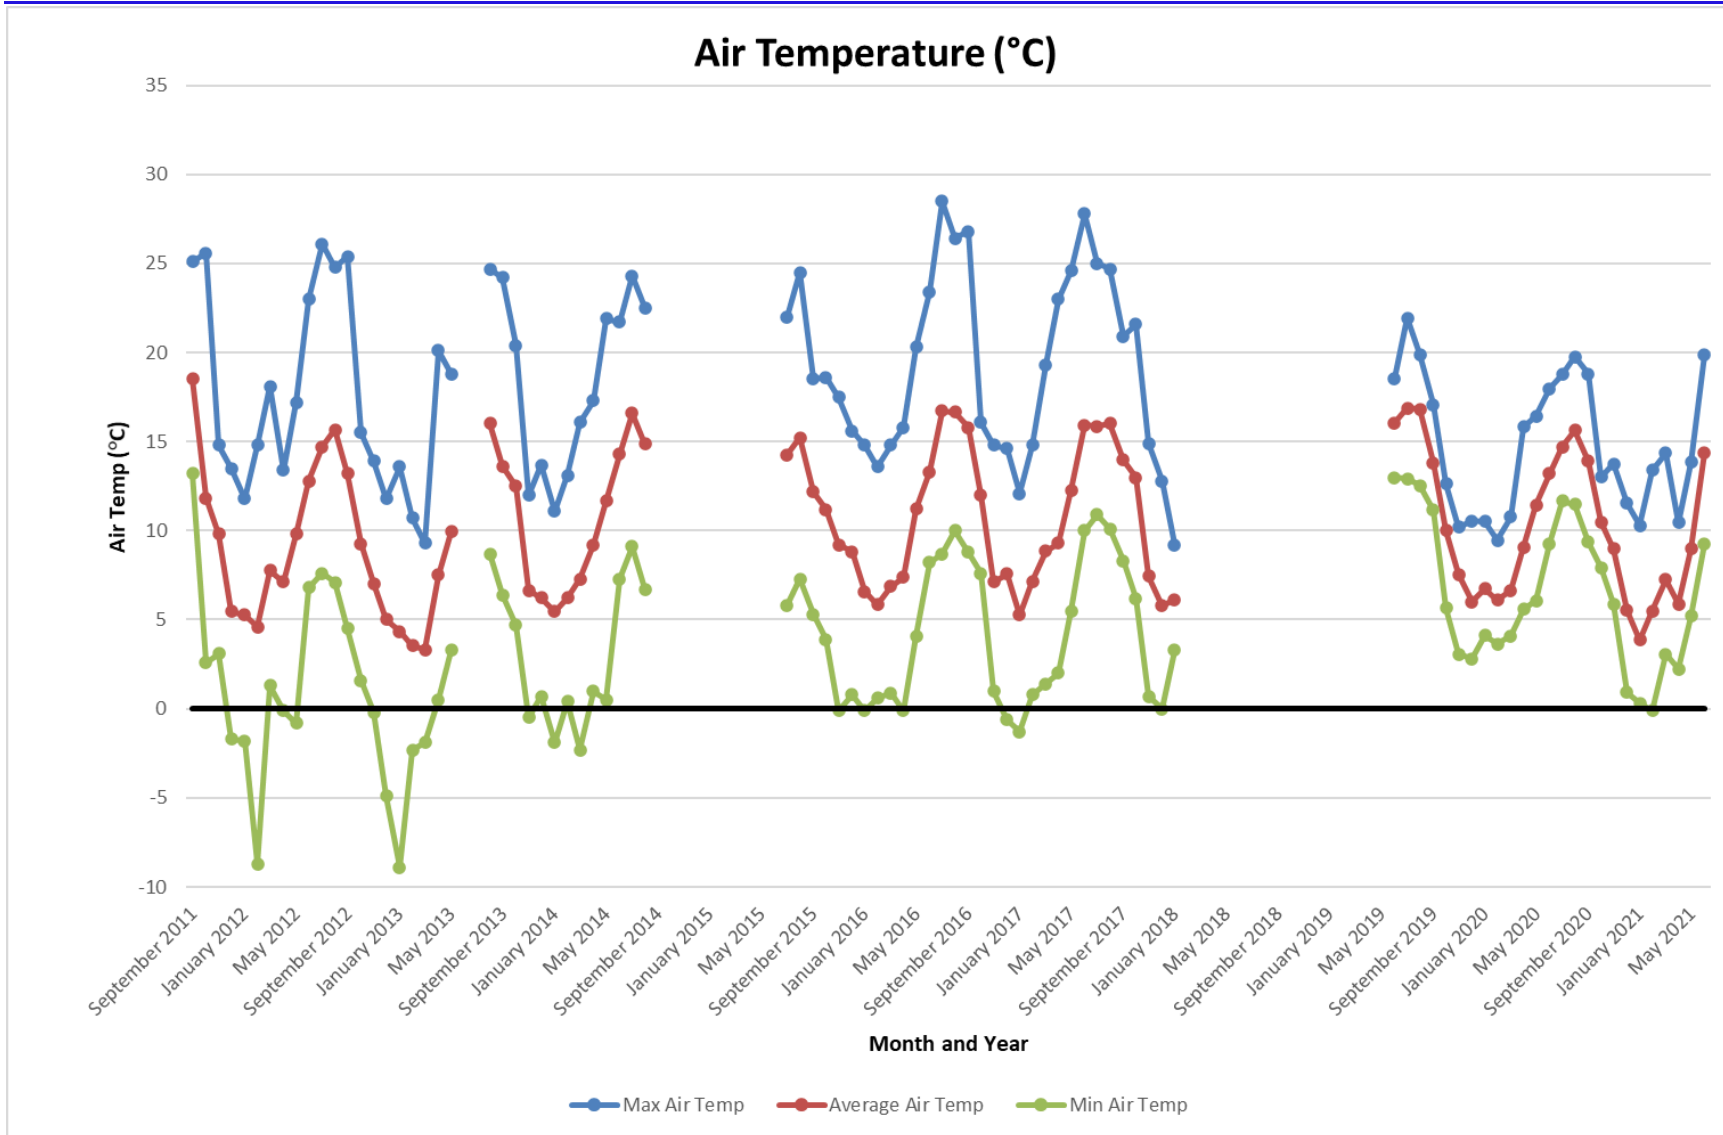
Figure 2.5 Air temperature variation (2011 to 2021).

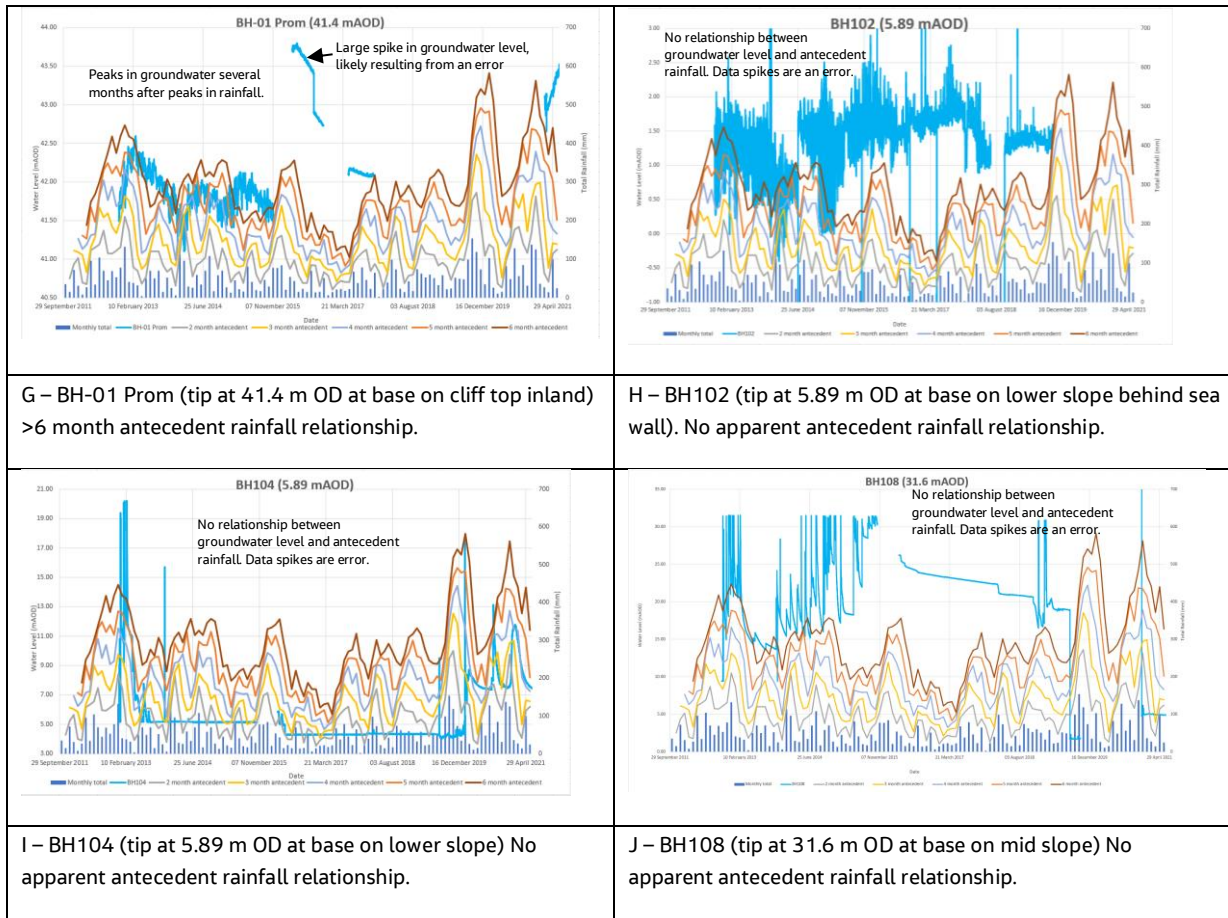
significantly greater than 6 months. The picture is similar at The Spa (Figure 9.4), where BH-01a Spa and BH-01 Prom also show responses of greater than 6 months. In contrast BH-H5, which is at the base of the slope behind the Spa building, suggests an antecedent rainfall relationship of 4 months. All other automated piezometers at the Spa do not have an apparent antecedent rainfall relationship. At South Cliff Gardens (Figure 9.5), the antecedent rainfall relationship is greater than 6 months at BH-D2a, BH-E2a and BH-E2b. Relationships at other automated piezometers at the South Cliff Gardens remain complex.

F – BH-01b Spa (tip at 10.1 m OD at base on lower slope at the toe of the Spa landslide) >6 month antecedent rainfall relationship.

Figure 9.4: Relationship between groundwater levels and antecedent rainfall at Spa.

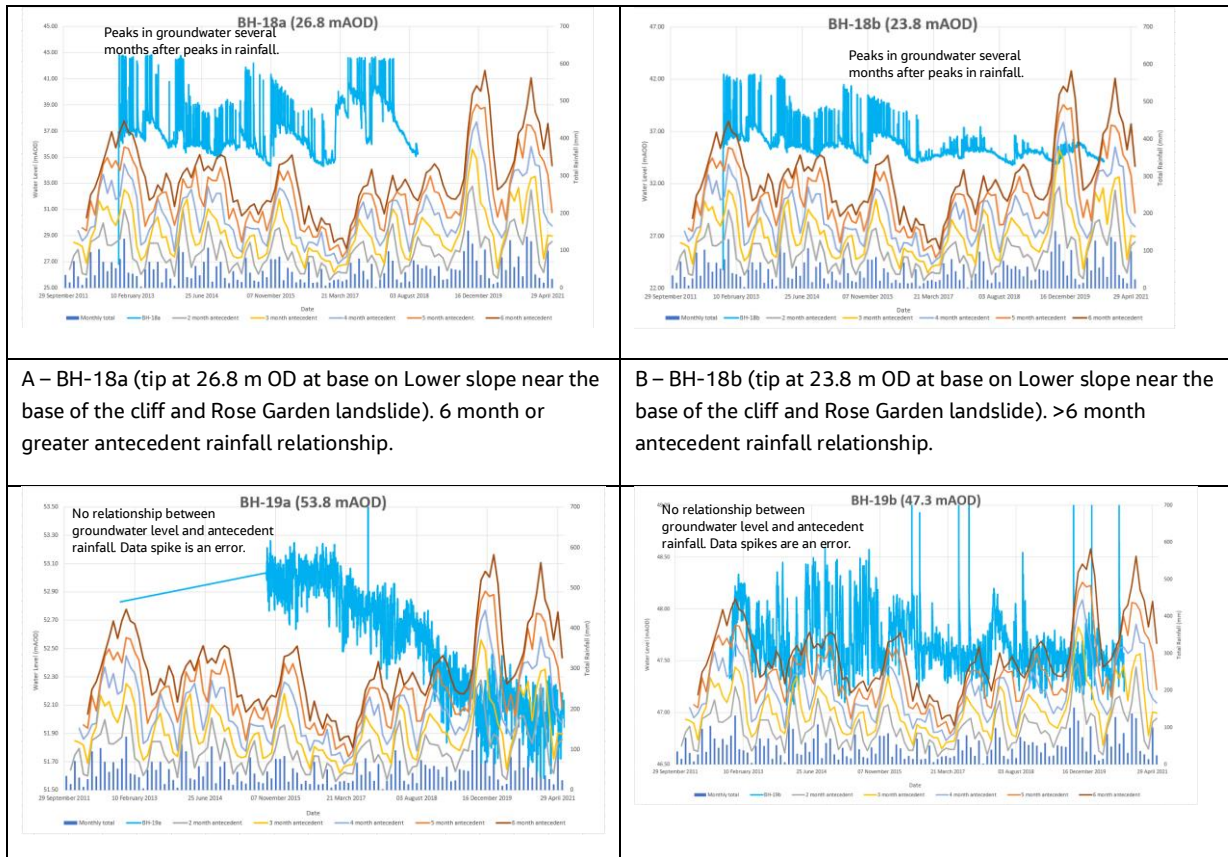
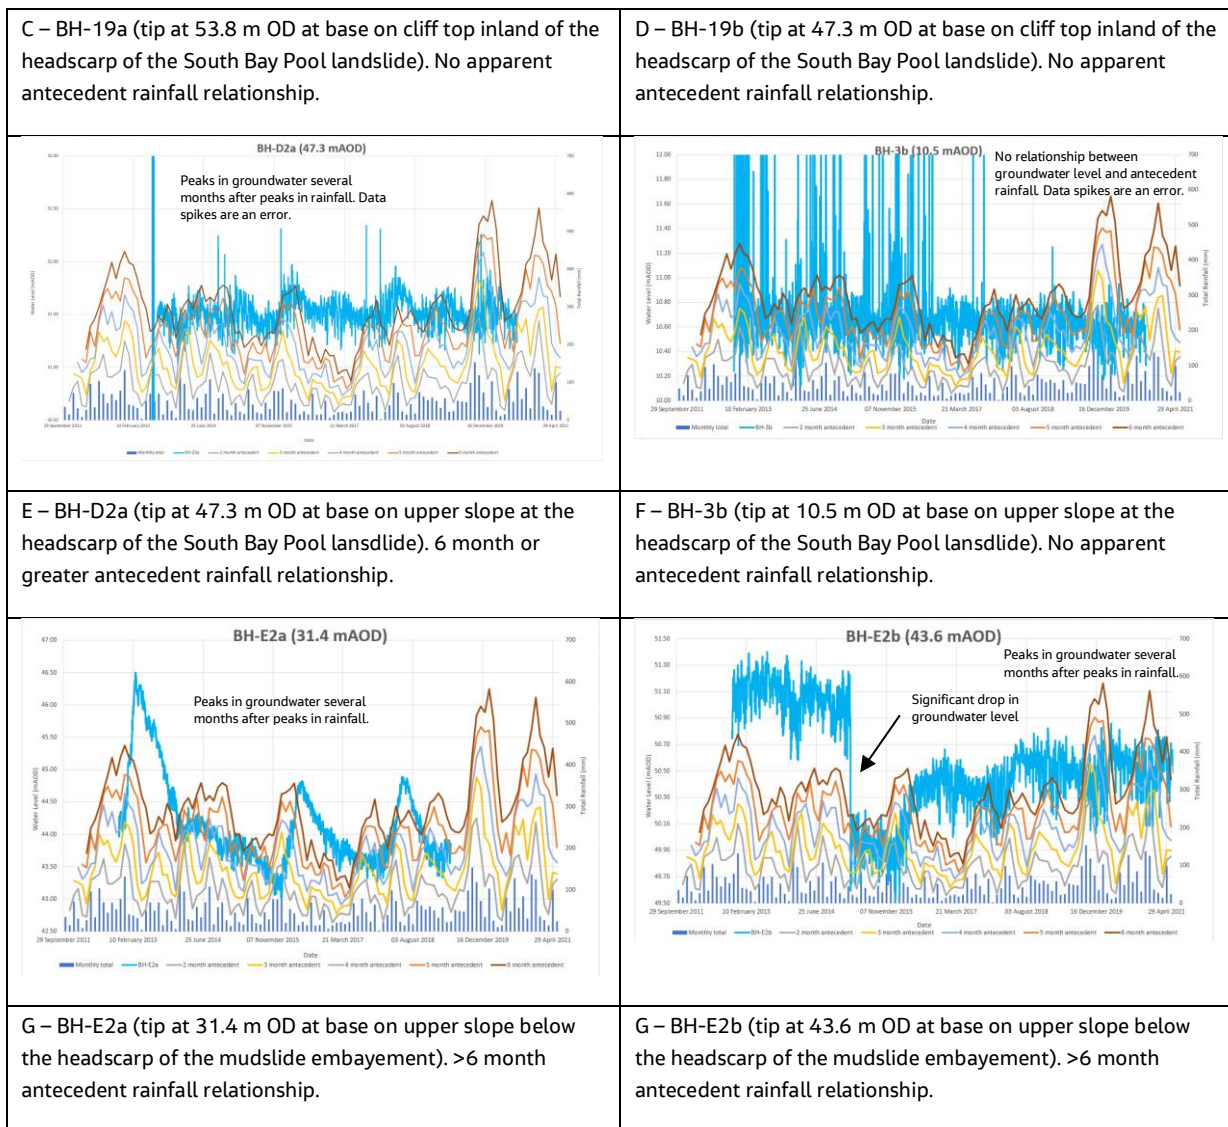
Figure 9.5: Relationship between groundwater levels and antecedent rainfall at South Cliff Gardens.
