Local Coastal Slope Monitoring Analysis: Interpretation Report 1

Prepared for
Scarborough Borough Council

February 2014

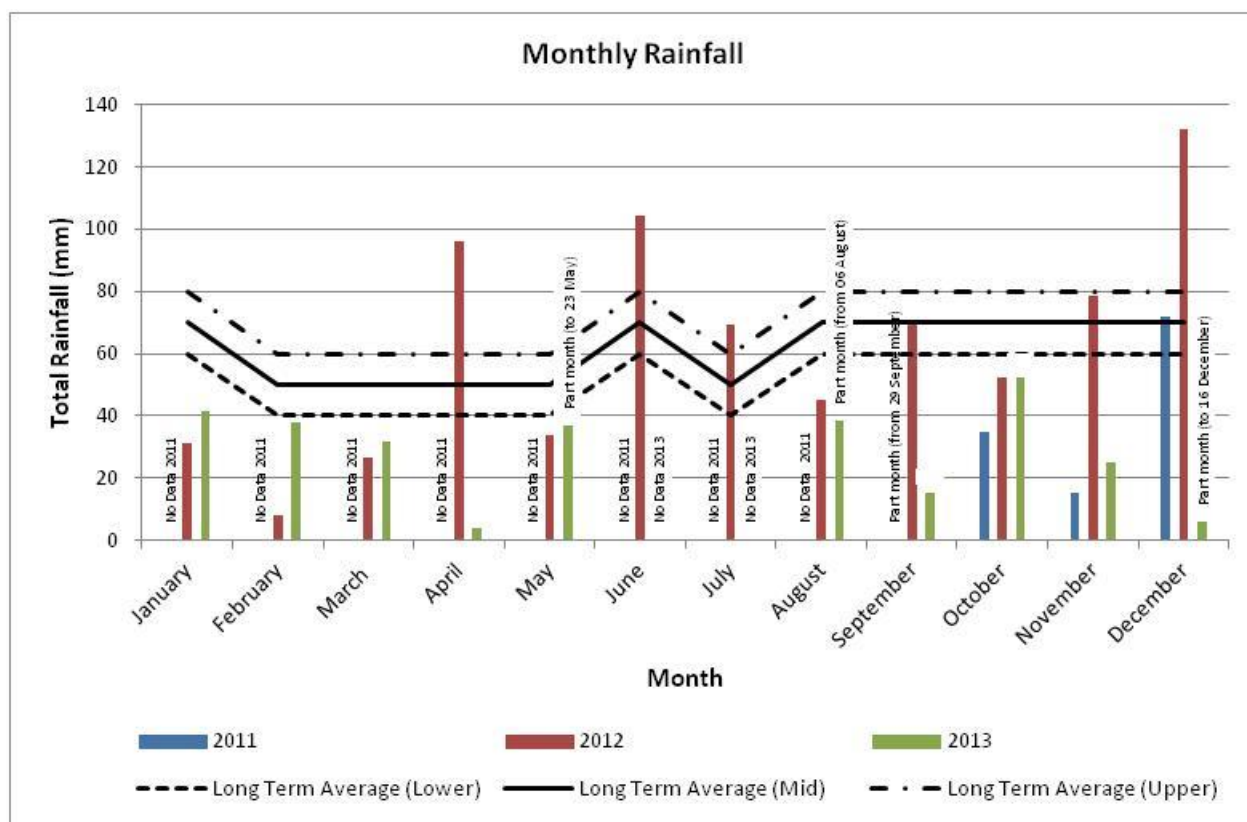
Figure 2.1. Rainfall records from the Flat Cliffs met station (October 2011 to December 2013)

Long-term monthly averages, maxima and minima (1981 to 2010) from Met Office records are indicated on the plot to provide context. The data highlight the following:

- Limited data from 2011 indicates dryer than average conditions in October and November and typically high rainfall in December.
- 2012 was an unusually wet year, with a reversed pattern of seasonal rainfall. Data from 2012 indicates exceptionally low rainfall in the early part of the year, from January to March, with December the only wet month of the 2011/12 winter. In contrast, the spring and summer were particularly wet, with April and June receiving almost twice the long-term average rainfall and

- 2013 was a dry year and the data shows below average rainfall in all months (NB no data were recorded during June and July). The pattern of rainfall shows limited seasonality, with only April, September and November having unusually dry conditions. It is likely that groundwater levels dropped to typical elevations through the year.

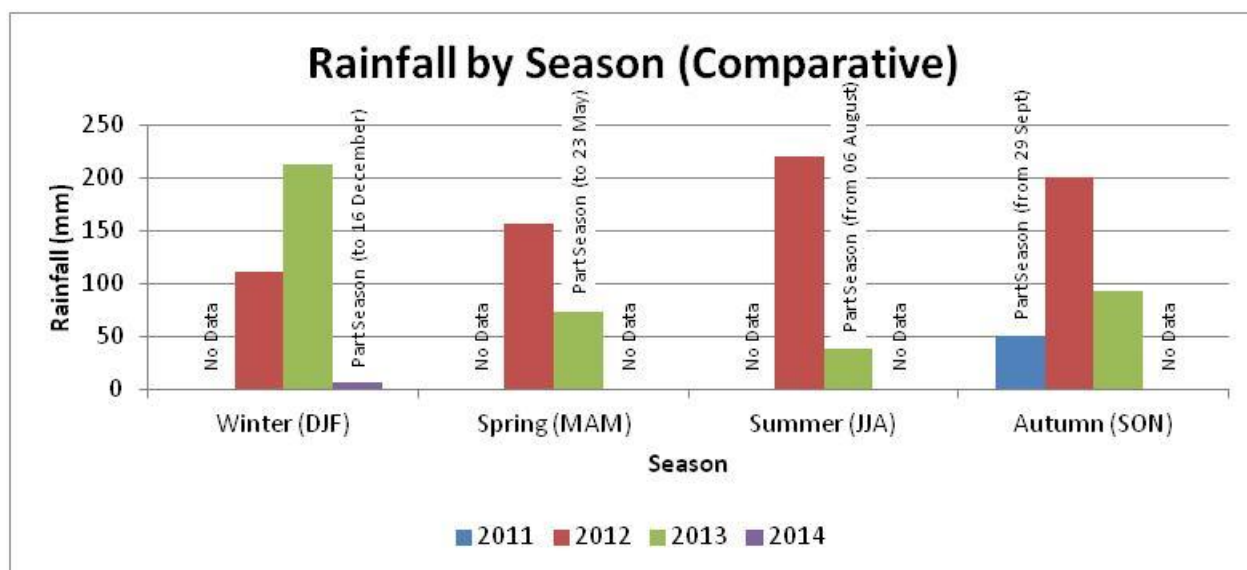
Figure 2.2. Seasonal monthly rainfall totals and antecedent conditions.

The seasonal pattern of rainfall is summarised in Figure 2.2. In the chart, 'winter' comprises the months of December, January and February and therefore spans the calendar year. The timing of 6 monthly monitoring reports coincides with the end of the summer-autumn and winter-spring periods. The data indicate:

- The preceding spring, summer and autumn 2013 period was considerably drier than that experienced in 2012 (this pattern is unaffected by the missing data from June and July that were dry months)
- In contrast, the winter of 2013 was wetter than 2012 and represents the most recent period of significant wet weather.
- Groundwater levels during the current July to December 2013 monitoring period are likely to have been low. Depending on the local hydrogeology, groundwater may have reached an equilibrium low level, or may still be falling following the higher than average rainfall of 2012 and the wet winter of 2013.

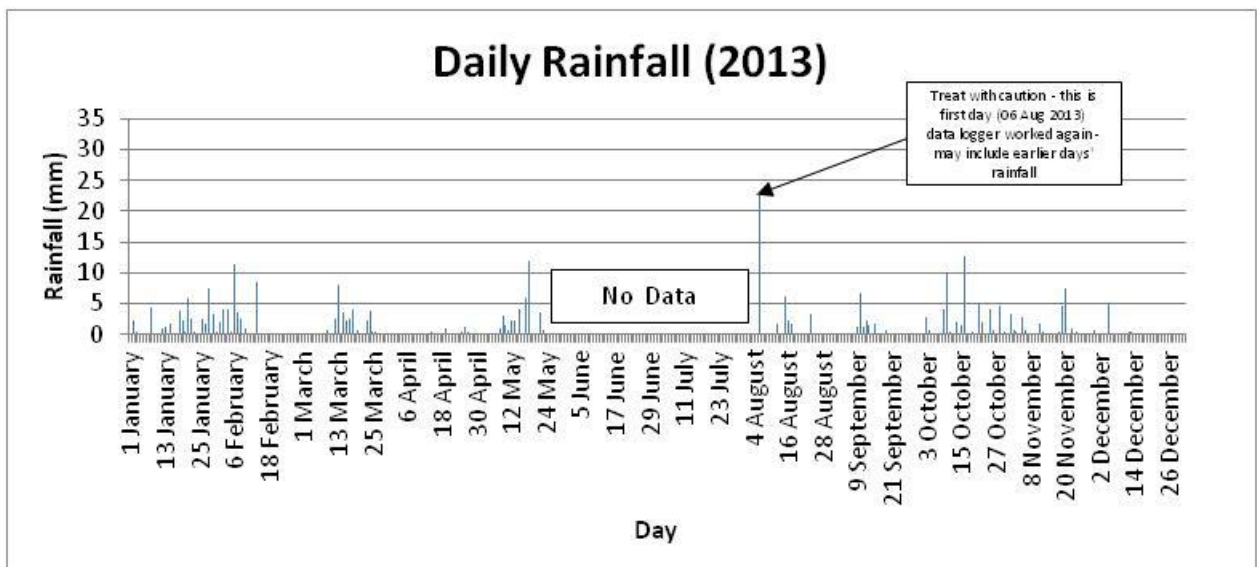
Figure 2.5. Daily rainfall recorded at Flat Cliffs during 2013.

Daily rainfall totals for each year monitored are provided in Figures 2.3, 2.4 and 2.5. These plots clearly exceptionally wet spring, summer and winter of 2012 and contrasting dry conditions of 2013. The data for the most recent period of monitoring, covering the latter half of 2013 shows:

- The very wet day on 6 August is likely to be an error following battery failure of the data logger
- Wet days occurred throughout October and November, with early October being particularly wet.

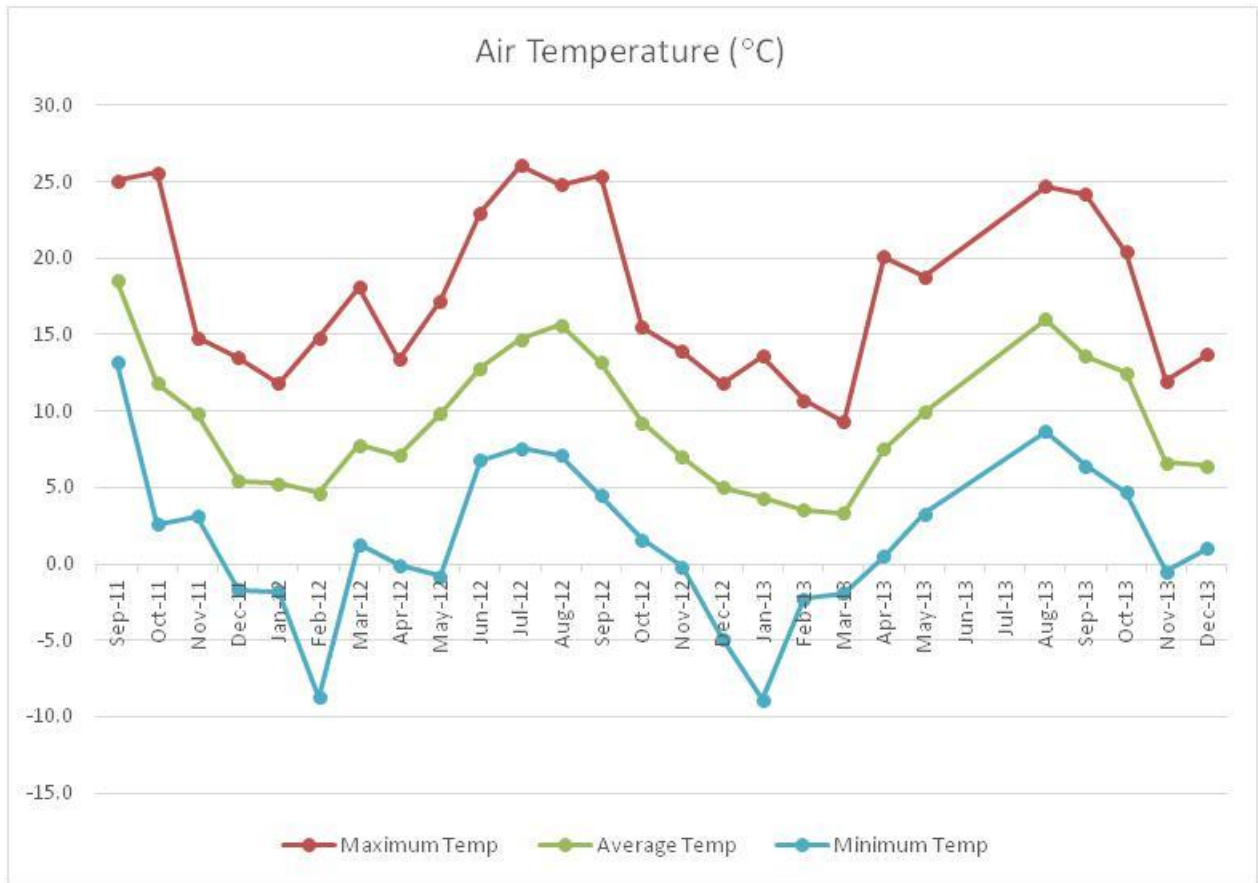
Figure 2.6. Record of air temperatures recorded at the Flat Cliffs met station

Air temperature is presented in Figure 2.6 that presents the data as minimum, maximum and mean for each month. The data highlight the atypically warm autumn of 2011. The temperature dropped below 0°C during February 2012 and January 2013. The data for June and July 2013 are missing and as a result the warm weather known to have been experienced during that period was not recorded.

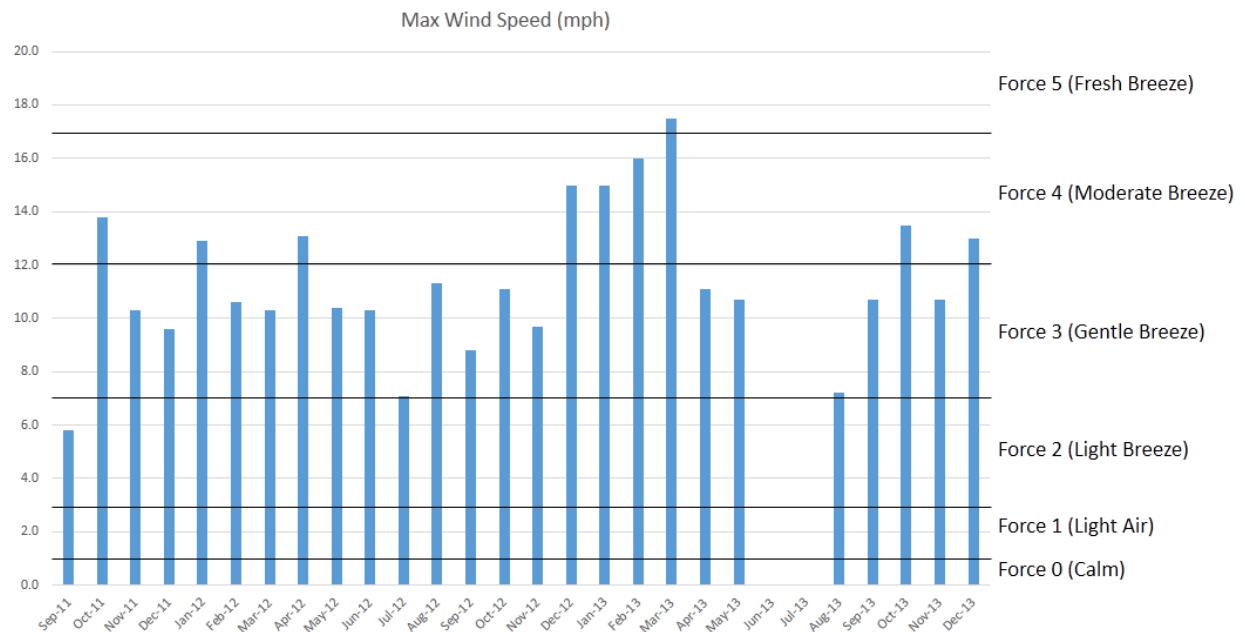
Figure 2.7. Maximum monthly wind speeds and equivalent storm forces recorded at the Flat Cliffs met station

Wind speed is summarised in Figure 2.7 that shows the maximum speed recorded in each month period and the Beaufort Scale storm force thresholds. The September 2011 and December 2013 records are incomplete and June and July 2013 records are missing.

The winter of 2012-2013 had particularly high wind speeds compared to the rest of the data record, with all of the months experiencing Force 4 or 5 winds. The highest wind speed recorded was 17.5mph in

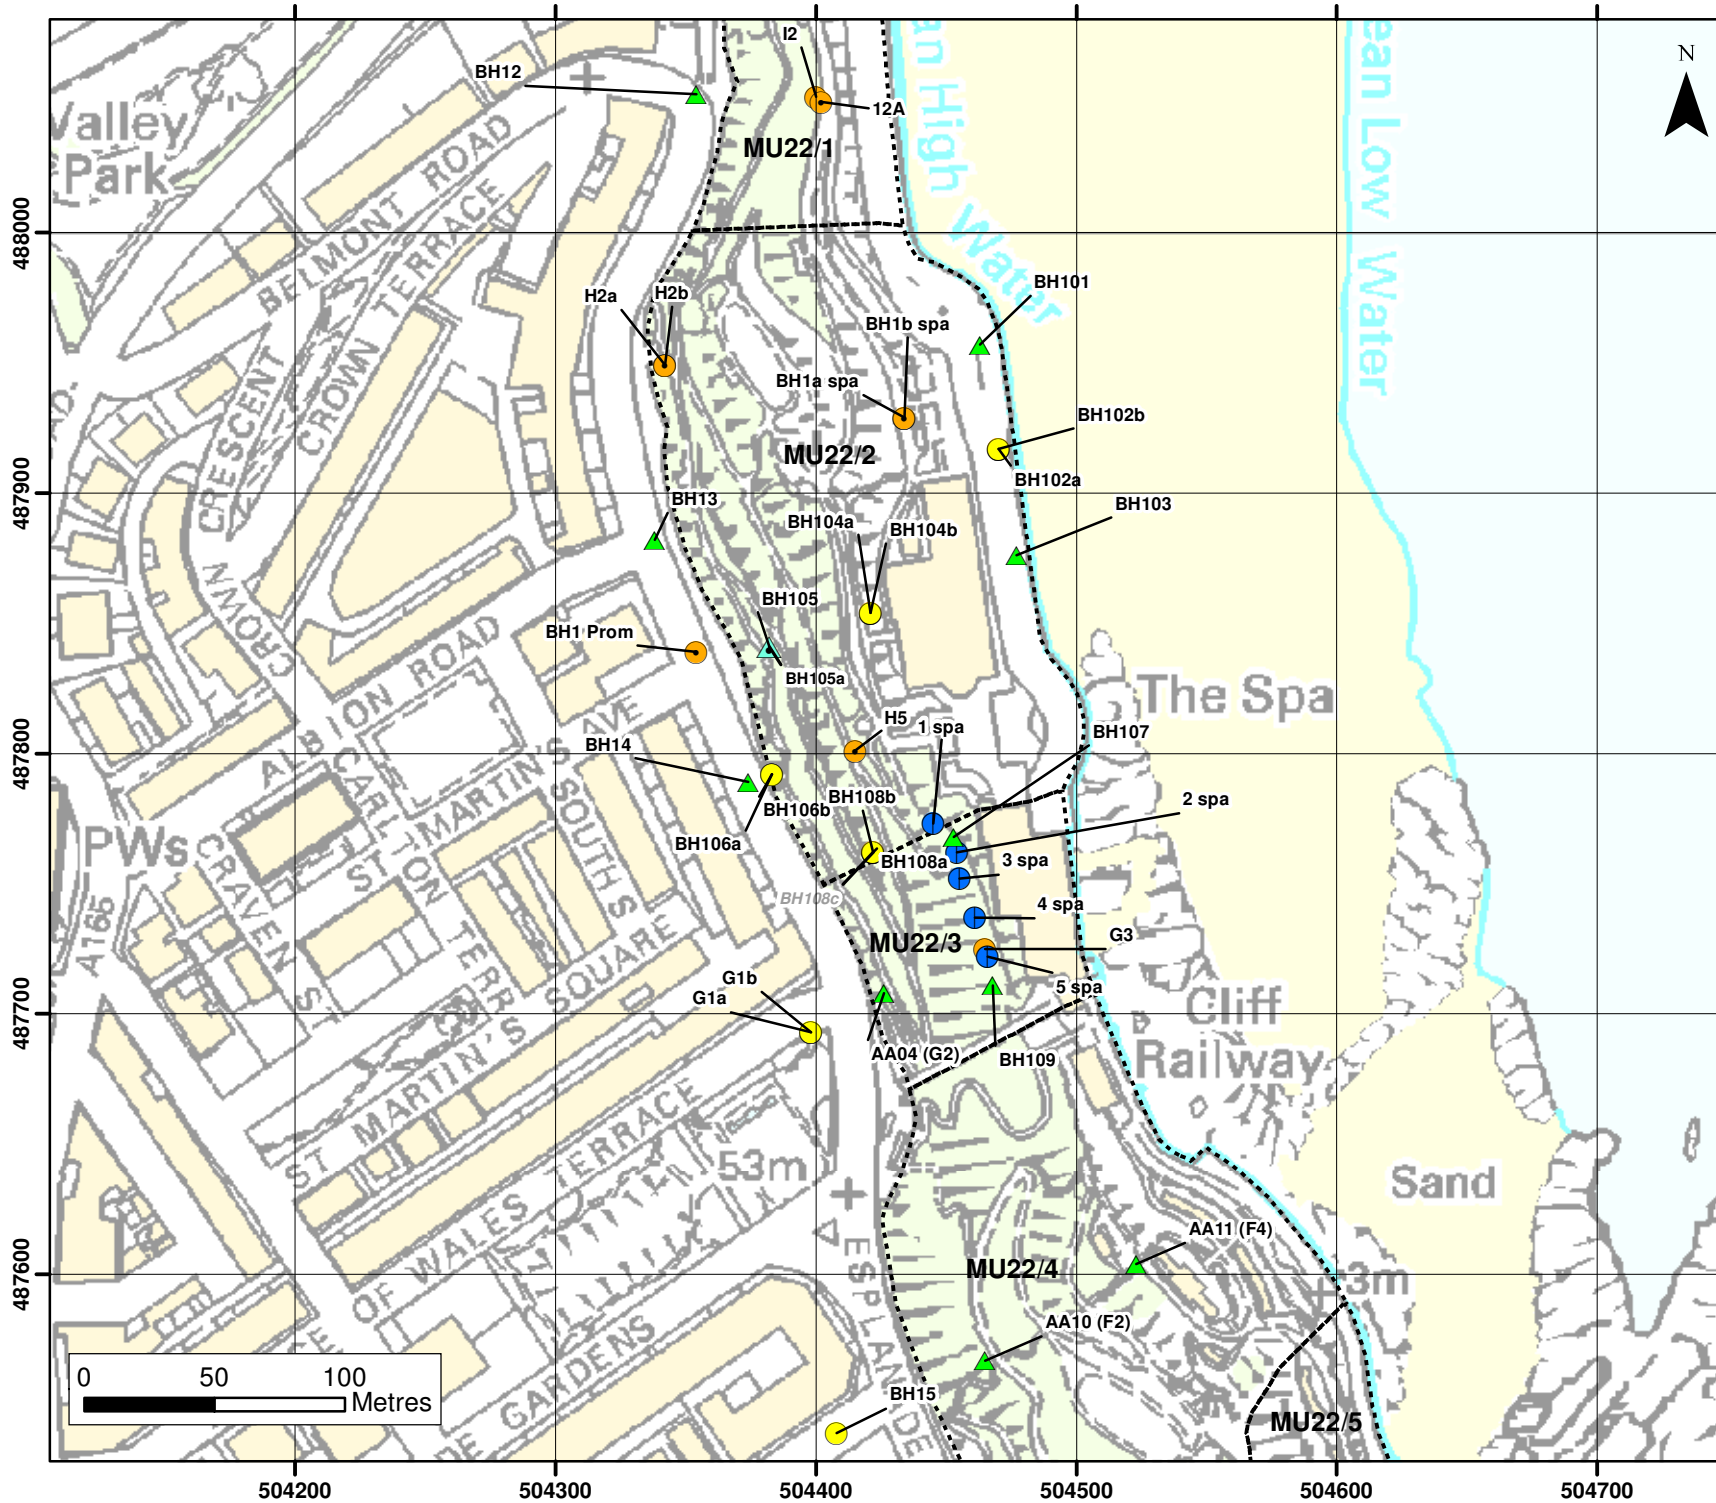
Figure 9.1A Location of monitoring at Scarborough South Bay

The monitoring regime at South Bay is summarised in Appendix A and Figure 9.1. It comprises an extensive suite of inclinometers and piezometers, most of which are automated, and an experimental acoustic inclinometer installed near the Spa Centre.
