*Local Coastal Slope Monitoring Analysis*

# Interpretation Report 3 June 2014 to November 2014

Prepared for  
**Scarborough Borough Council**

March 2015

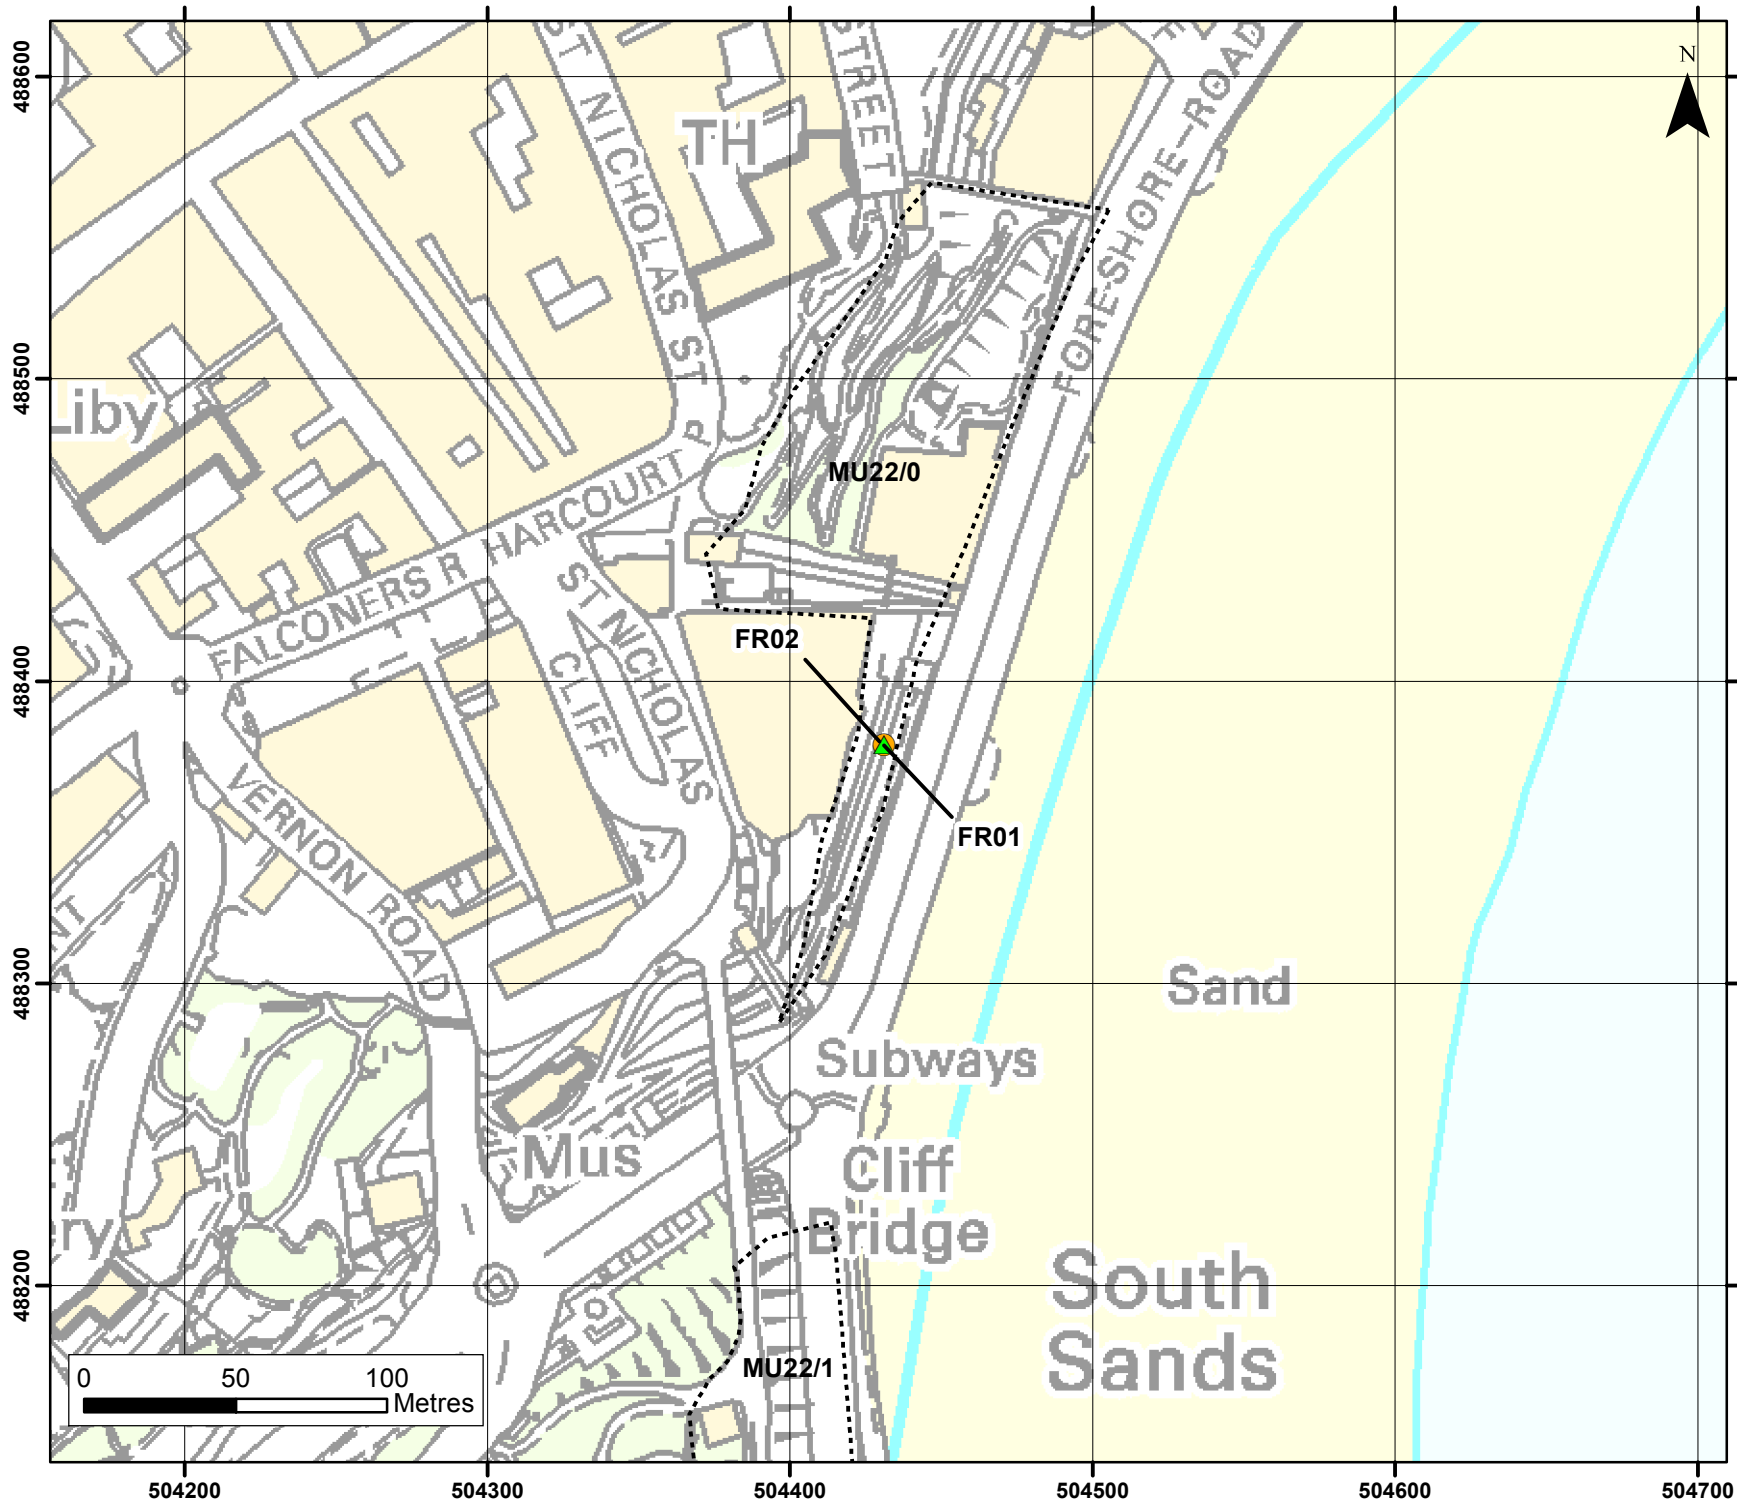
**Figure 9.1A Location of monitoring at Scarborough South Bay**

The cliff here is around 30m high and heavily landscaped with terraces and footpaths and formed in fine-grained glacial sediments (Figure 9.1A). Average slope angle is 20 to 30° but is locally steeper with sections supported by retaining walls. The cliff is crossed by a cliff lift and the cliff top is occupied by the Grand Hotel. There is no history of instability in recent years and this CBU was not reported by Mouchel.

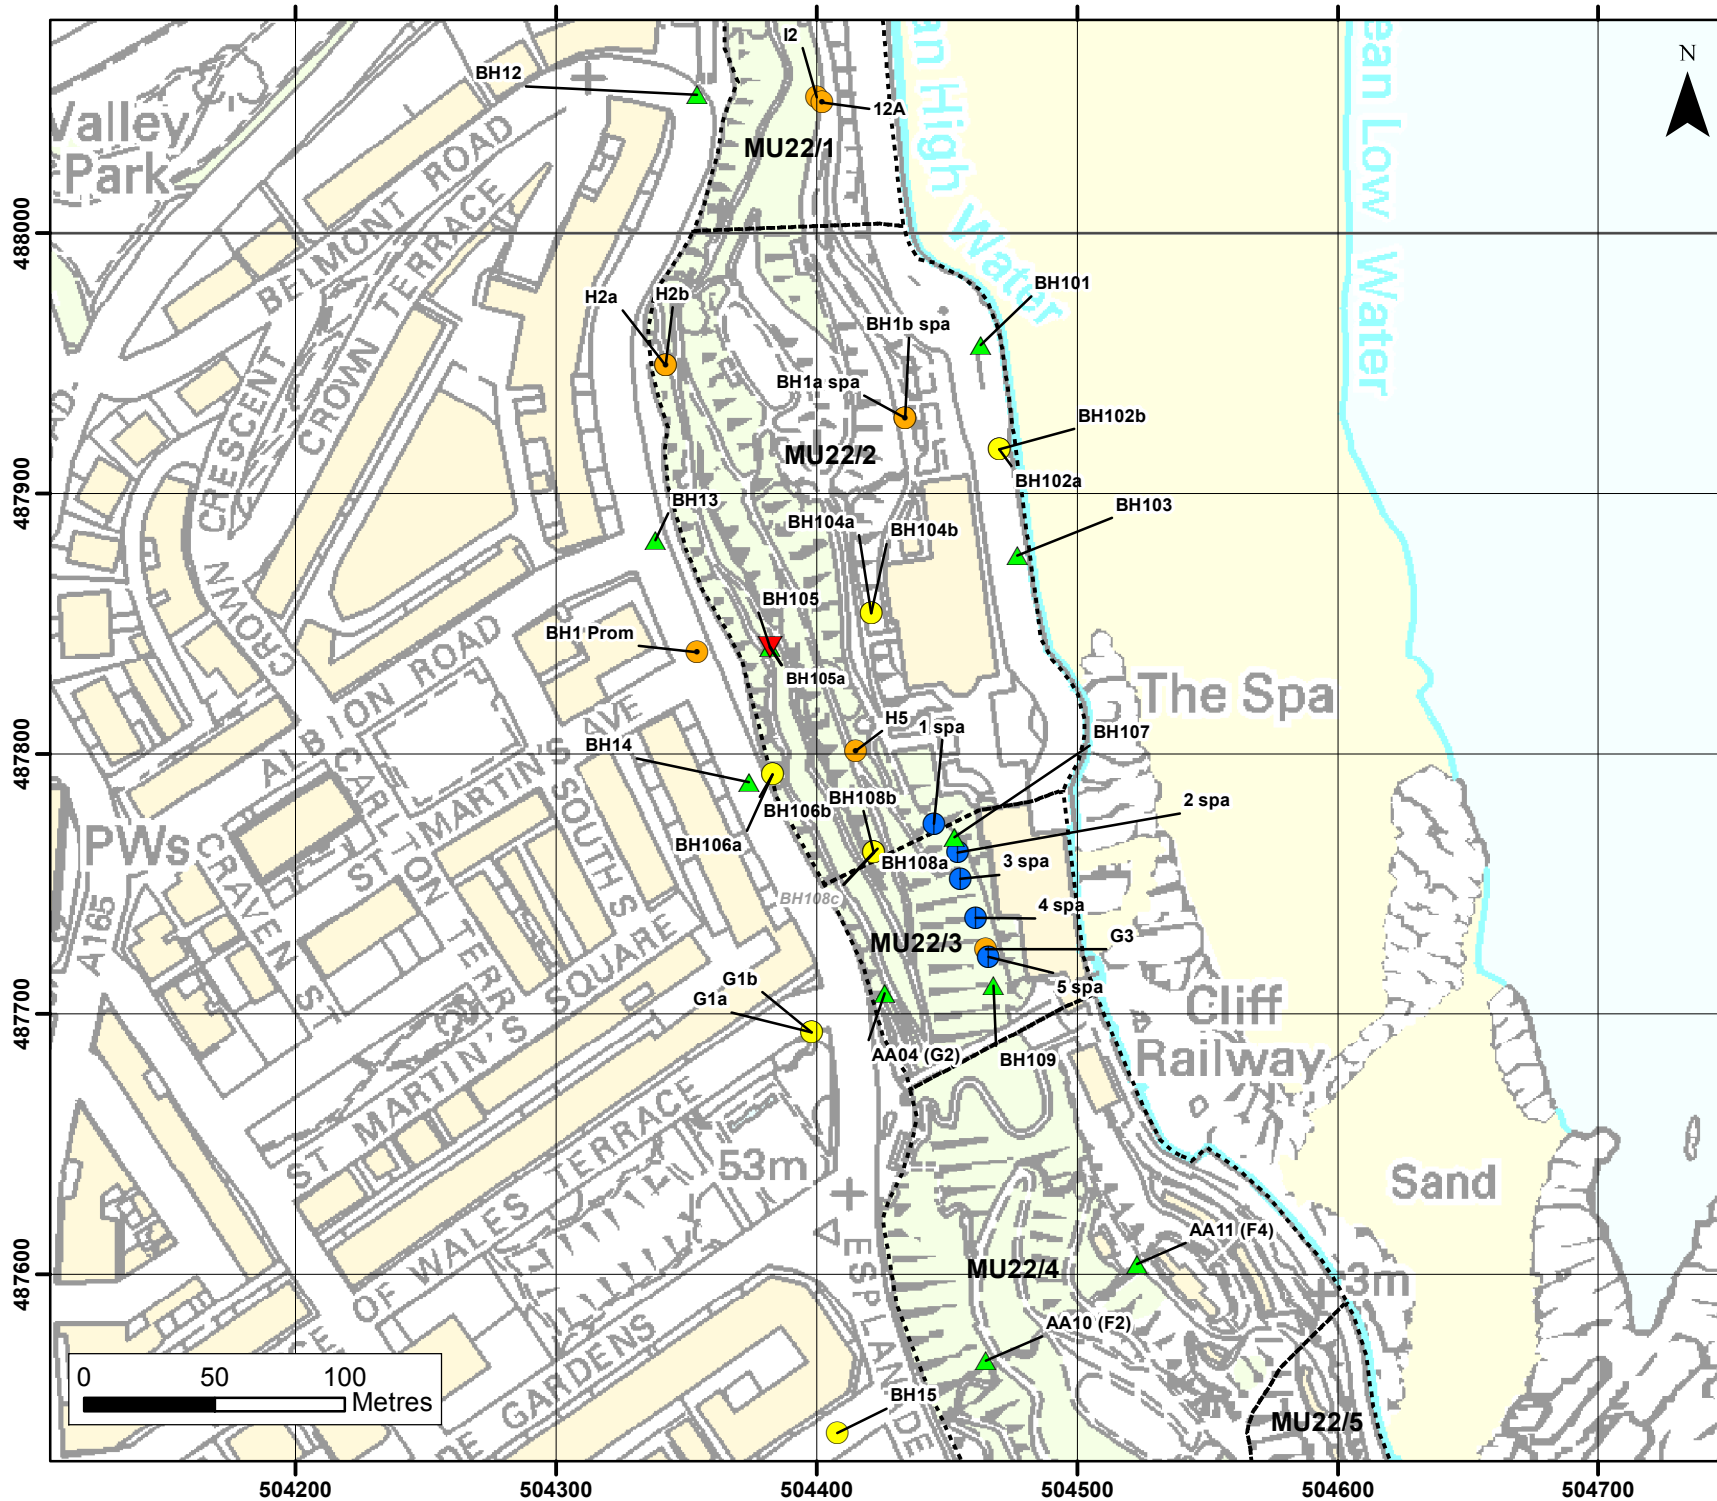
**Figure 9.1B Location of monitoring at Scarborough South Bay**

The Spa is the focus of monitoring in South Bay, with eight inclinometers and 21 piezometers installed in the area (Figure 9.1B). The cliffs are generally steep and formed in glacial sediment. Shallower cliff sections are associated with a deep-seated landslide seen immediately north of the Spa Centre and localised shallow landslides. The monitoring results are described in Tables 9.6 and 9.7.

Monitoring at the Clock Café comprises a line of three boreholes from the promenade (BH15) to the midslope (AA10 F2) and lower slope (AA11 F4) (Table 9.8, Figure 9.1B).

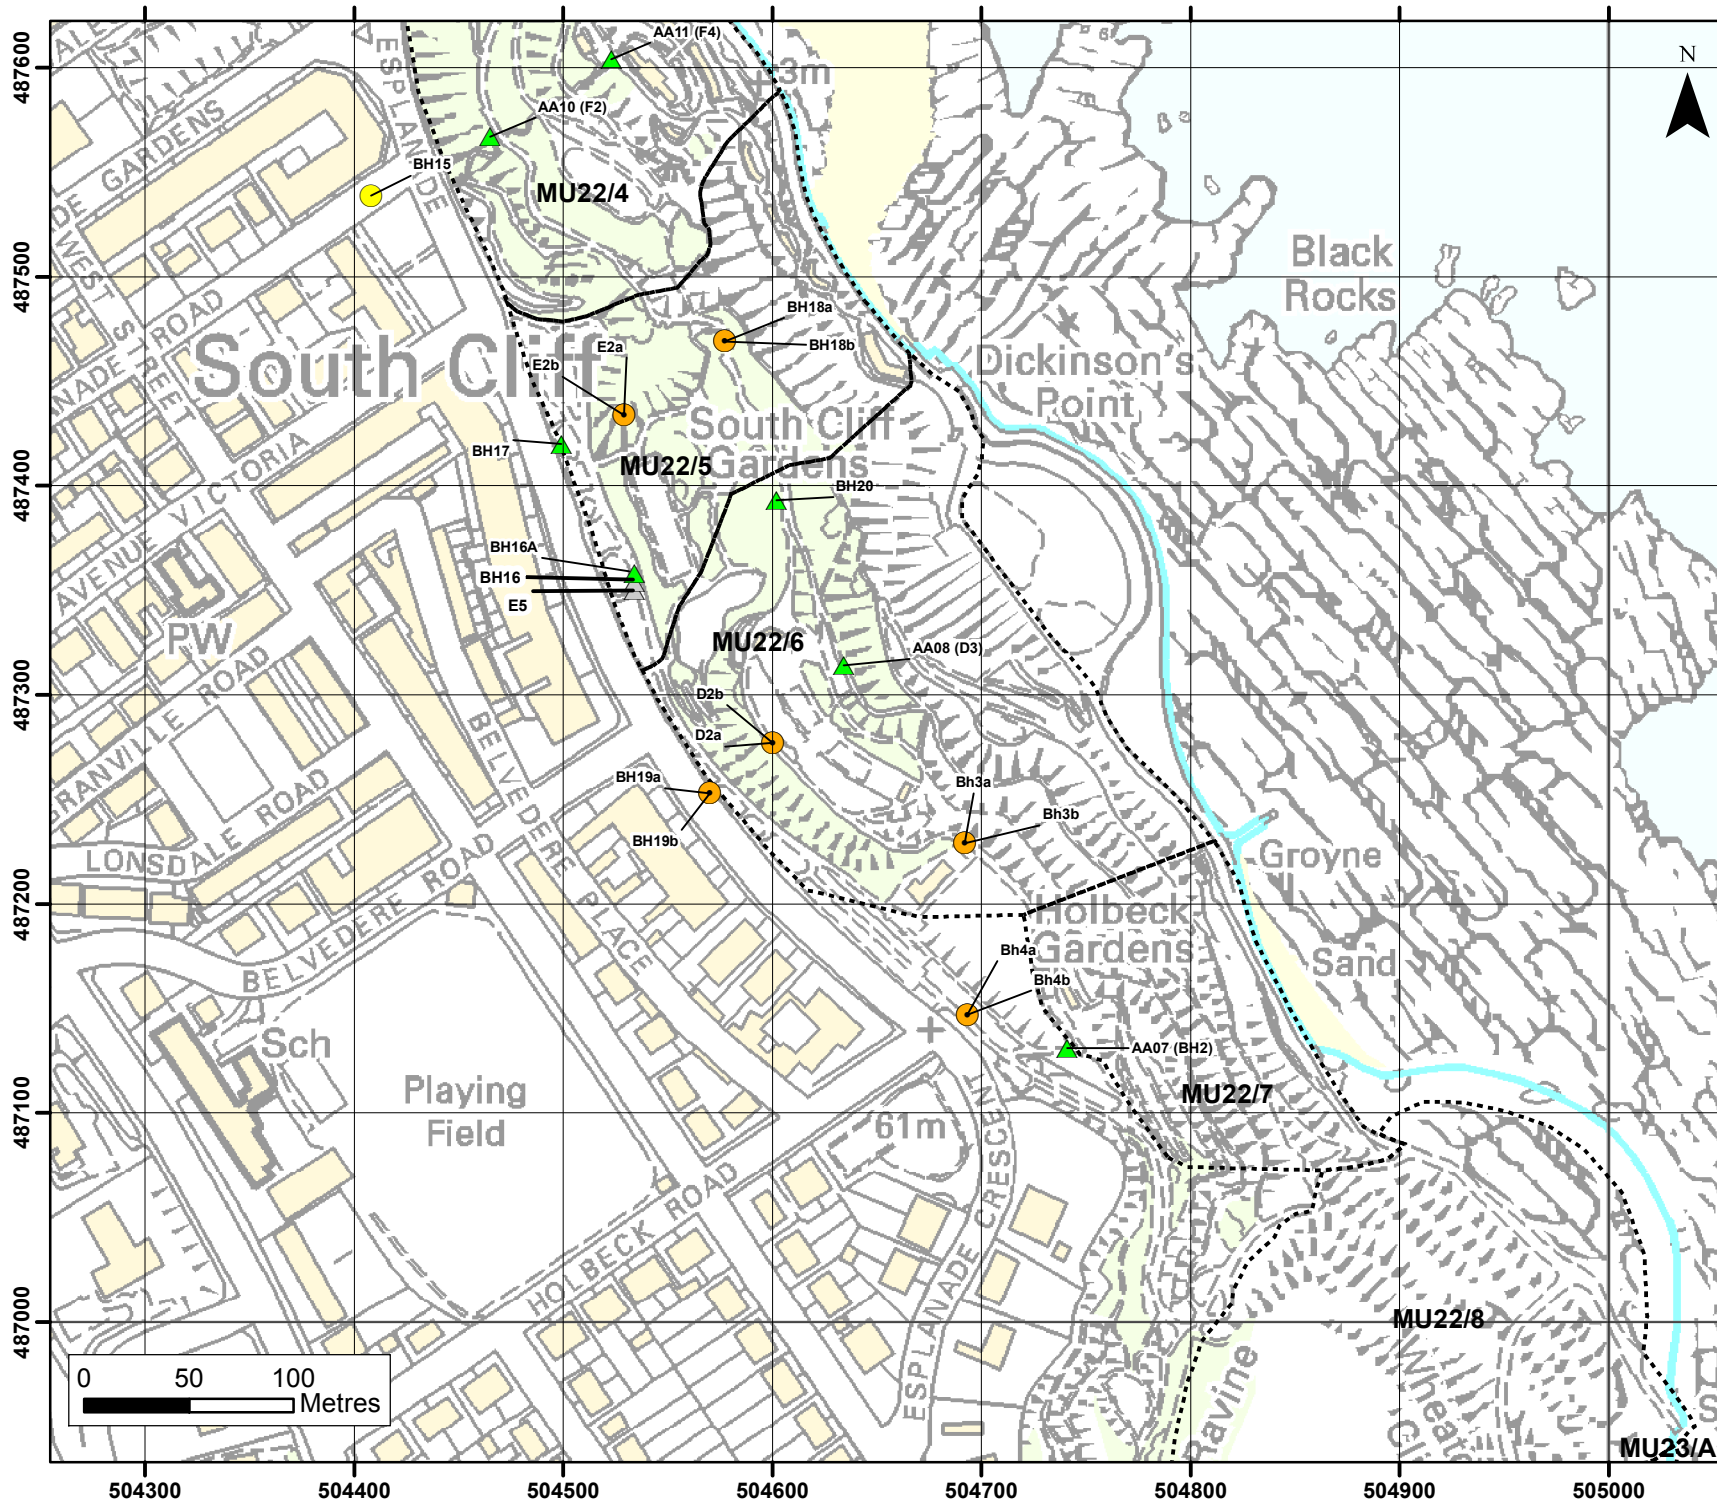
**Figure 9.1C Location of monitoring at Scarborough South Bay**

The South Cliff Gardens area comprises landscaped public areas and the former South Bay Pool, which lies at the foot of a relict landslide complex (the South Bay Pool landslide). There are three transects of monitoring locations (Tables 9.10 and 9.11; Figure 9.1C).

This area comprises two monitoring locations (Figure 9.1C); water levels are monitored at two depths along the promenade and ground movements are recorded by an inclinometer on the upper slope (Tables 9.12 and 9.13).
