# Ongoing Analysis and Interpretation of Coastal Monitoring Data

Initial Review of Restricted Suite Monitoring

## Geotechnical Interpretative Report

Document Ref. No. 721229/002/GIR/003/Final

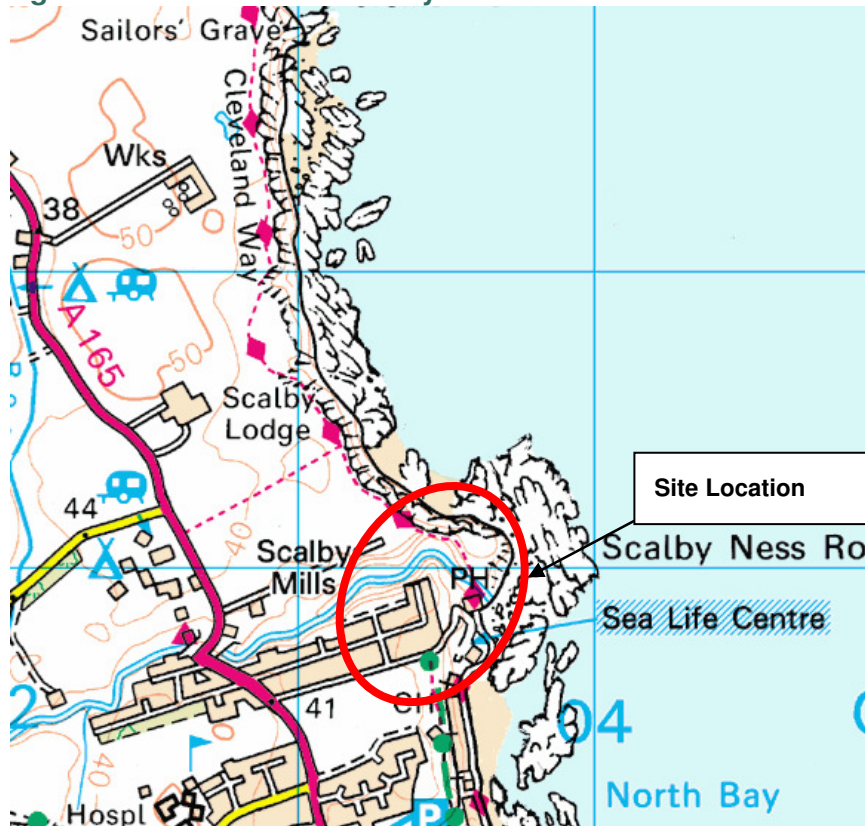
Figure 3 Site Location – Scalby Ness

A housing development was constructed during the 1970's and 1980's on land forming a plateau approximately 25-30 m above the beck at Scalby Ness. Over-steepened glacial till cliffs are present on the north west and north east sides of the development, falling down towards the beck. The beck contributes to toe erosion of these slopes and is a contributing factor of the mechanism of slope instability. Scalby Mills Road bounds the southern edge of the north east slopes. This road was constructed to give access to the Sea Life Centre on the coast. Part of the works involved re-profiling slopes with toe protection offered by rock outcrops at Scalby Beck and emplaced toe protection around the Sea Life Centre.

Site location plans are presented as Figures 2 to 6 within the relevant chapters and exploratory holes location plans, illustrating the locations of instrumentation, are presented in Appendix A.

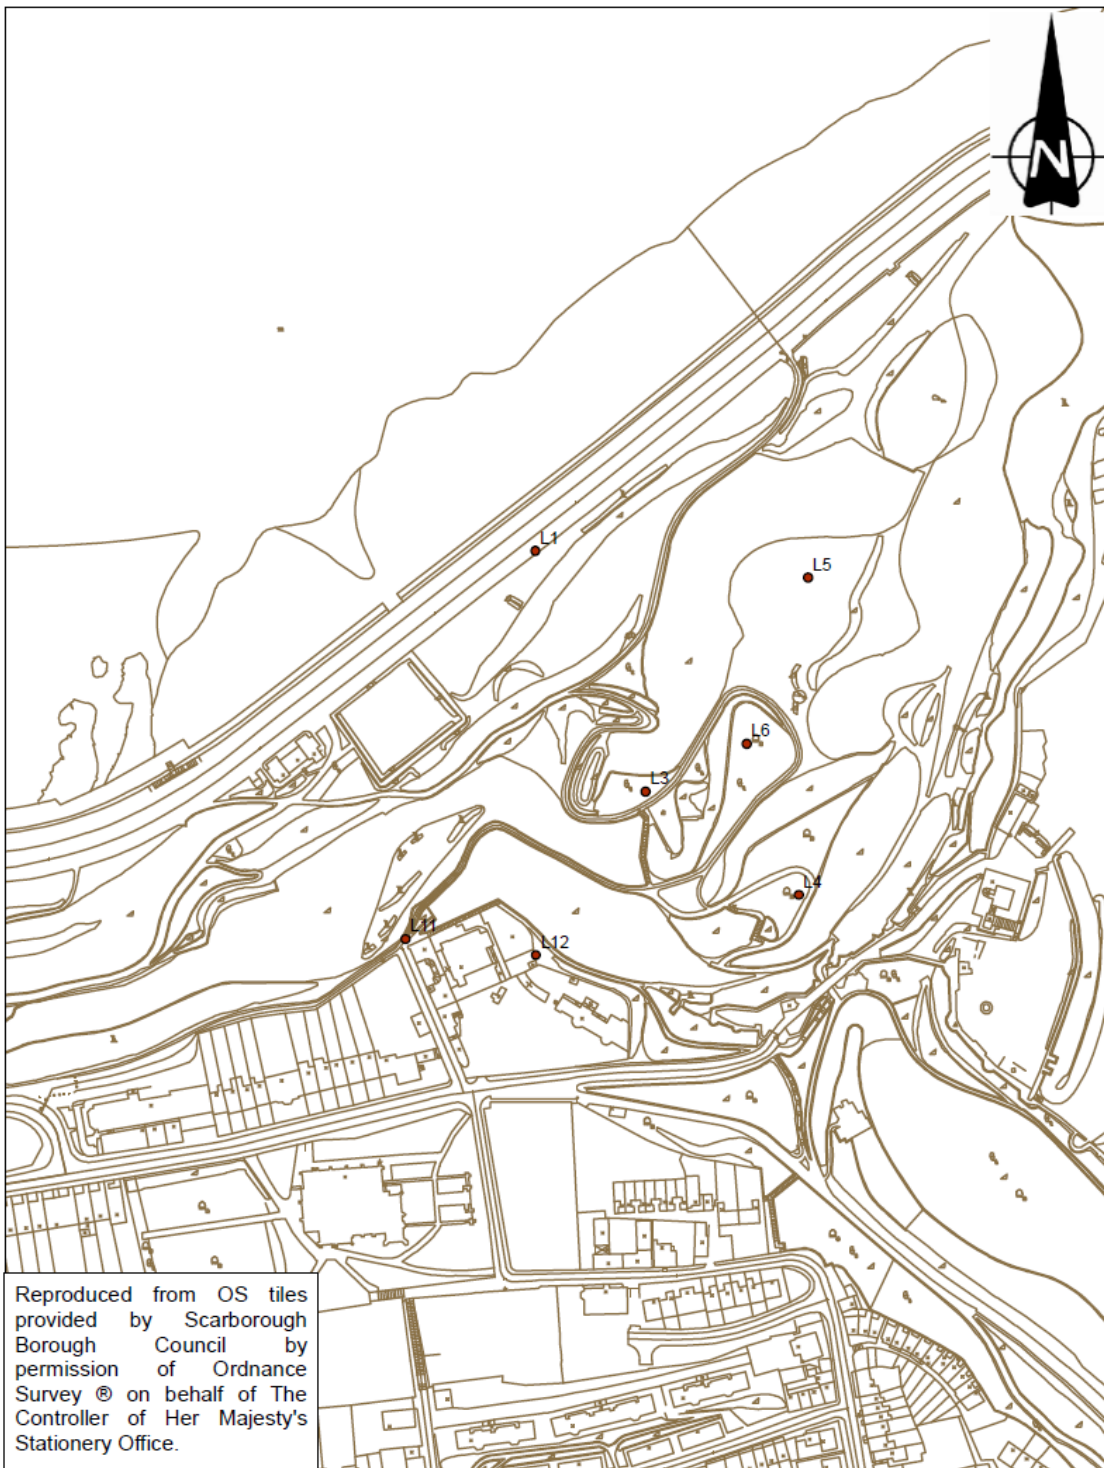
Drawing No. 4 Location Plan of Scarborough North Bay (East)

<p>Scarborough North Bay (East Section) Exploratory Holes Location Plan</p>	<p>Scale: 1:2,500</p>

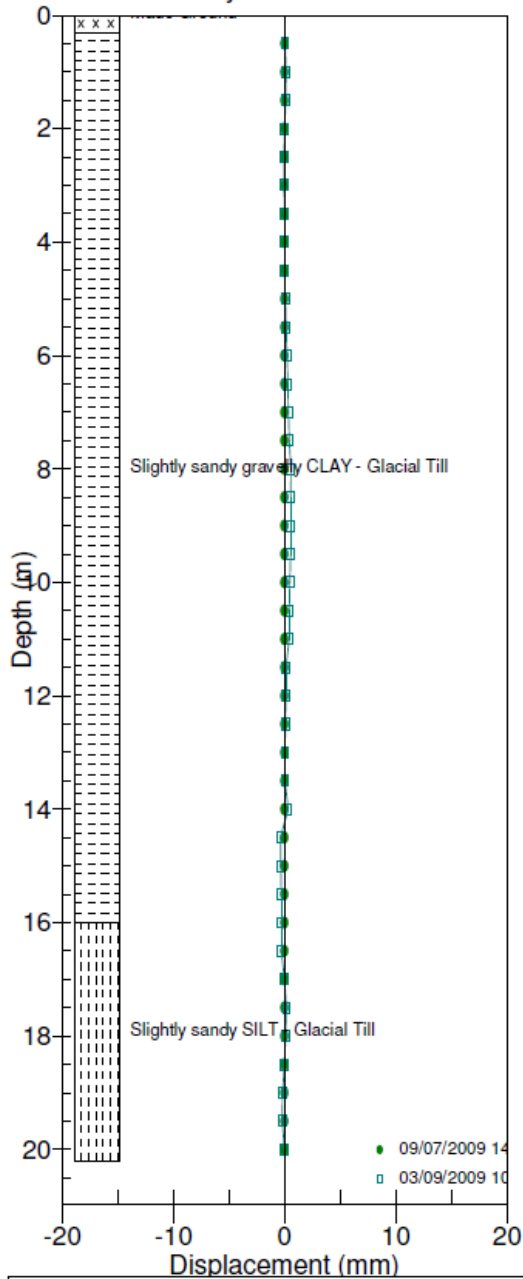
WWC: BH2 - A Axis Cumulative WWC: BH2 - B Axis Cumulative  
 Initial survey: 09/07/2009 14:40 Initial survey: 09/07/2009 14:40

PROJECT: 721229 Ongoing Analysis of Coastal Monitoring Data  
 SITE: Whitby West Cliff  
 INSTALLATION: BH2  
 COMPANY: Mouchel Ltd  
 CLIENT: Scarborough Borough Council  
 NOTE: A0 direction: North

The ongoing monitoring regime was initialised in July 2009 and follows that detailed in Section 2.5.1, above. Following on from the findings of the *Condition Survey Report*, monitoring consists of a single inclinometer (B001 / BH2) located within a path near the base of the coastal slope of West Cliff and the monitoring of surveying points. Groundwater was measured using a dip meter.

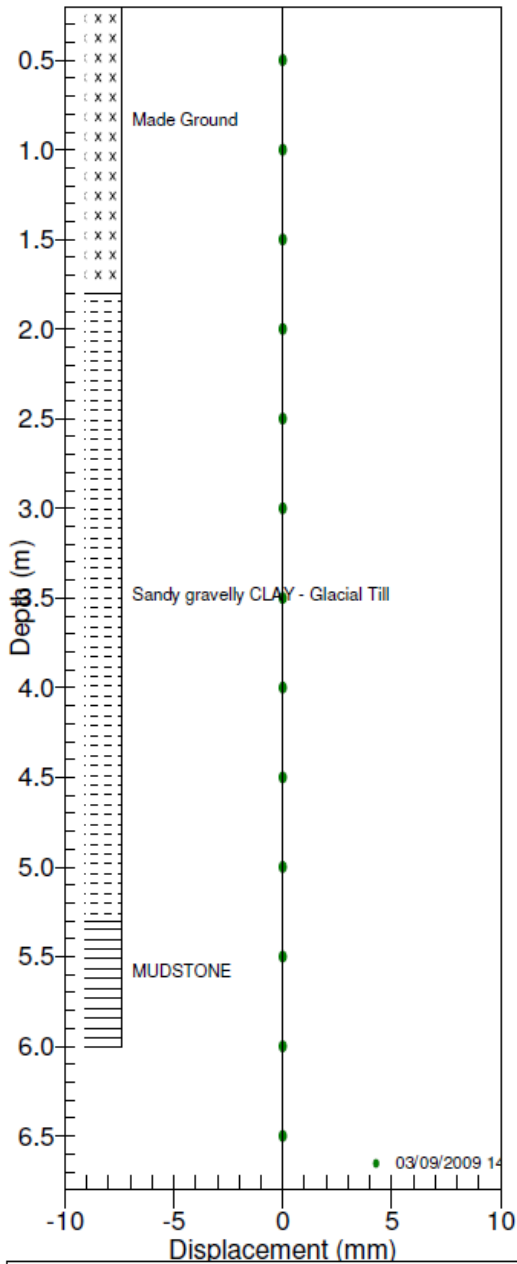
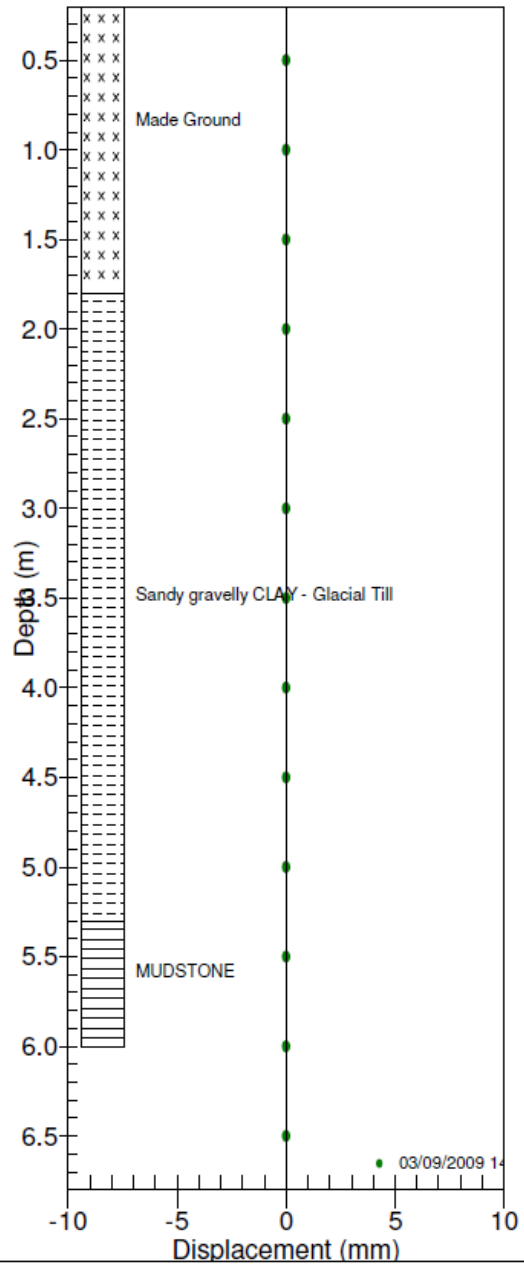
# OASIS:BH1 - A Axis Cumulative

# OASIS:BH1 - B Axis Cumulative

PROJECT: 721229 Ongoing Analysis of Coastal Monitoring Data

SITE: Oasis North Bay

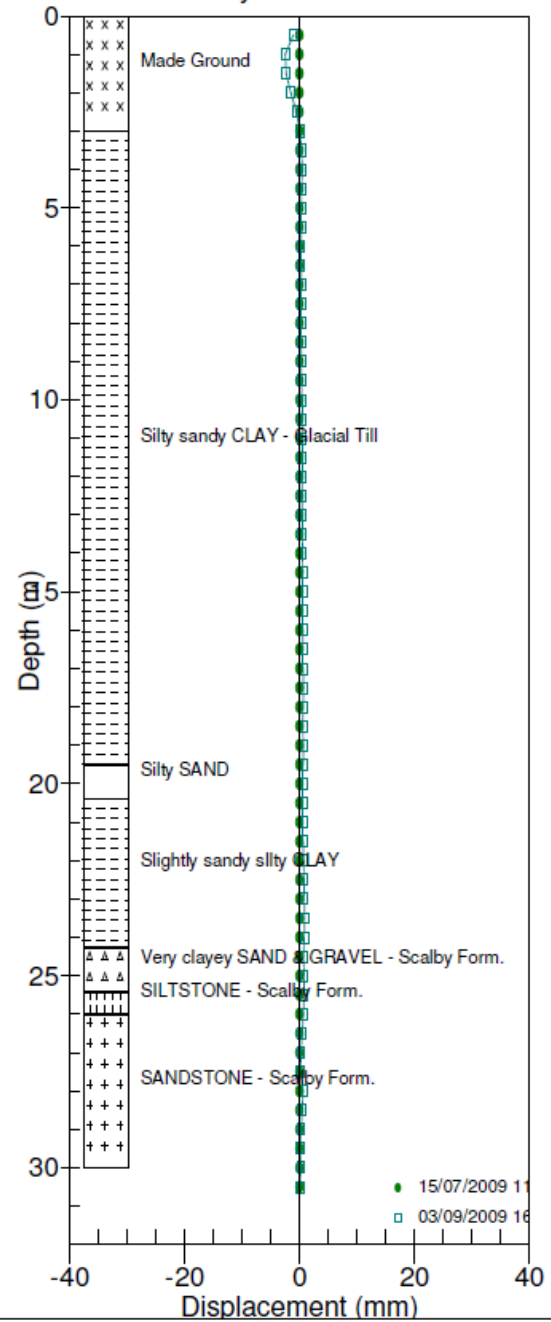
SSC:AA10 - A Axis Cumulative Initial survey: 15/07/2009 11:20

SSC:AA10 - B Axis Cumulative Initial survey: 15/07/2009 11:20

PROJECT: 721229 Ongoing Analysis of Coastal Monitoring Data

SITE: Scarborough South Cliff

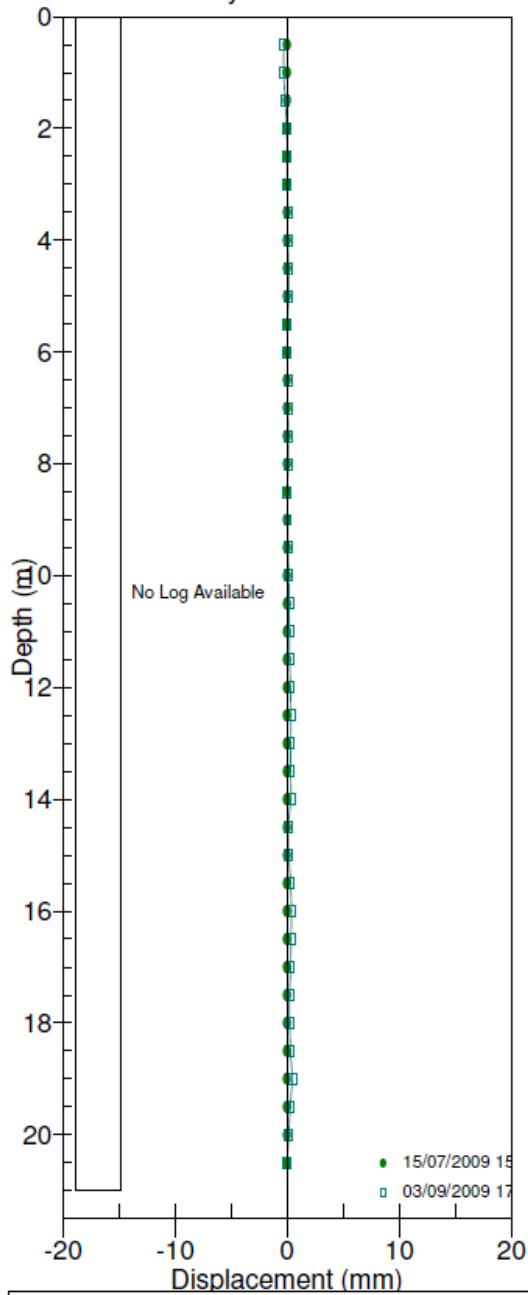
# SSC:AA11 - A Axis Cumulative

# SSC:AA11 - B Axis Cumulative

PROJECT: 721229 Ongoing Analysis of Coastal Monitoring Data  
 SITE: Scarborough South Cliff  
 INSTALLATION: AA11 (F4)  
 COMPANY: Mouchel Ltd  
 CLIENT: Scarborough Borough Council  
 NOTE: A0 direction: North East

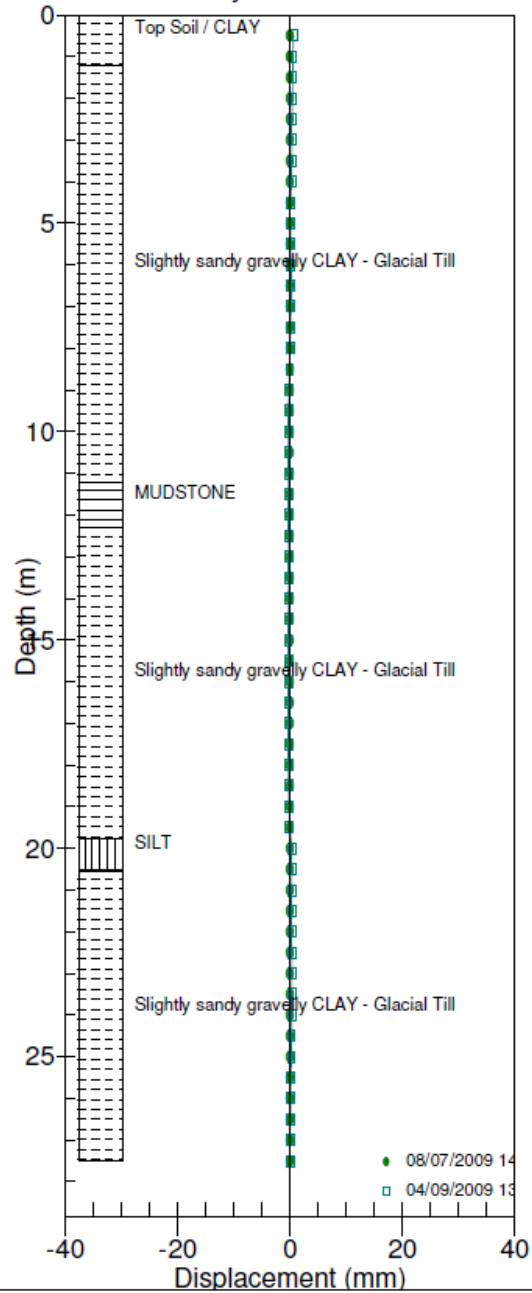
# FFC:BB02 - A Axis Cumulative

# FFC:BB02 - B Axis Cumulative

PROJECT: 721229 Ongoing Analysis of Coastal Monitoring Data

SITE: Filey Flat Cliffs

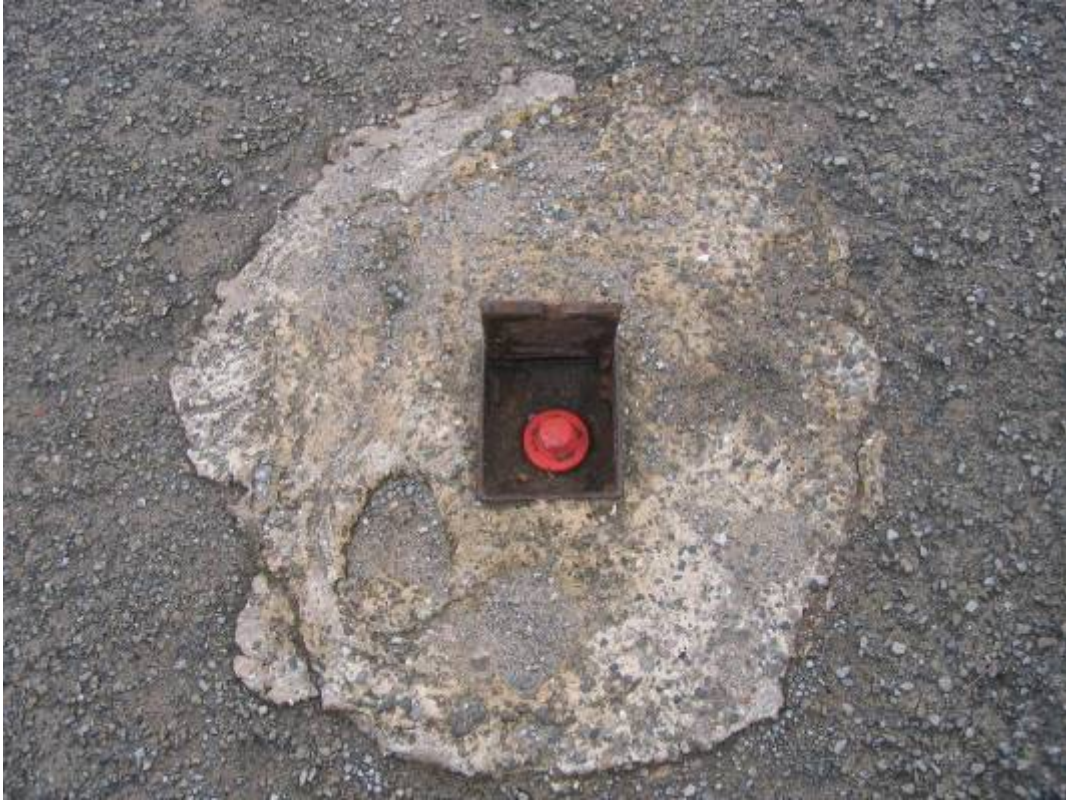
Plate 1. Whitby West Cliff BH2

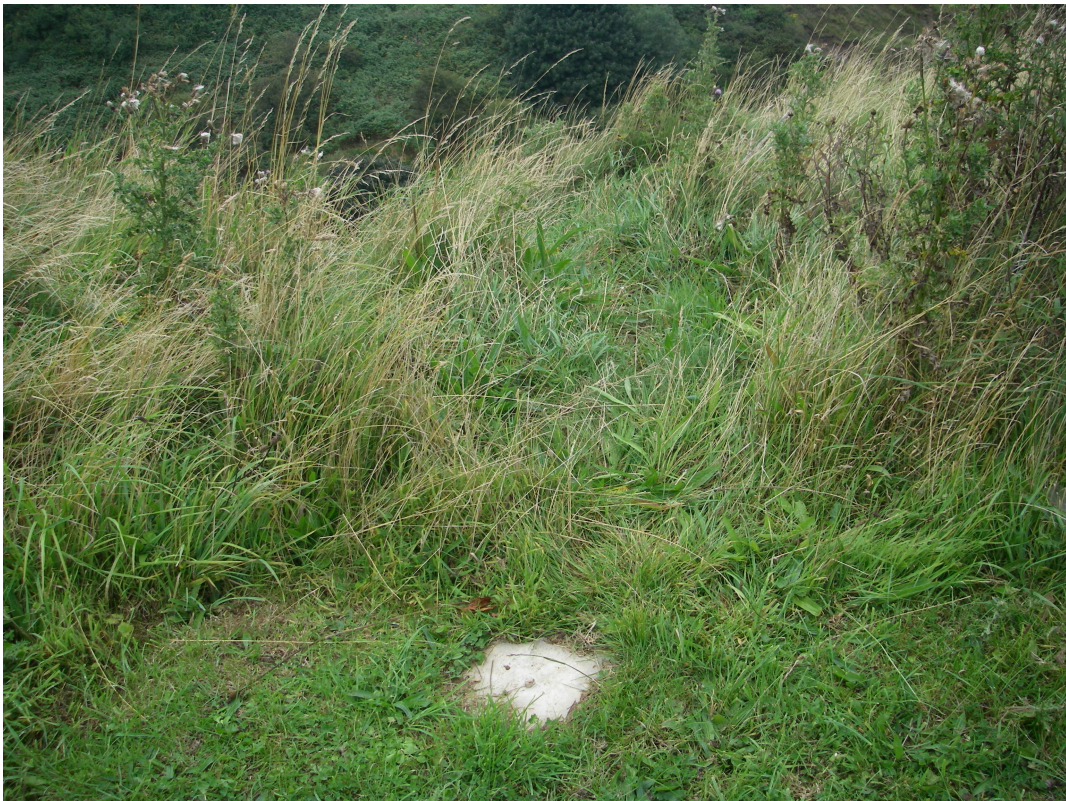
Plate 2 Scalby Ness MP1

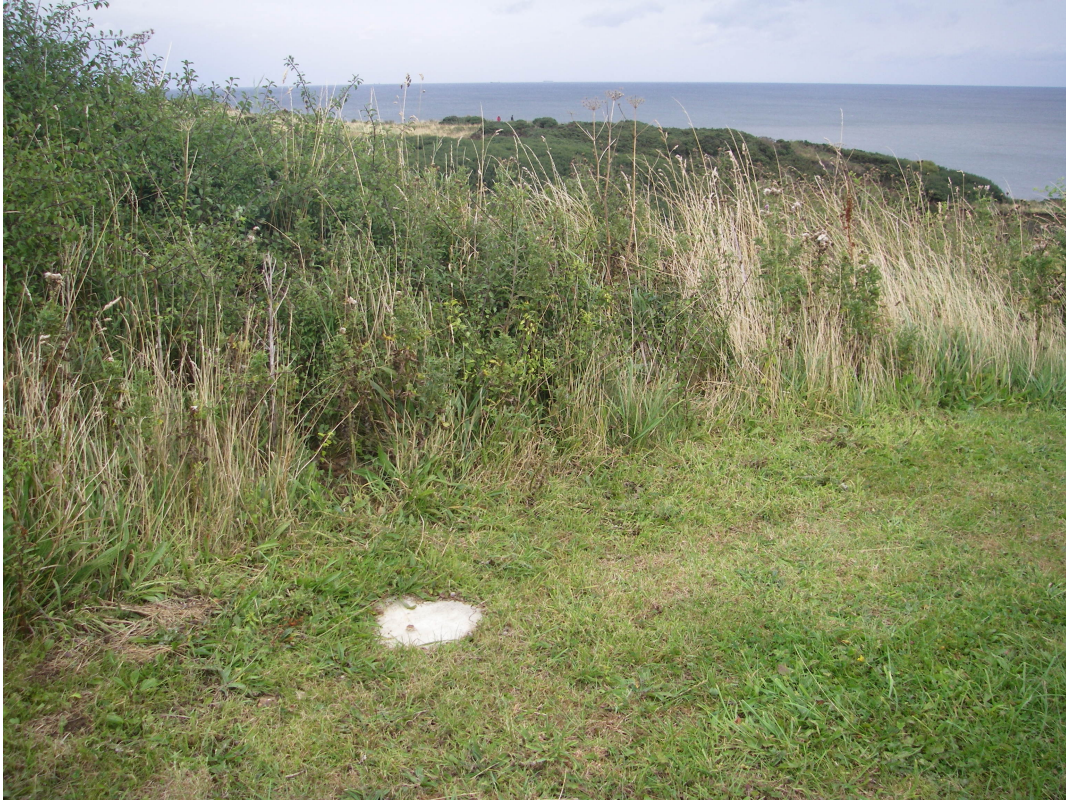
Plate 3 Scalby Ness MP2

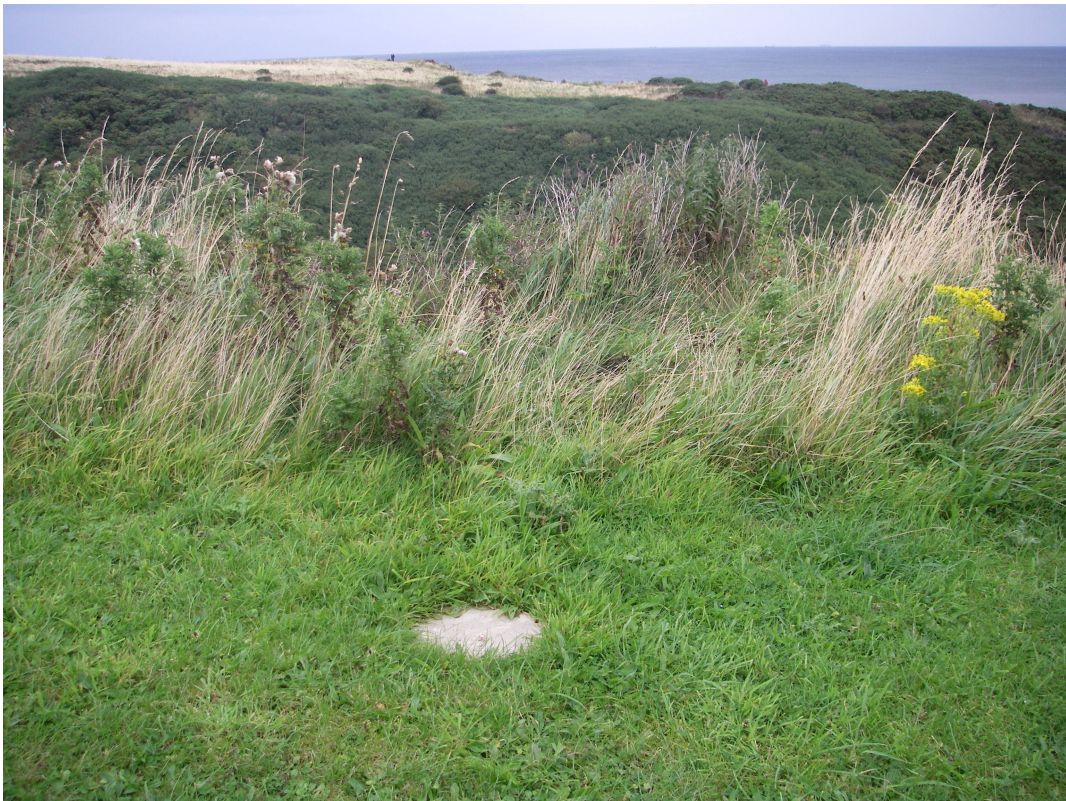
Plate 4 Scalby Ness MP3

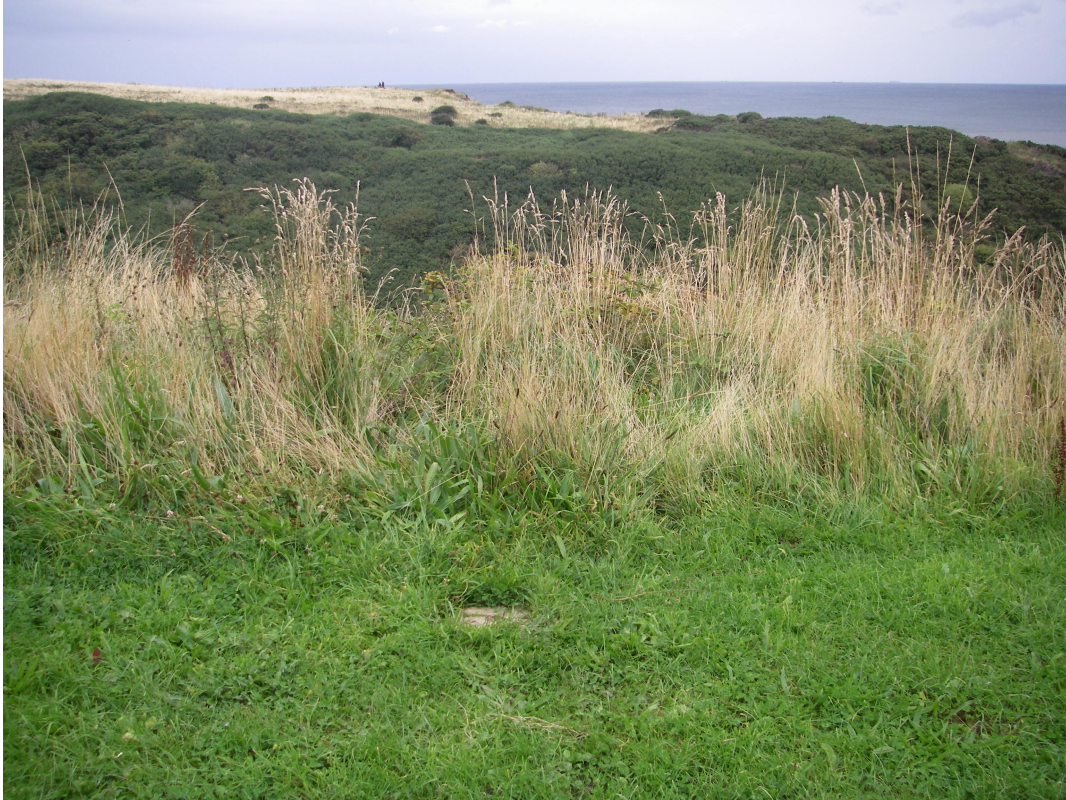
Plate 5 Scalby Ness MP4

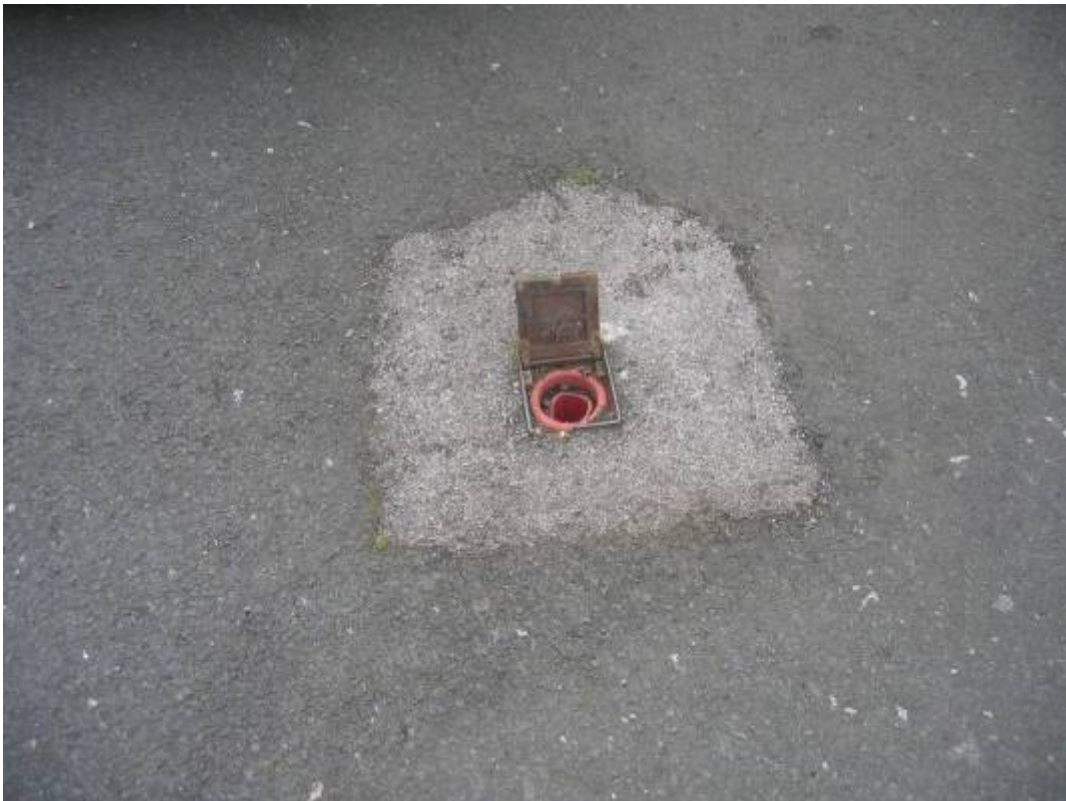
Plate 6 Scarborough North Bay L11

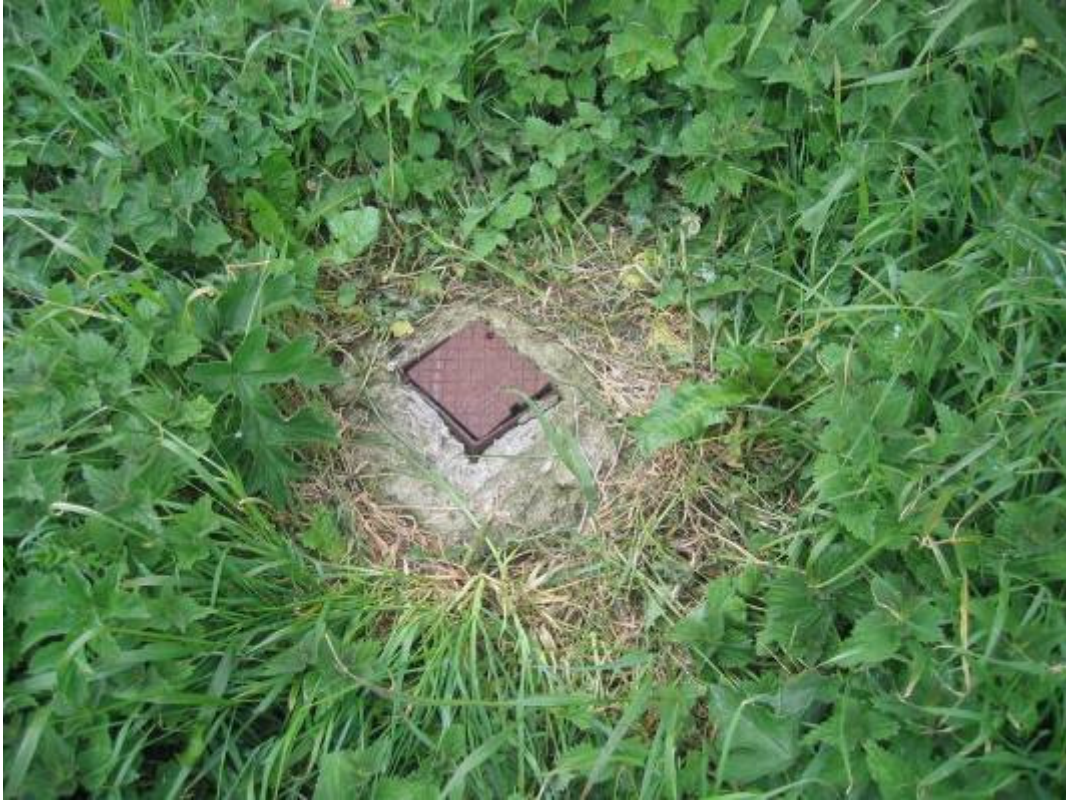
Plate 7 Scarborough North Bay L12

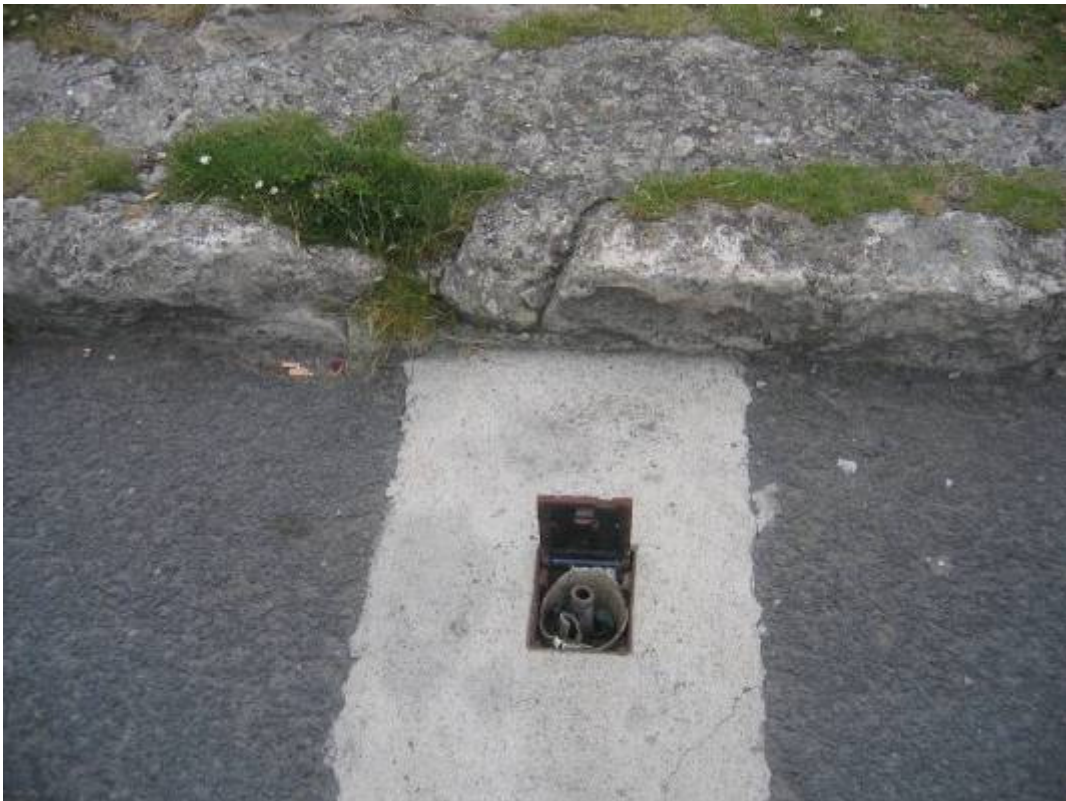
Plate 8 Scarborough North Bay L1
