# Ongoing Analysis and Interpretation of Coastal Monitoring Data

Fourth Review of Restricted Suite Monitoring

## Geotechnical Interpretative Report

Document Ref. No. 721229/002/GIR/006/Final

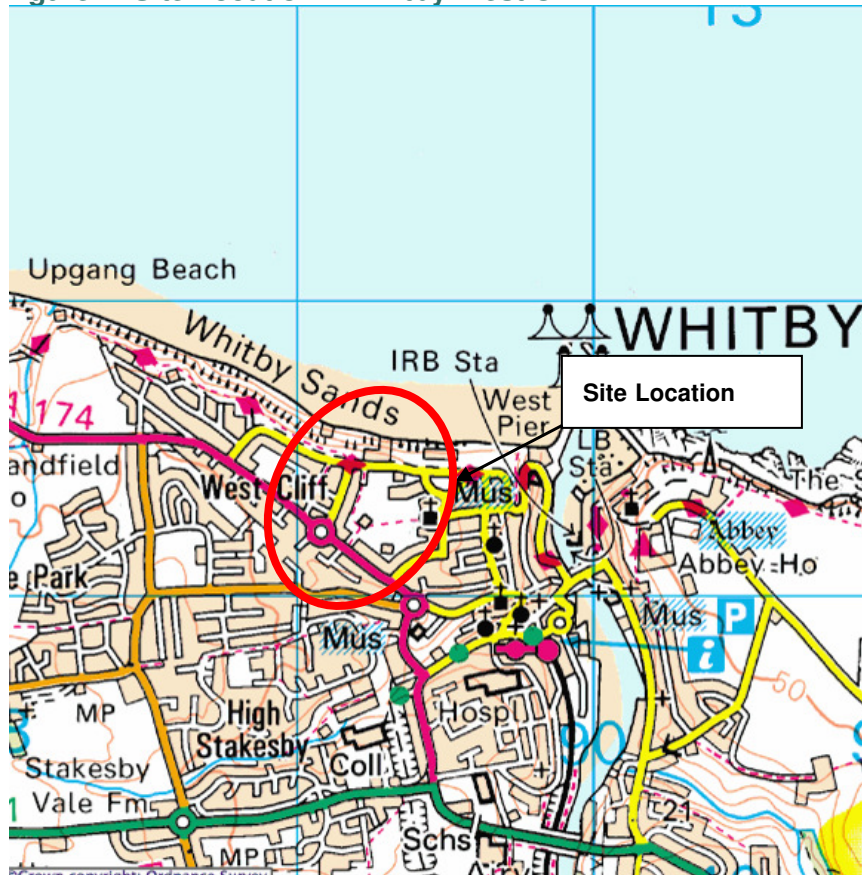
Figure 2. Site Location – Whitby West Cliff

The West Cliff site is bounded by The Spa complex to the east and the Cliff Lift towards the west. The natural slope morphology of the protected cliffs has been modified by several phases of slope stabilisation works which included drainage and slope re-profiling that has been undertaken since the 1960's. The slopes attain a height of up to 40-45 metres at slope angles of 25 to 35 degrees. Set back approximately 10 metres from the crest of the slopes is a main road (North Terrace) and beyond this are large terraced, residential and commercial properties. The faces of the slopes are criss-crossed by pedestrian footpaths which give public access from the top of the cliffs to the beach below. Other features present over the slopes are low retaining walls, gabion walls and relict slip failure scars. At the base of the slopes is a sea wall with a promenade, forming a sea defence, with a wide sandy beach foreshore.

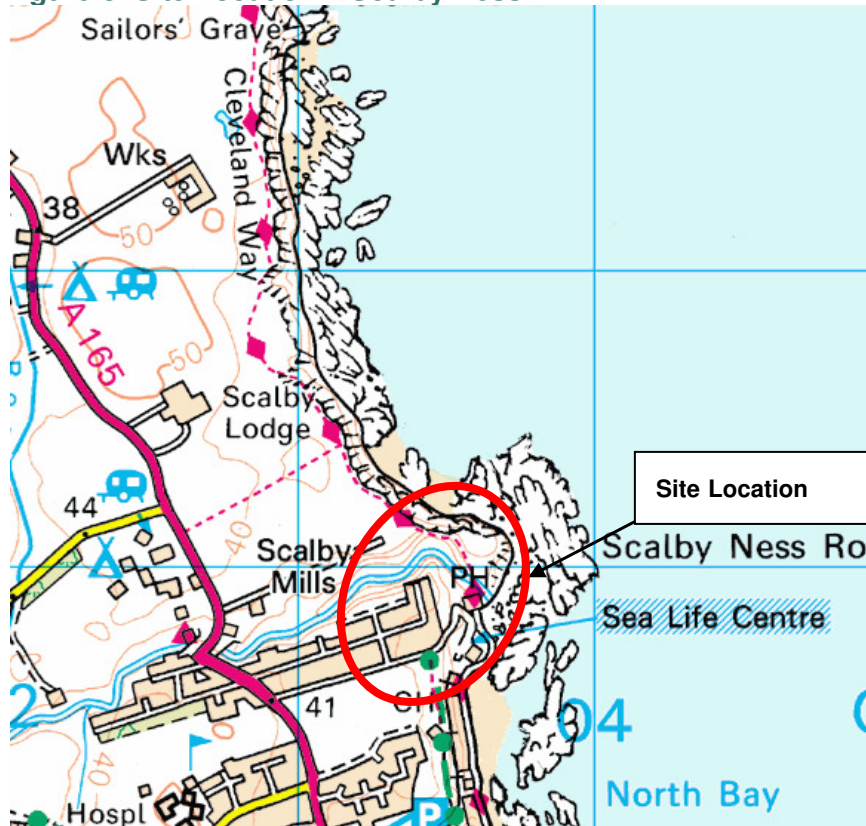
Figure 3. Site Location – Scalby Ness

A housing development was constructed during the 1970's and 1980's on land forming a plateau approximately 25-30 m above the beck at Scalby Ness. Over-steepened glacial till cliffs are present on the north west and north eastern sides of the development, falling down towards the beck. The beck contributes to toe erosion of these slopes and is a contributing factor of the mechanism of slope instability. Scalby Mills Road bounds the southern edge of the north east slopes. This road was constructed to give access to the Sea Life Centre on the coast. Part of the works involved re-profiling slopes with toe protection offered by rock outcrops at Scalby Beck and emplaced toe protection around the Sea Life Centre.

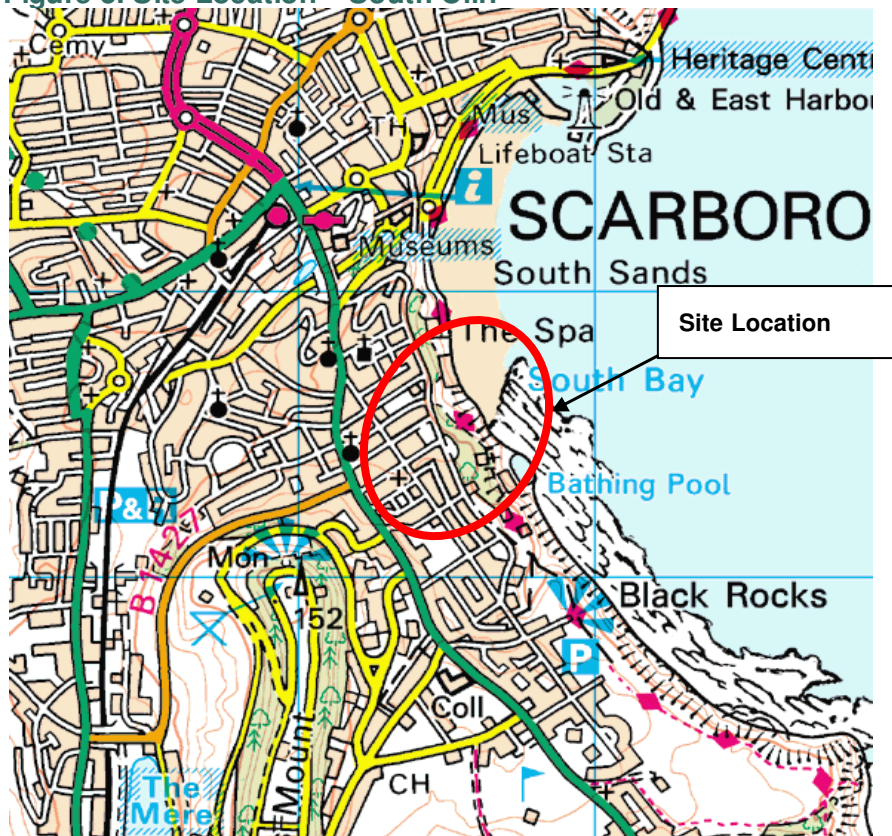
Figure 5. Site Location – South Cliff

Scarborough is a popular sea-side resort located on the north east coast of England. The South Cliff occupies the southern bay of Scarborough town with a gently sweeping coastline from the northern promontory of Castle Hill to the Black Rocks some 2km southwards. The South Cliff site comprises a variety of landscaped gardens stretching from north to south in the following order: Spa Chalet Cliff, Spa Cliff, Prince of Wales Cliff, South Cliff Gardens, Rose Gardens, South Bay Pool Cliff, Holbeck Gardens, Holbeck Cliff and Wheatcroft Cliff. The cliff top is a gently undulating plateau surface with a road, Esplanade Crescent, running parallel to the cliff line. Large houses and hotels line the landward side of the road, set-back generally 30metres, but up to 100metres in places, from the cliff edge.

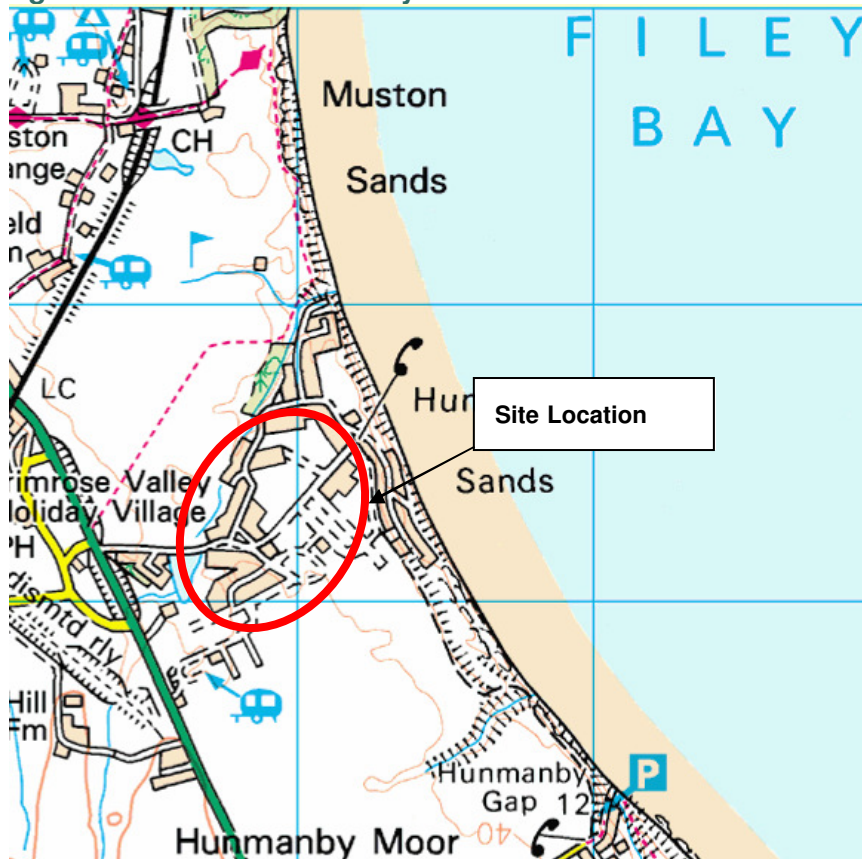
Figure 6. Site Location – Filey Flat Cliffs

Filey Flat Cliffs is situated near Primrose Valley Holiday Park, 2 km south of Filey town centre on the north east coast of England. The site comprises steep unprotected coastal slopes of glacial till on which holiday homes and static caravans have been constructed with narrow tarmac access roads. The site is bounded to the north, west and south by the holiday park and to the east by the cliffs.

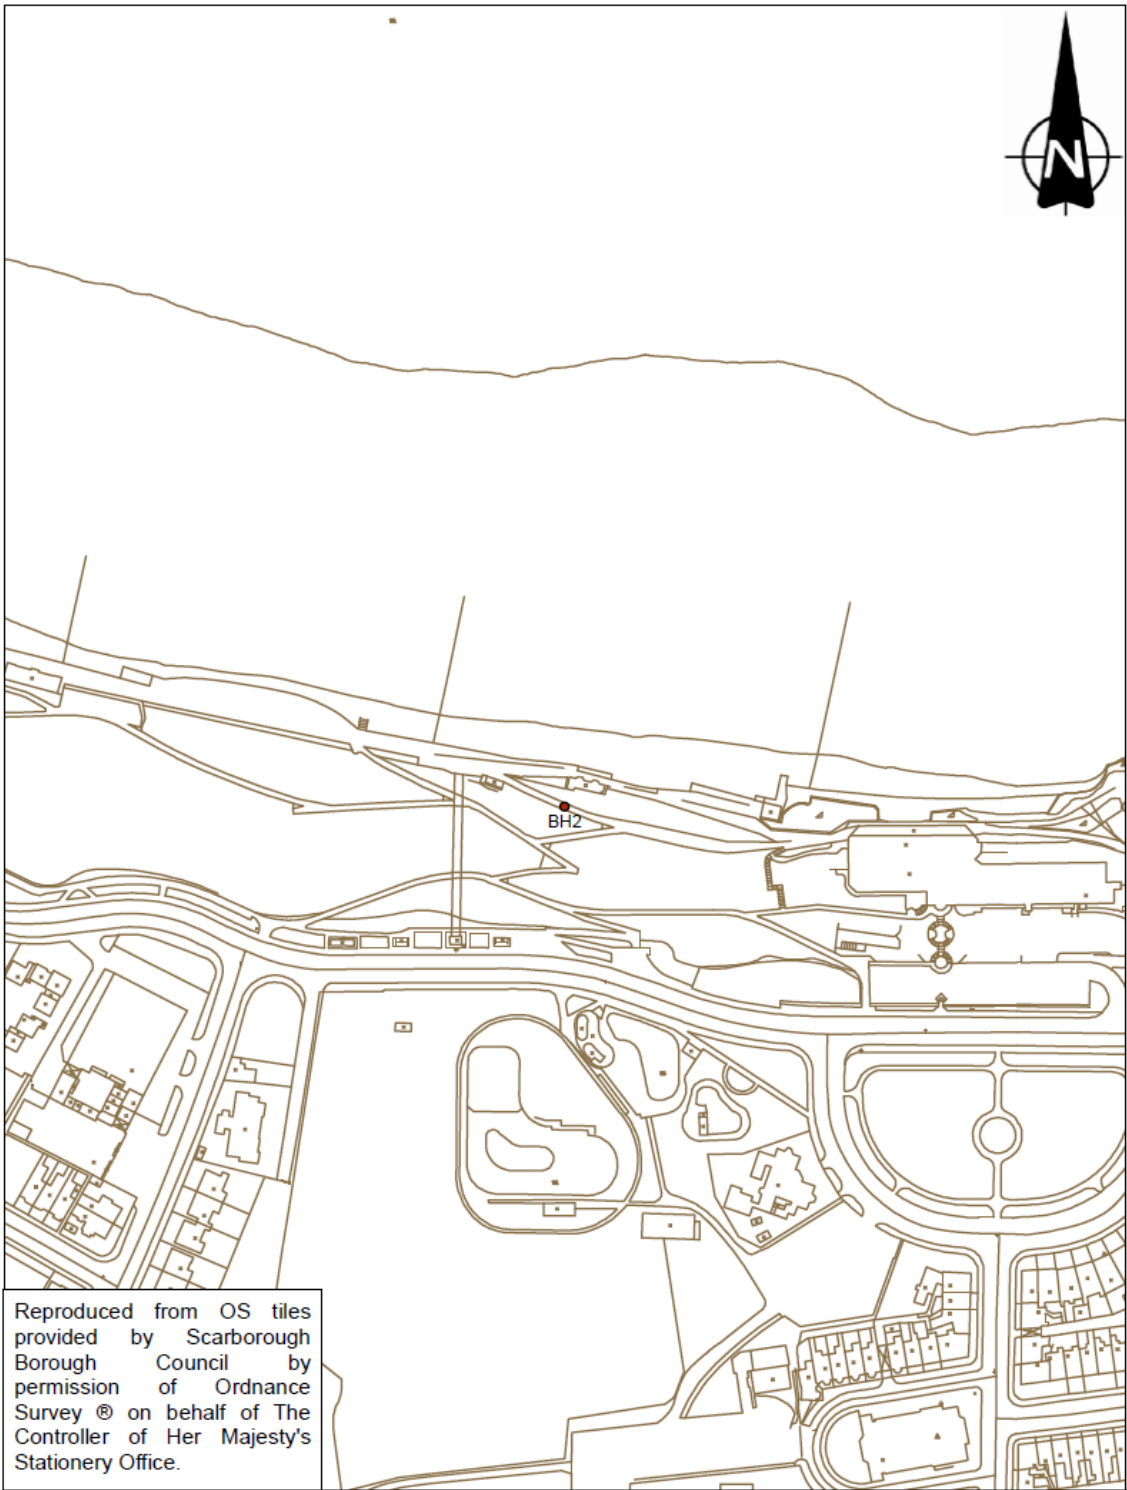
Drawing No. 1 Location Plan of Whitby West Cliff

Whitby West Cliff Inclinometer Location Plan	Scale: 1:2,500

Site location plans are presented as Figures 2 to 6 within the relevant chapters and exploratory holes location plans, illustrating the locations of instrumentation, are presented in Appendix A.

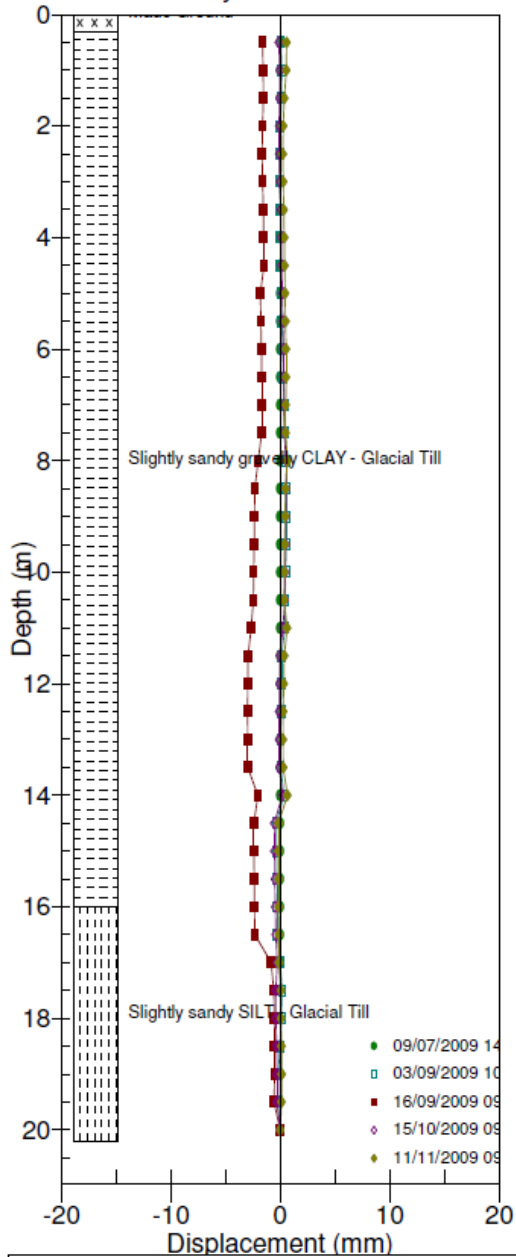
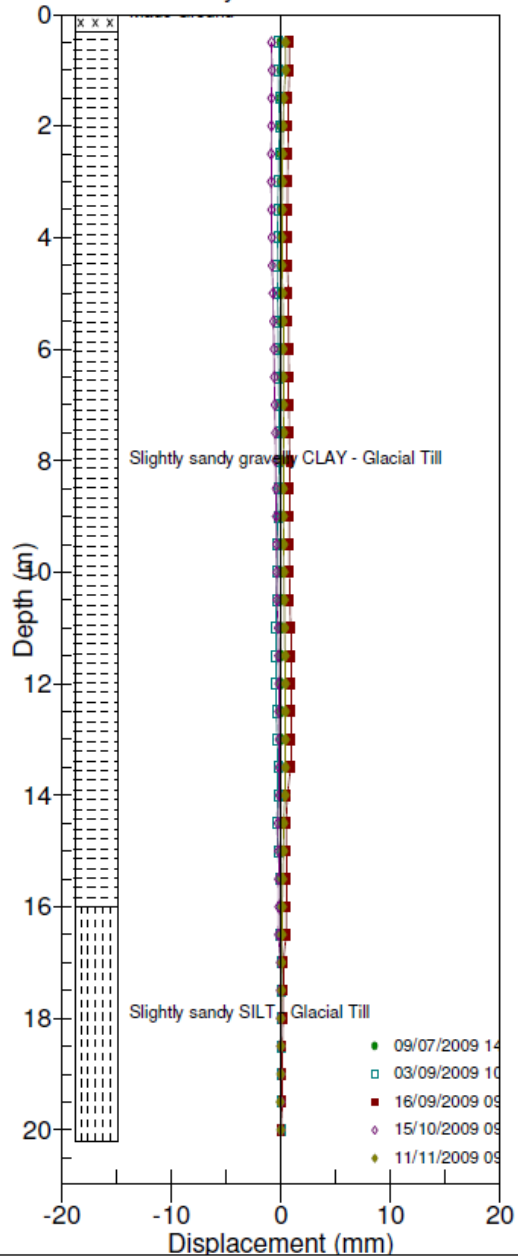
PROJECT: 721229 Ongoing Analysis of Coastal Monitoring Data  
 SITE: Whitby West Cliff  
 INSTALLATION: BH2  
 COMPANY: Mouchel Ltd  
 CLIENT: Scarborough Borough Council  
 NOTE: A0 direction: North

The ongoing monitoring regime was initialised in July 2009 and follows that detailed in Section 2.5.1, above. Following on from the findings of the *Condition Survey Report*, monitoring consists of a single inclinometer (B001 / BH2) located within a path near the base of the coastal slope of West Cliff and the monitoring of surveying points. Groundwater was measured using a dip meter.

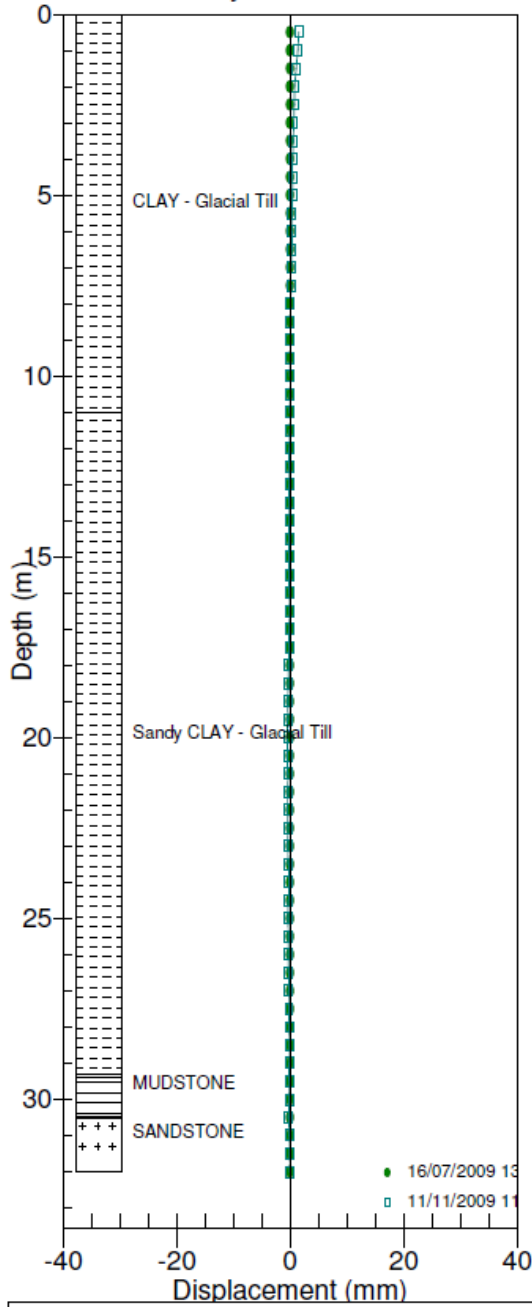
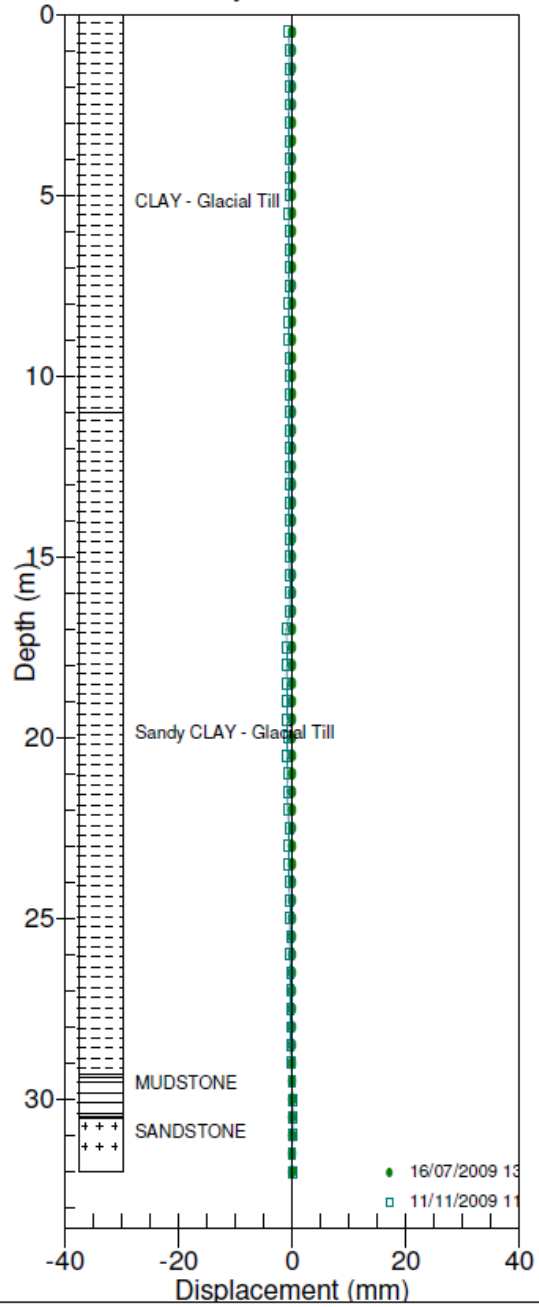
### SN:I1 - A Axis Cumulative

### SN:I1 - B Axis Cumulative

SITE: Scalby Ness

The ongoing monitoring regime was initialised in July 2009 and follows that detailed in Section 3.5.1, above. Further to the findings of the *Condition Survey Report*, monitoring at Scalby consists of 3no. inclinometers (I1, I2 and I3) and 2no. piezometers (B6 and B9) located within the inner headland of Scalby Ness. The monitoring of the automated piezometers (P1, P2, P3 and P4) was carried out on 12<sup>th</sup> November 2009. The inclinometers were monitored using a Vertical Digital Bluetooth Inclinometer system (MkII) with a TDS Recon 200 PDA and piezometers were monitored using a dip meter.

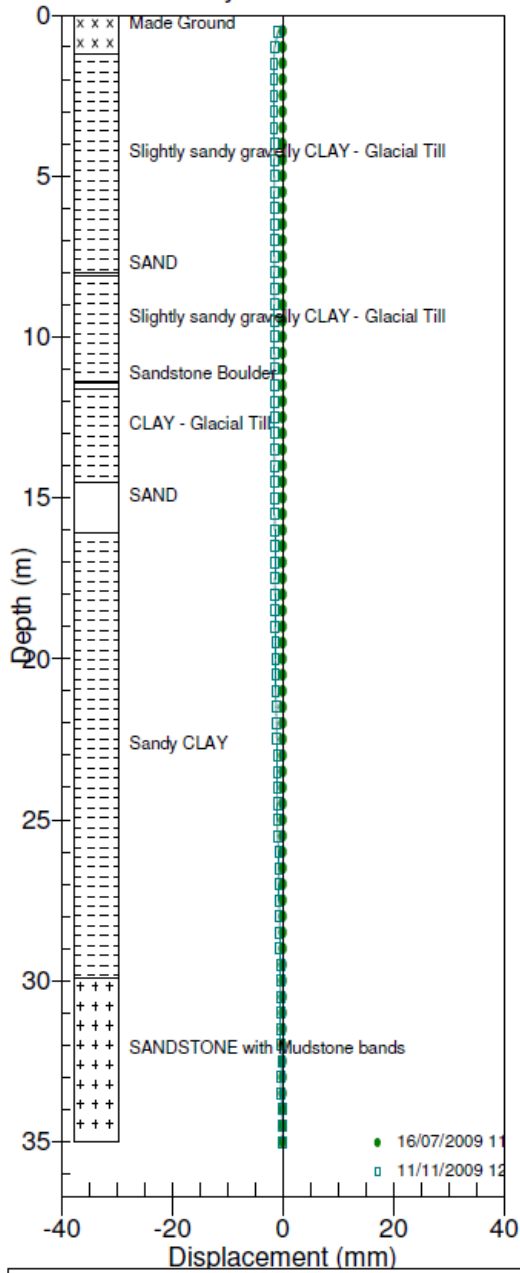
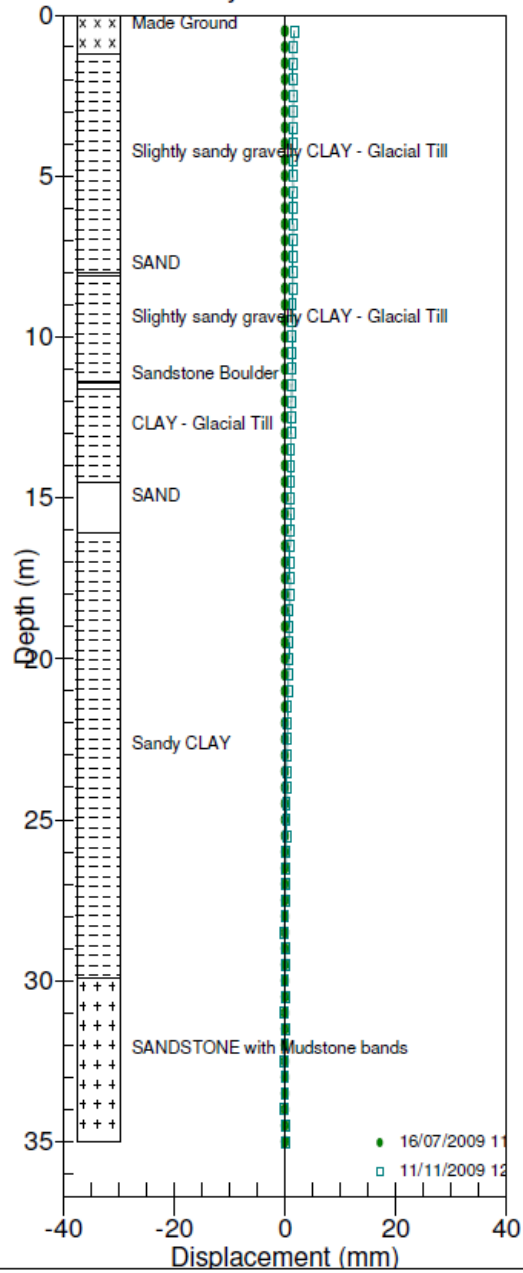
SN:I2 - A Axis Cumulative  
Initial survey: 16/07/2009 11:33

SN:I2 - B Axis Cumulative  
Initial survey: 16/07/2009 11:33

SITE: Scalby Ness

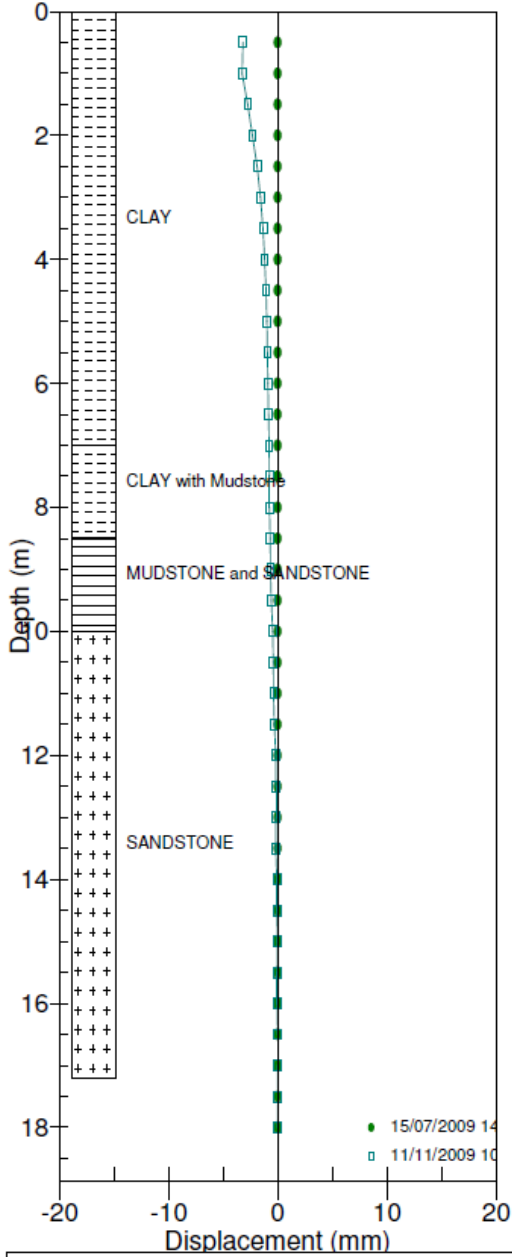
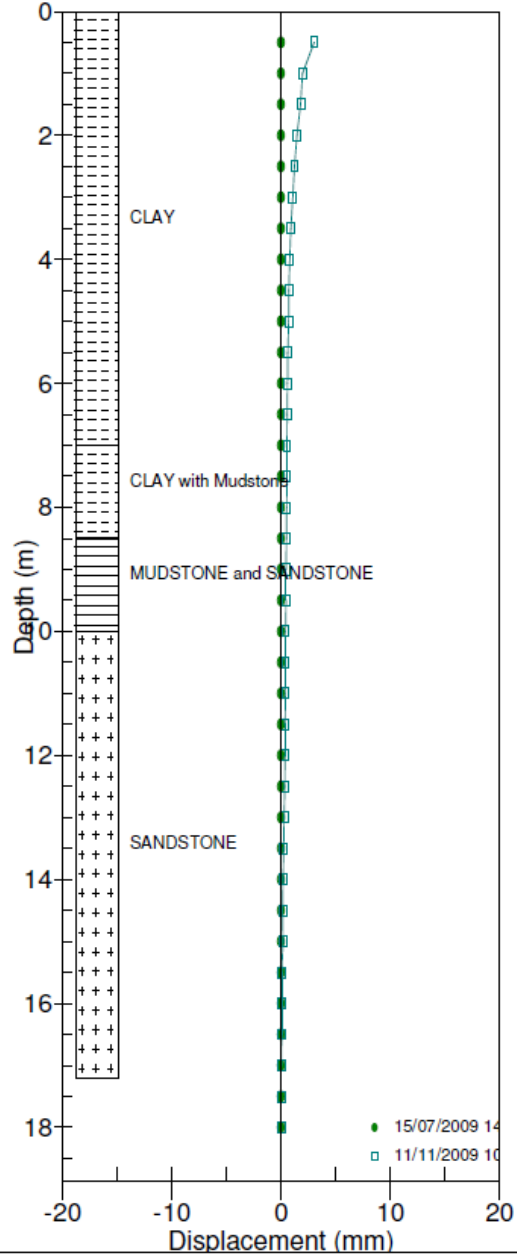
SN:I3 - A Axis Cumulative  
Initial survey: 15/07/2009 14:32

SN:I3 - B Axis Cumulative  
Initial survey: 15/07/2009 14:32

SITE: Scalby Ness

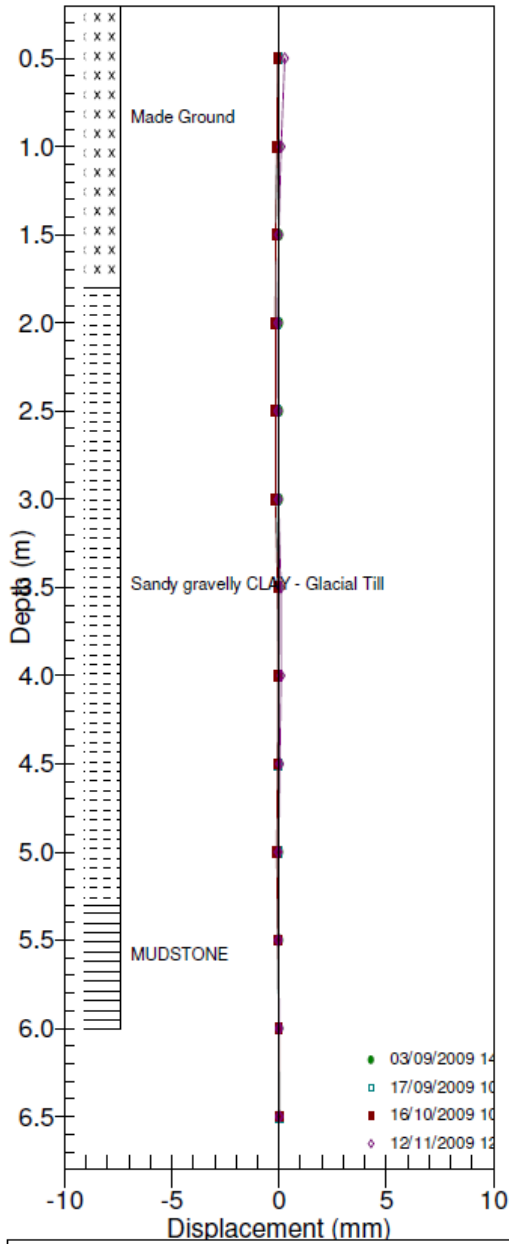
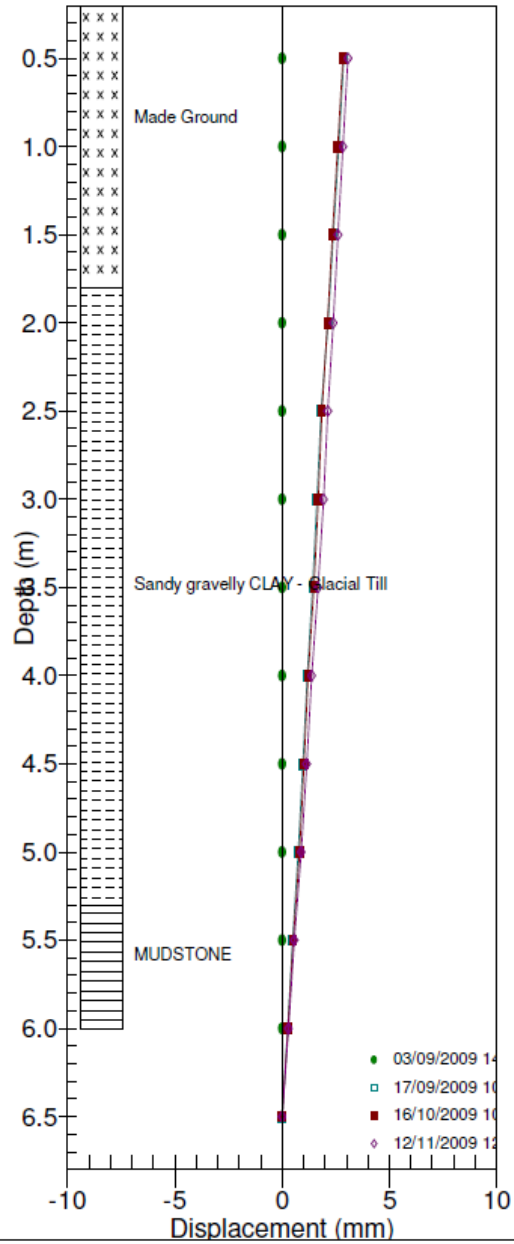
# OASIS:BH1 - A Axis Cumulative

# OASIS:BH1 - B Axis Cumulative

SITE: Oasis North Bay

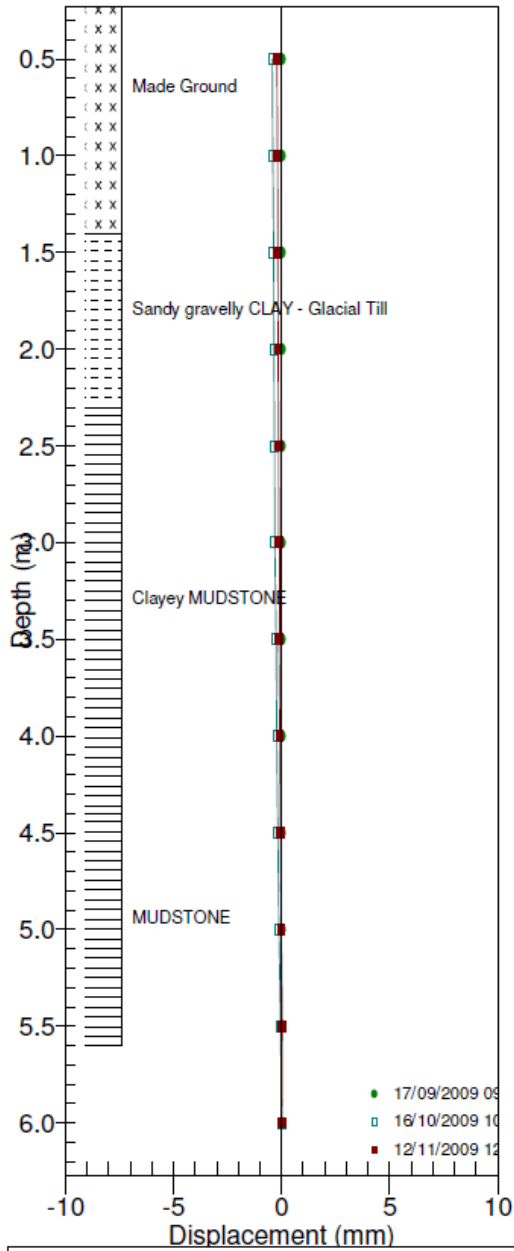
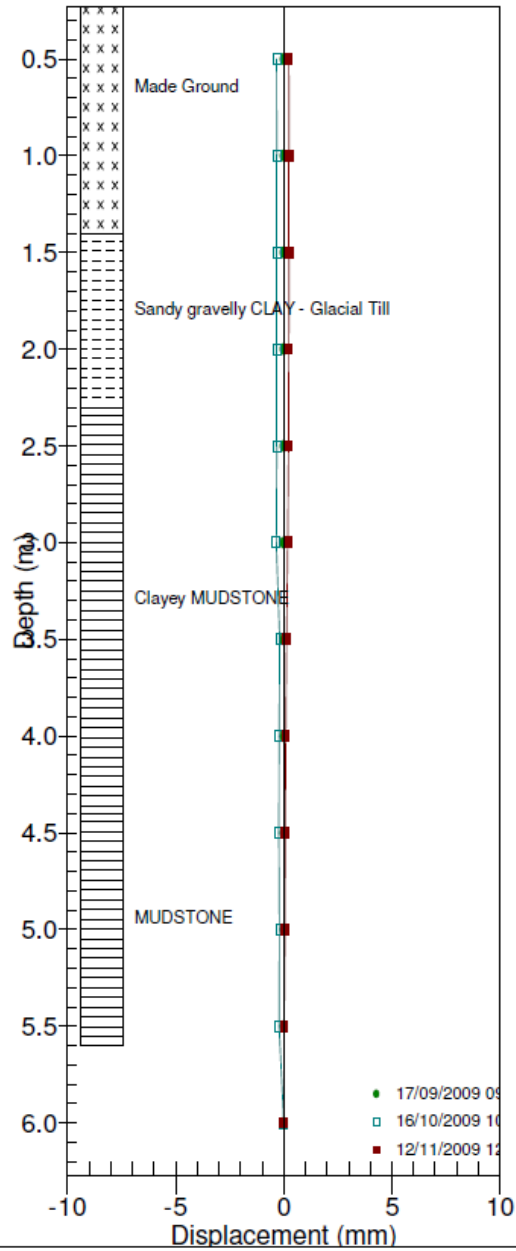
OASIS:BH3 - A Axis Cumulative Initial survey: 17/09/2009 09:51

OASIS:BH3 - B Axis Cumulative Initial survey: 17/09/2009 09:51

PROJECT: 721229 Ongoing Analysis of Coastal Monitoring Data  
 SITE: Oasis North Bay  
 INSTALLATION: BH3  
 COMPANY: Mouchel Ltd  
 CLIENT: Scarborough Borough Council  
 NOTE: A0 direction:

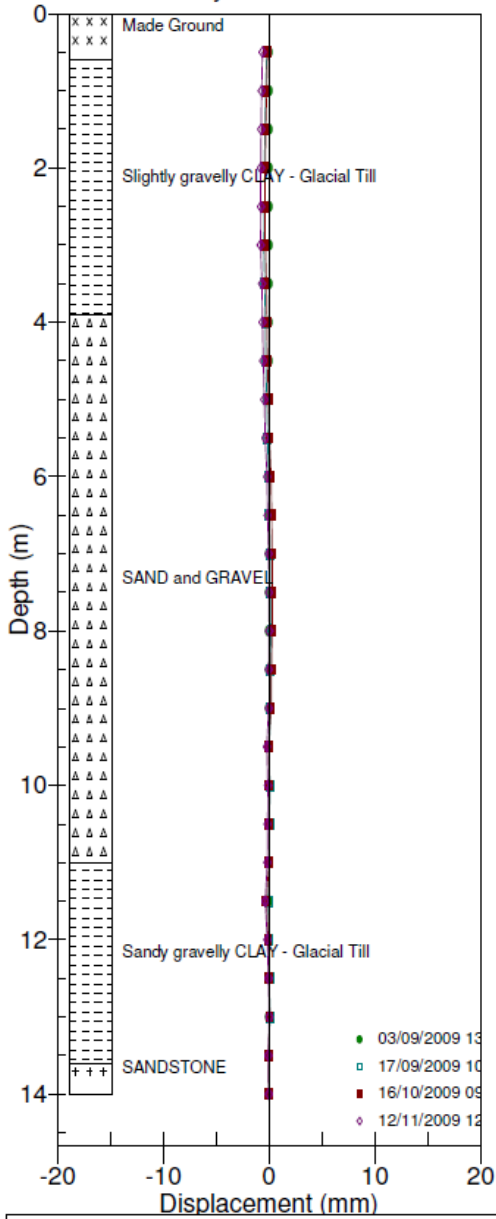
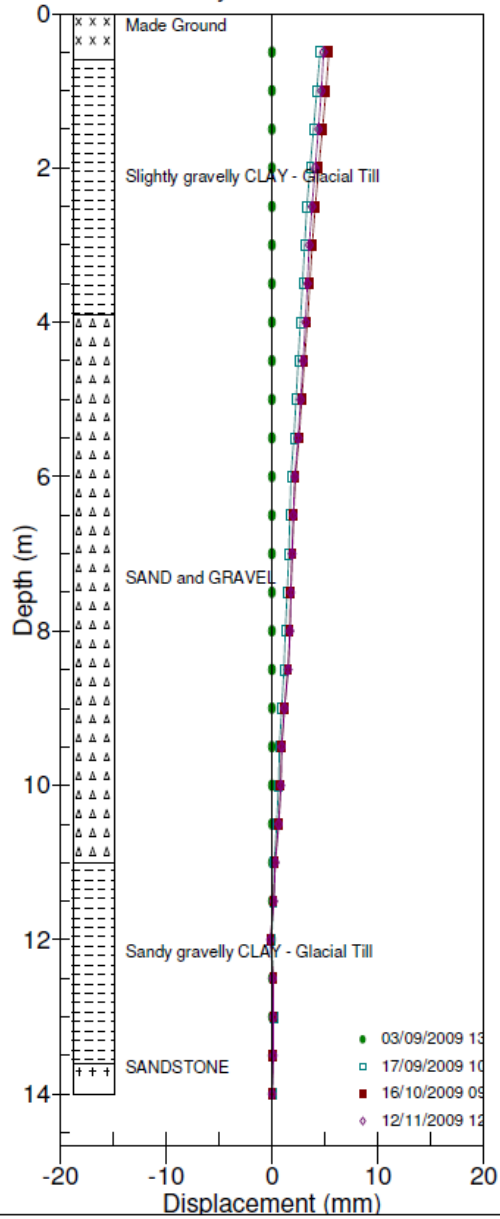
OASIS:BH4 - A Axis Cumulative Initial survey: 03/09/2009 13:33

OASIS:BH4 - B Axis Cumulative Initial survey: 03/09/2009 13:33

PROJECT: 721229 Ongoing Analysis of Coastal Monitoring Data  
 SITE: Oasis North Bay  
 INSTALLATION: BH4  
 COMPANY: Mouchel Ltd  
 CLIENT: Scarborough Borough Council  
 NOTE: A0 direction: East

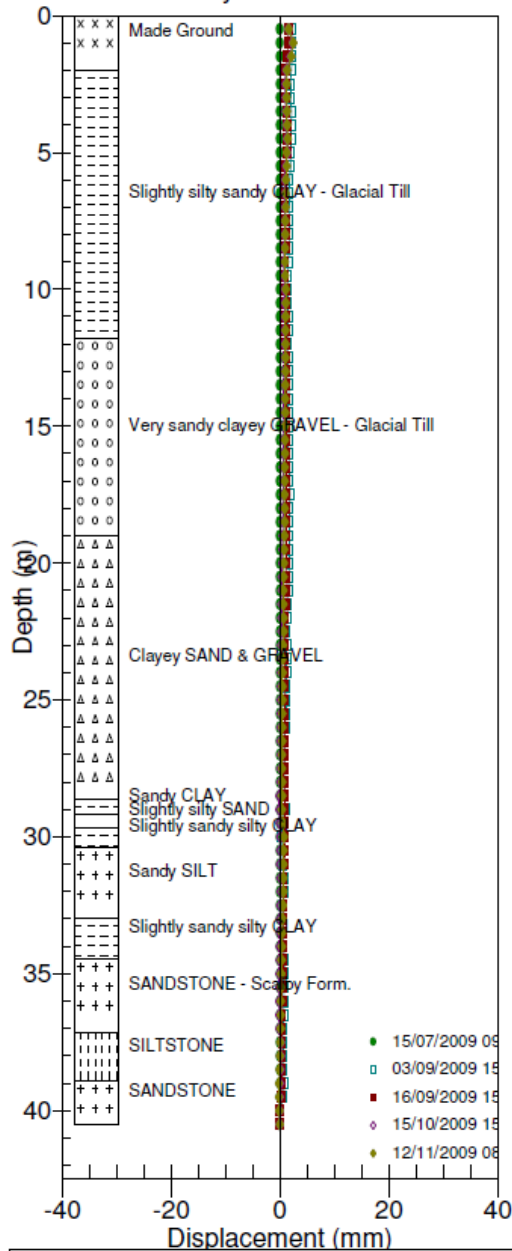
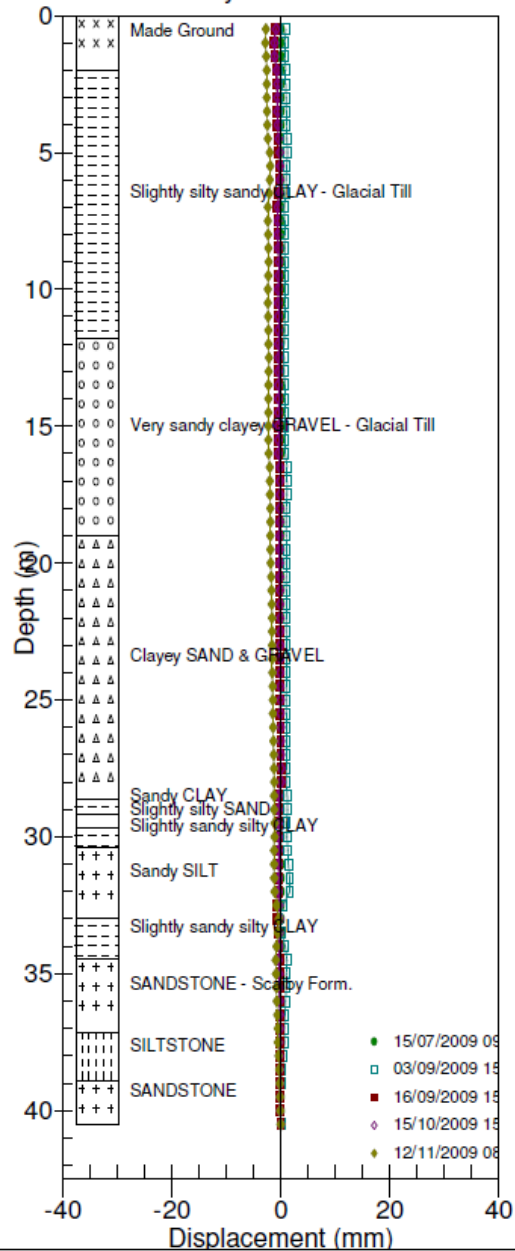
# SSC:AA04 - A Axis Cumulative

# SSC:AA04 - B Axis Cumulative

SITE: Scarborough South Cliff

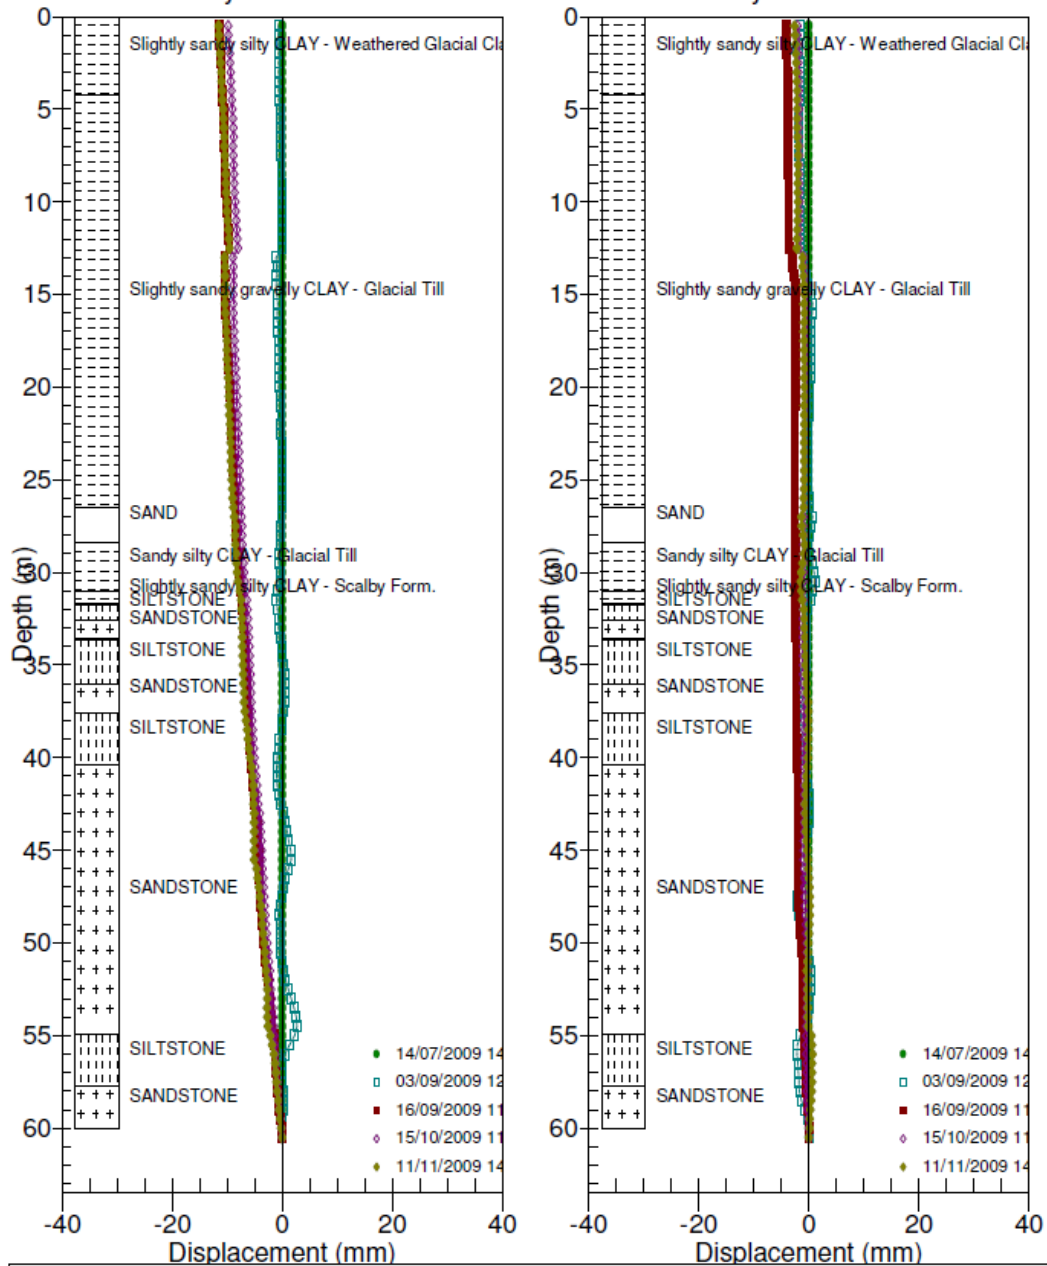
SSC:AA07 - A Axis Cumulative      SSC:AA07 - B Axis Cumulative  
 Initial survey: 14/07/2009 14:12      Initial survey: 14/07/2009 14:12

PROJECT: 721229 Ongoing Analysis of Coastal Monitoring Data  
 SITE: Scarborough South Cliff  
 INSTALLATION: AA07 (BH2)  
 COMPANY: Mouchel Ltd  
 CLIENT: Scarborough Borough Council  
 NOTE: A0 direction: North East

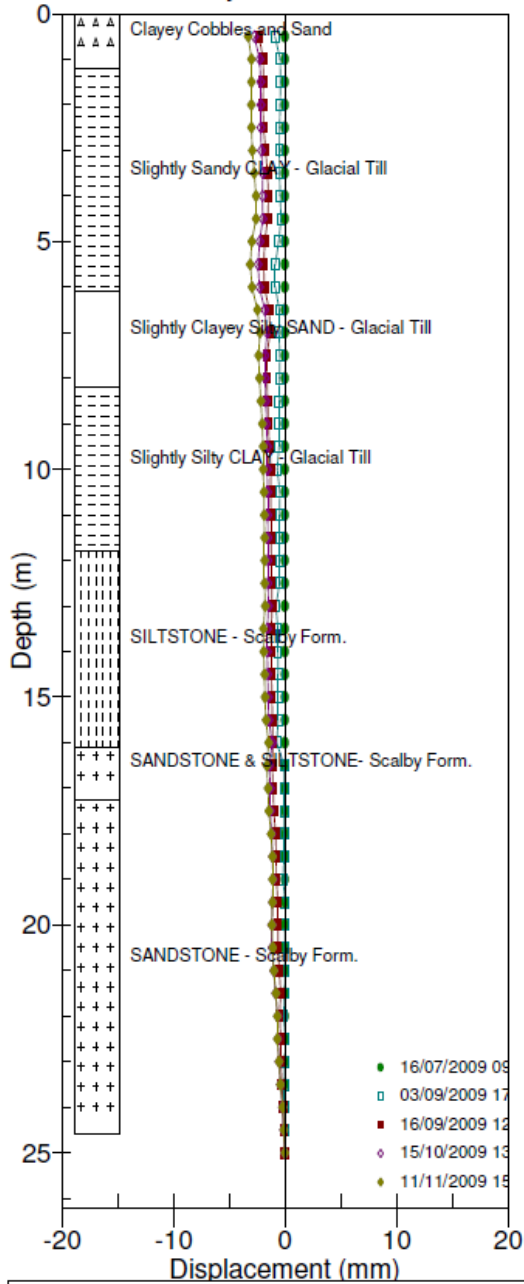
SSC:AA08 - A Axis Cumulative Initial survey: 16/07/2009 09:39

SSC:AA08 - B Axis Cumulative Initial survey: 16/07/2009 09:39

PROJECT: 721229 Ongoing Analysis of Coastal Monitoring Data  
 SITE: Scarborough South Cliff  
 INSTALLATION: AA08 (D3)  
 COMPANY: Mouchel Ltd  
 CLIENT: Scarborough Borough Council  
 NOTE: A0 direction: East

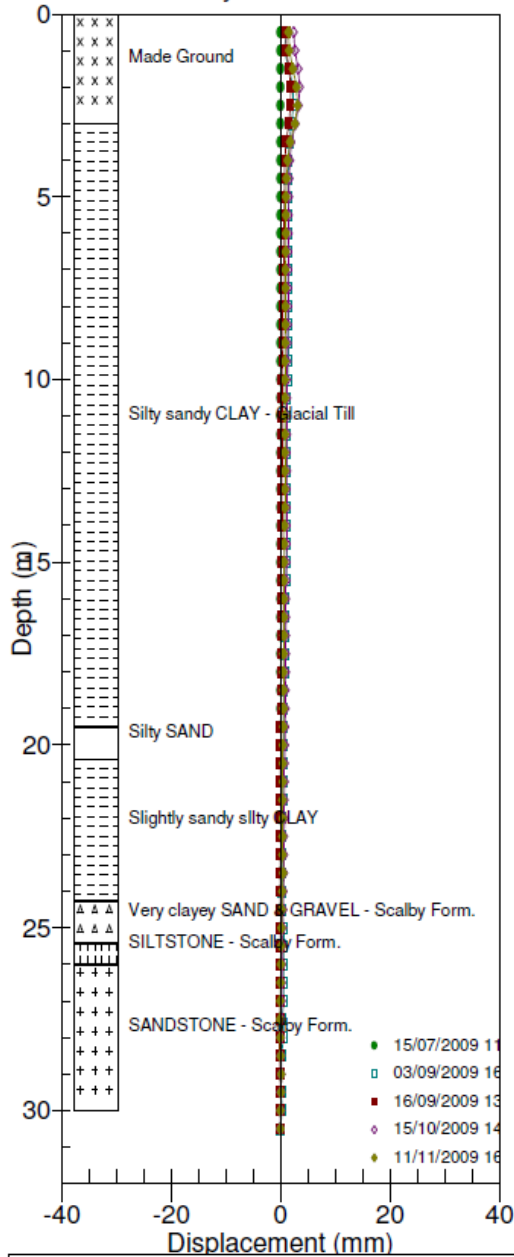
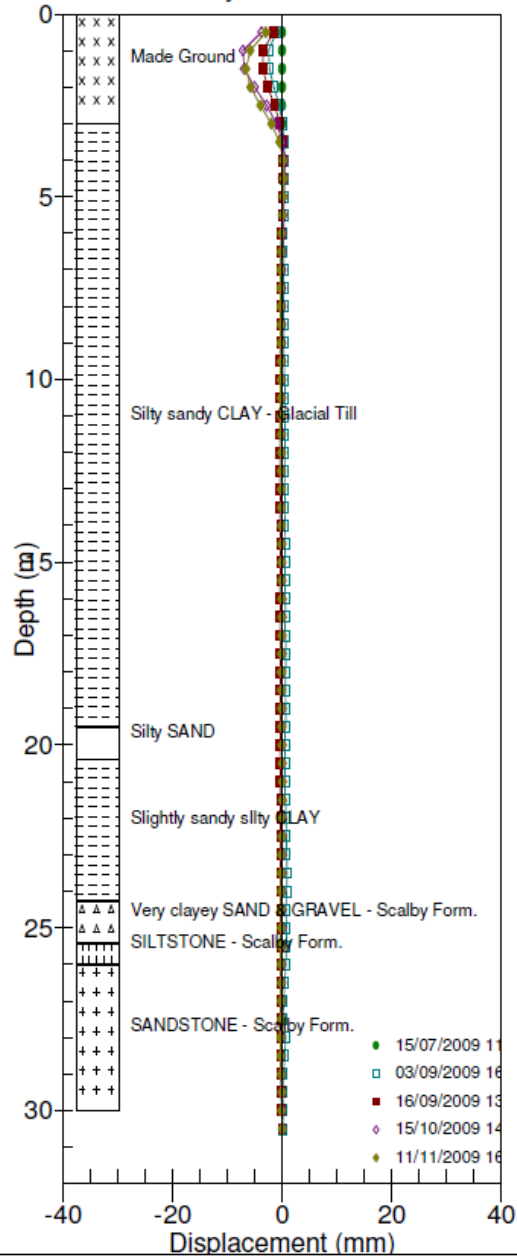
# SSC:AA10 - A Axis Cumulative

# SSC:AA10 - B Axis Cumulative

SITE: Scarborough South Cliff

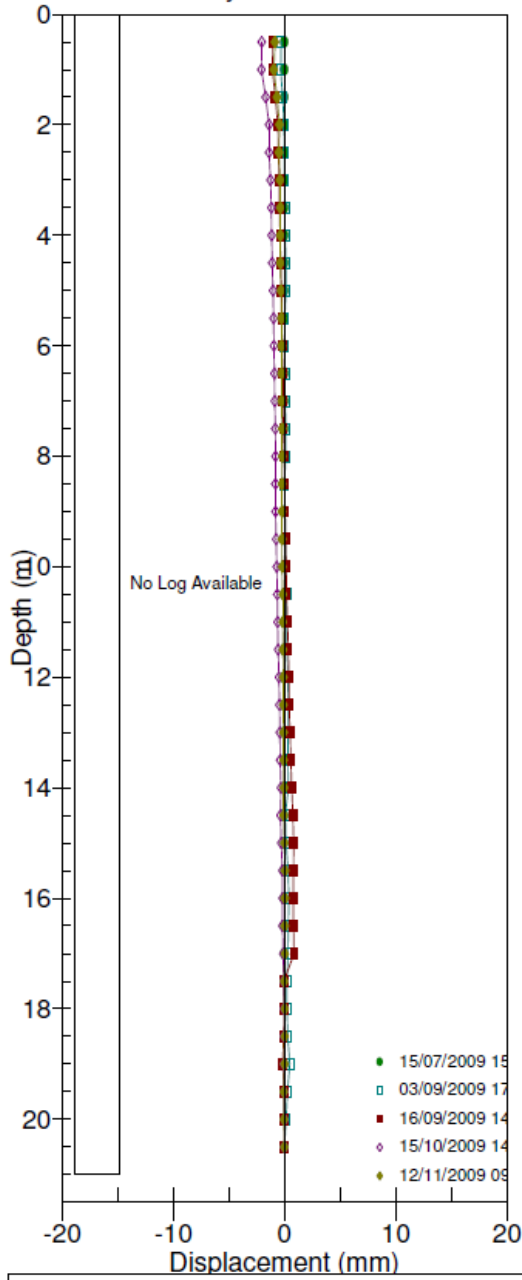
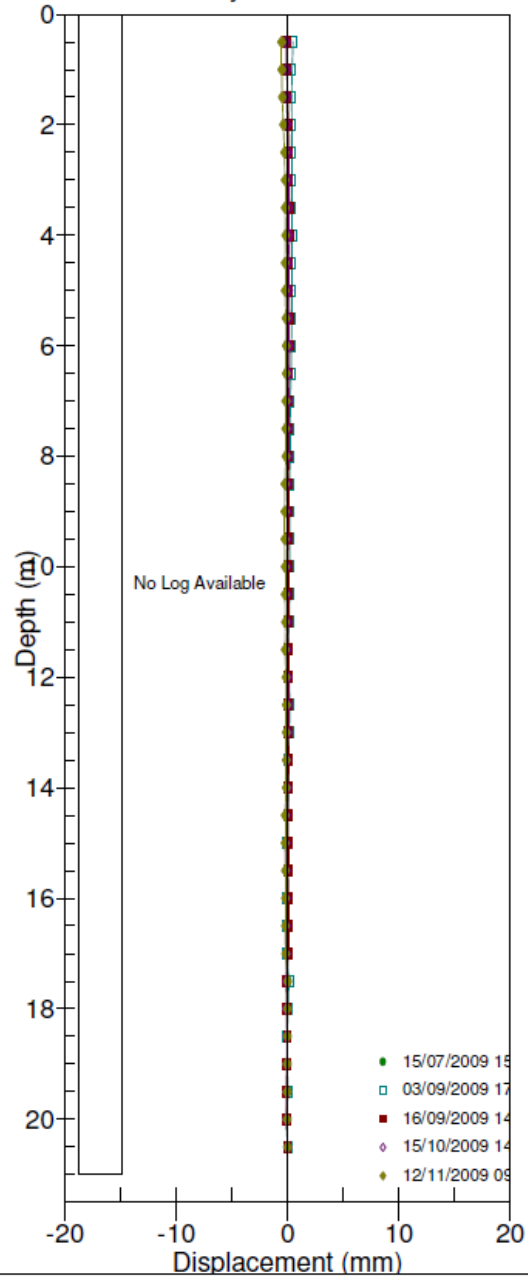
# SSC:AA11 - A Axis Cumulative

# SSC:AA11 - B Axis Cumulative

PROJECT: 721229 Ongoing Analysis of Coastal Monitoring Data  
 SITE: Scarborough South Cliff  
 INSTALLATION: AA11 (F4)  
 COMPANY: Mouchel Ltd  
 CLIENT: Scarborough Borough Council  
 NOTE: A0 direction: North East

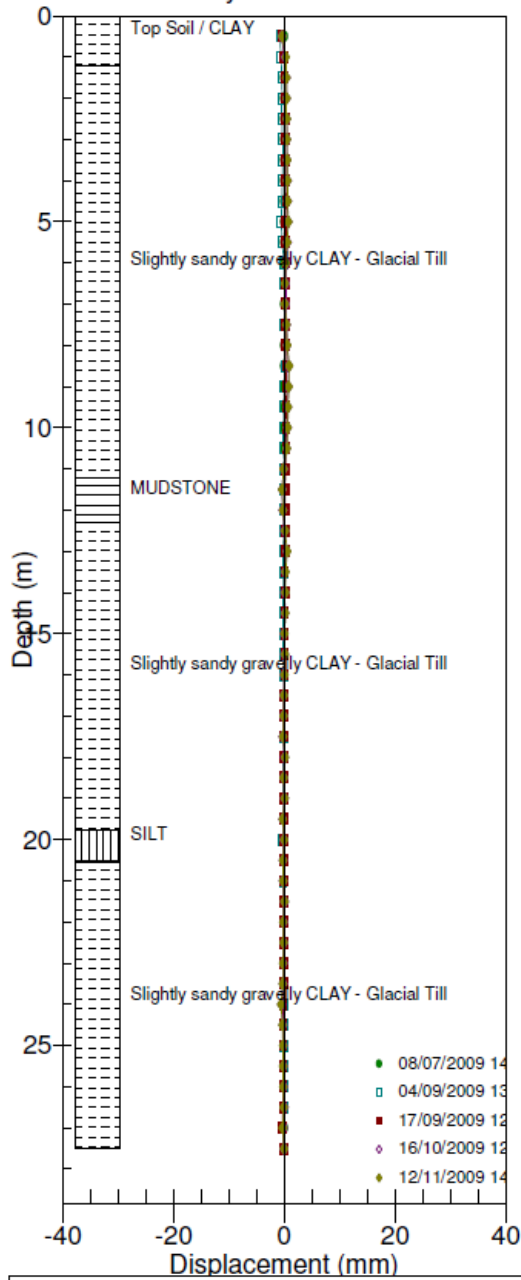
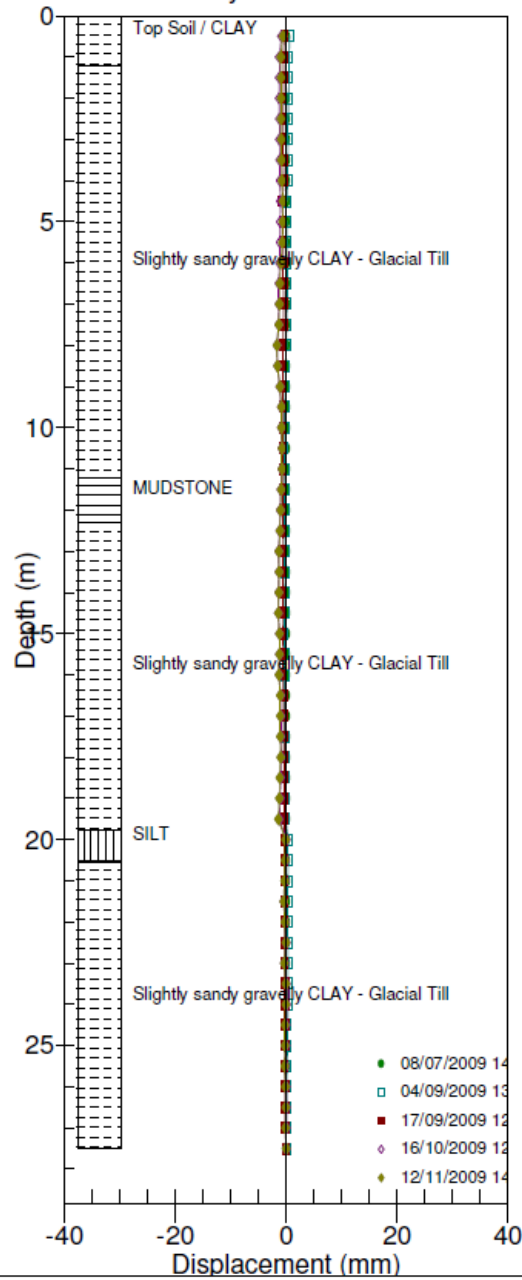
Initial survey: 08/07/2009 14:13

SITE: Filey Flat Cliffs
