# Ongoing Analysis and Interpretation of Coastal Monitoring Data

Fourth Review of Restricted Suite Monitoring

## Geotechnical Interpretative Report

Document Ref. No. 721229/002/GIR/006/Final

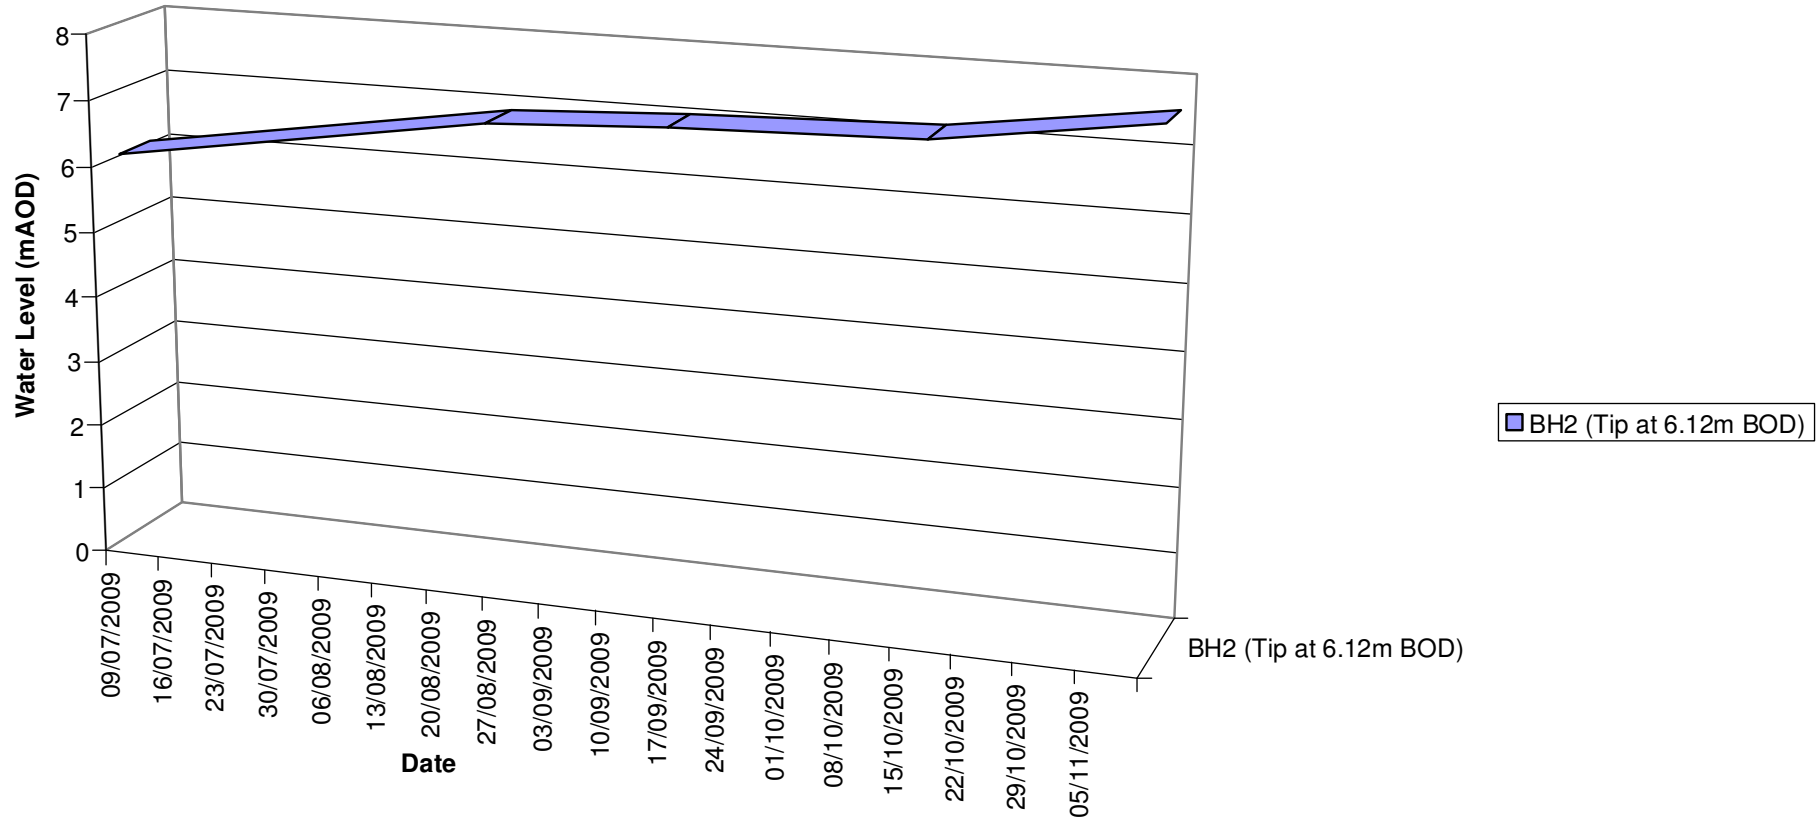
# WHITBY WEST CLIFF GROUNDWATER LEVELS

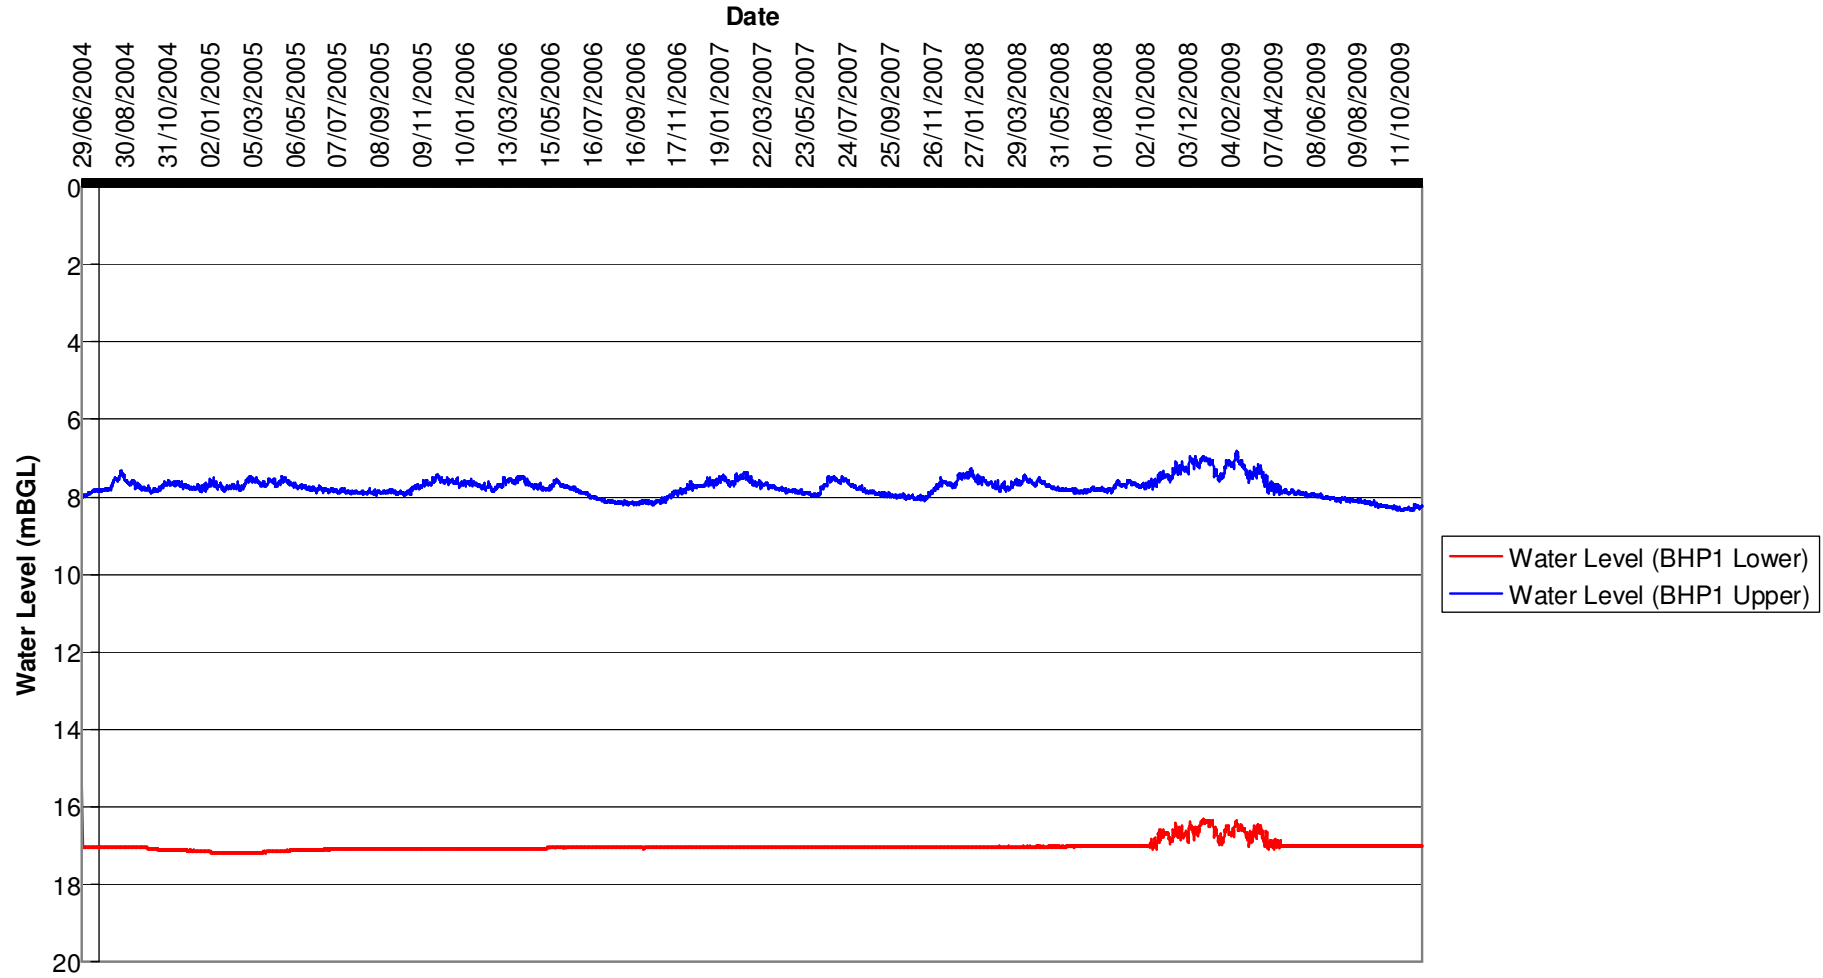
# SCALBY NESS (AUTOMATED) GROUNDWATER LEVELS

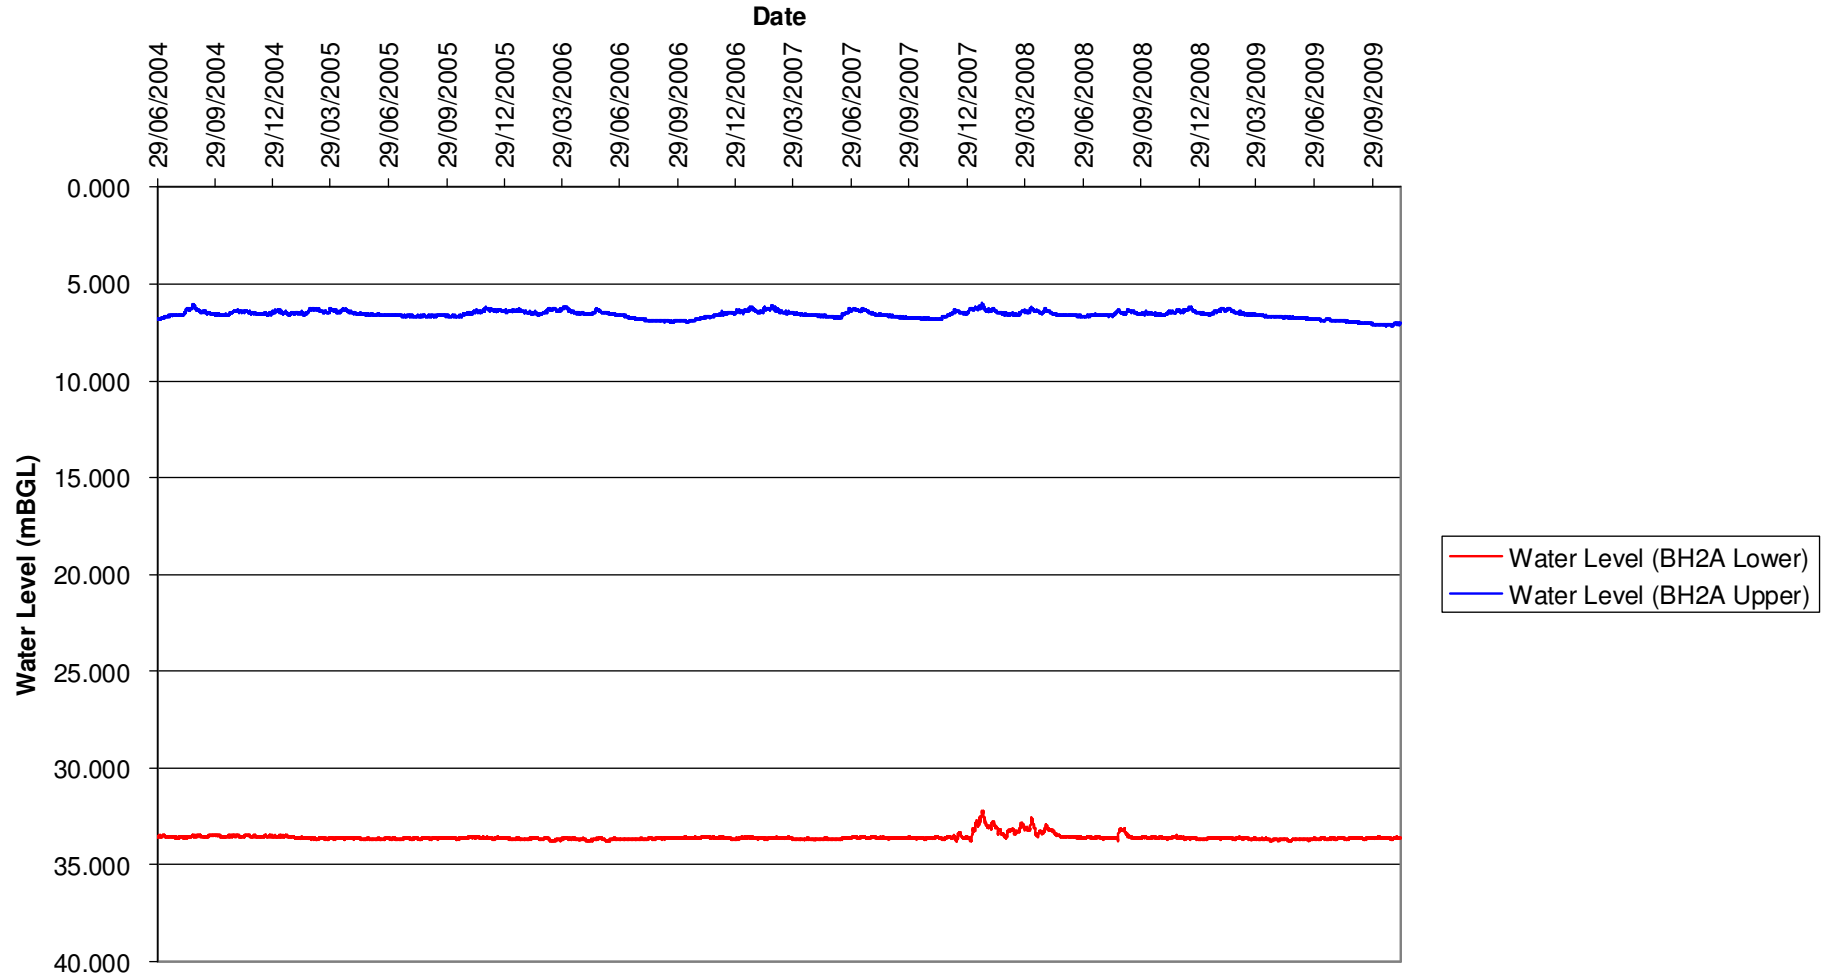
# SCALBY NESS (AUTOMATED) GROUNDWATER LEVELS

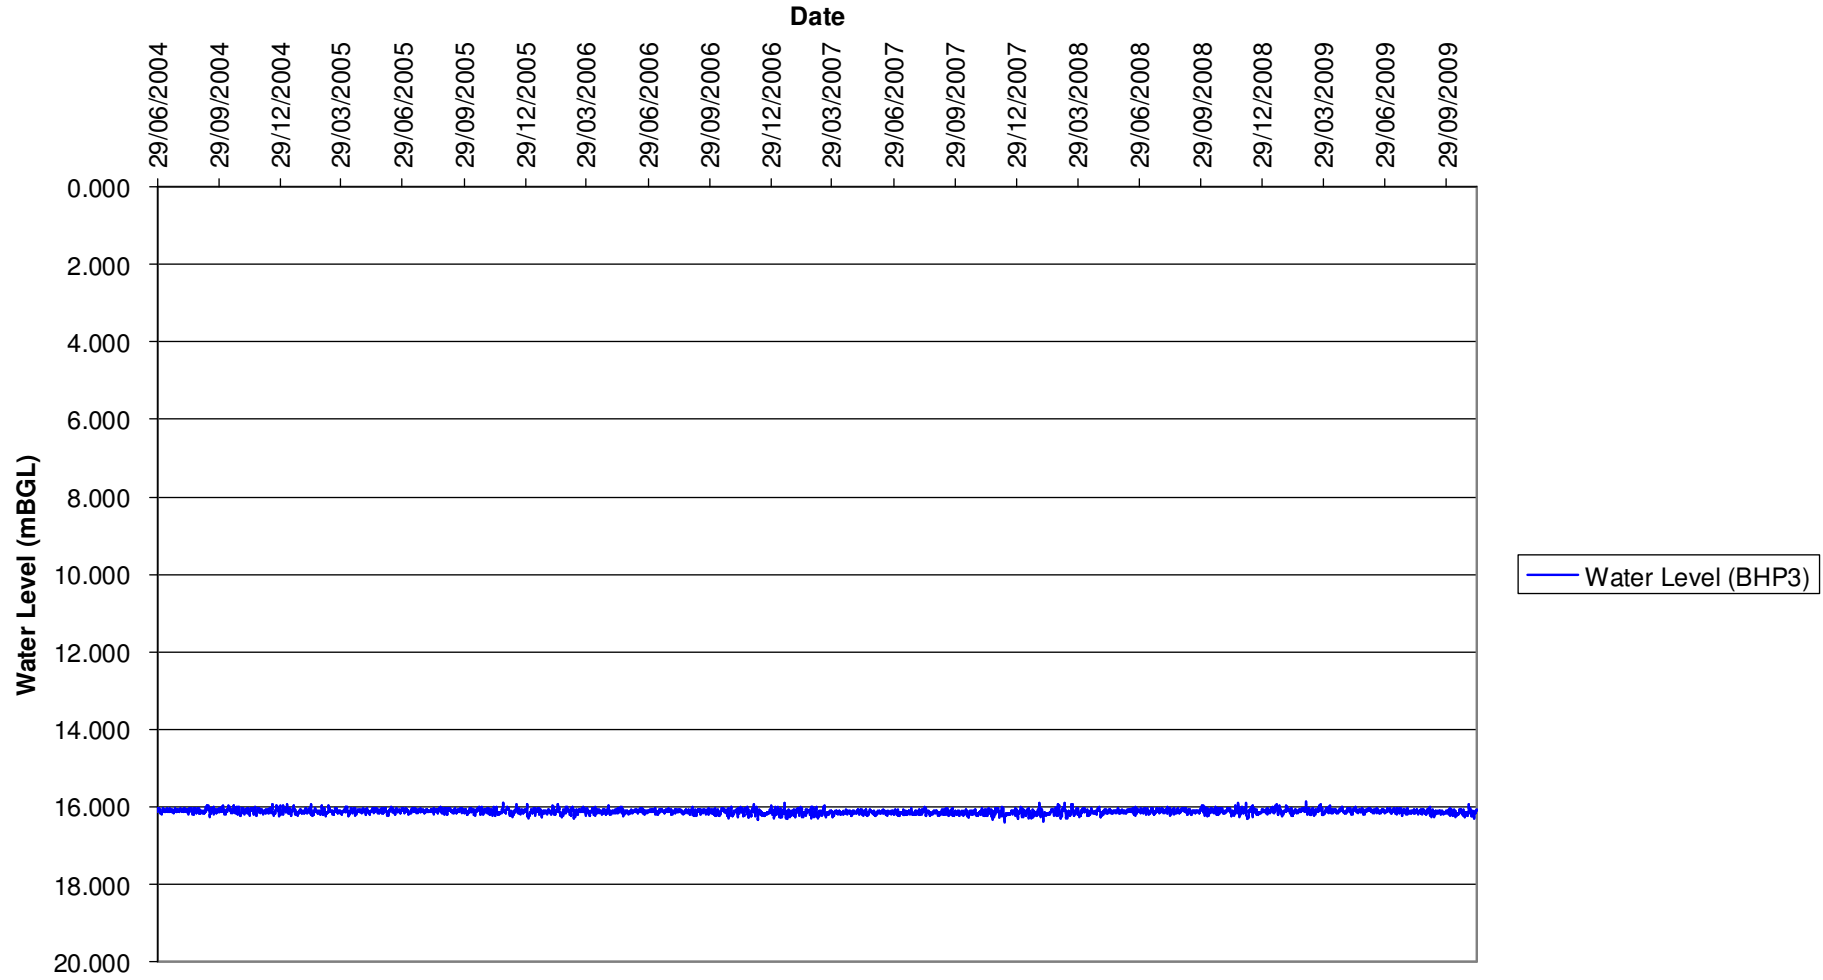
# SCALBY NESS (AUTOMATED) GROUNDWATER LEVELS

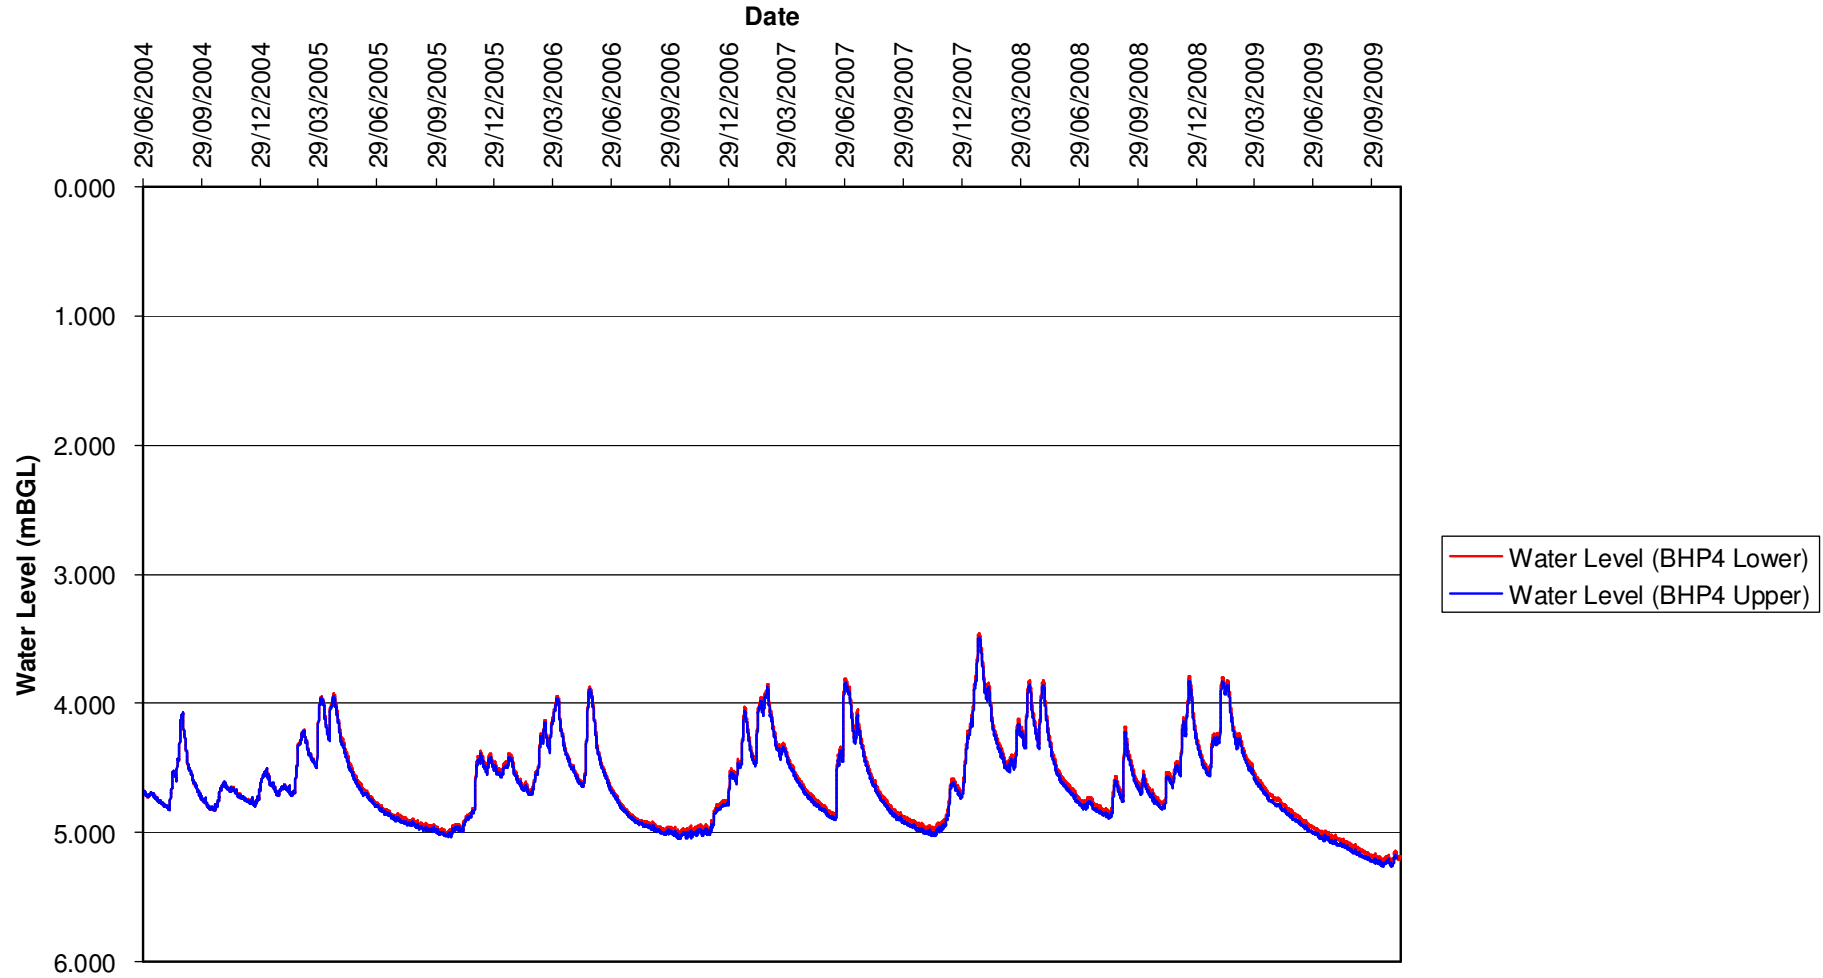
# SCALBY NESS (AUTOMATED) GROUNDWATER LEVELS

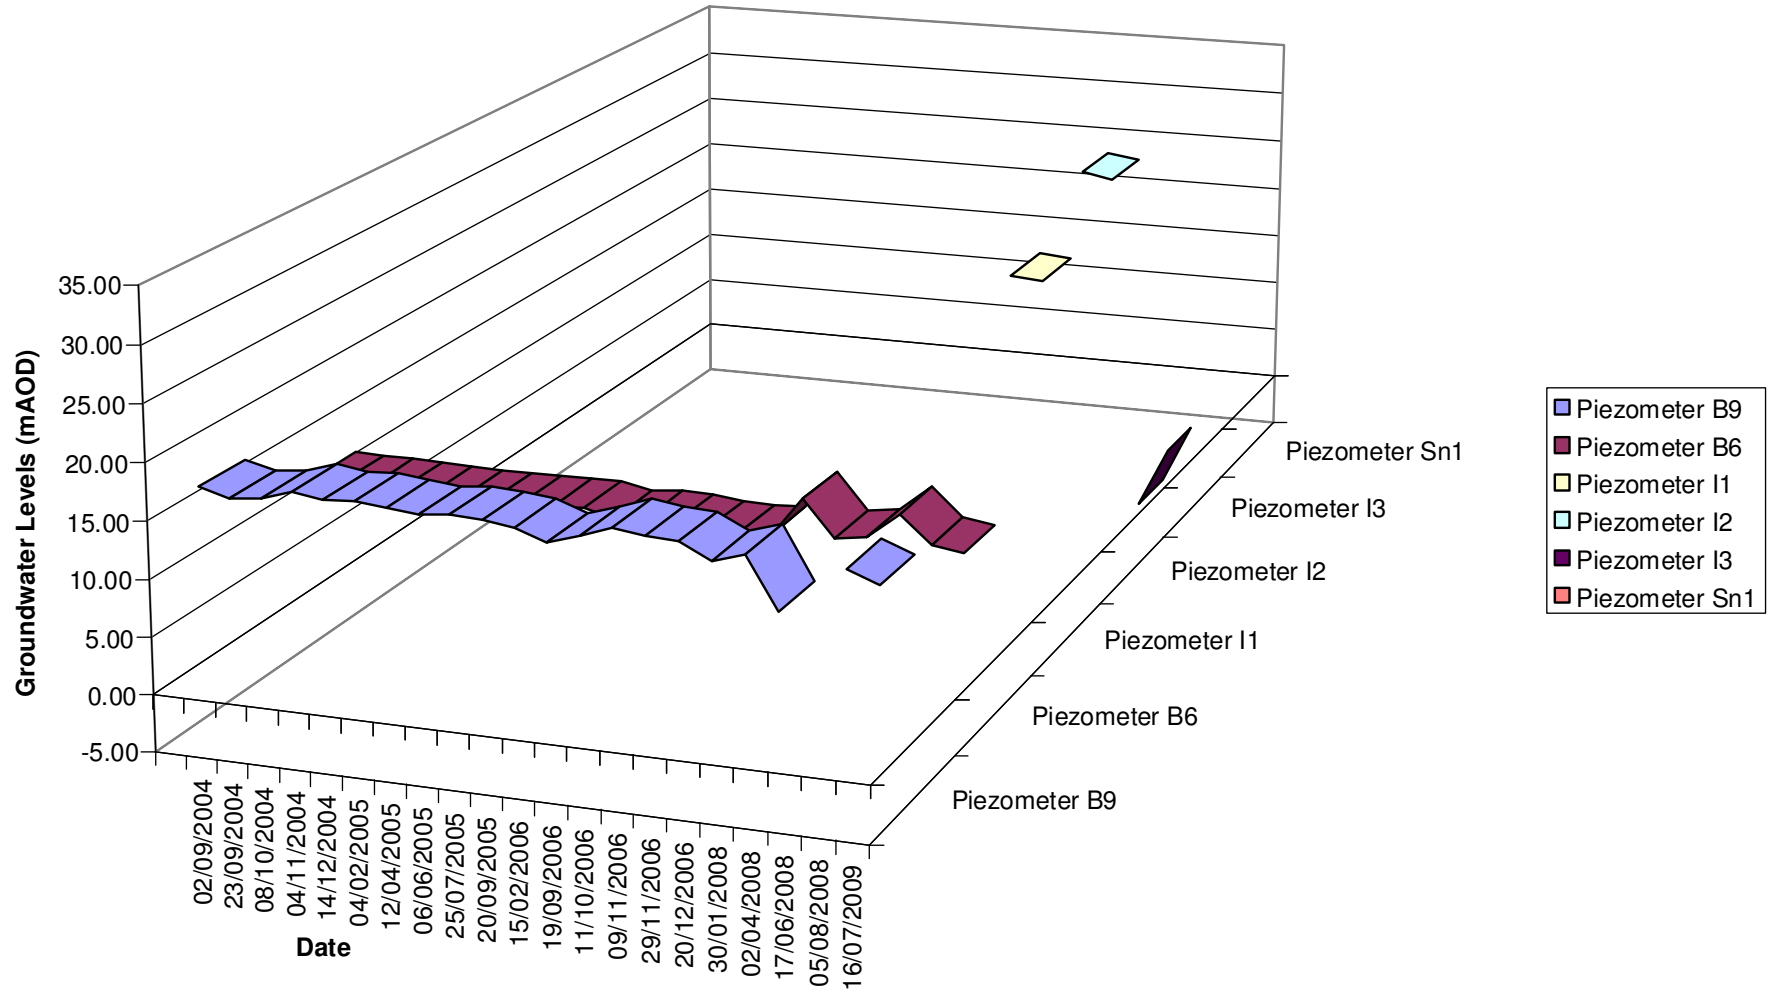
# SCALBY NESS GROUNDWATER LEVELS

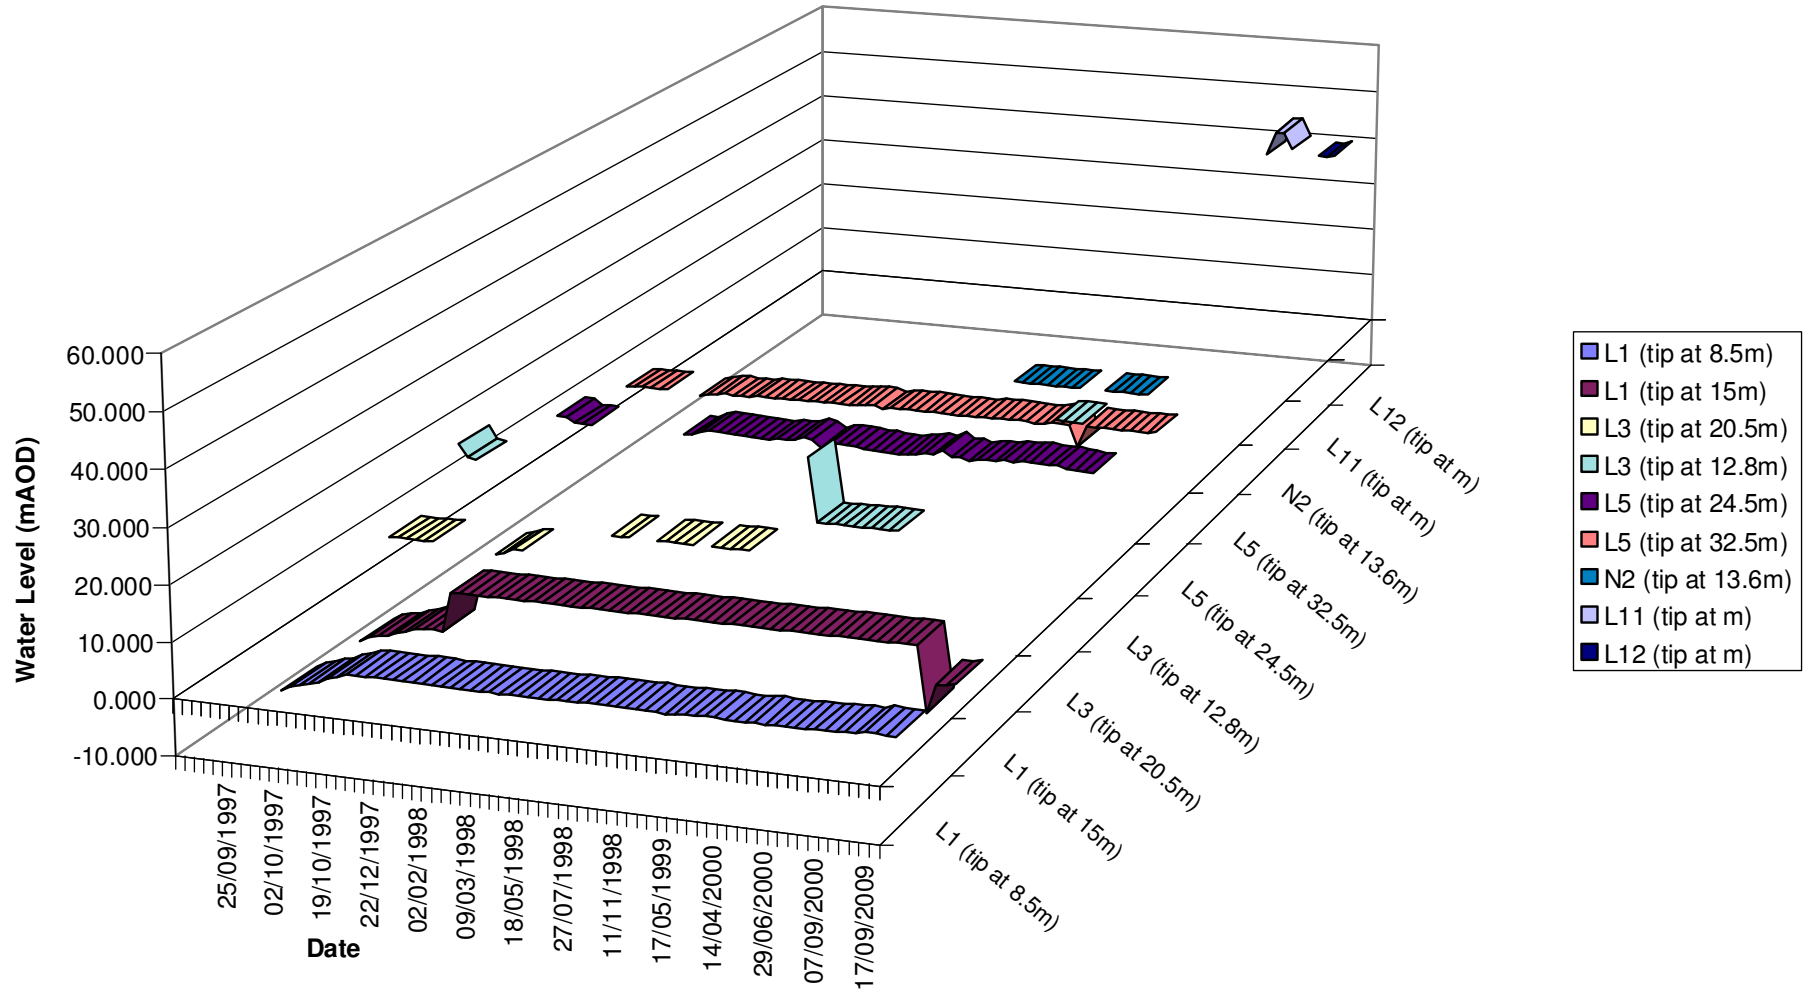
# SCARBOROUGH NORTH BAY GROUNDWATER LEVELS

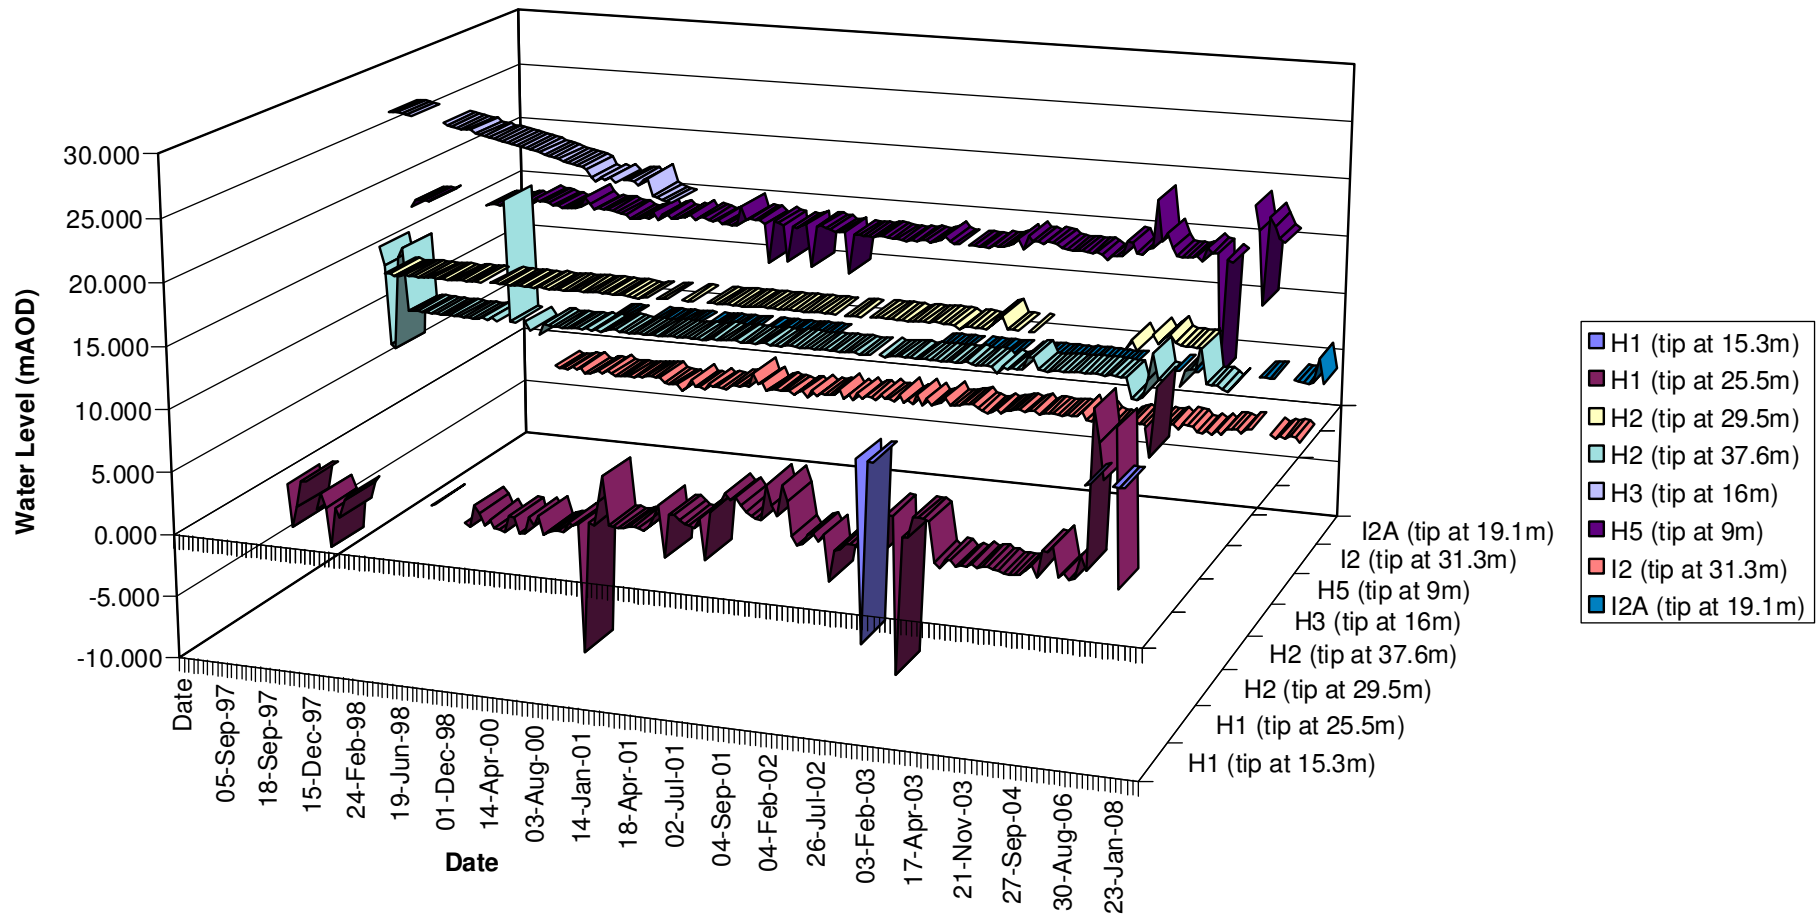
## SCARBOROUGH SOUTH CLIFF (NORTH) GROUNDWATER LEVELS

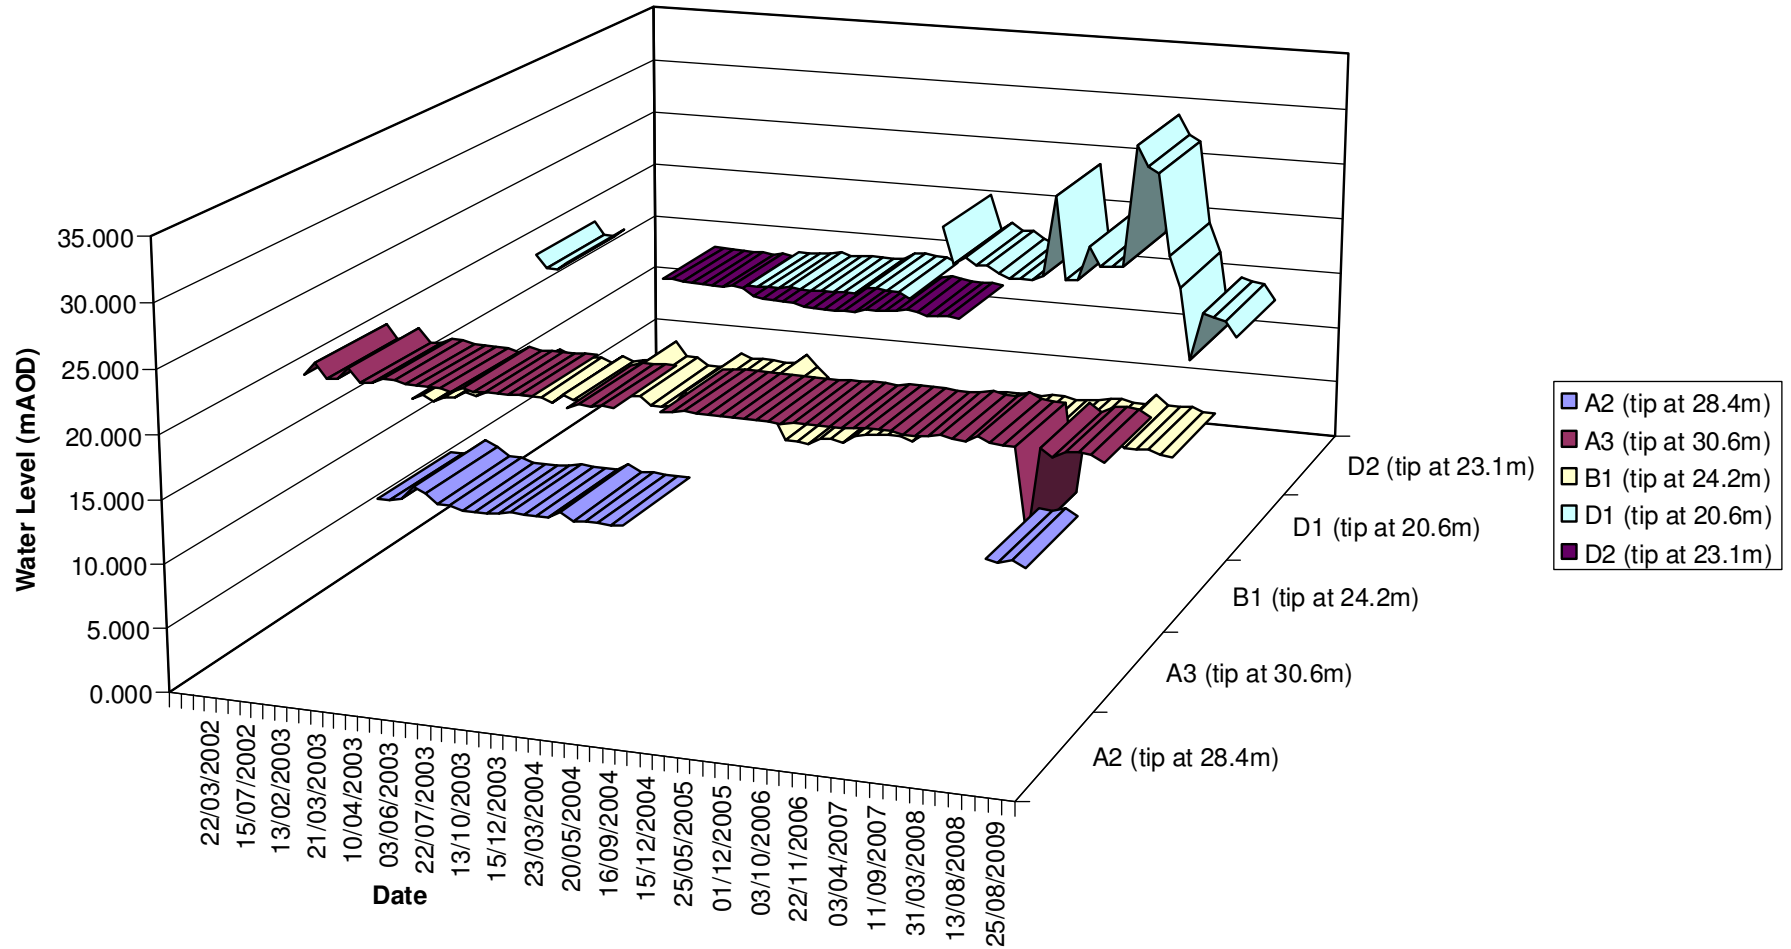
# FILEY FLAT CLIFFS GROUNDWATER LEVELS
