# Ongoing Analysis and Interpretation of Coastal Monitoring Data

Fifth Review of Restricted Suite Monitoring

## Geotechnical Interpretative Report

Document Ref. No. 721229/002/GIR/008/Final

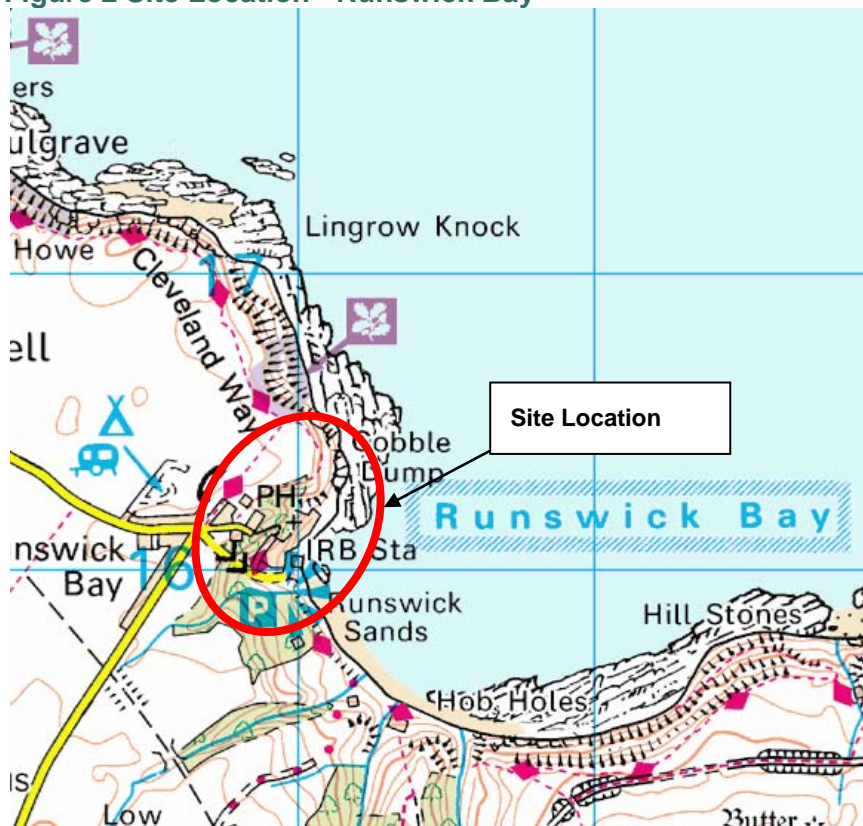
Figure 2 Site Location - Runswick Bay

Runswick Bay is situated on the north east coast of England some 16 km north west of Whitby town at NGR NZ 800 160. It is formed between the headlands of Caldron Cliff to the north and Kettleness to the south and comprises a deeply indented sandy bay approximately 2 km in length. The bay is backed mostly by cliffs and steep glacial till coastal slopes. The village of Runswick Bay is developed within the general valley formed by the Runswick and Nettledale Becks. The village straddles the boundary between the glacial till slopes which occupy most of the bay and the Jurassic shale and sandstone cliffs to the north. Most of the village is founded on weathered shale but properties to the southern edge and the access road (Runswick Bank) and car parks are founded on glacial till landslide debris. The village is fronted by four separate sea defences, of varying age and construction, which stretch from Runswick Beck north of Caldron Cliff around to Nettledale Beck to the south.

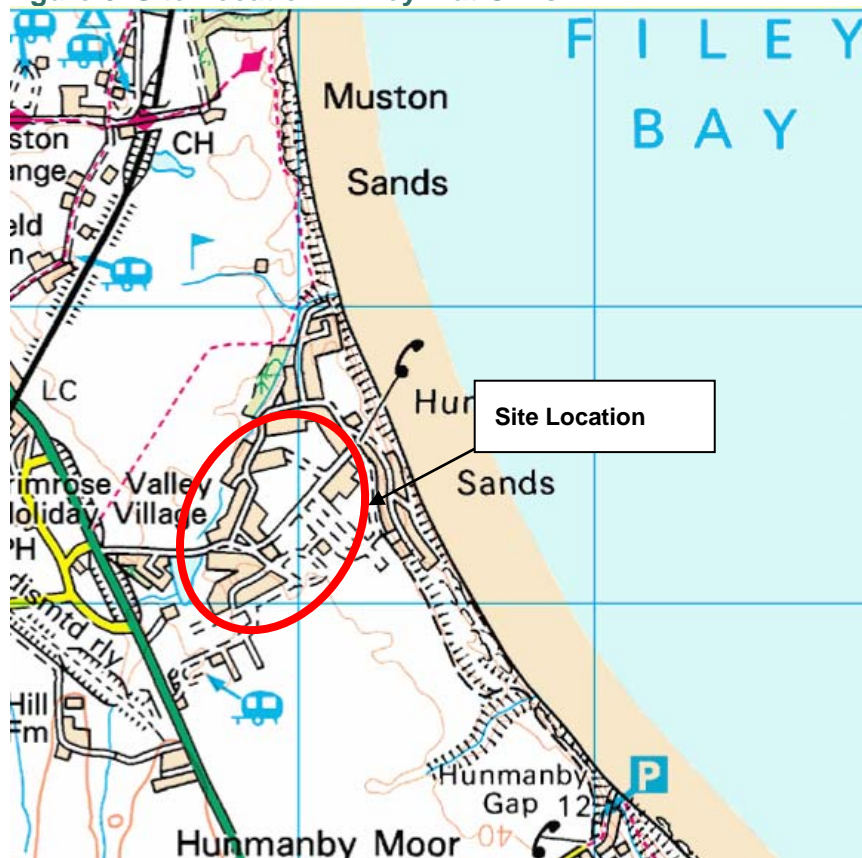
Figure 6. Site Location – Filey Flat Cliffs

Filey Flat Cliffs is situated near Primrose Valley Holiday Park, 2 km south of Filey town centre on the north east coast of England. The site comprises steep unprotected coastal slopes of glacial till on which holiday homes and static caravans have been constructed with narrow tarmac access roads. The site is bounded to the north, west and south by the holiday park and to the east by the cliffs.

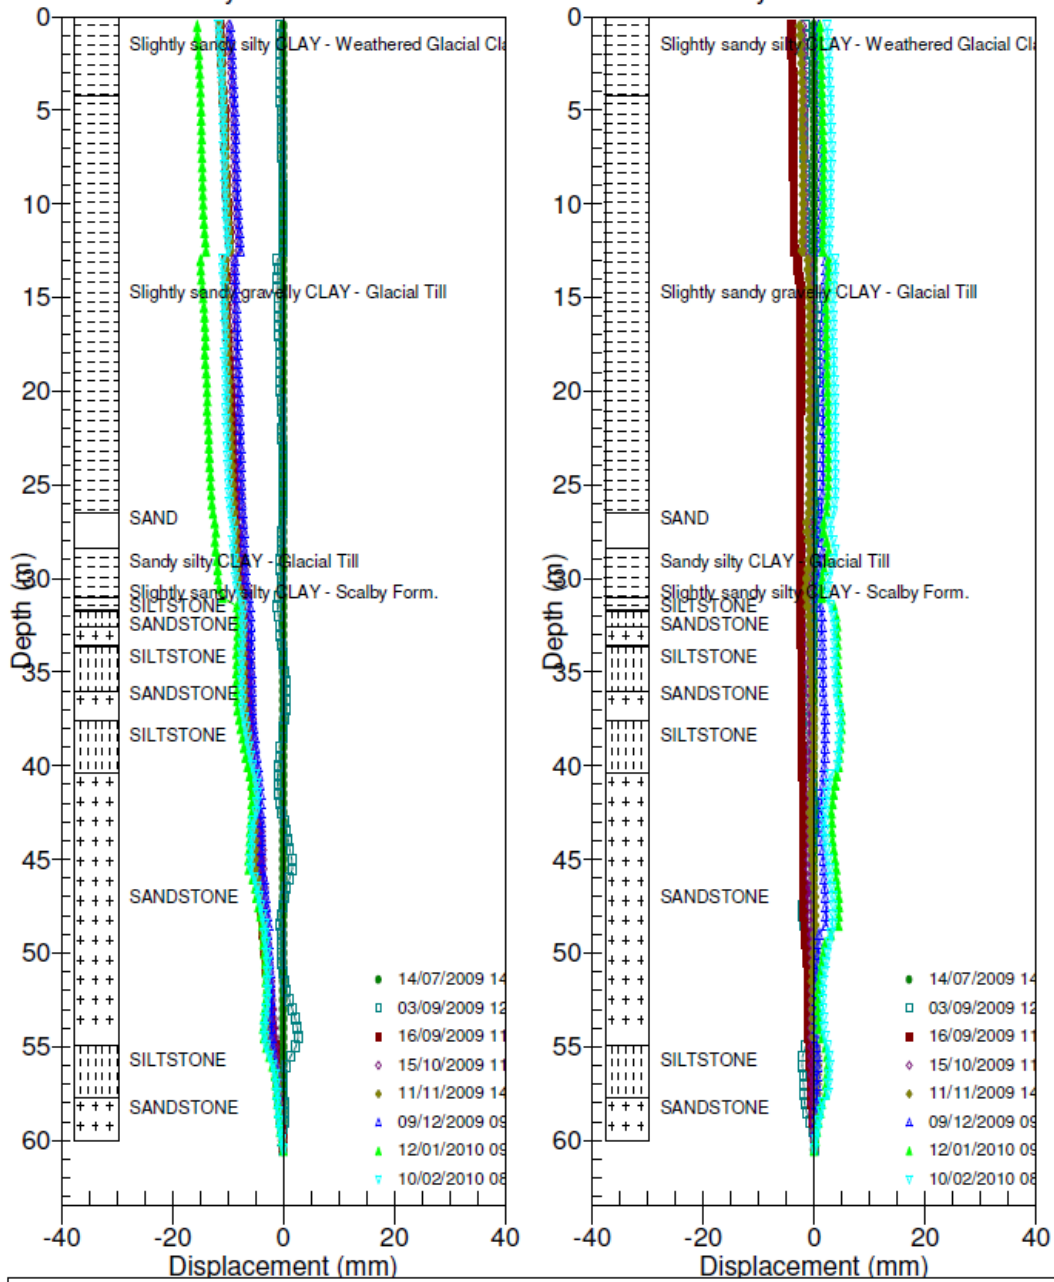
SSC:AA07 - A Axis Cumulative      SSC:AA07 - B Axis Cumulative  
 Initial survey: 14/07/2009 14:12      Initial survey: 14/07/2009 14:12

PROJECT: 721229 Ongoing Analysis of Coastal Monitoring Data  
 SITE: Scarborough South Cliff  
 INSTALLATION: AA07 (BH2)  
 COMPANY: Mouchel Ltd  
 CLIENT: Scarborough Borough Council  
 NOTE: A0 direction: North East
