**Cell 1 Regional Coastal Monitoring Programme:
Walkover Visual Inspections of Assets**

**South Tyneside Council
Final Report**

September 2012

Walkover Visual Inspection of Assets

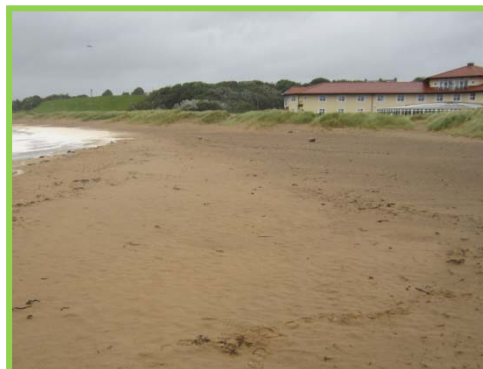
Wide beach fronting Littlehaven Dunes

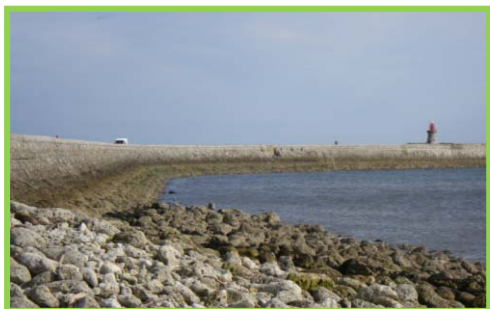
Access to the South Pier was restricted during the inspections. The structure is privately owned and maintained by the Port of Tyne. When visited on the 24/09/12 the gate to the seawards 2/3 was closed due to the stormy weather. When it was visited again on 28/09/12 it was closed because the Port of Tyne was undertaking maintenance inspections and repair work. The landward end remains in overall good condition, with minor repointing and replacement of missing or cracked blocks expected to be undertaken as part of routine maintenance.

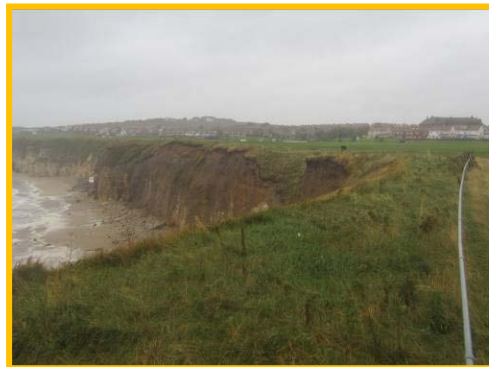
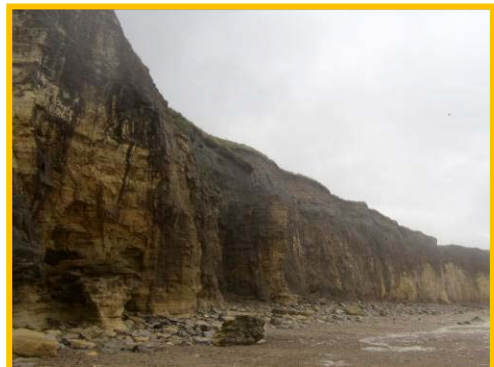
At the north end of Marsden Bay the cliff and arch formations at the toe continues with ongoing evidence of relatively recent rock falls and slips of the overlying soft material. The concrete bunker close to the cliff edge adjacent to Camel Island remains perilously close to the cliff edge with a corner section of the bunker overhanging.

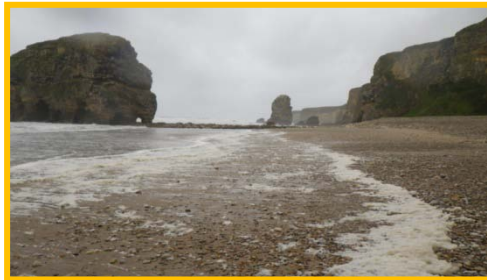
Cobble beach in Marsden bay, looking south from near Grotto.

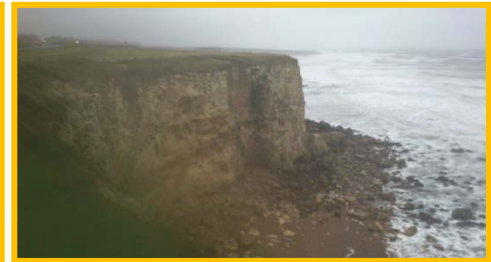
Cliff fall near south end of Marsden Bay.

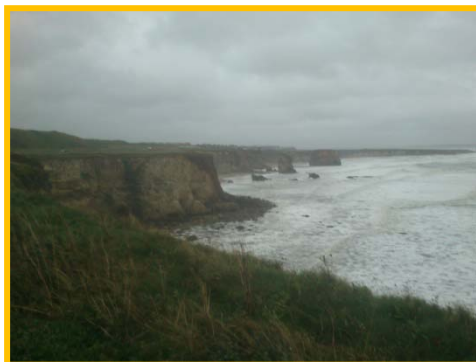
Southern section of Marsden bay from near Lizard Point

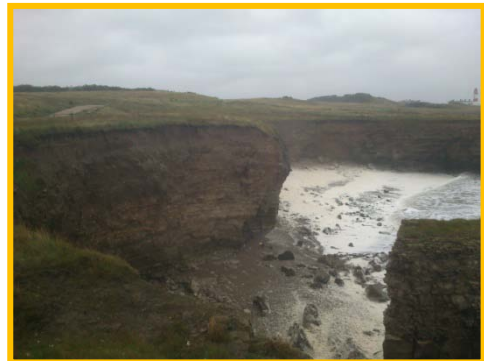
Caves and cliff falls

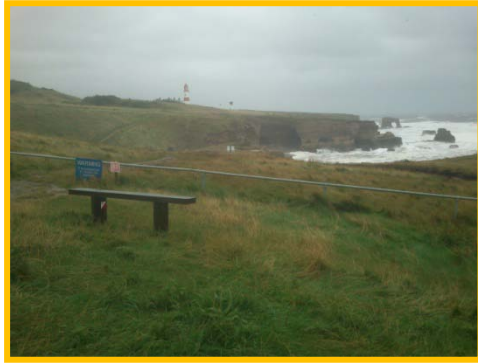
Fencing relocated at sink hole (on right mid field) View into sink hole 24.09.2012

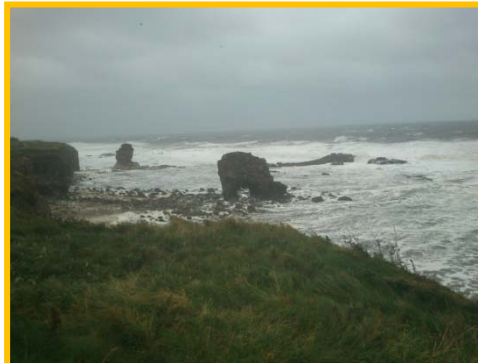
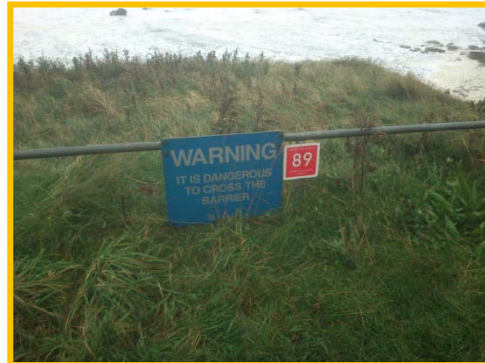
South of Potter's Hole along Whitburn Point Nature Reserve the localised erosion and cave formation continues to cut back the cliff edge towards the foot path. This should be monitored and the rails and warning signs erected by the National Trust may need to be moved back in future.

Stacks and arches at Whitburn Point nature Reserve.

Warning signs where coastal path is close to cliff edge.

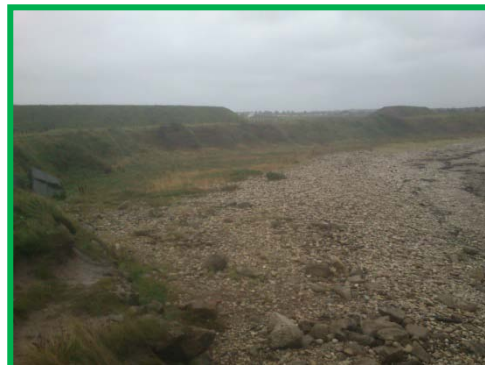
Raised beach protecting stable cliffs at northern section of Rifle Ranges.

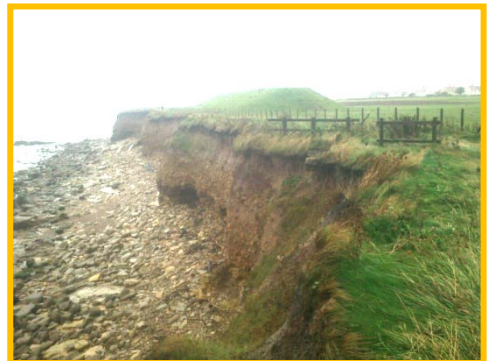
Photo from 24.09.2012 inspection shows limited change

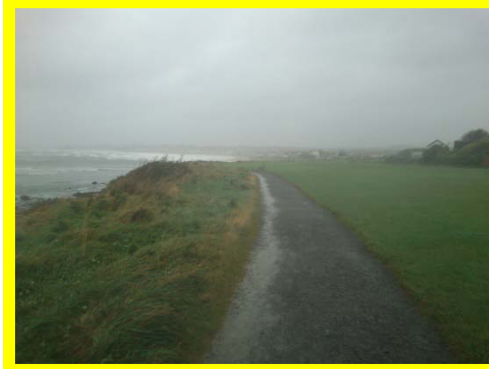
South of the rifle ranges the eroding till cliffs are afforded some protection by the inter-tidal rocky outcrops extending from White Steel to Whitburn Steel, at the northern end of Whitburn Bay. Here there is a fairly wide grassed area at the top of the cliffs, although in places the cliff top path is close to the edge and relocation will be needed in future, below left.

Coastal path adjacent to locally active cliffs at the Steels.
