**Cell 1 Regional Coastal Monitoring Programme
Walk-over Visual Inspections of Assets**

**Sunderland City Council
Final Report**

May 2013

Walk-over Visual Inspections of Assets

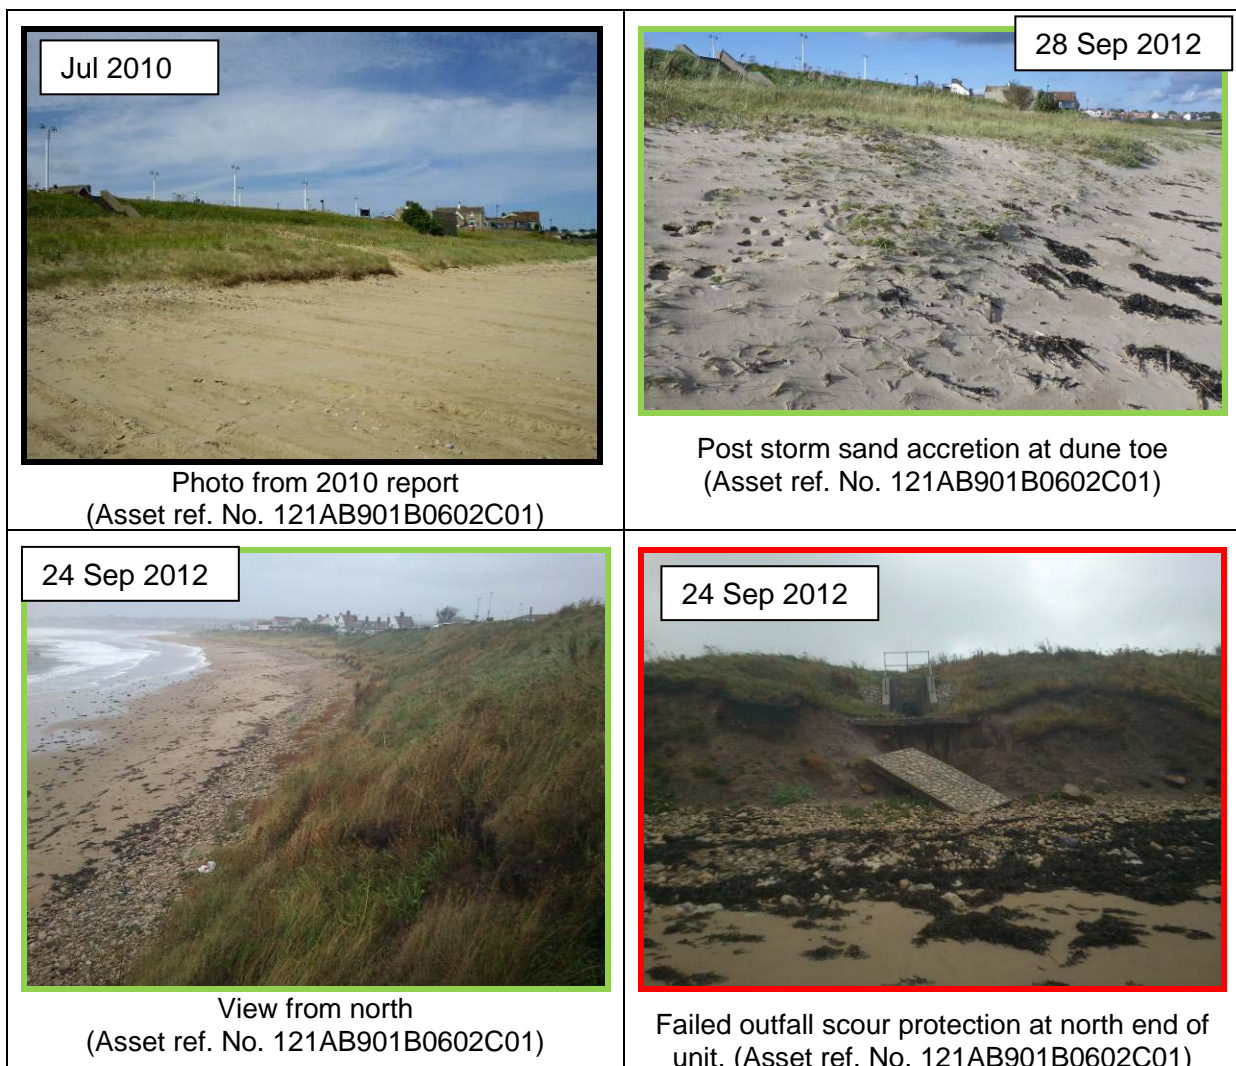
The Sunderland City Council area starts mid-way through the SMP2 Management Area 06 at The Bents. The most northerly asset is an undefended grassed slope, NFCDD Asset Ref. No. 121AB901B0602C01 located to landward of the Whitburn Steel rock outcrop. This asset length is continuous across the district boundary into South Tyneside area and consists of a grassy coastal slope fronted by vegetated sand dunes, below left and (right). The dunes appeared relatively stable with good vegetation cover and appear to have accreted slightly since 2010. There was evidence of recent sand deposition within the dune toe vegetation following the storms at the end of September 2012. The northern part of this asset switches to an eroding clay cliff north of the district boundary, see lower photos below. There is an outfall structure with failed scour protection apron located close to / north of the boundary, lower right.

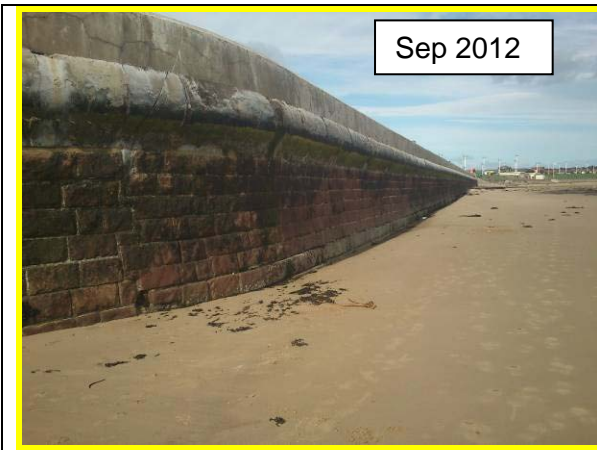
Sep 2012

High beach level in September 2012
(Asset ref. No. 121AB901B0603C03)

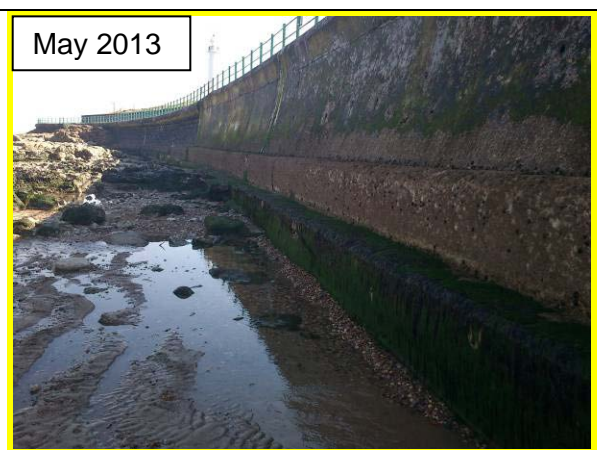
Low beach levels exposing lower section of wall in May 2013
(Asset ref. No. 121AB901B0604C01)

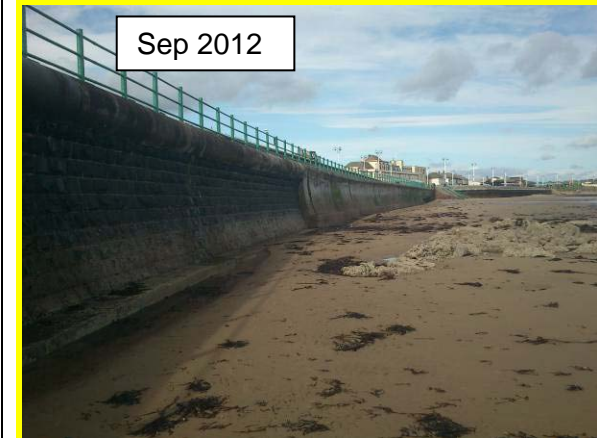
Sep 2012

View of asset from south
(Asset ref. No. 121AB901B0604C01)

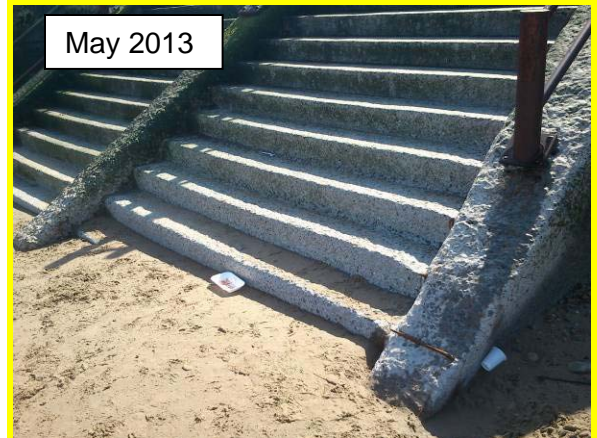
May 2013

The beach access steps at Seaburn Terrace and the section of wall to the south were in fair overall condition, see photos below. The rear concrete retaining wall appeared to be in good condition. The lower section of the steps were heavily abraded, exposing reinforcement in the wing wall.

Abrasion of steps visible at low beach levels
(Asset ref. No. 121AB901B0604C01)

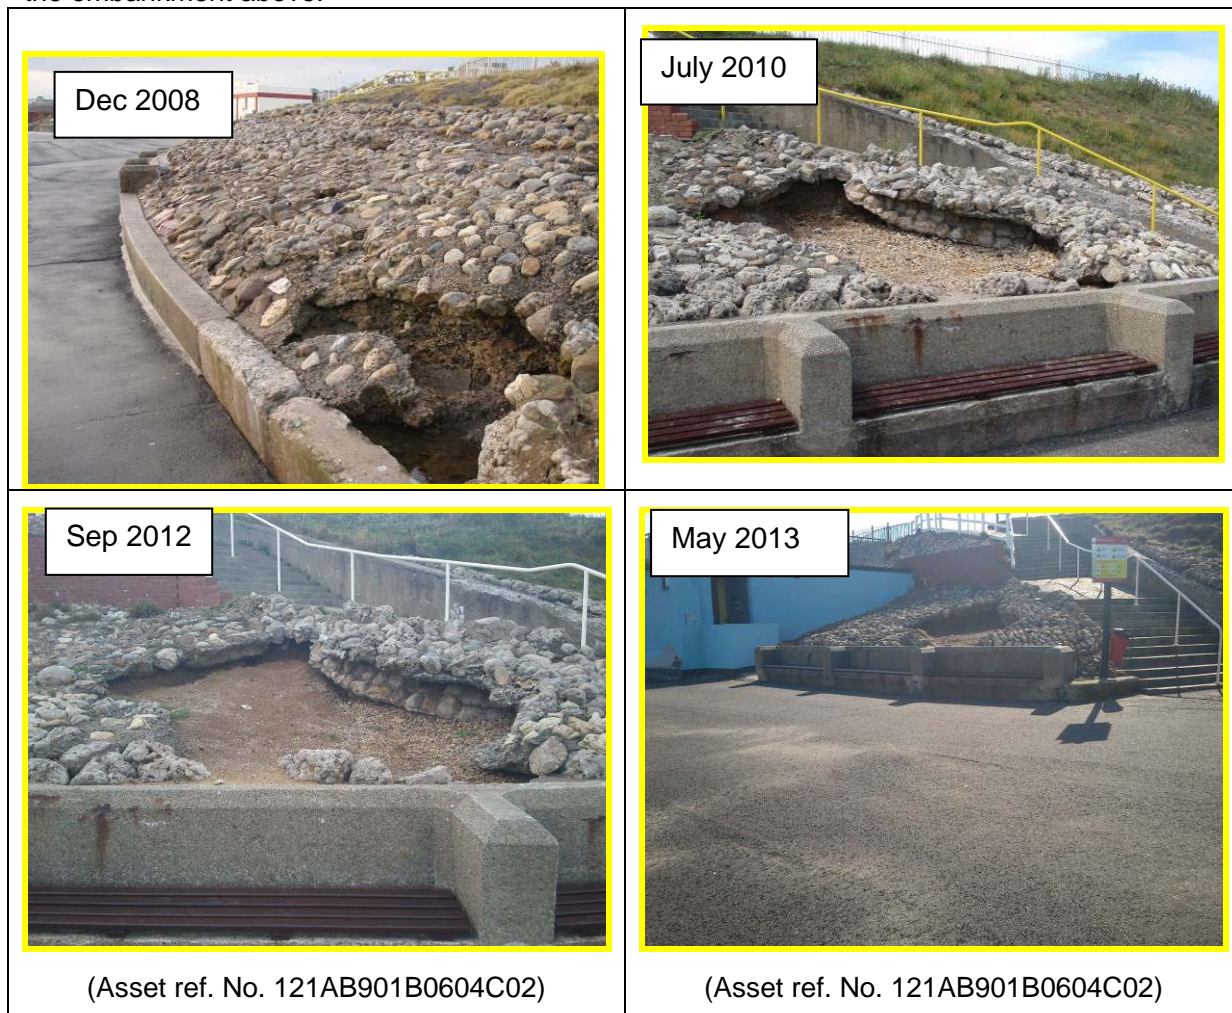
The grouted stone revetment landward of the promenade around Roker Cliff Park has had voids and damage identified in all inspections since 2008 (below). This appears to be at least partly related to storm wave overtopping damage and, as noted in previous reports, it would be prudent to infill the voids to minimise the risk of further expansion and the potential reduction in stability of the embankment above.

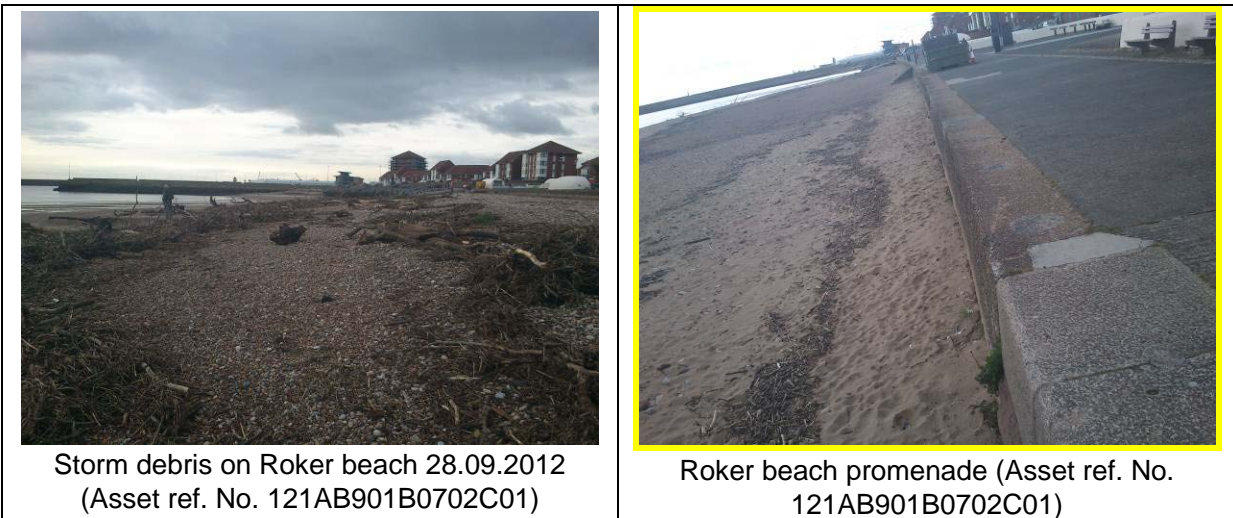
There was a significant amount of debris washed up on the beach from the storms at the end of September, see below left.

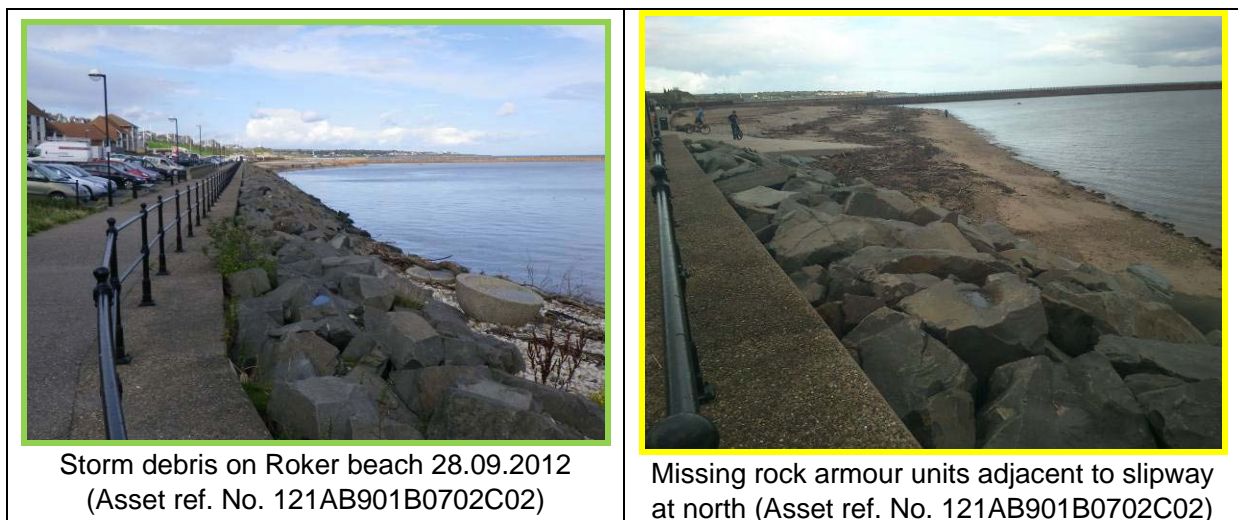
The rock armour revetment to the south of the public car park was in good overall condition. The concrete wall capping was in good condition, but the front face of the wall is covered with rock armour so not inspected. The rock armour was in generally good condition, but it appeared as though some blocks were missing / had been removed adjacent to the slipway at the north end, see below right. The armour should be topped up and re-profiled to ensure good interlock.

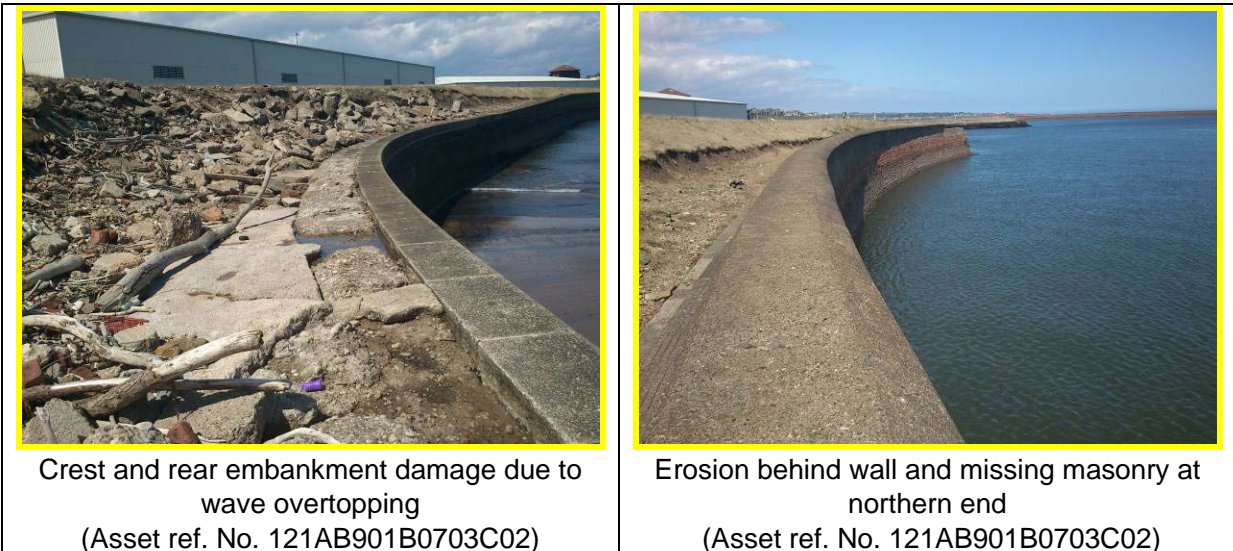
The masonry and concrete seawall to the south, which links into the north face of New South Pier is in fair overall condition. There is evidence of minor impact damage and spalling to the seaward face. There are missing blocks at the northern end, where there is risk of outflanking

causing the wall to start unravelling, although the situation in 2013 looks very similar to the photographs from 2010. The concrete apron to the rear of the wall (south part only) has experienced a significant deterioration due to overtopping with sections missing. The rubble embankment landward of the seawall has been eroded on the seaward face by wave overtopping. It is recommended that the surfacing to the rear is repaired / replaced and voids in the rubble surface immediately behind the wall are filled in order to avoid wave overtopping causing further erosion and pooling behind the wall destabilising the structure.

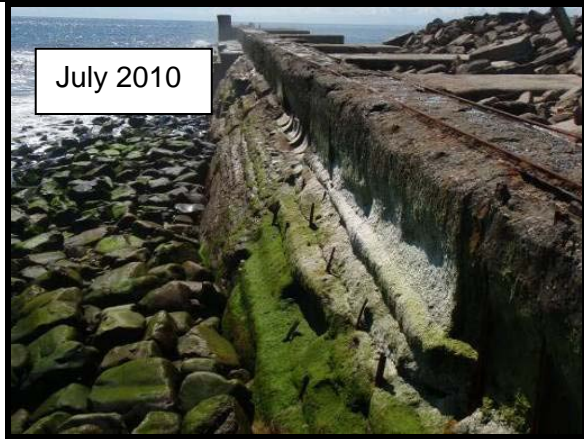
July 2010

The seaward section of North East Pier, including the roundhead and both faces is asset 121AB901B0801C04, and this is in very poor condition, although there appears to have been little change since 2010, see below. The deck was severely abraded and there were missing sections and exposed reinforcement observed throughout. As reported in previous years the roundhead of the structure has become detached, leaving the exposed nose of the pier vulnerable to wave attack and the photos below indicate that further loss of material from the end of the breakwater has occurred.

North East Pier – Photo from 2010 report
(Asset ref. No. 121AB901B0801C04)

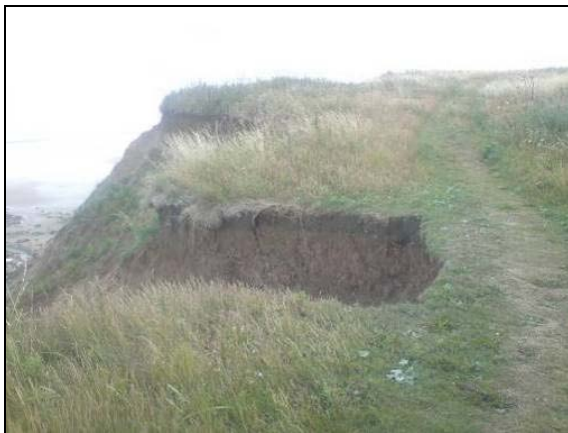
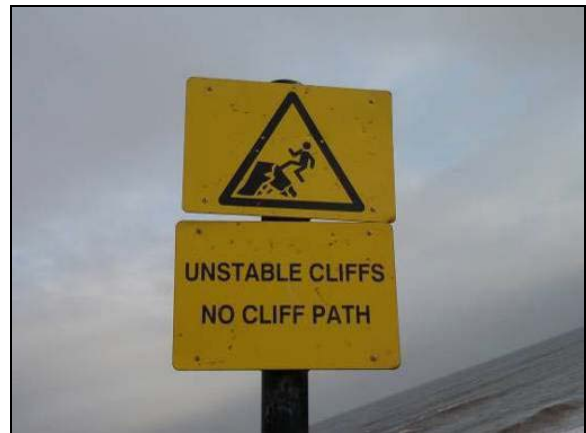
The 2010 report noted that there were slope failures in close proximity to the cliff top footpath, particularly at Halliwell Banks, see photos below from the 2010 report. This remains the case. Although signs are present to warn members of the public that the cliffs are unstable, there is a public footpath along the cliff edge on the Ordnance Survey mapping and the track appeared to still be well worn at the time of the 2012 inspections. The proximity of the retreating cliff edge to the footpath is therefore an ongoing public health and safety concern.
