## Walk-over Visual Inspections of Assets

**Hartlepool Borough Council  
Final Report**

**July 2014**

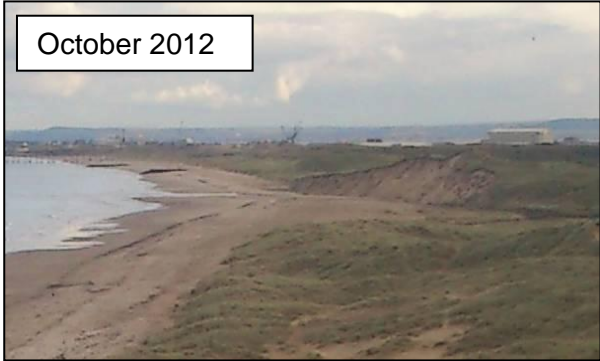
<p>October 2012</p> <p>Photograph from 2012. (Asset ref. No. 1221C901C0301C01)</p>

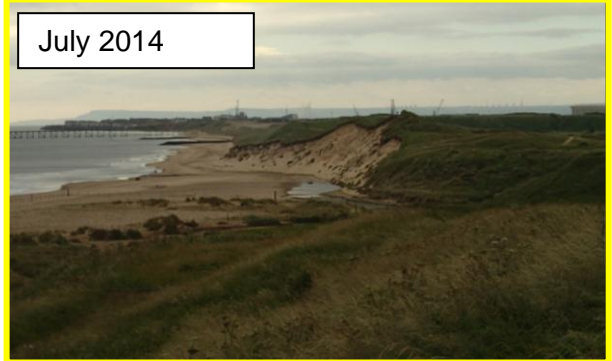
<p>July 2014</p> <p>Crimdon beck in mid photo. Eroding dune face where beck is close to toe very similar to 2012. (Asset ref. No. 1221C901C0301C01)</p>

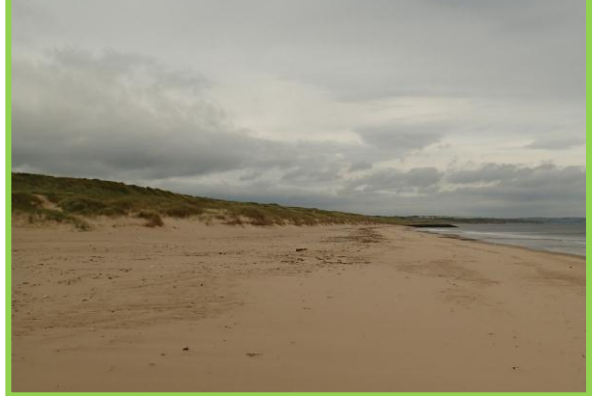
<p>Looking towards Crimdon from near Winterbottom Avenue underpass, showing wide beach (Asset ref. No. 1221C901C0302C01)</p>

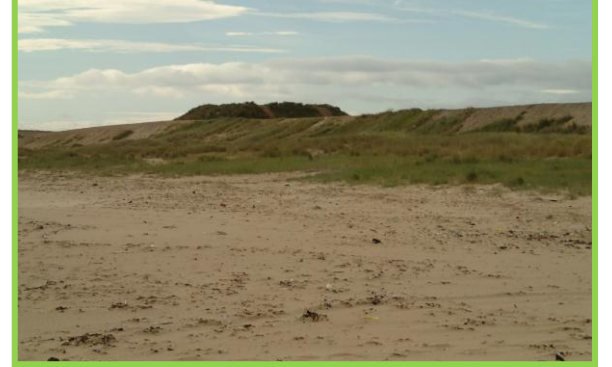
<p>Embryo dunes fronting the former Britmag site. (Asset ref. No. 1221C901C0302C01)</p>

At North Sands the demolition work and site remediation that was underway at the former Steetley Magnesite Britmag works in 2012 is complete. The beach is wide here and although the dunes are low they still appear to be accreting with embryo dune vegetation building to seaward, above right.

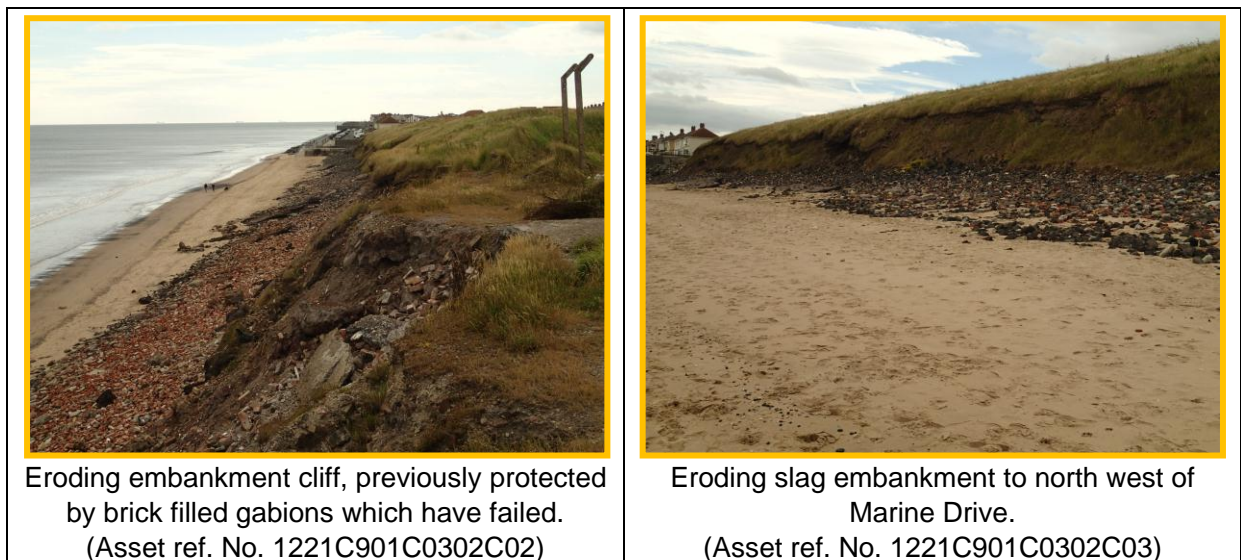
The slag embankment previously had a short, around 100m near vertical section (Asset ref. No. 1221C901C0302C02) protecting the cliff adjacent to a former large industrial building, that was protected by brick filled wire gabions, see photos from 2008 and 2010 below. Many of the failing gabion baskets were removed on health and safety grounds prior to the 2010 inspections and the asset now consists of an eroding brick / waste rubble slope (above right) rather than the vertical structure observed in 2008.

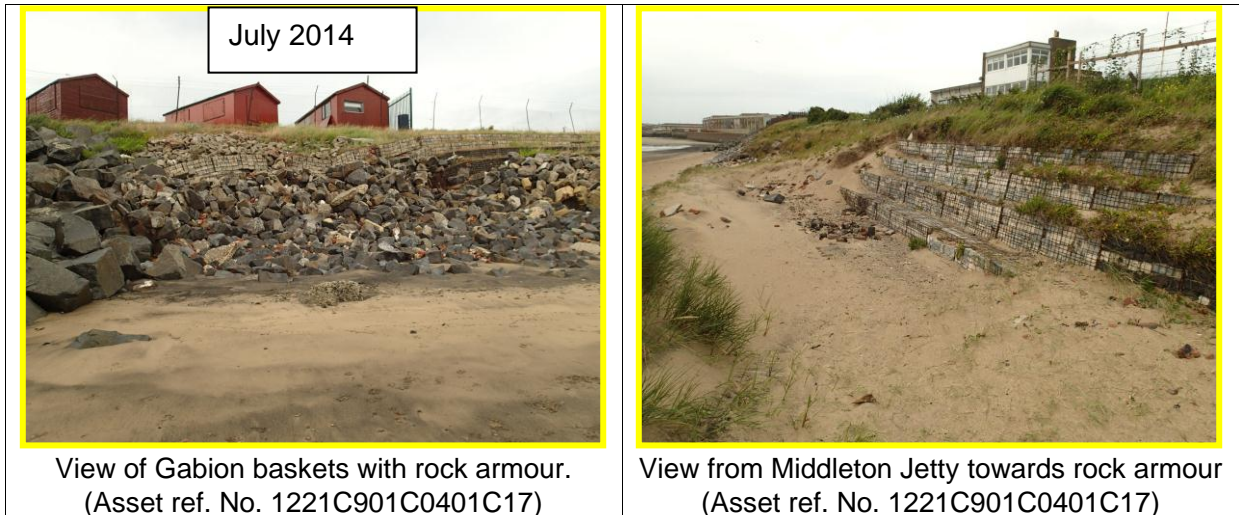
South west of the rock armour, there is an informal access ramp to the beach, which is recorded as 'undefended' in NFCDD. Demolition waste rubble appeared to have been tipped informally, possibly to help resist erosion or to prevent / reduce public vehicle access onto the beach. The slope to the southern side of the access appeared to be less stable than that to the north, indicating potential for outflanking of the defences to the south if left unmanaged.

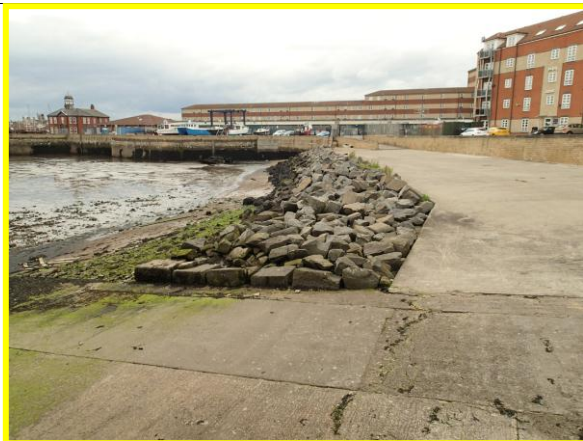
The rock armour revetment overlaying the former stone stepped revetment at the north end of West Harbour (Asset ref. No. 1221C901C0401C23) appeared to be in fair condition, below left as in previous inspections. The wide promenade crest slab behind the revetment has some surface damage that has expanded since 2012 and needs a minor repair. The mass quay wall structure at the rear of the harbour, to the north side of the lock (Asset ref. No. 1221C901C0401C24) has a newer masonry flood wall on the crest that was built when the area was redeveloped. The flood wall appeared to be in good condition, although as noted in previous reports it ties in to the lock structure at a slightly lower level, see below right; presumably this was to allow for wave action on the main wall, which would be less at the lock as it is more sheltered. There was extensive seaweed coverage to the lower wall that prevented inspection although there was no obvious global movement or distress apparent in the structure to suggest any major problem.

Revetment at north end of West harbour. (Asset ref. No. 1221C901C0401C23)

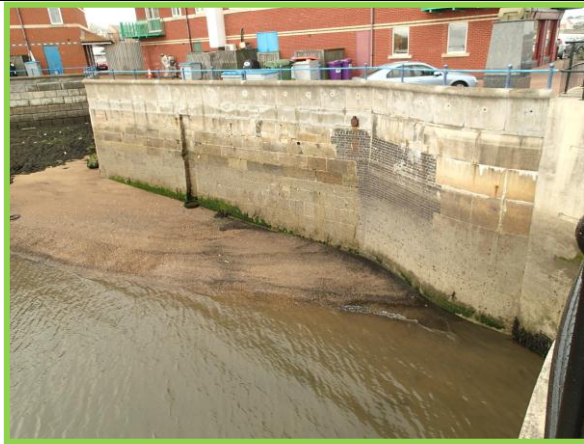
The concrete structures forming the lock entrance were in good condition, although water level prevented the inspection of the lower section of these walls. The toe apron of the short section of wall to the south of the lock, (Asset ref. No. 1221C901C0401C25) was again covered in seaweed so not able to be inspected, but there were no obvious problems and the wall itself is in good condition.

Wall to south side of lock entrance.  
(Asset ref. No. 1221C901C0401C25)
