**Cell 1 Regional Coastal Monitoring Programme
Coastal Walkover Inspections 2010**

**Redcar and Cleveland
Borough Council
Final Report
December 2010**

This report documents the condition of the coastal cliffs and assets along Redcar and Cleveland Borough Council's frontage, which extends from the South Gare Breakwater in the north, to Cowbar Nab, Staithes in the south.

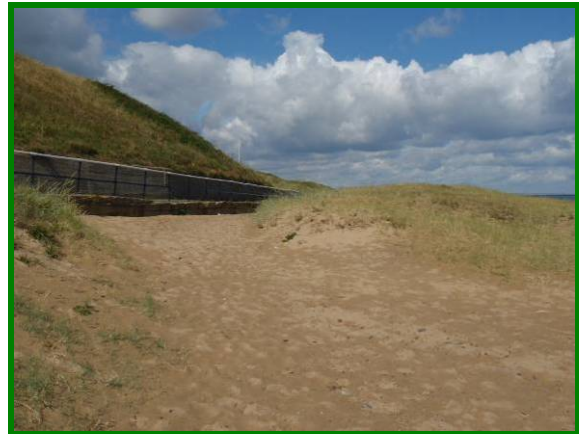
To the north of Marske, E52/7 is classified as Dormant as it is defended at its toe by low level sand dunes and a series of masonry and concrete walls and shows no evidence of landslide activity. From Marske to Saltburn the crest level of the coastal slopes increases and the slopes become vegetated with localised erosion at the toe. CBU's E52/6 to E52/4 are classified as Inactive.

E52/7 Sand dunes and walls to toe of vegetated slope (Dormant)

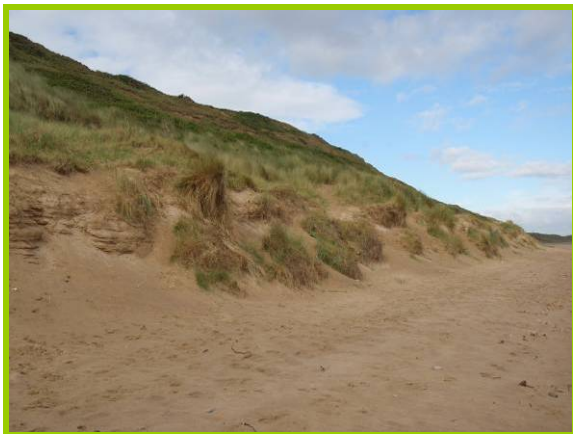
E52/5: Coastal slopes viewed looking north (Inactive)

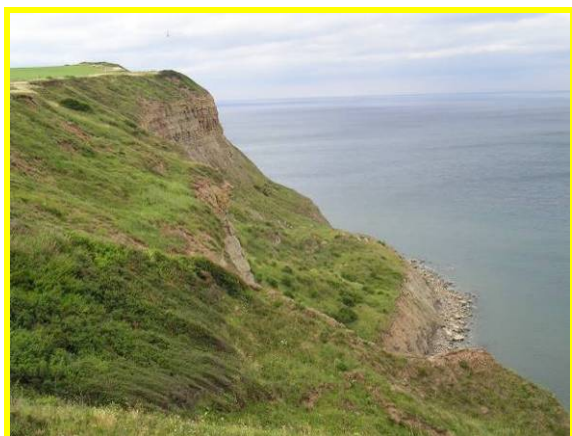
E54/1 looking northwest (Locally Active)

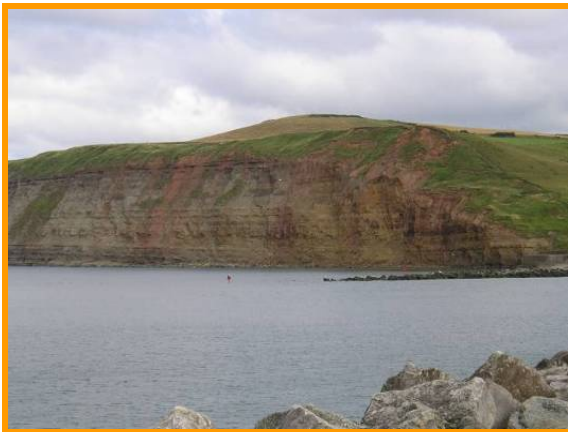
E57/7 looking southeast across the bay at Skinninggrove (Partly Active)

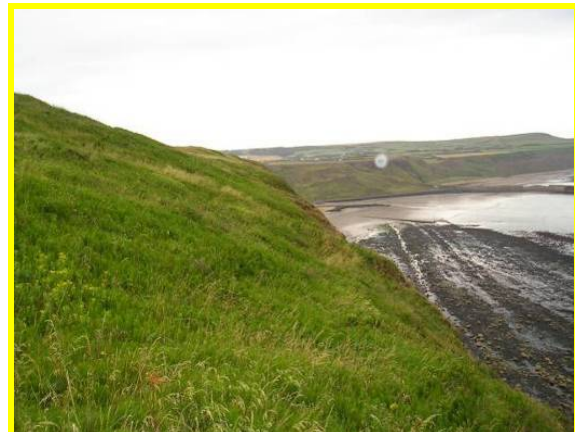
E57/6 looking west across the well vegetated upper slopes (Locally Active) (Note this unit has moved down a class since 2008)

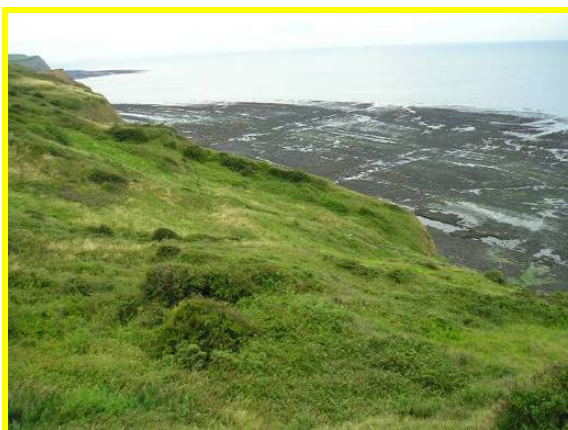
E57/3 well vegetated upper slopes (Locally Active)

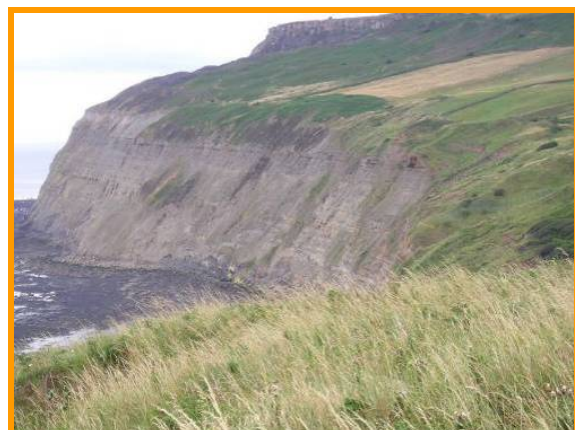
E57/1 steep, exposed lower slopes (Partly Active)

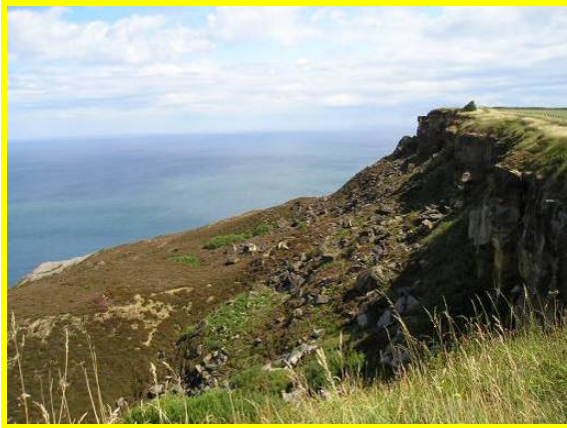
E58/5upper looking across to the east (Locally Active)

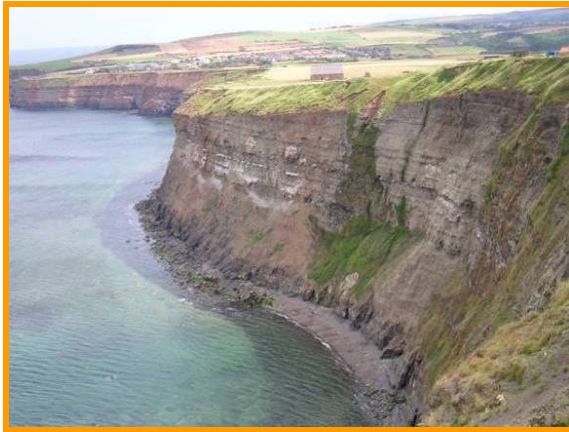
E59/8 looking towards Staithes from Boulby (Partly Active)
