**Walk-over Visual Inspections of Assets
including Coastal Slopes**

**Redcar and Cleveland
Borough Council
Final Report**

July- August 2014

Cell One Coast Protection Assets and Coastal Slope Condition Analysis

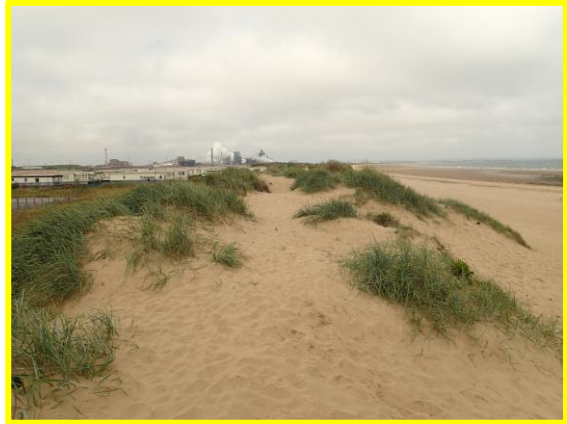
Narrow dune ridge near caravan park

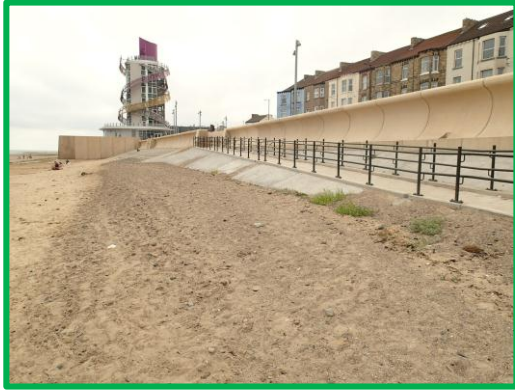
High beach levels to east of cinema
Asset ref No. 1221C901C0602C04

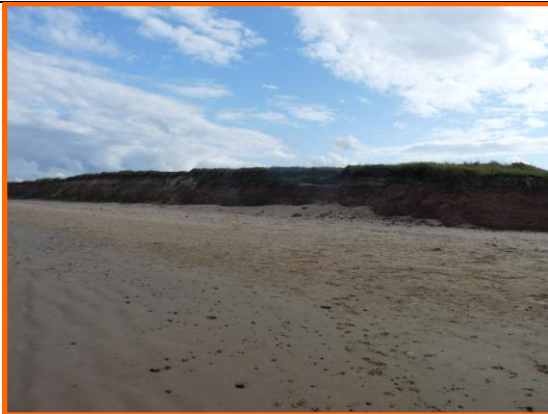
E52/10 Eroding till cliff (Partly Active). Photo August 2014

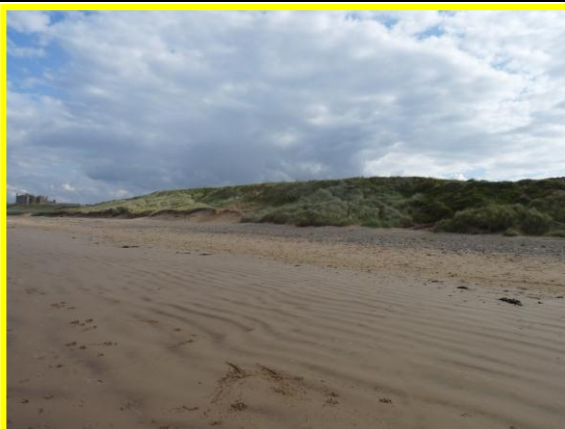
E52/6: Sand dunes and walls to toe of vegetated slope (Dormant) Photo August 2014

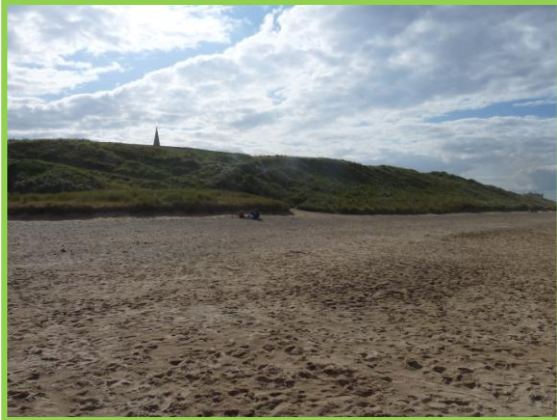
At the headland at Marske, **E52/6** there are low accreting dunes protecting the cliff toe and the unit is therefore classified as Inactive.

E52/6: Well Vegetated coastal slopes (Inactive)
Photo August 2014

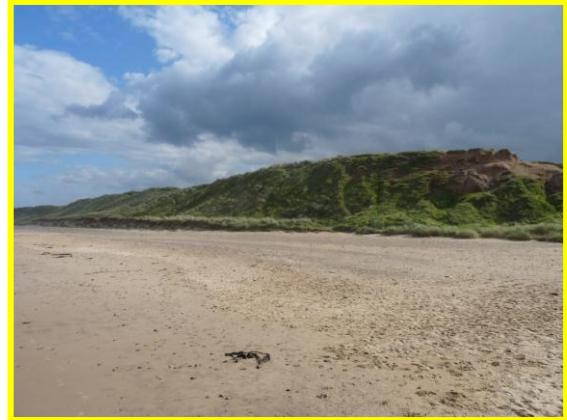
From Marske to Saltburn the crest level of the coastal slopes increases and the slopes increasingly active. **E52/5** shows evidence of toe erosion and localised activity in the upper slopes and is classified as Locally Active, whereas erosion of the toe and mudsliding is more widespread in **E52/4** which is classified as Partly Active.

E52/5: Coastal slopes viewed looking south
(Locally Active) Photo August 2014

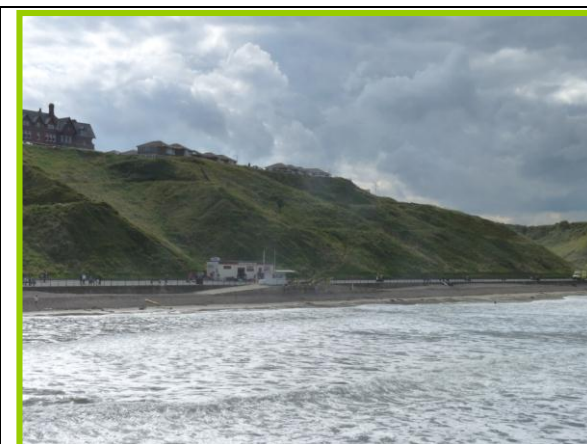
E52/3a the stabilised slopes close to the Cliff Lift (Inactive) Photo August 2014

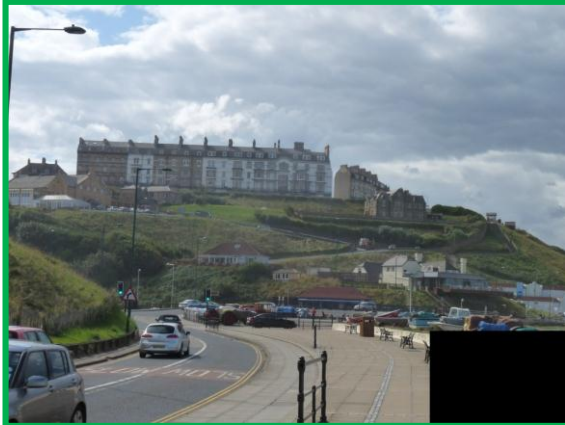
E52/2 the stable cliffs below marine parade (Inactive) Photo August 2014

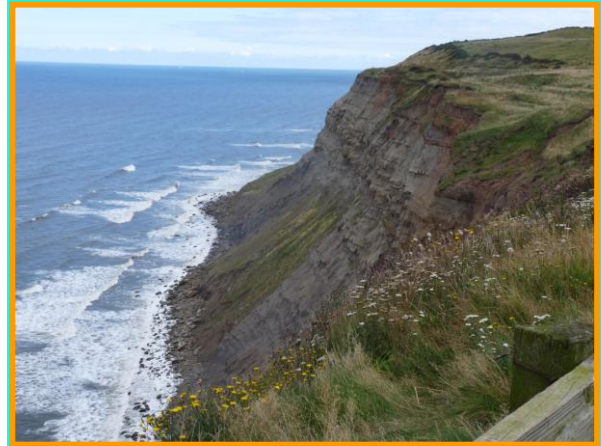
E54/3b looking southeast along Warsett Hill (Partly Active) Photo August 2014

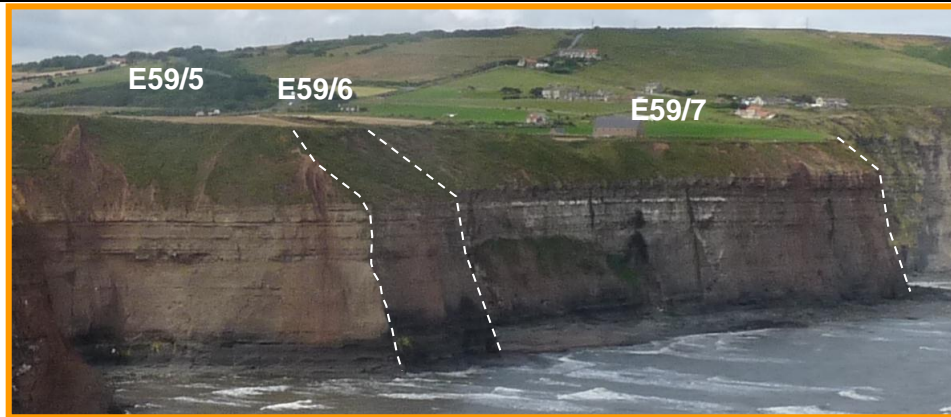
E57/7 to E59/5 looking towards Boulby from Staithes (Partly Active).
