## **Cell 1 Regional Coastal Monitoring Programme Walkover Inspection Surveys 2016**

**Redcar & Cleveland  
Borough Council**

**September 2016**

## Walkover Inspection Surveys 2016

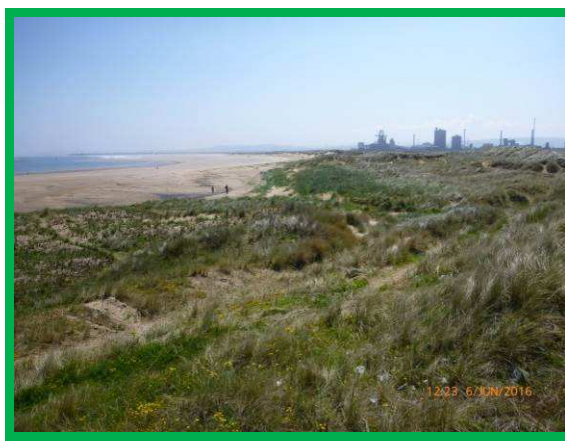
*View looking south east from South Gare Breakwater (/C0506C01)*

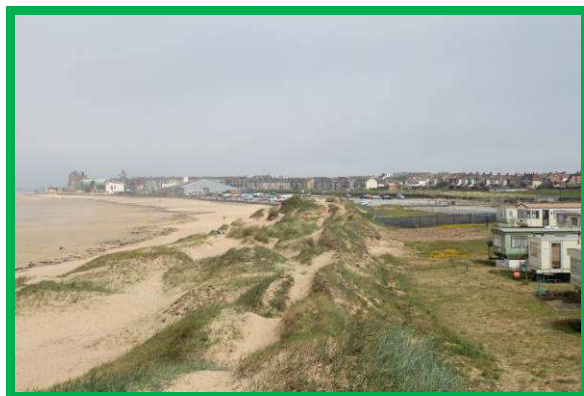
*Dunes fronting caravan site (/C0506C01)*

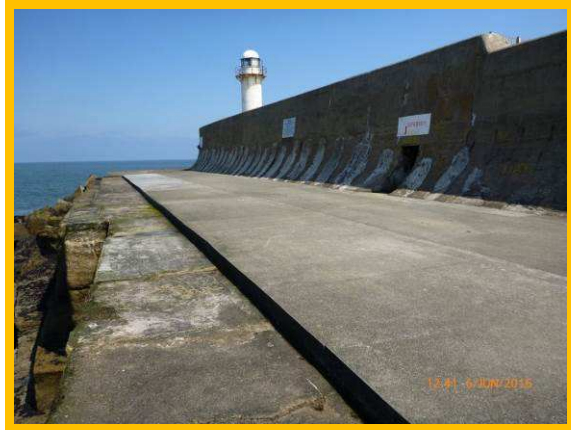
Western face (/C0506C01)

Observed defects to the structure included extensive cracking and spalling, exposure of reinforcing steel, missing mortar/open joints, damaged render, missing masonry, undercutting and void formation beneath slag embankments, failure/collapse of historic western pier arm structure, damaged concrete Accropode units and rock armour units and displacement of/poor interlock between armour units. Multiple patchwork and ad-hoc repairs were evident throughout. As noted in previous surveys, a detailed survey of the structure is beyond the scope of the present inspections and a full structural survey of the breakwater is recommended in order to establish the full extent of the damage and identify any remedial works.

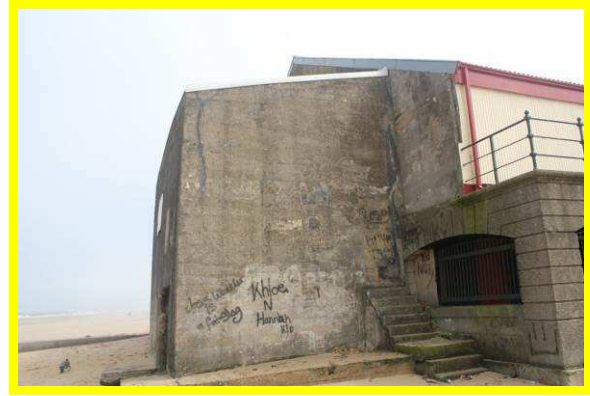
*Cinema seawall (/C0602C05)*

The seawall at the cinema was not upgraded as part of the Redcar scheme. Beach levels were higher than in 2014 and the undermining of the toe apron at the north west corner was obscured. The wall is generally in fair condition, with cracking locally and evidence of previous repairs. The interfaces with the more recently constructed defences adjacent on both sides remained in good condition.

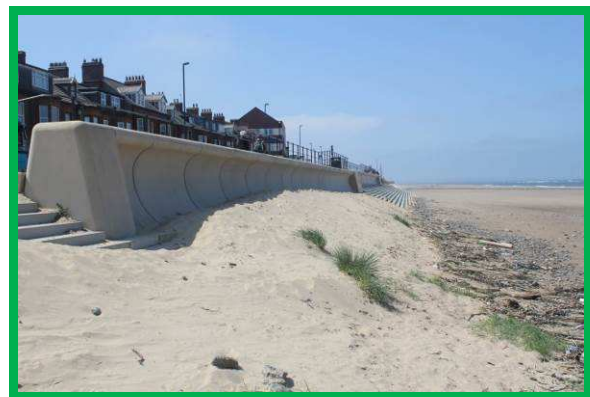
*Accretion of sand and formation of embryo dunes (/C0602C01)*

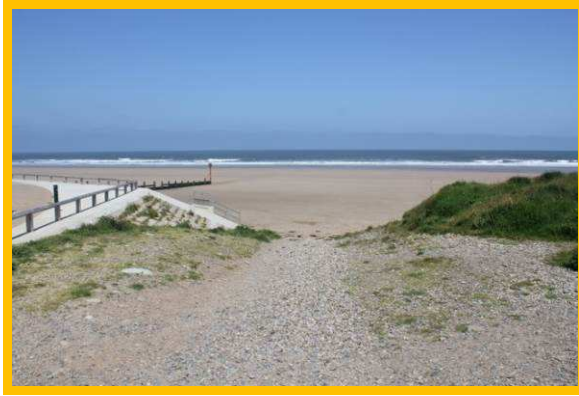
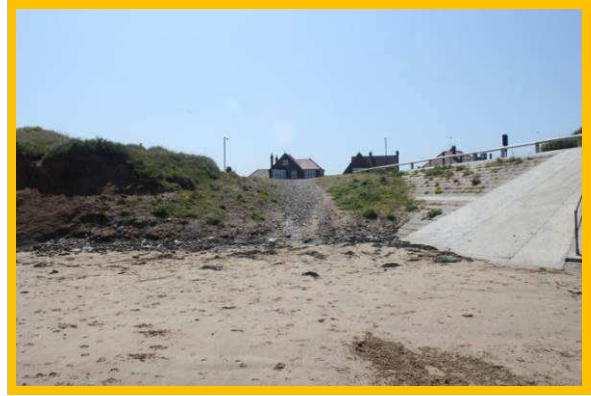
Unit **E52/10** was graded as Partly Active during the 2014 inspection as the whole unit was showing signs of erosion, particularly around the subtle headland approximately mid-length of the unit. This continues to be the case and the status of Partly Active has been retained. A concrete outfall structure is present within this unit and instability/scour was evident adjacent to the same. The gabion baskets fronting the outfall were failing and the concrete blockwork revetment showed signs of settlement. An informal access ramp was present at the interface with the hard defences at the south eastern extent of The Stray and the crest level is lower in this location. This should be monitored to ensure the condition does not deteriorate with consideration given to fencing/signage to marshal pedestrian access towards the formal access points.

*Informal access at interface with hard defences (/C0701C01) CBU E52/10*

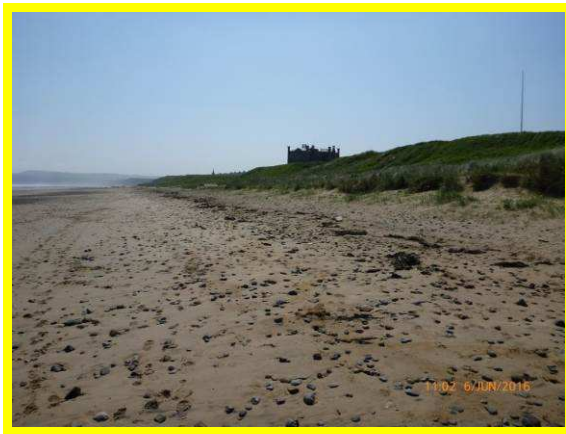
*View looking south east (CBU E52/8)*

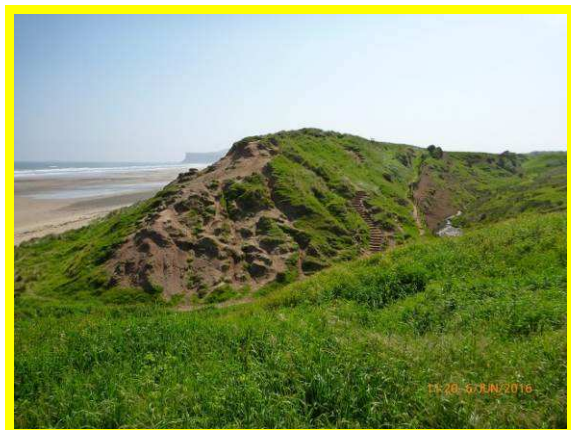
*North western extent of CBU (CBU E52/5)*

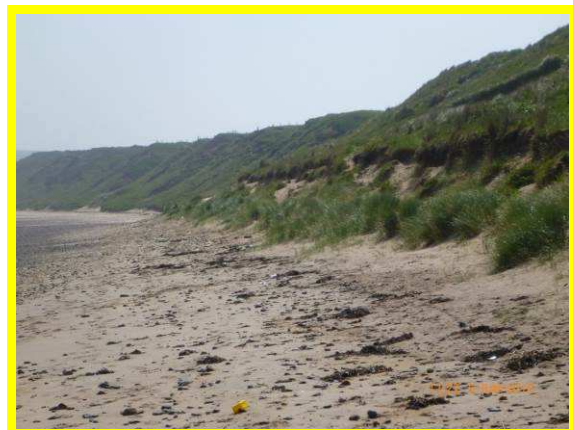
*View looking south east (CBU E52/5)*

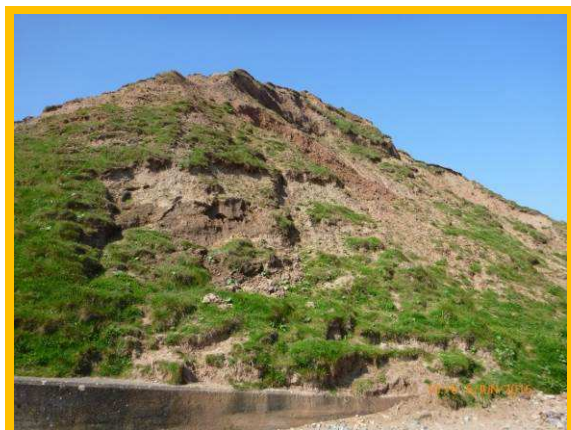
From Marske to Saltburn the crest level of the coastal slopes increases and the slopes increasingly active. **E52/5** shows evidence of toe erosion and localised activity in the upper slopes and is classified as Locally Active, whereas erosion of the toe and mudsliding is more widespread in **E52/4** which is classified as Partly Active.

*Southern extent of CBU (CBU E52/4)*

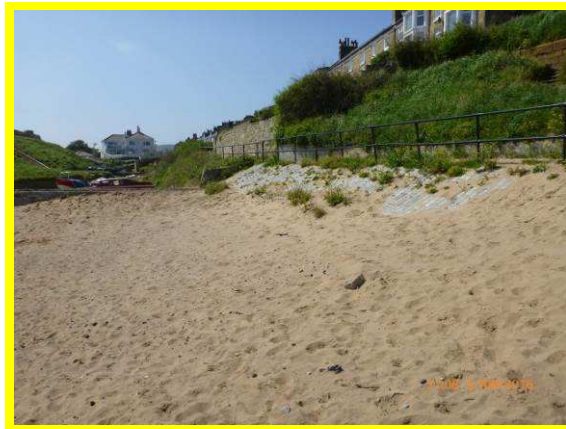
*High beach levels and vegetation cover obscuring masonry wall and revetment north west of beach entrance (/C0702C01)*

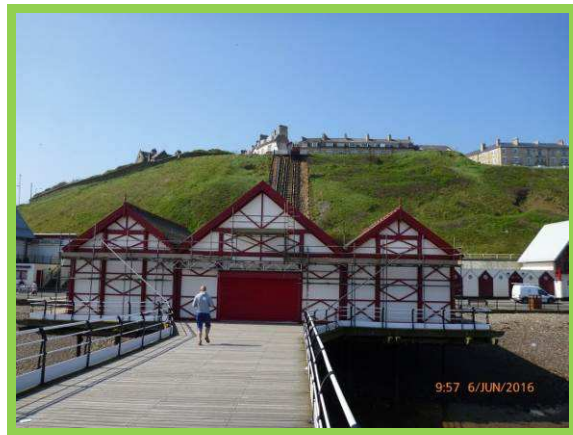
*View from pier (/E52/3a)*

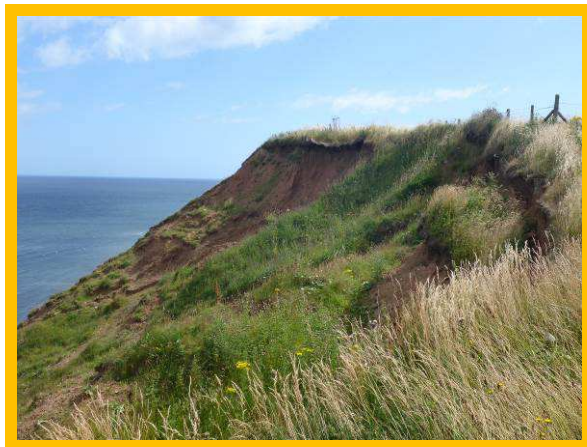
Unit **E57/7** has widespread erosion and is classed as Partly Active in 2016. Unit **E57/6** is a high rock cliff with a thin cap of till above which is deemed to be Locally Active.

**E57/7** Slumping cliffs (Partly Active)

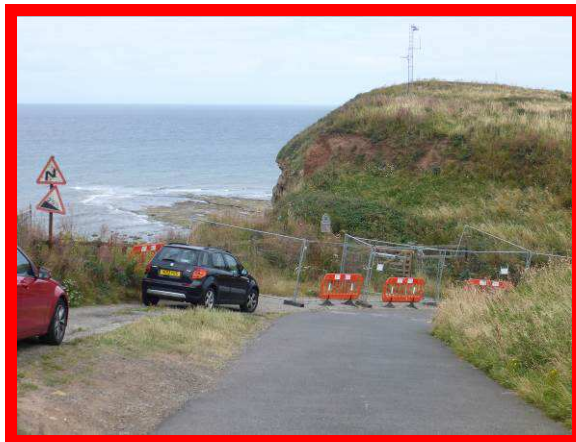
**E60/1** Closure of access to Cowbar Nab
