**Walk-over Visual Inspections of Assets  
including Coastal Slopes**

**Scarborough Borough Council  
Final Report**

**October - November 2012**

## Coast Protection Assets and Coastal Slope Condition Analysis

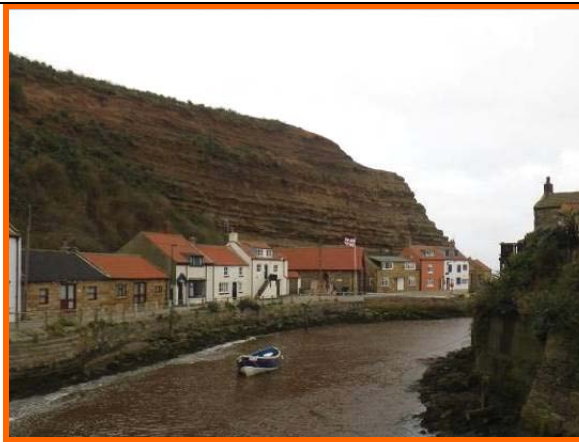
**MU4/1b** - The southwards facing side of Cowbar Nab which runs along Staithes Beck (Partly Active).

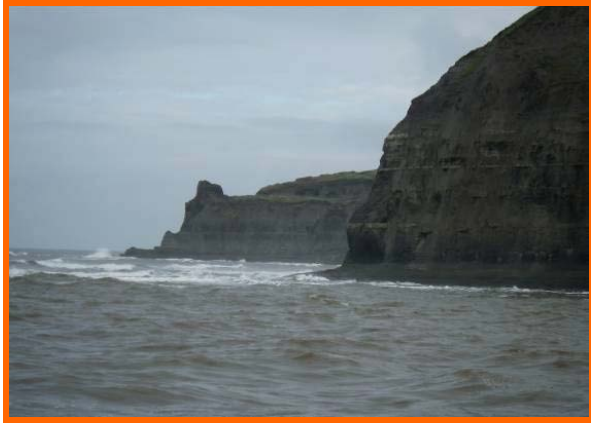
**MU5/1** – The highly weather headland at Old Nab (Partly Active).

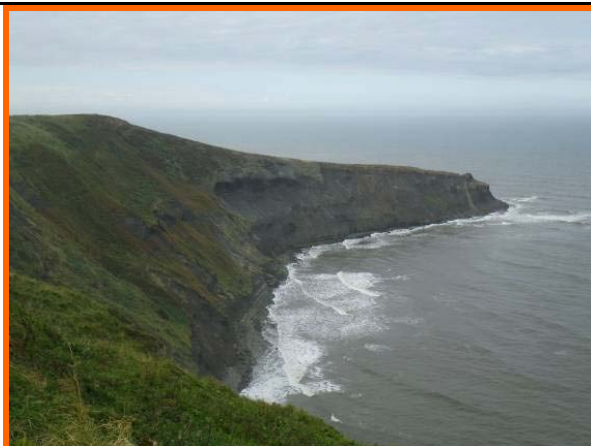
**MU6/1** – Looking southeast across Brackenberry Wyke from Old Nab (Partly Active)

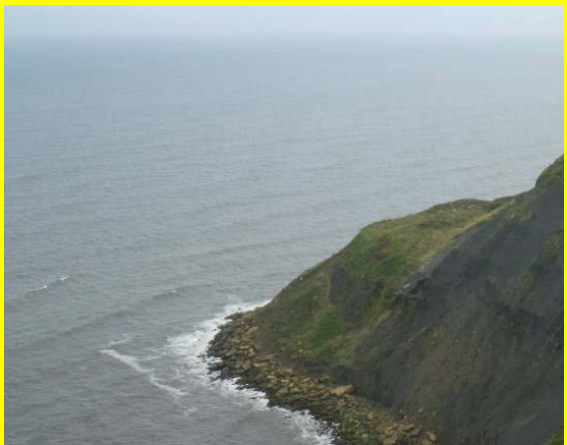
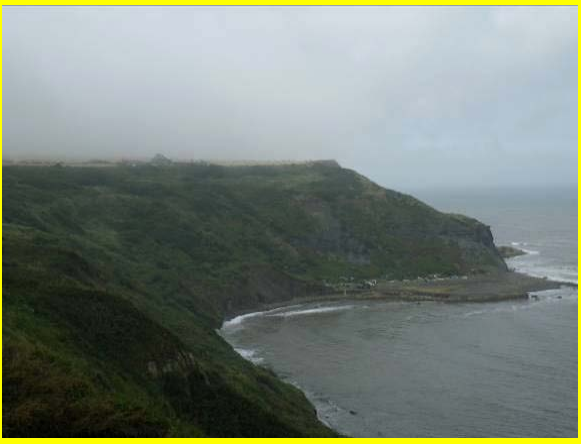
<p><b>MU6/2</b> – The lobe of material shows vegetation on the shallower slopes while the steeper slopes are exposed. There were a number of small failures (Locally Active).</p>	<p><b>MU6/3</b> – There are a number of small failures on the cliff above the hard standing at Port Mulgrave (Locally Active).</p>

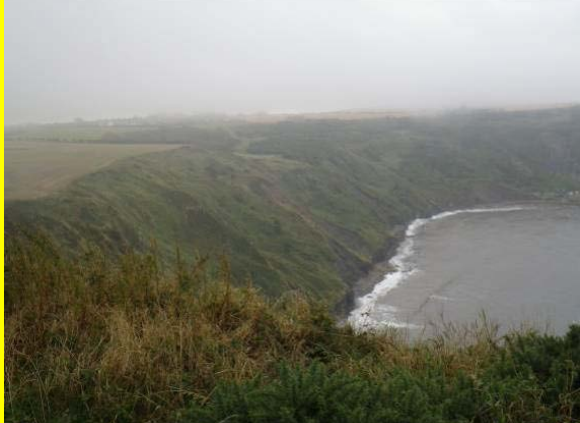
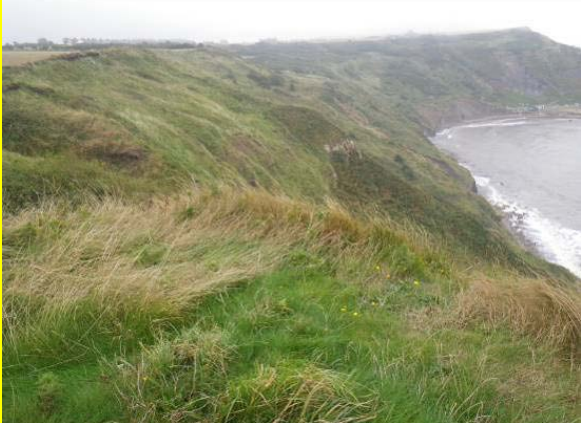
<p><b>MU 6/4</b> - Rosedale Cliffs, south of Port Mulgrave (Locally Active)</p>	<p><b>MU6/5</b> – The upper part of the cliff, which is vegetated (Locally active)</p>

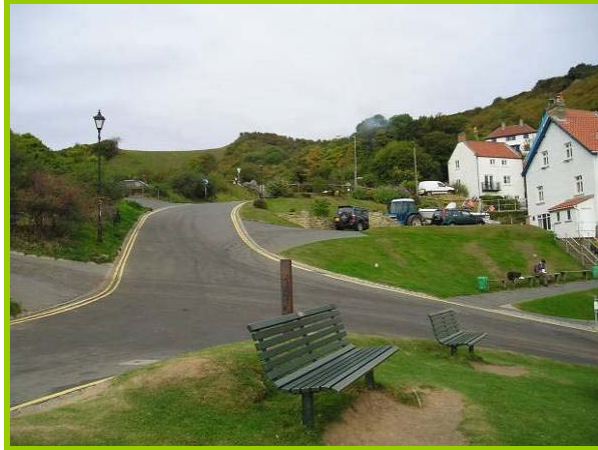
**MU7/1** – The slopes of Runswick Bay village  
(Inactive)

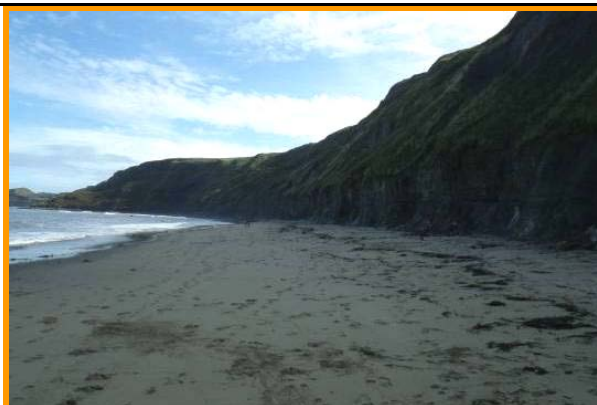
**MU8/1** The cliffs behind Runswick Sands (Partly Active)

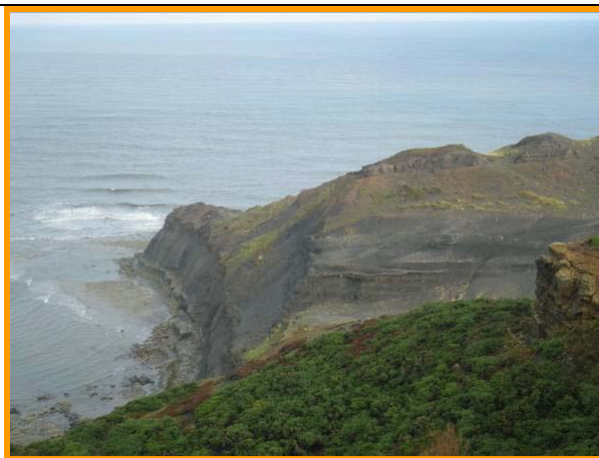
**MU8/5** The ongoing erosion of the Kettle Ness headland (Partly Active)

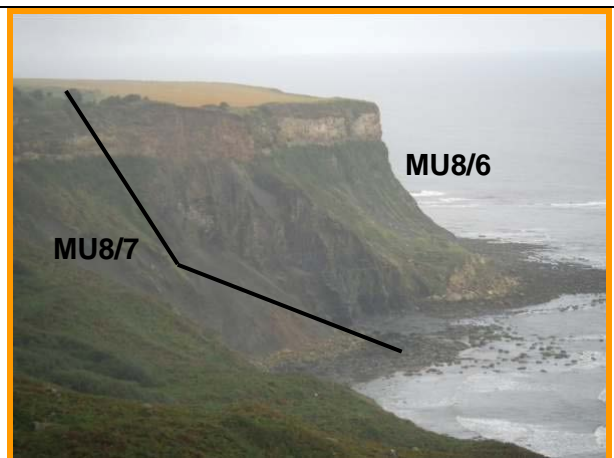
**MU8/6** (mid-distance) Steep, exposed slopes (Partly Active) (approx. extent shown).

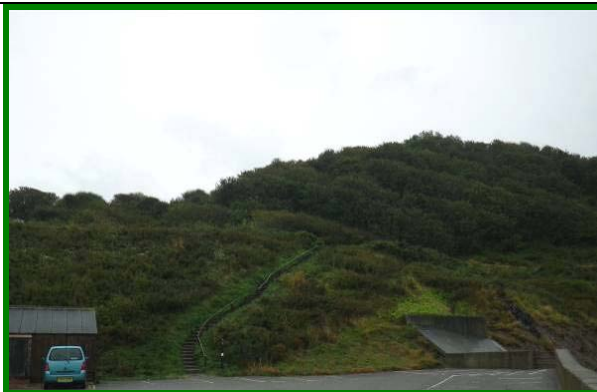
**MU9/1** is located close to Sandsend (Dormant)

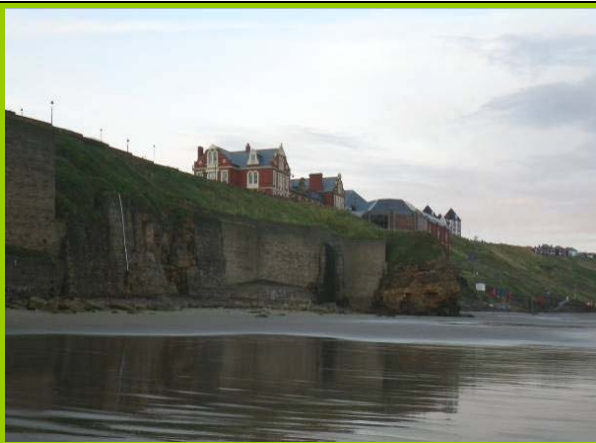
**MU11/3** Defended slopes with little evidence of recent activity (Inactive)

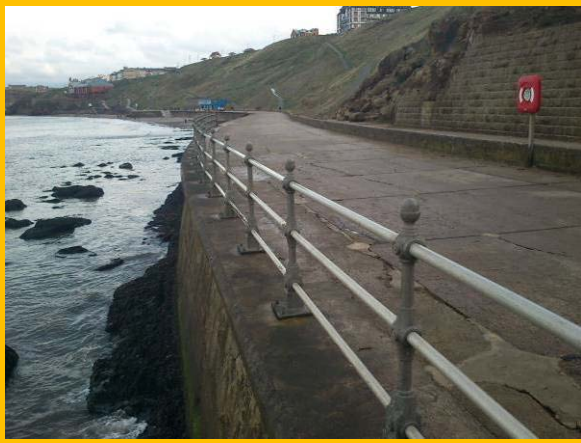
Washout of joints in slabs from wave overtopping (Asset Ref. 1221D901D0802C03)

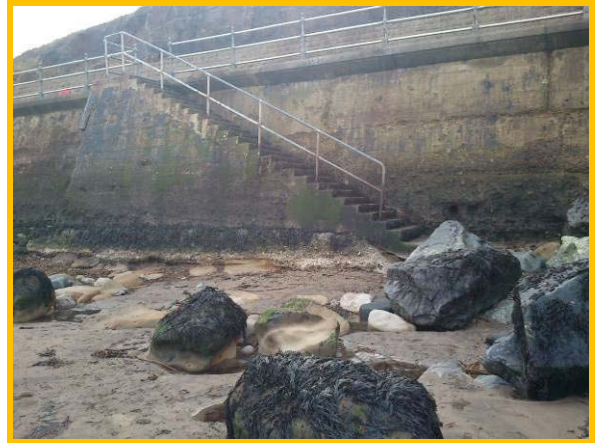
Undermining of wall adjacent to steps - (Asset Ref. 1221D901D0802C03)

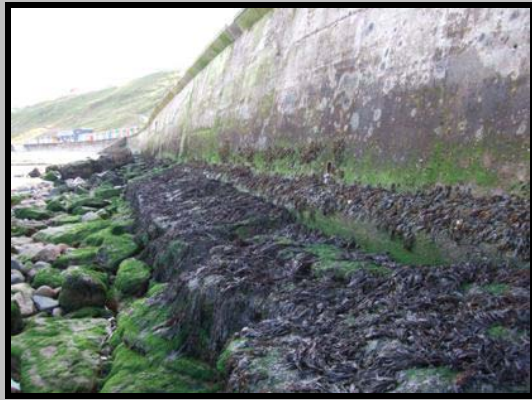
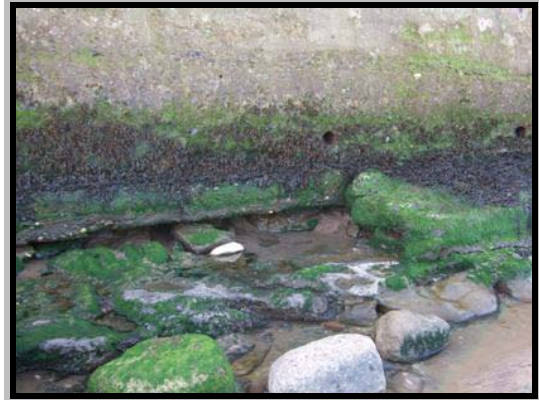
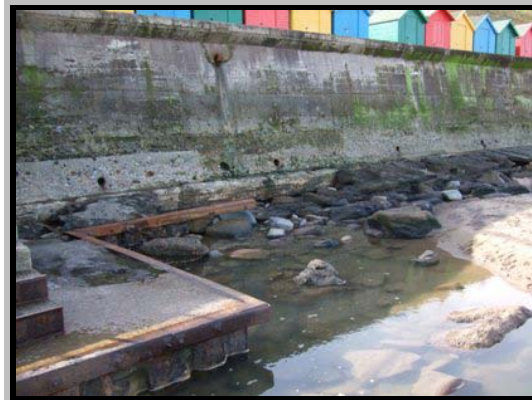
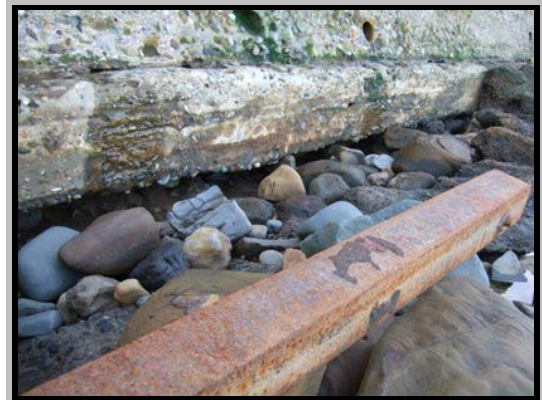
Photos of exposed and damaged toe (Asset Ref. 1221D901D0802C03) – **From 2009 inspections**

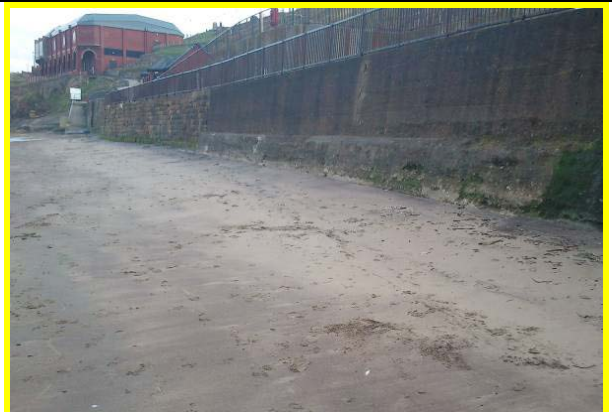
No significant change to asset from 2009 (Asset Ref. 1221D901D0802C04)

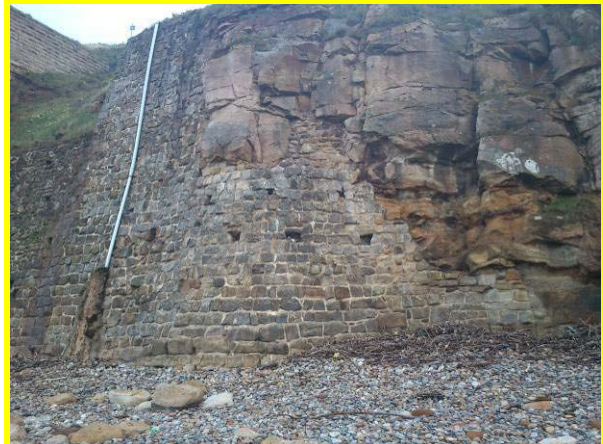
Cliff protected with blockwork, (Asset Refs. 1221D901D0802C09)

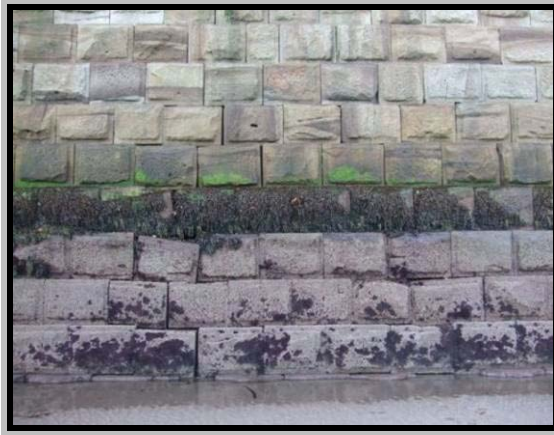
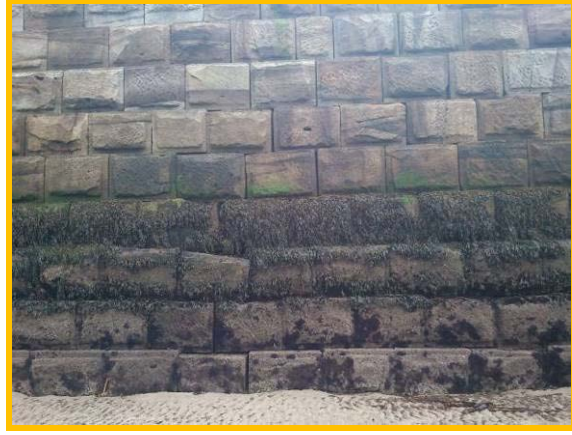
Displacement of block work on west side of West Breakwater - left image from 2009, right from 31/10/12  
(Asset Ref. 1221D901D0803C02)

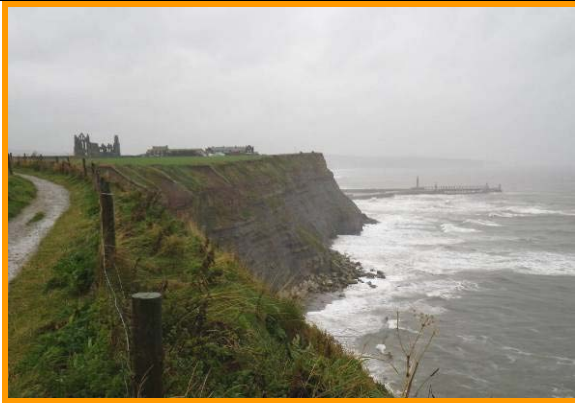
**MU13/1** Cliffs east of Whitby (Partly Active).

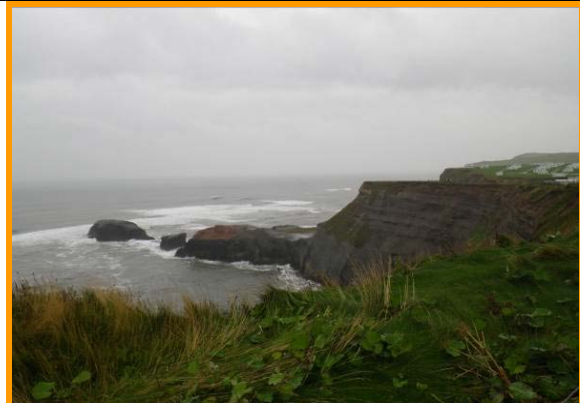
**MU13/2** The highly weathered headland of Saltwick Nab (Partly Active).

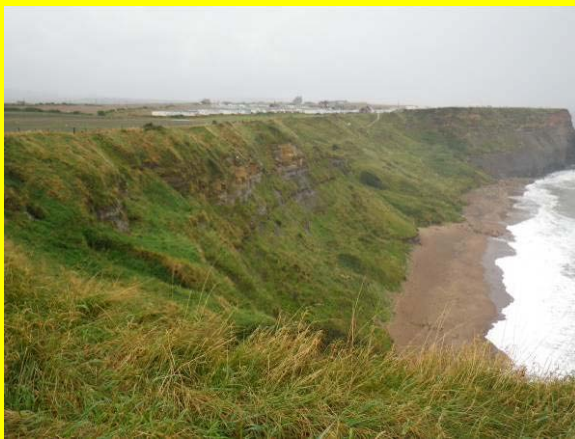
**MU13/3** Saltwick Bay cliffs and beach (Locally Active).

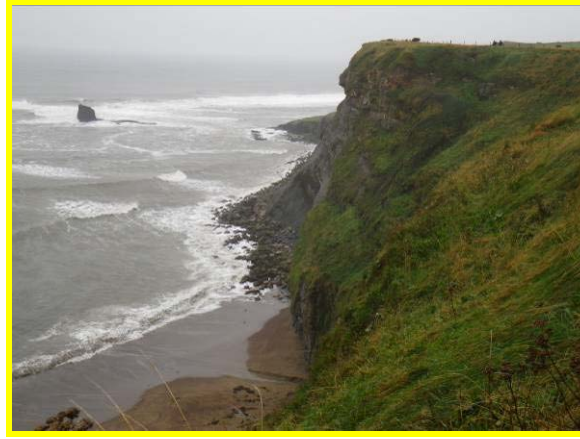
**MU13/4** Exposed, eroding cliff subject to marine erosion (Partly Active).

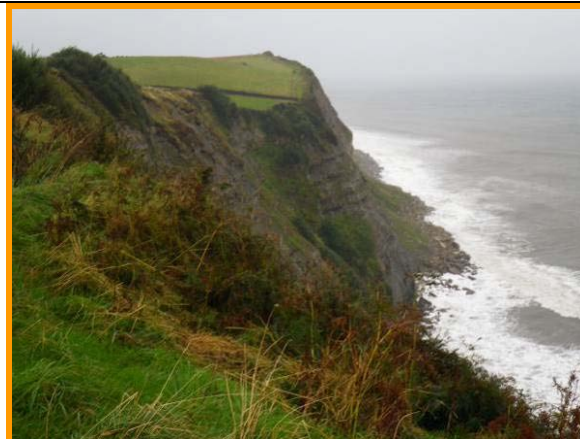
**Unit MU13/6** is a long, steep-faced unit near the Whitby Fog Signal and the former lighthouse. There is some intermittent vegetation cover, but the slopes are largely exposed with evidence of rockfalls from the upper strata. There are also signs of ongoing weathering and marine erosion of the lower layers. This unit is classified as Partly Active.

**MU13/6** Steep faces close to the Whitby Fog Signal (Partly Active).

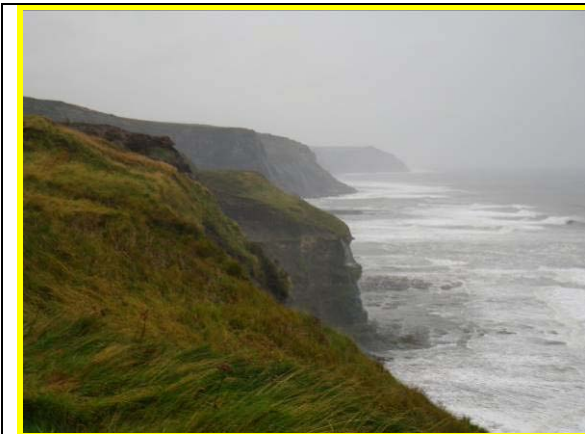
**MU15/1** Well vegetated slopes (Locally Active)

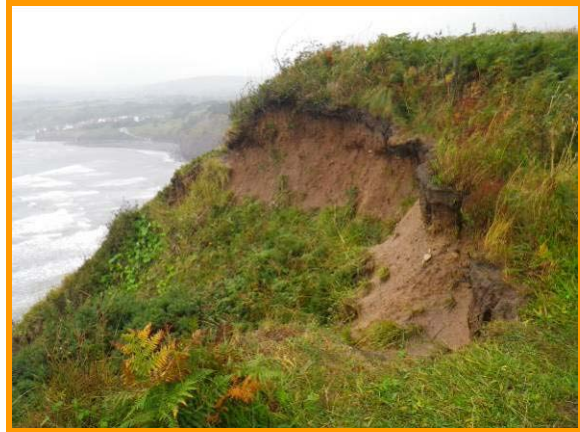
**MU15/3** Ongoing activity near the top of the cliff  
(Partly Active)

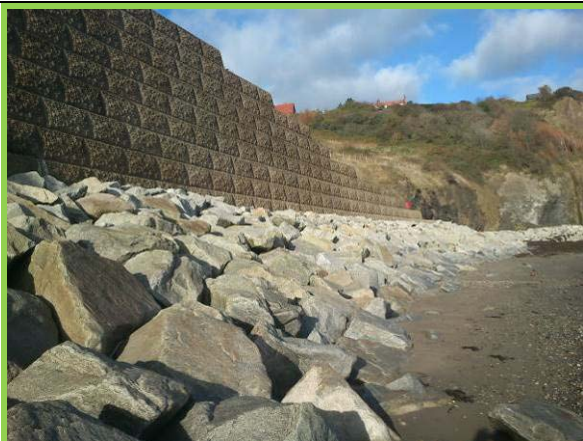
Sea wall with rock armour toe constructed in 2001 (Asset Ref. 1221D901D1003C01)

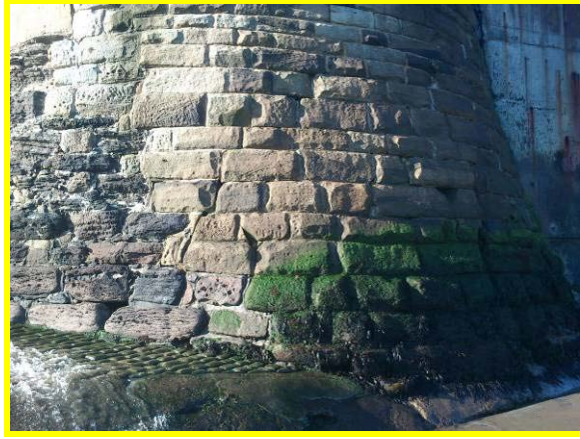
Open joints and voids visible in several places (Asset Ref. 1221D901D1003C04)

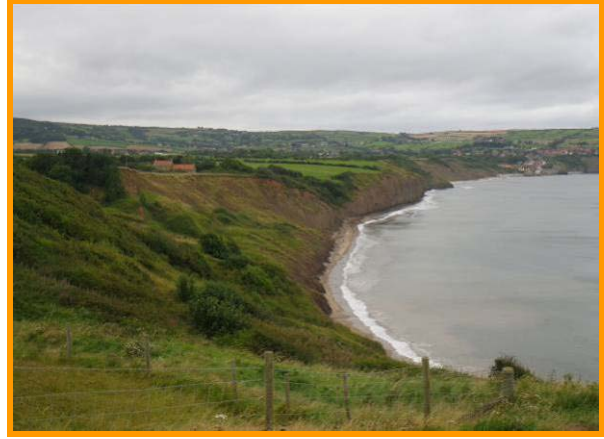
**MU175** Looking northwards (Partly Active)

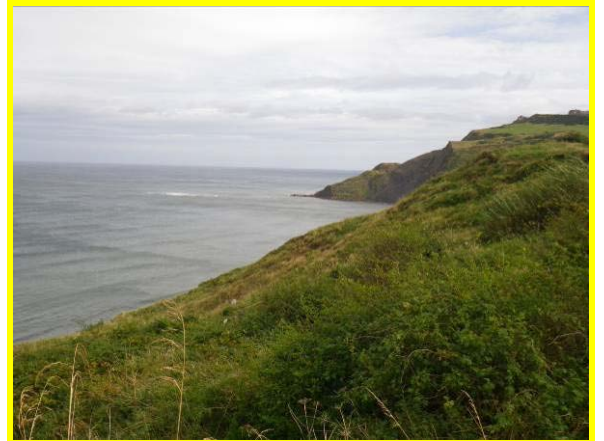
**MU177** west of Peak Steel (Locally Active).

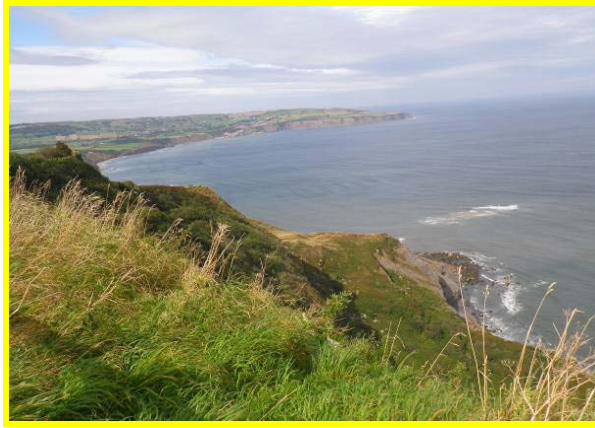
**MU18/1** Peak Steel (Locally Active)

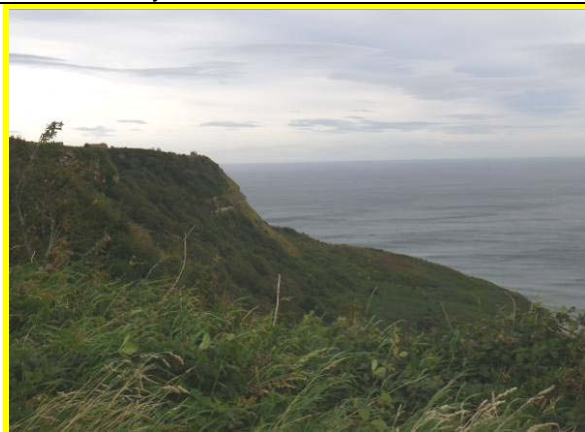
This Sub-Management Unit consists of **units MU18/3 and MU18/4**, both of which are classified as Locally Active. The cliffs have a distinct ‘undercliff’, formed by seepage erosion and landsliding conditioned by variations in the geology. The slopes are well vegetated with only localised patches of activity evident at the slope toe. These units have not changed activity status since 2009.

**MU18/3** Densely vegetated relict cliffs (Locally Active)

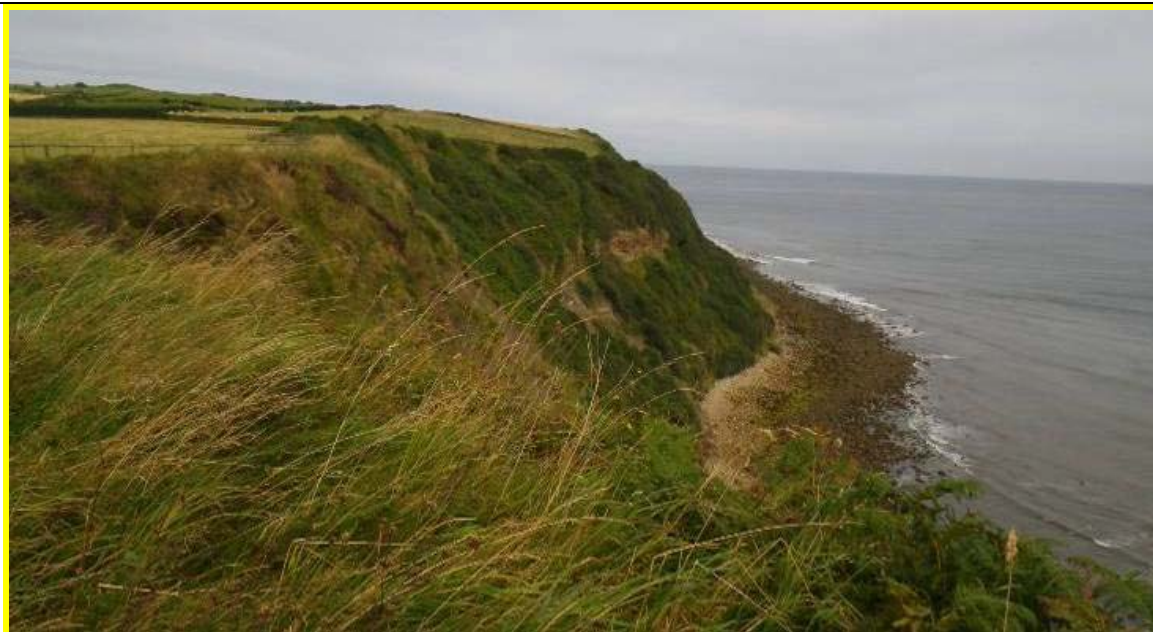
This Sub-Management Unit consists of **unit MU19/1** only. Within this unit the cliffs are generally well vegetated, with minor localised patches of erosion at the unit toe. There is some evidence of marine erosion and small scale rockfall. This unit is classified as Locally Active, and has not changed since 2009.

**MU19/1** the well vegetated cliff face (Locally Active)

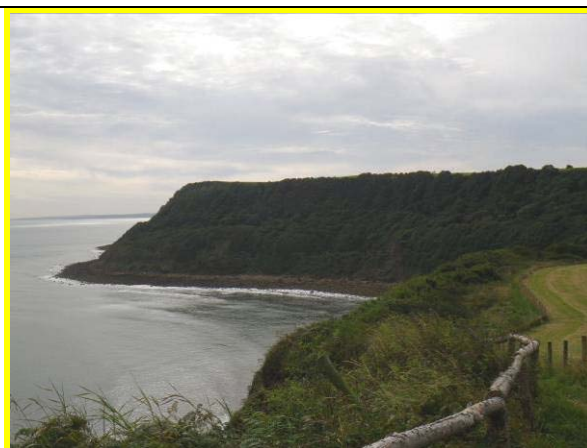
**Unit MU19/3** is located around and to the south of Hayburn Wyke. These cliffs are well vegetated in most places, with only minor localised erosion evident at the toe and headscarp.

**MU19/3** Looking south across Hayburn Wyke (Locally Active)

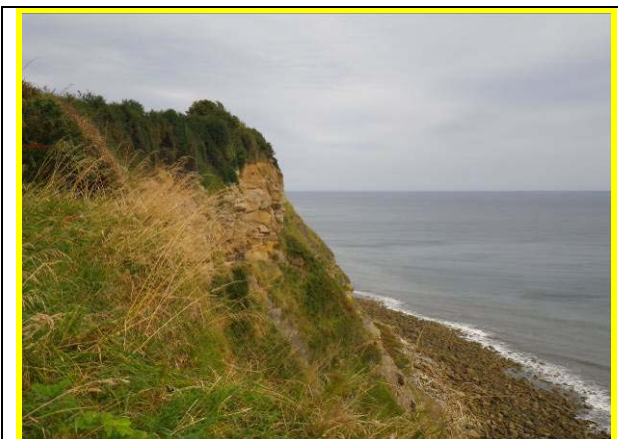
**Unit MU19/5** is located on the northern side of Cloughton Wyke and is classified as Locally Active. The near vertical cliffs are composed of hard rock which have failed through a series of small rockfalls. The cliffs support some vegetation cover and are subject to ongoing marine erosion at the toe.

**MU19/5** Northern side of Cloughton Wyke (Locally Active).

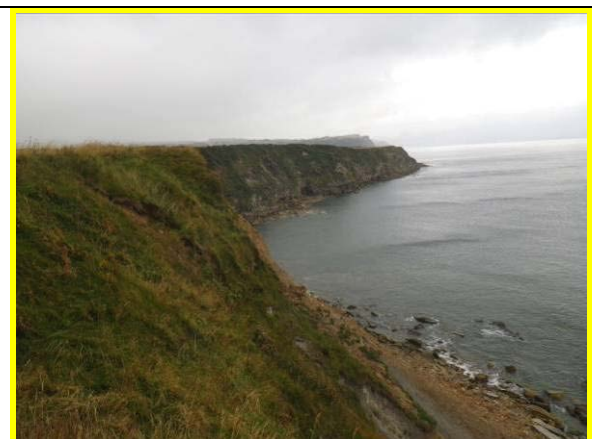
**Unit MU19/6** forms the southern part of Cloughton Wyke and extends southwards to Long Nab. The lower cliff is near vertical with a general absence of vegetation cover. There is evidence of rockfall from this layer onto the shoreline below. The upper part of the cliff is shallower, composed of softer material and is fairly well vegetated. This unit is classified as Locally Active.

**MU19/6** Southern side of Cloughton Wyke (Locally Active).

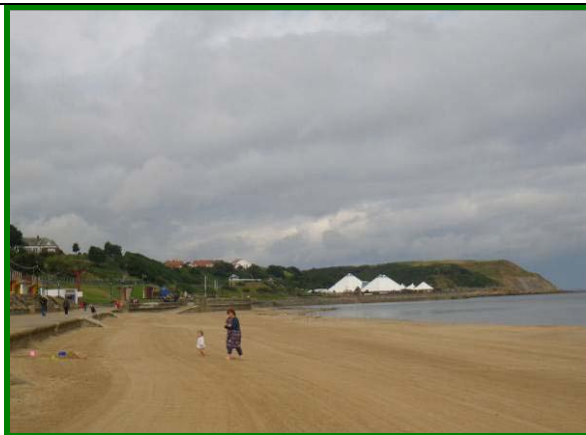
Both of these units are defended at the toe by the sea wall which runs the entire length of North Bay. The slopes are well vegetated and show no obvious evidence of recent activity, thus they are both classified as Dormant, as they were in 2009.

**MU20/1** Dormant

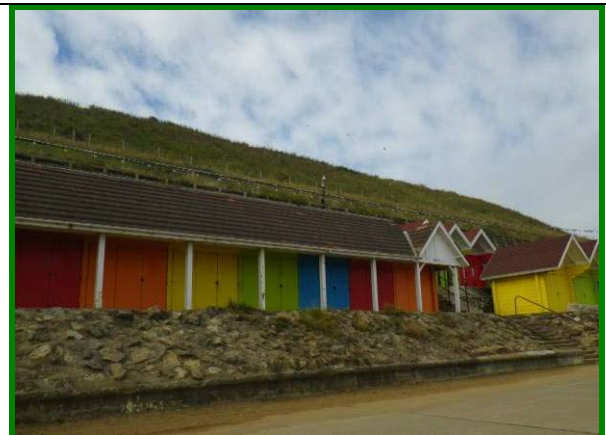
**MU20/2** Behind the sea wall (Dormant)

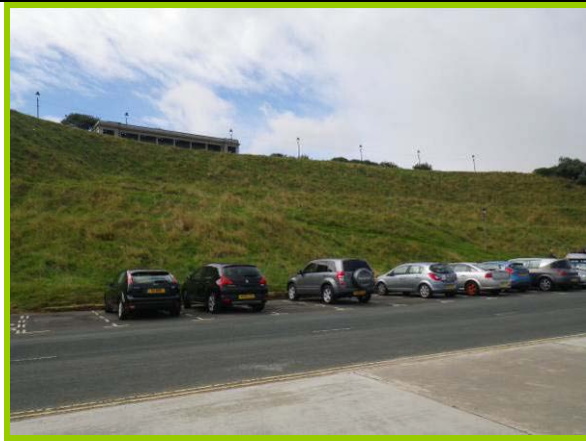
**MU20/3** Well vegetated slopes (Inactive)

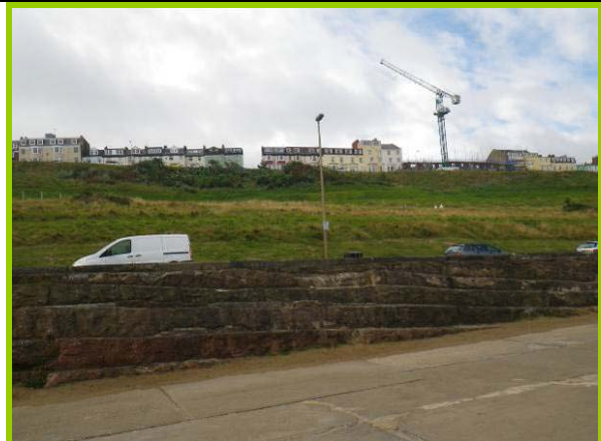
**Unit MU20/4a** is located to the rear of North Sands and is classified as Inactive. The relict slopes are well vegetated with only minor and localised evidence of erosion at the headscarp, it remains classified as inactive.

**MU20/4a** Relict slopes with localised activity (Inactive)

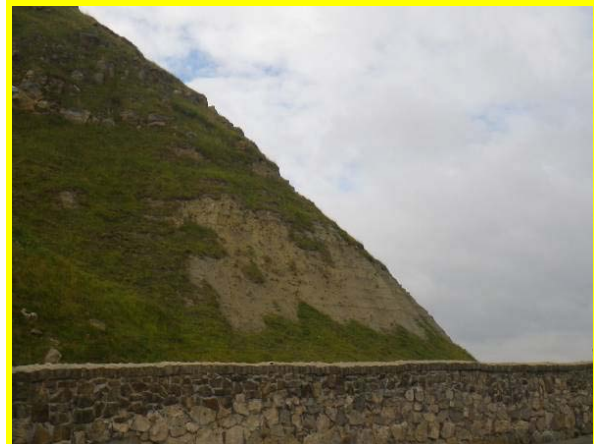
**Unit MU21/2** forms the Castle Cliff promontory and continues to be classified as Locally Active. The cliffs are steep with variable vegetation cover and extensive toe protection measures. Locally, bedrock is exposed where it is subject to ongoing weathering and erosion from rainfall

**MU21/2** Steep, exposed cliff (Locally Active)

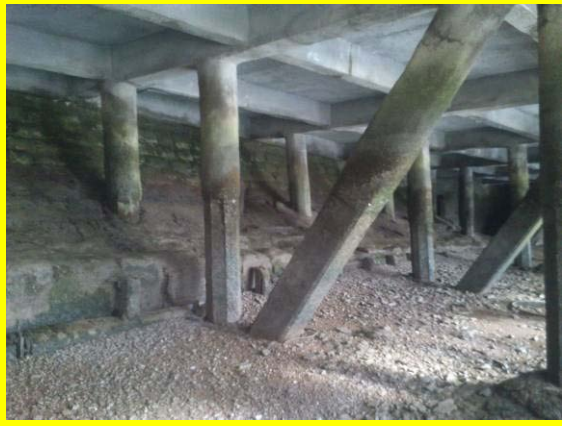
The original quay wall on Sandside (Asset Ref. 1221D901D1301C06) shows signs of deformation; missing joints and movement of blockwork. The newer concrete jetty which has been constructed above also shows signs of movement although still structurally sound. There are also cracks forming on the columns and beams to the underside of the extended jetty with exposed reinforcement bar in places. The section of steel sheet piling adjacent to the east is heavily corroded. At the east end of Sandside the promenade is supported by several arches built in front of the original quay. These appear in fair condition but there is damage to the concrete capping, see below right and the ladders are rusted.

The original quay wall beneath the newer concrete jetty (Asset Ref. 1221D901D1301C06)

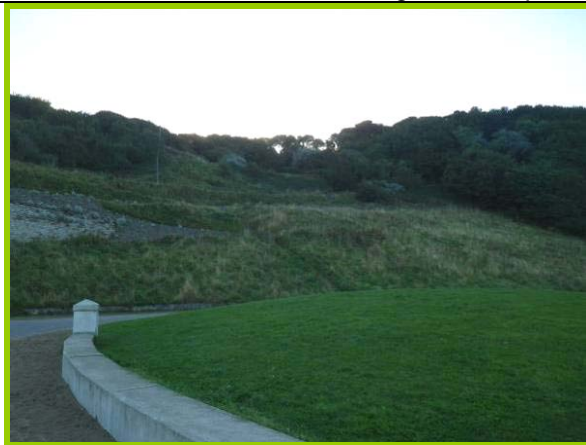
**MU22/6** Well-vegetated slopes behind the former bathing pool (Inactive).

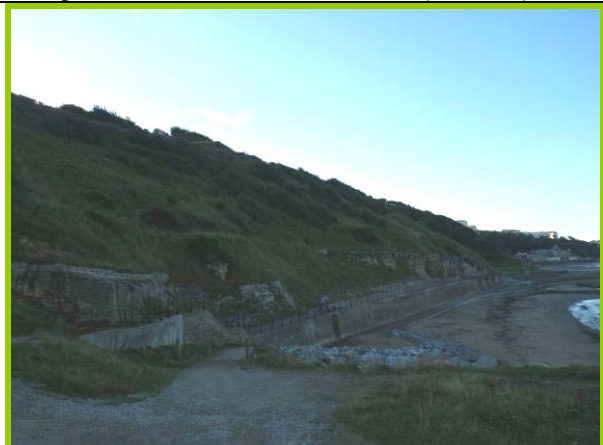
**Unit MU22/7** is located at Holbeck Gardens (just north of the run-out lobe) and is classified as Inactive. A number of footpaths in this area remain closed due to cracking and ongoing instability. However this does not represent an increase in activity since 2008. Otherwise, the slopes are well vegetated.

**MU22/7** The cliff face shows stability overall (Inactive).

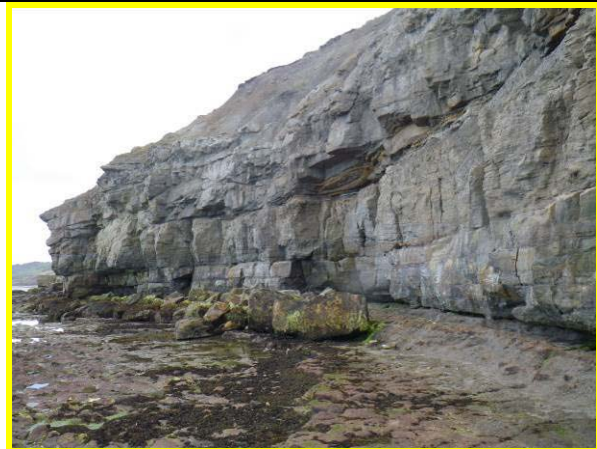
**MU23/D3** Joint bound blocks in the cliff face (Locally Active)

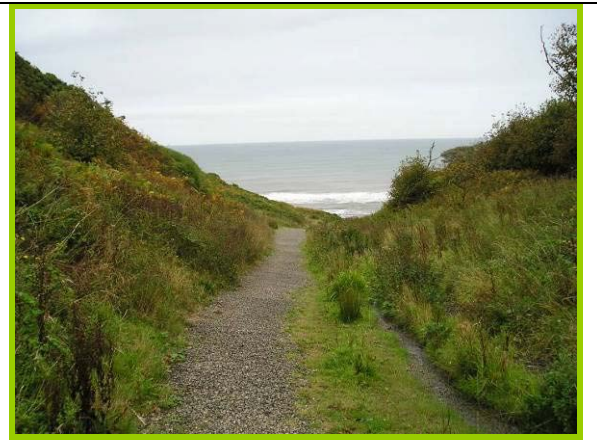
**Unit MU23/F** is a narrow, thin unit which follows a small valley occupied by a outflow channel for a pipeline and pumping station. The slopes are well vegetated and show very little evidence of recent activity. As a result, this unit is classified as Inactive.

**MU23/F** Engineered channel with little evidence of activity (Inactive) (photo from 2009)

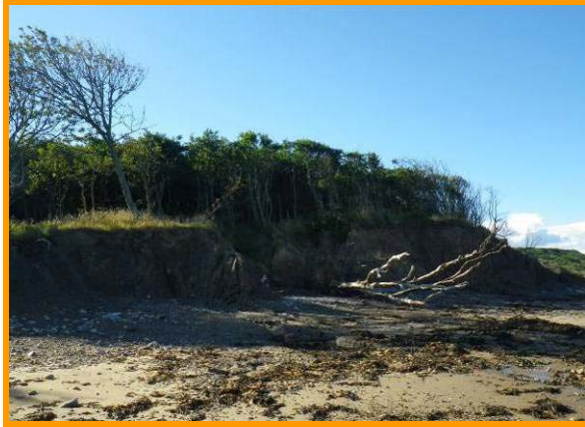
recent activity at the headscarp, which has experienced localised slumps. **Units MU23/I1, MU23/I2 and Mu23/I3** form smaller mudslides at the toe of unit 23/I. MU23/I1 is Partly Active while MU23/I2 and I3 are Locally Active.

**MU23/I1** Densely vegetated upper part of Cornelian cliff (Partly Active)

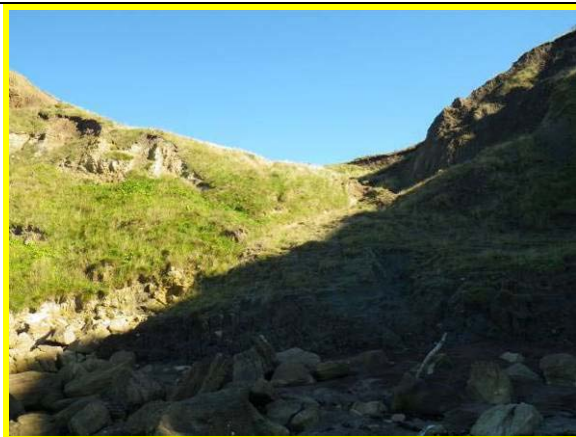
**Unit MU23/I4** situated on the north side of the Knipe Point headland and is composed of soft glacial material. The unit was classified as Totally Active in 2009, when the retreating cliffs of this unit were almost entirely affected by intense erosion, with little vegetative cover. The unit is more stable in 2012 and has been reclassified as Locally Active.

**MU23/I4** Recent headscarp activity between Cayton and Cornelian Bays (Locally Active)

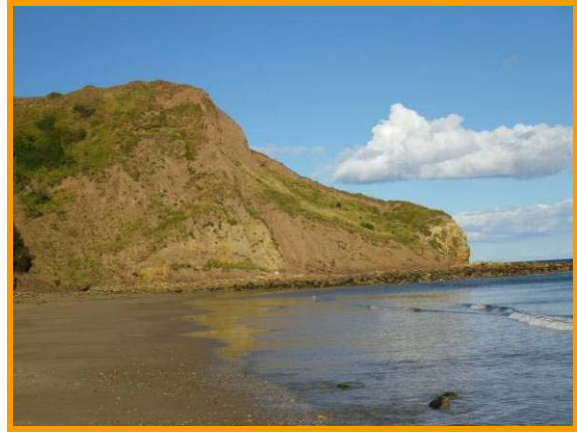
**Units MU24/A8 and MU24/A7** are situated on the east and south facing sides of Knipe Point respectively and are both classed as Partly Active. The unit frontages are almost entirely exposed and experiencing intense erosion. There is some evidence of past rockfall activity.

**MU24/A7 and A8** Exposed slopes (Partly Active)

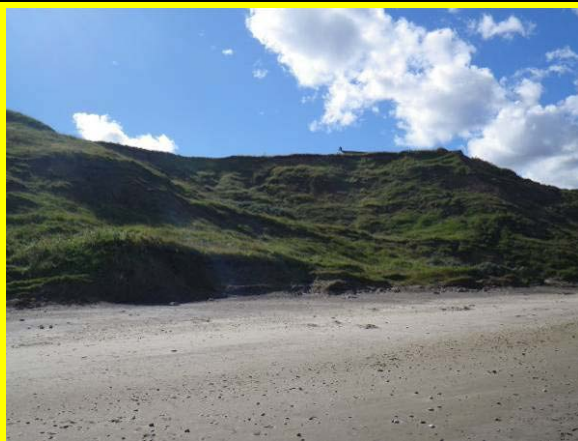
**MU24/E** Looking south (Partly Active)

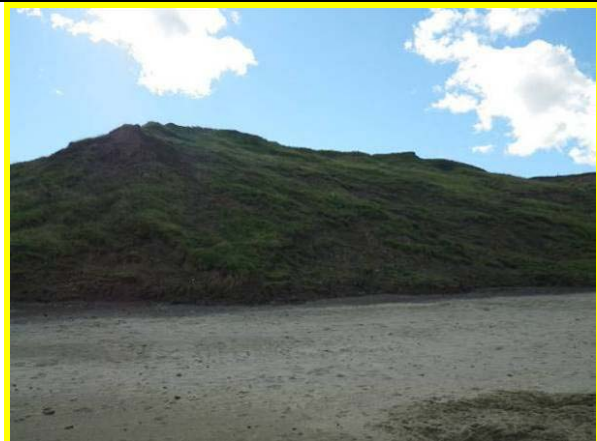
**MU24/F and G** Well vegetated slopes (Locally Active)

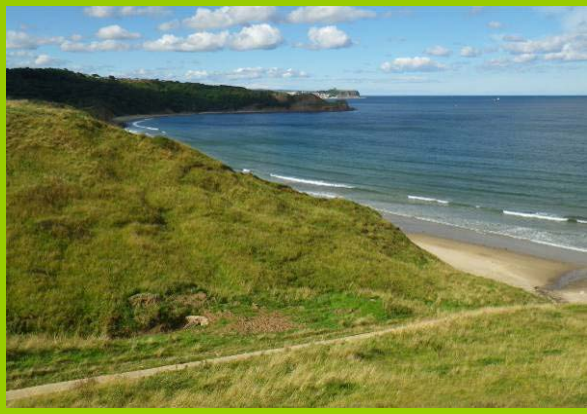
**MU24/H** Access route to Cayton Sands (Inactive)

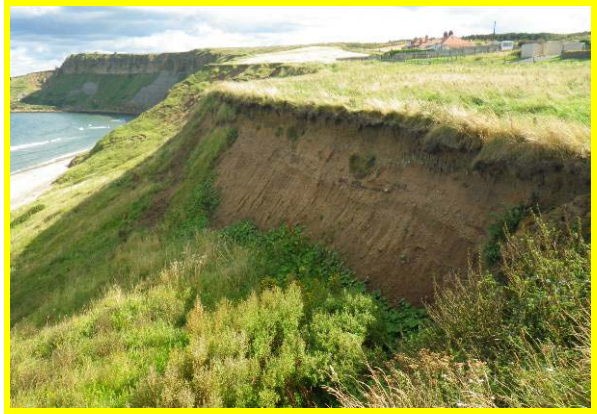
**MU24/J** Localised headscarp recession (Locally Active)

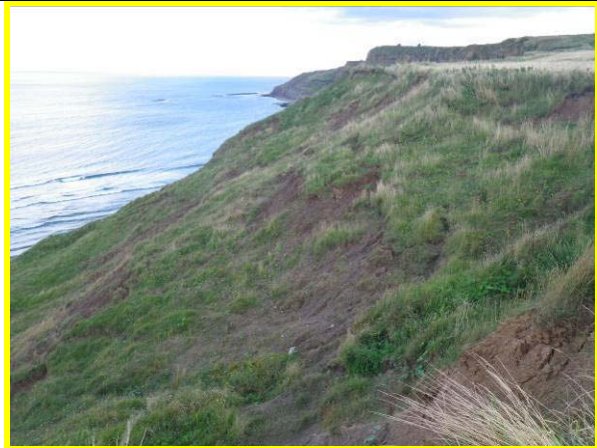
**MU24/L** Localised headscarp recession (Locally Active)

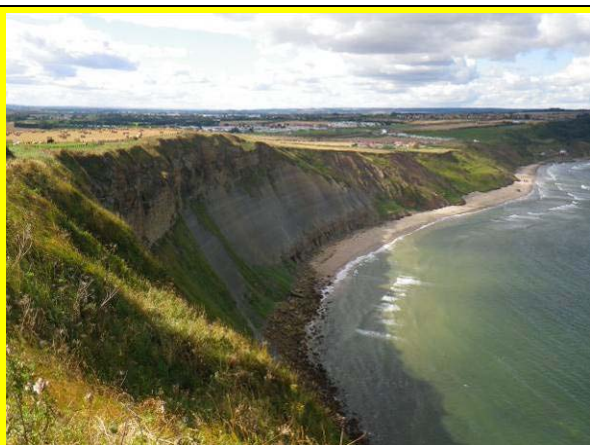
**MU25/U** Steep, exposed rock cliffs (Locally Active)

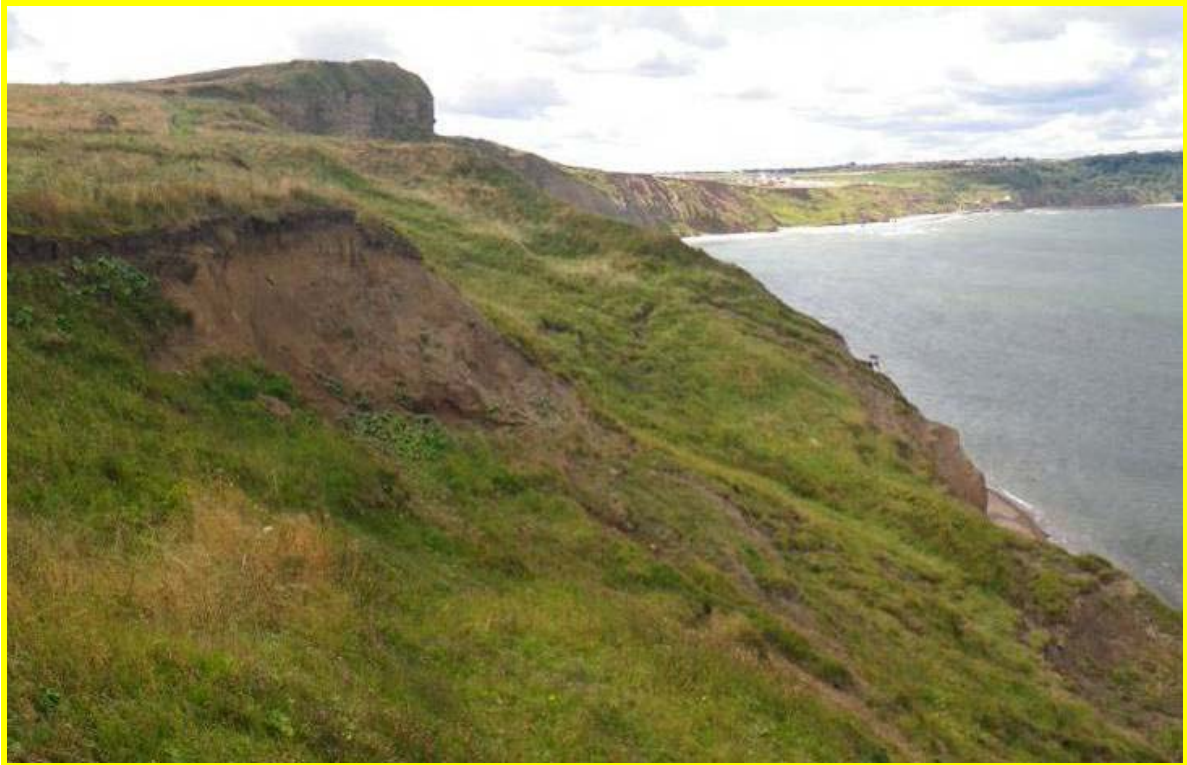
**Unit MU25/W** is situated at Red Cliff Point and is classified as Locally Active again in 2012. The slopes of this unit are well vegetated with localised cracks and freshly slumped material.

**MU25/W** Headscarp recession and patchy vegetation (Partly Active)

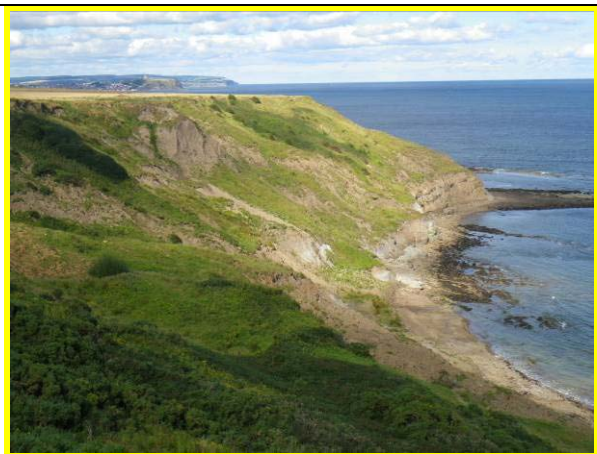
**Units MU25/Y and MU25/Z** are located at the northwest end of Gristhorpe Cliff and are classified as Partly Active. These units are characterised by localised areas of activity, with headscarp recession, slumps in the mid-slope and on-going erosion of the toe. Both units were previously classified Locally Active in the 2009 walkover survey.

**MU25/Y** Headscarp recession and mid-slope activity (Locally Active)

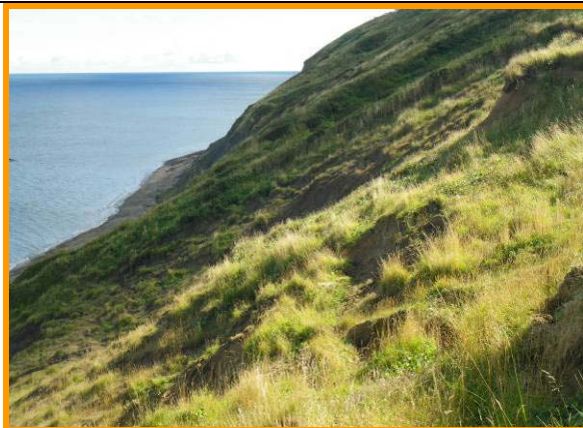
**Units MU25/AB and MU25/AC** form the main part of Gristhorpe Cliff and are adjacent to a caravan park. The upper cliff slopes are composed of soft glacial sediments and experience localised slumping, with headscarp recession. The face of the cliff is steeper with active erosion and formation of debris aprons. Unit MU25/AB is Partly Active, while MU25/AC is Locally Active, having been downgraded in 2012 from Partly Active.

**MU25/AB** Upper vegetated slopes (Partly Active)

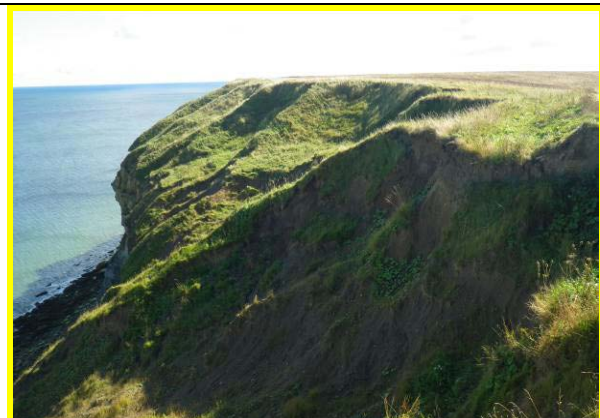
**MU26/AH** The soft upper layer of this unit (Locally Active)

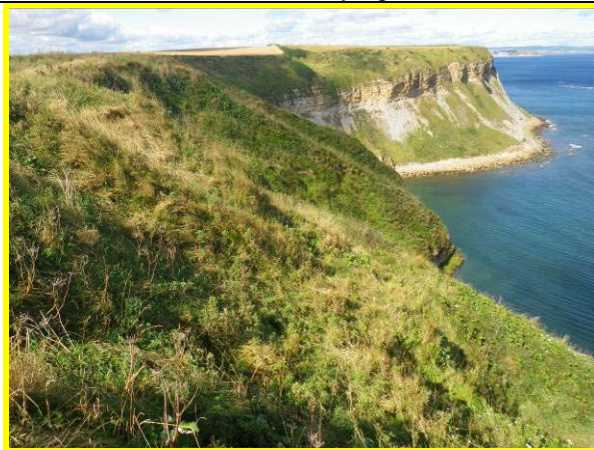
**MU26/AK and MU26/AL** have both been downgraded from Partly Active in 2009 to Locally Active in 2012. Both units are heavily vegetated and stable.

**MU26/AK** The vegetated upper cliff (Locally Active)

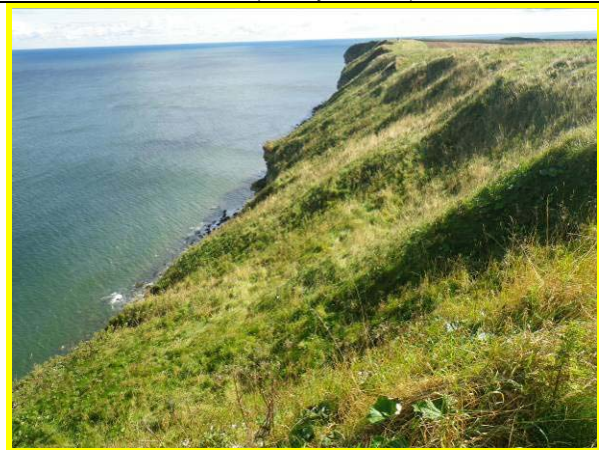
**MU26/AL** The vegetation on the top and mid-cliff (Locally Active)

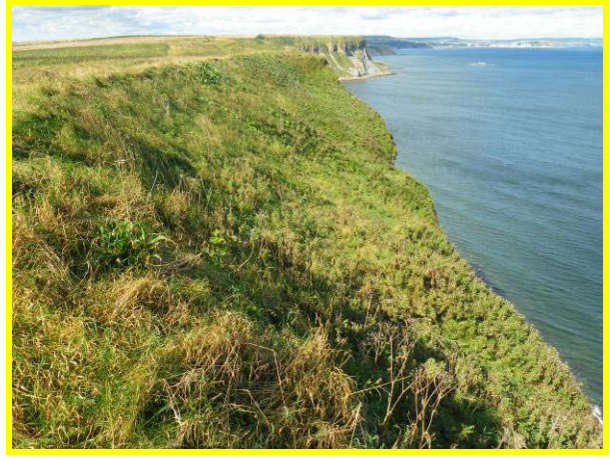
**MU26/AO** Locally Active, with vegetated upper slopes

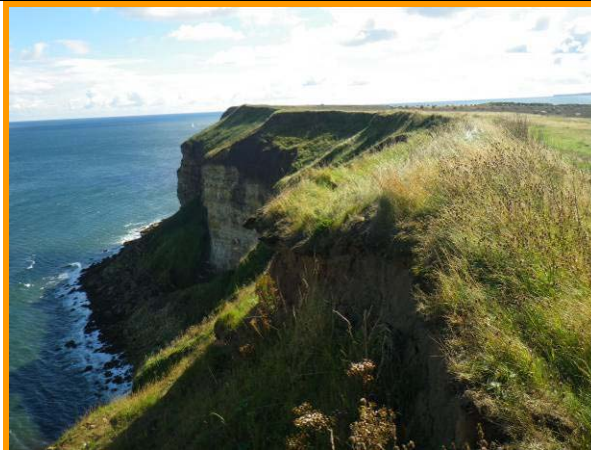
**MU26/AP** Partly Active, with vegetated upper slopes

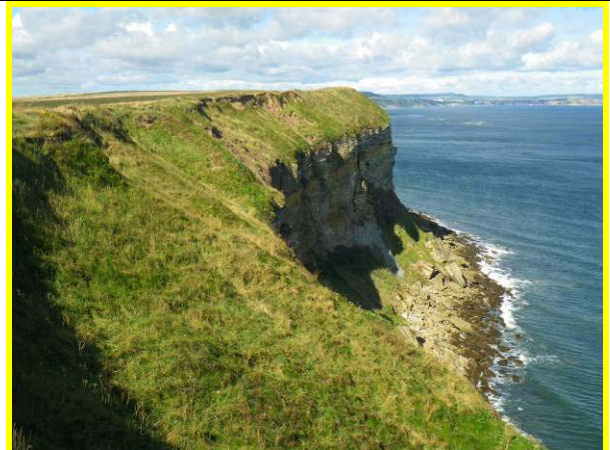
**MU26/AQ** Exposed, vertical lower cliff (Locally Active)

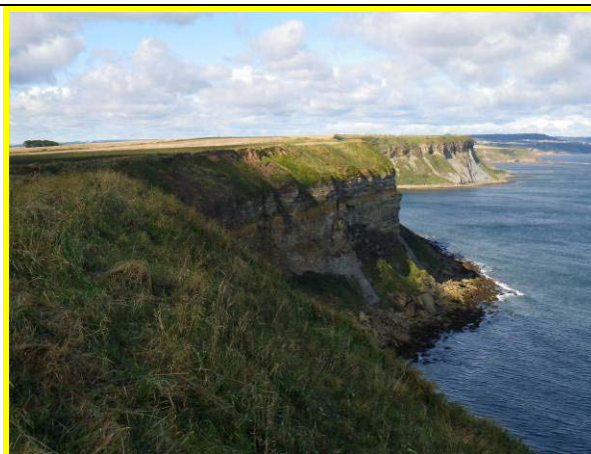
**MU26/AR** Three-tiered stratigraphy (Locally Active)

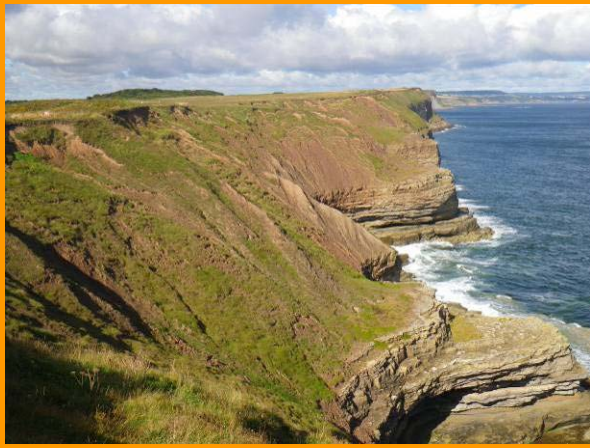
**MU27/BD** Erosion of the sea cliffs with a (Partly Active)

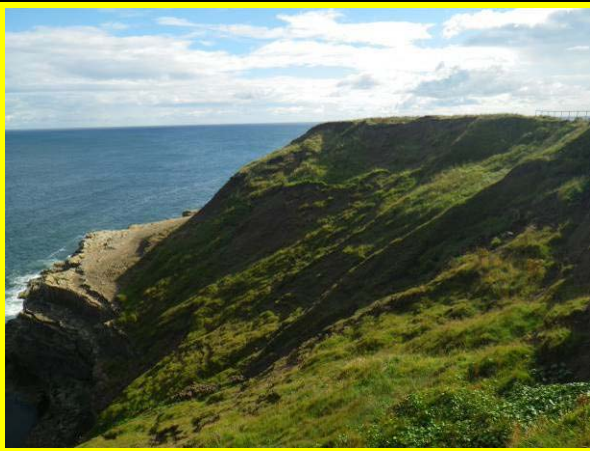
**MU27/BF** Well vegetated upper slopes (Locally Active)

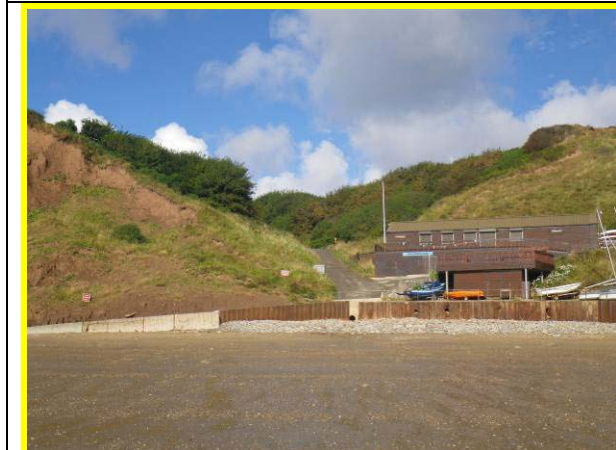
**MU27/U** entry to the sailing club (Locally Active)

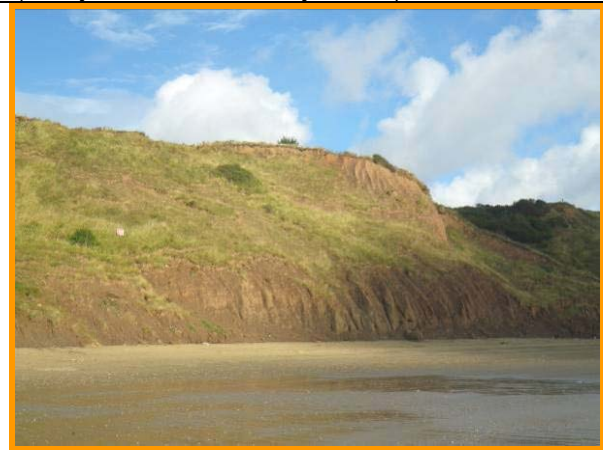
**Unit MU27/V**, is located just south of the sailing club. The unit was classified as Partly Active again in 2012. This unit is lacking in vegetation cover, has an eroding headscarp and is heavily rilled and gullied.

**MU27/V** Slopes around Filey sailing club (Partly Active)
