**Walk-over Visual Inspections of Assets  
including Coastal Slopes**

**Scarborough Borough Council  
Final Report**

**October - November 2012**

## Coast Protection Assets and Coastal Slope Condition Analysis

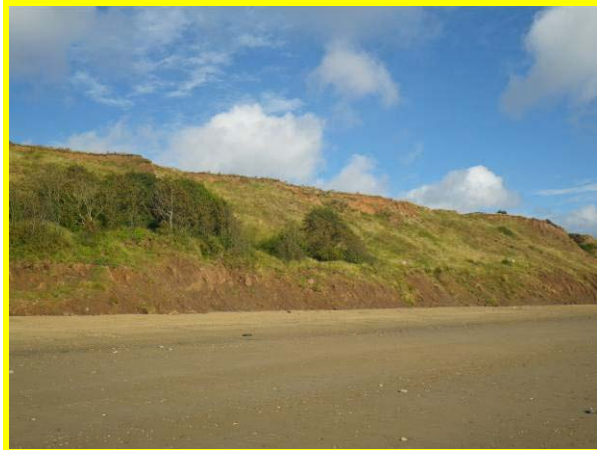
**Units MU27/W and MU27/X** lie immediately north of Filey town. Vegetation cover of these units is variable, with localised areas of activity throughout. There is ongoing recession at the headscarp and erosion of the toe by marine activity. These units are classified as Locally Active in 2009 and 2012.

**MU27/W** entry to the sailing club (Locally Active)

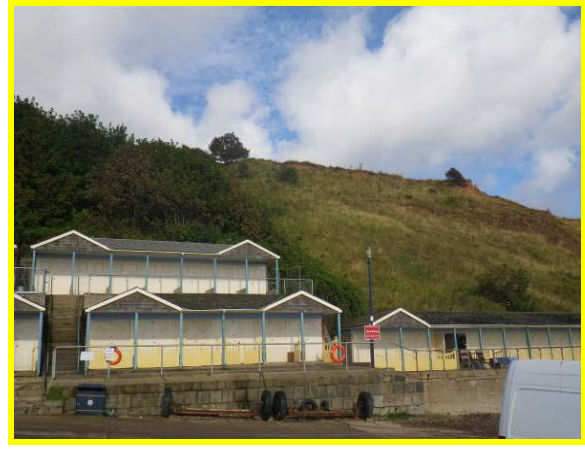
**MU27/X** entry to the sailing club (Locally Active)

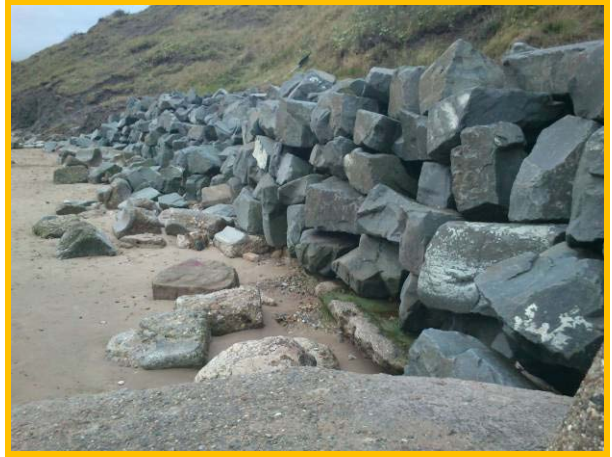
A short section of rock revetment with gabion baskets beneath is located at the southern end of Filey Seawall near Martin's Gill, (Asset Ref. 1221D901D1602C02). This defence extends into Sub-Management Unit Mu29A and is to manage the interface between the hard defences to the north and eroding natural cliff to the south. The rock armour has degraded again since the previous inspection. The rock is in a single layer and is stacked near vertically, so is unstable, particularly as the slumping cliffs behind may be pushing rock over. There were two areas of collapse - at the centre and at the south end. The rock needs rebuilding with additional rock to a more stable profile.

Rock revetment with gabion baskets beneath. 09/11/2012. (Asset Ref. 1221D901D1602C02)

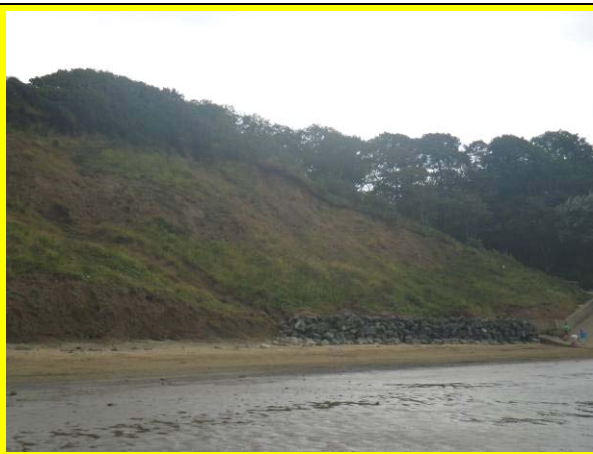
**Units MU29/AA and MU29/AB** are located immediately south of Filey town and are classified as Locally Active. Despite the presence of some rock armour protecting the toe of **unit MU29/AA**, there are very common areas of intense erosion and active recession of the headscarp. **Unit MU29/AB** is not defended at the toe and is steep and undergoing active erosion as a result. Both units were classified as Partly Active in the 2009 walkover survey.

**MU29/AA** Very common intense erosion and headscarp recession (Locally Active)

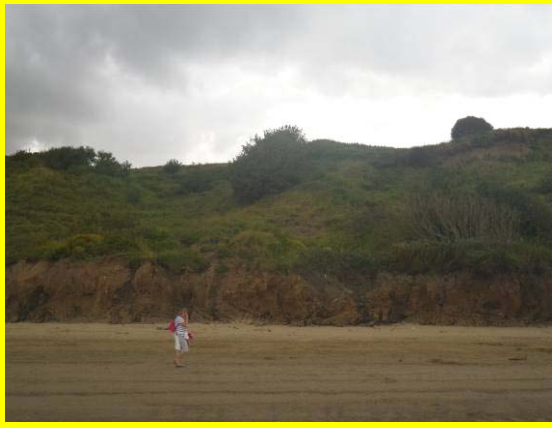
**MU29/AC** Well vegetated with some toe erosion (Locally Active)

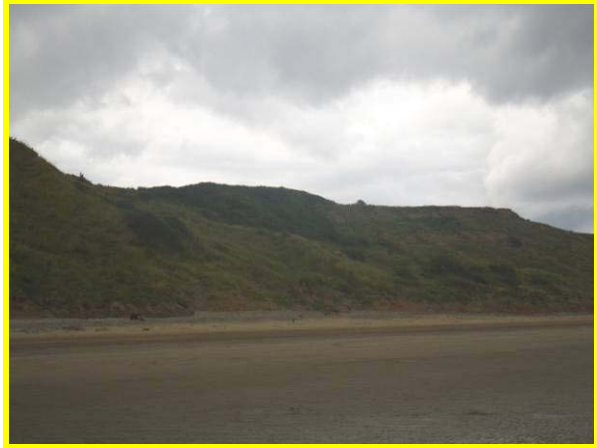
**MU29/AD** Recession of the headscarp (Locally Active)

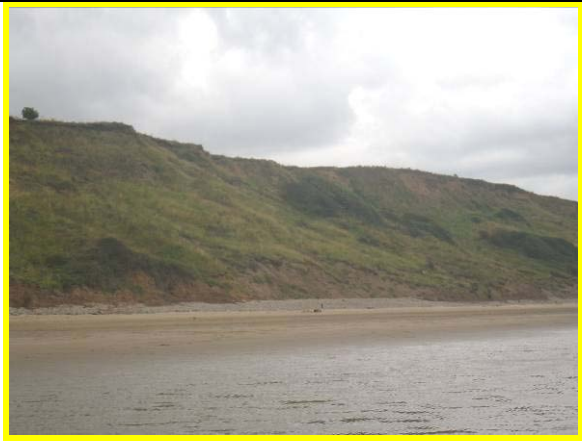
**MU29/AF** Well vegetated with some toe erosion (Locally Active)

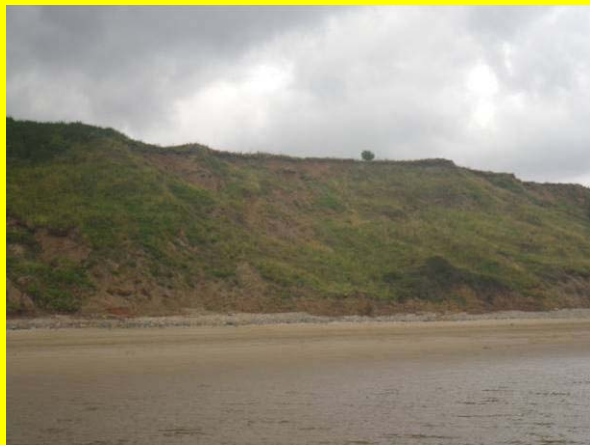
**MU29/AG** The slope is showing localised signs of erosion (Locally Active)

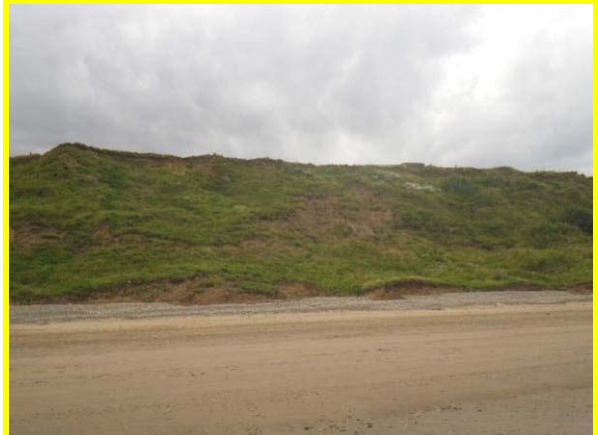
**MU29/AK** Well-vegetated low lying cliffs (Locally Active).

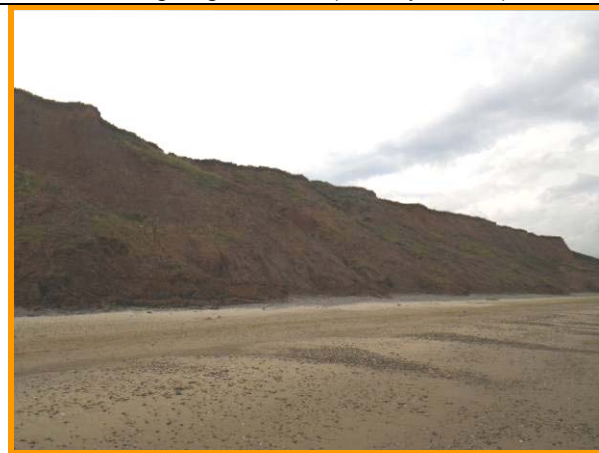
**MU29/BD** Slumping and sliding on the beach (Partly Active).

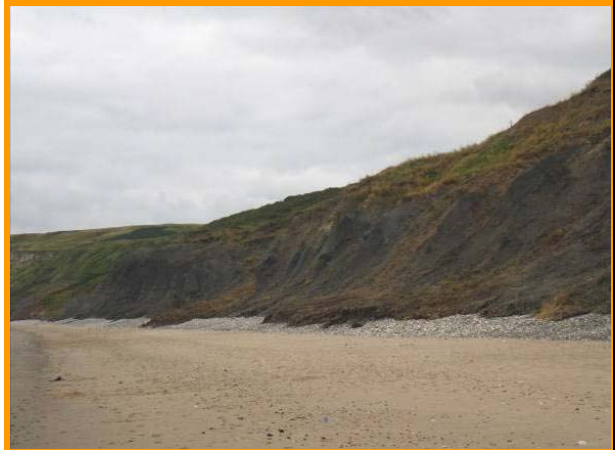
**Unit MU29/CD** forms another large shallow embayment which is also well vegetated. Despite this though, the slopes are almost entirely affected by activity in the form of cracking and sliding especially on the mid-slopes. As a result this unit is classified as Partly Active, as it was in 2009.

**MU29/CD** Mid-slope mudsliding (Partly Active)

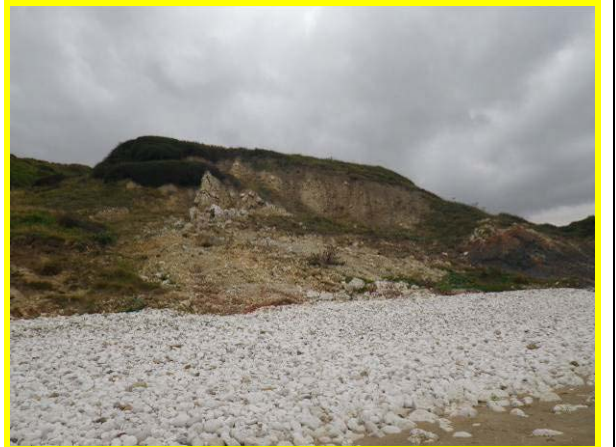
**MU29/CF** Actively eroding cliff toe (Locally Active)

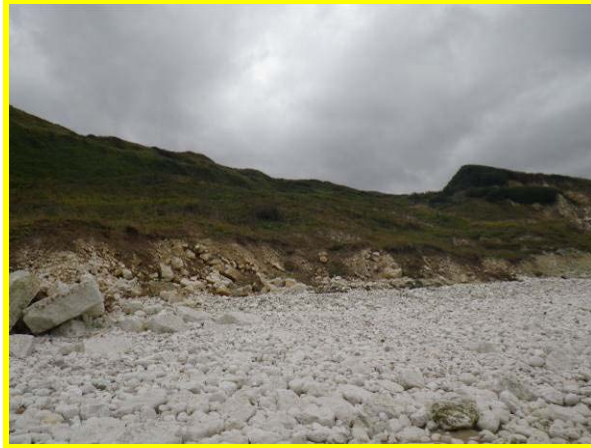
**MU29/CG** Actively eroding cliff toe (Locally Active)
