Analysis and Interpretation of Coastal Monitoring Data

Geotechnical Interpretative Report

Document Ref No 721228/001/GR/01/FINAL
February 2009

Scarborough Borough Council
Town Hall
St. Nicholas Street
Scarborough
N. Yorkshire
YO11 2HG

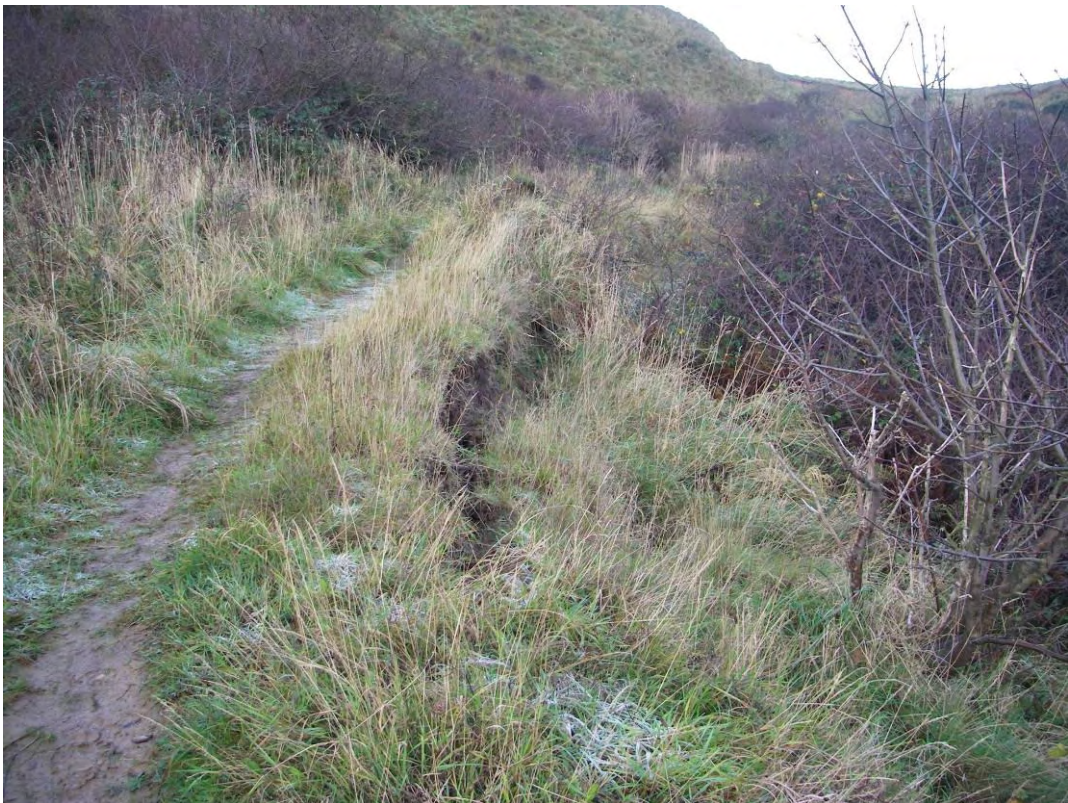
Plate 14. Site view of slopes showing mid-slope back rotated block and surface tension cracking.

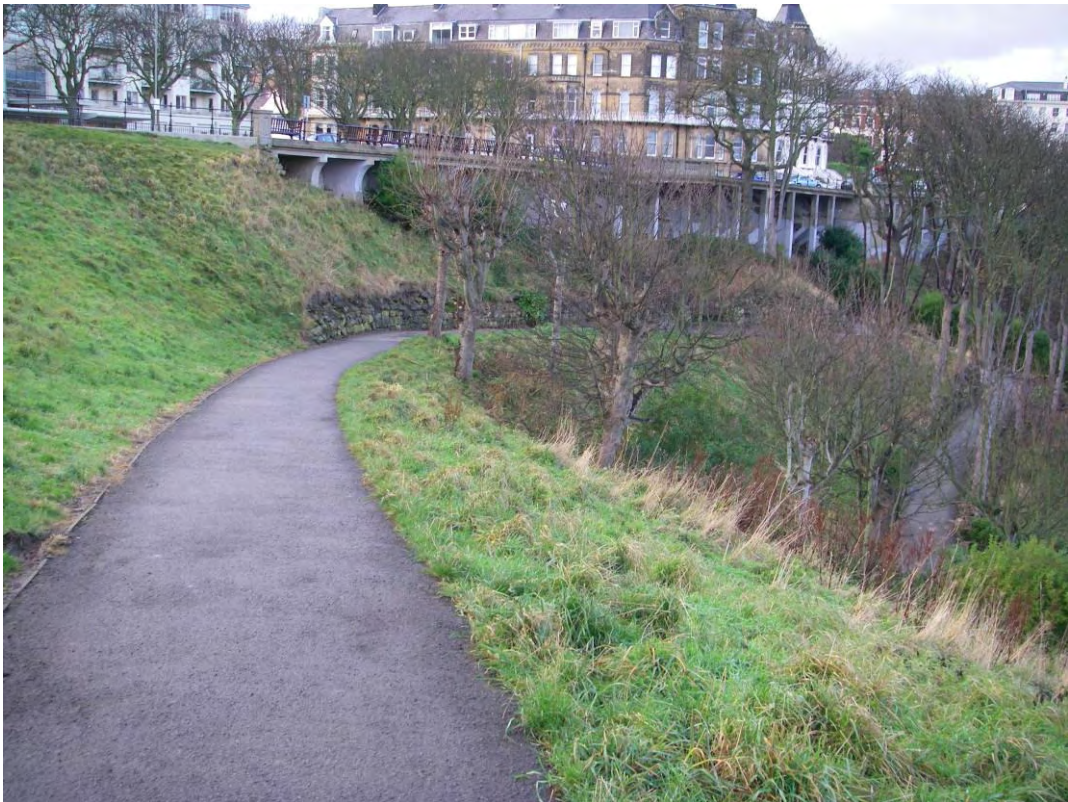
Plate 24. Site view looking north at arcuate embayment at South Cliff Gardens.

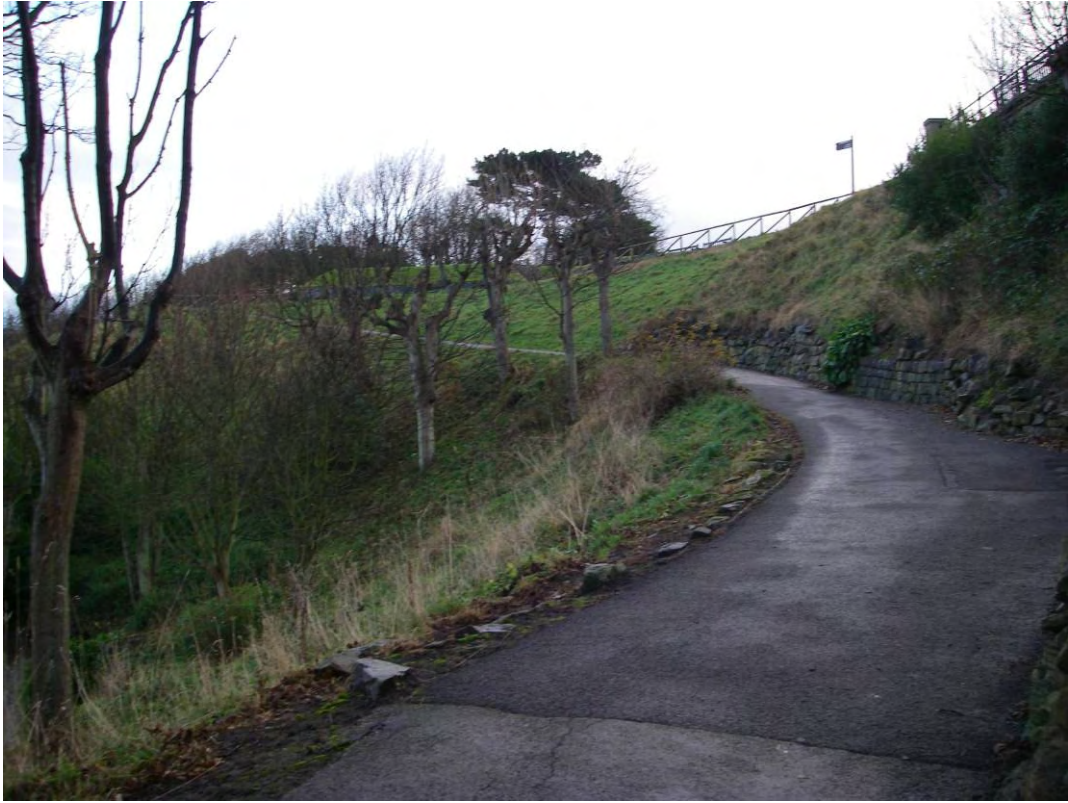
Plate 25. Site view looking south at arcuate embayment at South Cliff Gardens.

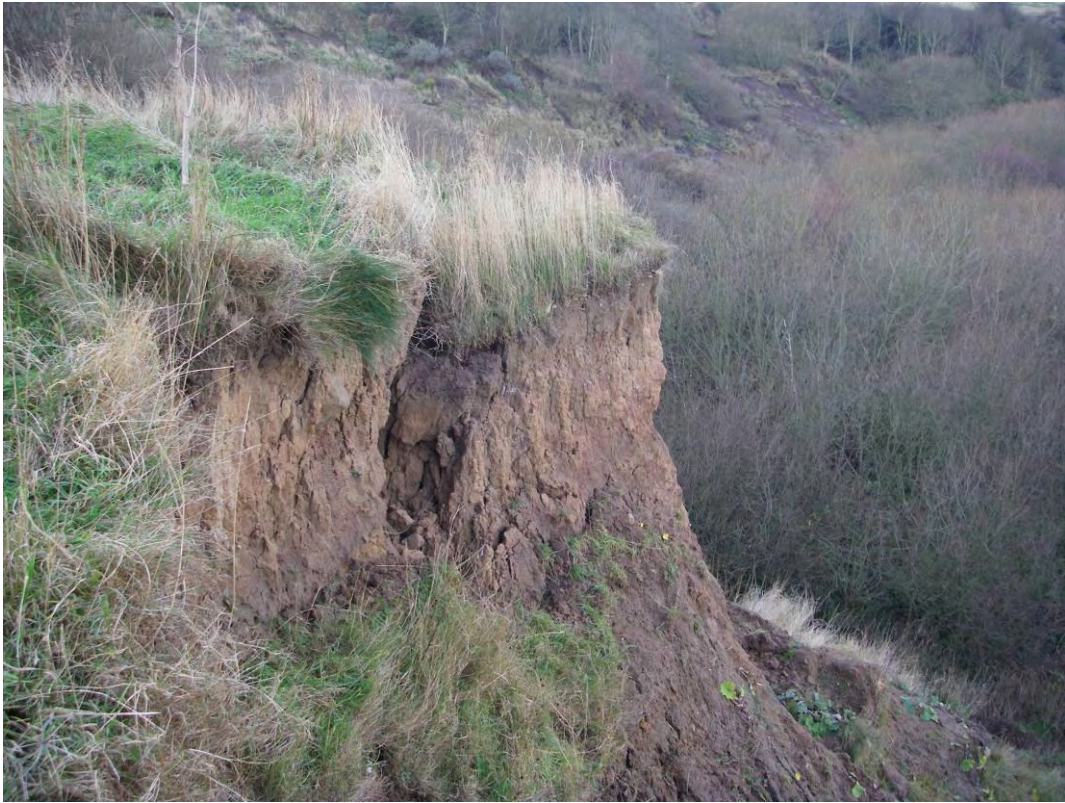
Plate 36. Site view looking north across north side of Knipe Point.

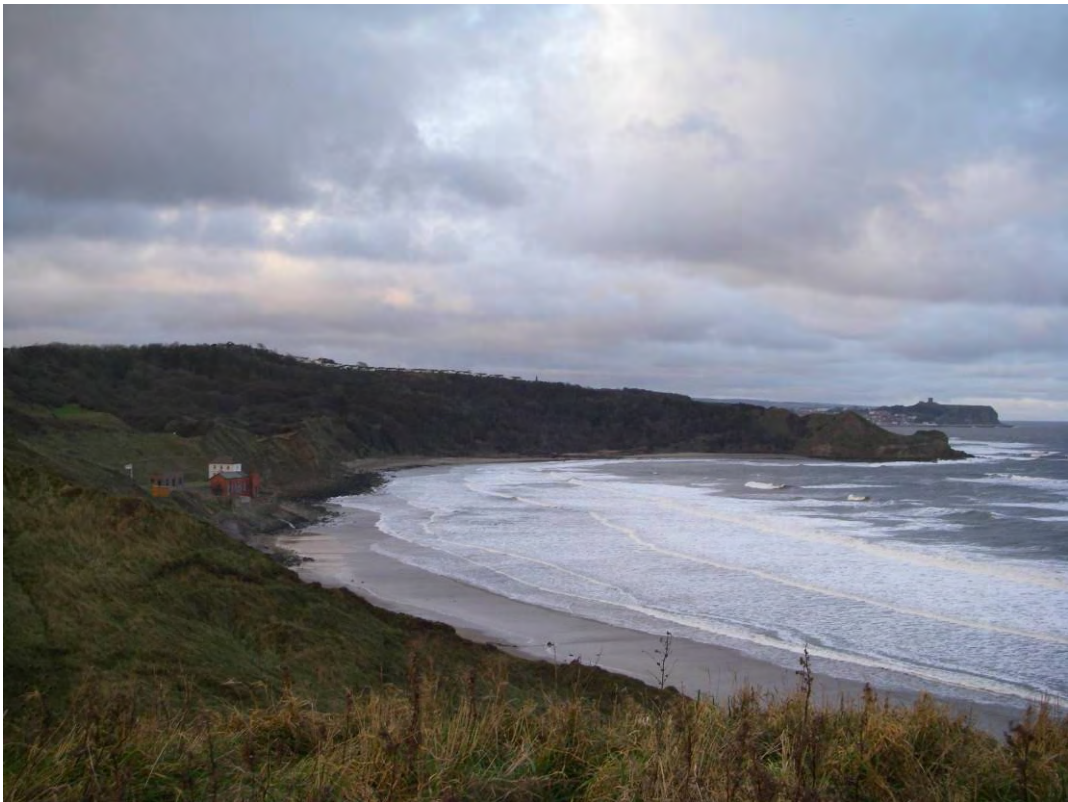
Plate 41. Site view looking north across Cayton Bay towards Knipe Point.

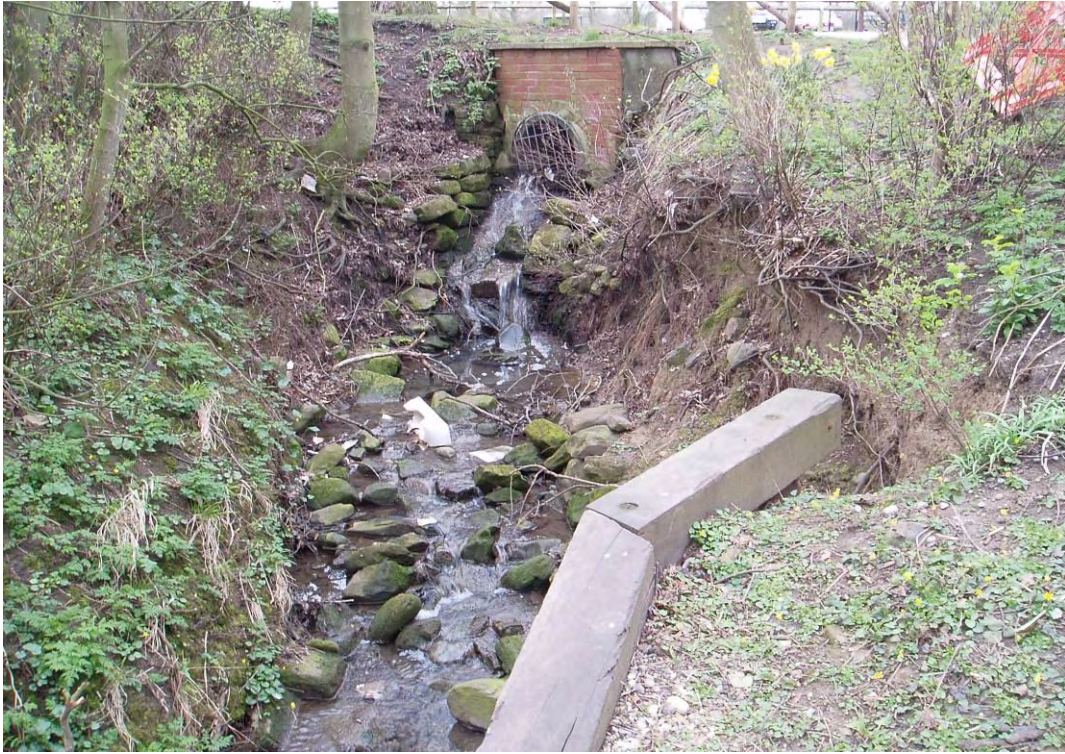
Plate 45. Site view looking up Martin's Ravine at outfall.

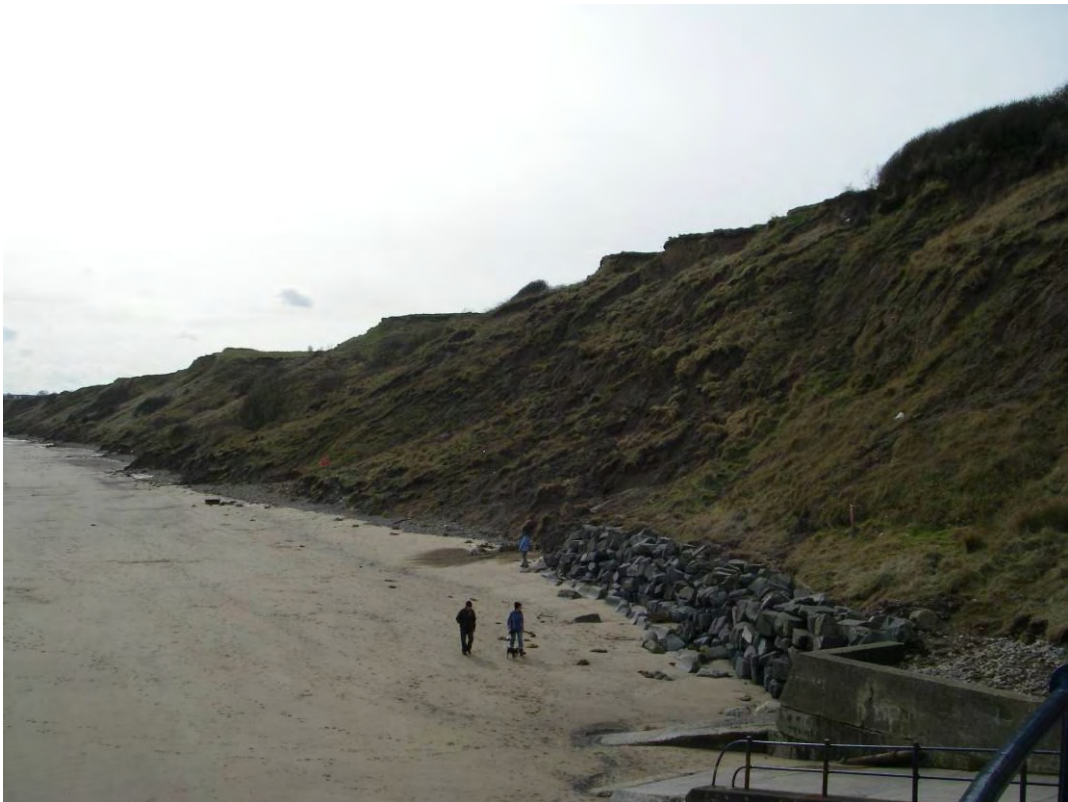
Plate 48. Site view of coastal slopes immediately south of Martin's Ravine.

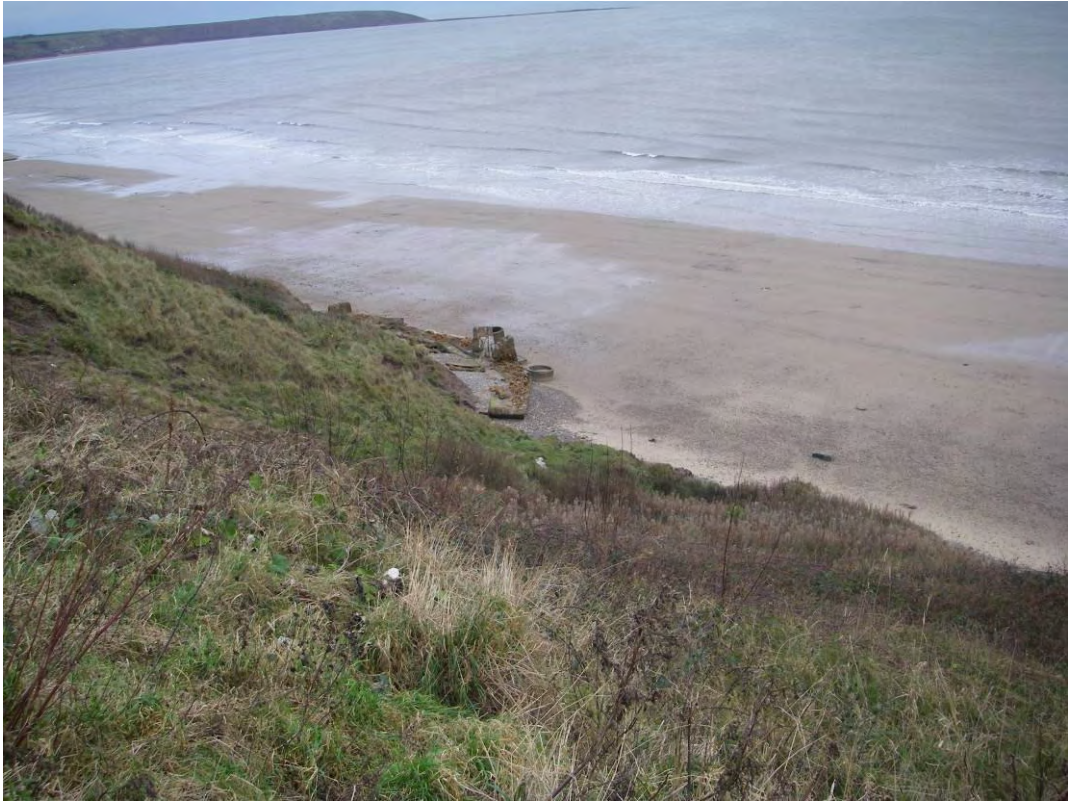
Plate 53. Site view looking north across Filey Bay towards Filey Brigg.

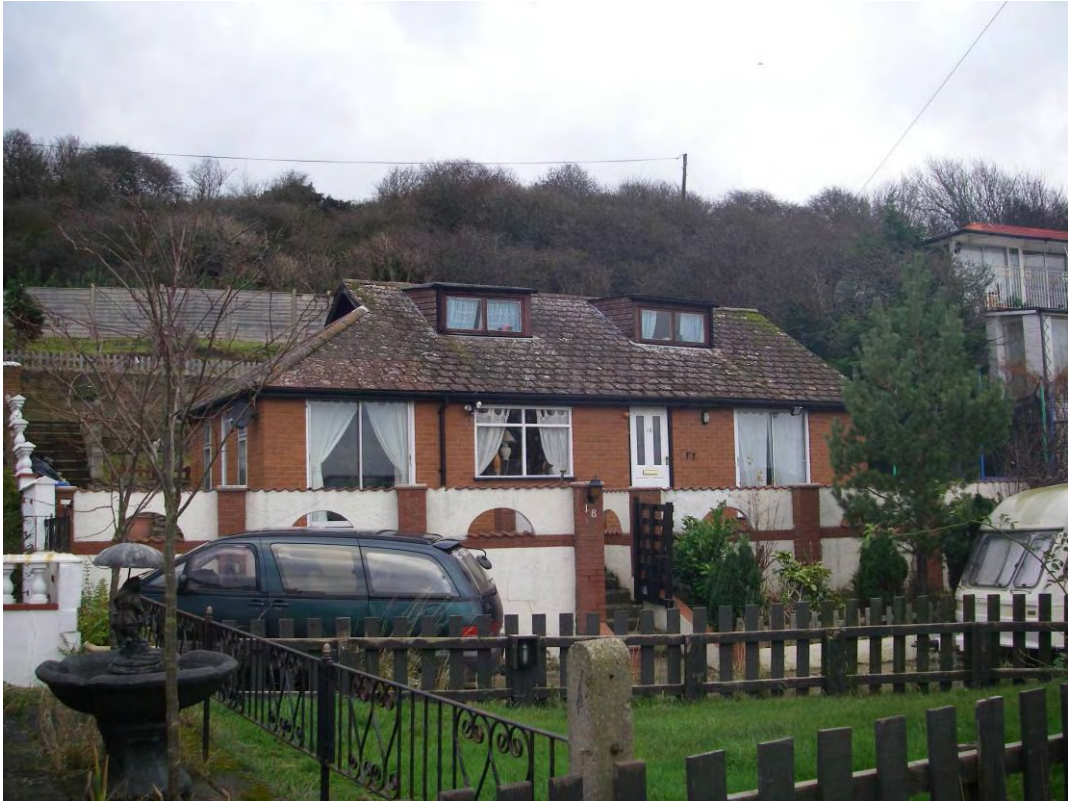
Plate 57. Site view of property on 'level' mid-slope bench with steep back slopes in background.
