Ongoing Analysis and Interpretation of Coastal Monitoring Data

Initial Review of Full Suite Monitoring

Geotechnical Interpretative Report

Document Ref. No. 721229/002/GIR/002/Final

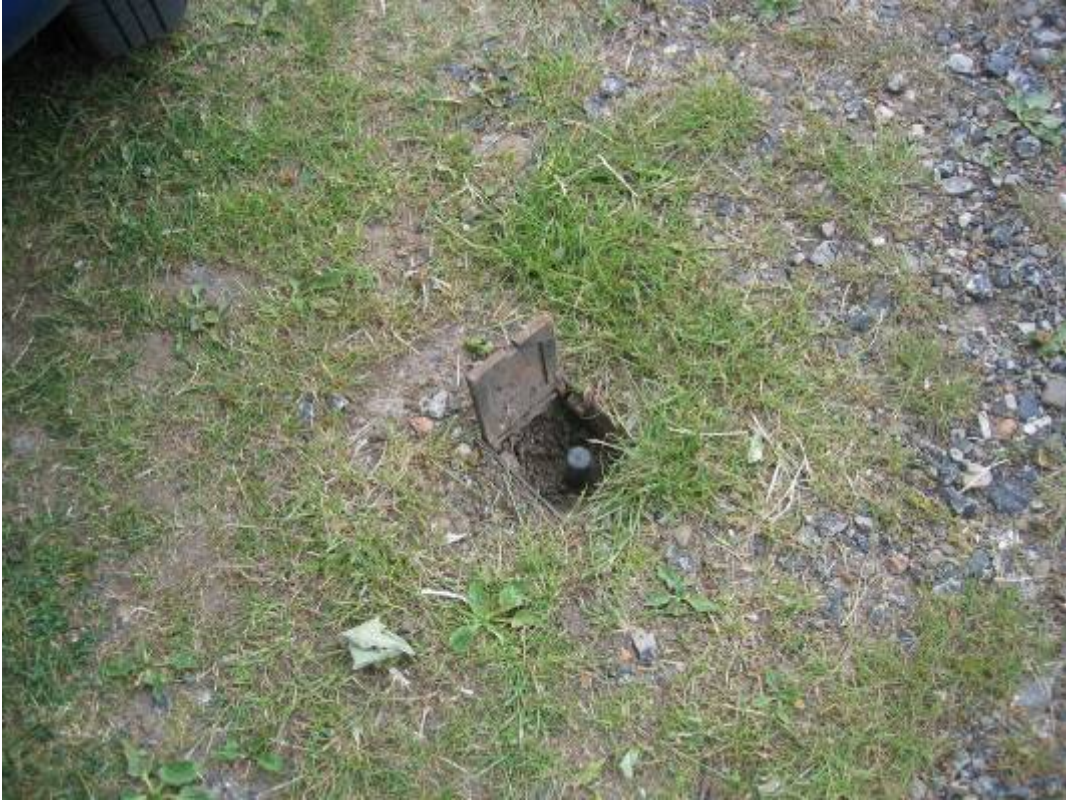
Plate 53 Filey Flat Cliffs A2

During a ground investigation undertaken at Flatt Cliffs in 2001, two inclinometers (A2 and D2) and three piezometers (A3, B1 and D1) were installed as part of this fieldwork. The location of the instrumentation is presented on Figure No. 8. Following a review of data provided by SBC, monitoring details have not been made available for the two inclinometers. However, data has been made available for the three piezometers installed at this site during a ground investigation in 2001. The readings start from the earliest date of March 2001 up to September 2008. Ground water level readings have also been provided from the inclinometer tube instruments (A2 and D2) from February-May 2003 to October 2004.

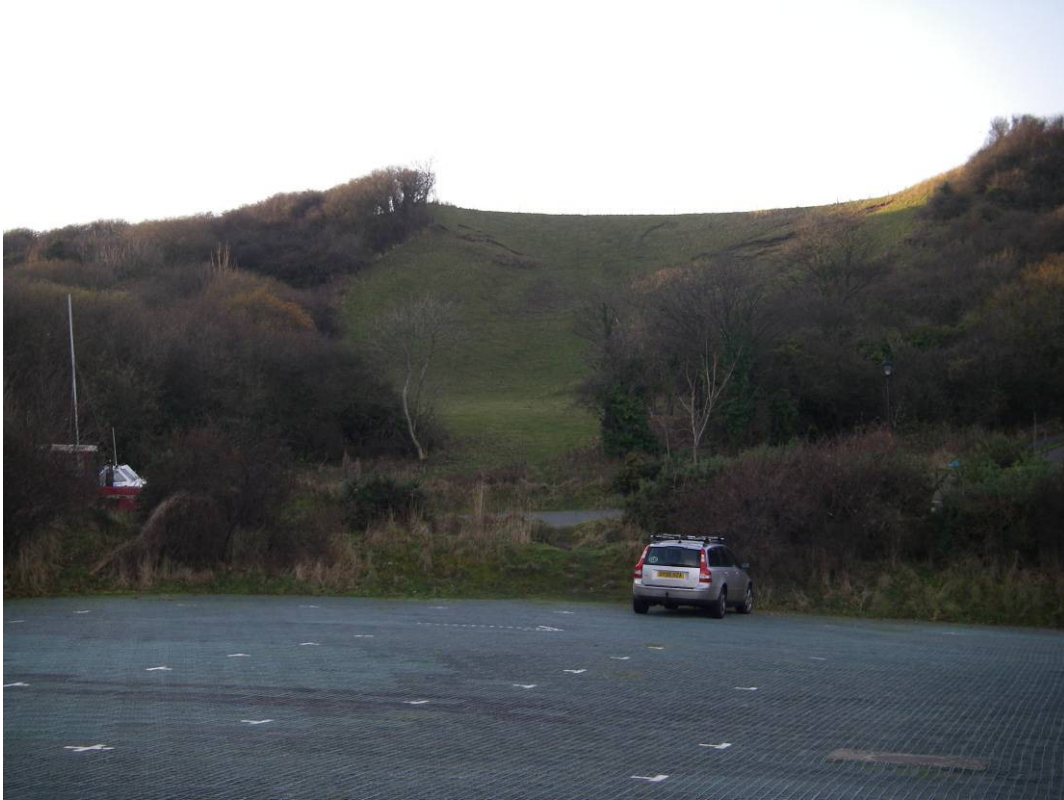
Plate 1 Site view showing slope morphology looking west towards Ings End.

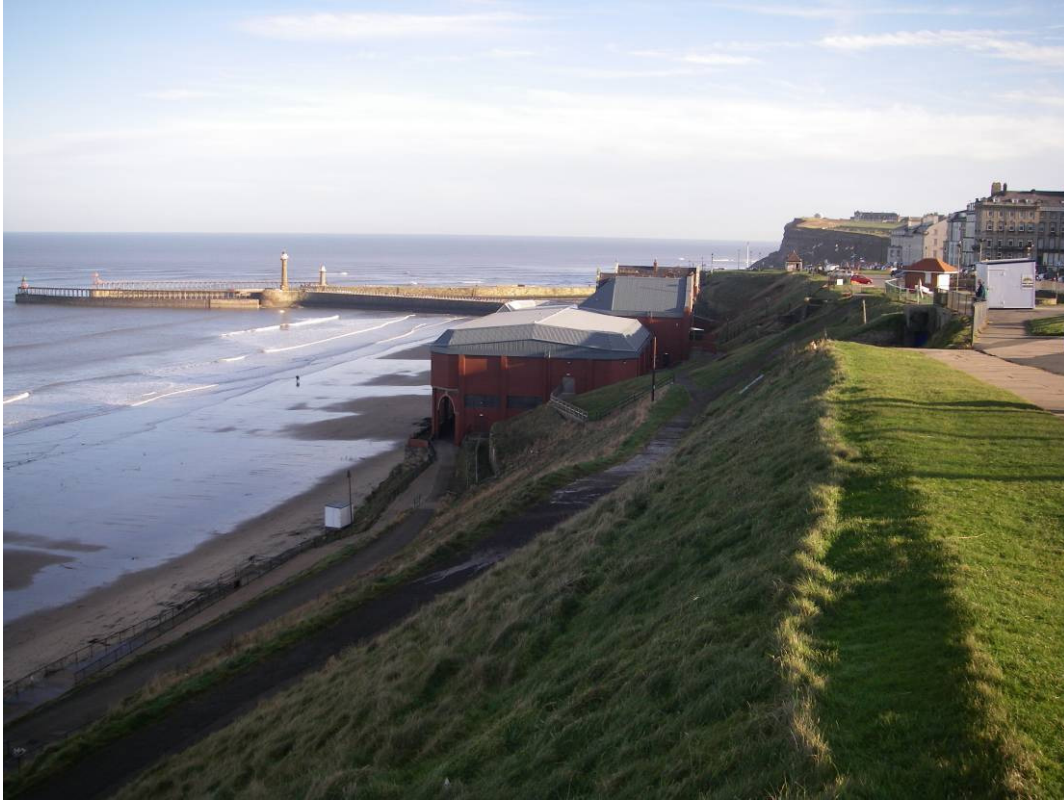
Plate 5 Site view looking east along West Cliff towards The Spa.

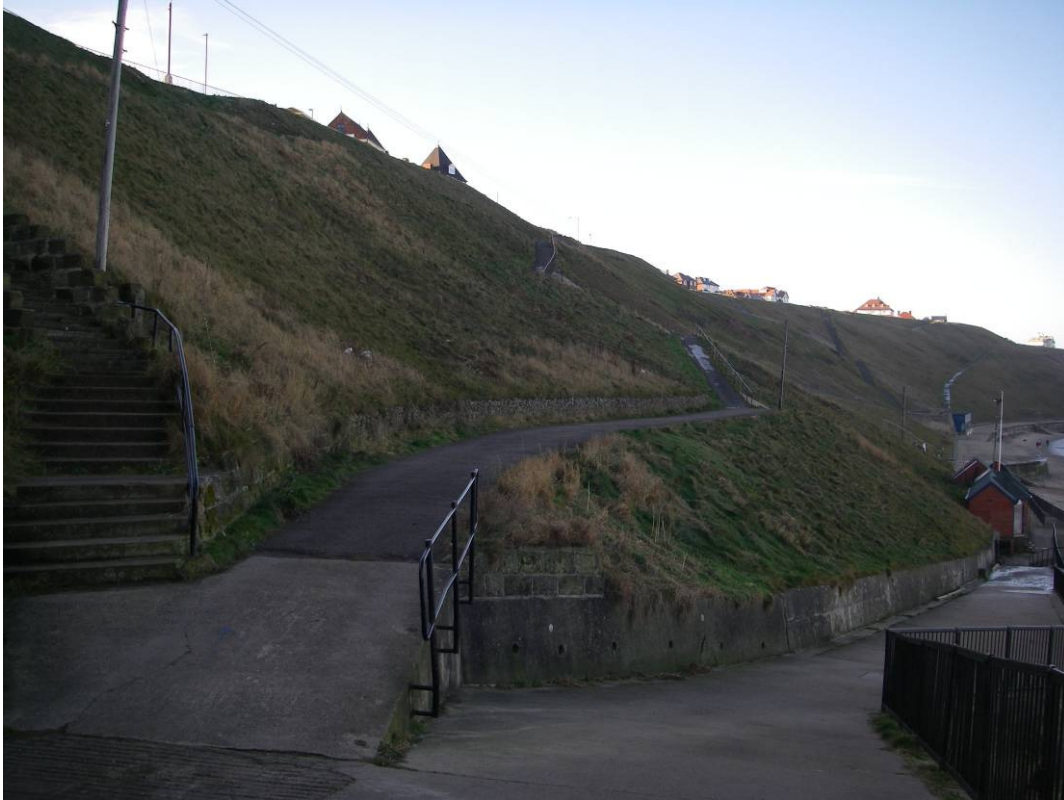
Plate 7 Site view of West Cliff slopes looking west.

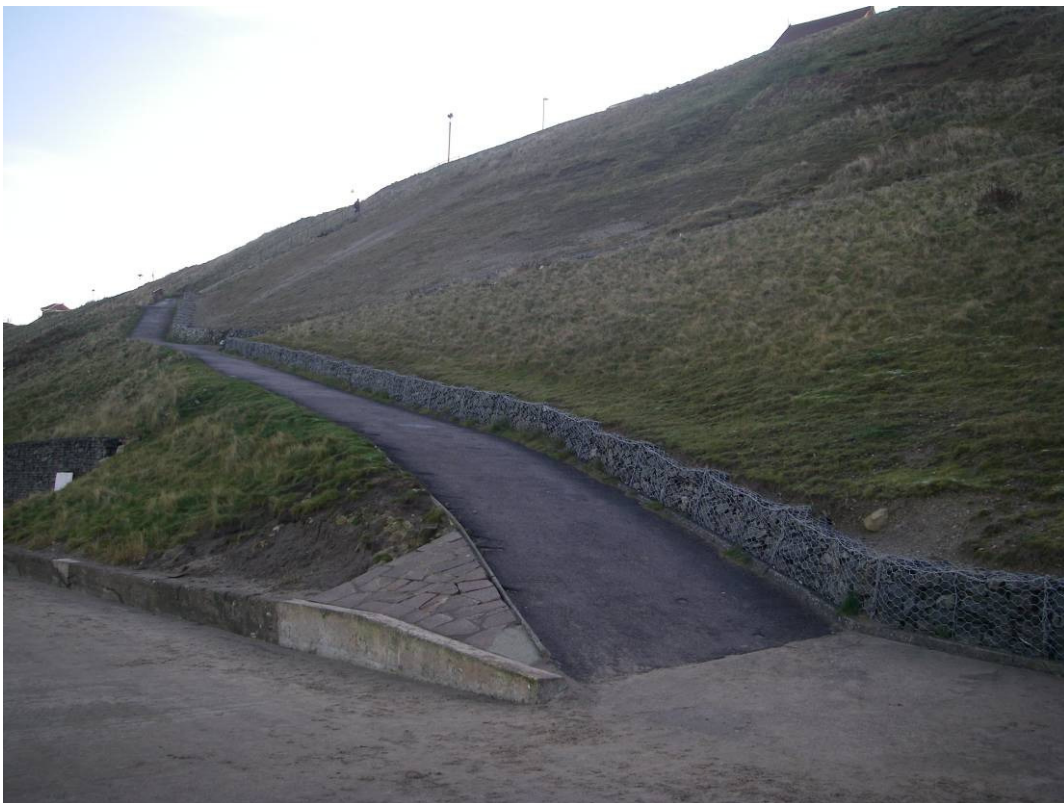
Plate 8 Site view of West Cliff slopes looking east.

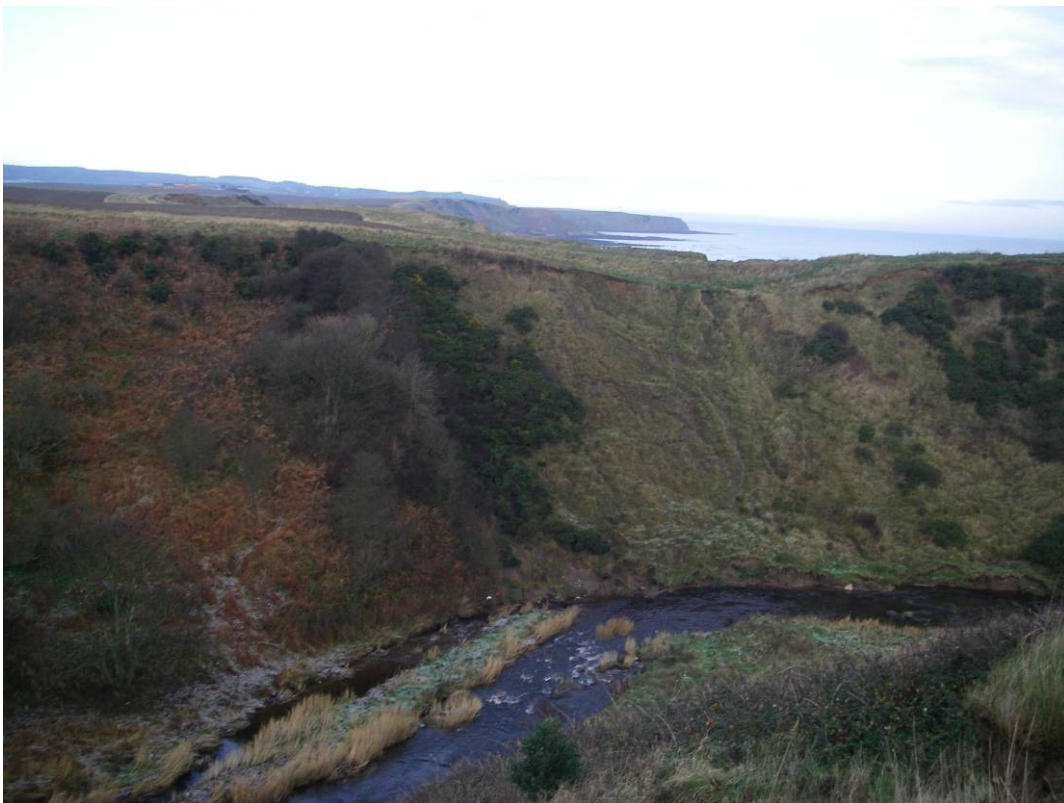
Plate 10 Site view looking north across Scalby Beck from the Upper Plateau.

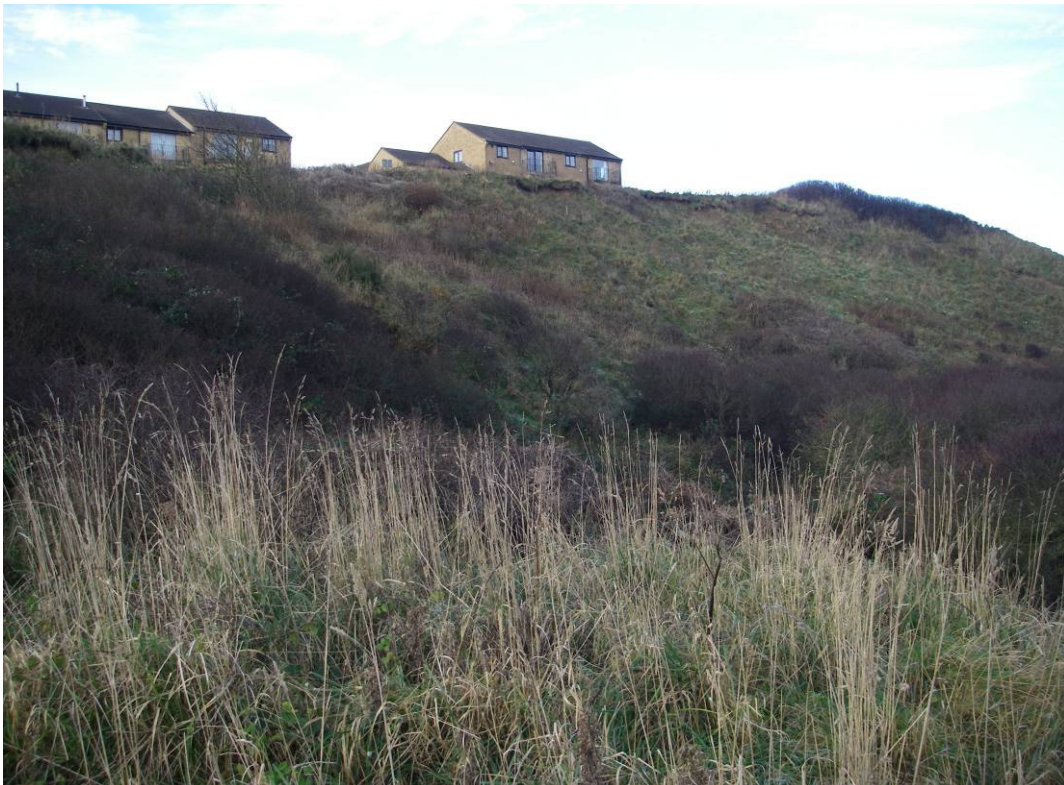
Plate 12 Site view of Behaviour Unit II showing over steepened back-scarp below Upper Plateau.

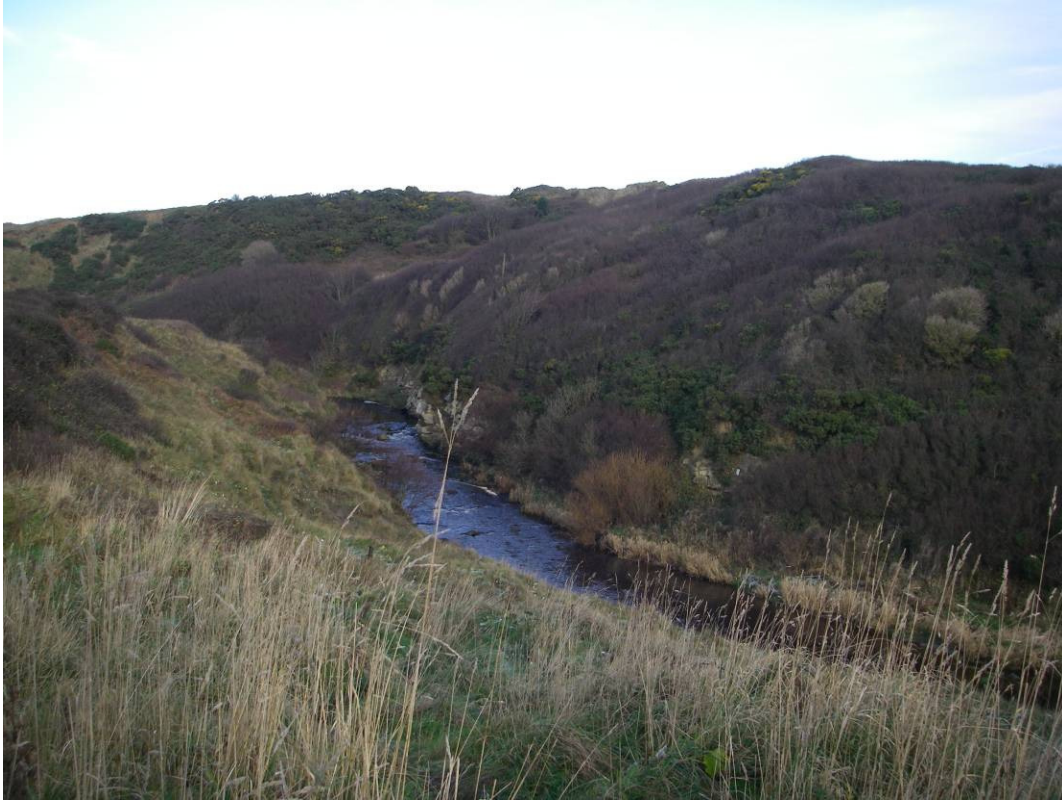
Plate 13 Site view looking north at Scalby Beck showing rock outcrops.

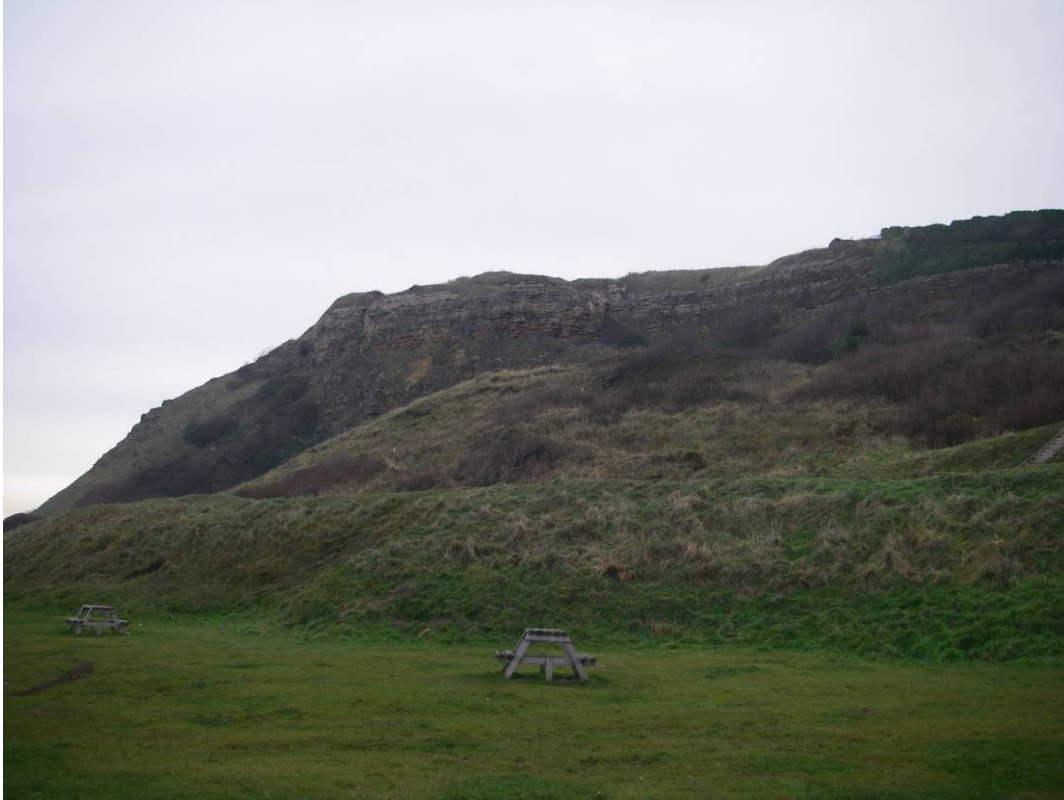
Plate 15 Site view of The Holms towards Castle Cliff.

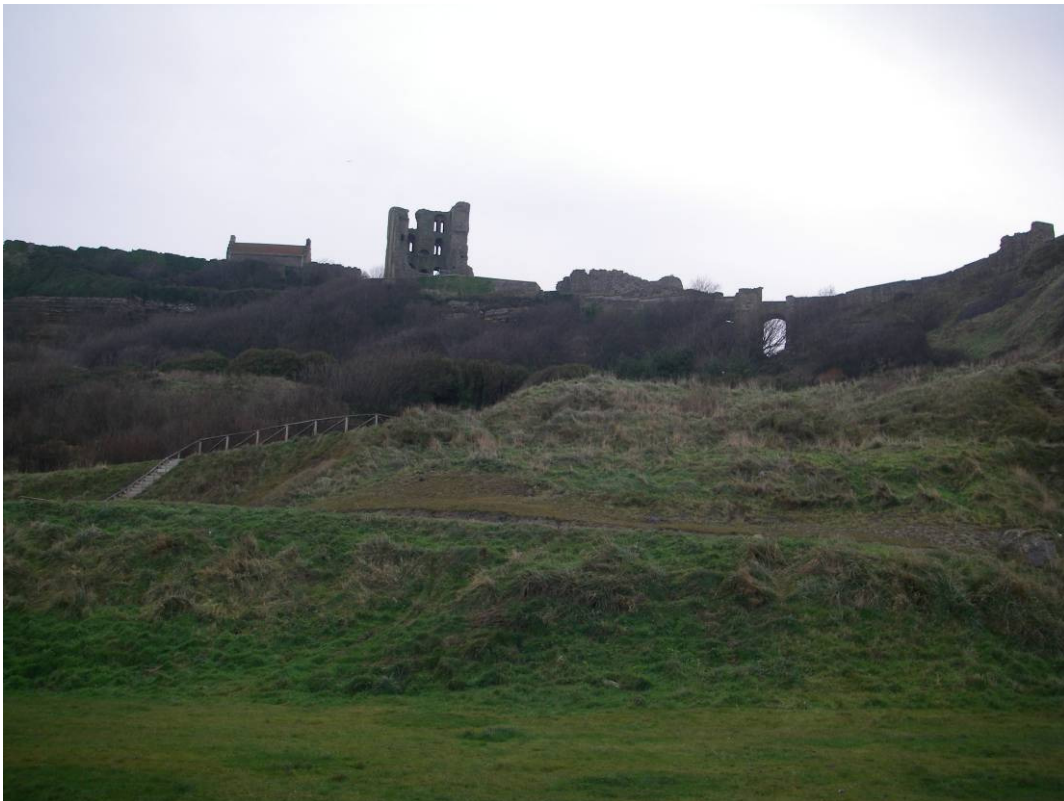
Plate 16 Site view of The Holms looking up towards Scarborough Castle.

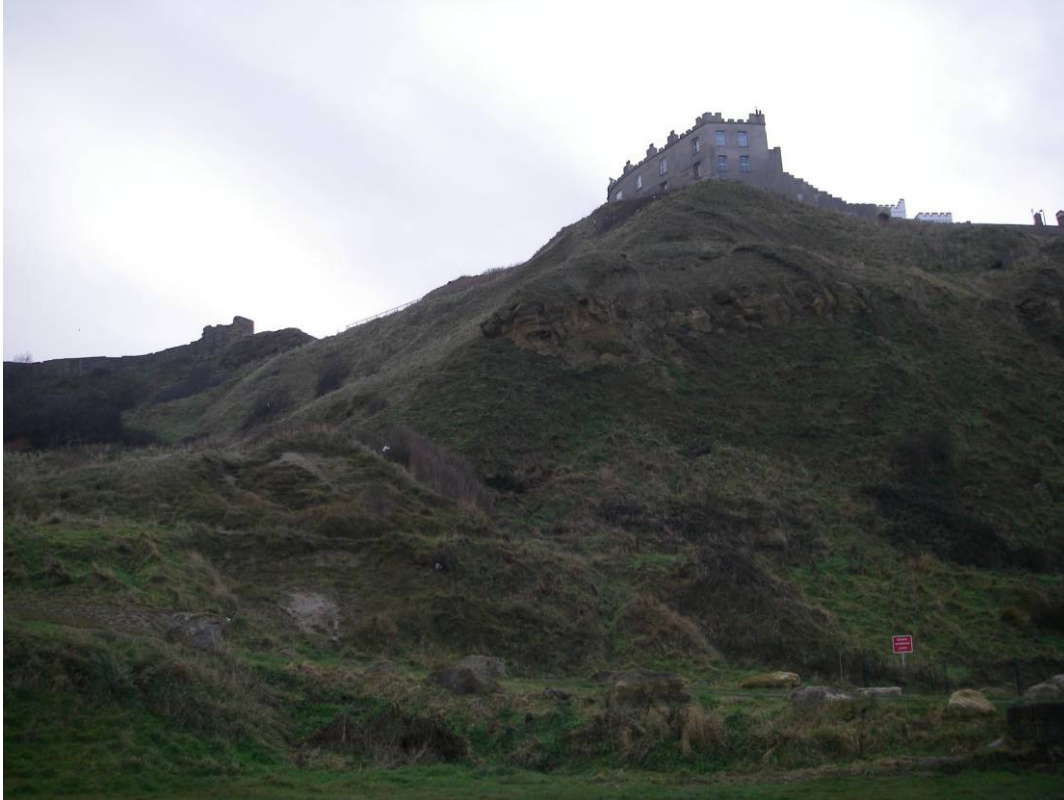
Plate 17 Site view of The Holms looking up towards Castle by The Sea.

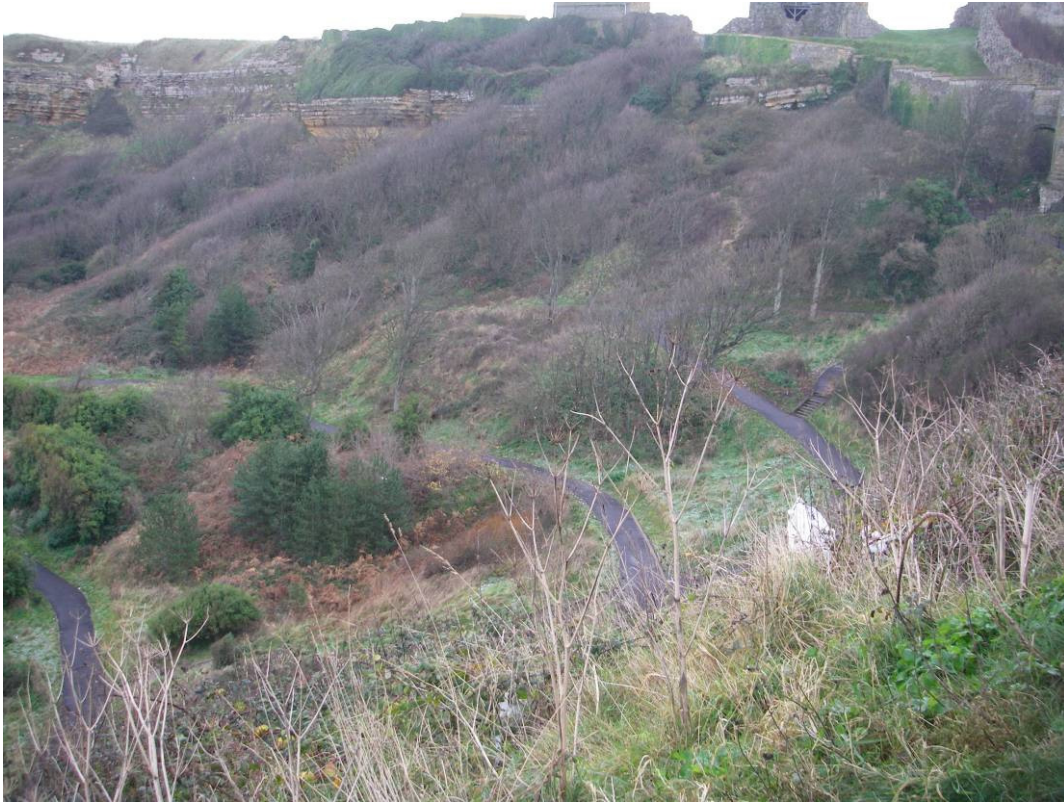
Plate 19 Site view of The Holms with Castle Cliff in the background.

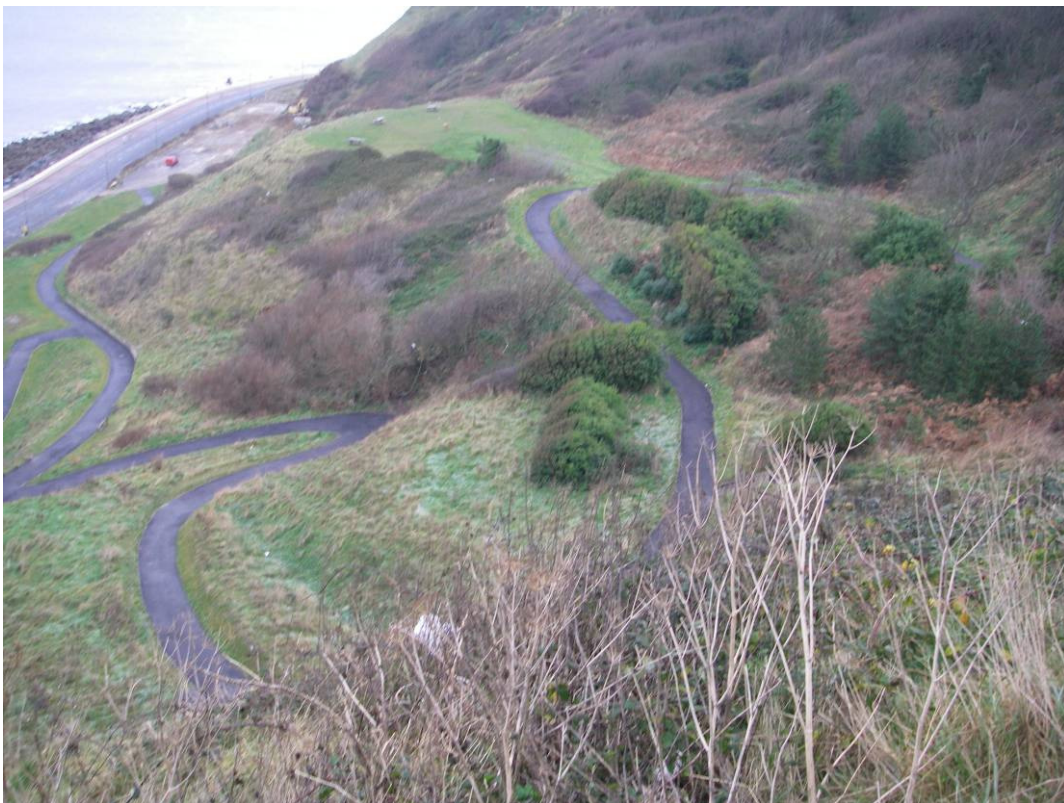
Plate 20 Site view of The Holms

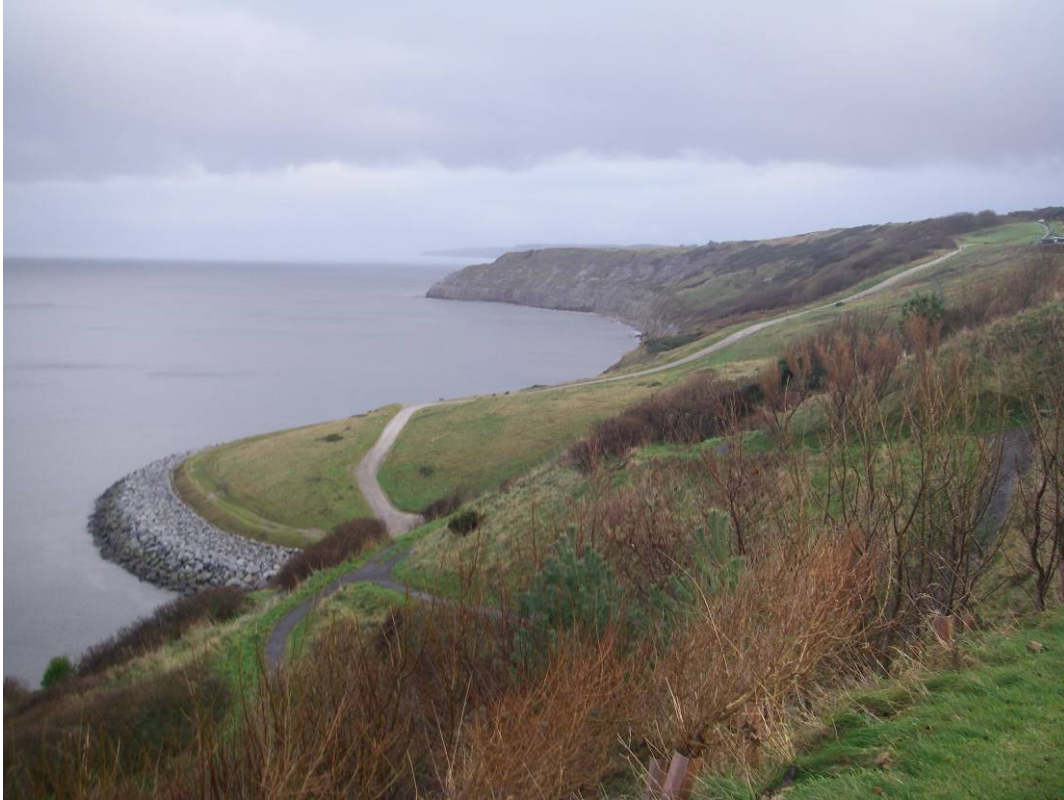
Plate 21 Site view looking south towards Holbeck Gardens and Holbeck Cliff.

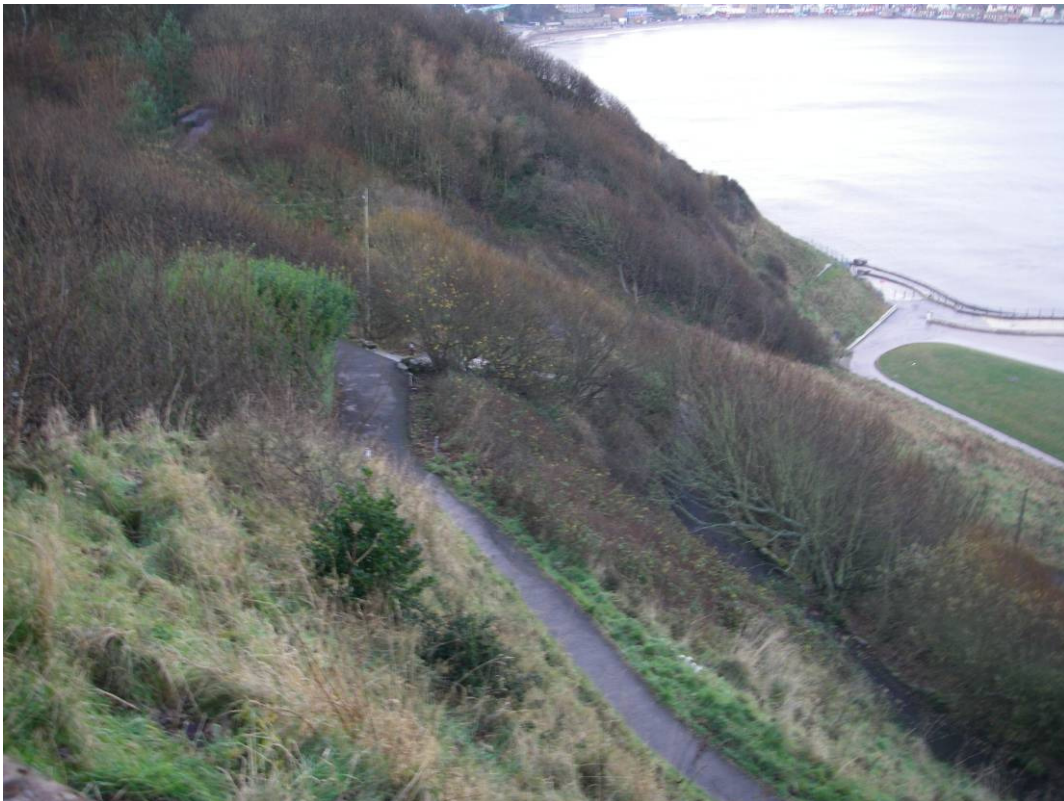
Plate 22 Site view showing steep slope angles above South Bay Pool Cliff.

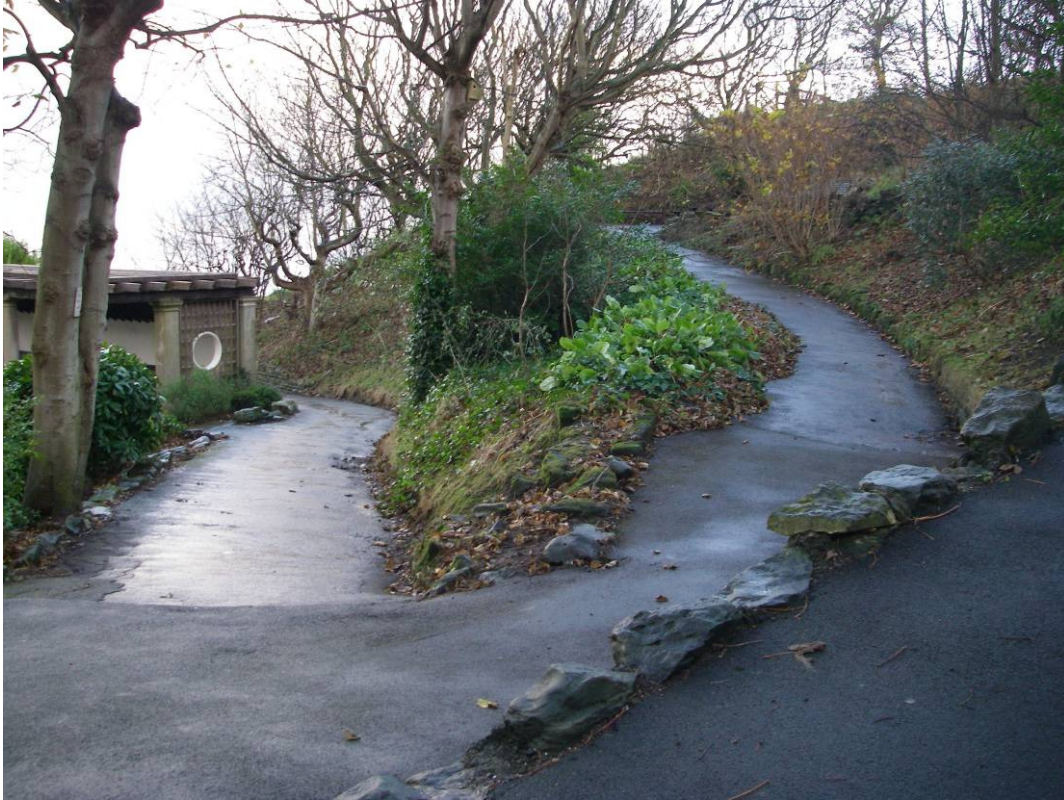
Plate 23 Site view of Italian Gardens showing bench-cut paths and slope angles.

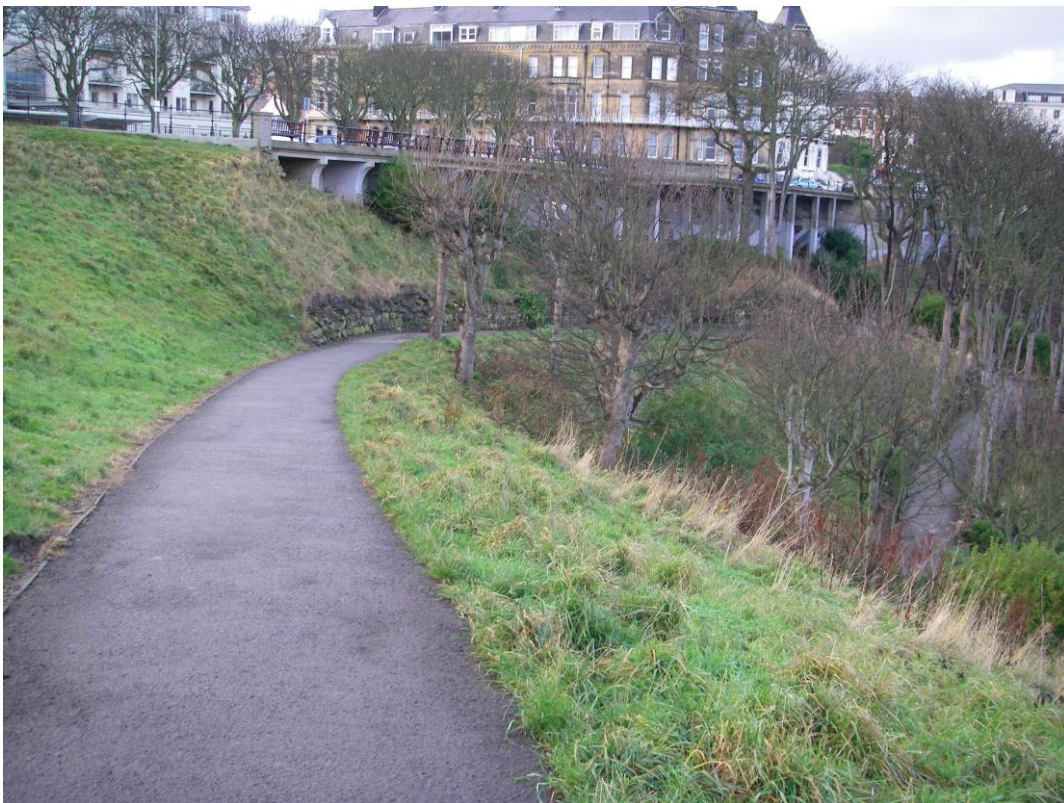
Plate 24 Site view looking north at arcuate embayment at South Cliff Gardens.

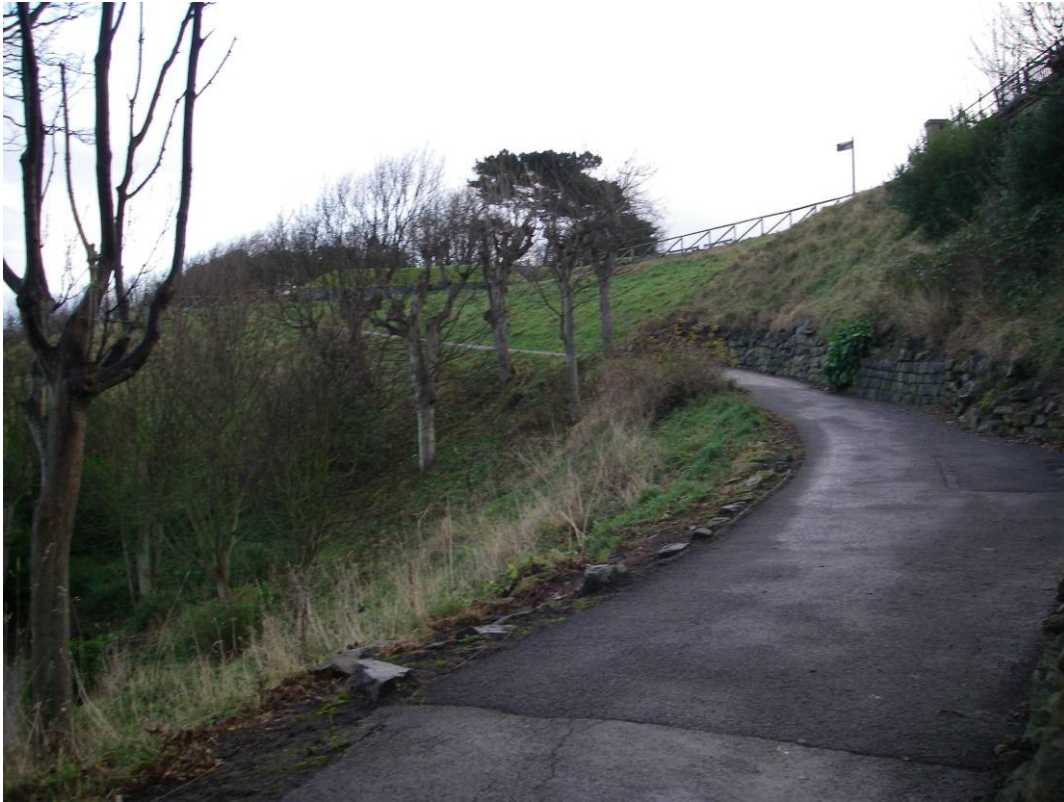
Plate 25 Site view looking south at arcuate embayment at South Cliff Gardens.

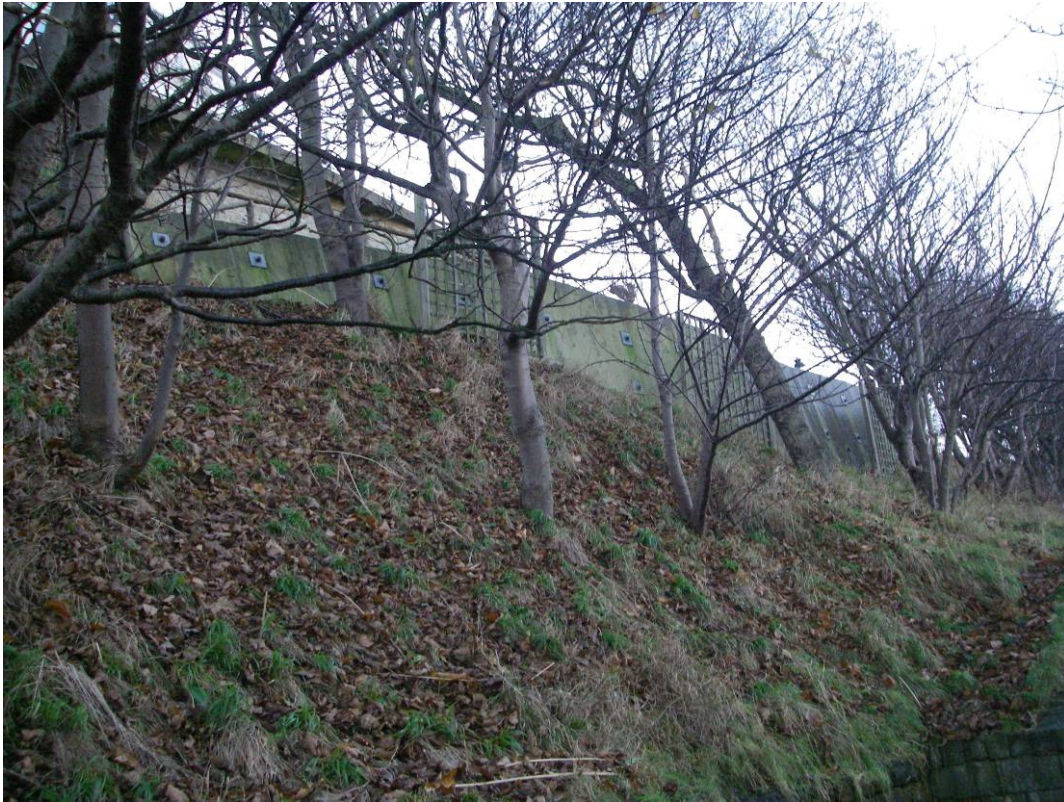
Plate 27 Site view of slope crest retaining walls at Prince of Wales Cliff.

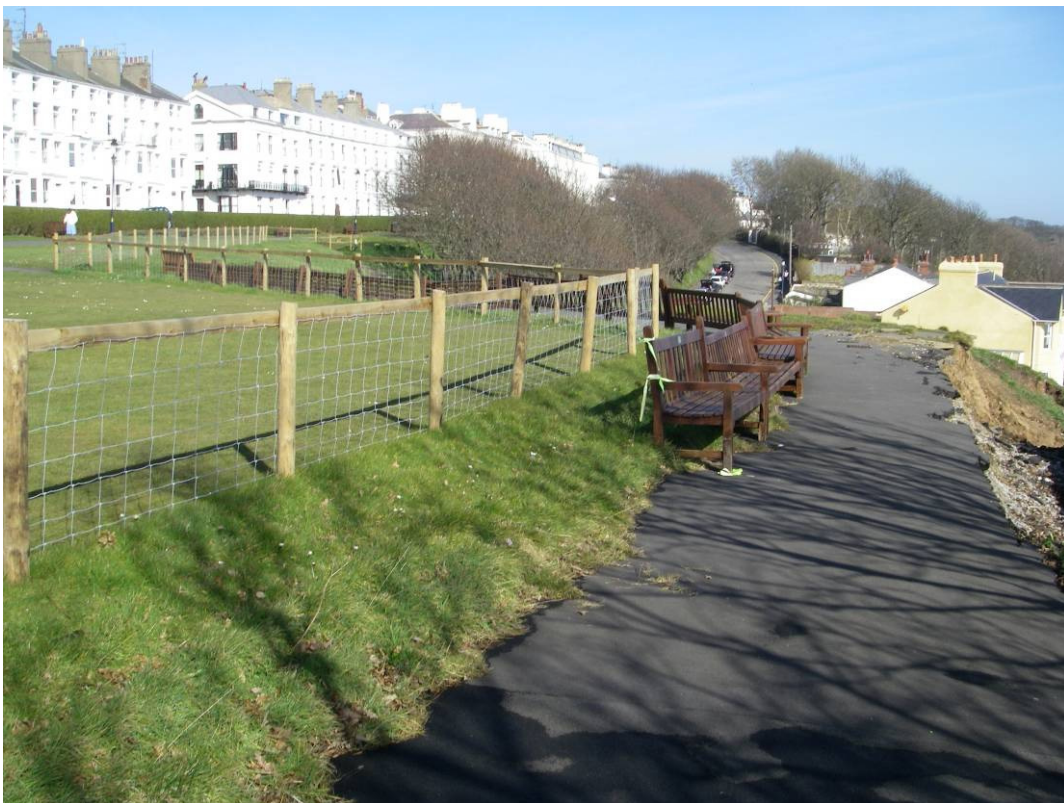
Plate 44 Site view looking north across Glen Gardens.

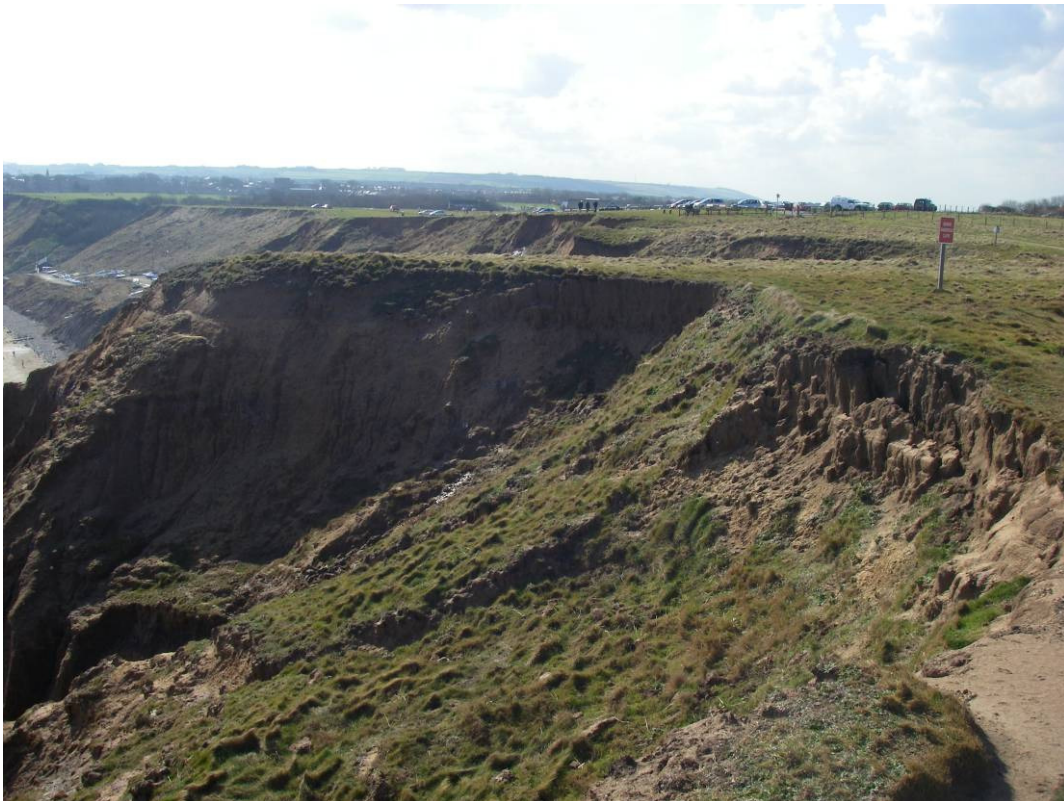
Plate 48 Site view of Filey Brigg looking west.

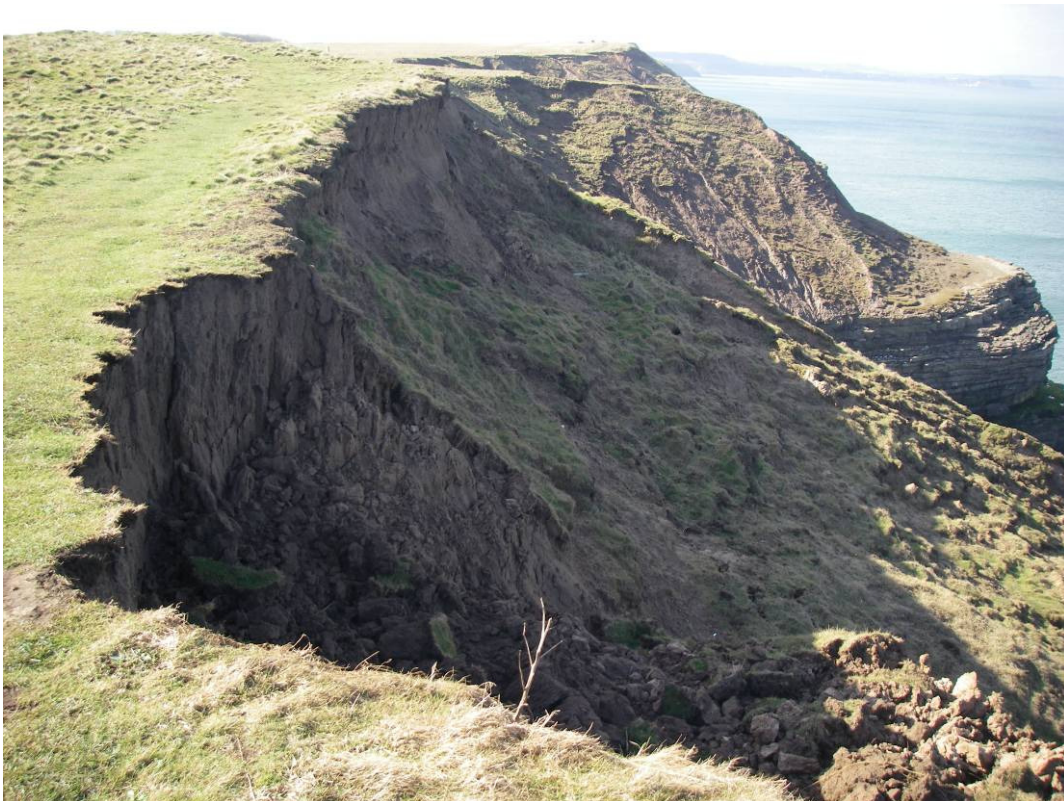
Plate 50 Site view looking east at slumped glacial tills at Filey Brigg.

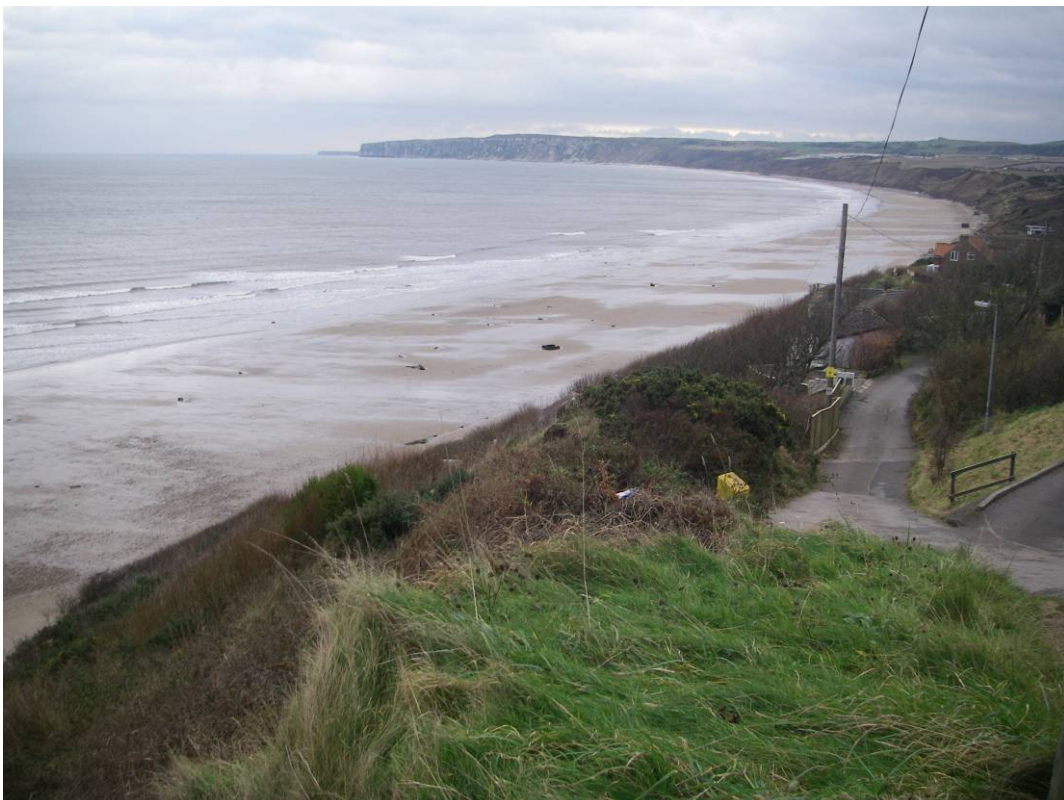
Plate 54 Site view looking south across Filey Bay towards Flamborough Head.
