Ongoing Analysis and Interpretation of Coastal Monitoring Data

Sixth Review of Restricted Suite Monitoring

Geotechnical Interpretative Report

Document Ref. No. 721229/002/GIR/009/Final

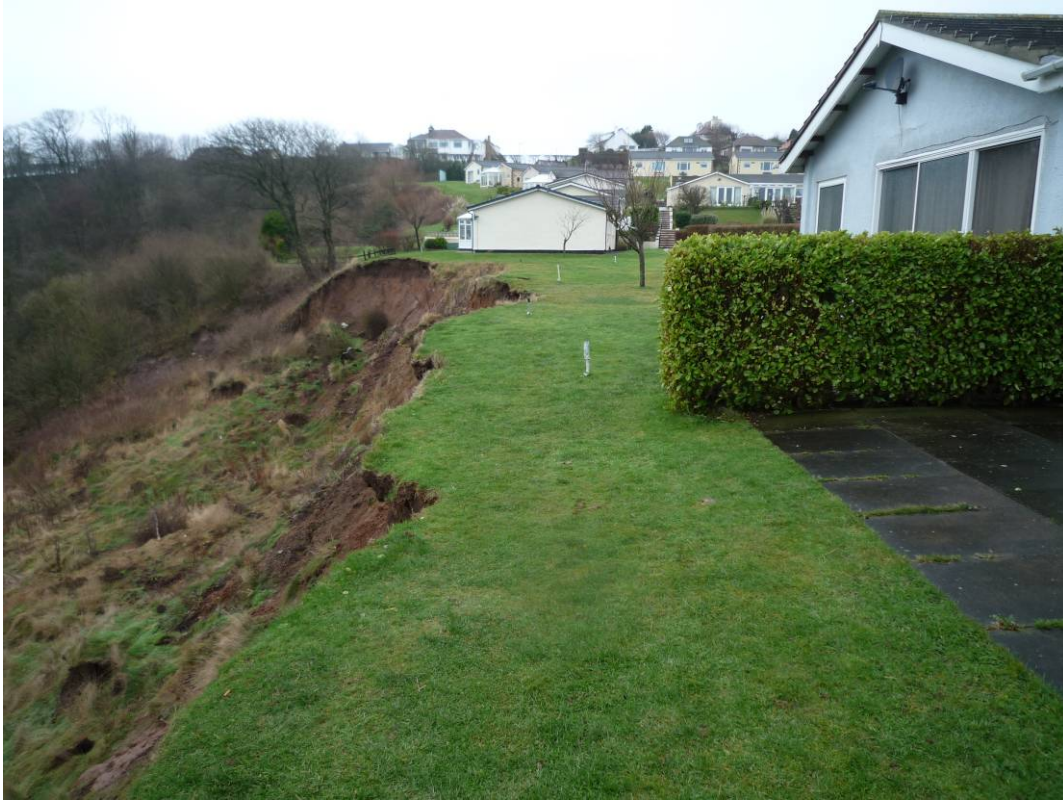
During the survey of April 2010 a 'fresh' mudslide was observed on the slopes of Knipe Point immediately below monitoring point H06I. The mudslide can be seen approximately 10 metres below ground level and extends some way down the slopes (Appendix H, Plate 6). Ground water seepages can be observed to be active from this point in the slope and are coincident with the mudslide.

Plate 6 View of 'fresh' mudslide on Knipe Point Headscarp below Property No. 18 (14th April 2010)

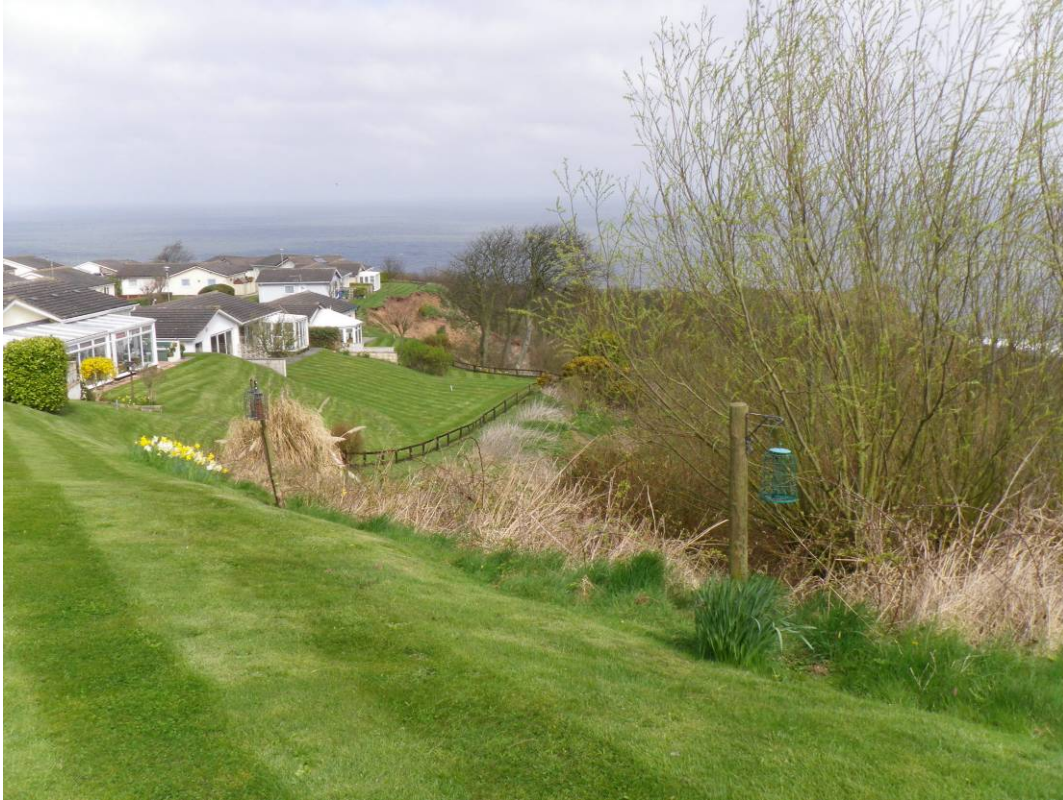
Plate 13 Cliff recession at Knipe Point Headscarp (14th April 2010) looking east

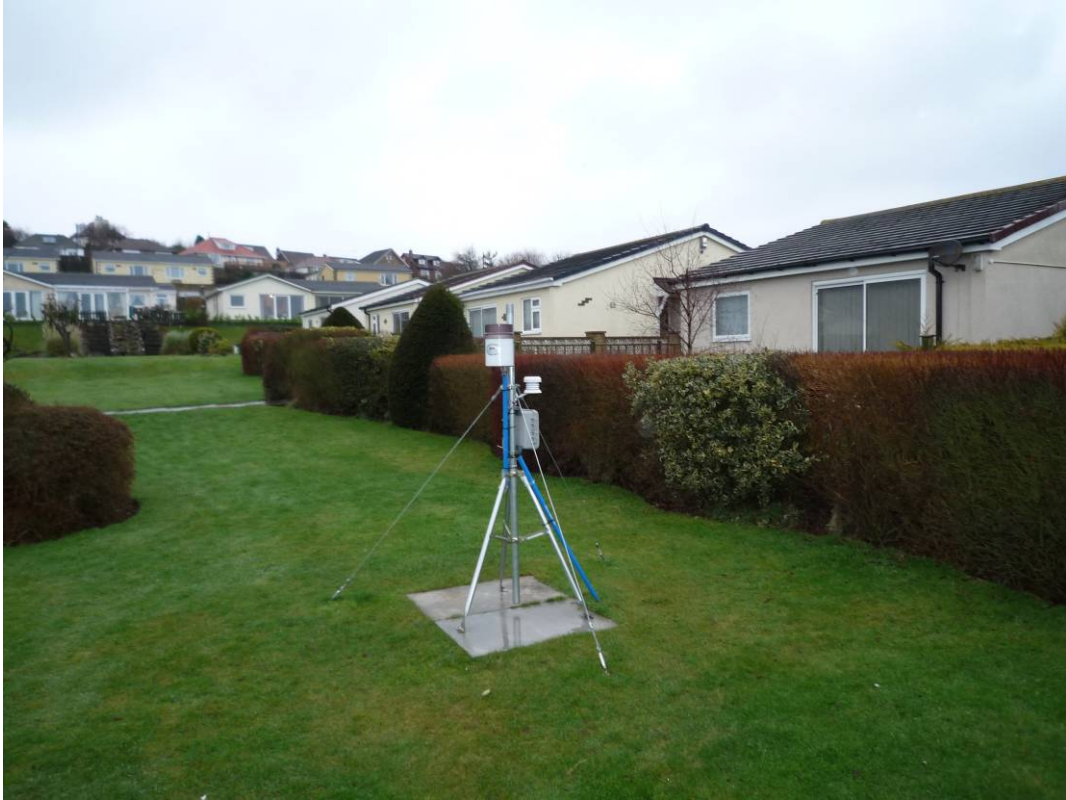
Continuous rainfall, air and ground temperatures are recorded on site by an automatic weather station located within the residential area of the site. Data from this is to be downloaded in April 2010 following a hand-over meeting with NT and SBC. A photograph of this equipment is presented in Appendix H, Plate 15.

Plate 15 Knipe Point Weather Station with Chalet No. 50 behind this.
